Ancient Monuments Laboratory
Report 42/97

WALL PAINTING CONDITION AUDIT,
WHARRAM PERCY CHURCH, NORTH
YORKSHIRE

J Davies
T Manning

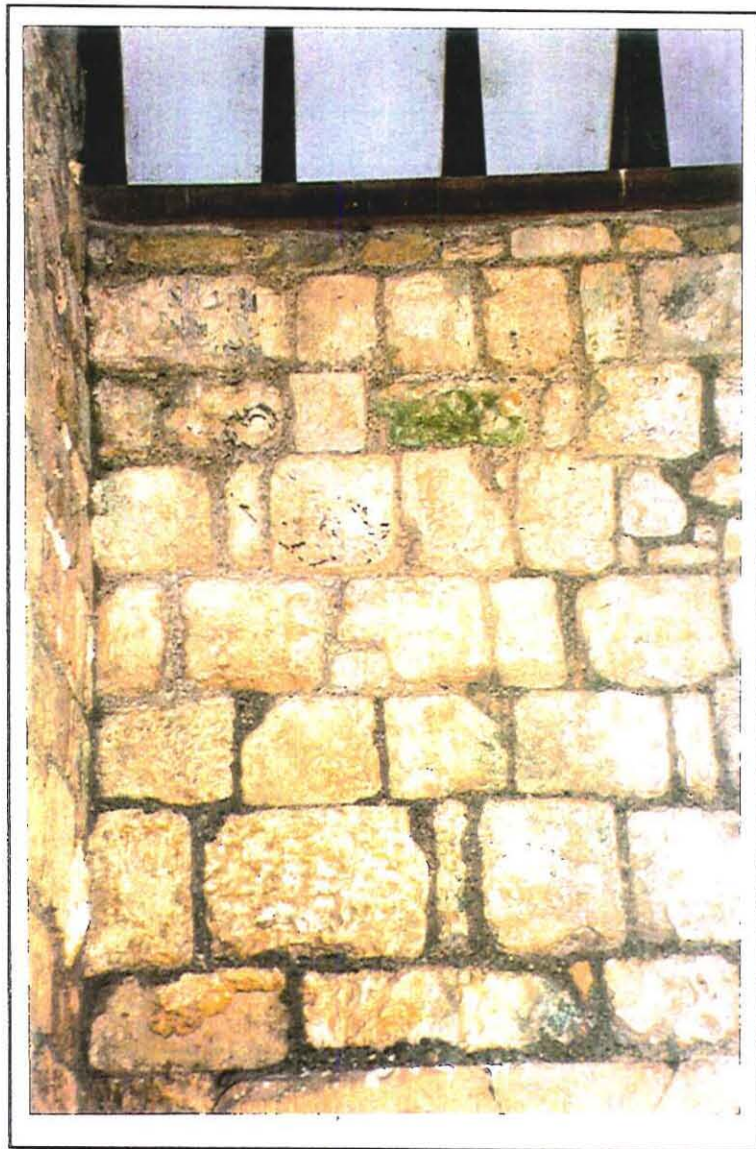
Fragments of black painted post-reformation text and border decoration are present on the upper central area of the north wall and on the upper eastern area of the south wall.

South wall, chancel, east end, traces of text and other decoration

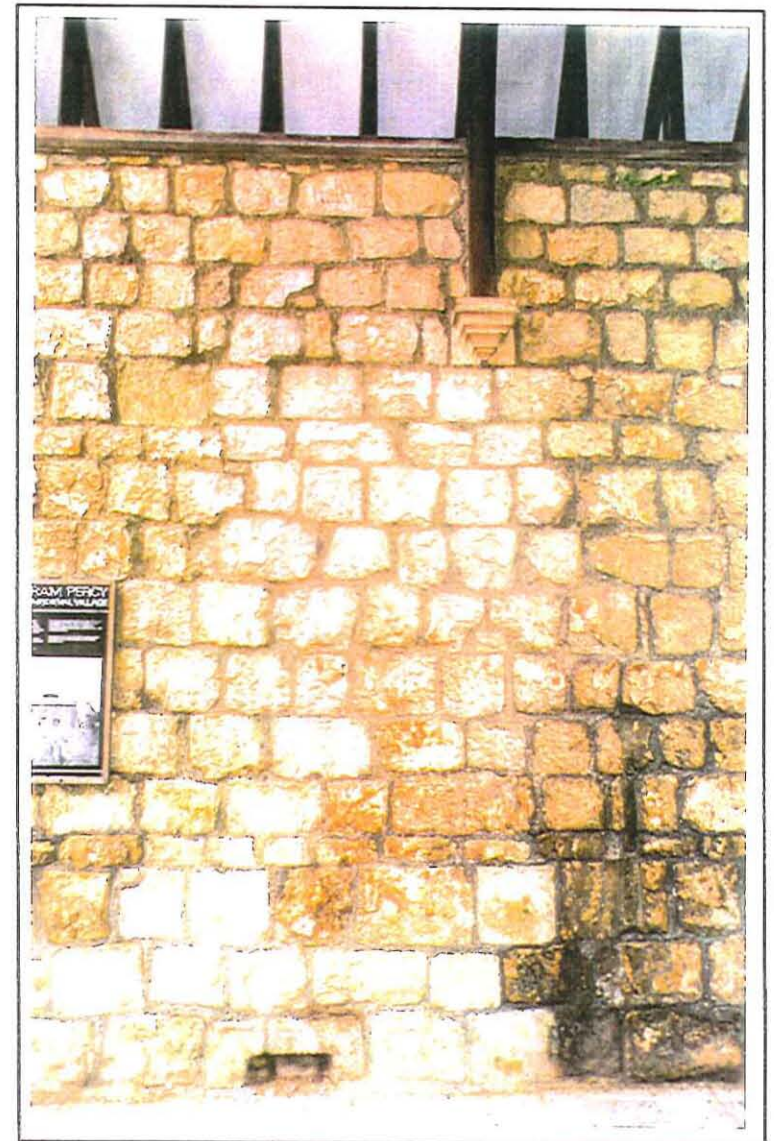
North wall, chancel, note painted inscription at top of wall
