# Rooswijk, Protected Wreck Site, Goodwin Sands Conservation of copper alloy artefacts from the Dutch East Indiaman the Rooswijk

Elisabeth Kuiper

Research Report Series 036-2018

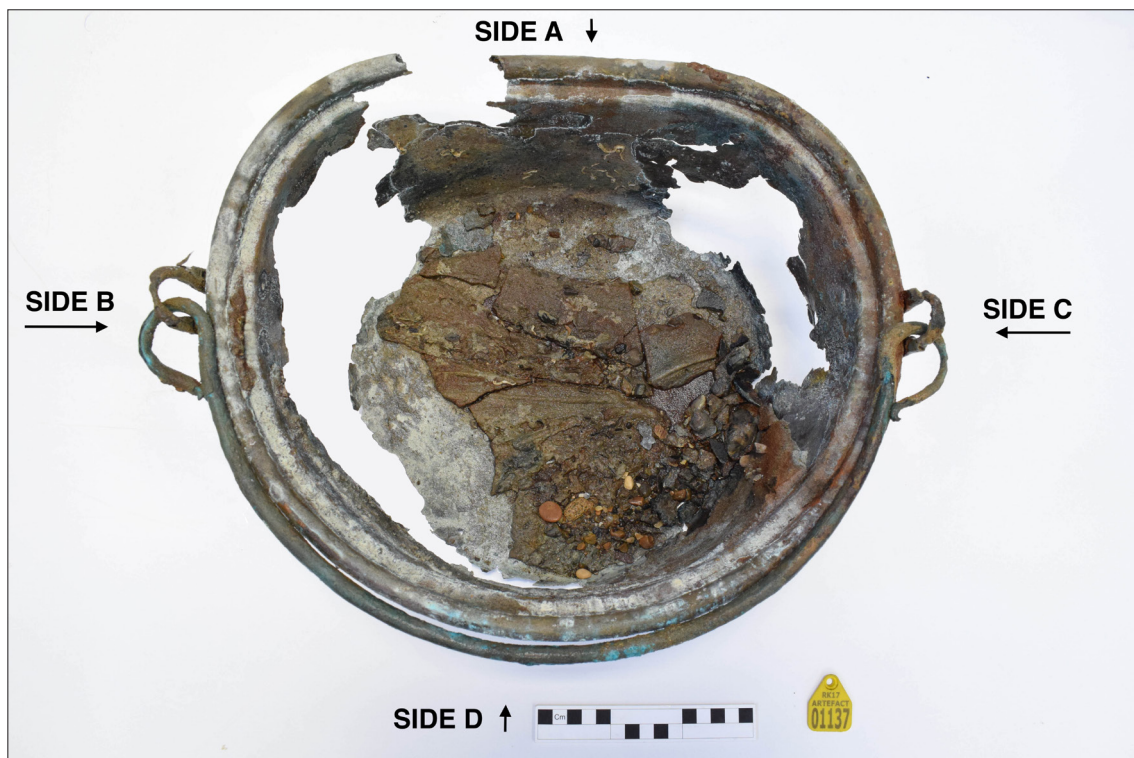
The cauldron is in a fragmentary and therefore fragile state (Fig 1-5). Cracks can be seen to run through the material and large parts of the object are missing. The rim, which seems otherwise complete, has broken. This part needs support in order to prevent further damage. The wall of the cauldron is very thin, about a millimetre thick. Pieces along the edges run a risk of breaking off during handling as small fractures run all along the edges and into the material.

In the bottom of the cauldron sediment is concreted to the surface (Fig 1). The sediment contains small pebbles and shells. Concreted iron corrosion is adhered to the surface on side C of the cauldron (Fig 4 and 5). The overall surface of the object is red brown with local light green staining. In some areas brighter green corrosion spots are visible, especially in small areas on the handle.

Fig 1: Top view of object RK17 A01137: before conservation; with viewpoints for subsequent object photos.

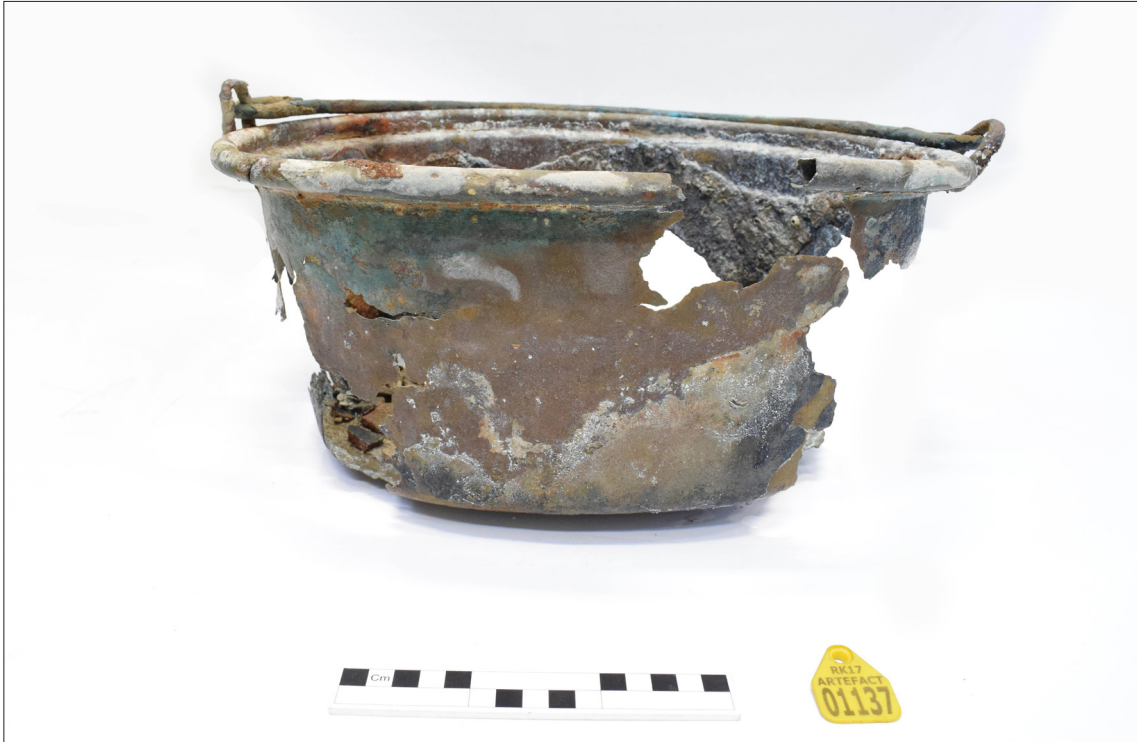
Fig 2: View from side A of object RK17 A01137: before conservation.

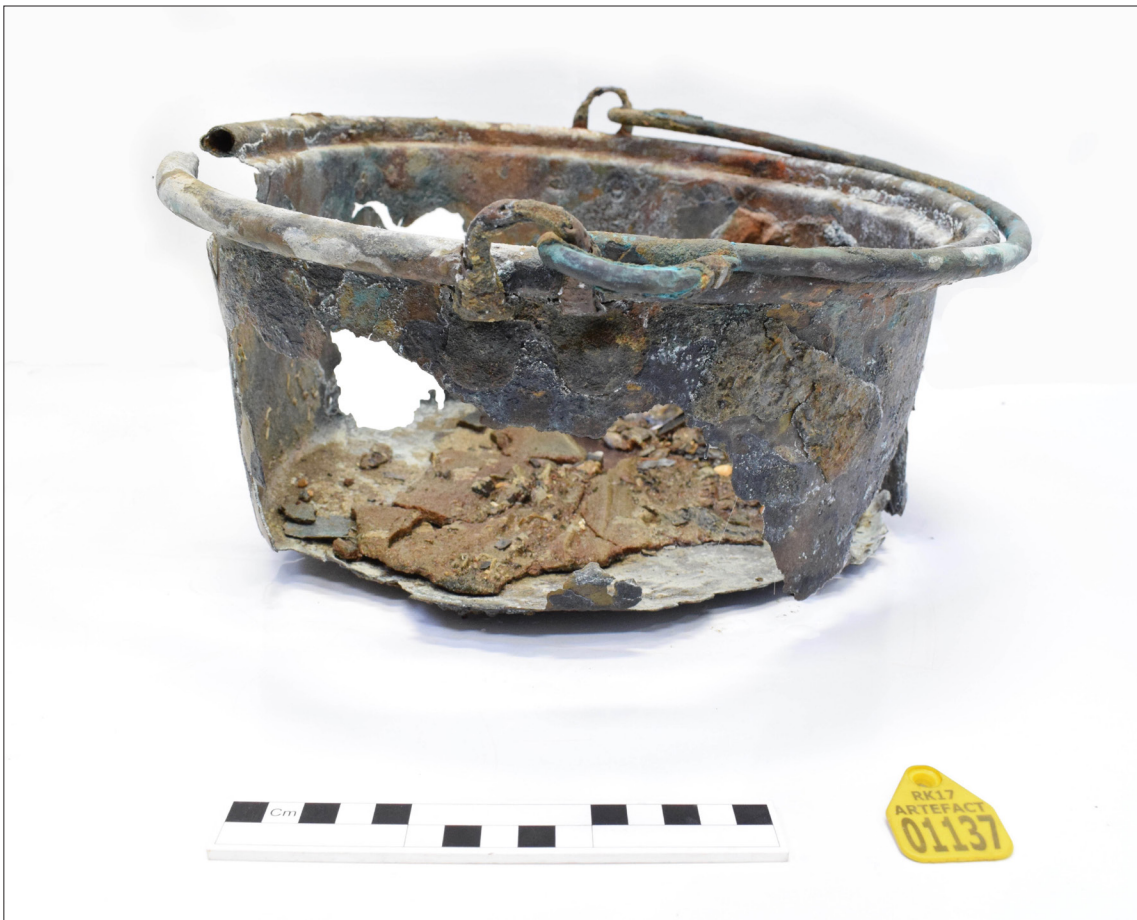
Fig 3: View from side B of object RK17 A01137: before conservation.

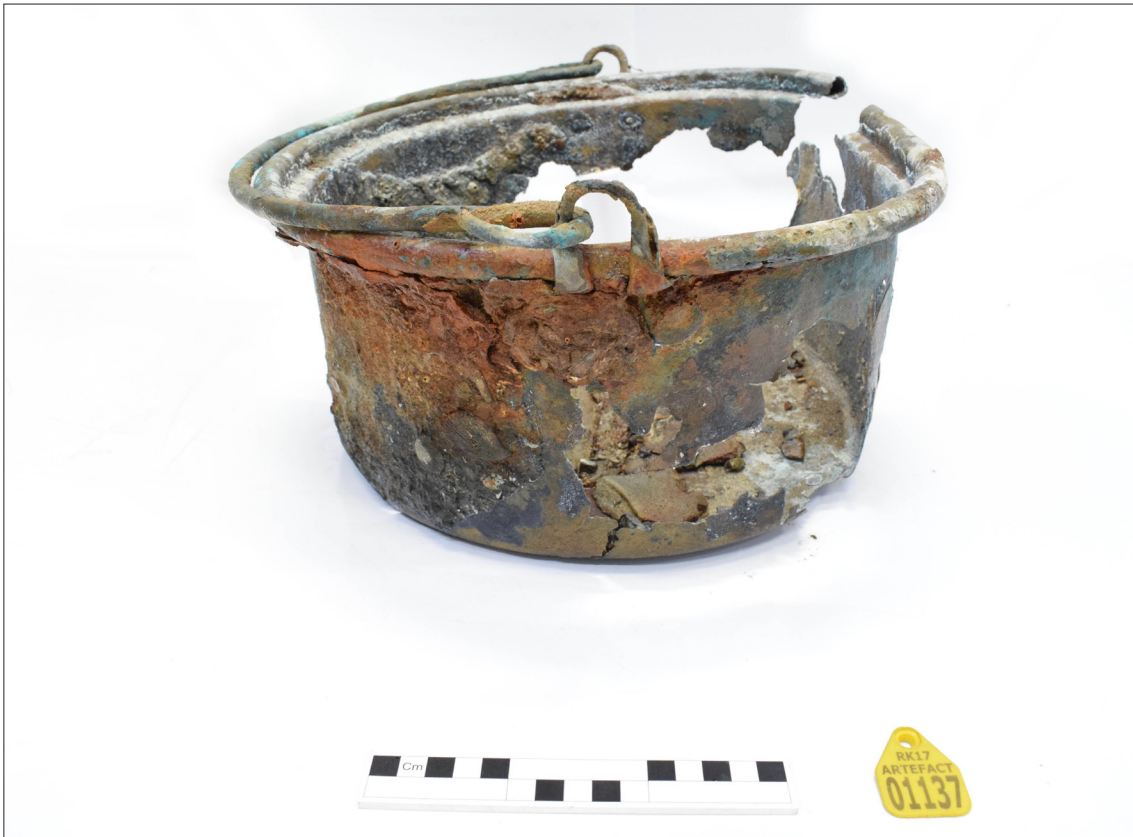
Fig 4: View from side C of object RK17 A01137: before conservation.

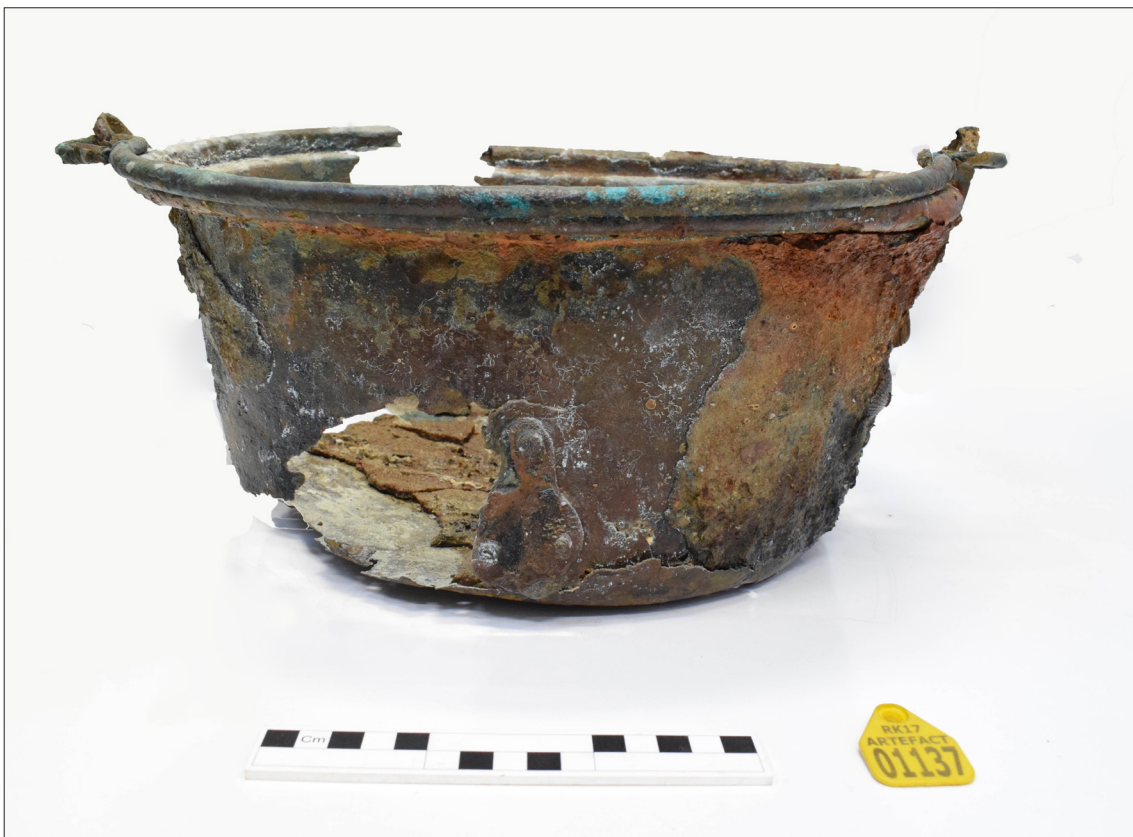
The cauldron consists of a basin completed with a round rim. Lugs are attached on opposite sides, which hold a handle in place (Fig 1). On the lower face of side D a separate riveted feature is clearly visible (Fig 5). This could have served as a reinforcement to attach a leg, making this cauldron a three legged cooking pot.

Fig 5: View from side D of object RK17 A01137: before conservation.

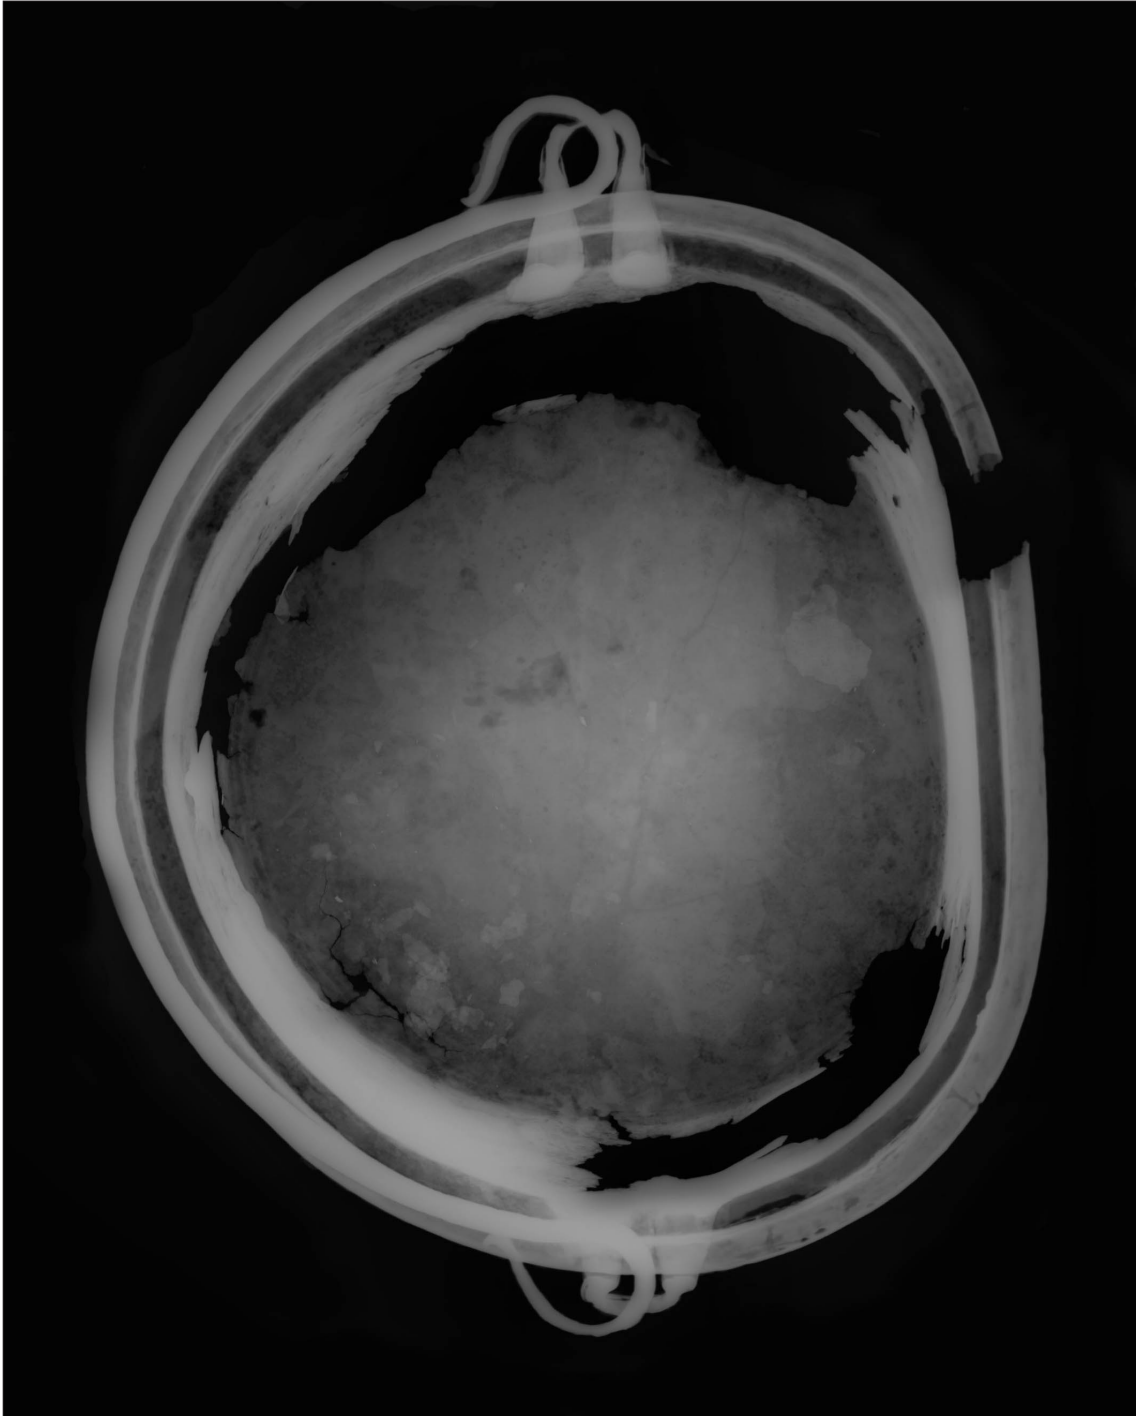
Fig 6: X-radiograph showing top view of the object RK17 A01137 (P4476-4479, kV: 100, mA: 3, exposure time in sec.: 1.5).

The entire object was studied by X-radiography in order to create a record of the current state of preservation and to see if any unusual or otherwise invisible features could be found (Fig 6). The object was studied both from above and from the sides.

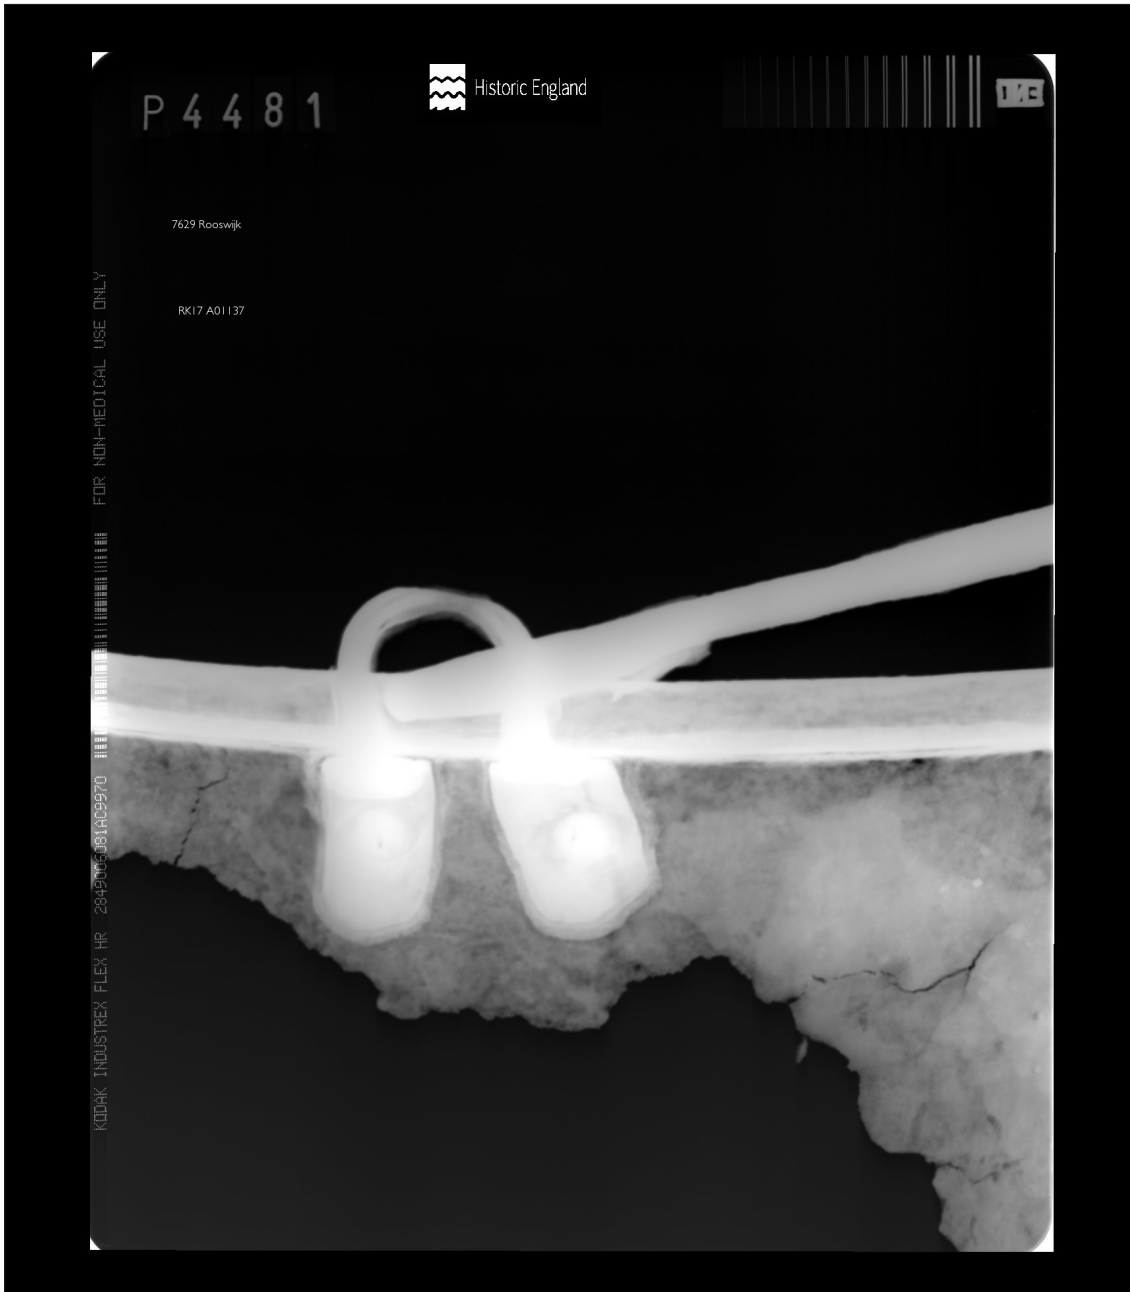
No maker's mark or hammer marks were found in the material. Fractures could be seen to run into the metal at various points (Fig 7). In particular, the joints of the riveted feature and the metal loop were investigated (Fig 7 and 8). It is clear that the lugs, as well the reinforcement plate, are riveted to the cauldron wall.

Fig 8: X-radiograph showing loop and handle of object RK17 A01137 (P4481, kV: 100, mA: 3, exposure time in sec.: 2.5).

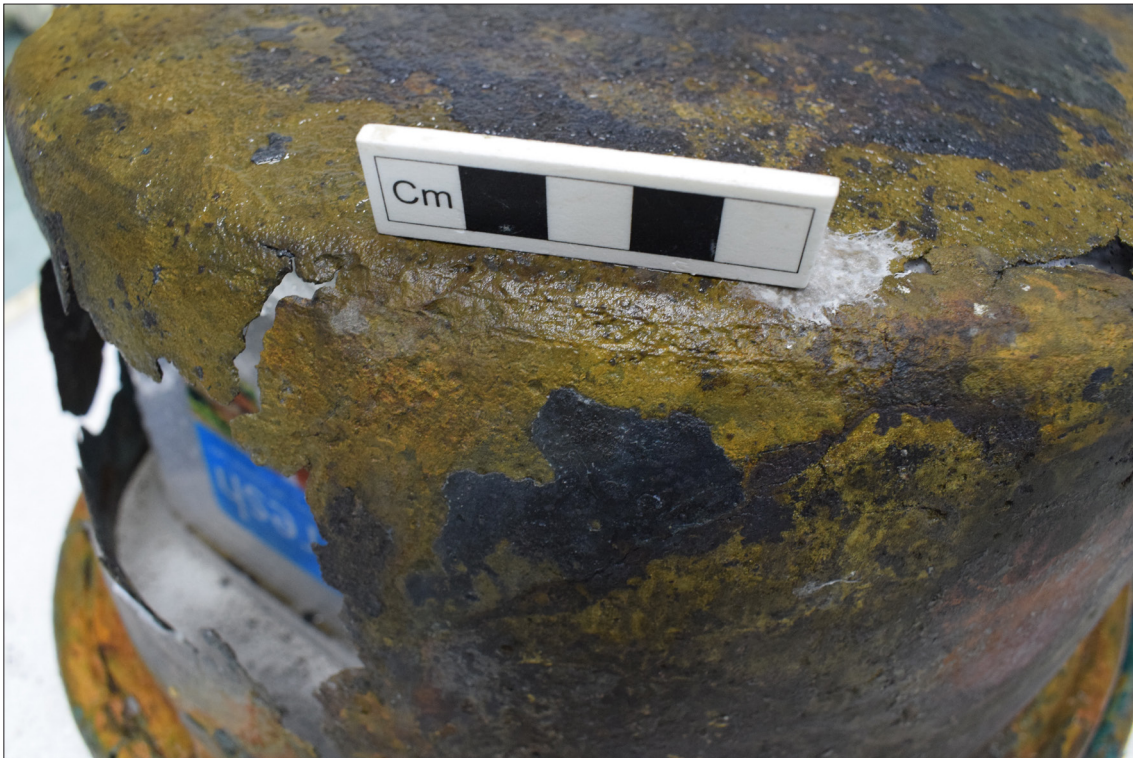
Fig 9: Incision lines on the outer surface of the cauldron.

During cleaning of the object a feature was revealed: two small incision lines were found to run along the external wall of the cauldron (Fig 9). Possibly these were decorative or created during the manufacturing process; as the lines are located on the edge of the wall. They might have been used as an indication for the metalworker on the placement of the wall of the cauldron.

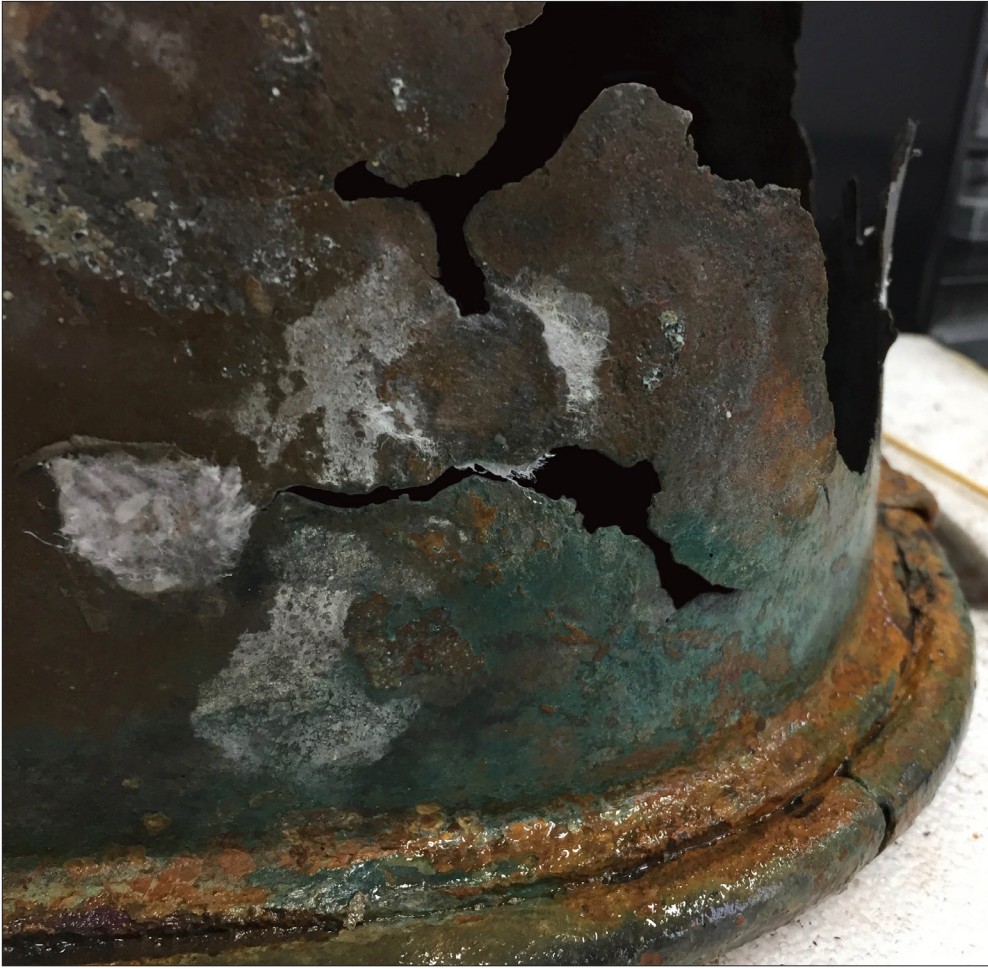
Fig 10: Object RK17 A01137 during conservation with two areas where Japanese tissue paper was applied.

Some areas, with long cracks and minimally adhered fragments required consolidation. These areas were dried temporarily with acetone. Subsequently, a layer of Japanese tissue paper soaked in Paraloid B72 in acetone was applied over the fractures. In total thirteen places were reinforced in this manner. The X-radiographs were used to locate fractures and insecure areas as seen in Figs 10 and 11.

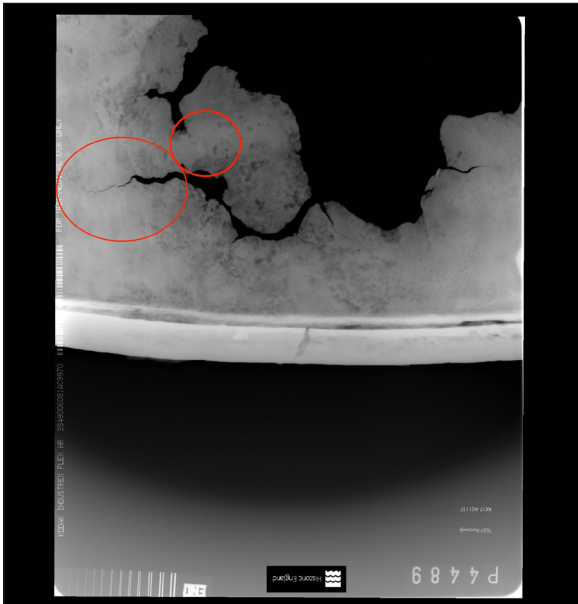
Fig 11: X-radiograph showing fractures running into material of object RK17 A01137 (P4489, kV: 100, mA: 3.5, exposure time in sec.: 2.5); red circles showing areas where Japanese tissue paper was applied.

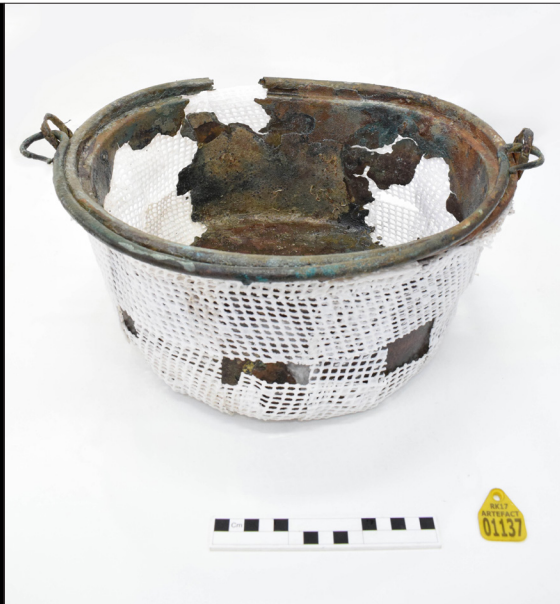
Fig 12: Object RK17 A01137 during conservation with external X-Lite support in place.

A support cradle for the entire cauldron was made out of X-Lite Classic sheets (Fig 12). This material consists of natural mesh cotton fabric impregnated by an aliphatic polyester (polycaprolactone) based polymeric solution. These solid, white, flat sheets are insoluble in water and transition from a rigid, solid state to a soft rubber-like material at a temperature of ca. 50°C. When heated, the sheets can be formed onto a pre-existing shape; they set when cooled down and retain this form. This process was carried out on the cauldron with a layer of tin foil in between the object and the sheets to prevent the soft material from adhering to the surface of the object.

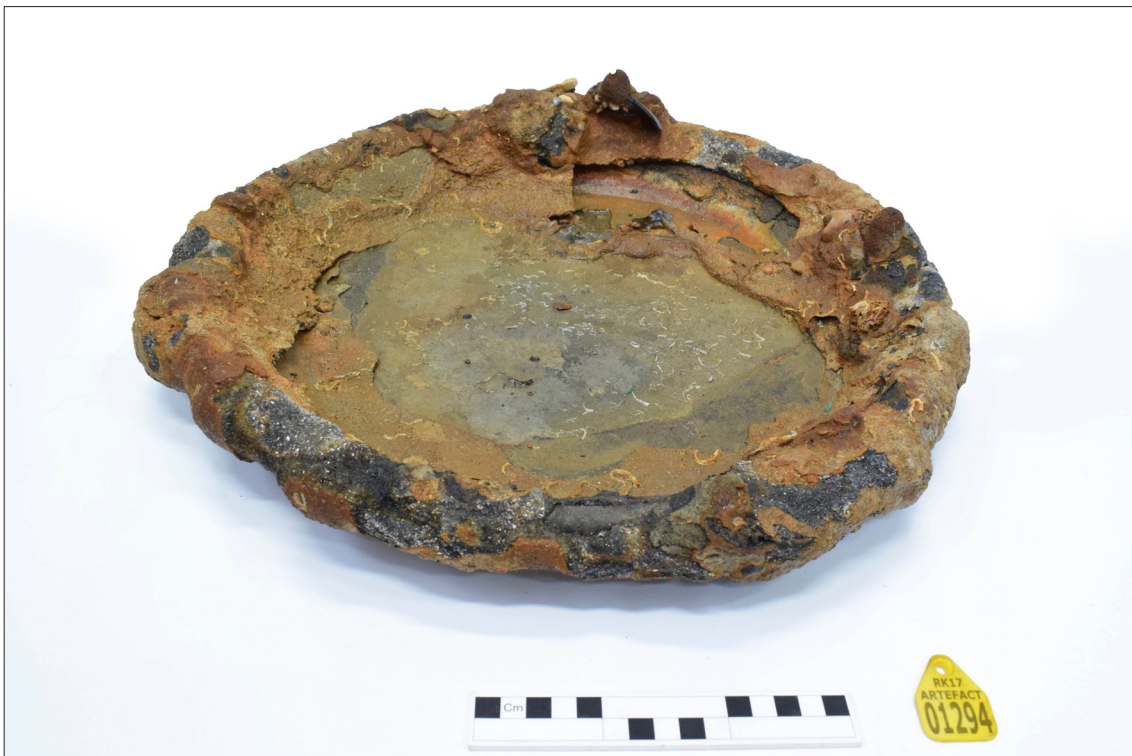
Object RK17 A01294 is a heavily concreted artefact with pieces of glass, shells and stones encapsulated in the concretion layers. The general shape of the object is round, but the encrusted corrosion layers concealed its true shape. In one area on the rim the object could be made out, demonstrating the thick corrosion crust (see lower left hand corner in Fig 13).

The colour and composition of the thick concretion layer suggested it mainly consisted of iron corrosion. The origin of the iron corrosion is at this stage unknown. The artefact itself was assumed to consist of a copper alloy.

Fig 13: Object RK17 A01294 before conservation.

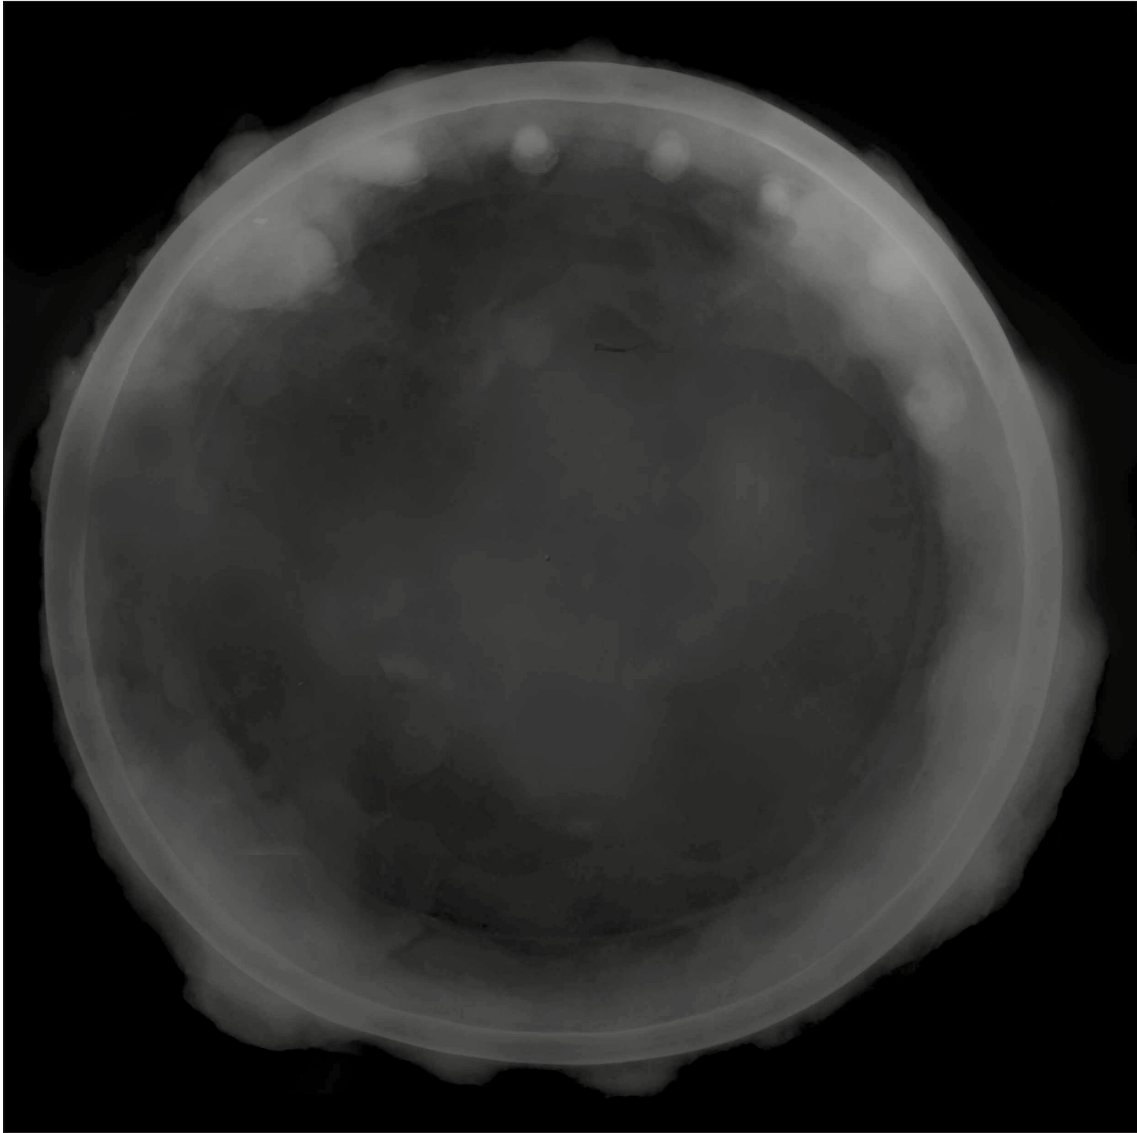
The object was studied by X-radiography. No fractures in the material or maker's marks were discovered. The metal appeared solid but covered by a layer of concreted iron corrosion. At four successive places small, round features showed in the X-radiograph. These were thought to relate to construction and likely to be rivets.

Fig 14: X-radiograph showing top view of the object RK17 A01294 (P4466-4469, kV: 210, mA: 5, exposure time in sec.: 3); possible riveting visible as denser spots on upper side image.

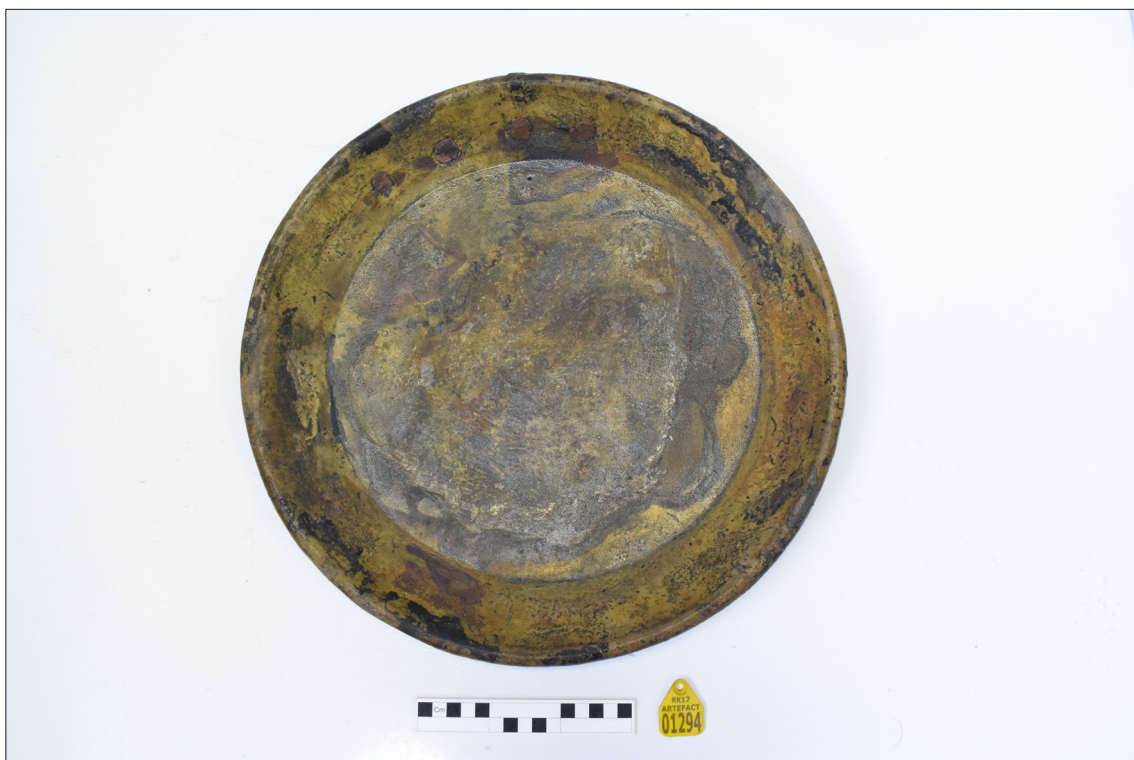
The material composition of the pan was studied using pXRF in four different areas following cleaning (Fig 15 and 16. The copper alloy of the pan itself was analysed on two different places: on the base of the pan and on the rim. The analysis gave a clear result showing a copper alloy of approximately 66wt% Cu, 27wt% Zn, 2.3wt% Pb with traces of As and Ni. This composition is commonly referred to as brass. The rivets, as will be shown next, were on the other hand made from copper.

Fig 15: Top view obverse side of object RK17 A01294 after corrosion removal.

Corrosion layers and sediment were cleaned from the surface of the dish using a pneumatic air-scribe. The main corrosion products on the surface of the object seemed to be concreted iron corrosion together with sediment. Although the origin of the iron corrosion product could not be determined it was clear that the original surface lay underneath. In one area the surface of the object could be seen underneath the corrosion layer and this was used to guide the cleaning of the object. The external markers like stones and shells confirmed this. The features that were seen earlier on the X-radiograph were found to be copper rivets (see above). On the inside of the pan the rivets are flattened, but on the outside they protrude from the surface of the object (Fig 17 and 18). The square rivets stick out about 1 cm and end in a flat head. Possibly they would have held an iron handle in place, which would also explain the concreted iron covering the object. In most areas the corrosion did not adhere to the surface of the object much, but near the rivets the iron corrosion was somewhat more solid. Despite this it was not possible to conserve this potential iron component as it was mineralized in such a manner that no remains could be kept in place.

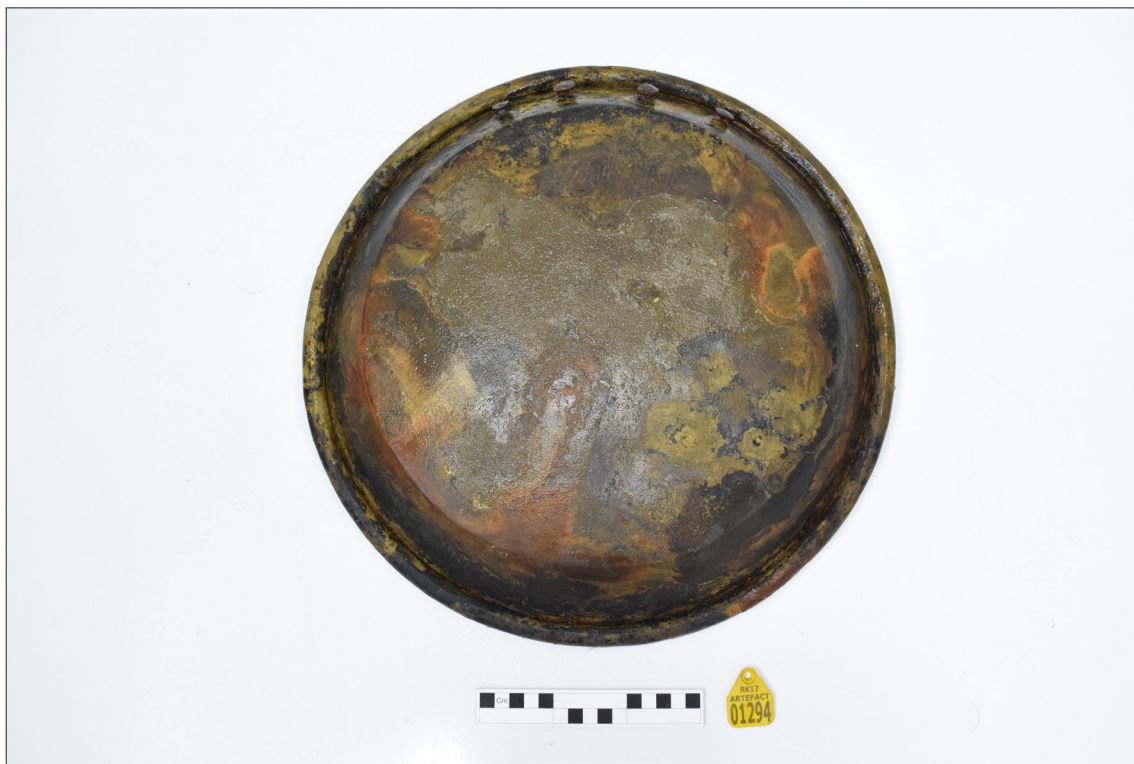
Fig 16: Top view of reverse side of object RK17 A01294 after corrosion removal.

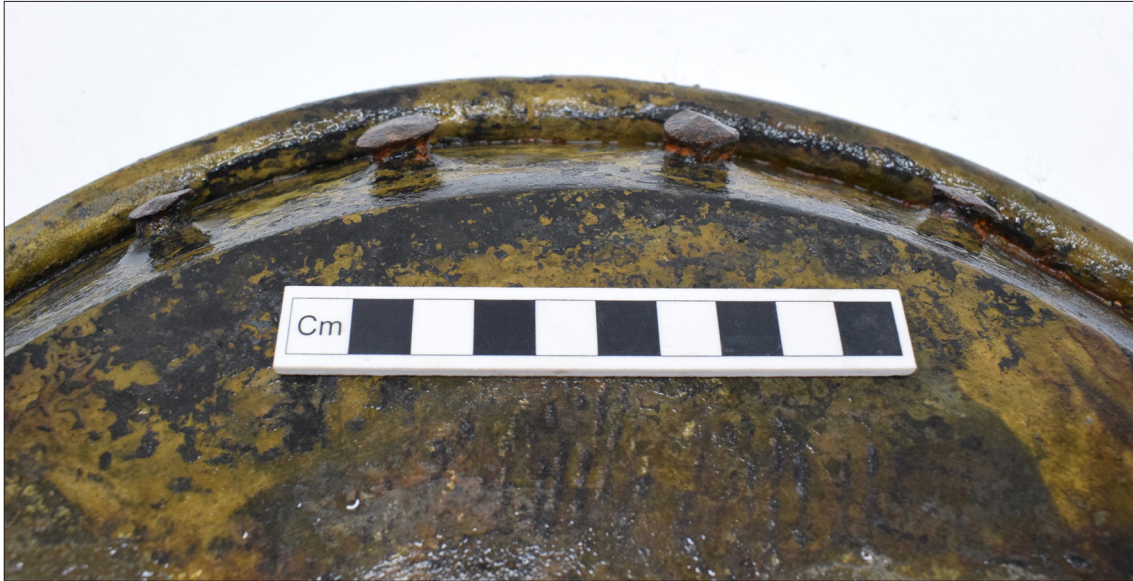
Fig 18: Object RK17 A01294 after corrosion removal showing rivets on the outside of rim.

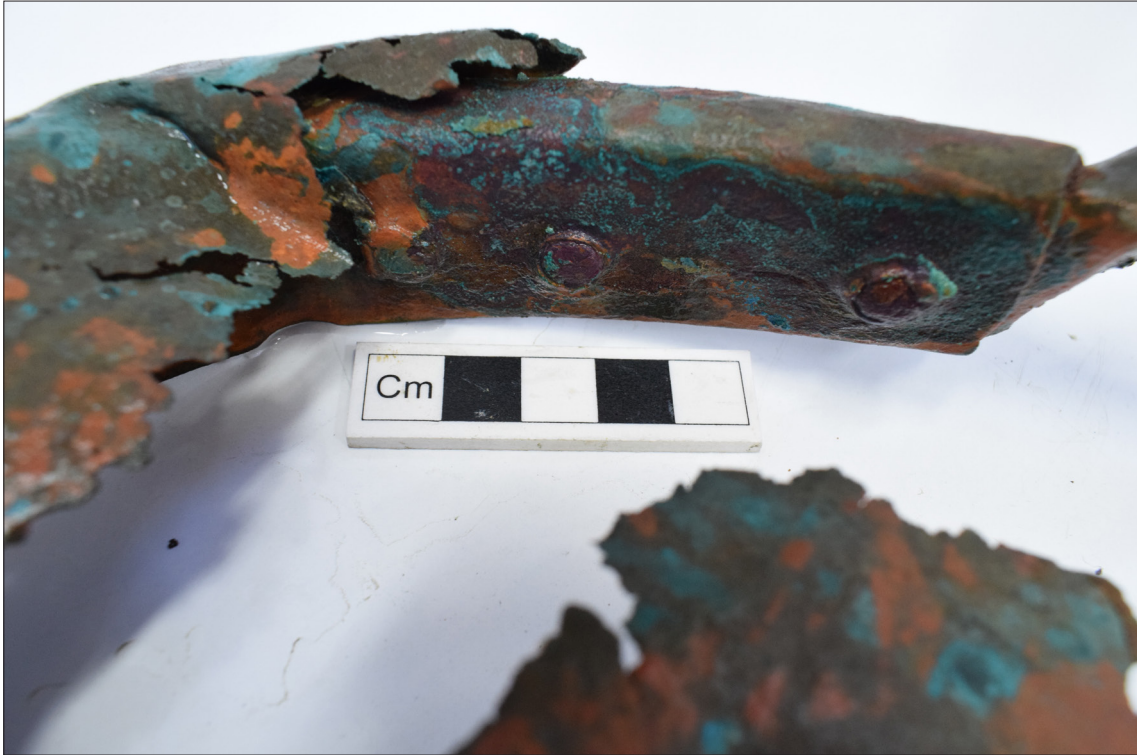
One of the artefacts from the Rooswijk is a large lid. The lid consists of a round sheet metal that has been folded over a round metal hoop. The hoop was created from a metal strip made into a circle and riveted together at the ends (Fig 19). On top of the lid, a handle likely also to be attached to the lid with rivets was obscured by layers of concreted sediment (Fig 20).

Fig 19: Object RK17 A01073 before conservation showing riveted rim.

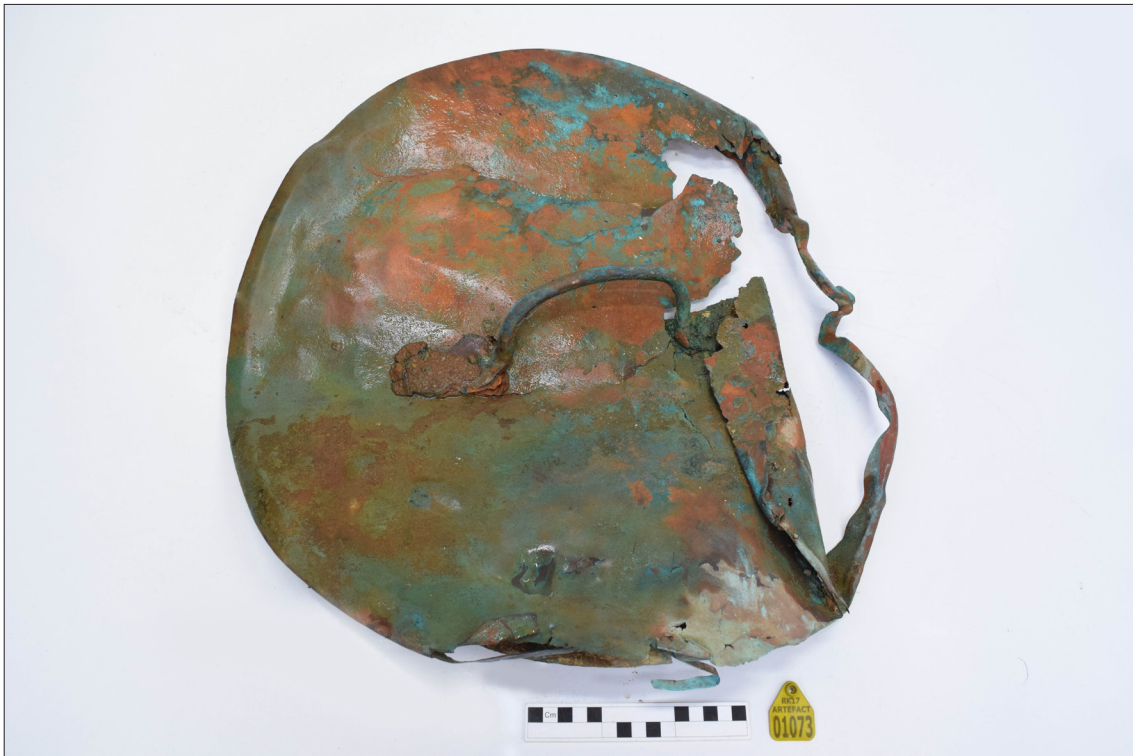
The entire object seems to consist of a copper alloy as typical superficial reddish brown and green corrosion layers can be seen on the surface (Fig 21 and 22). In some local areas sediment has adhered to the surface of the object and can be found around rivets and under folds in the metal.

The object is broken and incomplete. The top is detached from the hoop in multiple areas and along these edges the metal can be seen to be very fragile and deformed. The material has long fractures running into the metal.

Fig 21: Top view of obverse side of object RK17 A01073 before conservation.

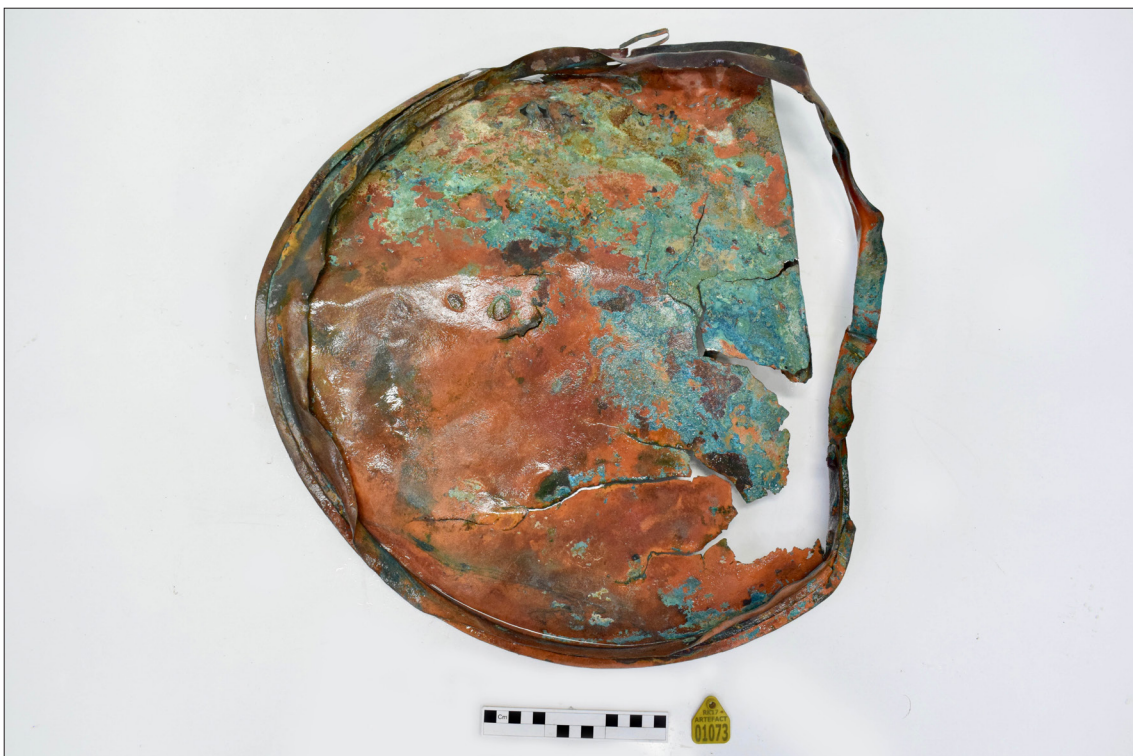
Fig 22: Top view of reverse side of object RK17 A01073 before conservation.

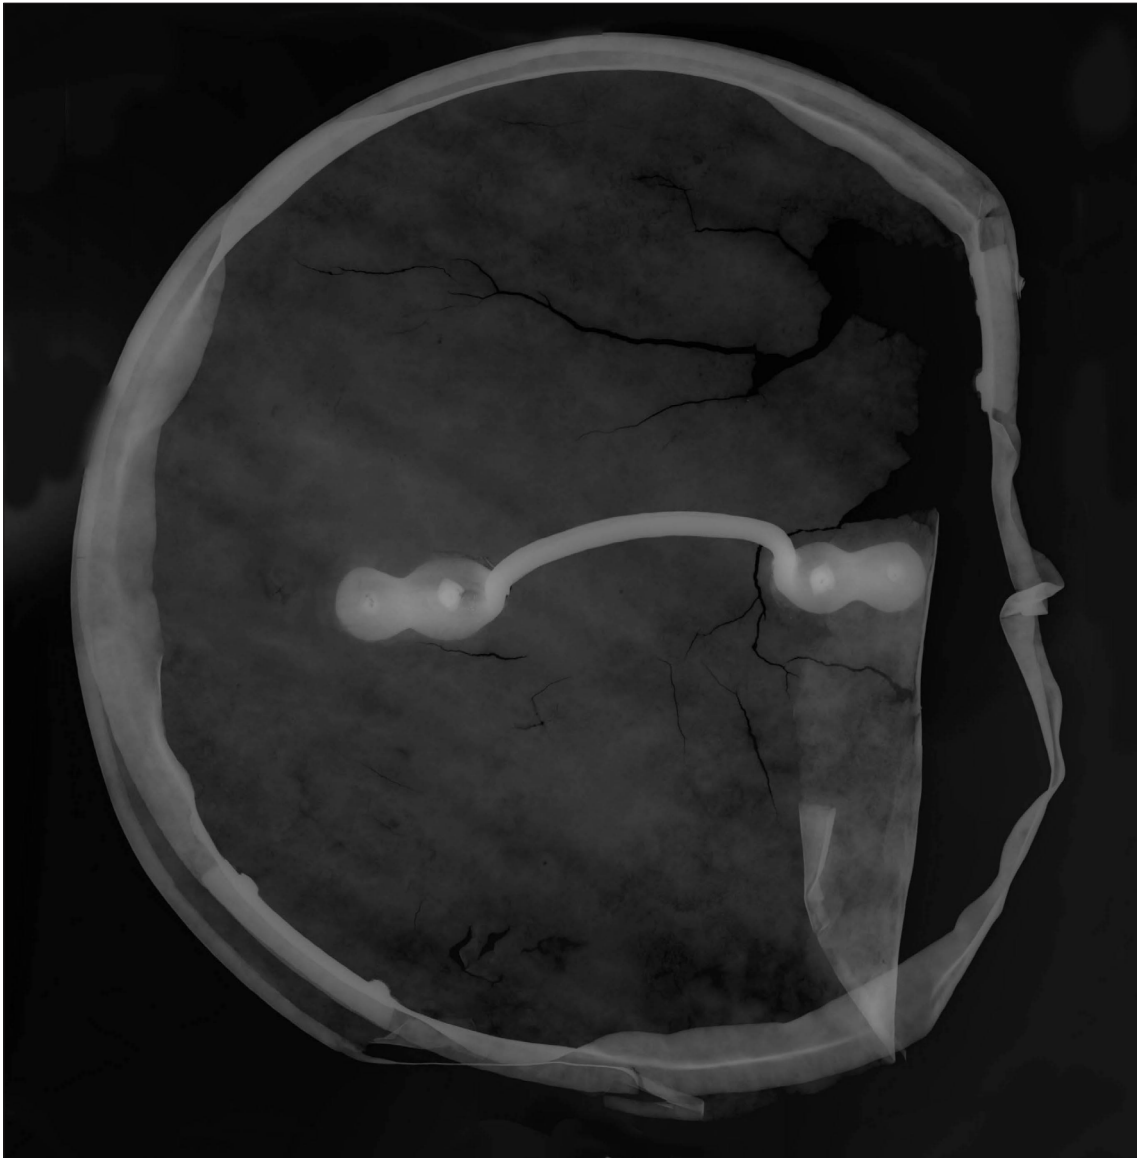
The object was studied by X-radiography for any features that were not visible to the naked eye (Fig 23). The riveted joints on the handle could clearly be seen on the X-radiograph. Also, the X-radiographic investigation gave more insight into the fractures in the material and the stability of the object.

Fig 23: X-radiograph of object RK17 A01073 (P4472-4475, kV: 100, mA: 3, exposure time in sec.: 2).

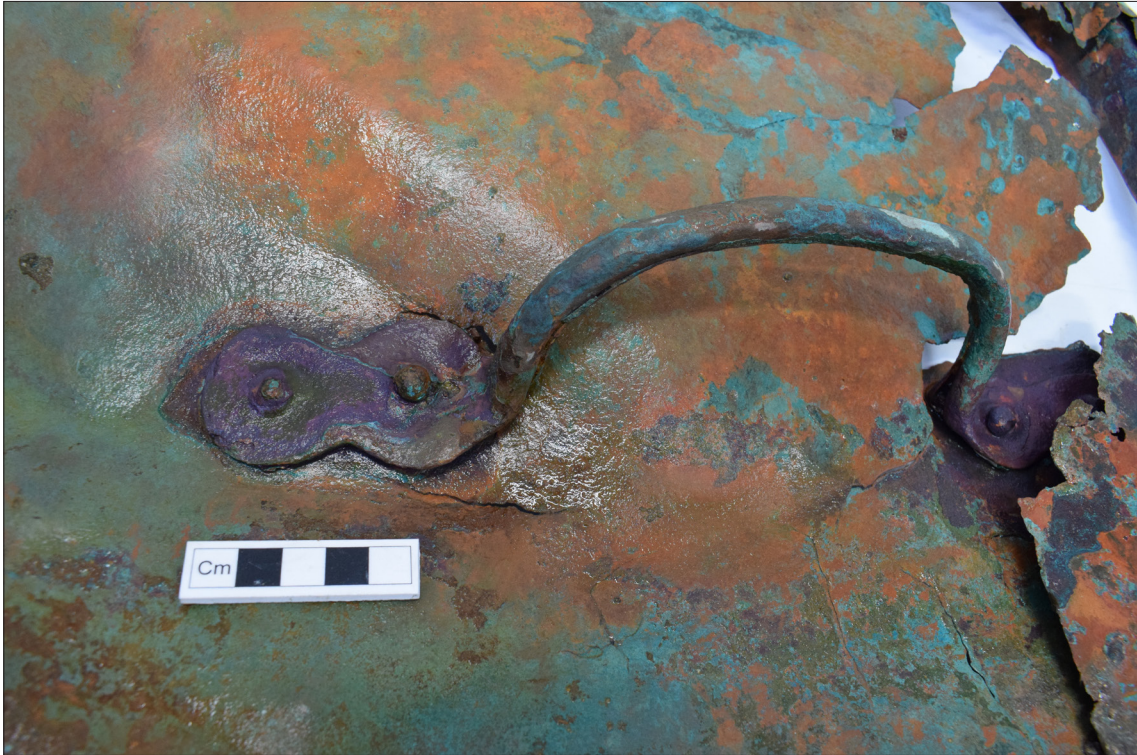
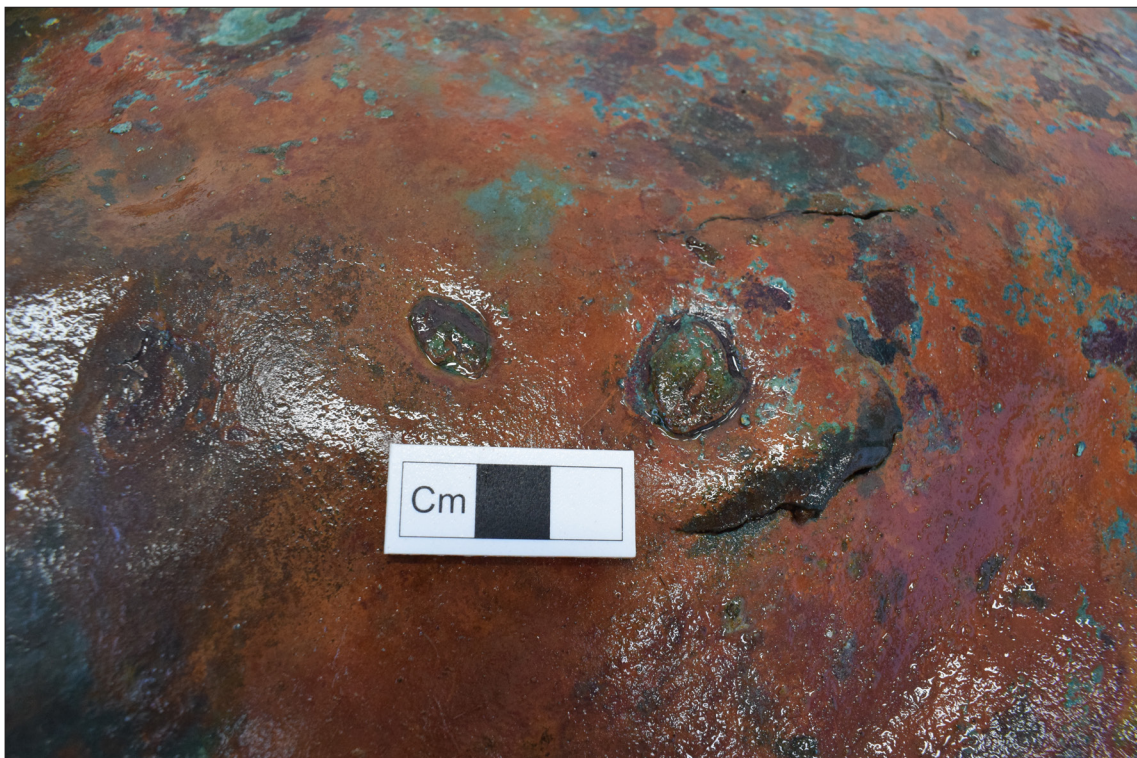
Only corrosion layers with adhered sediment like sand and shells were removed as these were identified as external corrosion layers and not part of the original object. This sediment was mainly located under folds in the metal and in small depressions. No new features were discovered, but the riveting mechanism was uncovered, allowing it to be visually studied (Figs 24 a-b).

Fig 24a (top) and 24b (bottom): Object RK17 A01073 showing riveting of handle on obverse and reverse side of the lid.

The object was mechanically cleaned using a scalpel and wooden skewer. Adhering sediment was found to detach easily from the object.
