Little Toller Farmhouse, Toller Fratrum, Dorset

Building analysis and survey

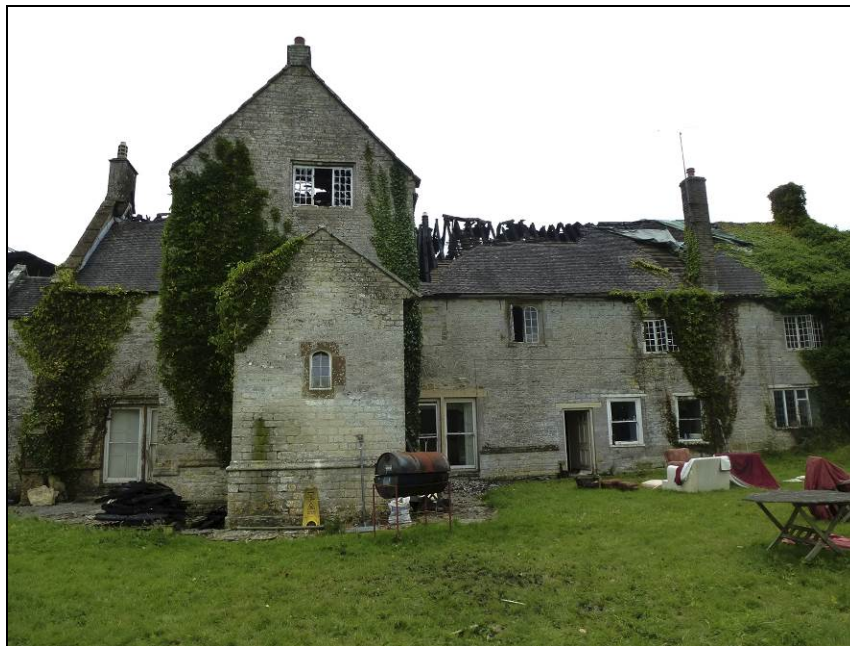
Fig 8 The north (rear) elevation shortly after the fire.

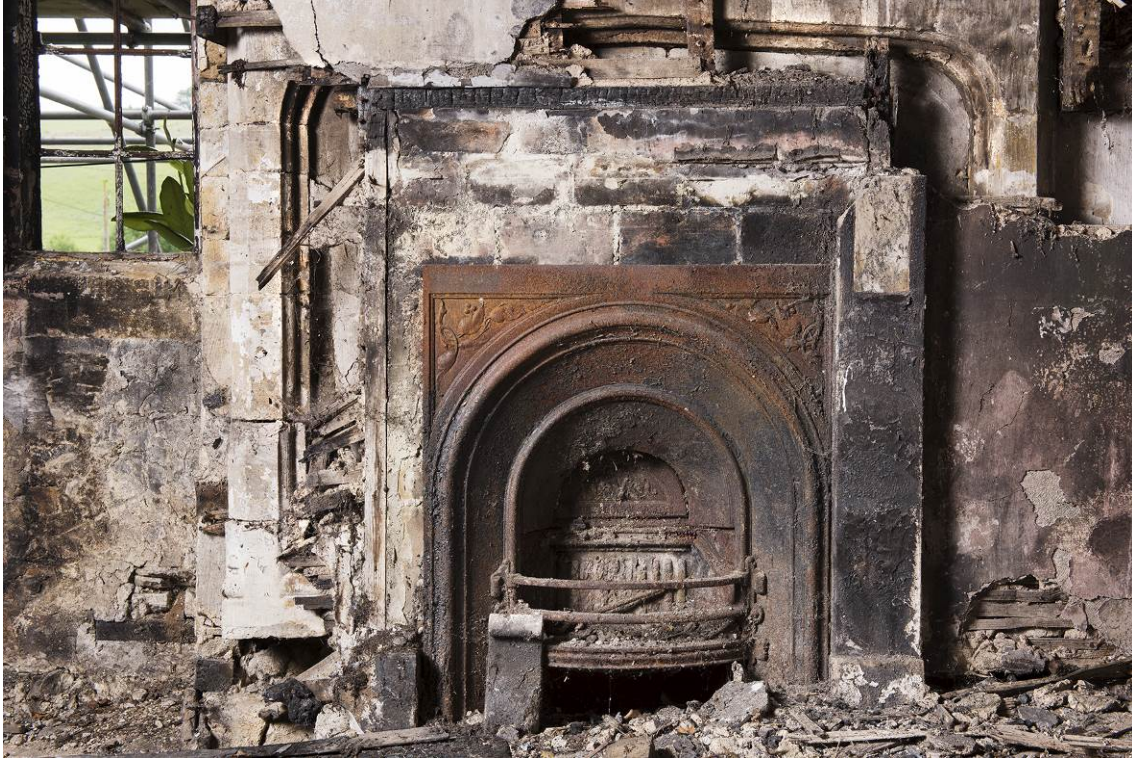
depressed arch defined by hollow chamfered moulding. The left hand jamb of the fireplace has a vase stop at its base. Removal of the plaster by the 2015 fire also revealed the original plain stone internal splays of the four-light window next to the fireplace. It is likely that the other original four-light window on the first floor has similar splays, although these are currently concealed.

Fig 15 The 16th-century fireplace behind plaster and a 19th-century fire surround on the first floor. HEA DP196753.

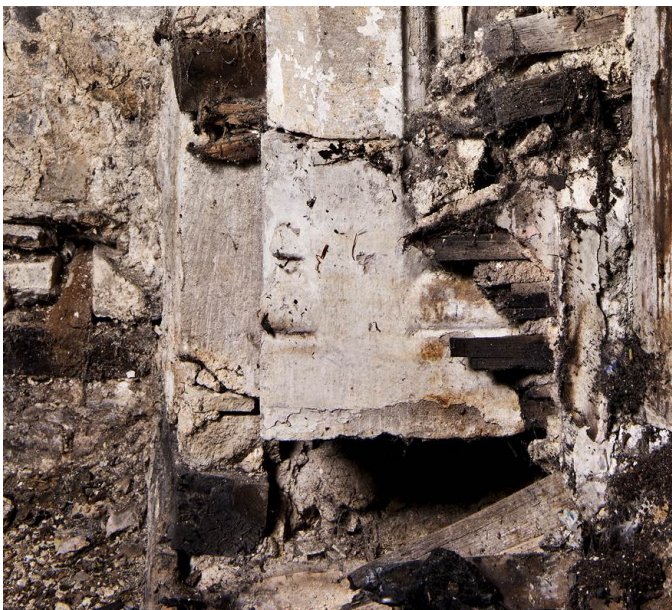
Fig 16 Detail of the lower part of the left hand side of the fireplace showing the vase stop. HEA DP196752.

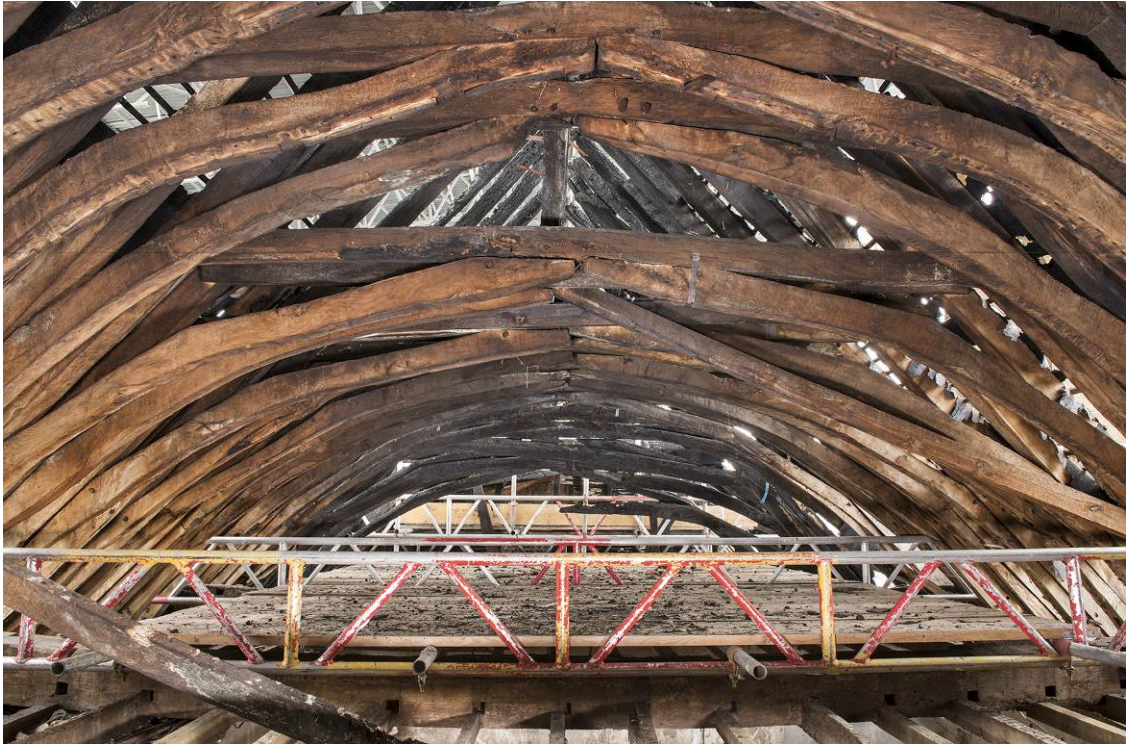
Fig 17 Looking east along the interior of the roof. The post in the upper-centre of the frame is a later addition. HEA DP196761.

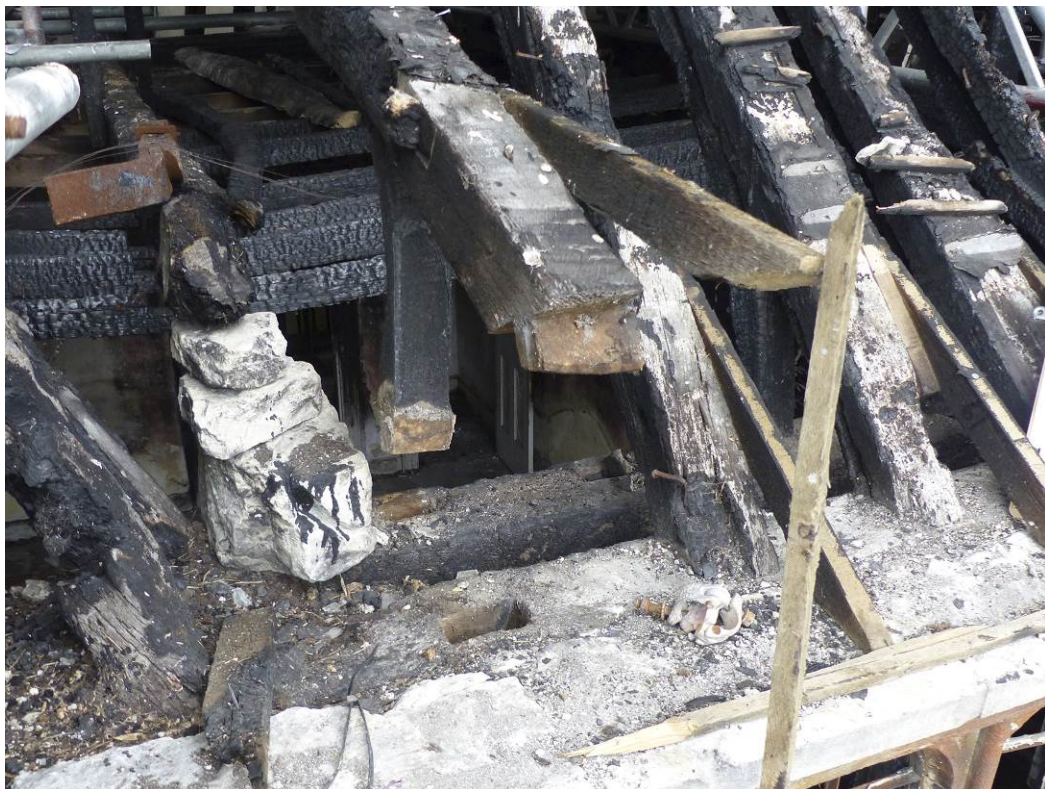
Fig 18 Truss 21 on the south side showing the mortices in the wall-plates and the tenons in the rafter and lower brace. Photo: Helen Winton.

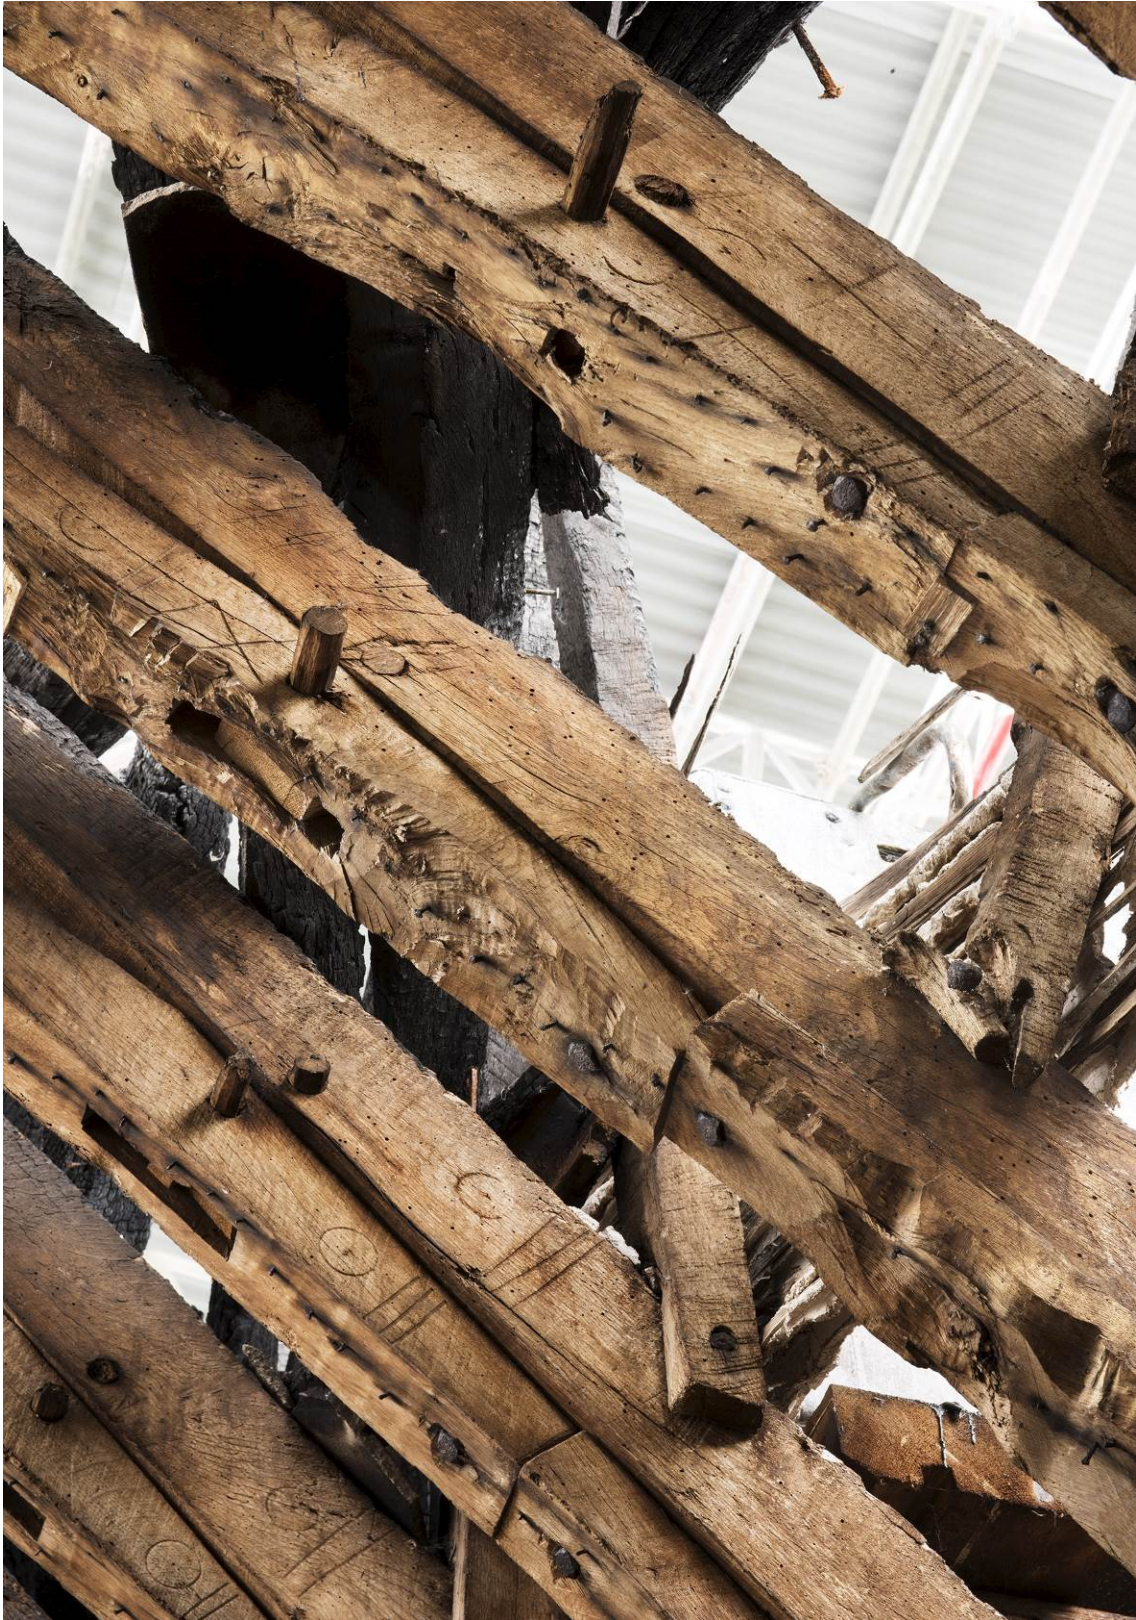
Fig 21 Looking west at the upper braces and rafters on trusses 11 to 14 on the south side of the roof. The underside of the upper braces on trusses 12 and 13 have been cut back, revealing the slip tenon in the joint between the rafter and brace. HEA DP196757.

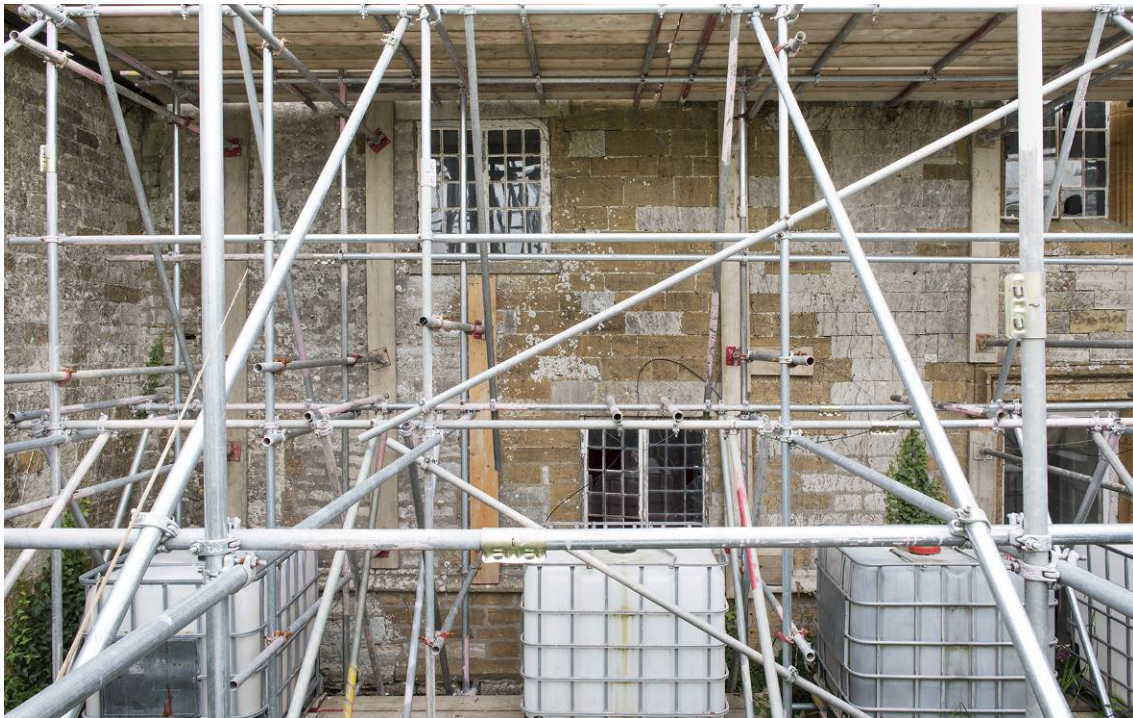
Fig 23 The straight joint between the two phases of the main range is behind the scaffolding plank below the left hand first-floor window. HEA DP196820.

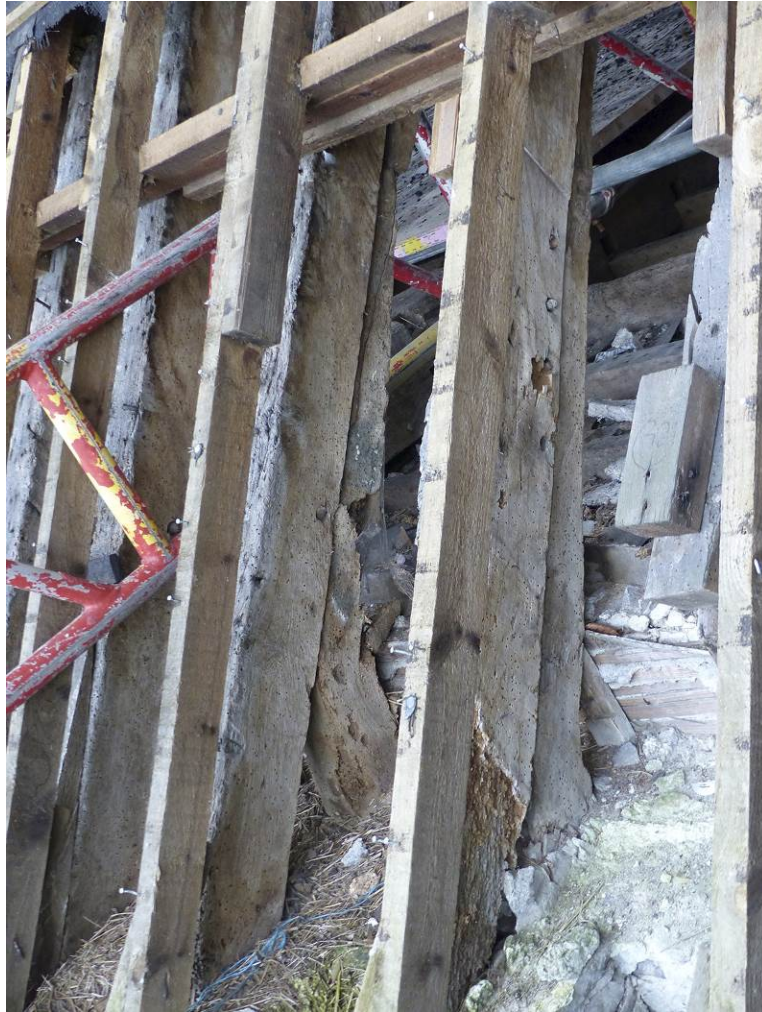
Fig 25 A view looking east at trusses 36 (left) and 37(right) on the north side of the roof. Note the different number of pegs and the curved foot on truss 36 and the straight one on truss 37. Photo: Helen Winton.

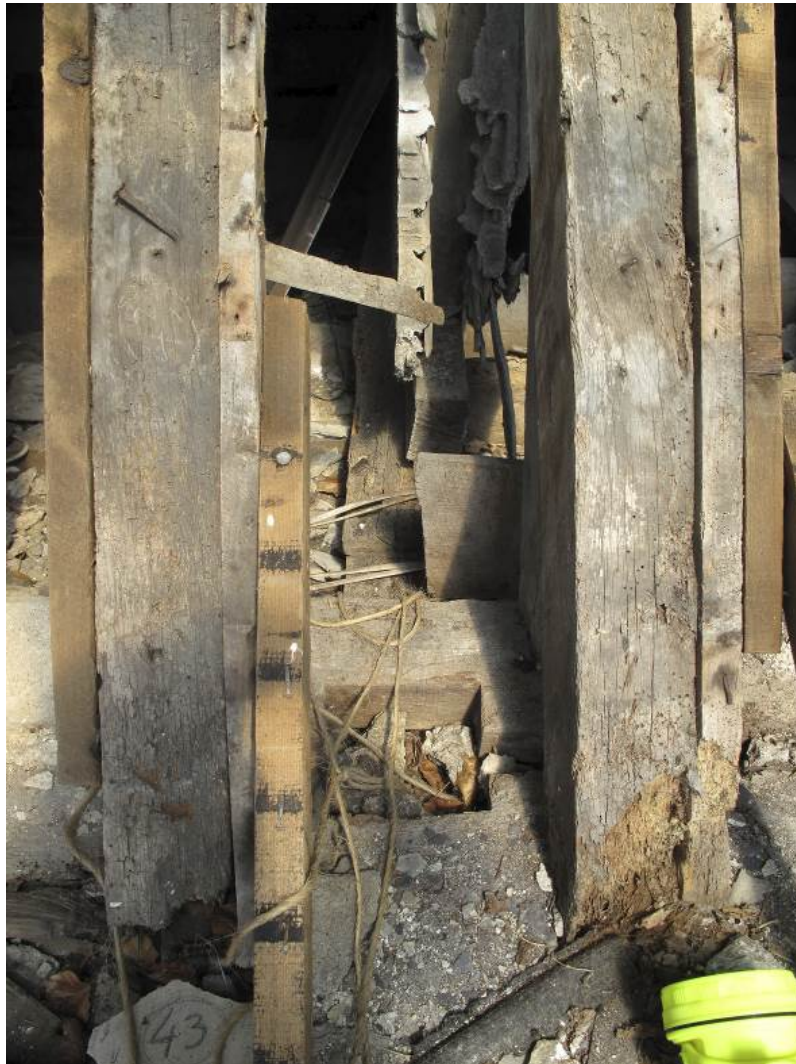
Fig 27 The cuts in the wall plates between trusses 42 (right) and 43 (left) on the south side of the roof. West is to the left. Photo: Rebecca Lane.
