An Earthwork Site on
Western Dartmoor,
Devon

SURVEY REPORT

ISSN 1478-7008
Archaeological Investigation Report Series AI/12/2004

County: Devon
District: West Devon
Parish: Brentor
NGR: SX 4708 8044
NMR No: SX 48 SE 5/**HOBUID:** 438139
SAM/RSM No: SX 48 SE 13; SX 48 SE
Date of survey: June 2003 & March 2004
Surveyed by: Phil Newman, Simon Probert
Report author: P Newman
Illustrations by: Elaine Jamieson
Photography by: P Newman, D Grady

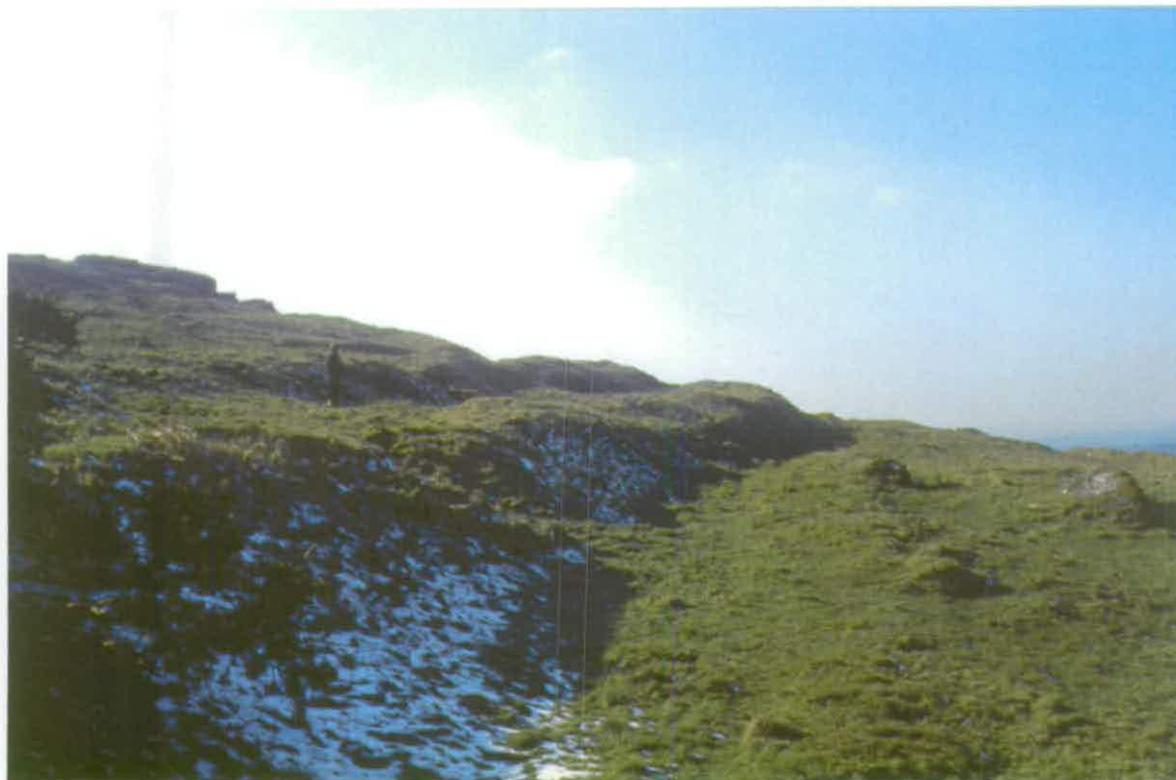
Figure 4
The double linear earthwork viewed from the south-east

A series of linear earthworks within the area enclosed by the rampart, has been identified by some past researchers as an additional set of ramparts. The form of these earthworks however, is quite unlike a rampart as there are no banks and no ditches. What does survive is two parallel, steeply cut scarps with uneven sides and bottoms which extend obliquely across the slope from just to the east of the footpath, to follow a straight south-easterly course then turn south before merging and eventually blending in with the natural scarp at the southern lower slopes of the tor.

These features are most clearly defined at the northern tip. Here the upper, western sharply-cut scarp (p) is steep and has a drop of 2.3m. At the foot of the scarp, running parallel to it, there is a strip of ground approximately 5m wide, covered in amorphous pits and low mounds (q). To the east of this strip there is another scarp (r) which drops 2.8m down to an area of further mounds, which are mostly linear and run parallel to the scarp. As these features extend south-east there is a break in the earthworks where what appears to be an access route takes precedence. This has the form of a sunken area (s), with its axis set at right angles to the terrace and extending further into the interior of the enclosure. Curiously this apparent former entrance aligns at right angles with the southern terminal of the main rampart at the exact point where the rampart construction stops in favour of a hedgebank style construction.

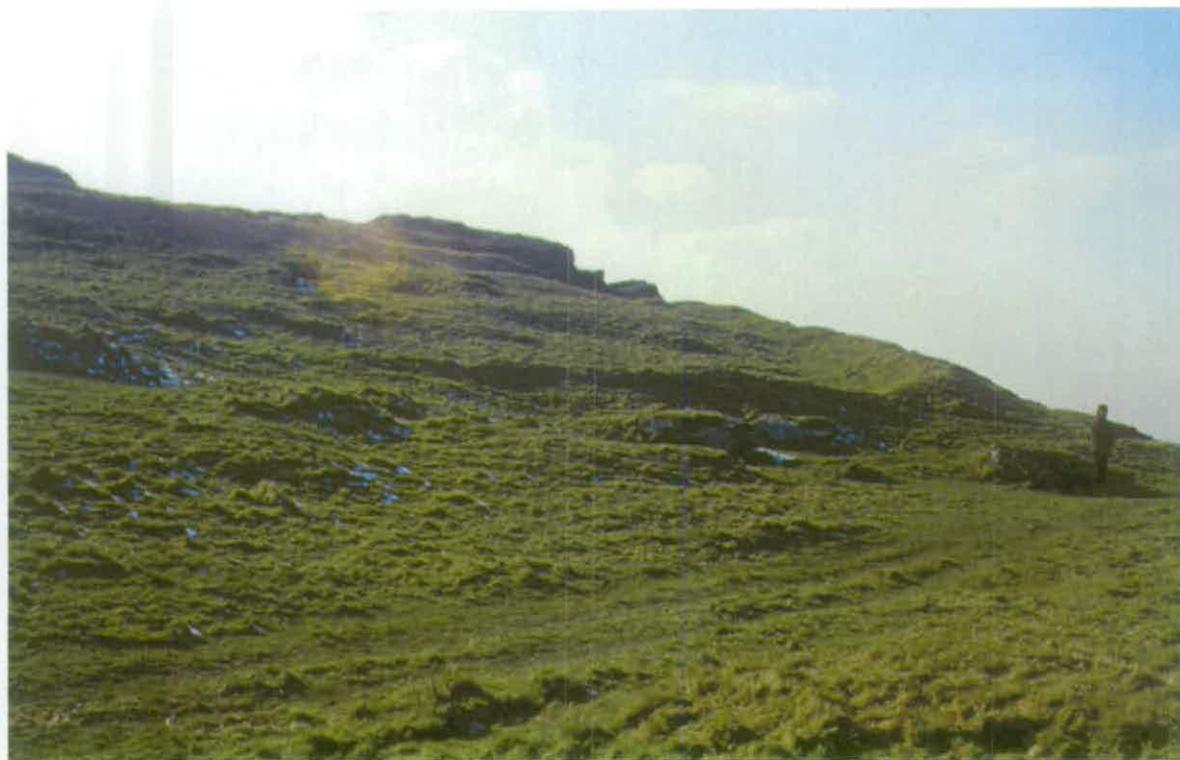
Figure 6
The lower enclosure bank (u) viewed from the south-east

The lower of the two banks (u) is sited just above the modern footpath and was built to enhance the lip of a natural slope. It is constructed of earth and stone with dimensions of approximately 4.4m wide by 1.3m high. The bank originates near the northern summit outcrop, descends the hill obliquely to the east, before curving back up the hill to the south and merging into the hillside beside the track. There are three narrow breaches in the bank, though all three appear to be the result of modern erosion. On the northern exterior of the bank a series of pits, cuttings and a small spoil mound indicate small-scale removal of stone in this area.

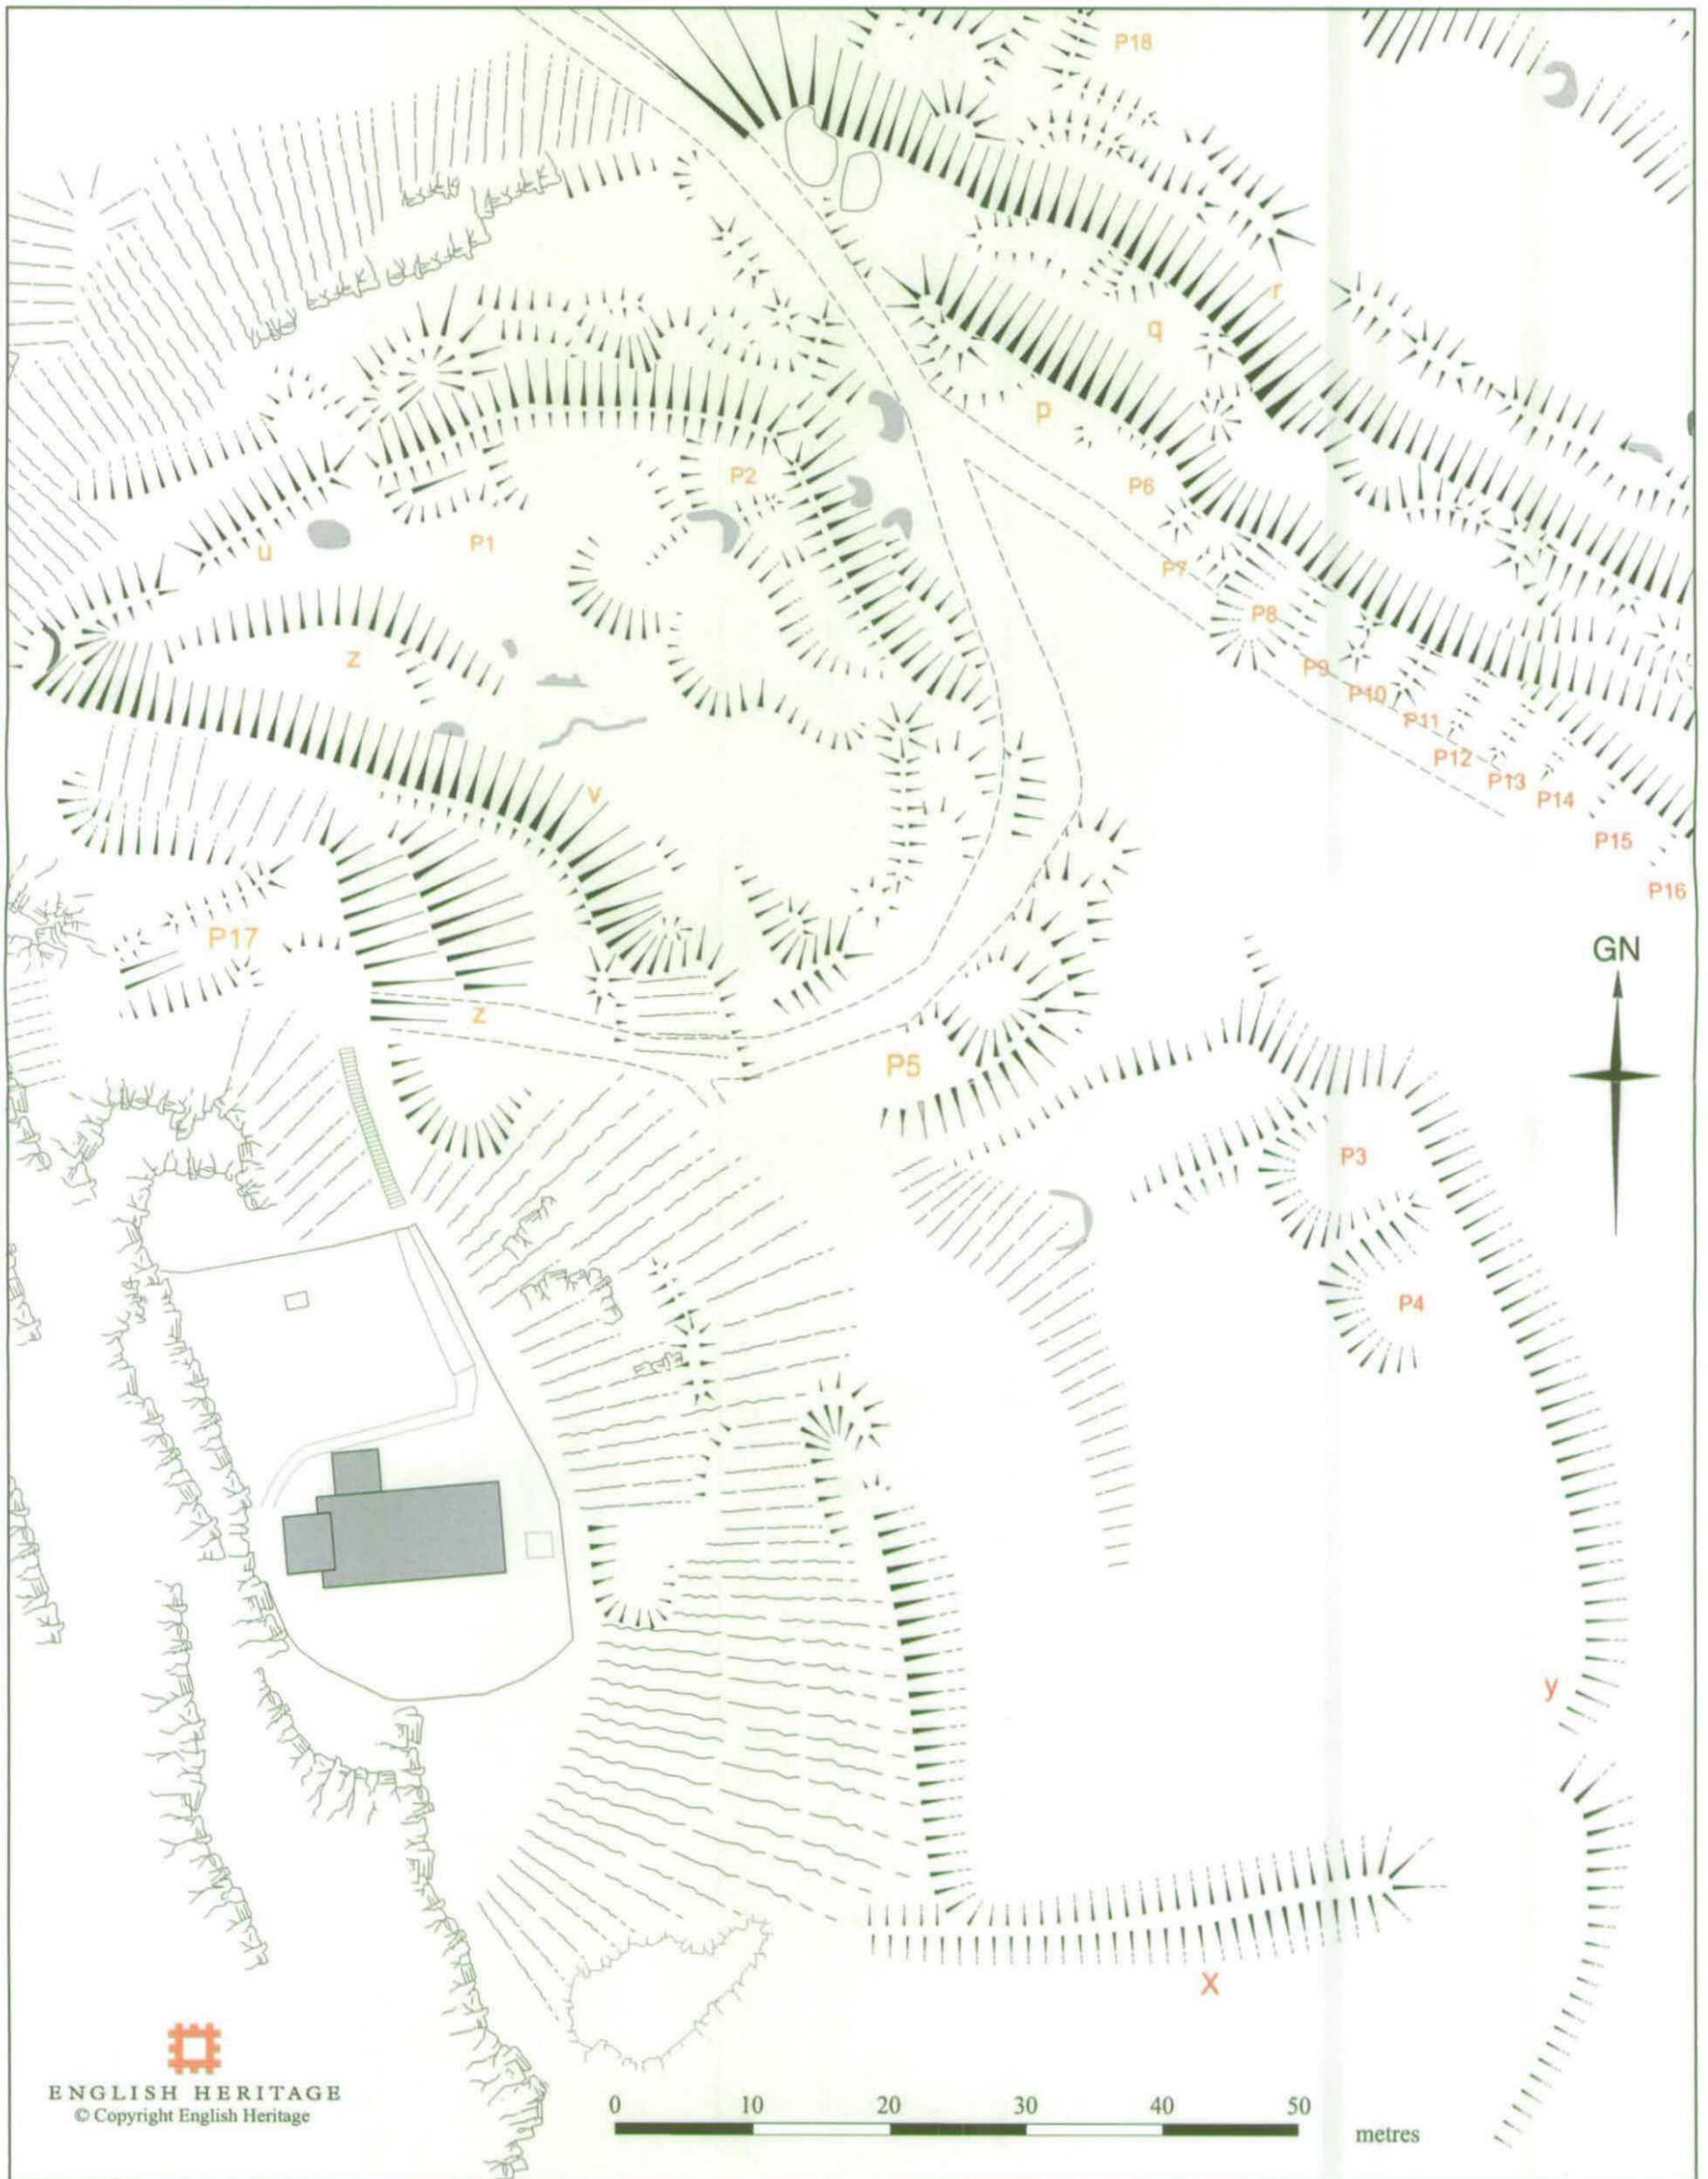
Figure 7 1:500 earthwork survey of the central area of the tor.

Within the enclosed area is a series of smaller earthworks which Greeves has also suggested may be house platforms. What certainly appears to be a small number of artificial earthworks are however integrated with natural geological features making interpretation difficult. At least two of these (P1 and P2) do have an approximately rectangular outline and could be interpreted as hollows which may once have contained timber structures. Both are built against the back of the lower enclosure bank (u). P1 measures 7m by 4m and has a sloping interior and P2 is 5m by 3m and has an approximately level interior.

Placed centrally between the north and south enclosures on the south side of the church path is a series of five conjoined raised platforms, stepped against the slope (P5). The largest is the upper of the five which measures 7m by 5m. This and the platform immediately below are rectangular in plan while the lower three, all of which are smaller, have curved outlines. Together these earthworks form what may be interpreted as a base for a series of small attached timber structures as suggested by Greeves (2003, 8), or perhaps a single partitioned building with level floors within the partitions.

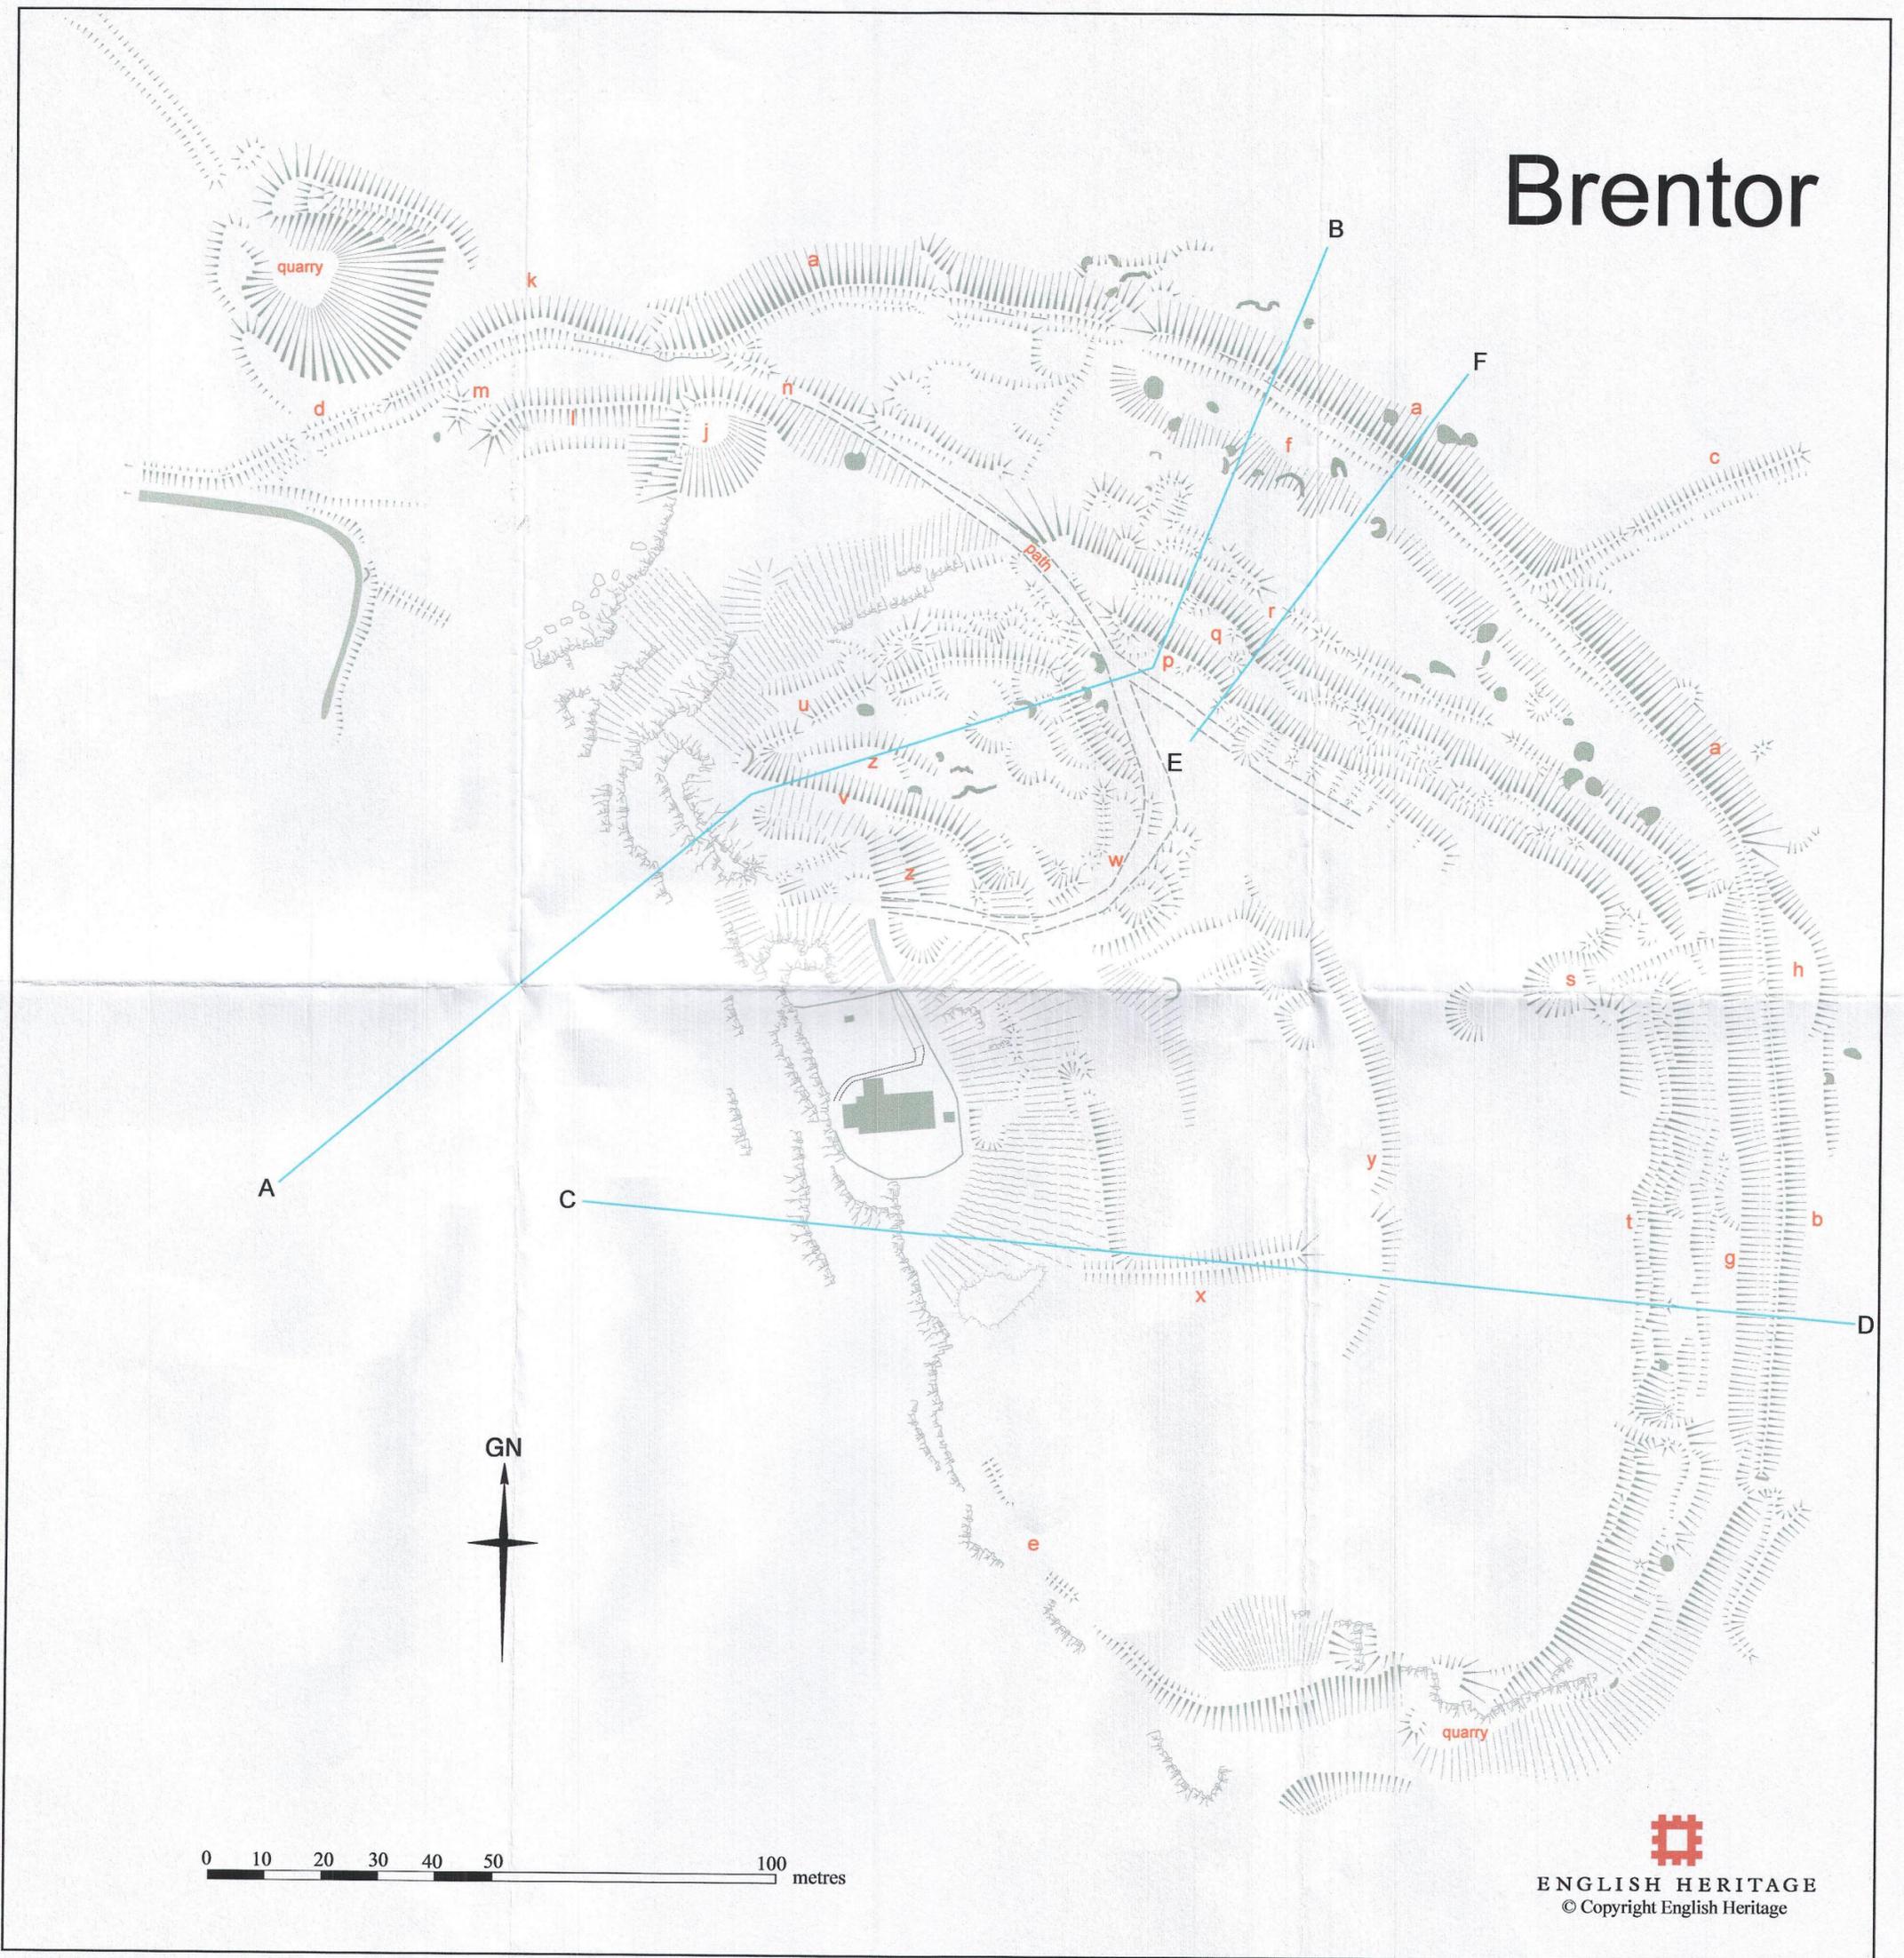
Figure 8 1:1000 earthwork plan highlighting features mentioned in the text and section lines A-F.

The rampart, consists of a substantial earth bank. The main element of this bank (a) is arc-shaped in plan and follows the contour, curving around the base on the northern and north-eastern side of the tor for a total of 216m.

This rampart could never have been used to form a secure boundary to the tor as it was never completed, and extends along approximately only three-quarters of the eastern arc of the tor base. The remaining gap at the south-eastern terminal was filled at a later date by a wall-bank of much smaller proportions, being only 2m high by 5.7m wide (b). How soon this boundary was added after the builders of the rampart decided to abandon the project is not known but it was clearly designed to utilise the existing earthwork to create an enclosed field in conjunction with other field boundaries in the locale. This would have included the bank and ditch (c), now abandoned, which meets the rampart at right angles from the north-east, and, at the other end, the hedgebank (d) which extends from the rampart down to the road parallel with the footpath. Vestiges of a very ruined and spread stony bank are also
