**ARCHAEOLOGICAL ASSESSMENT OF THE DESIGNATED WRECK
OF THE *NORTHUMBERLAND* ON THE GOODWIN SANDS**

**PROJECT REPORT
2018**

Ref: 7700

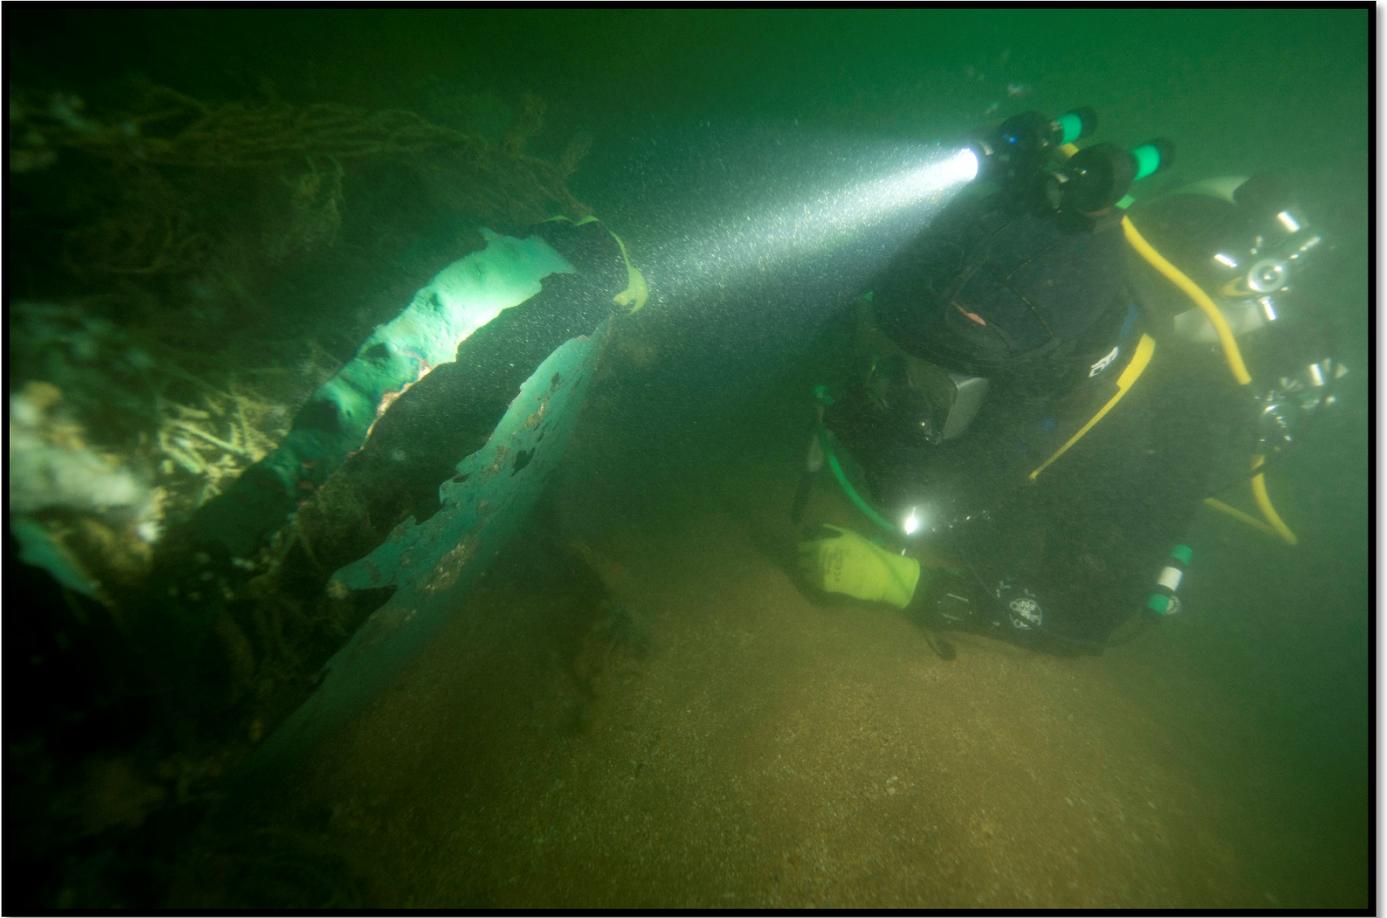
- 4.2.6. Beginning at the bottom of the west side of the feature there is a large riveted copper vessel lying on its side. It is in poor condition with part separation between the sides and base of the vessel. The diameter of the vessel measured from its base is 600mm. It is entangled with fishing net, which has probably contributed to its poor condition (Figures 4 and 5). This has been exposed previously and recorded on past site plans and reports (Pascoe *et al* 2015, 135 & WA 2010, 8). These previous site plans and reports have described it as a twin copper cauldron. This suggests there has been significant deterioration or even loss of one of the vessels previously seen.

- 4.2.28. The entangled fishing gear is also a hazard to the archaeology. This is apparent from the poor condition of the copper vessel and the broken piece from the sword assemblage. Given that, in 2009, WA removed fishing net from this vessel to prevent further damage (WA 2010, 8), this net has come into the site since that time. The fishing gear is moving around the site with the movement of the mobile seabed, strong tides and currents, and during high energy storm events. This is clearly damaging the more fragile objects, but the sheer volume of netting is also obscuring the archaeology. While the net is there, many archaeological features are not easily recognisable and remain undetected.

Figure 5: Diver inspecting the copper vessel. Notice the amount of fishing net entangled with it.

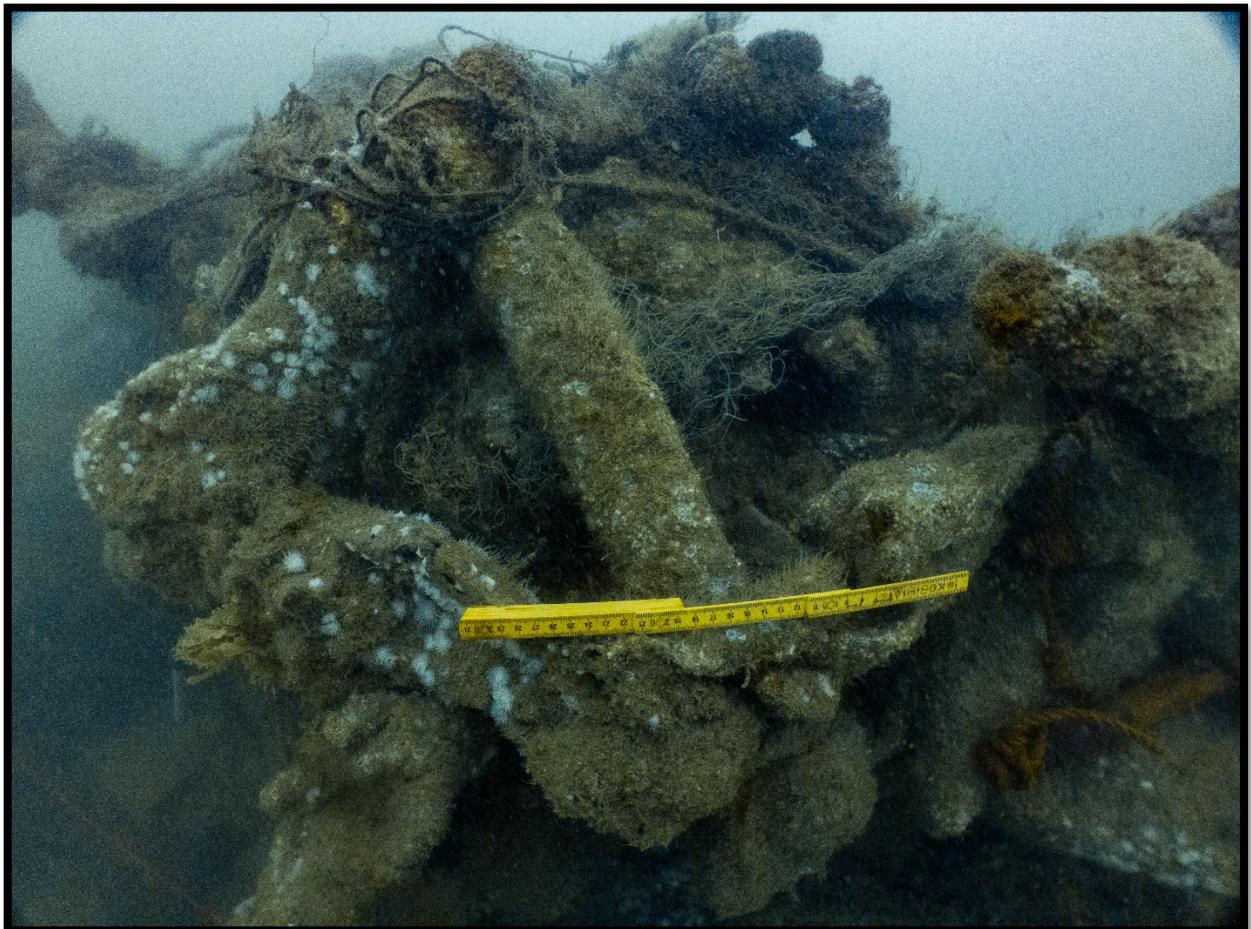
- 4.3.4. As mentioned above, a lead scupper was identified near the top of the concretion. Scuppers were found on the sides of the hull at the level of the main gundeck. This was the first deck above the waterline and allowed unwanted water to drain out of the ship. The location of the scupper could suggest that the side of the vessel was, at some point, present here, but has since eroded away.

Figure 6: Image of lead scupper near the top of the concretion.

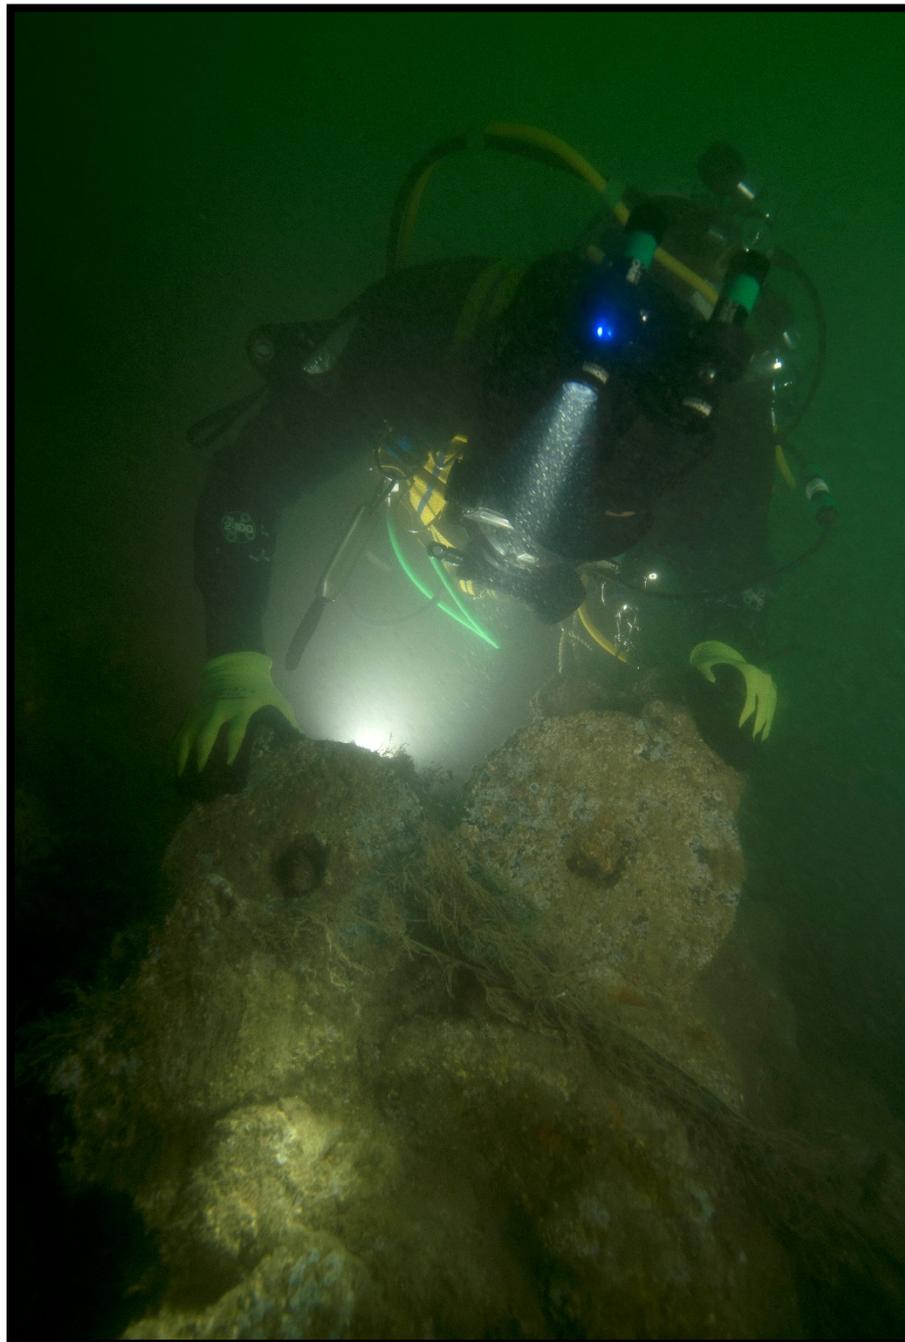
- 4.2.10. Continuing around the base of the concretion, approximately 3m to the northeast, is a concreted group of at least three pulley sheaves. The top two sheaves are clearly visible and have a diameter of 300mm, and a thickness of 60mm. The holes at their centres have a diameter of 60mm. Below these two sheaves, the edge of a third sheave can be made out. Tangled around the sheaves and surrounding concretion is gill netting with small floats attached. Further netting with floats can be seen coming out of the sand and floating up to 300mm above the surrounding seabed (Figures 10 and 11).

Figure 10: A diver inspecting a group of pulley sheaves at the SE end of the site. Photo by Michael Pitts.

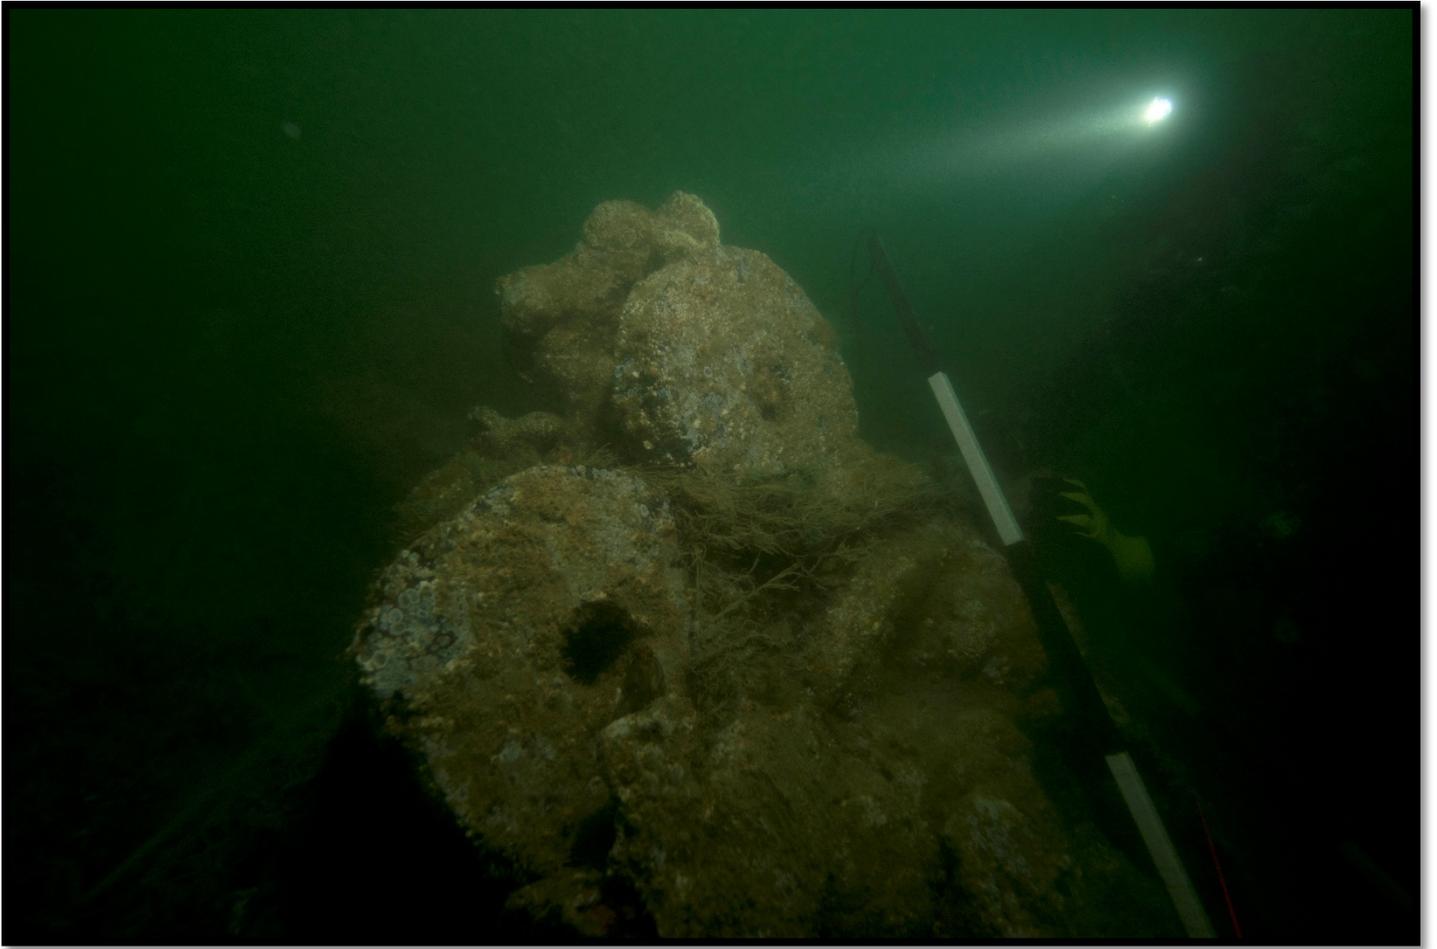
Figure 11: Diver inspecting the group of pulley sheaves. Photo by Michael Pitts.

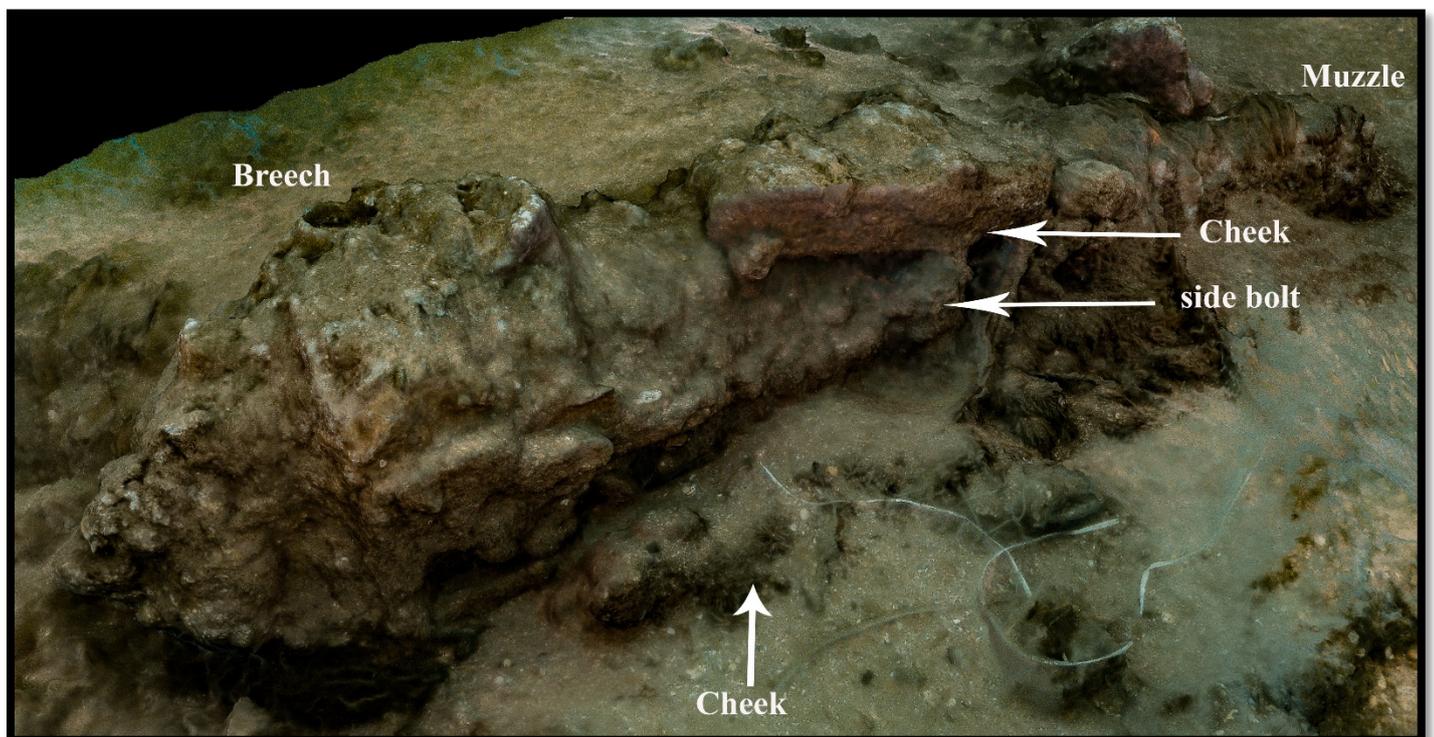
- 4.2.17. Gun 3 also has the remains of its associated carriage attached. The gun lies on its side, and the upper side has a small section of the carriage cheek surviving from around the trunnion recess. This extends back to the first step of the cheek. Below the trunnion recess are the remains of the iron side bolt, which extends down under the belly of the gun and into the other cheek. The bottom edge of this cheek can just be seen protruding from the sand and it extends a little further back than the upper cheek (Figures 16 and 17). The bed of the carriage is missing. The surviving parts are consistent with a truck carriage. This type of carriage has two stepped cheeks, fastened to a wooden bed, with two wooden axles and four trucks (wheels). Similar examples have been recovered from the wrecks of the *Stirling Castle* (1703) and the *London* (1665) (Pascoe 2018, 46 and McElvogue 2008, 42).

Figure 16: A photogrammetry model of Gun 3 showing the survival of parts of its associated gun carriage. The gun is lying on its side with the remains of parts of both cheeks present.

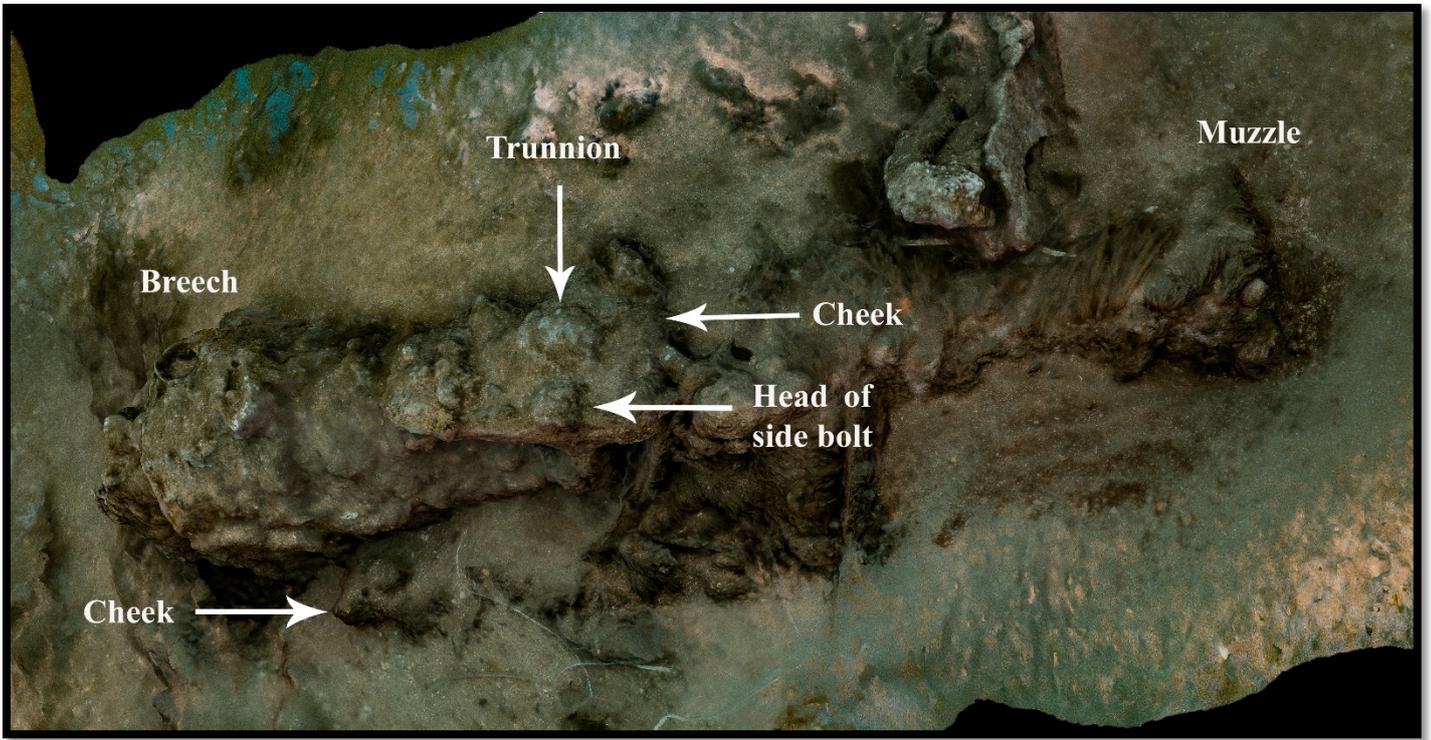
Figure 17: A photogrammetry model of Gun 3 from the view looking down. It shows the survival of parts of its associated carriage. The trunnion of the gun is slotted into the trunnion recess of the cheek. Below the trunnion recess is the head of the side bolt supports the two cheeks together. The bottom edge of the opposite cheek can just be seen protruding through the sand.

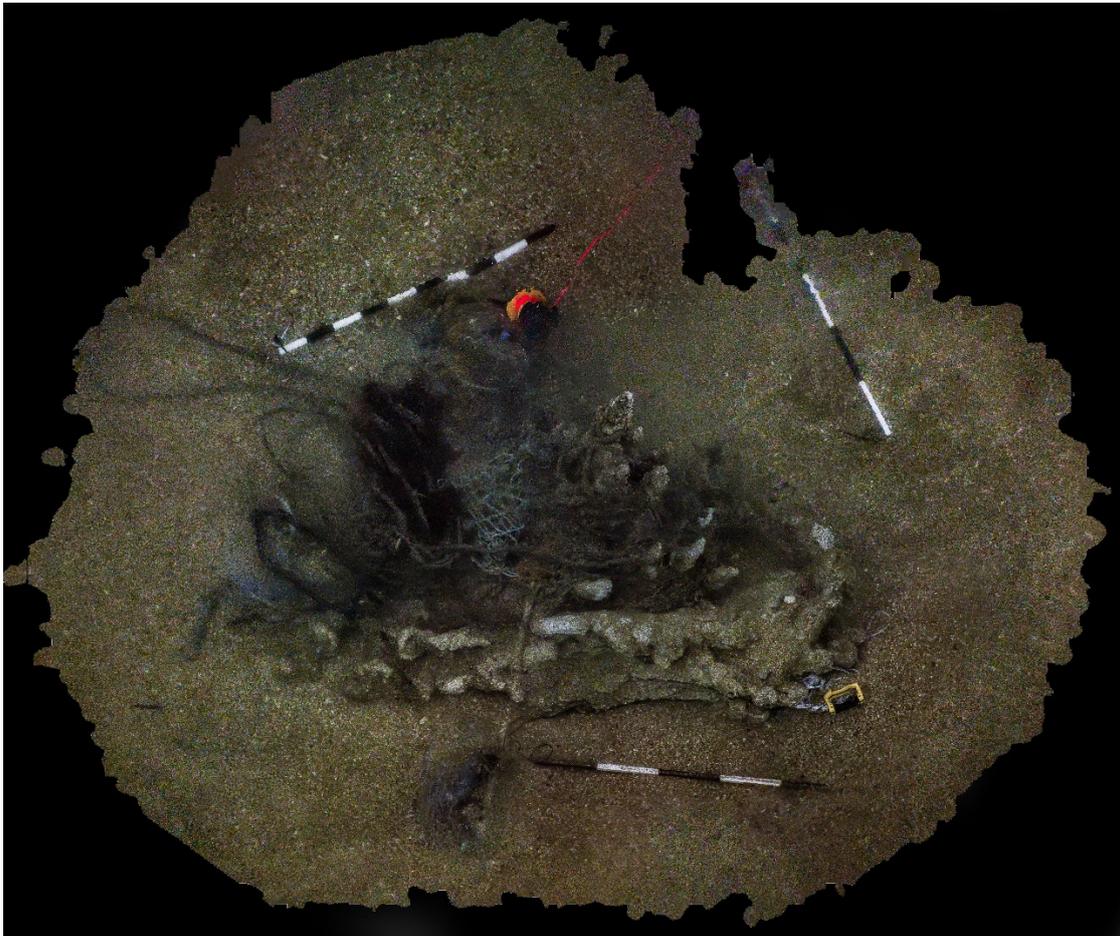
Figure 18: An orthophotomosaic of the assemblage of swords looking down. The scales are 1m with 10 and 20 cm increments. There is a lot of net entangled around the swords sticking up.

- 4.3.9. The discovery of the assemblage of swords was an unexpected find. The photogrammetric model clearly shows that there is the potential for many swords to be among this feature. According to the gunner's stores of the *Lennox*, the sister ship to the *Northumberland*, there should be 40 swords and 40 hangers (Endsor 2009, 164). Hangers had a slightly curved blade, which appears to fit with the shape of the concretion recovered; this could be a very significant find. This assemblage needs all the fishing gear to be removed, so it does not cause any more damage and so it can be recorded properly.

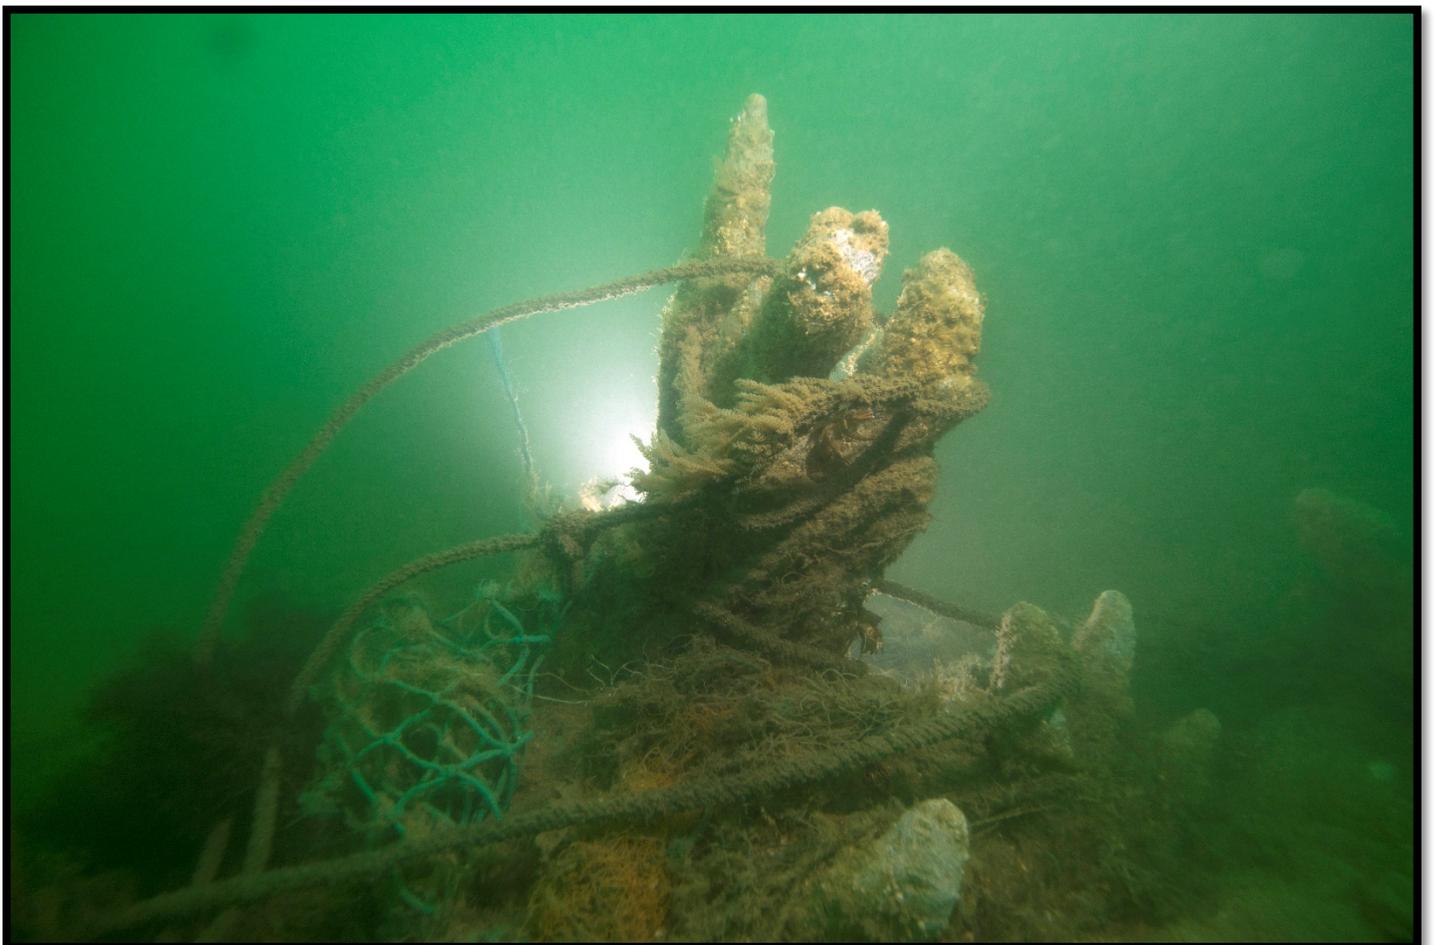
Figure 20: A photo showing the amount of fishing gear entangled around the assemblage. Photo by Michael Pitts.

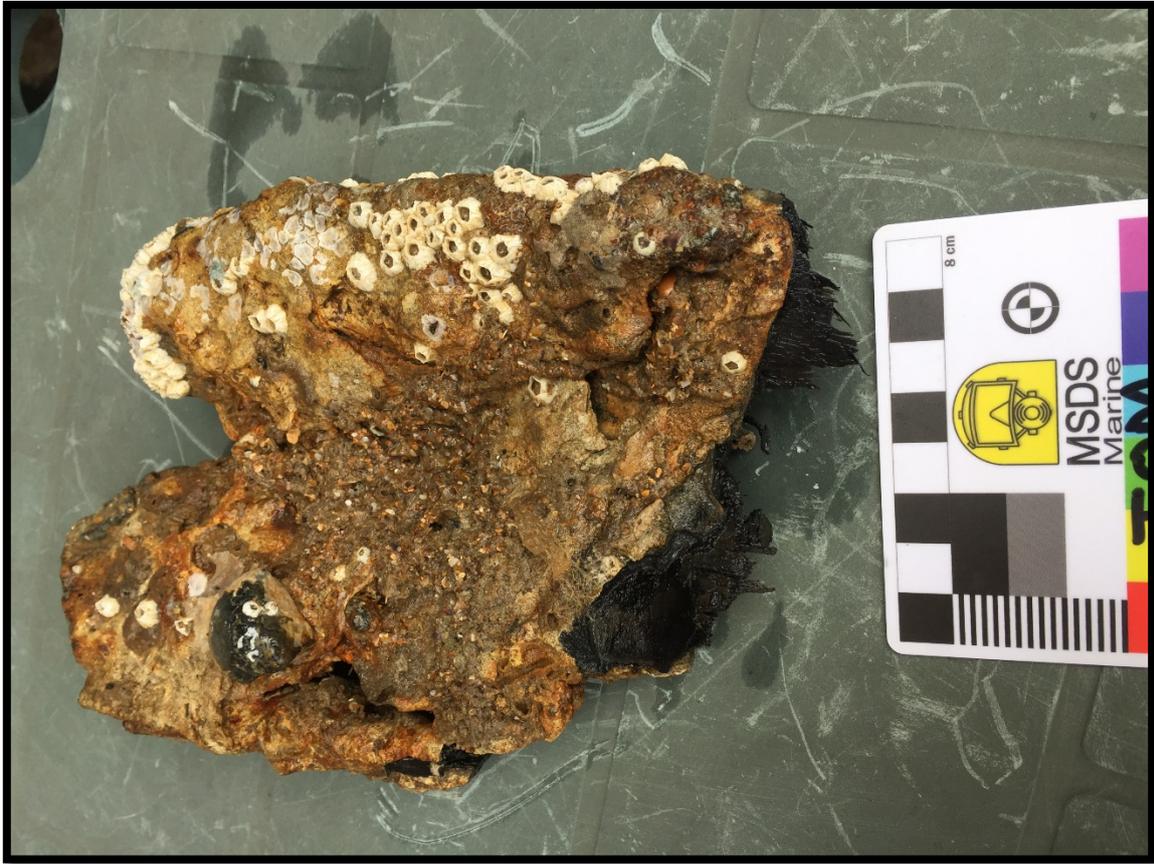
- 4.2.22. The fishing gear had damaged a small section of the feature. The damaged piece was at risk and vulnerable to loss and was therefore recovered. On closer inspection, following recovery, it was possible to see the shapes of three blades. Also, at the cross section, where it had broken away, it was possible to make out the remains of wood and leather scabbards (Figure 21 and 22).

Figure 21: Photo of the concretion recovered.

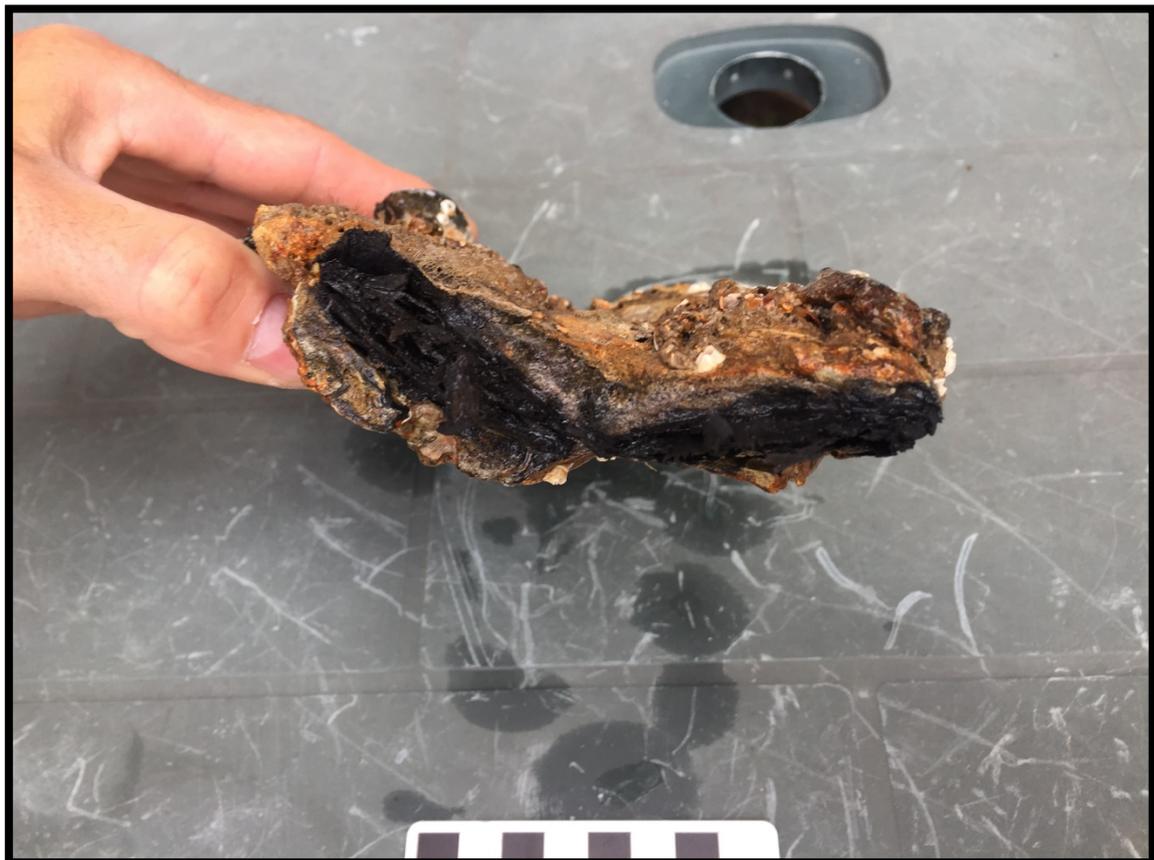
Figure 22: At the break wood and leather can be seen.

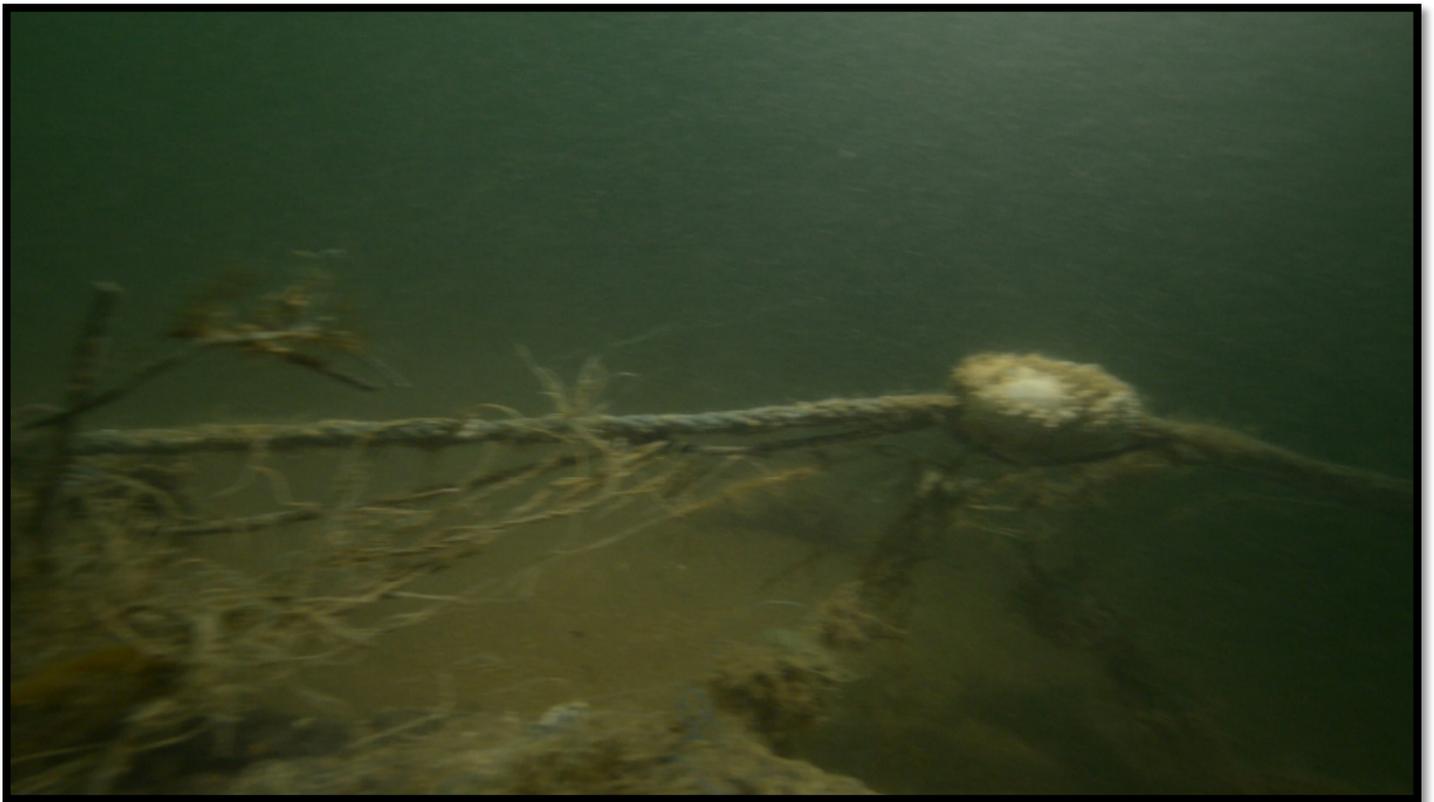
- 4.2.26. Considering the *Northumberland* is a designated site it was extremely alarming to find that all exposed features of the wreck were covered in fishing gear. The gear consisted of a variety of different types including: heavy robust trawl netting; lobster pots and their accompanying ropes; and, most alarming, a large amount of gill netting. The gill netting is particularly hazardous as it is made of an extremely fine nylon mesh with small floats attached. The floats enable it to float above the seabed making it a real entanglement hazard. On many areas of the site the net was floating up to 0.5m above the seabed (Figures 26-31).

- 4.2.27. We were extremely fortunate when we were diving that the visibility was reasonably good, which enabled us to see the net. The site and the Goodwin Sands, however, are renowned for poor visibility. In poor conditions divers generally crawl on hands and knees, rather than swim. With a lot of the gill net up to 0.5m above the seabed, it is therefore at just the right height for a diver to crawl into. This means diving the site in poor visibility is potentially extremely dangerous with risk of entanglement (Figures 26-31).

Figure 26: An example of the gill net floating above the seabed due to the small floats.

4.4.4. Considerable amounts of fishing gear were found entangled on areas of exposed wreckage and much of it was floating above the seabed. This is a serious entanglement hazard to divers, especially when the underwater visibility is poor. The author was contacted by HE regarding issuing a visitor's license to a dive club. At present it would be irresponsible to have divers who are unfamiliar with the site and potential hazards. The net is also a hazard to the archaeology and has already damaged the assemblage of concreted swords and the large copper vessel. The net is also obscuring the archaeology and hindering further recording and identification. The net is, therefore, both a risk to divers and the archaeology. PA strongly recommends returning to the site next year to remove the netting and therefore the danger to divers and the archaeology.

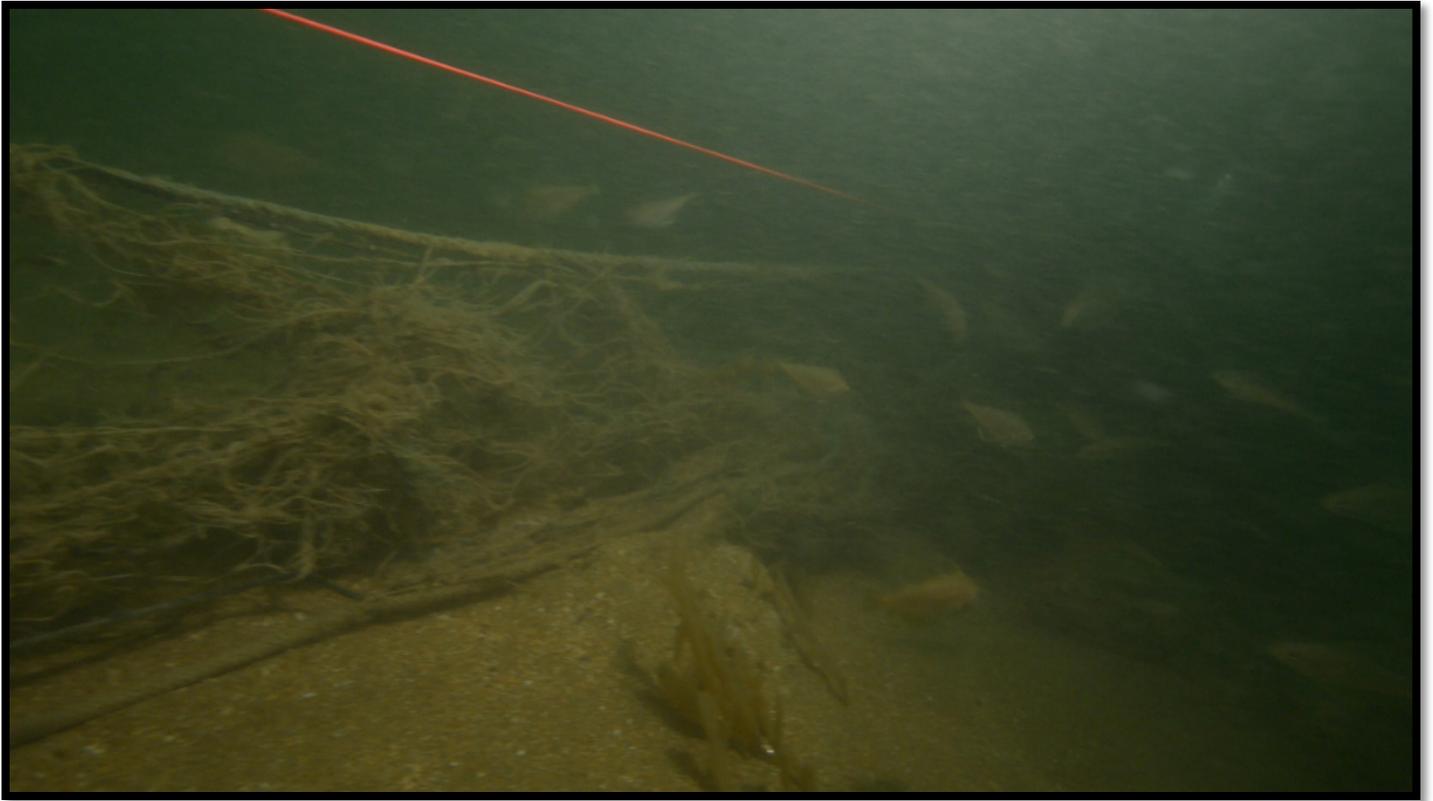
Figure 27: Gill net floating above the seabed.

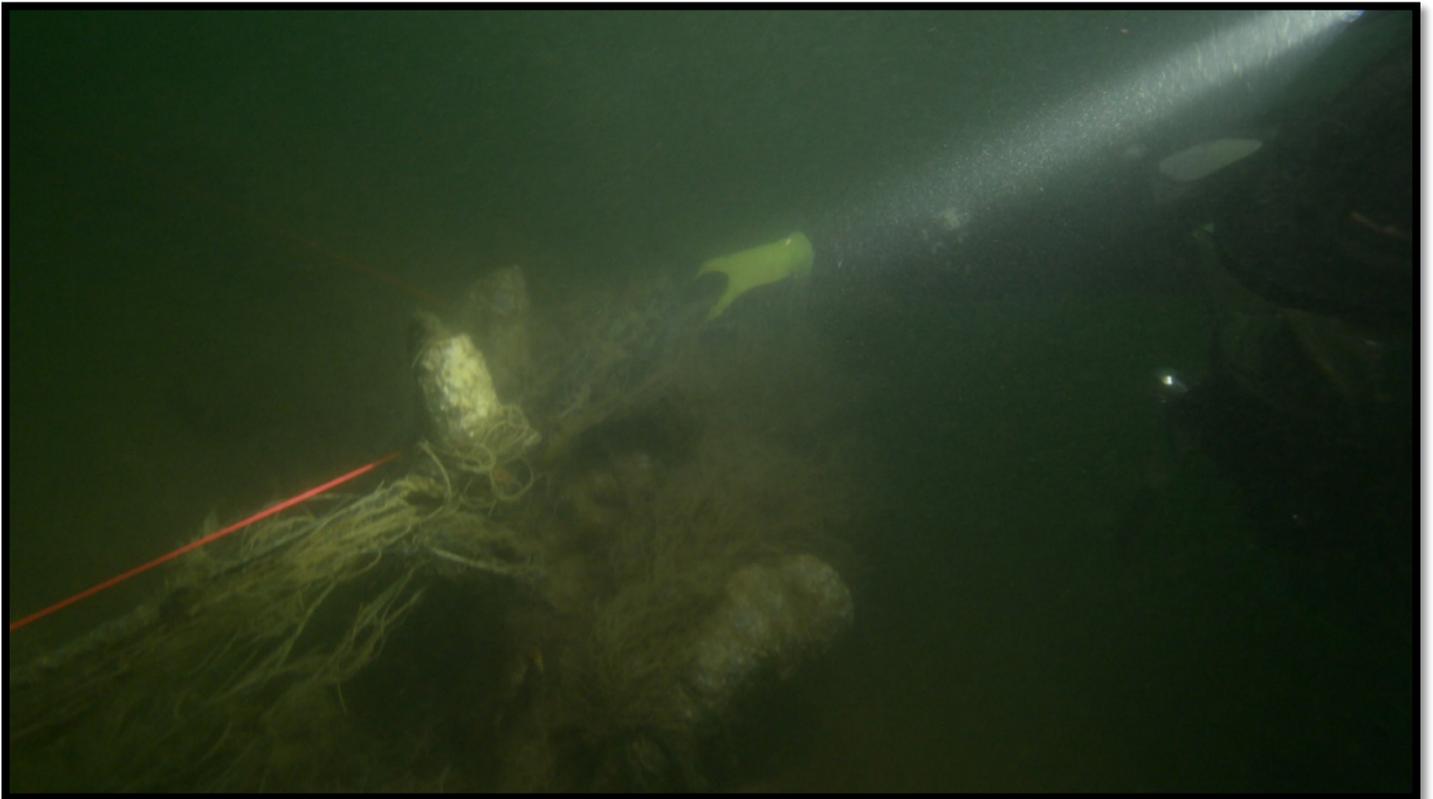
Figure 28: Diver holding a large bundle of gill net entangled on the wreck.

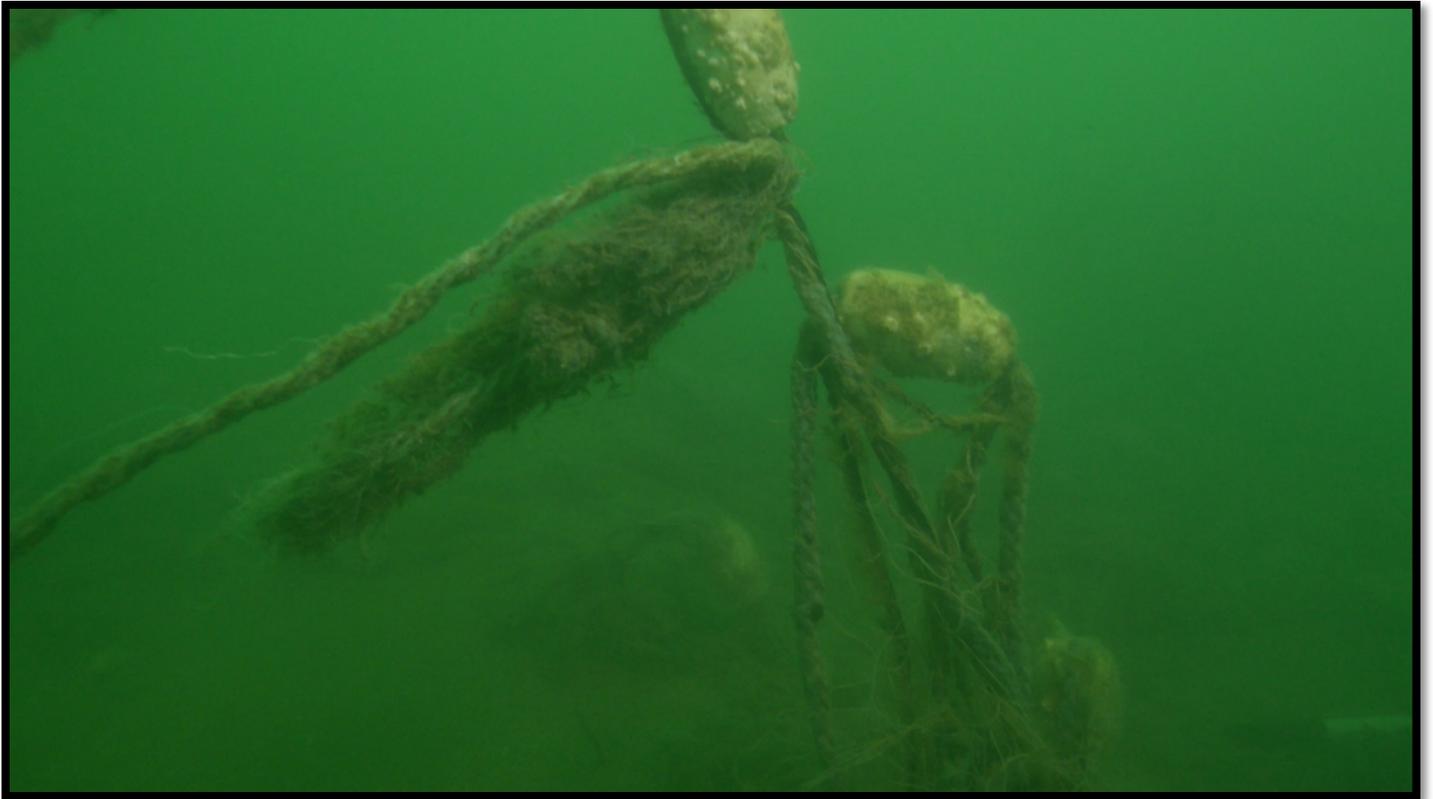
Figure 29: An example of the floats suspending the gill net above the seabed.

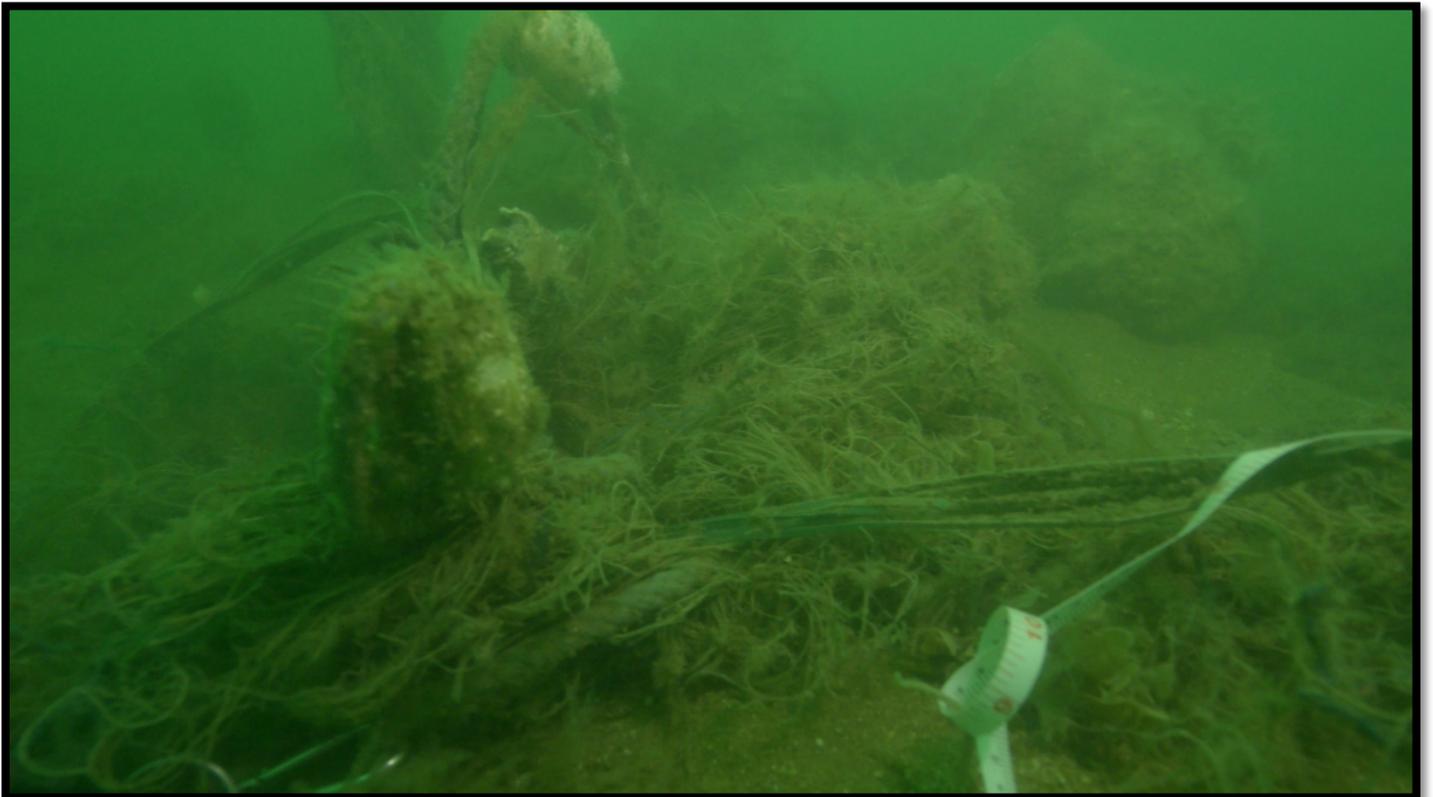
Figure 30: Gill net and floats entangled on exposed features. This totally obscures the archaeology.

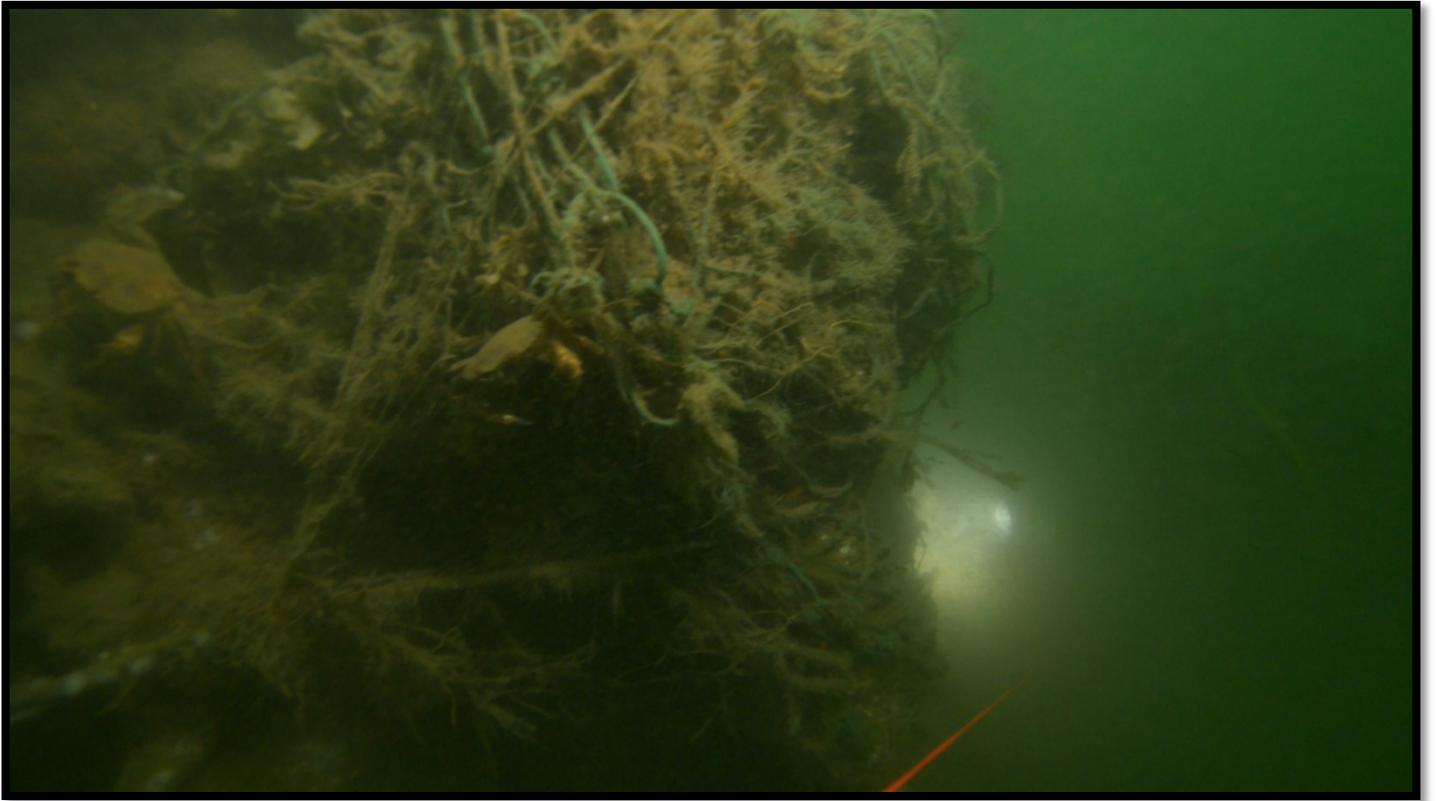
Figure 31: Trawl and gill net covering the exposed feature.
