Bunksland, East Anstey, Devon: Historic Building Assessment and Survey

Research Report Series 013-2022

HISTORIC BUILDING ASSESSMENT AND SURVEY

NGR: SS 85016 26274

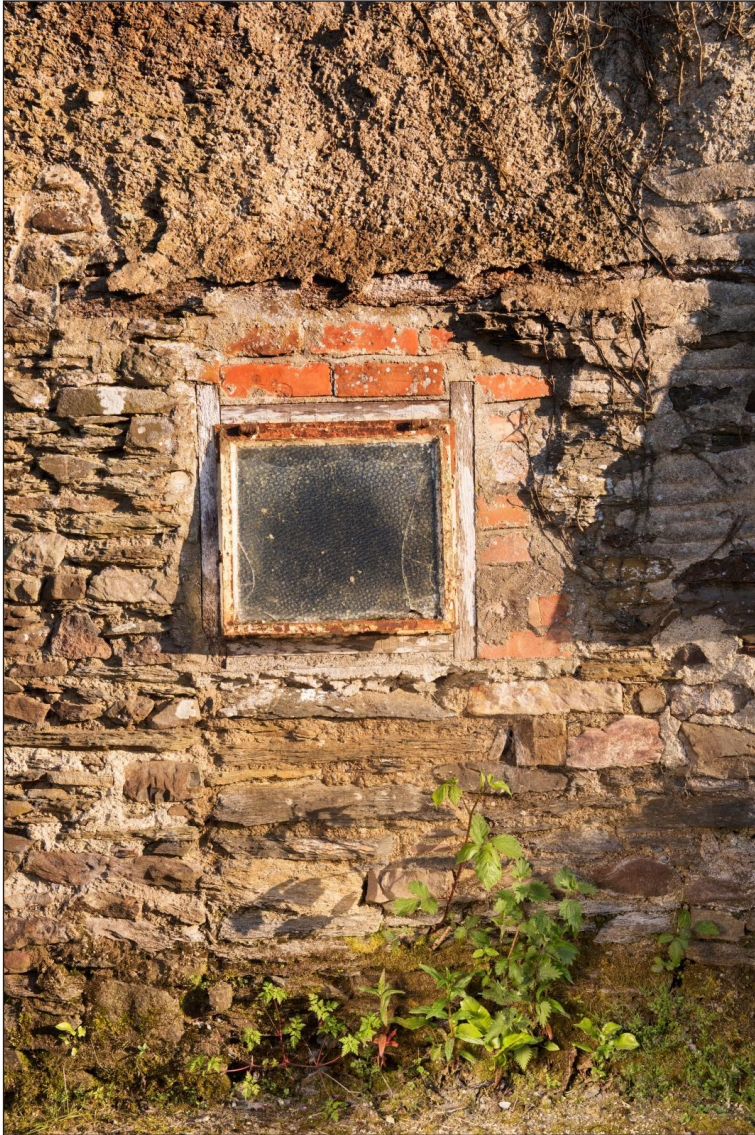
Figure 9 North elevation, showing bathroom window inserted into the former north doorway of the cross passage, looking south [DP220572]

At some stage, probably relatively early in the 20th century, the northern end of the cross passage was modified, with the original northern door blocked and a window inserted to create an indoor toilet (*see* Figure 9). It seems likely that this work was carried out at the same time as the insertion of the current stair, which almost certainly replaced an earlier one in the same position (Figure 60, and *see* Figure 7). At a later stage the room adjacent to the toilet was panelled out in plywood and a sink and bath inserted to form a bathroom arrangement.

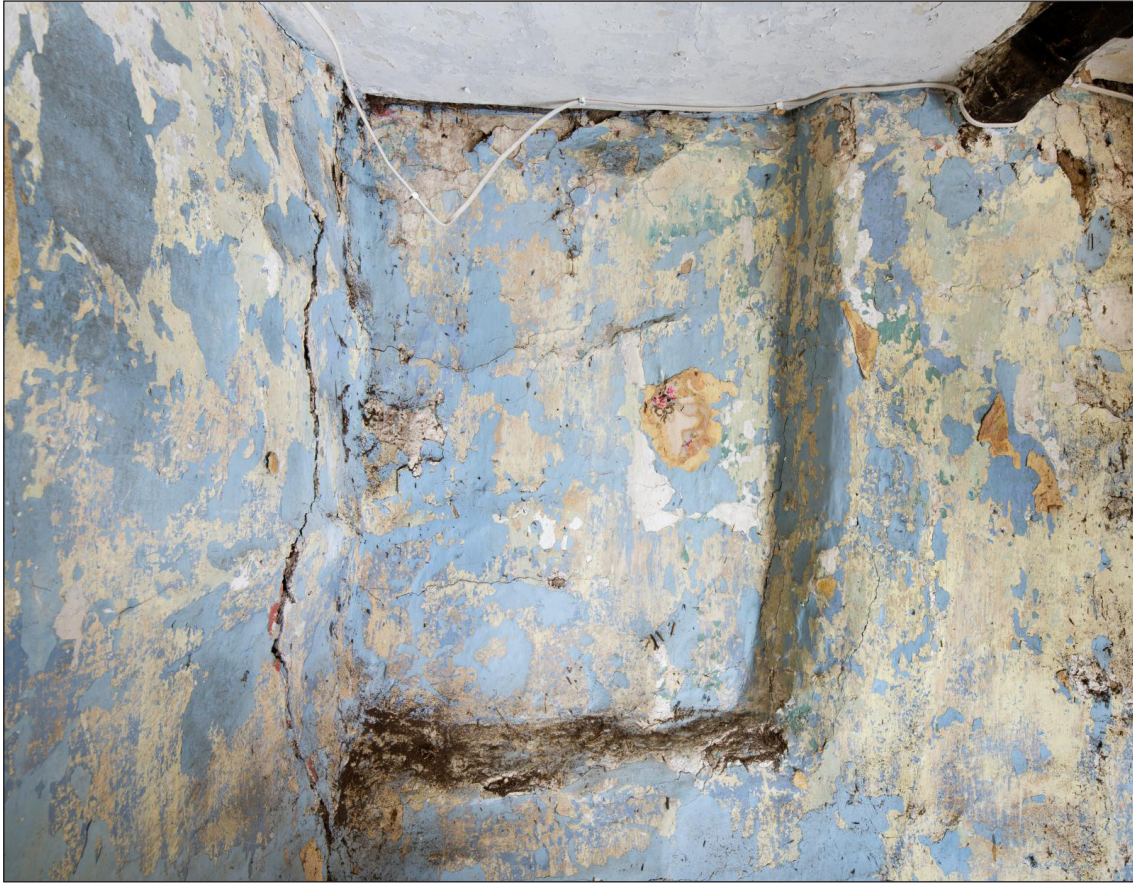
Figure 10 Recess visible in the south elevation in the hall, possibly an original window opening, looking south [DP220535]

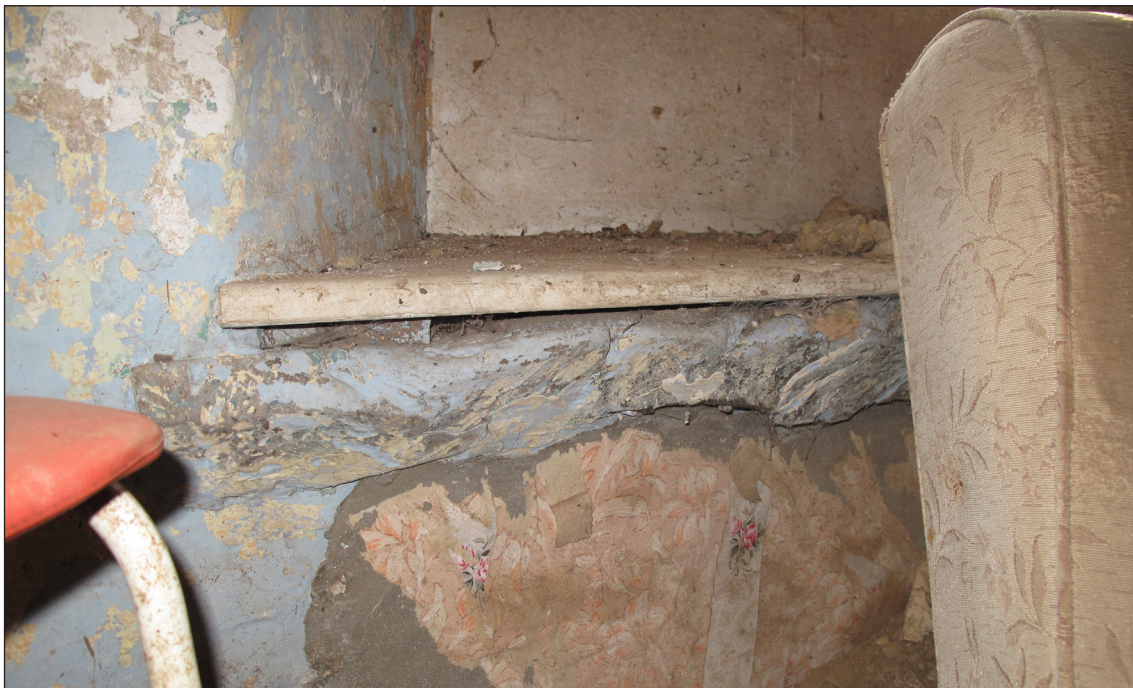
Figure 11 Earlier timber window sill visible underneath the later sill in the surviving hall window [© Historic England Rebecca Lane]

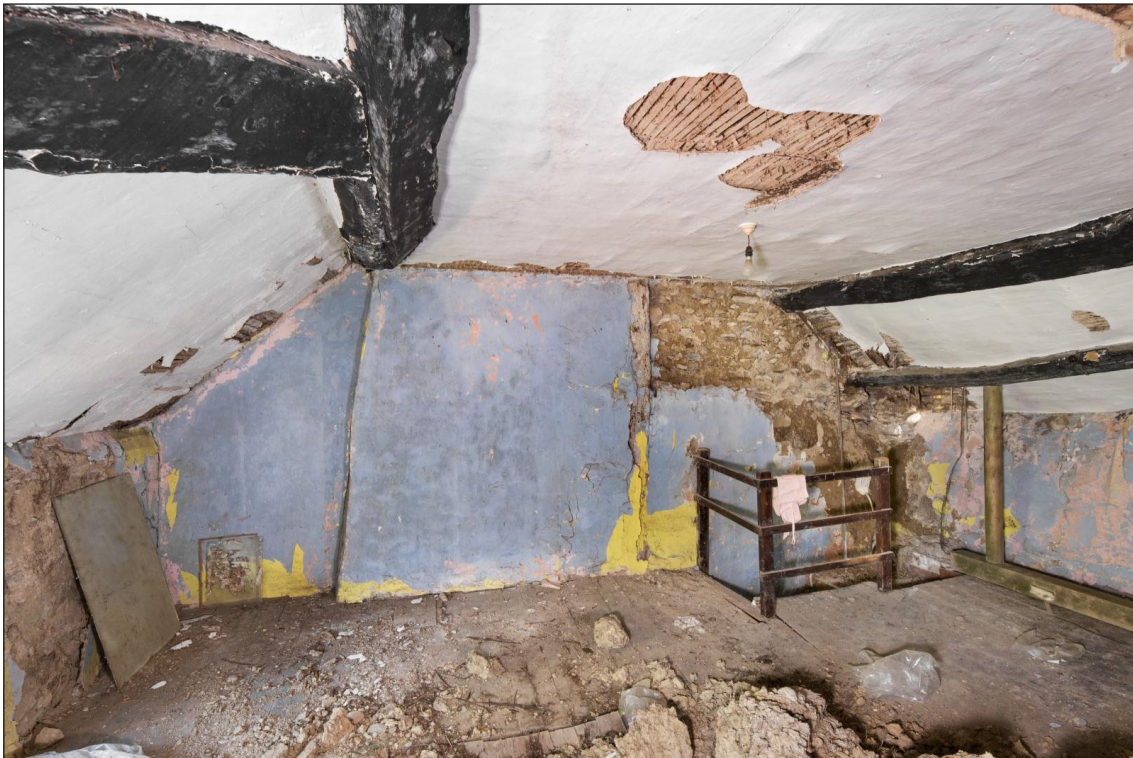
Figure 12 West gable wall, from the first-floor western room, looking west [DP220547]

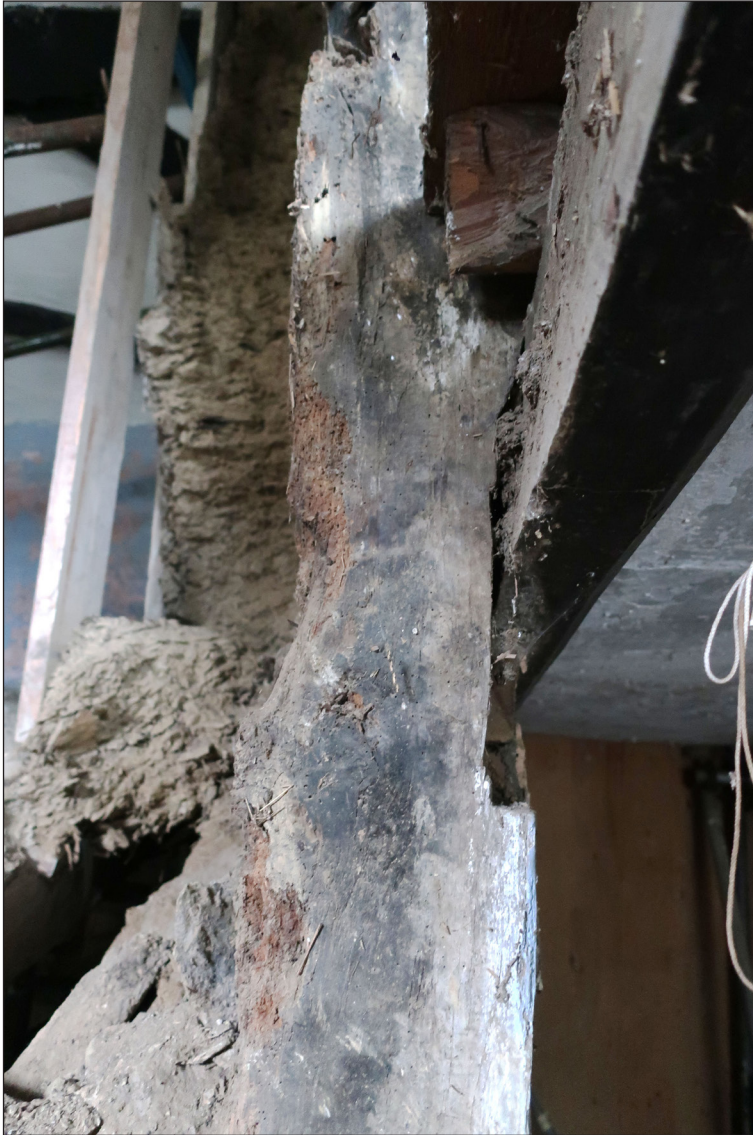
Figure 14 View of the southern side of the central post of the partition under truss A-A1, looking north, showing the joint for an original mid-rail with a smaller, later timber now in the same position [© Historic England Rebecca Lane]

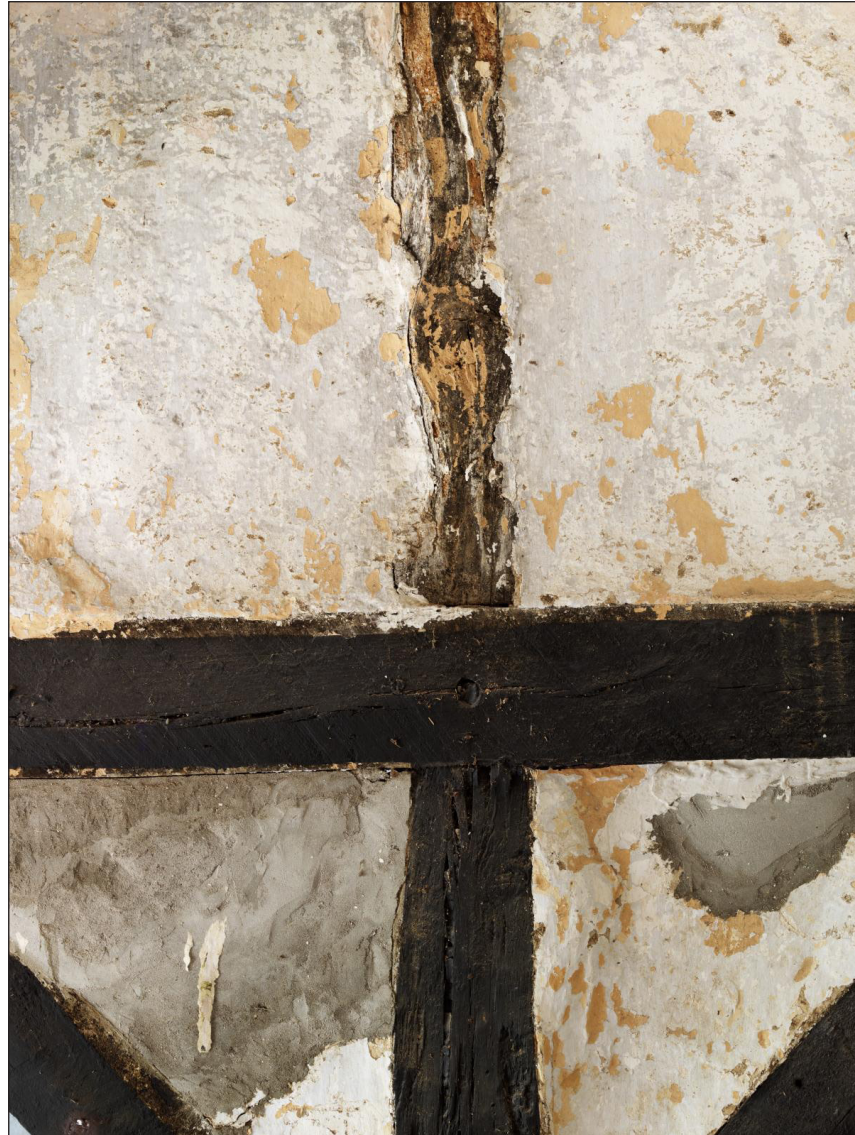
Figure 15 Eastern side of truss A-A1, looking west, showing the junction of the central post and the collar, with a large single peg joining the two [DP220759]

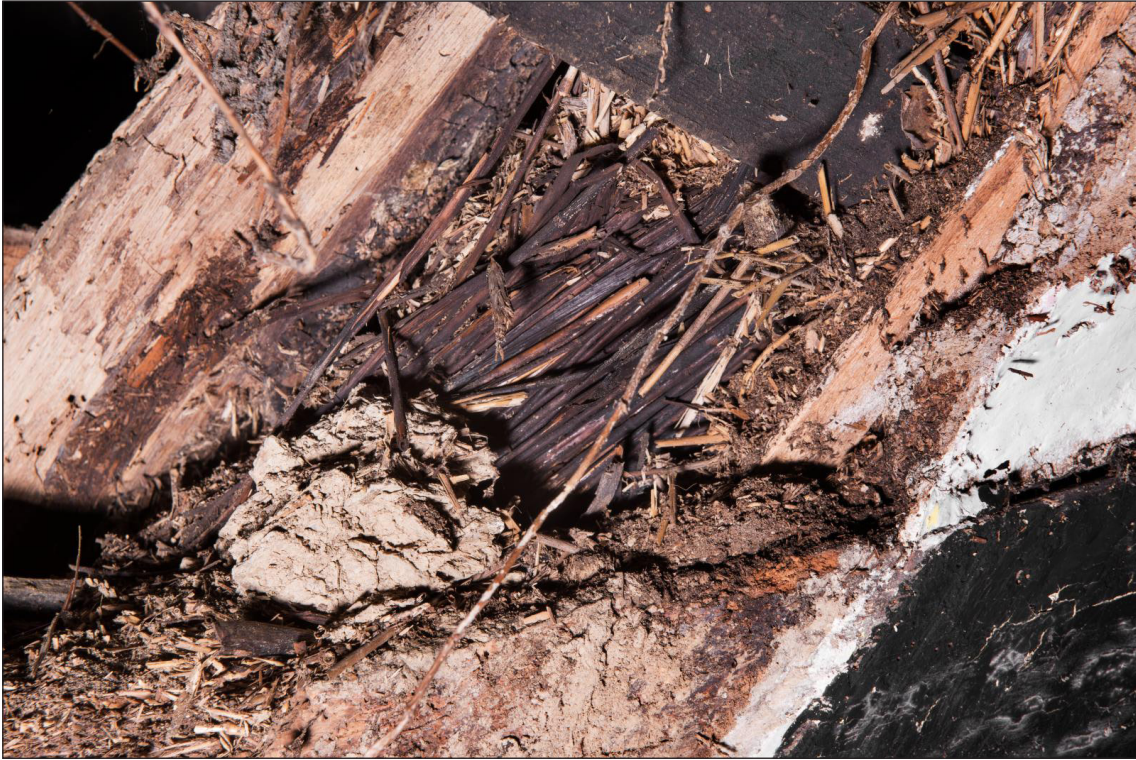
Figure 16 Surviving fragment of smoke-blackened thatch adjacent to the southern principal rafter of truss A-A1 [DP220570]

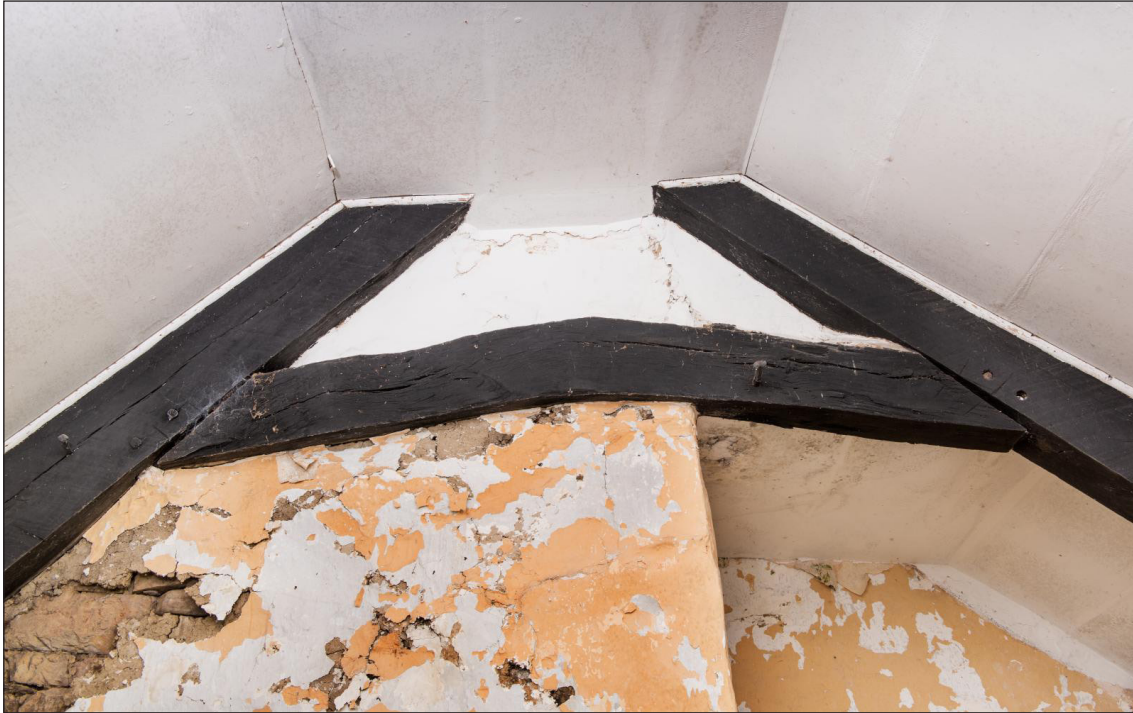
Figure 18 Upper part of truss B-B1, looking east, partially built into the later chimney breast [DP220564]

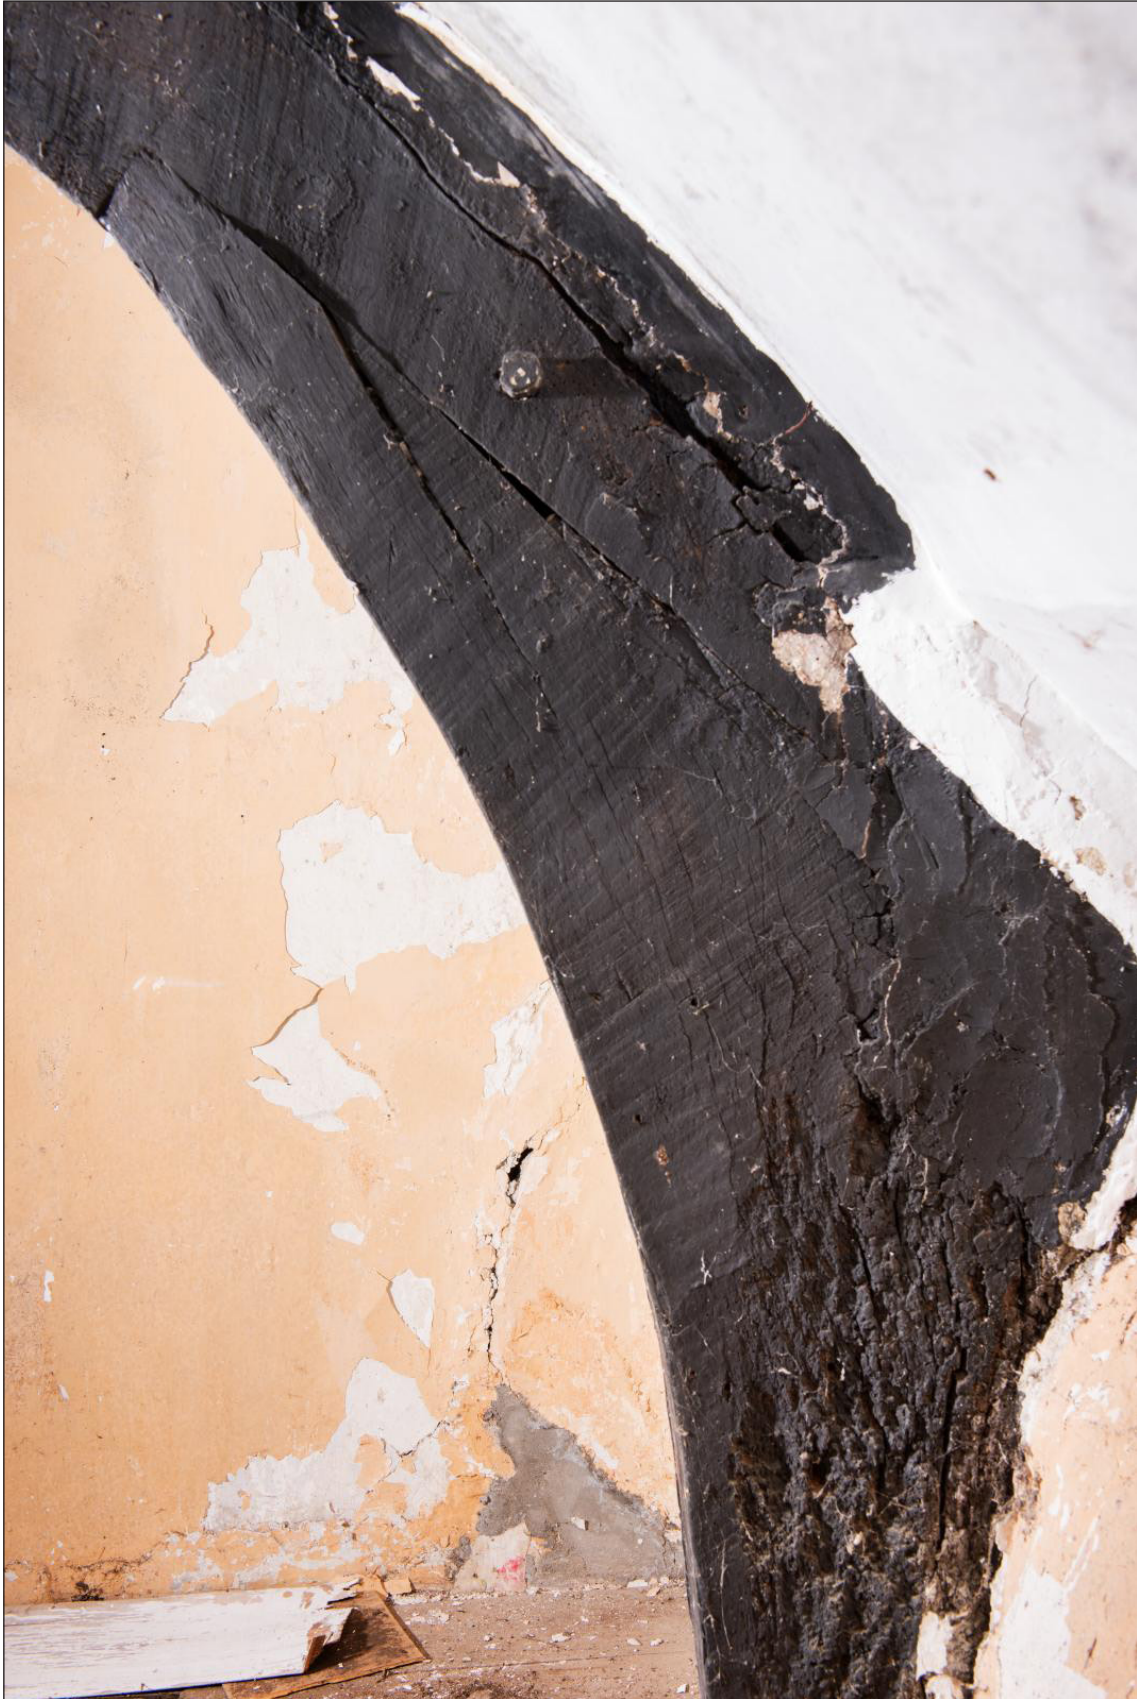
Figure 19 Western side of the southern cruck blade of truss B-B1, looking east, showing the junction of the two parts of the blade and the side pegging [DP220562]

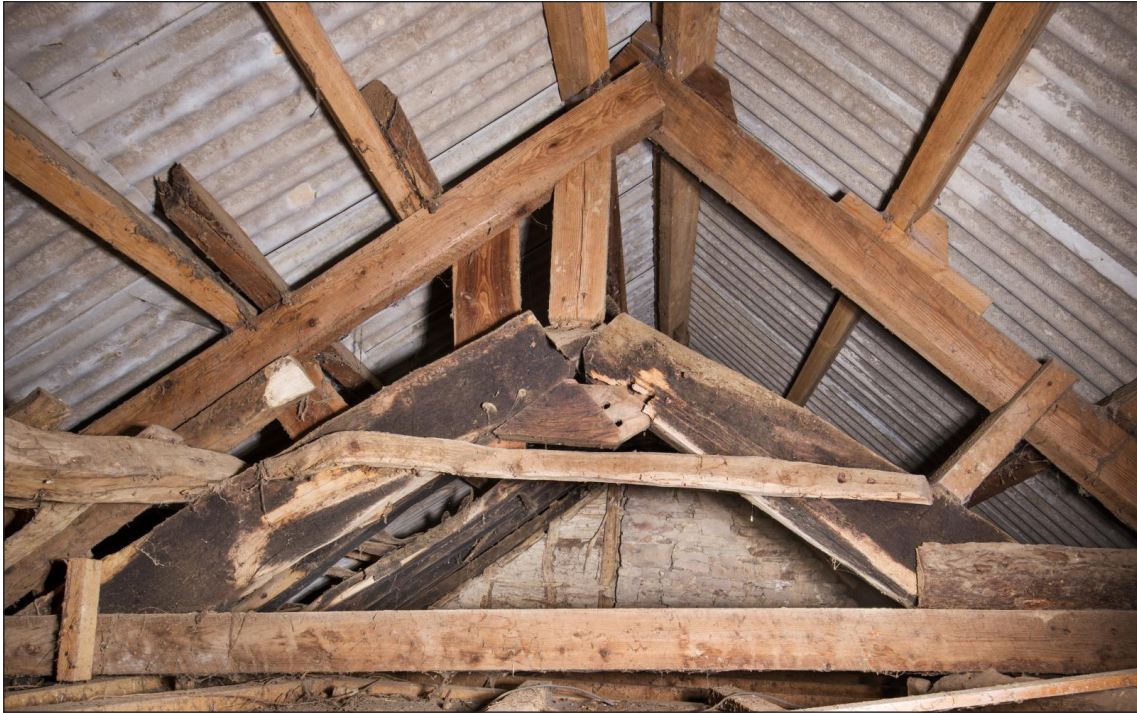
Figure 20 Apex of the eastern side of truss C-C1 as viewed from the linhay looking west, showing the yoke which joined the two blades together. The original truss is distinguished from the later timber by the surviving smoke blackening on the timbers. Also visible are smoke-blackened common rafters on the southern side of the roof [DP220553]

Another notable alteration was the removal of the original thatch covering and replacement with corrugated iron of the roof over the farmhouse and, perhaps at the same time, the lincay. This re-roofing clearly involved the relatively wholesale stripping out of the original thatch, although small elements have survived (*see* Phase One and *see* Figure 16). Much of the corrugated iron roof is supported on modern timbers, which have been rested or fixed to the earlier roof structure in an ad hoc way (*see* Figure 20). This appears to have taken place in the later 20th century.

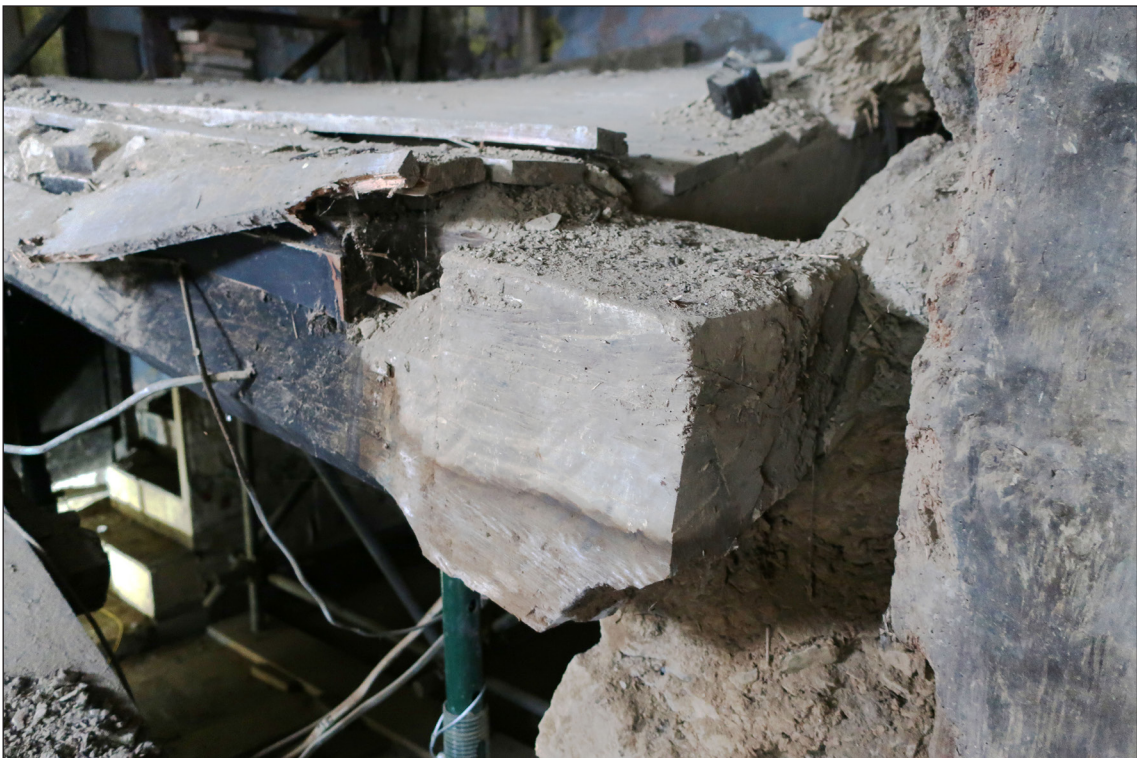
Figure 26 Detail of the east end of the inserted spine beam visible due to the collapse of the inserted cob wall, looking north west [© Historic England Rebecca Lane]

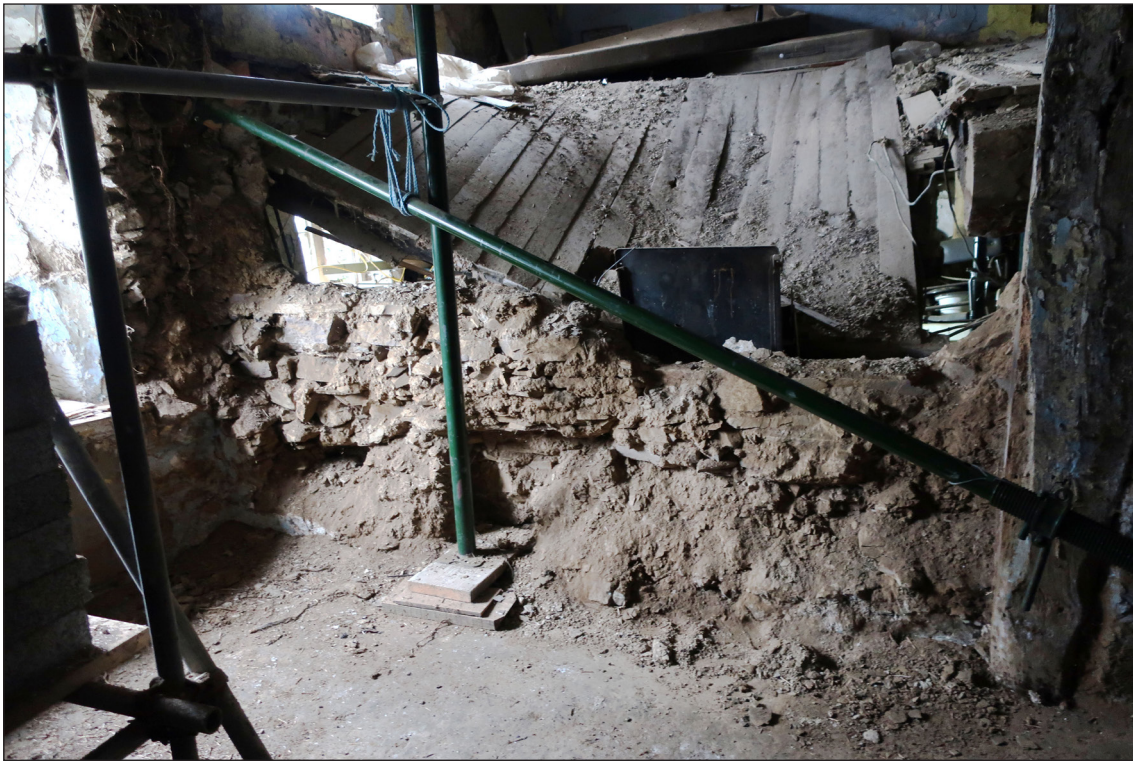
Figure 27 View of collapsed cob wall, built up against the earlier partition under truss A-A1, looking west [© Historic England Rebecca Lane]

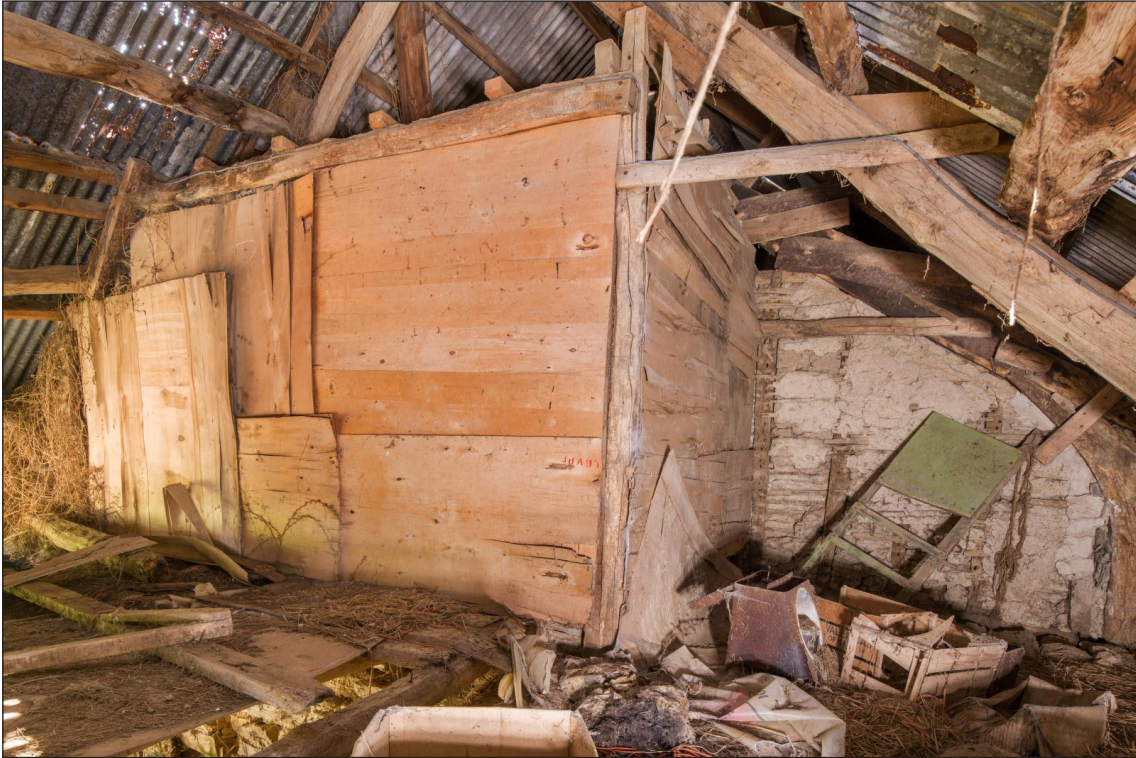
Figure 32 Partition between the former east first-floor room and the cross passage, looking west. Note the plaster visible on the eastern side of the partition wall immediately adjacent to the original northern cruck blade, on the right-hand side of this photograph [DP220519]

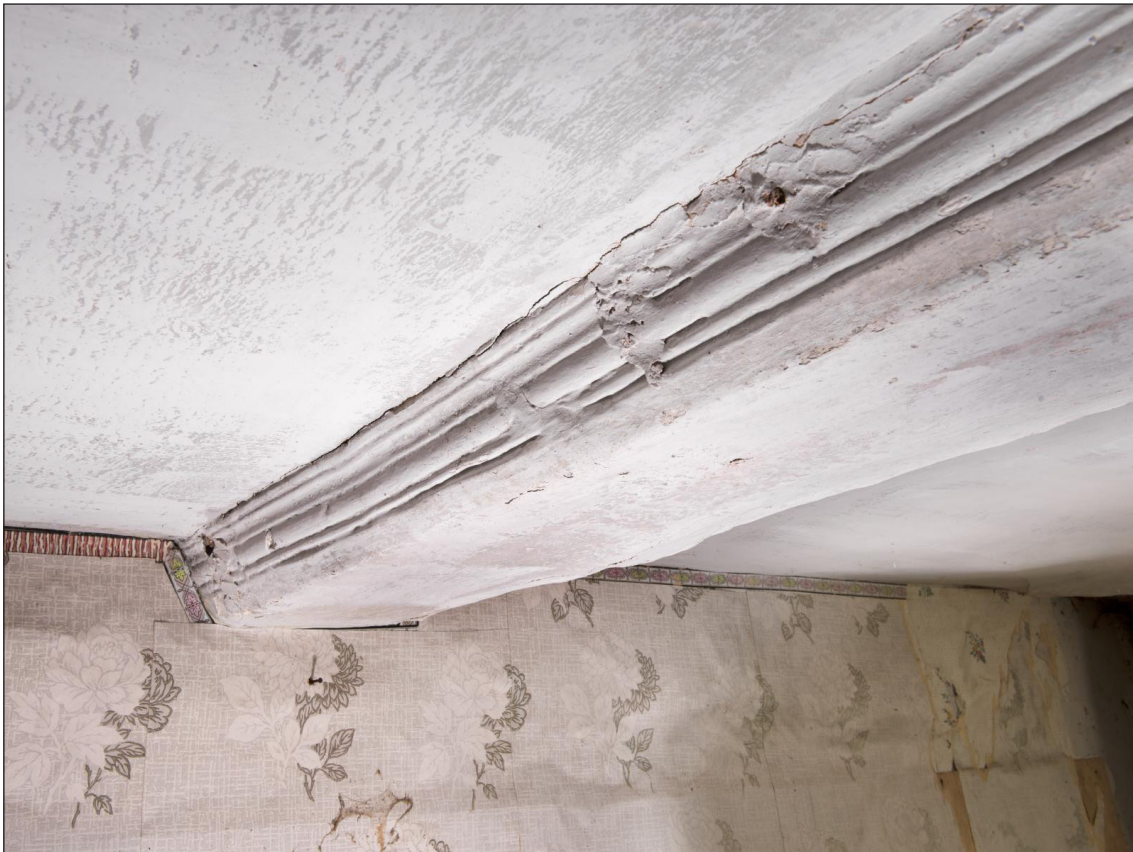
Figure 34 Encased spine beam in the eastern ground-floor room, looking south east. Note the residual plasterwork on its northern face [DP220560]

On the northern side of the spine beam some residual decorative plasterwork can be observed. This is the only element surviving within the ground-floor room, and it is absent from the southern side of the same beam. Dating this feature is extremely difficult but enriched plasterwork was a feature of late 16th- and early 17th-century farmhouses in Devon and it might be tentatively suggested that this could form a residual part of such a scheme (Thorp 1990, 131). If so, it would suggest that this end of the building became much higher in status following the creation of the upper floor. This again is a common feature of the way that older farmhouses were upgraded in the period, with first one end and then another receiving investment and becoming the higher-status rooms in the house. Such suggestions remain extremely tentative however, as there is so little evidence surviving.

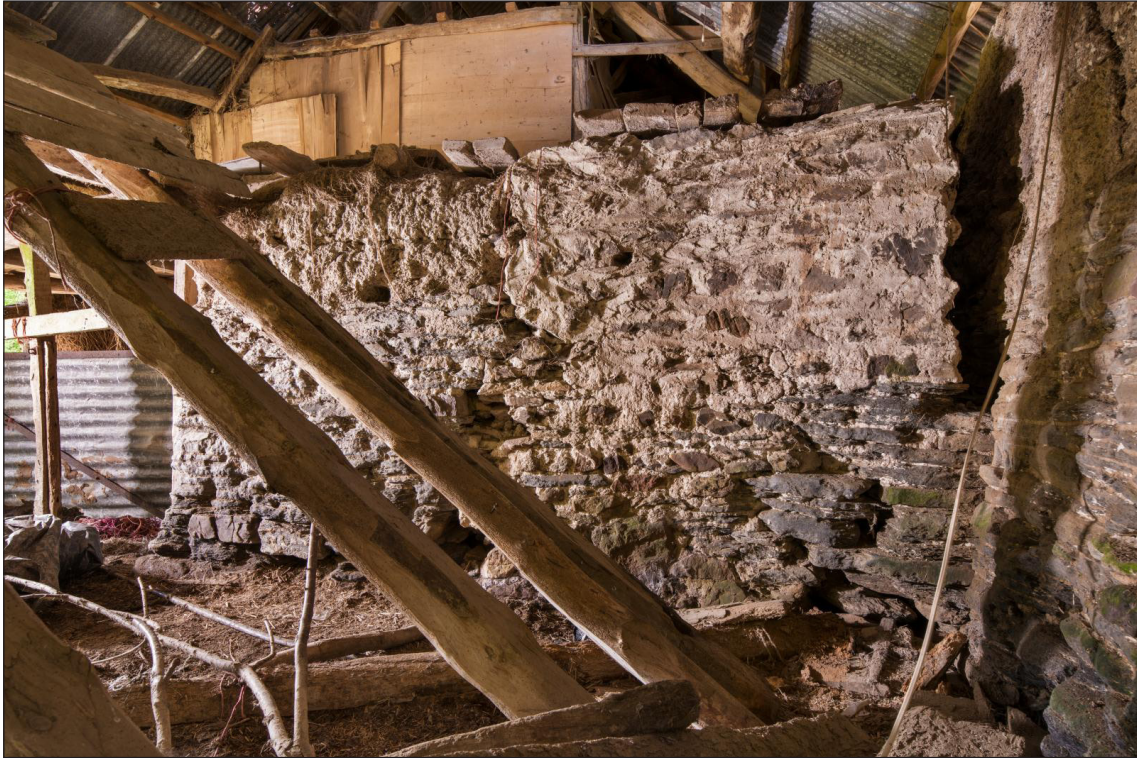
Figure 45 View of the former west wall of the linhay, looking west. The section to the south (left-hand side) appears to be formed of stone and cob, with the section further north formed of stone, the upper part of this is probably a later reconstruction [DP220520]

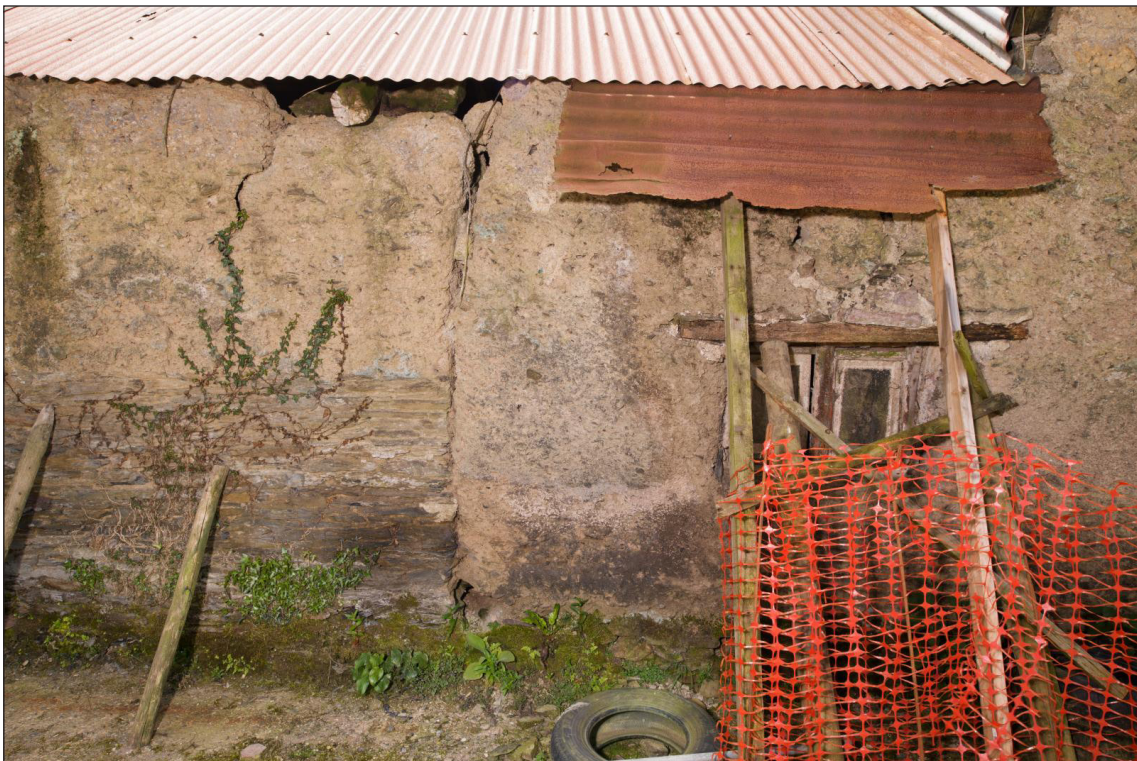
Figure 46 The north elevation of the linhay and farmhouse, looking south. Note the straight joint between the wall of the linhay and the wall of the farmhouse, and the significant difference in the height of the stone plinth between the two [DP220511]

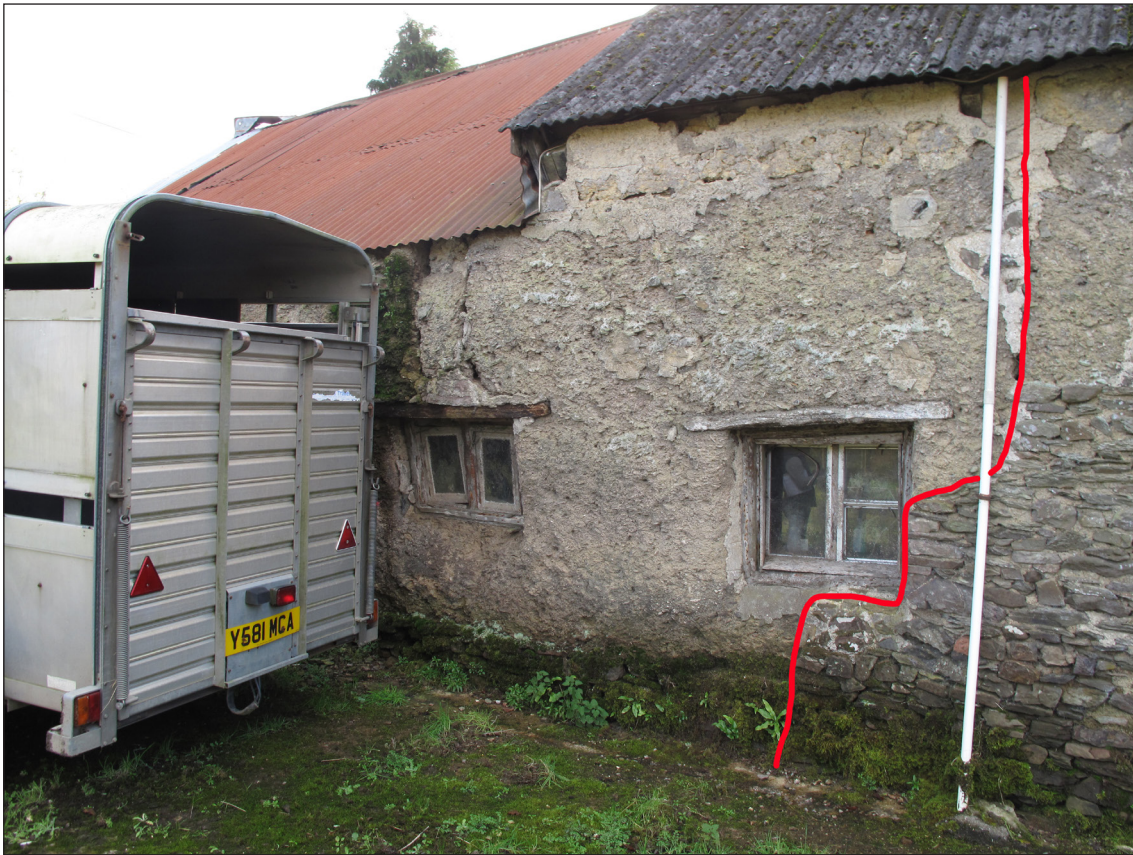
Figure 52 North wall of the farmhouse, looking south east. The uneven junction between the fabric of the original north wall and the later infill section of walling is marked with a red line [© Historic England Rebecca Lane]

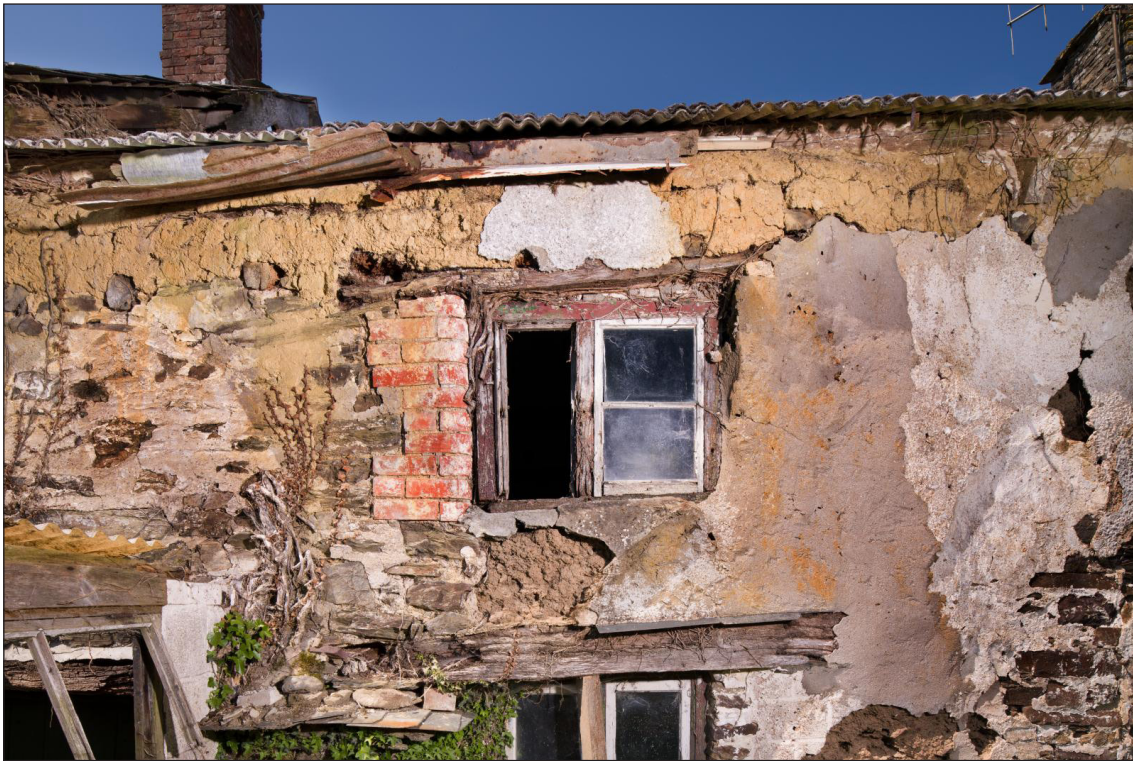
Figure 57 Window of the first-floor western room, looking north. Note the rebuilt western jamb in red brick with bull-nose profile [DP220528]

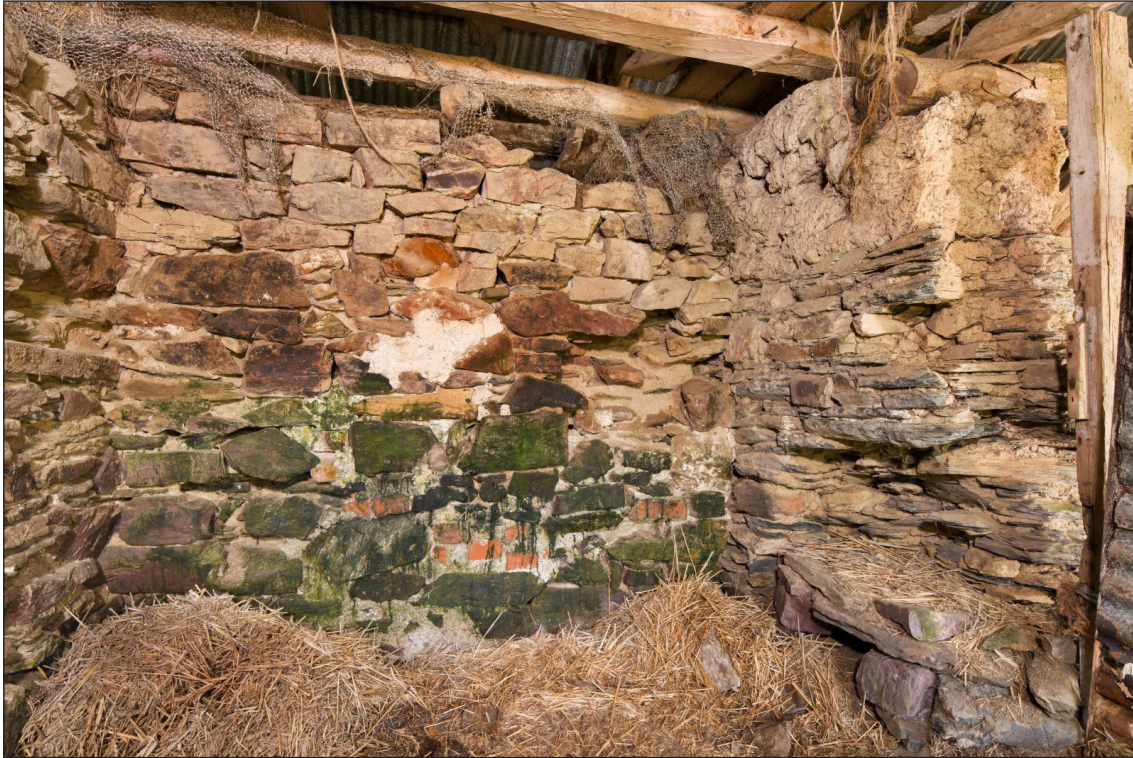
Figure 58 Rebuilt section of walling abutting the former west wall of the linhay, showing inclusions of bright red brick at low level, looking north east [DP220525]

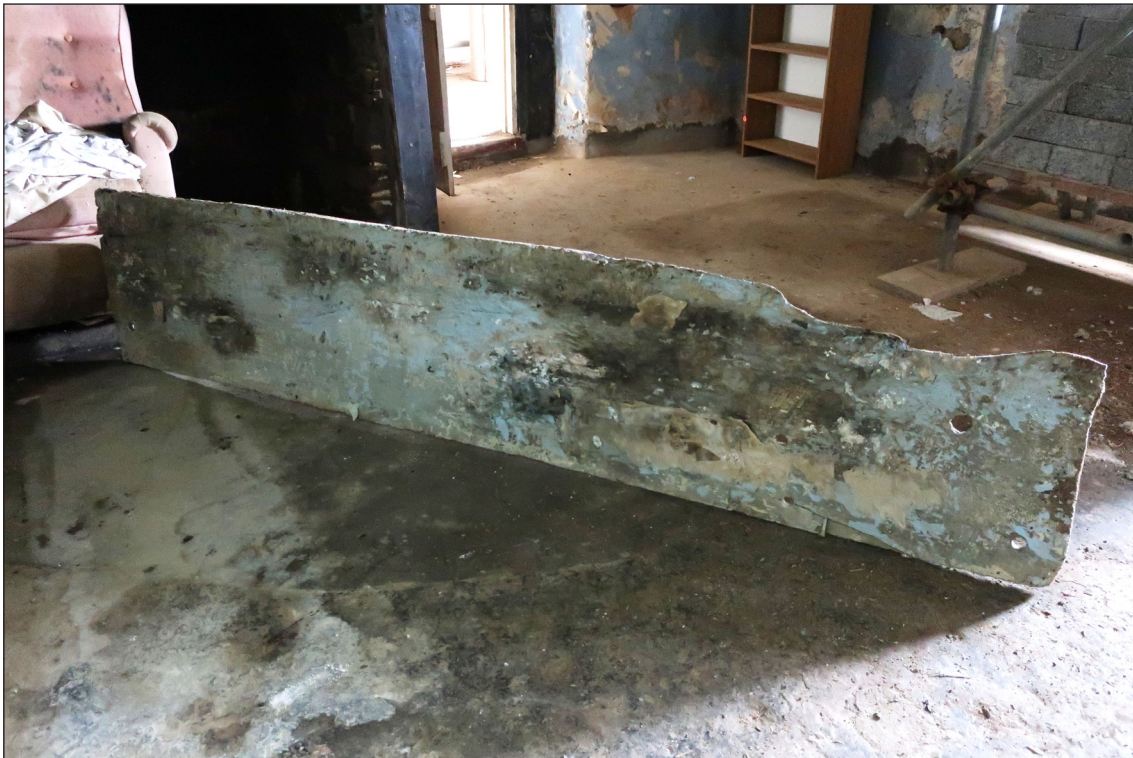
Figure 61 Timber plank found within the cob walling under truss A-A1 (Investigator photograph)

One notable survival has emerged from the programme of consolidation undertaken on the building in late 2019. During the removal of the collapsed cob walling (the southern part of the cob wall built under truss A-A1), a large plank was discovered and has been retained in the building (Figure 61). It is not clear exactly where it sat within the cob wall prior to the collapse. This measures 2.68m by 0.55m at its widest extent, although one end appears broken or slightly narrowed. It has several holes, some of which look like deliberately cut peg holes. The two smallest holes sit towards one edge of the plank. It seems unlikely that these peg holes relate to its use within the wall, which suggests that the plank was reused within the cob wall.
