St Wilfrid's Church, North Muskham Investigation of Evidence for External Render and Statement of Significance

**ST WILFRID'S CHURCH
NORTH MUSKHAM
NOTTINGHAMSHIRE**

**Investigation of Evidence for External Render and Statement
of Significance**

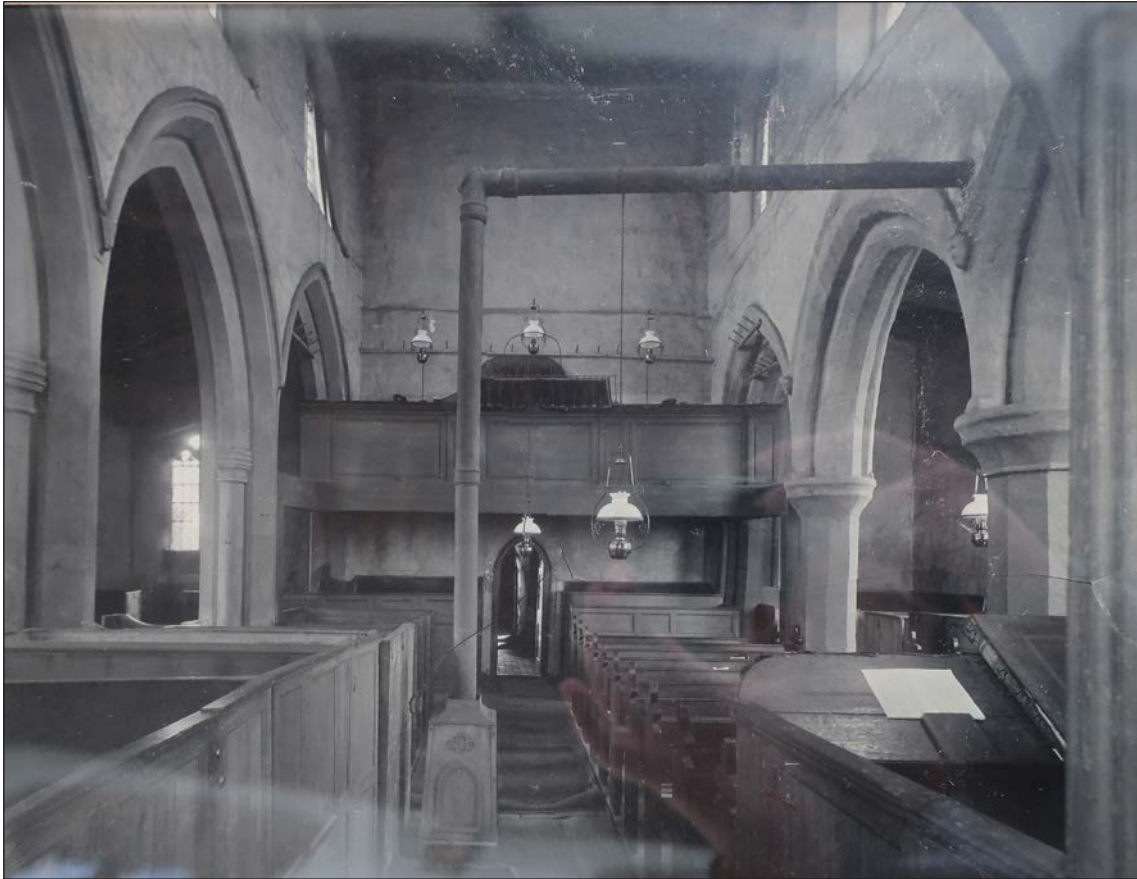
Figure 13: Church interior looking west c. 1900, note the infilled tower arch with the gallery above and surviving box pews [St Wilfrid's North Muskham PCC]⁷⁴

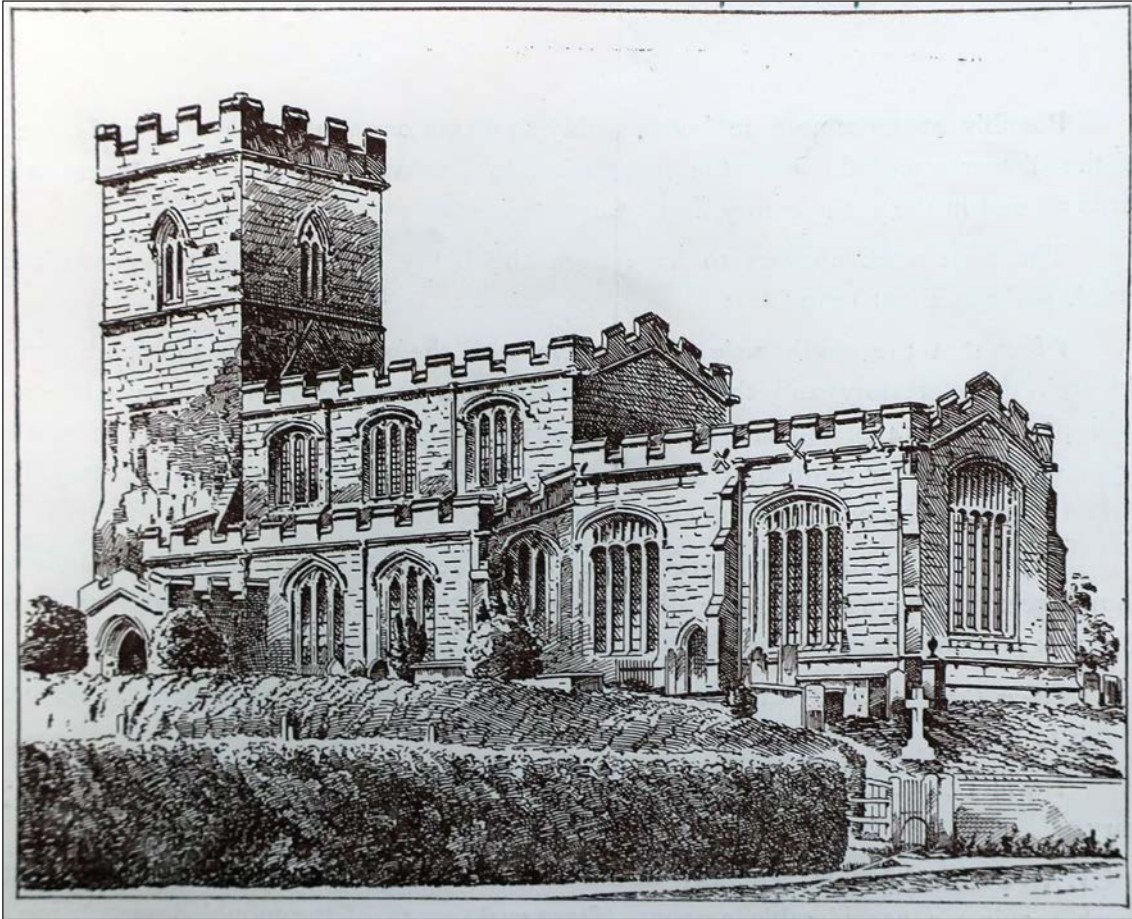
Figure 14: Drawing of St Wilfrid's North Muskham, 1904, note the hashed lines suggesting render on the lower stage of the tower. [Nottinghamshire Archives DR/1/1/2/1711A/15]

As a drawing, there is always a degree of interpretation and artistic licence which may put question to the accuracy of this representation. However, in the case of St Wilfrid's there is supporting evidence in the form of undated photographs which have recently been located by the churchwarden.⁹⁵ These photos show both the interior and exterior of the church as it was in around 1900, and one of which illustrates the condition of the tower prior to the restoration works in 1907 (Figures 15 and 16). It is clear from this photograph that the lowest stage of the tower was, at that time, covered with render, albeit in a degraded condition and largely flaking away. Although this photograph cannot tell us when this coating was applied, it is reasonable to conclude from its appearance that it had been on the tower for quite some time. It would also appear from this photograph that the render, though much degraded, had been applied only to the rubble masonry of the lowest stage and was cut in around the coursed masonry of the quoins, buttresses and window surrounds.

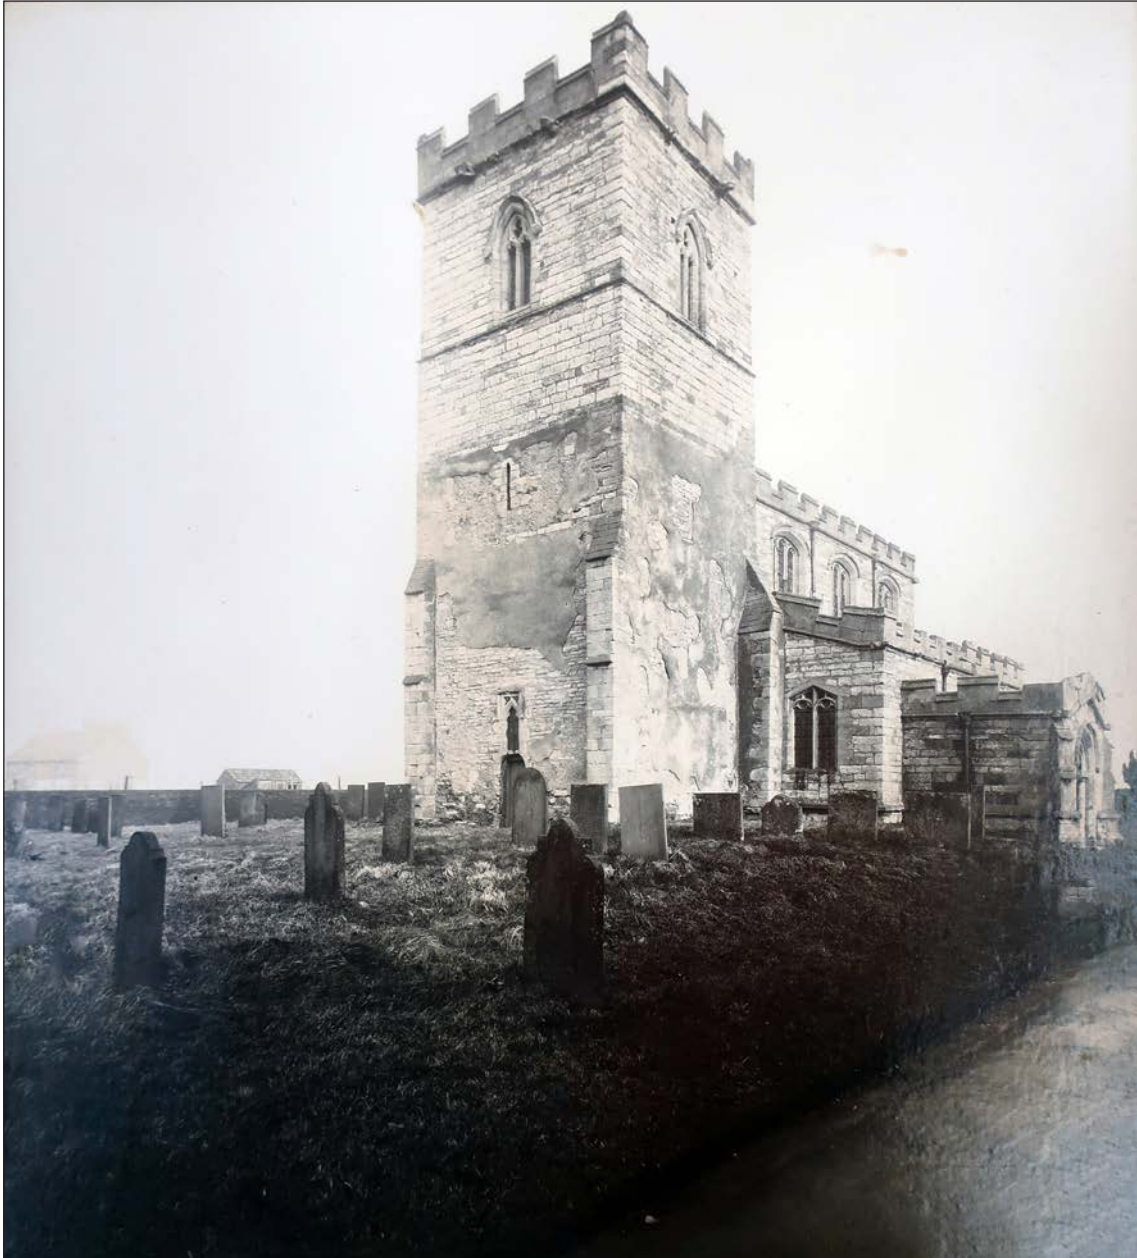
It is fortunate therefore, that the records for St Wilfrid's North Muskham include clear reference to the existence of external render on the tower. Hodgson Fowler's 1904 report made reference to the need to remove and replace the render on the exterior of the tower's lowest stage. Specifically, the report states that

This [the tower] is generally in fair condition, but the exterior of the lower part must be re-plastered and its stonework repaired in places, while the upper part needs repointing and some new stonework.⁹²

Figure 15: Undated photograph (estimated to be c. 1900) showing render on the exterior of the tower [St Wilfrid's North Muskham PCC]

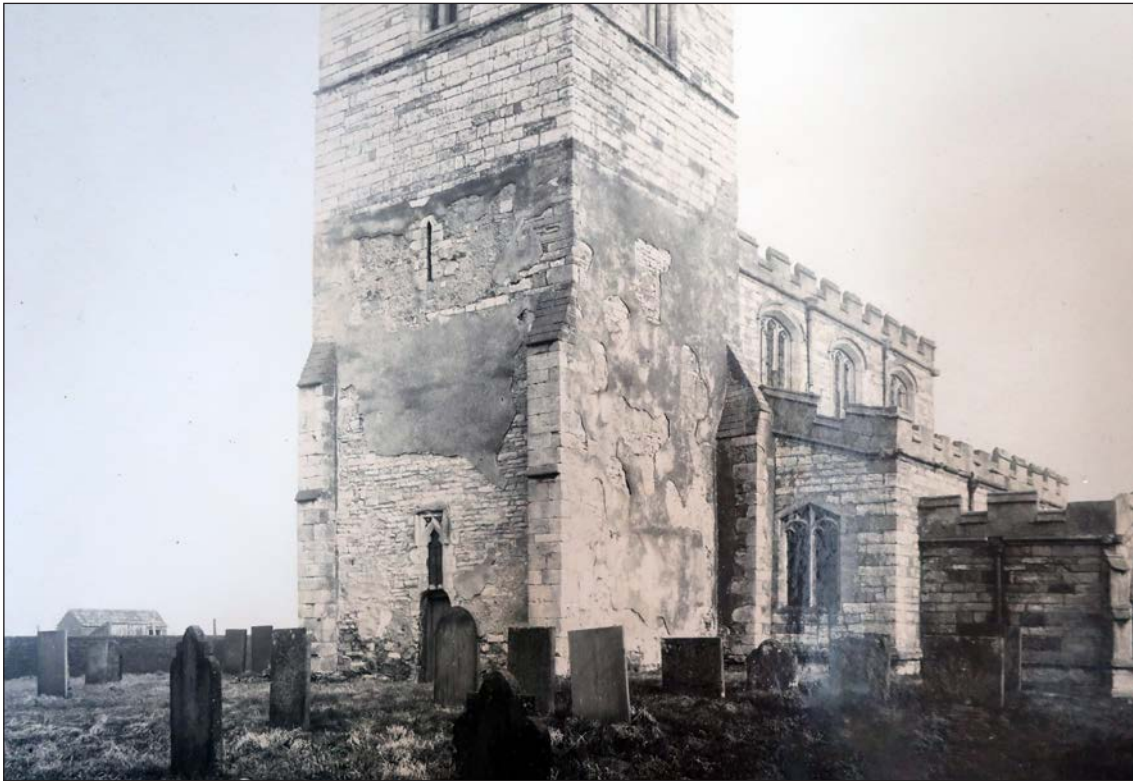
Figure 16: Undated photograph (estimated to be c. 1900) showing render on the exterior of the tower (detail). Note also the now blocked door in the western elevation. [St Wilfrid's North Muskham PCC]

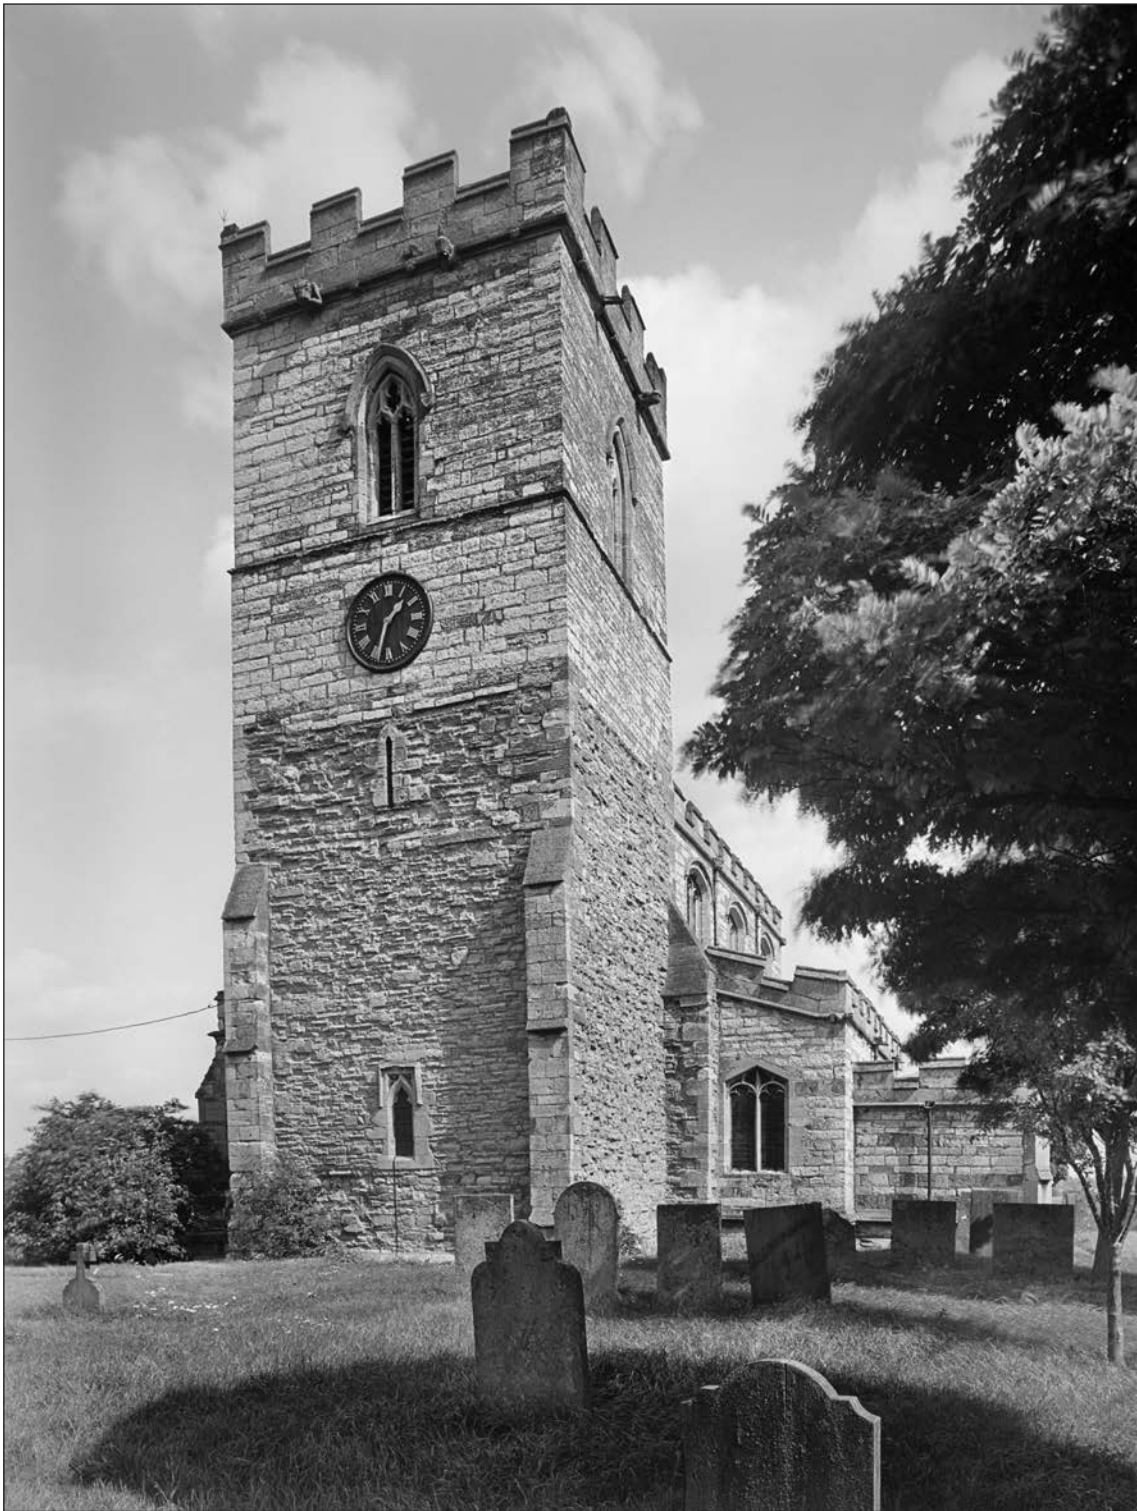
It appears that despite Hodgson Fowler's instructions, this was never actually carried out and there is no evidence of the church having been externally rendered after the 1907 restoration. Though it is possible that render was applied as per the faculty application and then subsequently removed. Photographs of the church taken by F J Palmer in 1950 for the National Monuments Record, now the Historic England Archive, show that by that date there is no sign of external render on the tower (Figure 17). It is unlikely that the render would have completely fallen away between 1907 and 1950, and no records indicate that it was removed during this period, so presumably it was never reapplied in 1907.

Figure 17: St Wilfrid's, tower viewed from the west, F. J. Palmer 1950 [4680/002]
