ARCHAEOLOGICAL ASSESSMENT AND NET REMOVAL FROM THE DESIGNATED
WRECK OF THE *NORTHUMBERLAND* ON THE GOODWIN SANDS

PROJECT REPORT
2022

February 2022

Ref: 7913

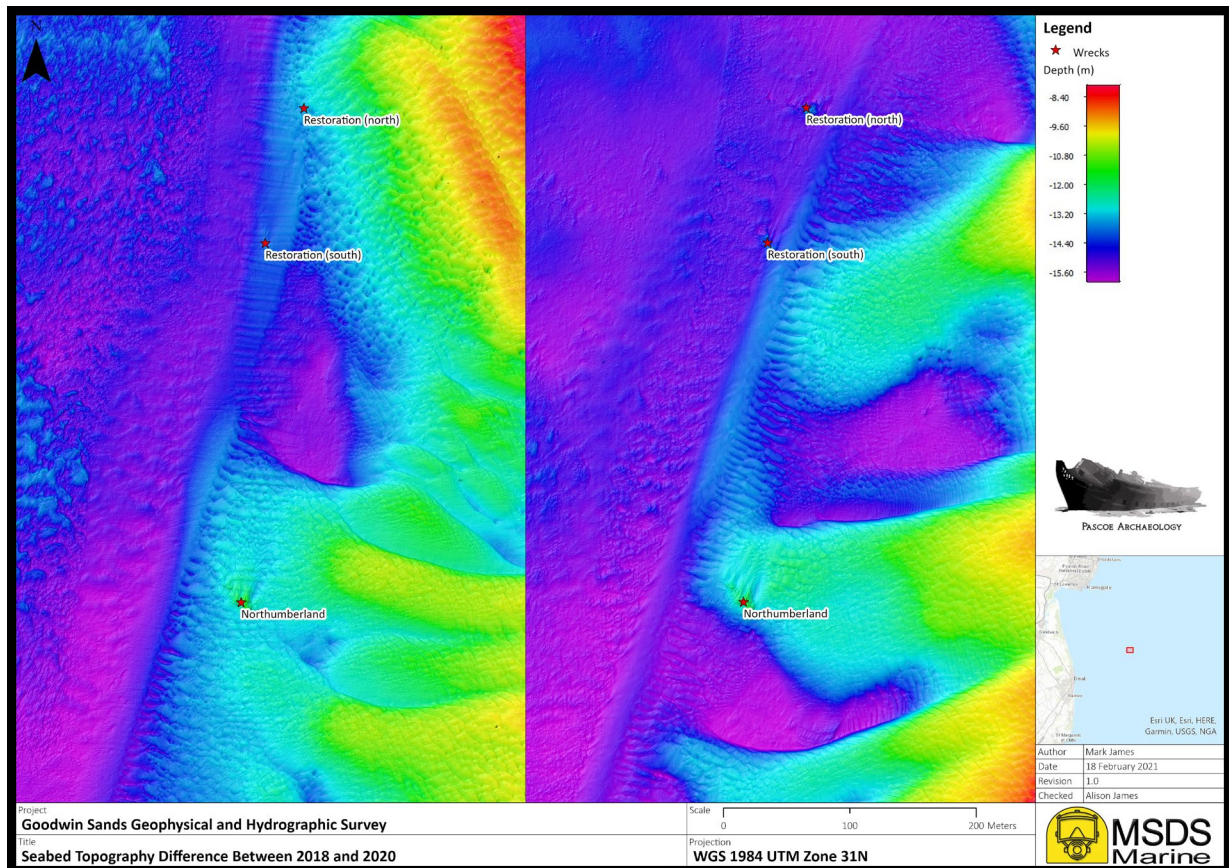
sediments resulting in new exposure of wreck material and the site situated on the very edge of a migrating dune. (PA, 2021, 21) (Figure 1). Sub-bottom data identified a depth of stratigraphy of up to 3.5m on the wreck but only 0.5m on the seabed to the west, north and south. Therefore, there is an insufficient burial environment should the dune migrate further to the northeast (PA, 2021, 32-33). These findings demonstrated the urgent need for stage 2 diving fieldwork to go ahead.

Figure 1: Comparison between the 2018 and 2020 MBES data, showing significant changes to the topography on the site.

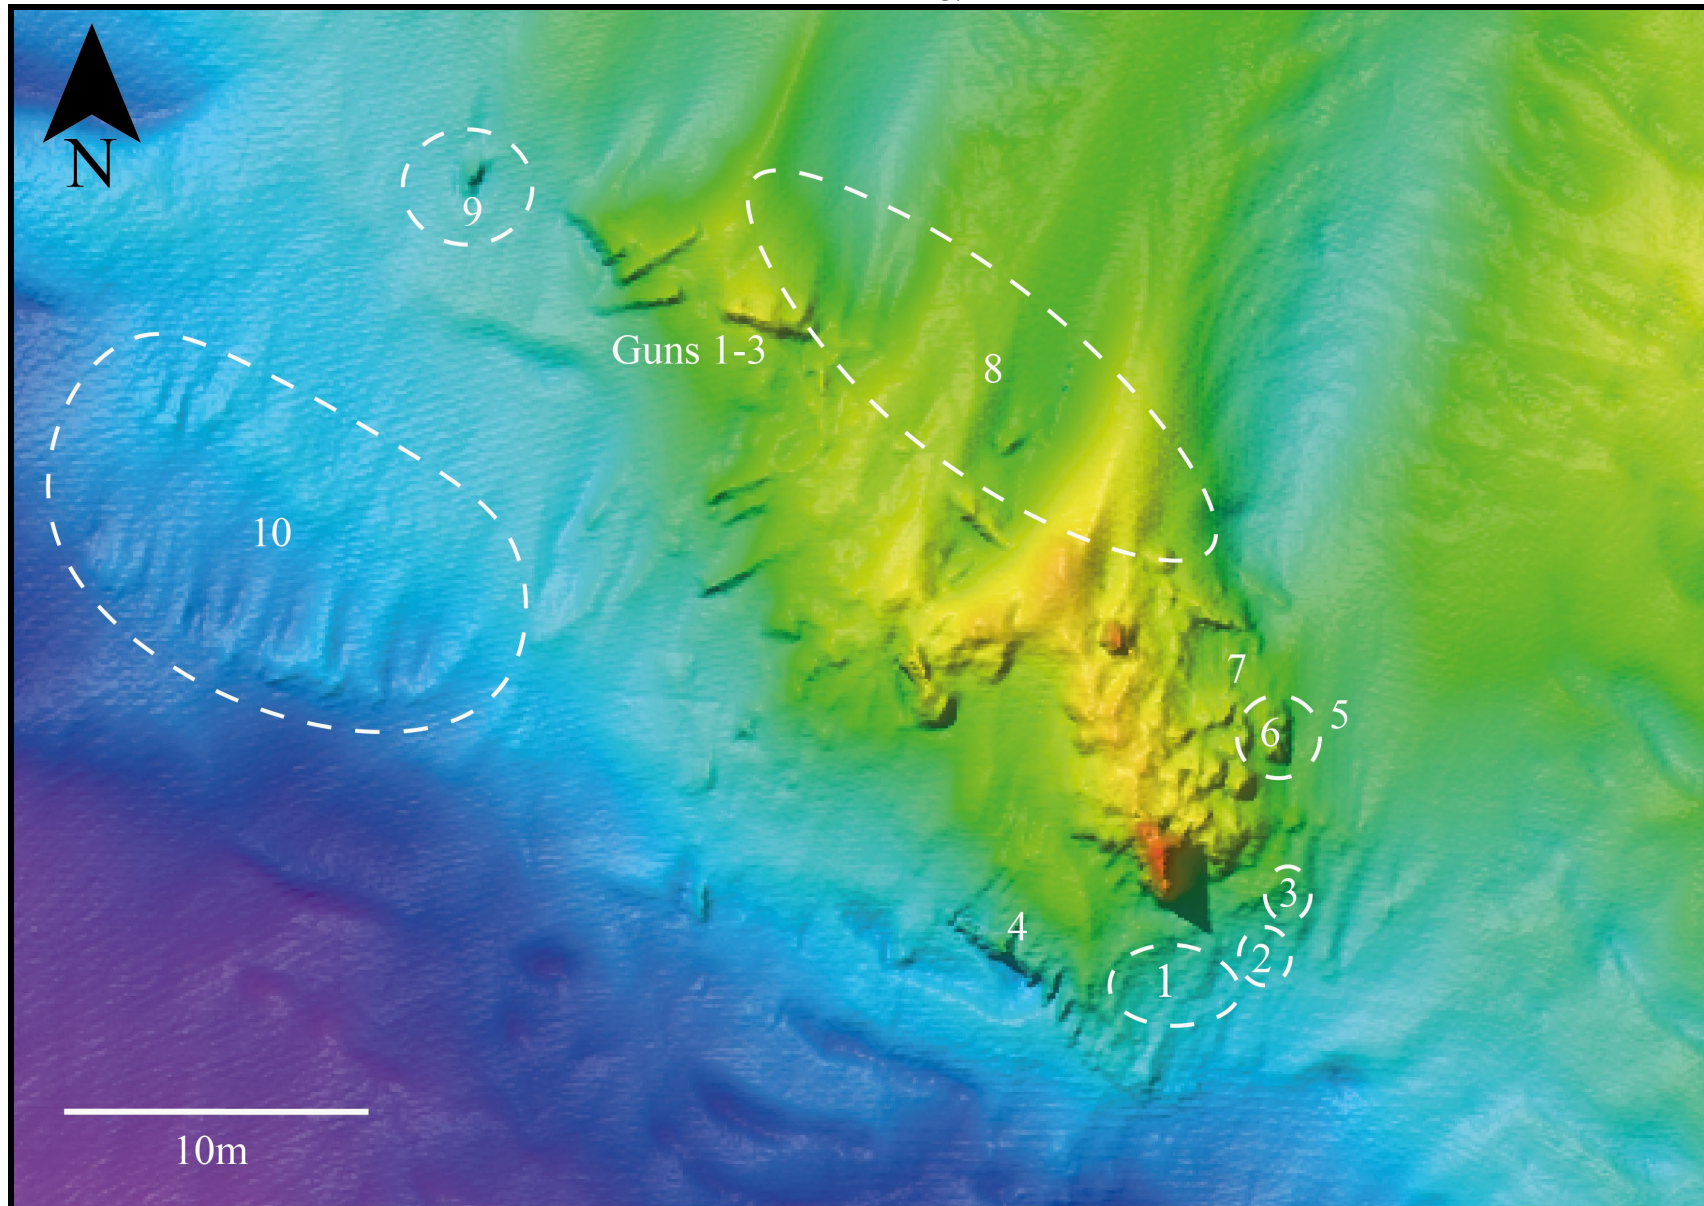
4.2.3. The interpretation of the exposed remains will start at the southeast end of the site and work systematically backwards to the extent of exposed features at the northwest end. The described features will be annotated on the 2020 bathymetry, however, many of these features were not visible when the bathymetry was recorded in November 2020. This demonstrates changes are continuous on site and considerable in a relatively short period of time. (Figure 2).

Figure 2: The 2020 multi-beam bathymetry of the wreck mound with annotations. 1. Rope area, 2. Gun with carriage, 3. Chest, 4. Keel and hull structure, 5. Cauldron, 6. Gun 4, 7. Cascabel of gun, 8. Area of guns, 9. Hand weapons, 10. Structure and netting.

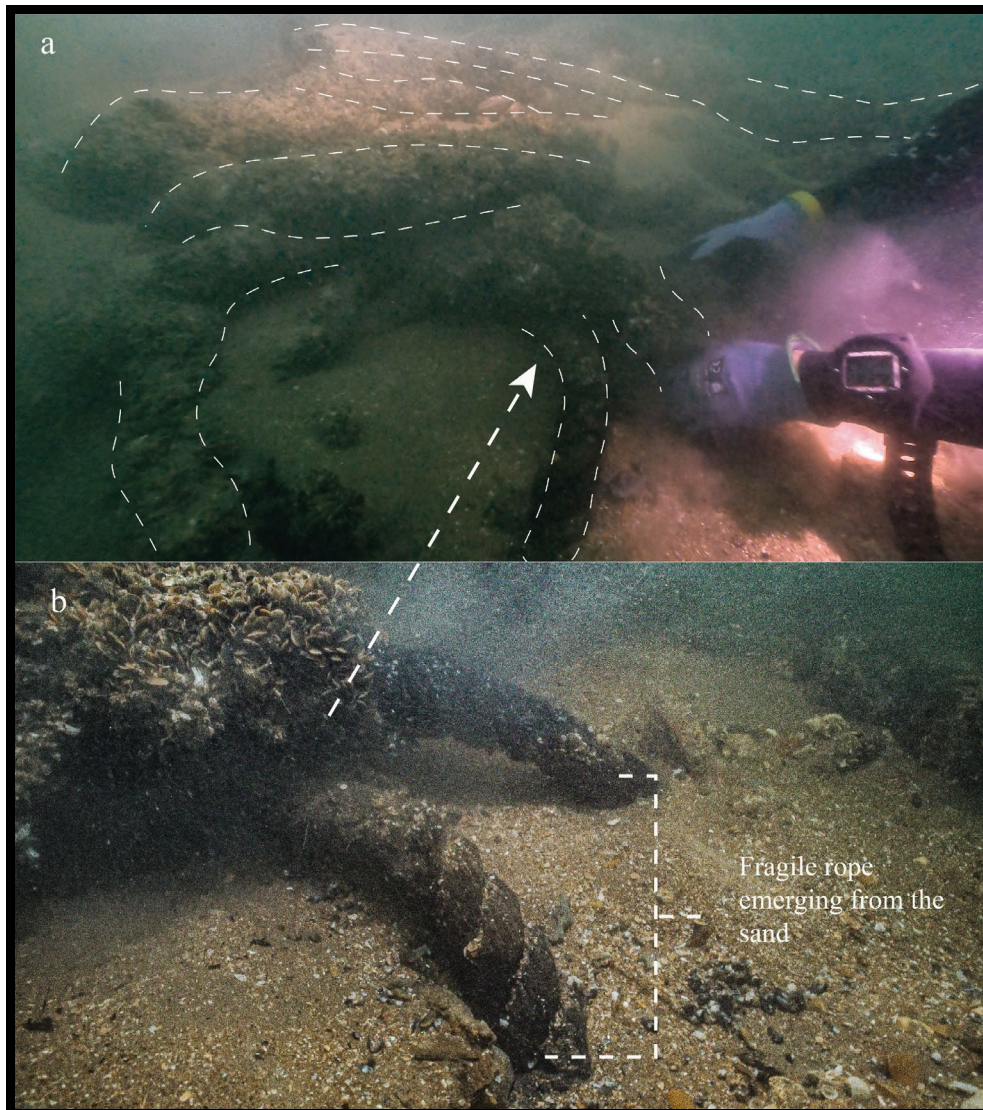
- 4.2.4. This end of the site was unrecognizable with the 2020 bathymetry with a much greater area of exposure extending southeast from the large concretion mound. Diver observations recorded an area of exposed wreck material 8m long by 8m wide. All of the exposed features were covered in a thick layer of juvenile mussels.
- 4.2.5. The mussels camouflaged much of the archaeology making identification difficult. Removal of small areas of mussels was necessary to identify the archaeology. This revealed that a significant proportion of the area consisted of coils of cordage still in a remarkable condition (Figure 3 and label 1 in Figure 2). The location of the cordage coincided with the previous licensee's site plan, which shows a mixture of different sizes of rope in neat coils southeast of the large concretion (Figure 4).

Figure 3: Image **a** partly shows the extent of the rope and how it is covered in mussels. Image **b** shows how small sections of mussels were removed to reveal well-preserved sections of rope.

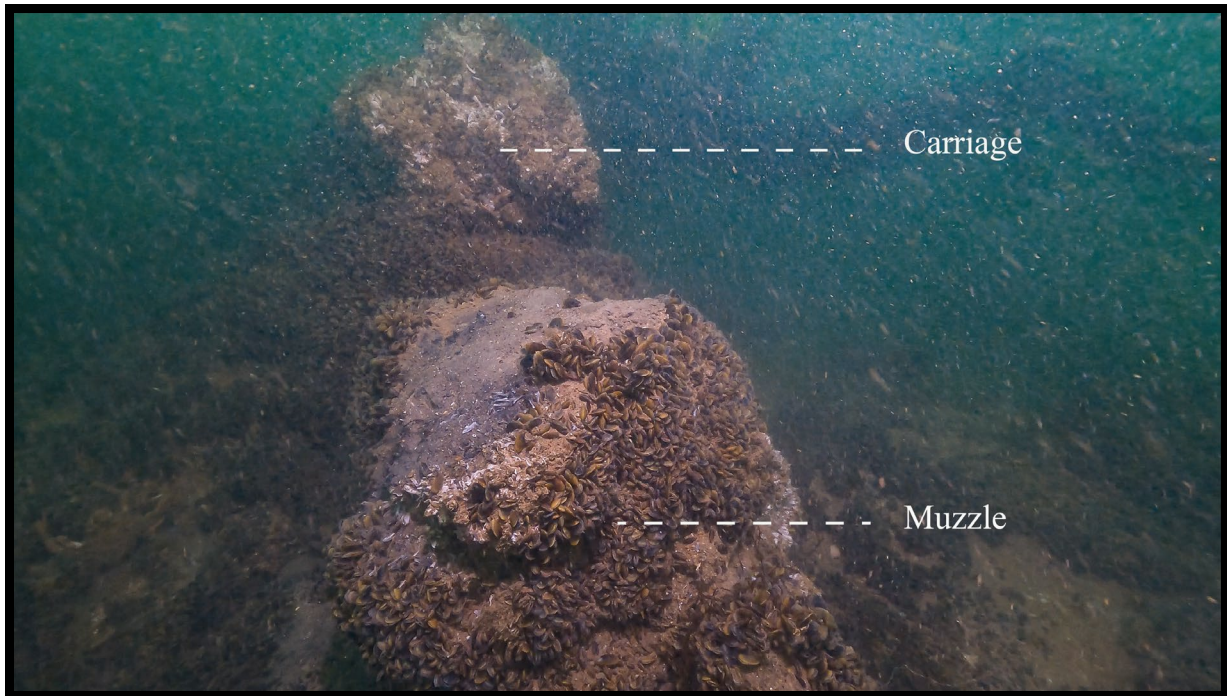
4.2.6. Heading just a few metres northeast of the area of rope was a gun heavily covered in mussels and it had part of its carriage still surviving (Figure 5 and label 2 Figure 2). The gun was lying on its side with the muzzle pointing roughly southwest and therefore its left cheek was exposed. This gun was not visible on the 2020 bathymetry and must have become exposed sometime between the November 2020 and July 2021. The gun was observed during an inspection of the whole site and the intention was to return the next day to record dimensions, however, poor visibility the following day hampered this task. From the quick inspection it would appear to be of a smaller type, possible demi-culverin or saker. Its location would appear to be slightly north of guns B3 and C4 illustrated on the 1993 sketch plan, so it is potential a gun that has not been seen before.

Figure 5: Exposed gun at southeast end of site from the view facing the muzzle.

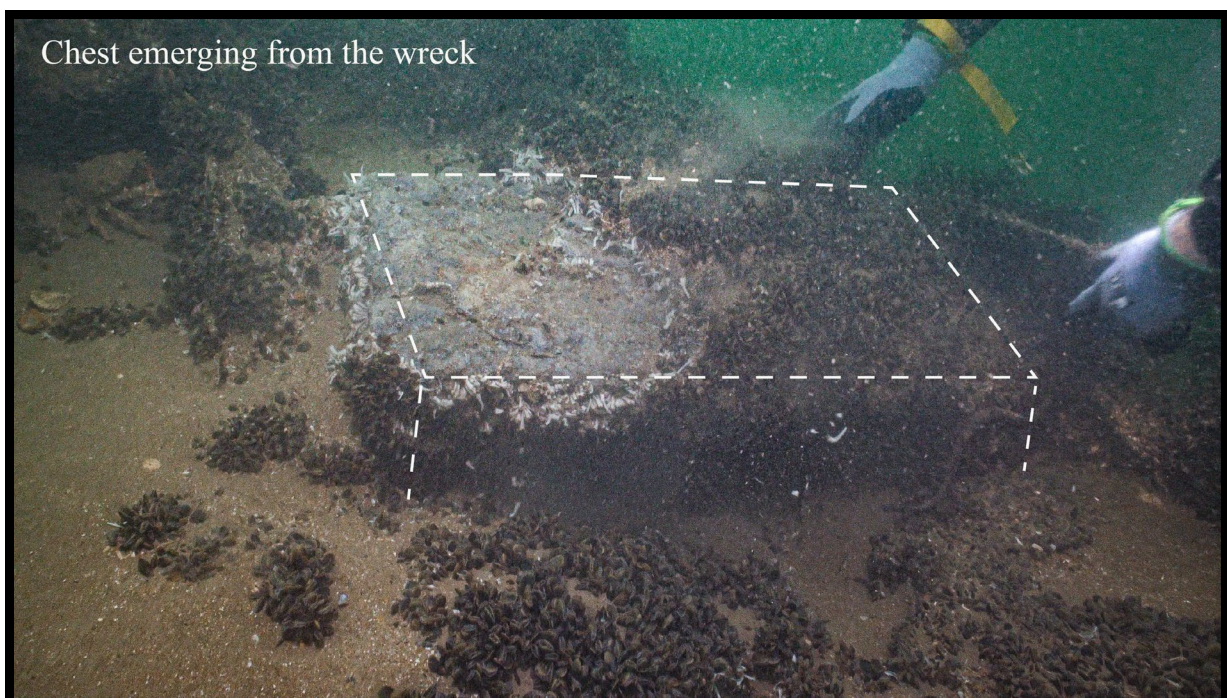
4.2.7. Within 1m of the breech end of the gun and towards the large concretion was a concreted chest. As well as being concreted it was covered by a thick layer of mussels. Although concreted and covered in mussels its form was perfectly rectangular. The top side was approximately 500 x 250mm with its sides predominantly buried (Figure 6 and label 3 Figure 2).

Figure 6: Concreted chest at the southeast end of the site.

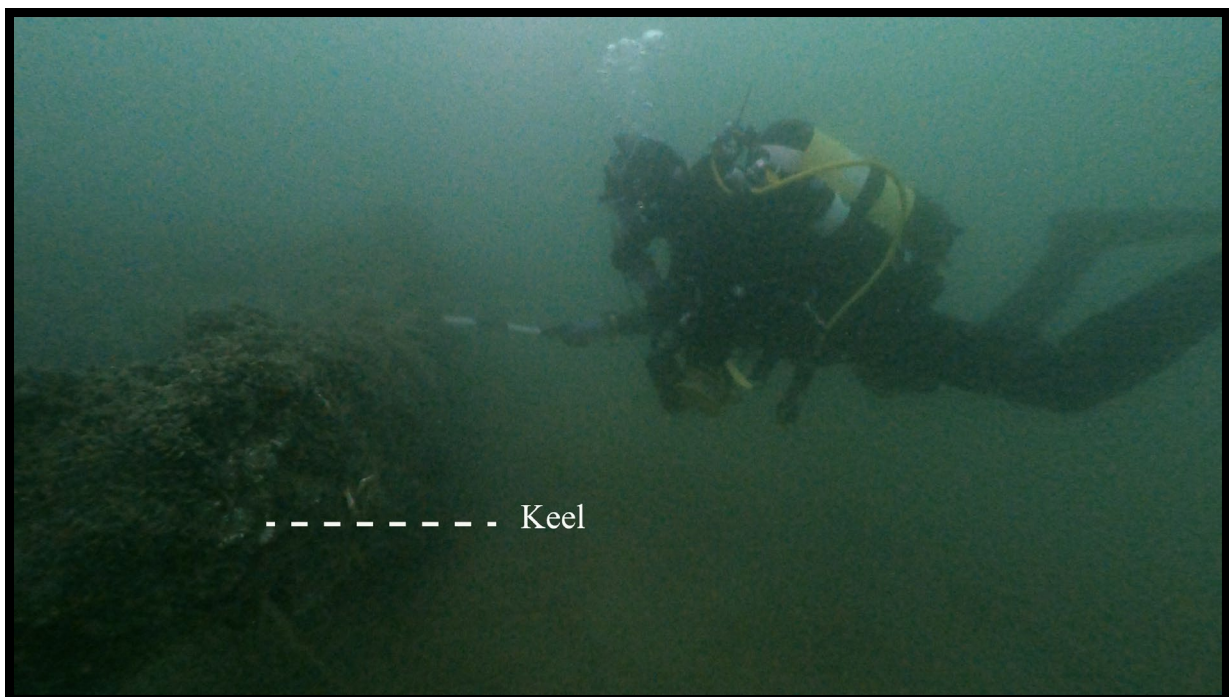
- 4.2.9. This section of structure is exposed for approximately 10m. The keel is orientated NW/SE and rises out of the sand at the northern end (Figure 7). The floors and futtocks are orientated NE/SW and were seen extending back to the large concretion (Figure 8). All of the exposed structure is heavily covered with fishing net and mussel growth. The level of netting and mussel growth meant it was not possible to gain measurements in the time available but much of it has been recorded in 2008.

Figure 7: Diver adjacent to the keel at the end of exposed lower hull structure.

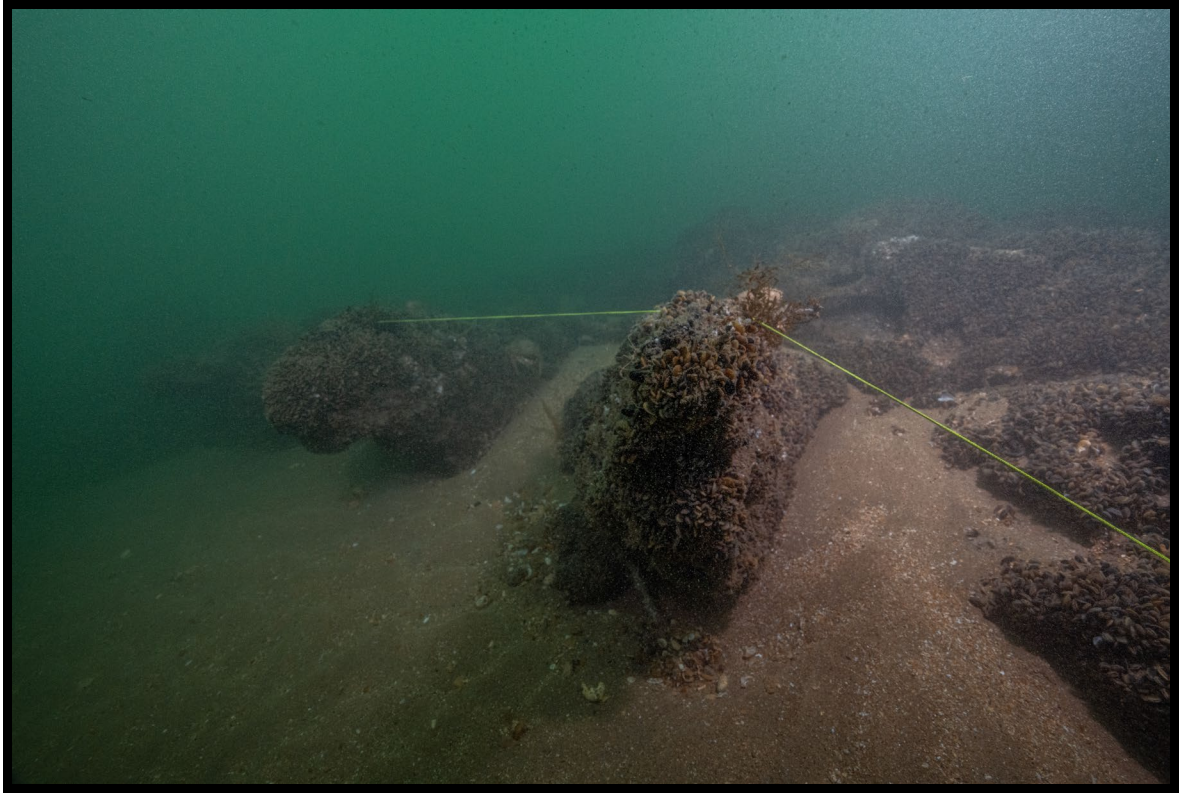
Figure 8: The broken end of floor timbers protruding from the sand.

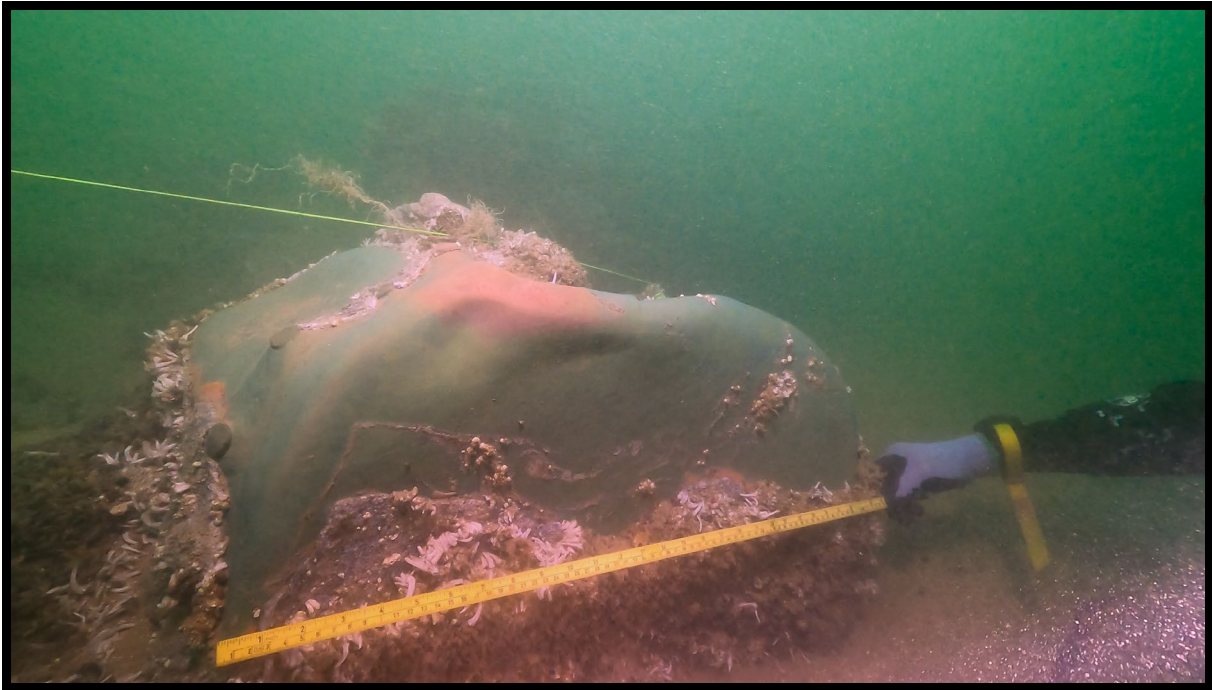
4.2.10. On the eastern side of the large concretion and near the bottom of the slope was a complete copper cauldron (Label 5 Figure 2). It was on its side with the base on the outside of the wreck mound. It was slightly squashed around the sides and open end. The sides of the cauldron were riveted to a separate base piece and its approximate diameter across the base was 700mm (Figure 9). Its location is consistent with the copper pot shown on the 1993 sketch plan (Figure 4). It is very similar to examples recovered from the wreck of the *Hazardous*, lost in 1706 off the coast of Bracklesham (Figure 10).

Figure 9: Copper cauldron found on the east side of the large concretion.

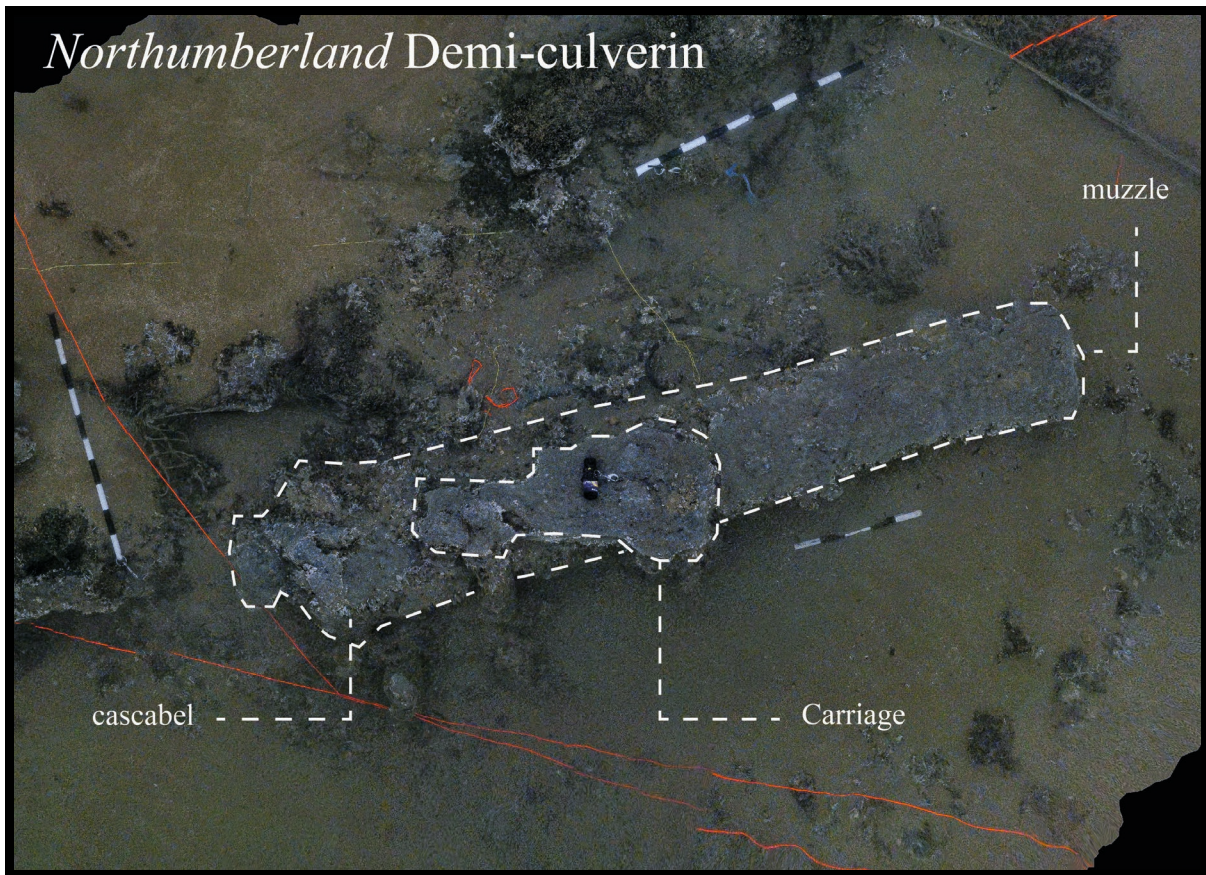
- 4.2.12. Gun 4 and its carriage are both heavily concreted and therefore dimensions are only an approximation. The muzzle and the button at the cascabel end are clearly discernable but the location of the base ring less so. The length from the end of the muzzle to the approximate location of the base ring is 2.95m (9ft 7in). If one takes into consideration the thickness of the concretion then this would suite a 9 ½ ft gun. According to the guns on board the *Northumberland*, recorded during the great ordnance survey of c. 1696, guns of 9 ½ ft included all her main gundeck demi-cannon and eight out of 26 upper deck demi-culverins (TNA WO55/1736).

- 4.2.13. The gun is so heavily concreted around the breech with other concreted objects that it is difficult to take a reliable measurement. The clue which suggests which type of gun this one is can be seen from the remains of its carriage. It's clear that the carriage was constructed with two iron through bolts to brace the two cheeks and support the weight of the gun (Figure 12). The evidence from a recovered demi-cannon with carriage, from the wreck of the *Stirling Castle*, identified that the cheeks were braced by three iron through bolts (McElvogue 2008, 42). The demi-cannon being a heavier gun would require the carriage to have extra support and therefore the identification of only two from the *Northumberland* gun carriage suggests a lighter gun, such as one of the demi-culverins.

Figure 11: Annotated orthophoto mosaic of demi-culverin and carriage (Gun 4).

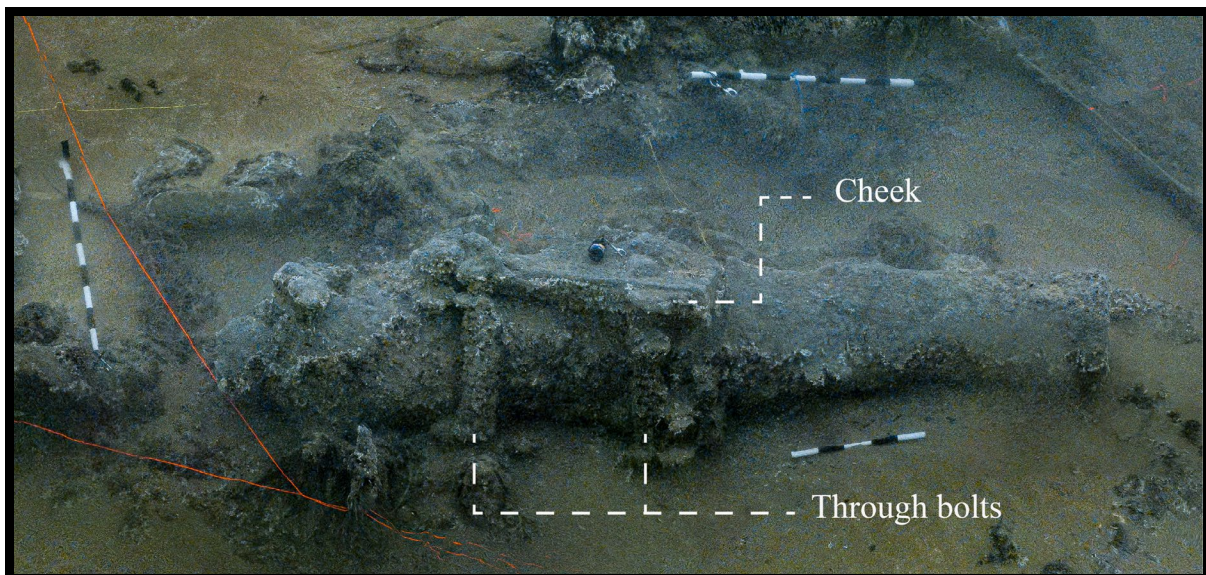
Figure 12: Annotated orthophoto mosaic of the demi-culverin from the view of the underside of the gun.

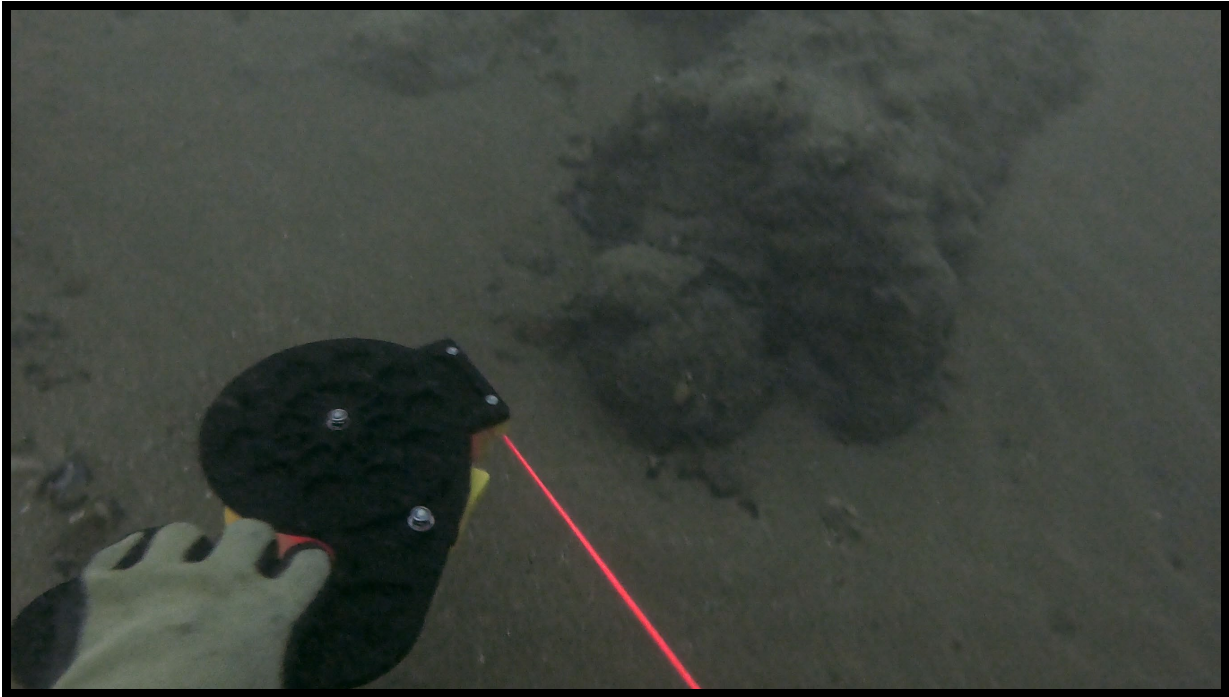
4.2.15. Less than 2m north of the muzzle of Gun 4 is another gun. This gun is exposed at the cascabel end and buried from the trunnions to the muzzle (Figure 14 and label 7 Figure 2). This gun was not recorded in detail but from diver Mark Hobbs hat cam footage it would appear to be a gun of one of the smaller calibres. Its location roughly coincides with gun C6 on the 1993 sketch plan. If this is C6 then it was recorded as 2.7m (8.85ft) in length and has tentatively been identified a possible demi-culverin (Pascoe and Peacock 2015, 139). This gun does not appear to be present on the 2020 bathymetry and therefore is another indication of the reduction in seabed sediments.

Figure 14: Frame grab from hat cam footage showing the cascabel end of another demi-culverin, potentially gun C6 shown on the 1993 site plan.

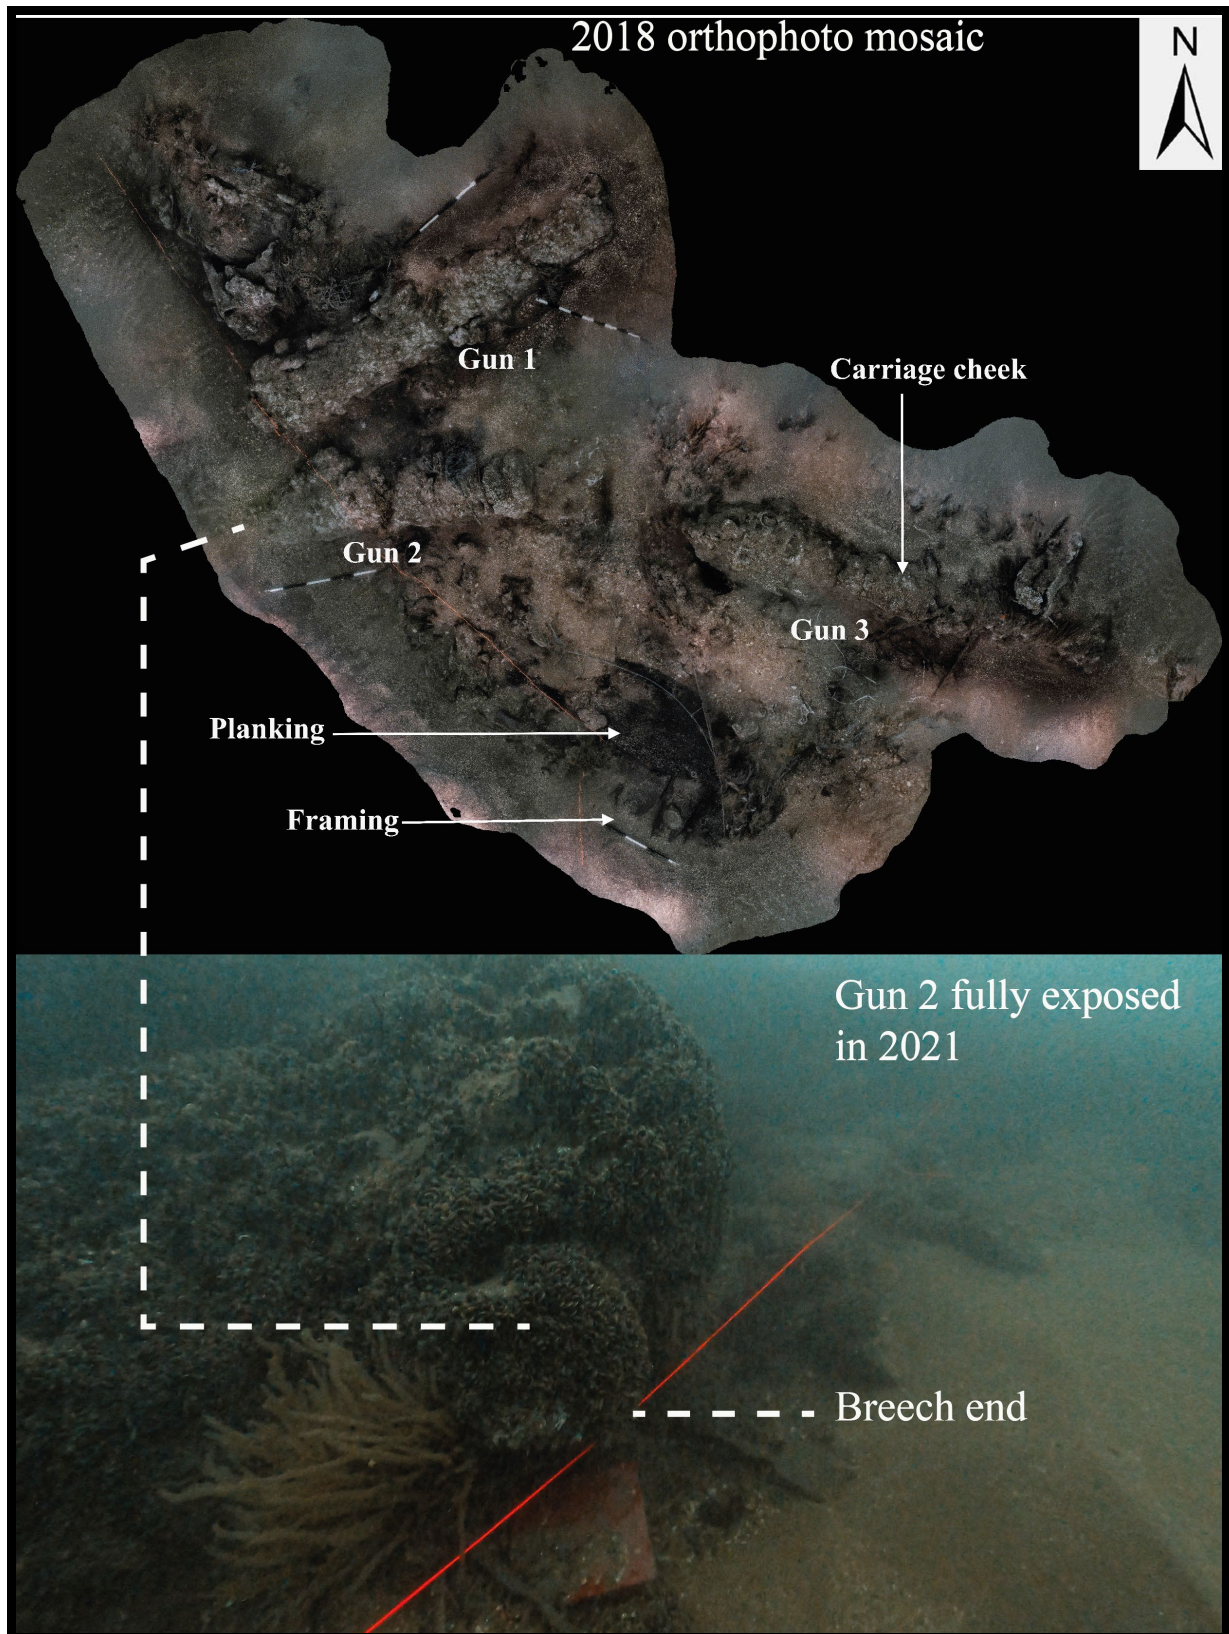
- 4.2.17. The guns recorded during the 2018 diving fieldwork and labelled guns 1-3 were much more exposed than they were in 2018. There was a distinct reduction in seabed sediments along the western side of the guns. This had fully exposed gun 2 which was only partially exposed in 2018 (Figure 15). The guns, as well as surrounding structure and concretions, were all heavily covered in mussel growth.

Figure 15: Images showing the comparison between 2018 and 2021. The loss of sediments has fully exposed Gun 2 from breech to muzzle. Gun 2 is now covered in a thick layer of mussels where it was not in 2018.

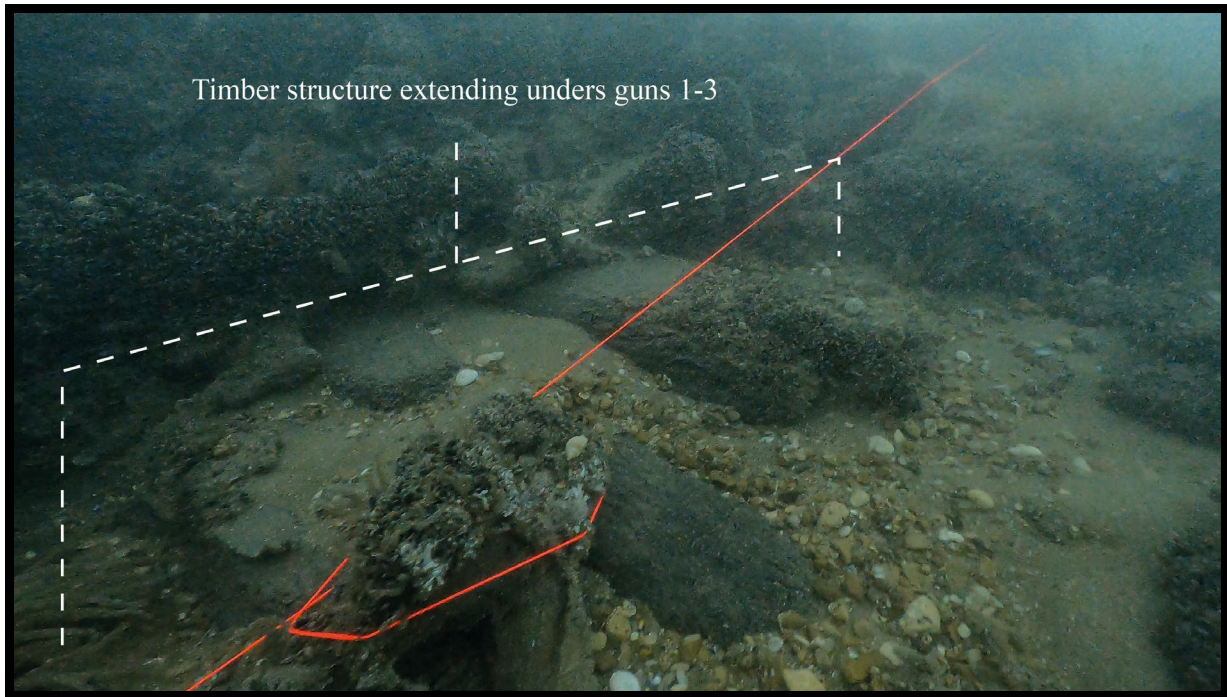
4.2.18. Coherent timber structure can be seen extending underneath Guns 1-3 (Figure 16). A section of this structure was observed below Gun 3 in 2018 but with the further loss

of sand it now can be seen extending under Guns 1 and 2. The structure looks like it is likely to be inside of the hull structure. Guns 1 and 2 are demi-cannon and 3 is a possible culverin, therefore the structure is possibly associated with the level of the main gundeck.

Figure 16: Image showing a section of the timber structure extending underneath Guns 1-3.

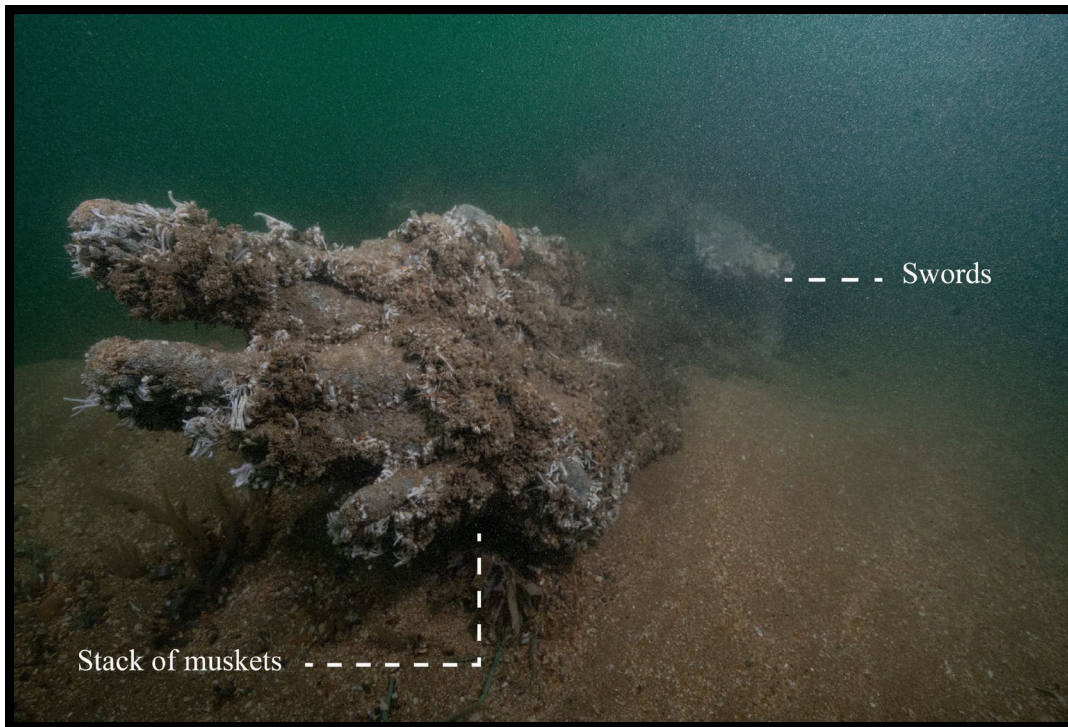
Figure 17: Annotated photo showing assemblage of muskets lying directly north of the swords.

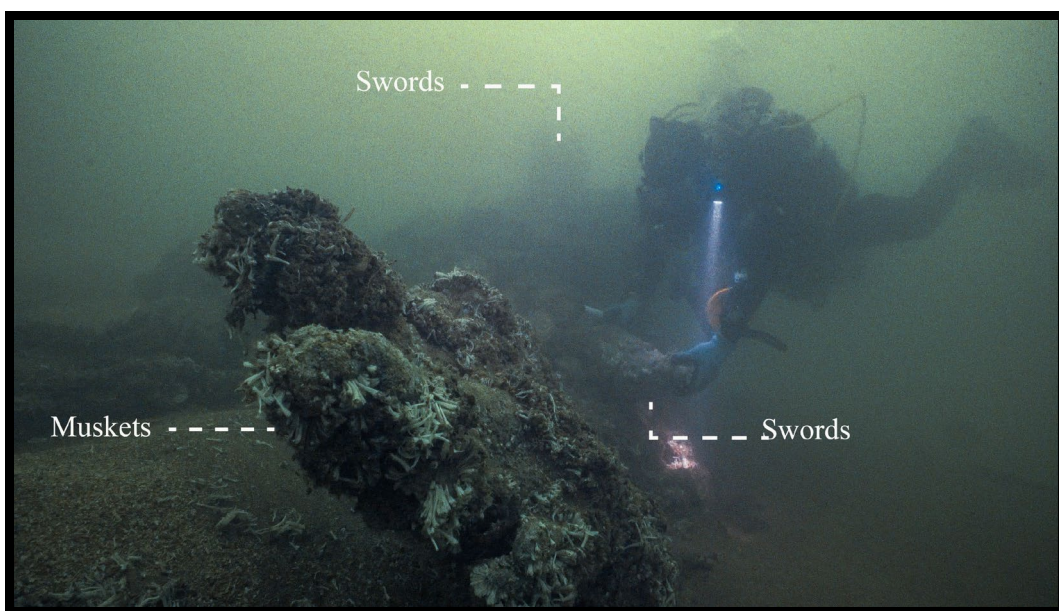
Figure 18: Annotated image showing diver inspecting concretions of muskets and swords. Also note the concretions behind the muskets and swords which look like more concreted small arms.

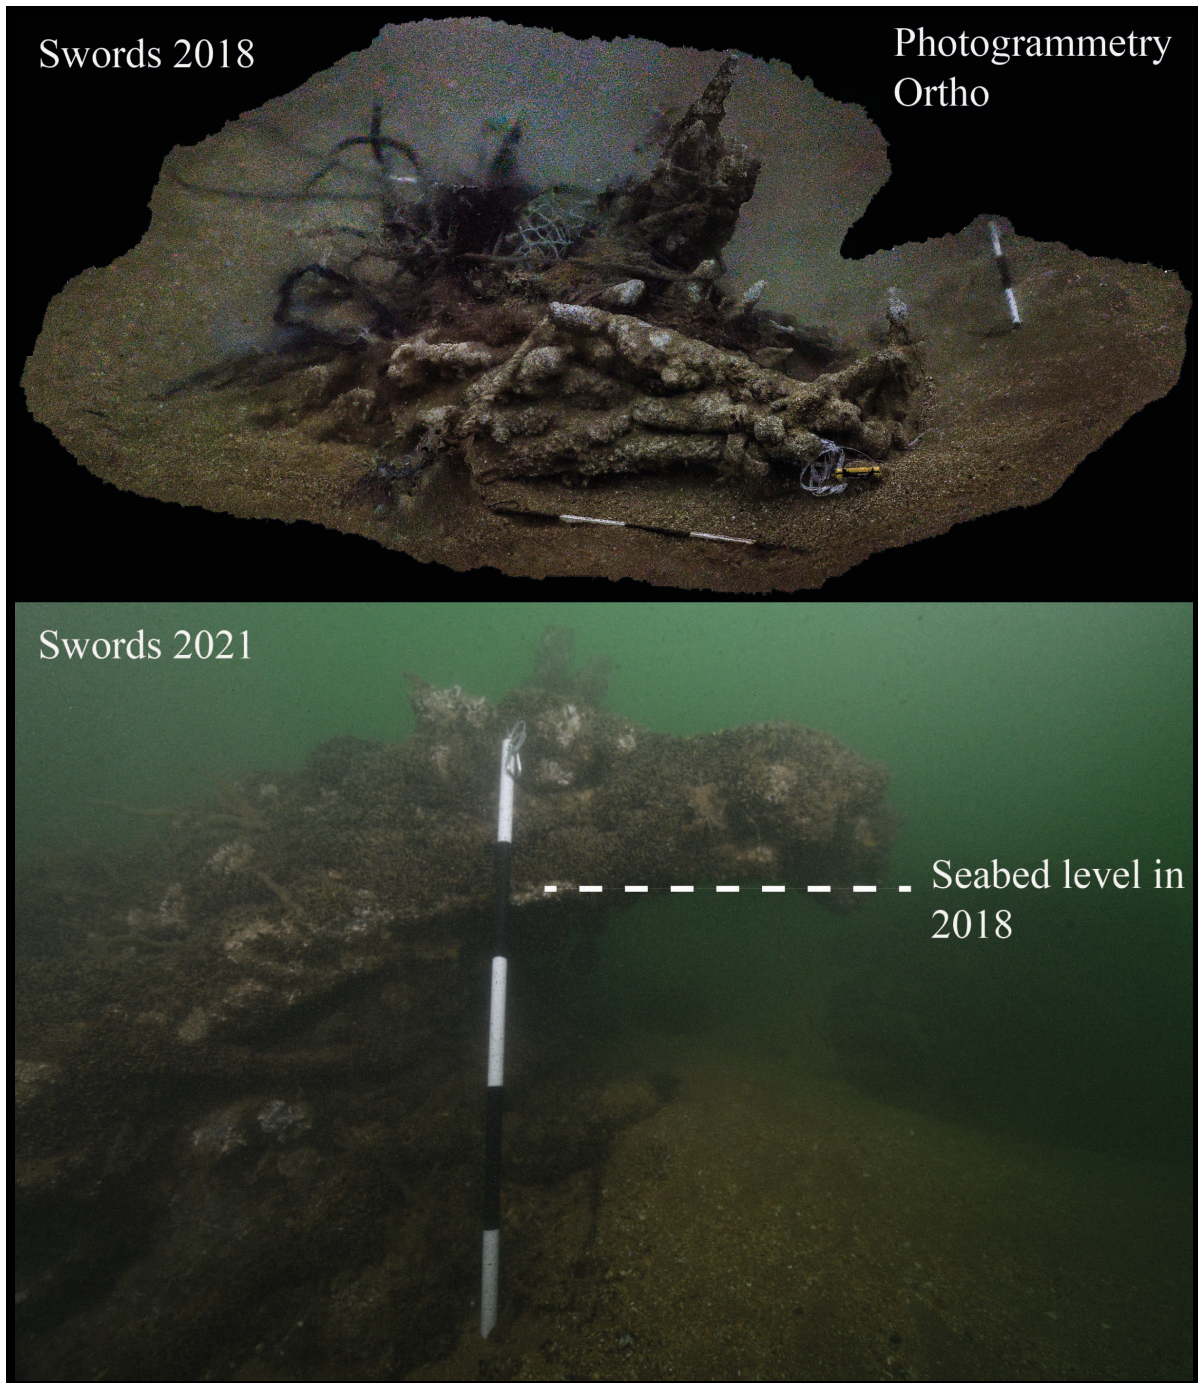
- 4.2.20. When comparing the 2018 photogrammetry model of the swords with a photograph with scale taken in 2021 it identifies a drop in sand of 0.7m in this area alone (Figure 19). The area of loss extends much further than the swords and muskets. It extends 6m southeast to Guns 1-3 with further large concretions now currently exposed between the swords and guns. There are possible further concreted small arms directly east of the swords too.

Figure 19: Comparison between the 2018 and 2021 images of the assemblage of swords which identifies a loss of 0.7m sand.

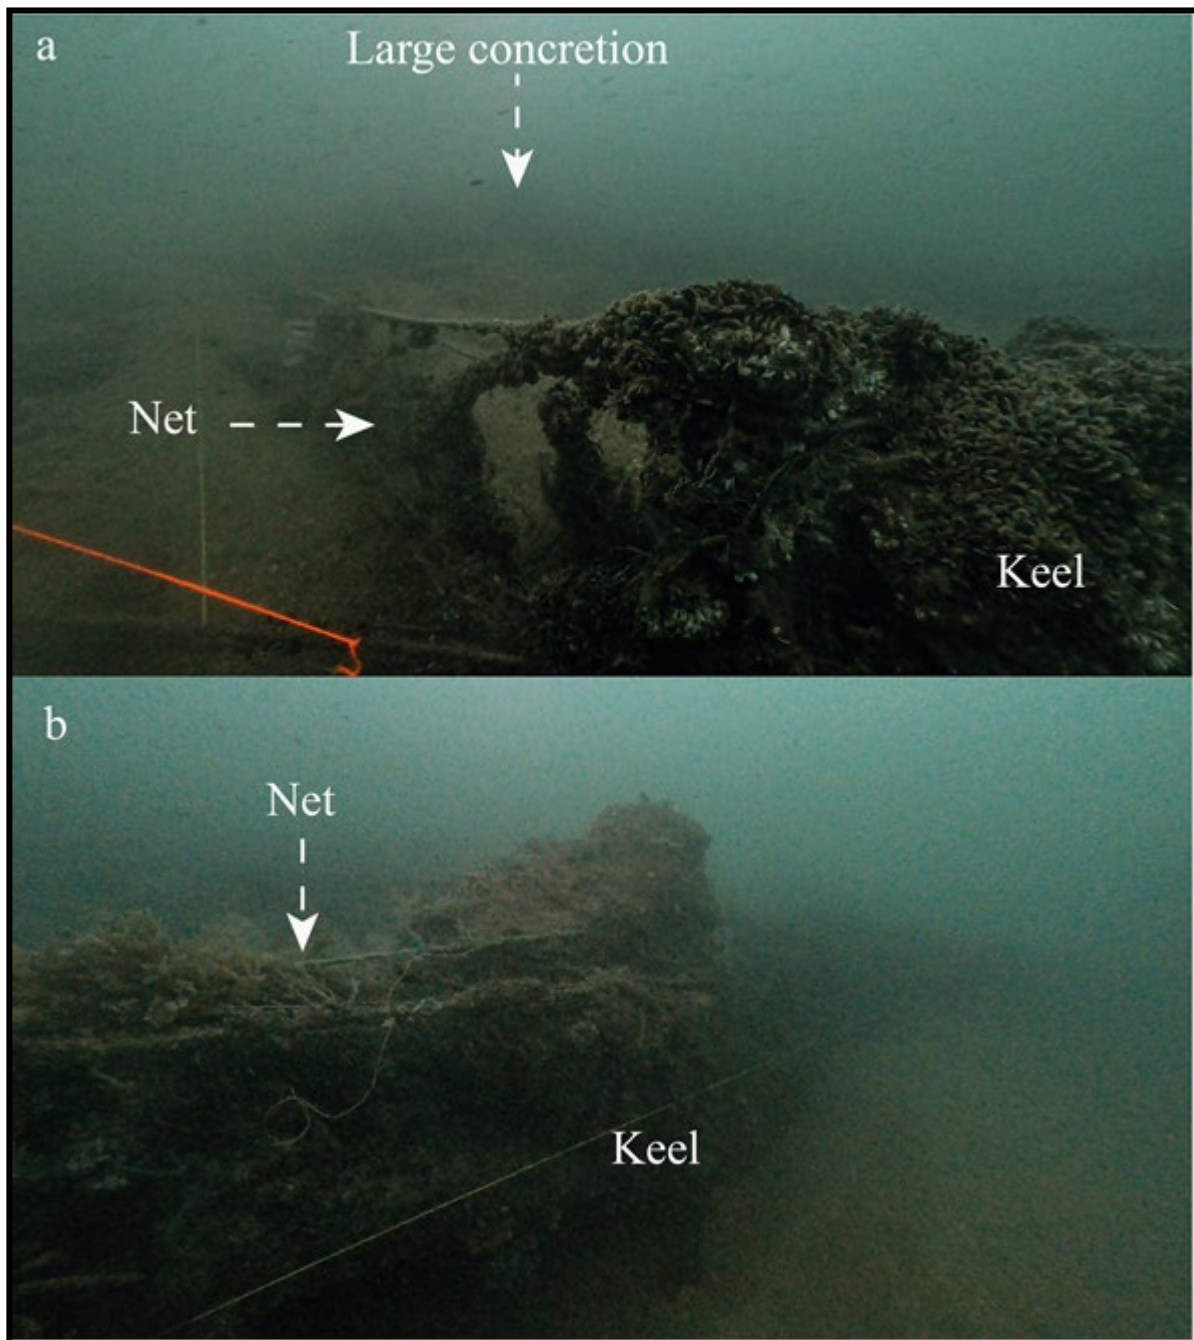
- 4.2.31. The fishing net which was observed in 2018 draping over much of the large concretion at the southeast end of the site was seen to extend west to the lower hull structure. The net is of the gill variety and although ripped and broken it covers the keel and end of frames (Figure 20).

Figure 20: Image **a** shows a gill net snagged on the section of exposed keel on the west side of the wreck and extending up to the large concretion towards the centre of the site. Image **b** shows the gill net is covering the exposed keel and much of the structure along the west side of the site.
