ARCHAEOLOGICAL ASSESSMENT AND NET REMOVAL FROM THE DESIGNATED
WRECK OF THE *NORTHUMBERLAND* ON THE GOODWIN SANDS

PROJECT REPORT
2022

February 2022

Ref: 7913

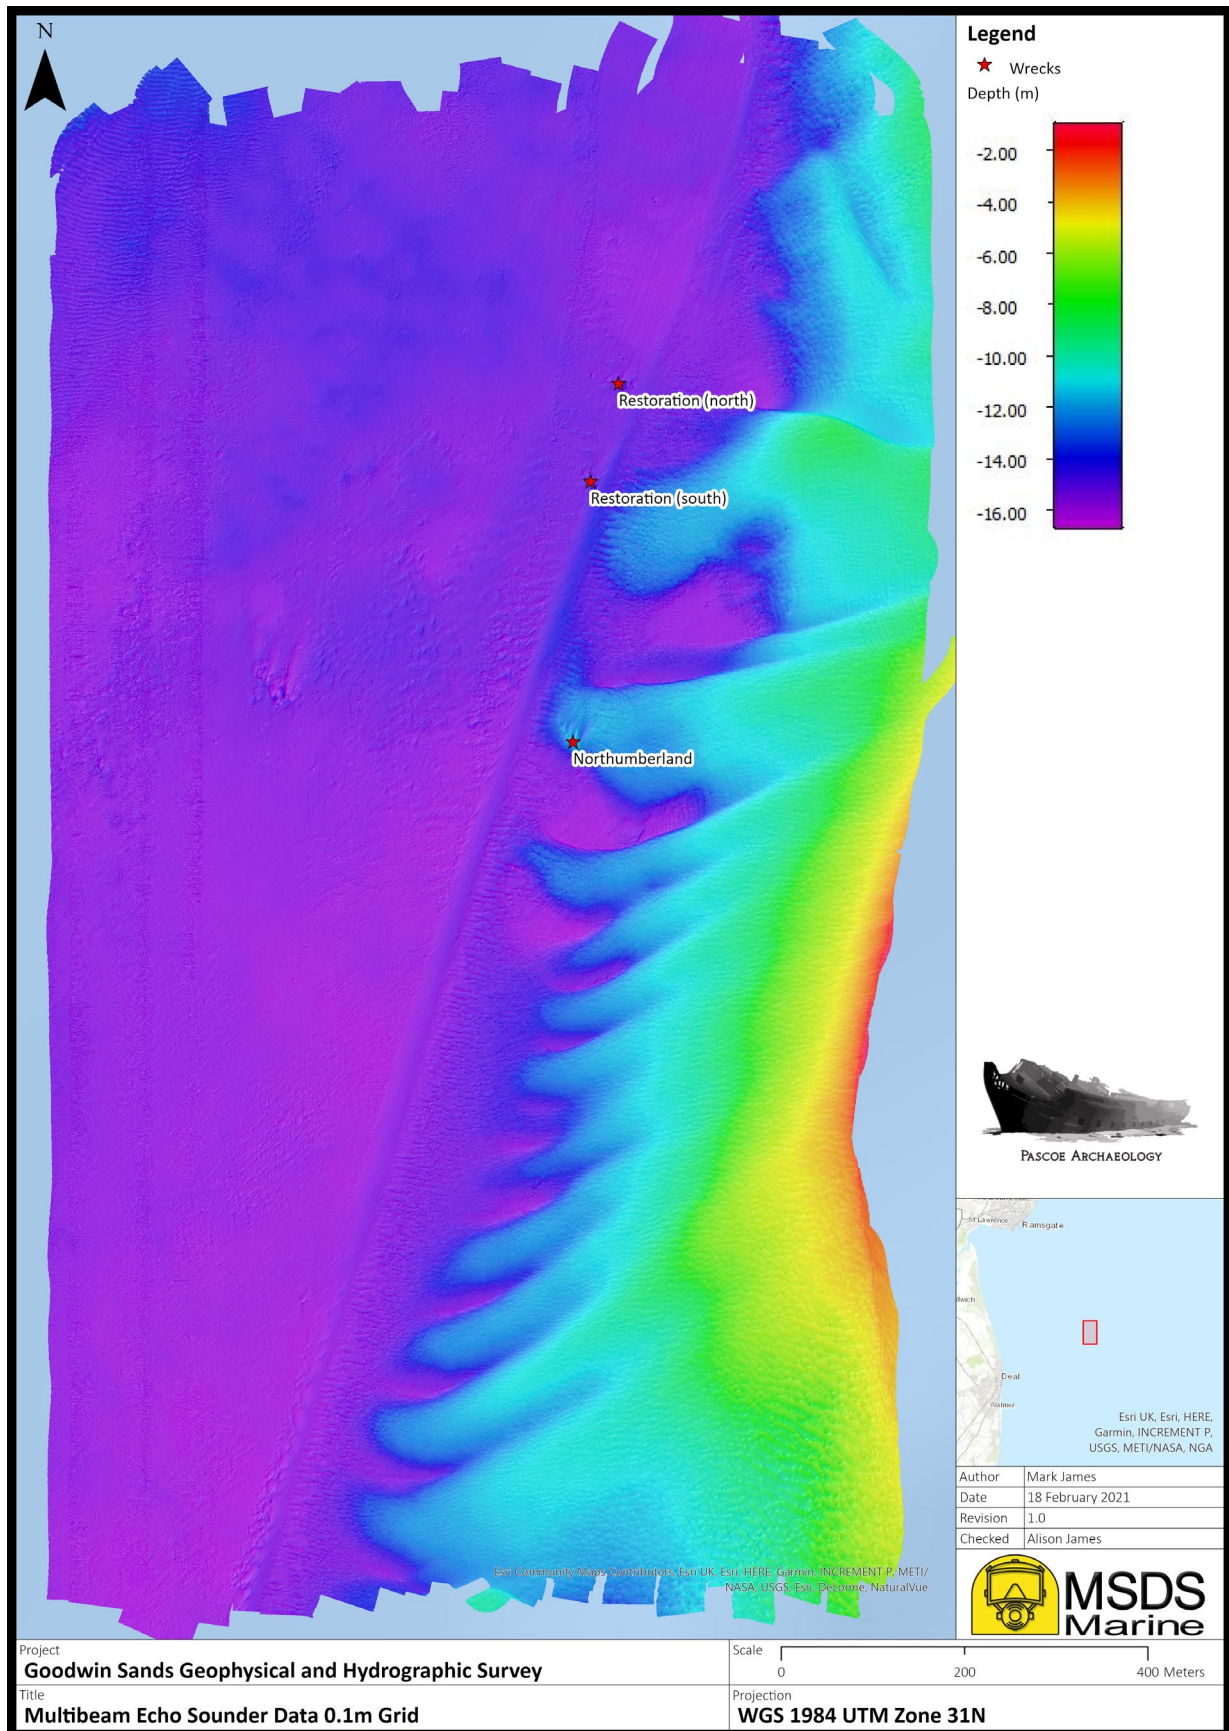
wider area around the wreck (Figure 21) and the general understanding of the seabed topography of the Goodwin Sands. The seabed around the site, and across the Goodwin Sands in general, is made up of sand waves. The only obstructions on the seabed for nets to snag comes from wrecks or other types of manmade obstructions. Wooden wrecks are not as easy to detect on vessel's echo-sounders (depth indicators), so, despite sites being marked on charts, trawlers may be unaware of their presence, resulting in the snagged and abandoned nets seen here.

Figure 21: Showing the 2020 bathymetry of the *Northumberland*, *Restoration* and the surrounding region. There are no other obstructions for nets to snag other than the wrecks themselves.

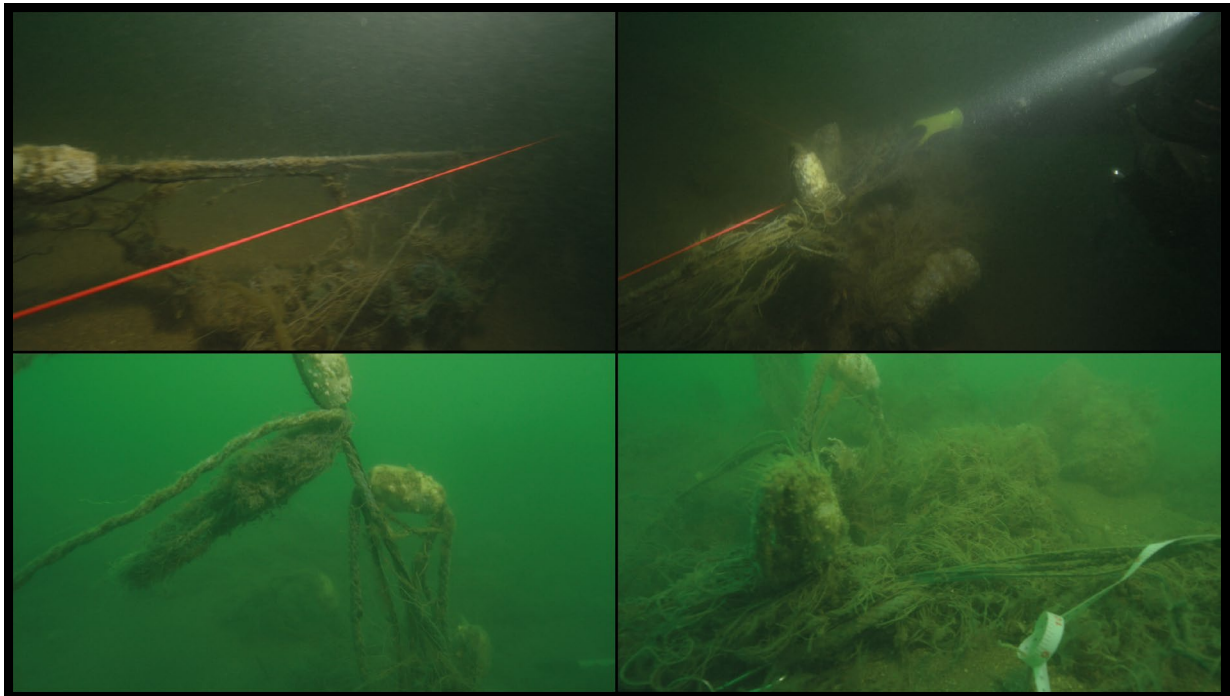
4.2.34. Another indicator that the nets on site have been abandoned following snagging on the wreck is that a significant proportion of the nets have the floats attached (Figure 22). These are gill nets and they have a very fine nylon mesh. The floats are attached to the top of the net to keep it upright and off the seabed. If these were broken nets which drifted in from elsewhere the likelihood is they would be floating near the surface and therefore passing over the wreck.

Figure 22: Showing gill net with floats still attached.
