Energy efficiency and historic buildings: Assessing the thermal and hygrothermal performance of two refurbished dwellings

Research Report Series 11/2023

2.0 BUILDING 1: NEW BOLSOVER, DERBYSHIRE

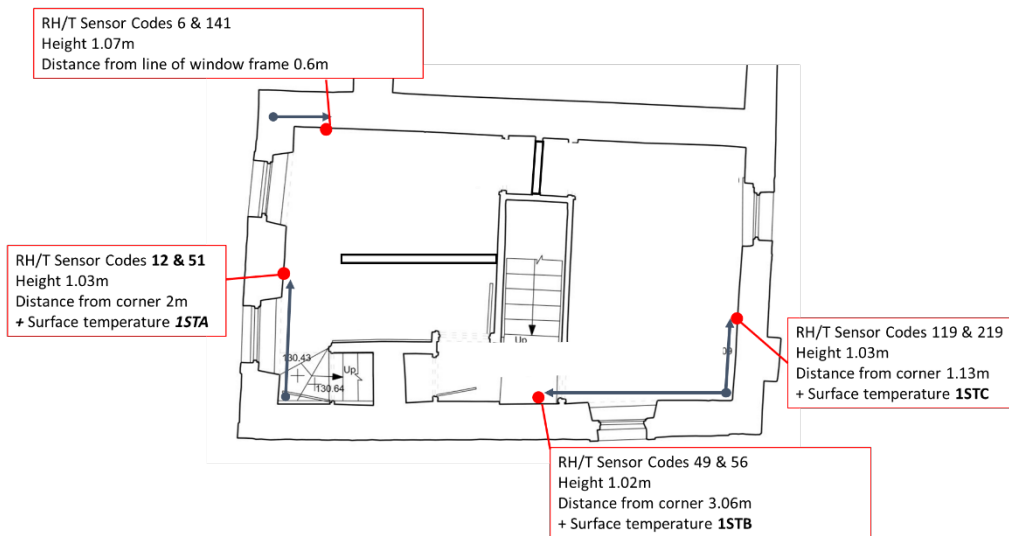
Figure B1.3: First floor plans – locations of temperature and humidity sensors.

In the east (rear) wall one of the pair of RH sensors located near the chimney (Figure B1.4) remained at 100% throughout the monitoring period. The other stayed at 100% until June 2021 and then fell to a minimum of 94%, before rising again to 100% in October 2021. Values started to decrease in December, and reached 92% at the end of monitoring. Dowel moisture contents remained above 20%.

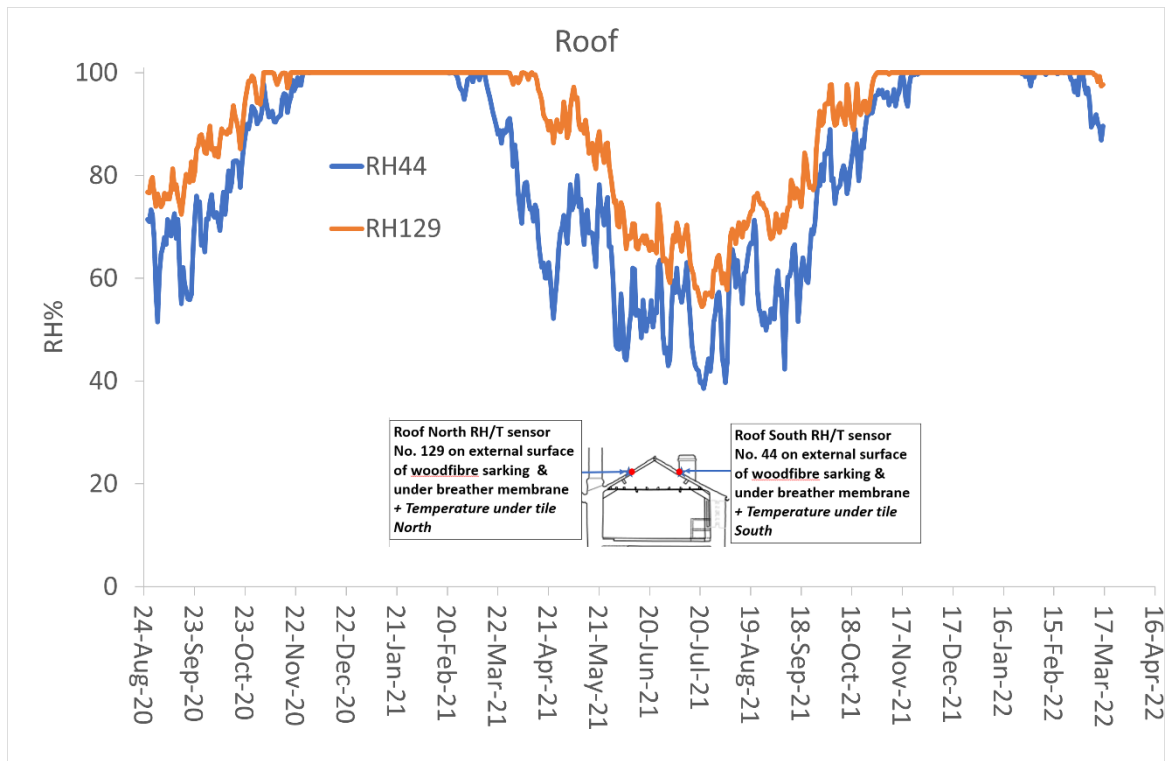
Figure B2.22a: Roof relative humidities between sarking and breather membrane

In autumn 2020, RH values between the external surface of the wood fibre sarking and the breather membrane beneath the slates rose to 100% on both north and south slopes and remained at this level over the winter (Figure B1.7). The south RH recovered in late February 2021 whilst the north RH recovered later in early April. A similar pattern was repeated in spring 2022. The south, with more exposure to solar radiation, dried out to lower humidities than the north during summer.
