Barracuda Aircraft wreck site, Solent, Hampshire

Examination, analysis and conservation of artefacts recovered from
a Second World War aircraft wreck

2024

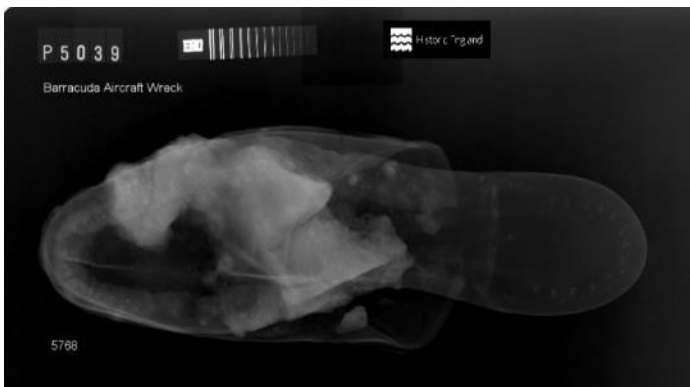
Figure 1: X-radiograph of shoe 5768, visualising the concretion attached to the underside.

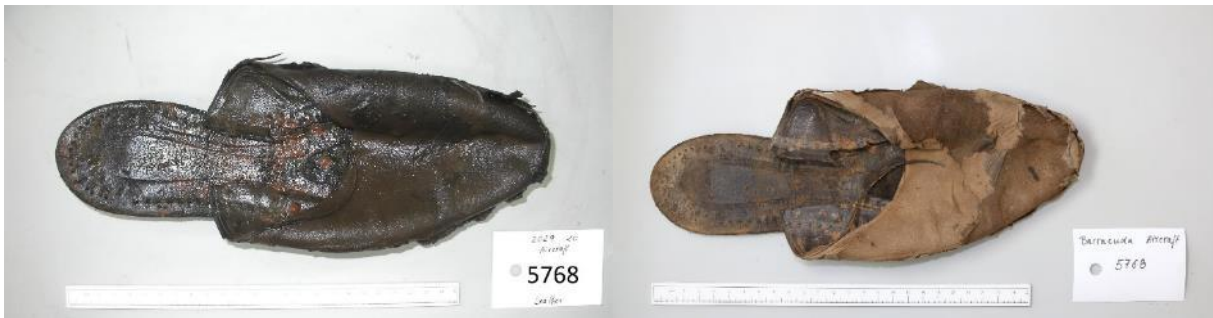
Figure 2: Leather shoe 5768 before conservation (left) and after conservation (right).

-30°C in a domestic chest freezer, before vacuum freeze-drying, which eliminates drying stress as the frozen water is removed by sublimation. Freeze-drying commenced in a LyoDry Midi Freeze Dryer s/n F012. The chamber temperature was set to -30°C and the condenser temperature to -45°C. The drying cycle was interrupted regularly to weigh the leathers and examine them for flexibility, distortion, and surface changes. The endpoint was determined when weight loss plateaued or slowed down significantly. Drying took about 31 hours. Only slight, powdery PEG residue was present after drying, which was removed by brushing (Figure 2).

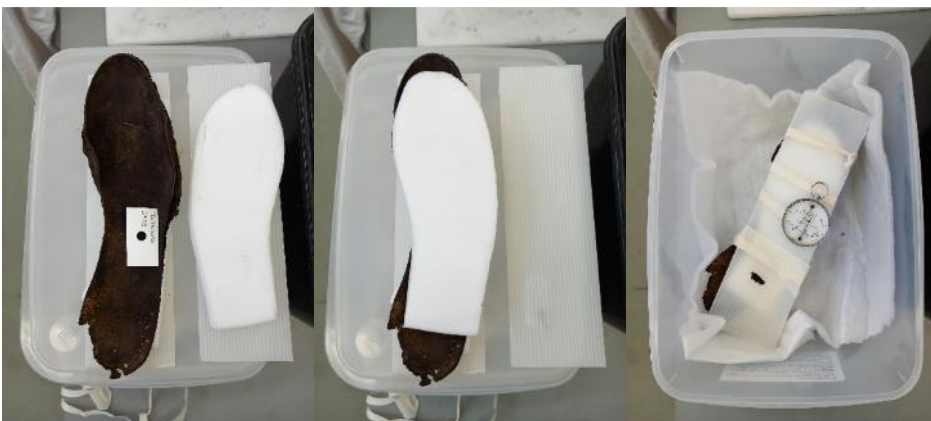
During freeze drying, leather will shrink a bit and some pieces may experience distortion. One such example was shoe insole 5353. This was gently re-shaped by placing it inside a closed system (box with tight-fitting lid) over a semipermeable membrane covering a box filled with water (Figure 3). Over the course of a couple of days the humidity inside the box rose and water molecules entered the leather fibre structure, making it supple. At this point it was sandwiched between layers of polyethylene foam (Plastazote®) and fluted polypropylene sheets (Corex®) and gently straightened out again (Figure 4). The sandwich boards were secured with ties and tapes and the leather placed back into the box, with the lid slightly open. As the water slowly evaporated, the humidity reduced to ambient, and the leather remained in the more sympathetic shape appropriate for an insole.

Figure 4: Shoe insole 5353 during re-shaping: after moisturising and regaining suppleness (left), with the re-shaping sandwich being applied (centre), inside the humidity box and with the sandwich attached (right).

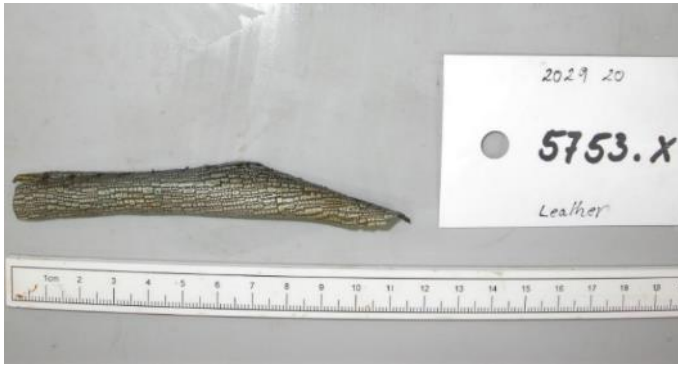
A single piece of polymer, with a scale pattern in white and black, was also recovered (5753.X) (Figure 5). The pattern resembles reptile skin with a dark cross hatch on a white ground.

Figure 5: Patterned polymer, possibly edging, 5753.X.

XRF analysis detected high levels of chlorine, likely to be a constituent of the polymer. The white opacity is due to titanium oxide (with minor barium) and the dark areas are coloured by an iron-containing clay-type mineral, as alumina and silica were detected (with minor chromium).

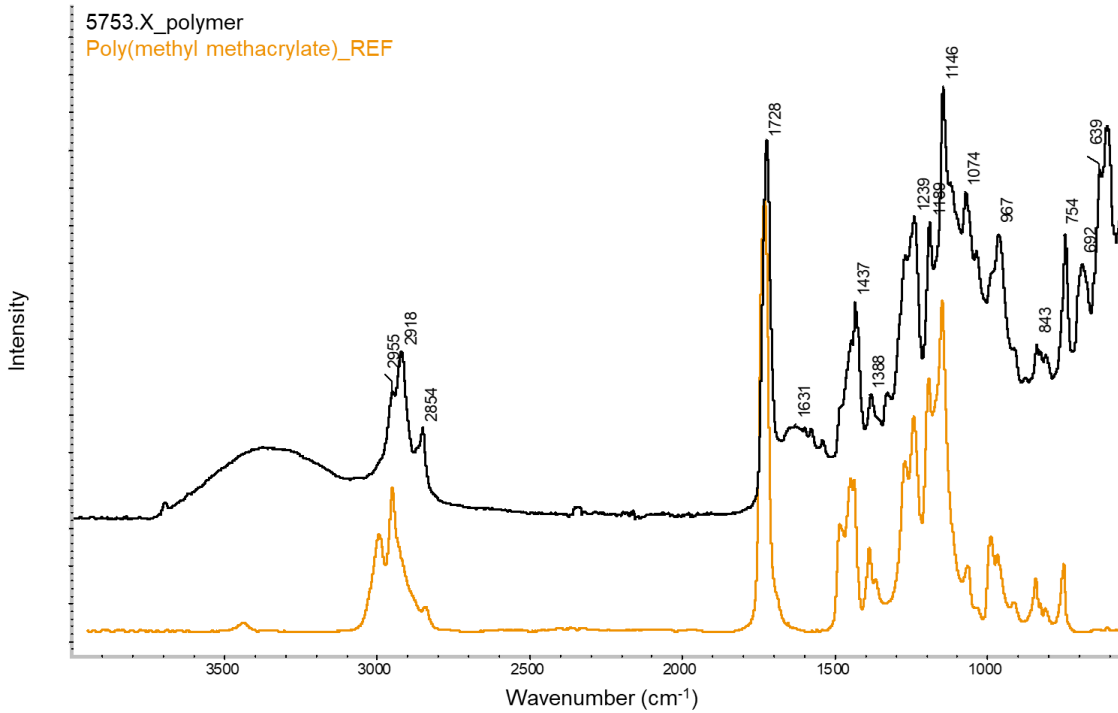
FTIR analysis of a sample from 5753.X shows the object is made of poly(methylmetacrylate) (Figure 6) and the presence of chlorine suggests it is a haloacrylate. Haloacrylates are substituted with a halogen atom, usually chlorine. They have been synthesised since 1938 and they are harder, stronger and with higher softening temperature compared to normal acrylics. These polymers were probably used because of their flame-retardant properties. In 1939, Imperial Chemical Industries in UK produced this polymer and during the war, the synthesis was optimised by different companies in the USA (National Institute of Industrial Research 2005). In the sample some white particles were also observed and identified as polyethylene (Figure 7).

Figure 6: FTIR spectrum of the sample of polymer 5753.X identifying polymethyl methacrylate.

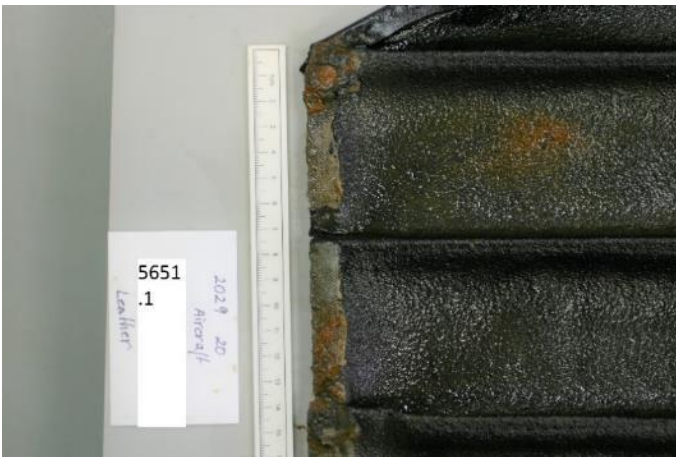
Several of the leather artefacts had the remains of a flexible, semi-transparent adhesive around their edges on the flesh side of the leather (eg. 5651.1 and 5651.3). These remains were sampled and analysed using FTIR for identification (Figures 8 and 9).

Figure 8: Part of the seat component 5651.1, leather (flesh side) with latex around the periphery.

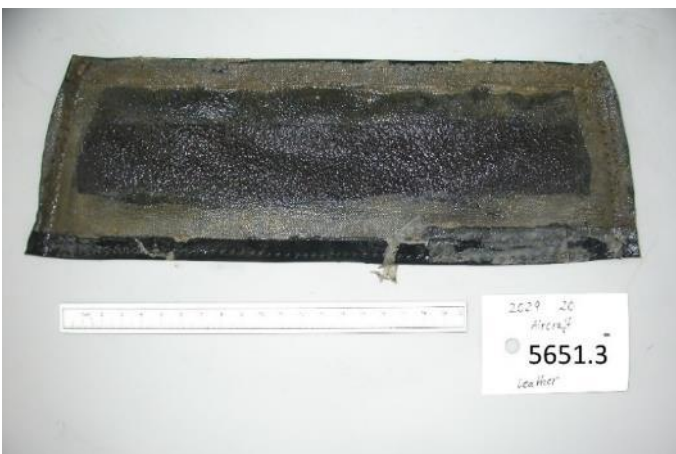
Figure 9: Part of the seat component 5651.3, leather (flesh side) with latex around the periphery.

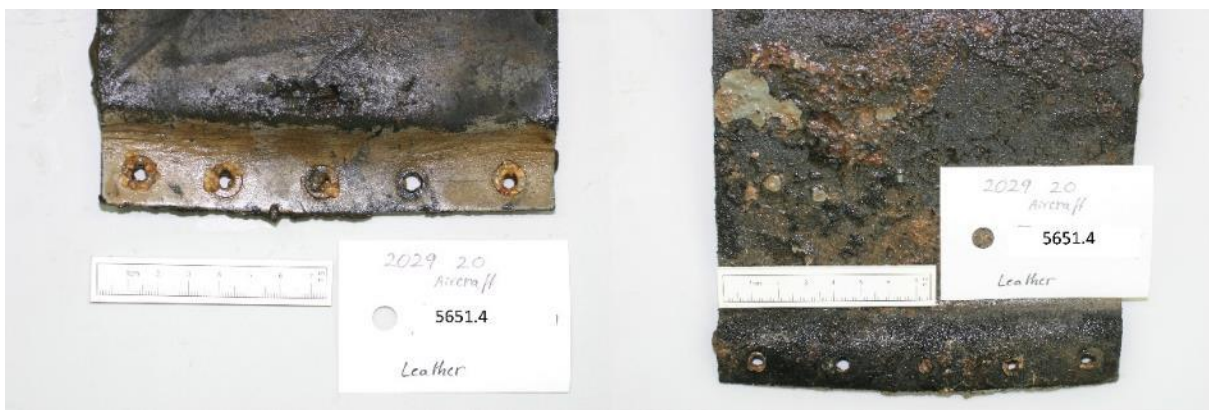
Some of the leather objects had metallic fixtures. The metal fittings in 5651.4 were analysed using μ XRF (without vacuum) and found to be an aluminium alloy (Figure 12).

Figure 12: Both sides of 5651.4 showing paint adhering to the leather and metal reinforcement of the rivet holes.

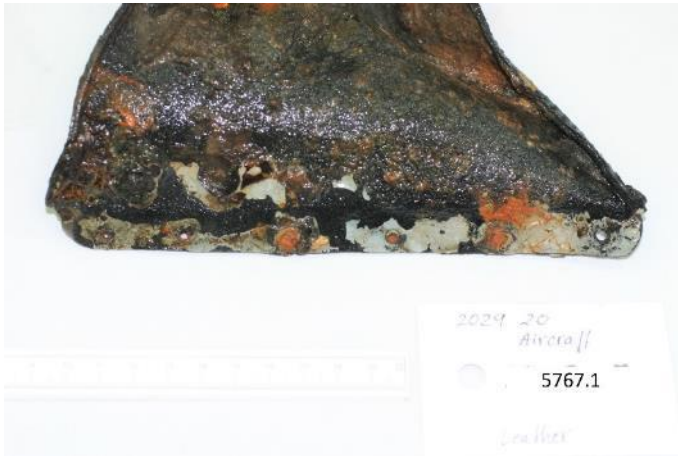
In some areas, the remains of thin matt grey paint in the same shade are adhered to the upper surface (grain side) of rigid leather items as well eg. 5651.4 (Figure 13); in these instances, the paint survives mainly in recessed areas, where it was probably protected from wear, but it may have been applied over a larger area originally.

Figure 13: Paint adhering to the leather on 5767.1.

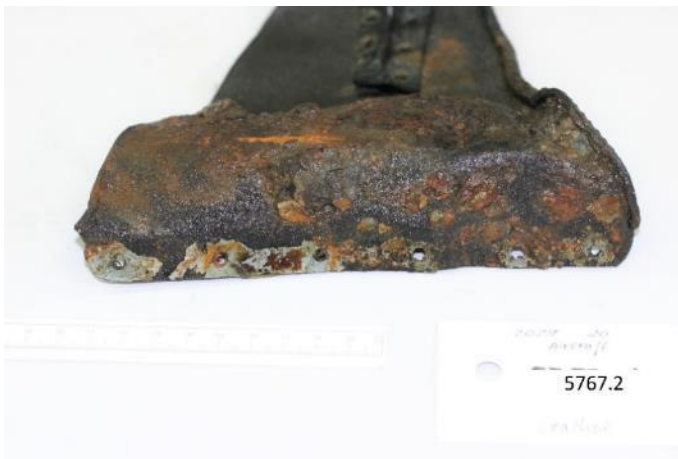
Figure 14: Paint adhering to the leather on 5767.2.

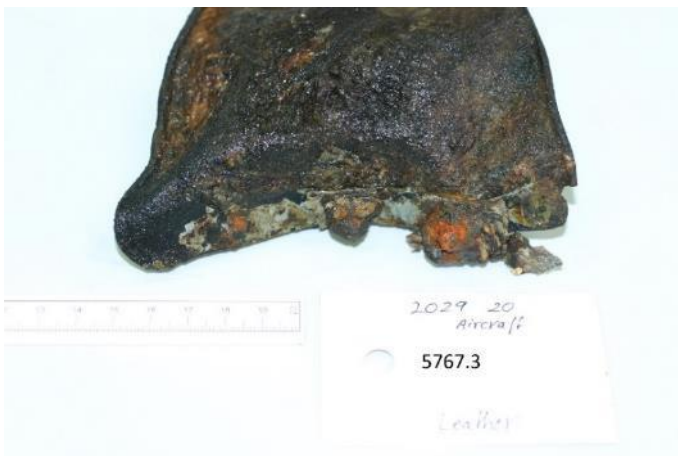
Figure 15: Paint adhering to the leather on 5767.3.

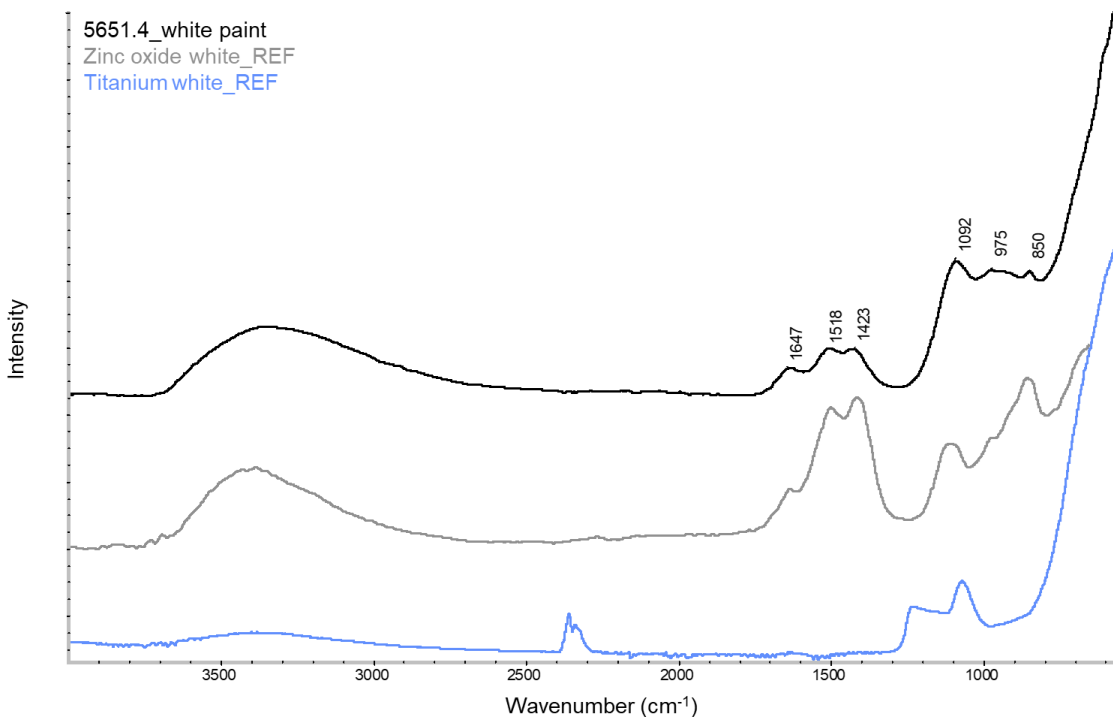
Two layers were visible in the sample from 5651.4, a white lower layer and a grey upper layer. The FTIR spectrum of the paint sample from 5651.4 (Figure 16) confirms the presence of titanium and zinc white pigments in the lower white layer of paint. The upper grey paint layer is an alkyd paint with a silicate-based pigment (such as green earth) and lithopone, which is a mixture of barium sulphate and zinc sulphide (Figure 17). No binder was found in either of these layers.

Figure 16: FTIR spectrum of the lower white paint layer sample from 5651.4 with reference spectra.

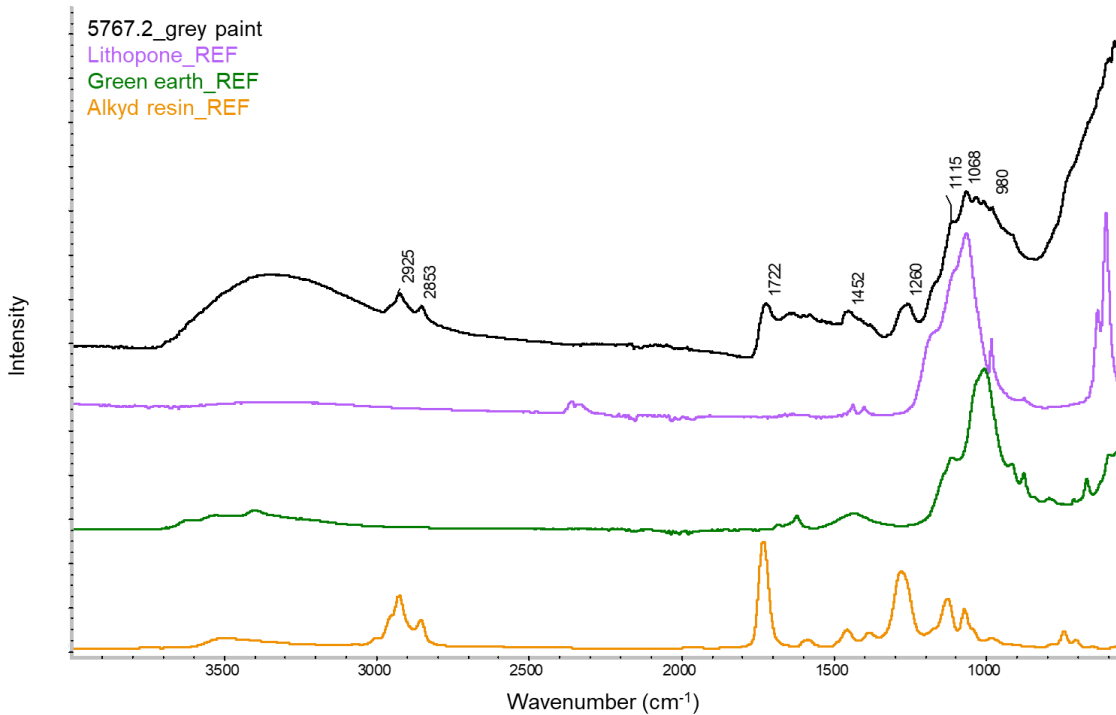
The analysis of a grey paint sample from 5767.2 gives a spectrum (Figure 18) that is very similar to the grey paint in sample 5651.4, so they are probably the same. It is an alkyd paint with a silicate-based pigment (such as green earth) and lithopone.

Figure 18: FTIR spectrum of the grey paint layer sample from 5767.2 with reference spectra.

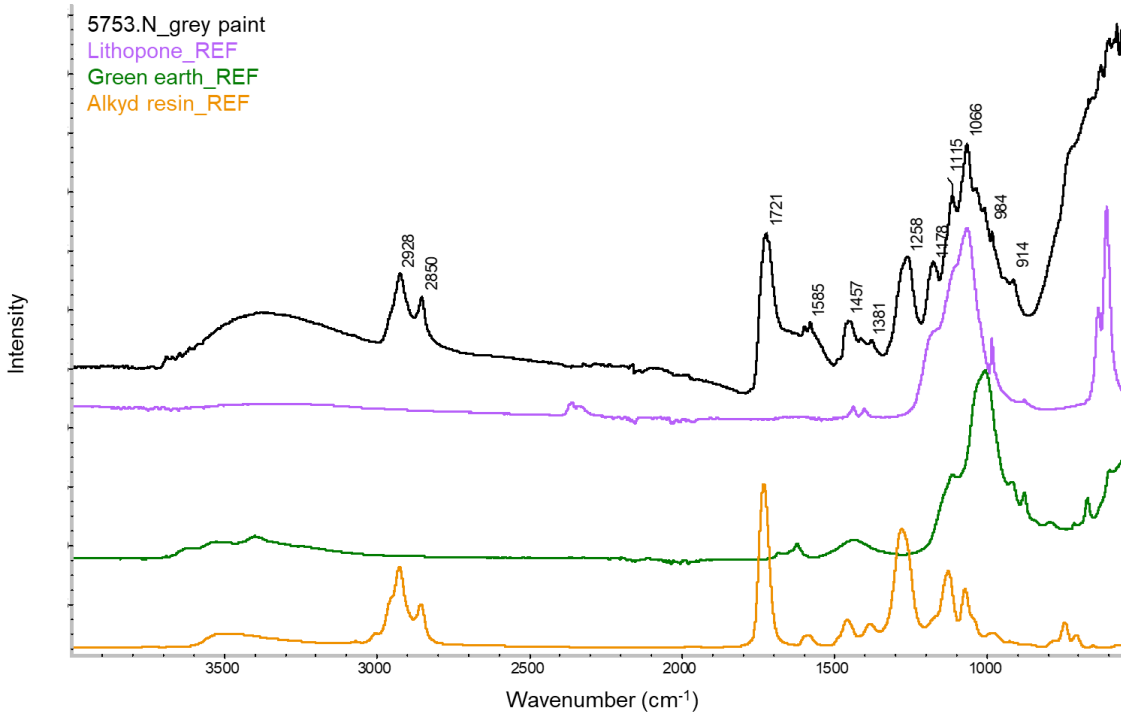
On 5753.N, the white lower paint layer and grey upper paint layer are both visible. A sample of the grey paint is again an alkyd paint with pigments based on silicates (such as green earth) and lithopone (Figure 19). This is confirmed by XRF data showing the presence of barium (Ba), zinc (Zn), silicon (Si) and sulphur (S) (Table 5). Titanium (Ti) was detected in the white paint, proving that titanium white was present in that layer as before (Figure 20 and Table 5).

Figure 19: FTIR spectrum of the grey paint layer sample from 5753.N with reference spectra.

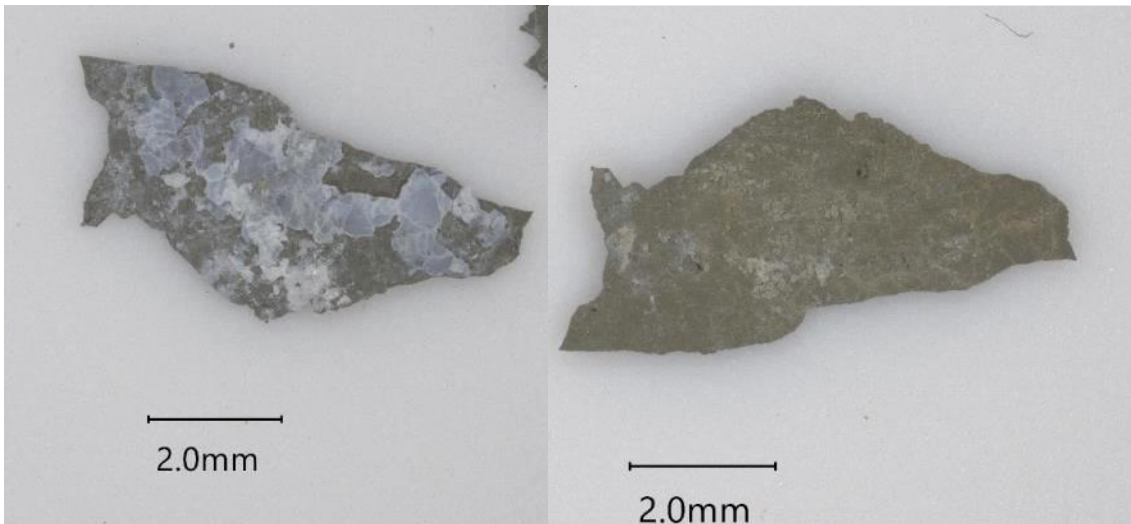
Figure 28: Optical images of two sides of a paint flake from the TAGs window frame of the Solent Wreck showing the grey/green paint and a white residue on one side (left).

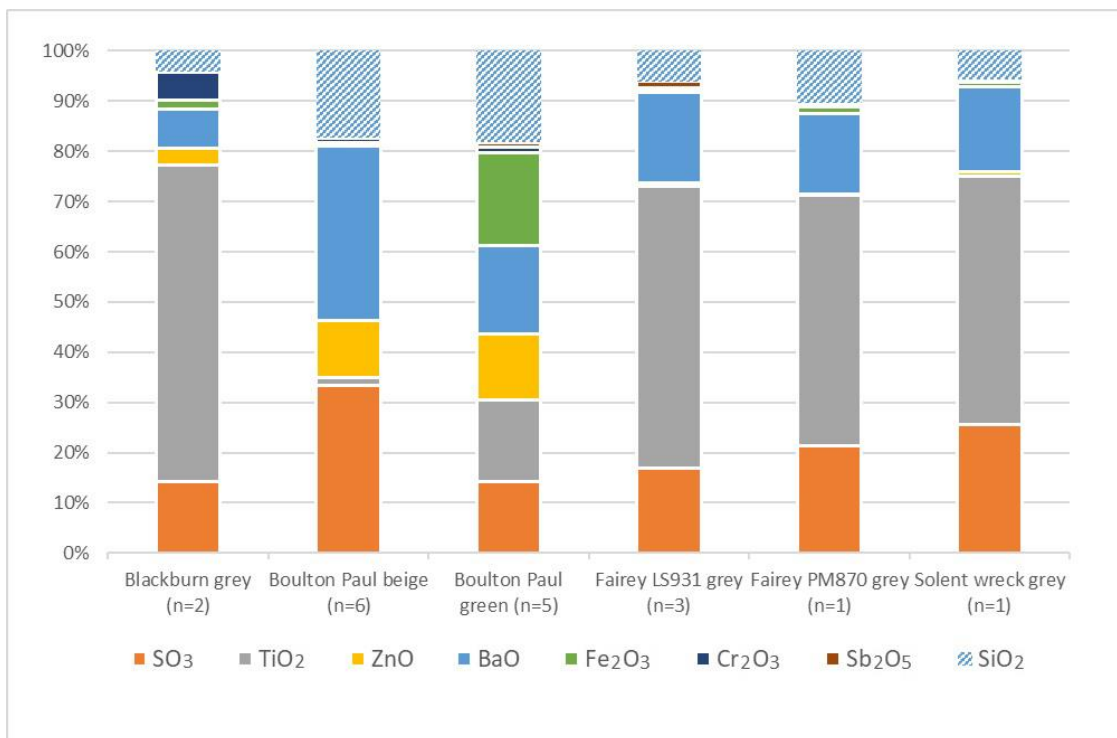
Despite the visual similarities, the μ XRF results for the paints used on each make of aircraft show distinct differences (Figures 29 and 30). Although many of the same pigments are present, particularly compounds of sulphur, barium, titanium and zinc (Table 5), the proportions of the major pigments in the paint differ between manufacturers, and there are also some diagnostic elements including antimony, chromium, iron and cobalt, which enable the manufacturers to be identified (Table 5).

Figure 29: Chart showing the key components of the paints analysed (wt%), normalised to 100%, showing the similarity between the Fairey grey paint from other aircraft and the grey paint from the Solent wreck (detached sample WF-1).

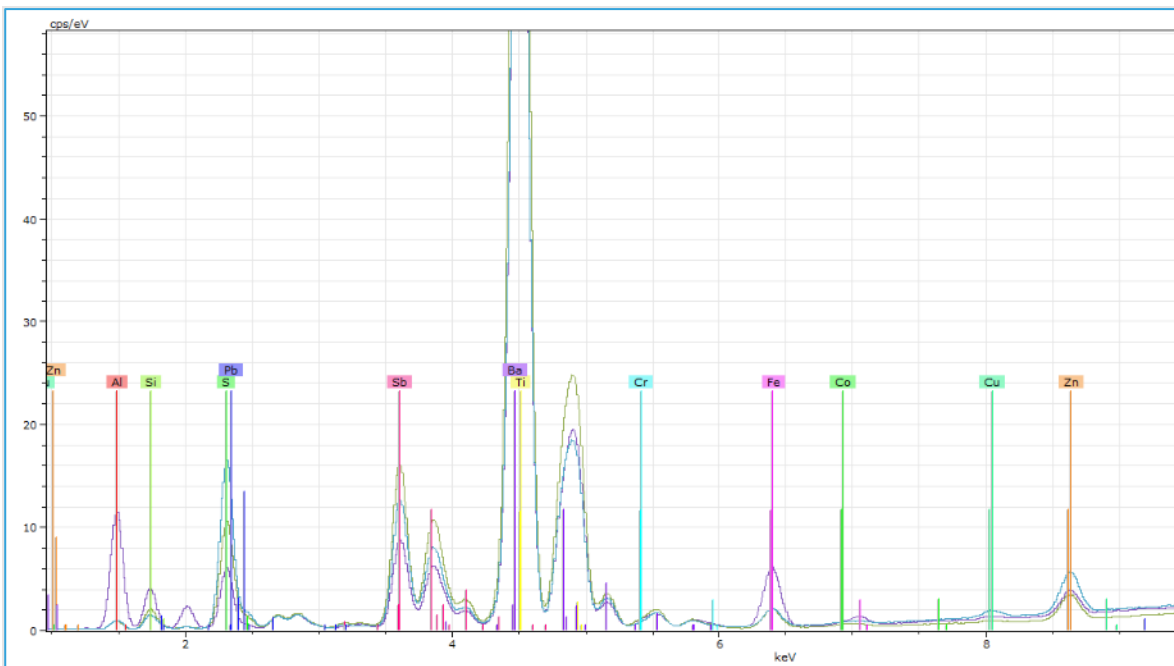
The grey paint formulation used by Fairey Aviation contains high levels of titanium, mid-levels of barium and small amounts of zinc, iron and antimony; the antimony is particularly distinctive. This formulation matches precisely the grey paint used on the Solent wreck aircraft components (Figure 31).

Figure 31: XRF spectra showing the close match between the grey paint from Fairey aircraft LS931 (green line) and PM870 (purple line) and the sample from the Solent wreck TAGs window WF-1 (light blue line).
