# Historic steel-framed windows

The Generator Building at Stow Maries

## Stow Maries Great War Aerodrome

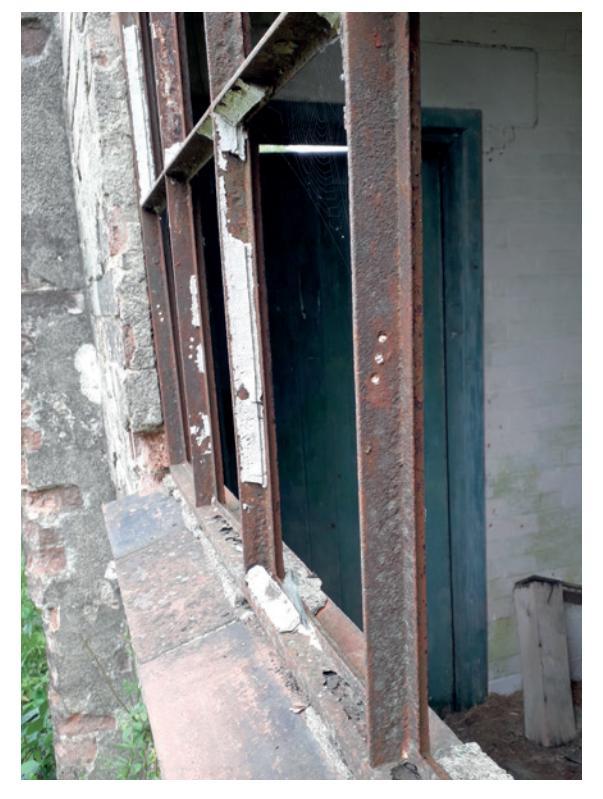
Distortion and loss where there has been water ponding

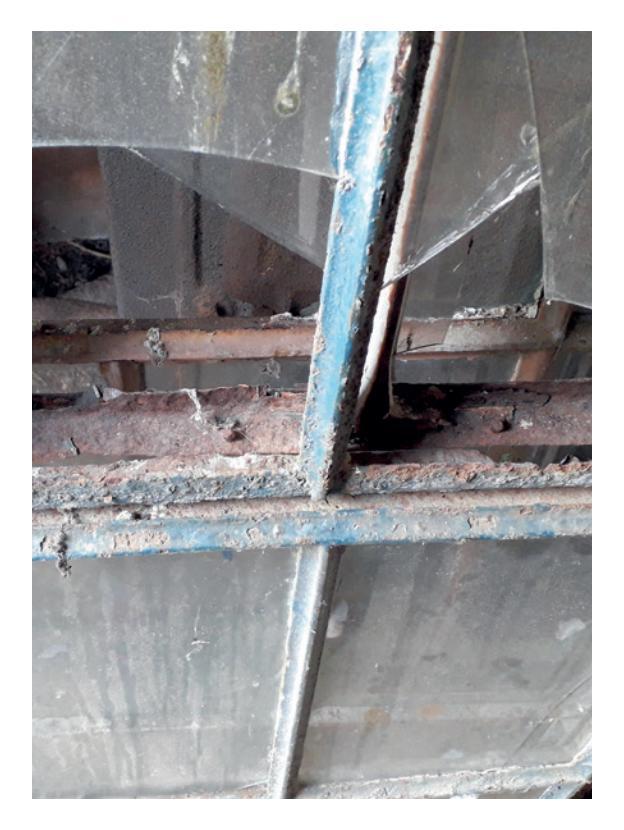
Steel windows in storage, showing the cavetto (curved) moulding

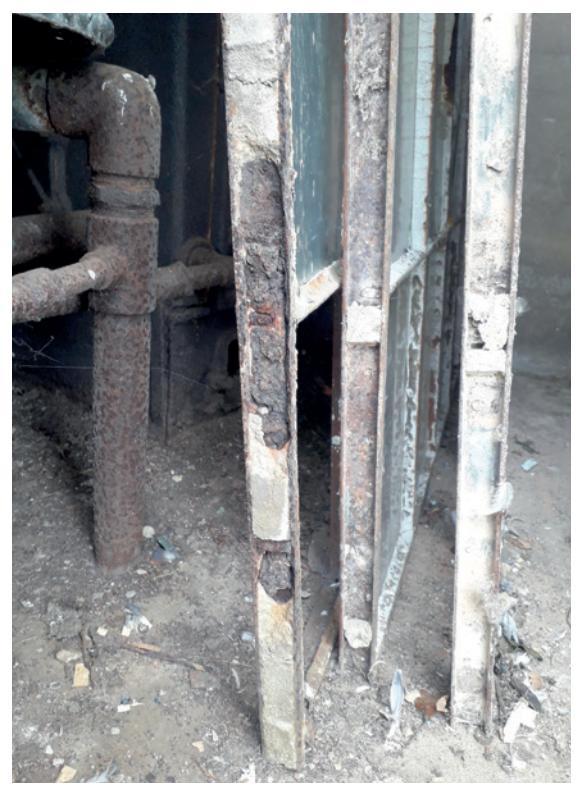
A side view of steel windows in storage, showing assembly detailing

Close inspection showed that the frames are riveted together, and the glazing bars are tenoned

through them and riveted over – evidence that they were assembled from individual rolled-steel components, not cast in iron as a single unit as had been previously thought. The sections comprising the fixed frame (including the glazing bars) carry cavetto mouldings, derived from the sections used in Victorian cast-iron windows. The weathering seal is poor, as the mouldings on the fixed frames have not been dressed off where they face the casement: this detail was improved in later windows designs.

The condition survey found that the steel frames and casements were rusting generally, but many sections were capable of repair and could be retained. Where corrosion is most severe (particularly at low level on the fixed frames and on the casements), affected sections will need to be renewed. Several casements are so badly corroded that they must be completely replaced; any serviceable sections will be salvaged and used to repair other casements. All replacement will follow the original moulding profiles and construction methods. The quoted costs for refurbishment and limited replacement using matching sections are lower than for wholesale replacement (with a profile different to the original) quoted for by current windows manufacturers.
