SURVEY: BUCKLERS HARD

DATE: 7-8/7/80

## 2. SURVEY

**Object:** to locate the presence of any buried structures or features relating to the original shipbuilding industry.

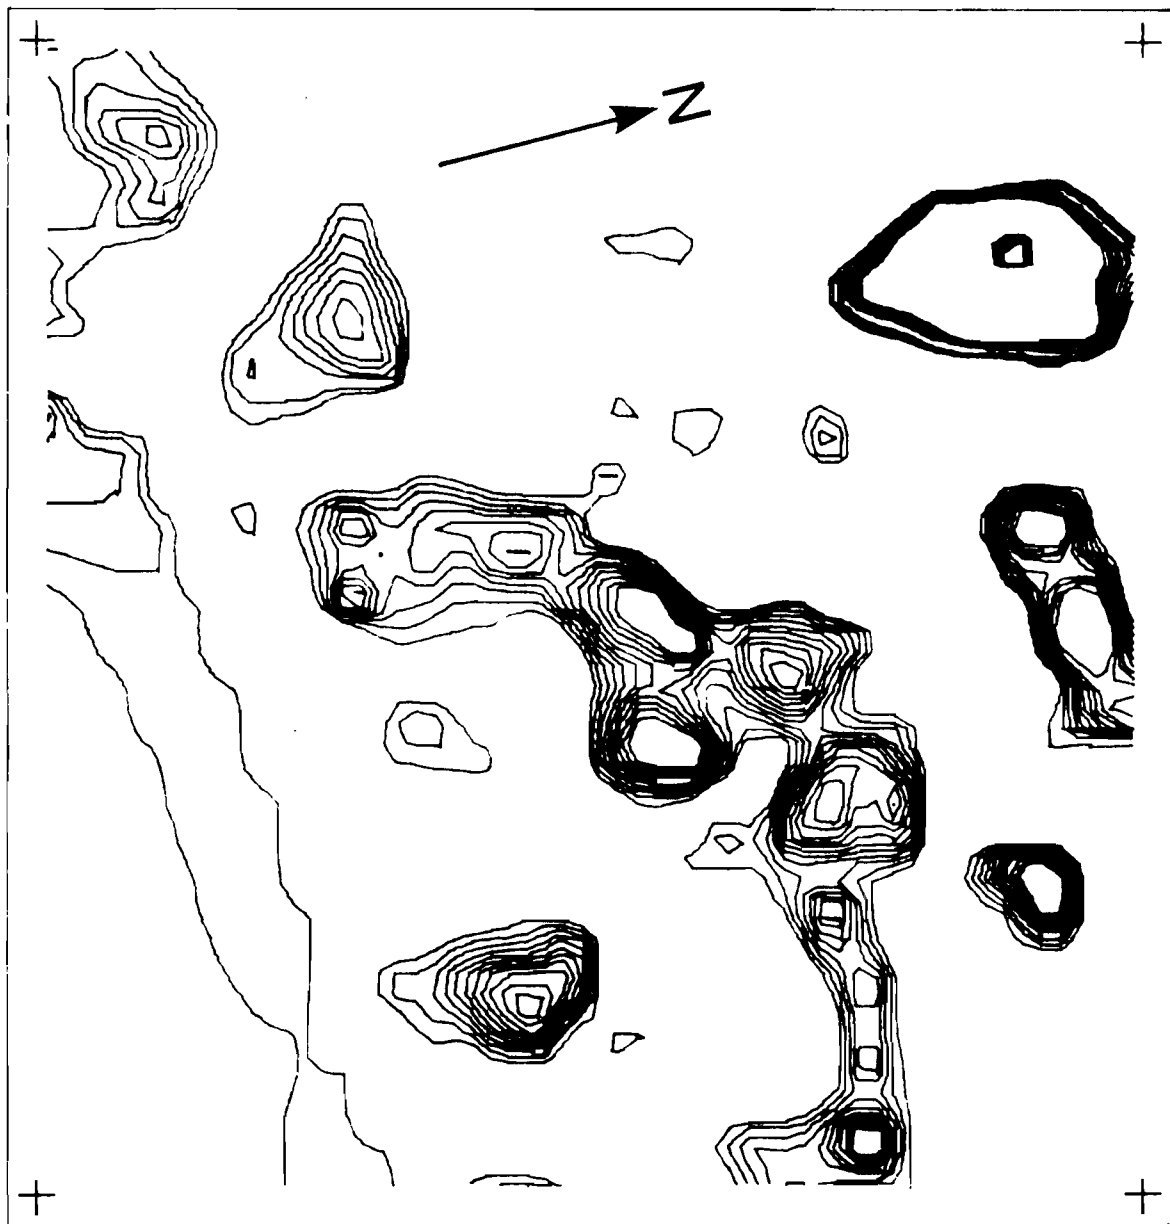
Plan 2

The area was initially surveyed for variations in ground resistance, as such variations are often liable to correspond with buried structures such as wall foundations. The data has been computed, and is presented as a contour plot (plan 2). The contours here surround anomalous areas of high resistance and these can be seen to concentrate in several discrete spots, and additionally in an arc-like pattern in the eastern half of the square. This arc probably continues under the adjacent track and may thus form part of a more extensive pattern very possibly relating to foundations. Masonry may actually remain in situ, or a foundation trench could be filled with a course fill such as rubble. Whatever the case, this particular feature must almost certainly indicate the presence of buried remains here, although it is surprising that what appears to be part of a circle (diameter about 30 m. is represented, rather than a linear arrangement. The other anomalies nearby are no less likely to result from artificial ground disturbance although no pattern is discernible. Accumulation of rubble or similar debris could well be responsible, and one is reminded of the uneven nature of the ground here.

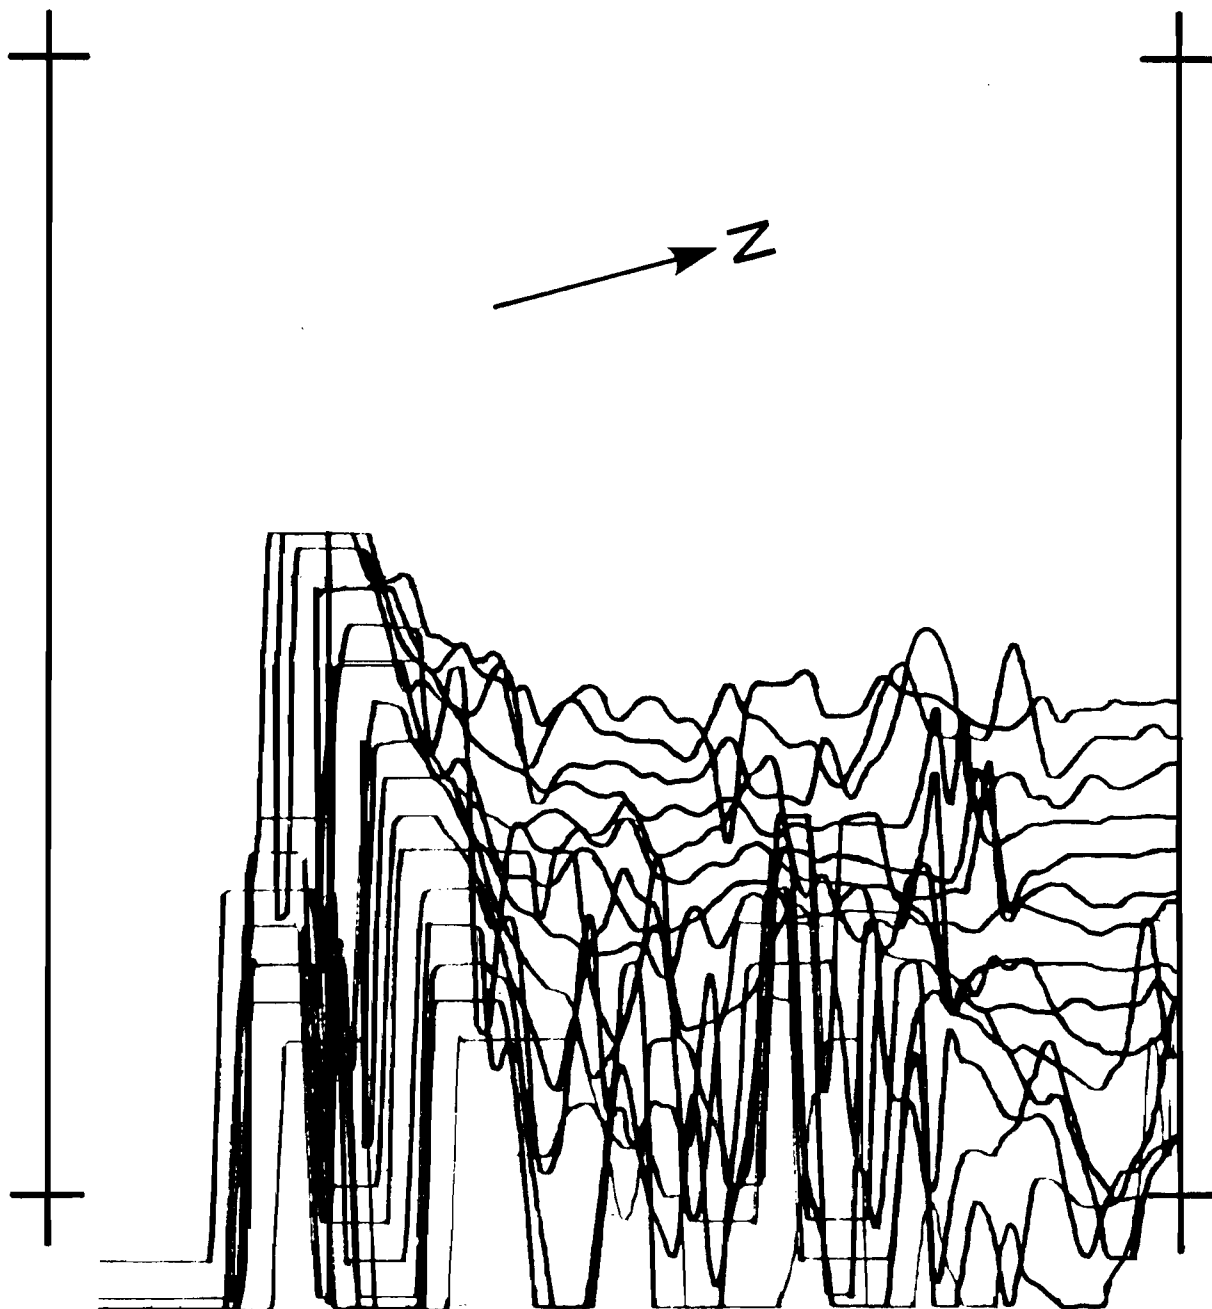
Plan 3

In addition to scanning widely over the site with the poor results already mentioned, a part of the resistivity survey area was also surveyed in detail with the magnetometer and automatic recording system. The magnetometer is carried along successive 30 m. traverses separated by 1 m. intervals and a trace recording the signal is plotted to scale, and here reproduced on plan 3 at 1:200. As suspected, anomalies from iron objects near the surface are profuse and so strong as to blot out any of the subtler anomalies that may correspond to normal archaeological features.
