Ancient Monuments Laboratory
Report 90/87

COPPERGATE, YORK METALLURGY REPORT
NUMBER 8. KNIVES 1532, 2270, 4035,
5096, 5107, 5111, 5719, 6487, 7662,
8574.

COPPERGATE YORK METALLURGY REPORT NUMBER 8

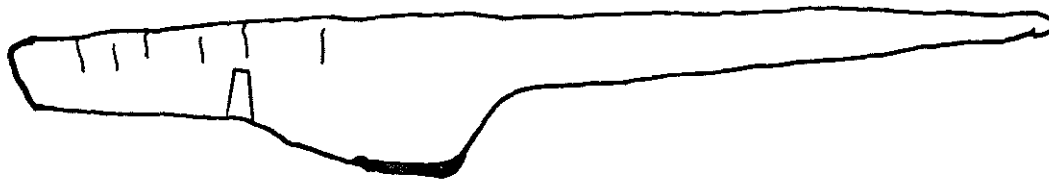
FIGURE 4 KNIFE 2270 CROSS-SECTION (X5)

Both sections revealed the same overall-structure of a high carbon martensitic cutting edge welded to the knife back which was a predominantly medium grained ferrite (Figure 4). Some small areas of pearlite were present in the knife back. The weld line was delineated by a white/yellow line (cf. Knife 10556). Towards the weld line the martensite contains a small amount of ferrite, and at the weld it degraded into pearlite. Beyond the weld line pearlite plus ferrite was present, clearly indicating carburisation of the knife back during welding.

The hardness and micro-hardness values obtained for Edge 1 and Edge 2 are given in Table 1. These show that the ferritic back contained no significant levels of alloying elements, and that the cutting edge had been successfully slack quenched.

The knife was of Type 2 manufacture, and of high quality. This would accord with it being a specialist tool. There was no difference in the quality of the two cutting edges and therefore it is probable that blade shape determined function rather than metallurgical quality.

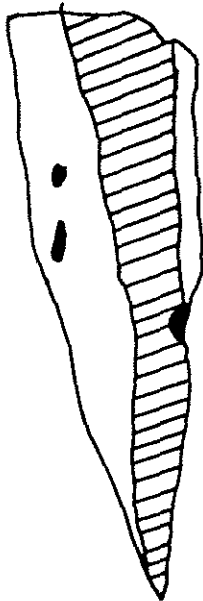
FIGURE 14 KNIFE 7662 INTERPRETATION OF X-RADIOGRAPHS (X1)

Knife 7662 was ascribed to Backform C. It was badly corroded, and X-radiographs showed some metal loss, especially along the cutting edge. It was fractured across the tang and also at about 10mm from the knife tip. Slag lines were observed in the X-radiograph (Figure 14). Two half-sections were removed.

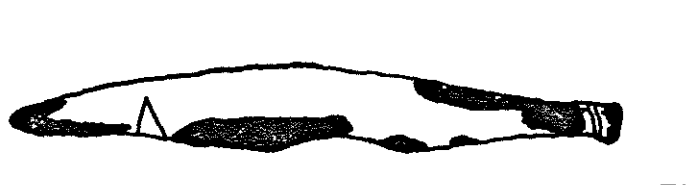
FIGURE 15 KNIFE 7662 CROSS-SECTION (X5)

were recorded, concentrated in the centre of the knife back section, suggestive of a Type 1 manufacture. Etching confirmed the method of manufacture (Figure 15), the steel core having a fine pearlite plus ferrite structure. The hardness results (Table 2) show no variation down the length of the knife, indicating that the effective cutting edge had not been heat treated, although the original edge may have been quenched, but its effect worn away. The evidence of extensive wear, being the difference in length of the two flanks. The two flanks were phosphoric/ferritic iron displaying some banding of varying grain size with some grain boundary carbide present in the ferritic bands and phosphoric ghost phasing present in other bands. There were fine precipitates, indicative of age hardening in the ferrite. The hardness results are shown in Table 2, and show that the largest grains were the hardest.

Knife 7662 was of Type 1 manufacture but had either not been heat treated when originally manufactured, or had been carelessly maintained as evidenced by the differential wear/sharpening of the flanks and the absence of a heat treated edge.
