Centre for Archaeology Report 70/2005

**Conservation and analysis of a Roman glass vessel and
associated material from Botchergate, Carlisle**

Jennifer Jones

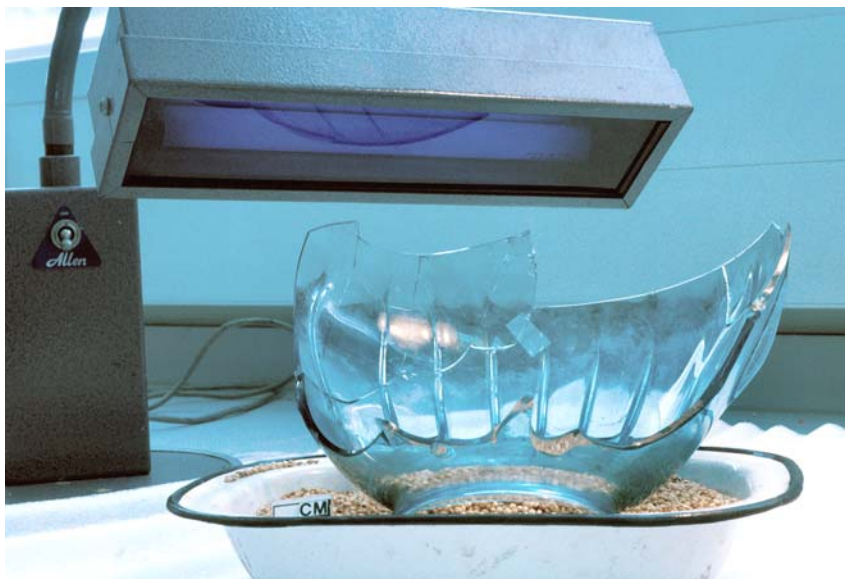
Fig 2 : Cyanoacrylate adhesive curing under UV light

Epo-Tek 301-2™, a clear two-part epoxy adhesive with very low viscosity and good optical properties, was chosen to join the glass. Because of the adhesive's tendency to run out of the joins before curing, the fragments were first tacked using spots of Loctite Glassbond, a cyanoacrylate adhesive which is cured by exposure to ultraviolet (UV) light. This was done to hold the awkward joins in place, while the epoxy was curing. A UV lamp was used to accelerate the curing of the cyanoacrylate.

The Epo-Tek was then introduced using a very thin brush applied to minor points of imperfection along the tacked joins, and the adhesive carried in by capillary action. Curing of the epoxy was complete in two days. Reassembly of the vessel was fairly successful. One or two joins could not be made perfectly, possibly due to differences in the thickness of the glass having led to 'springing'.

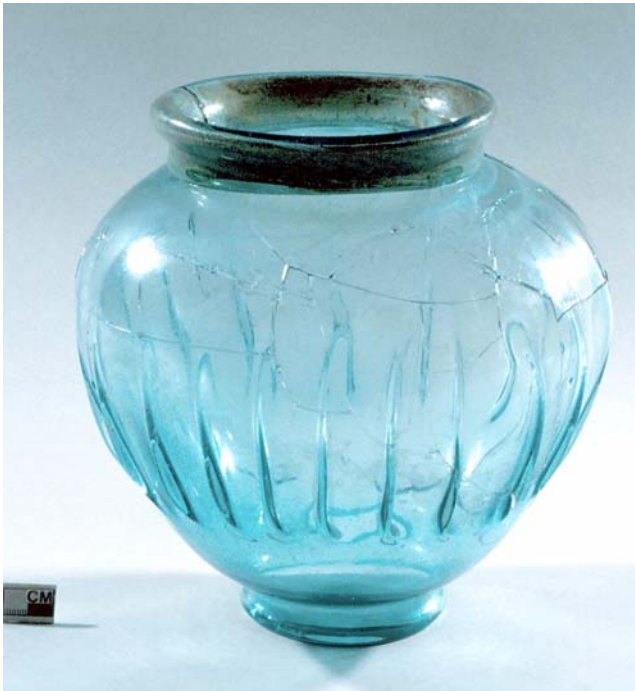
When it was reassembled, it could be seen that the vessel is somewhat misshapen, with the curve of the shoulder being greater on one side than on the other. Above the foot ring on the outside of the glass are several fairly deep scratches. The cause of these is not clear. They could be the result of some part of the manufacturing process, and were not removed either because the (slightly sub-standard?) vessel was destined for burial or because it was not customary. Alternatively, they may have been acquired during the life of the vessel. A further deep 'serrated' scratch is visible on the outside of the rim, and contained traces of a red material. It was not possible to analyse this material due to difficulties with positioning the fragment inside the EDXRF chamber.

Fig 3 : Assembled vessel

The dried glass fragments were first assembled temporarily using narrow strips of Scotch Magic Tape™, to assess the vessel's completeness. Very little was found to be missing, and only a few small fragments could not be placed. Assembly of the pieces was carried out with the vessel upside down in a sand tray for stability, as the rim was the thickest and heaviest part

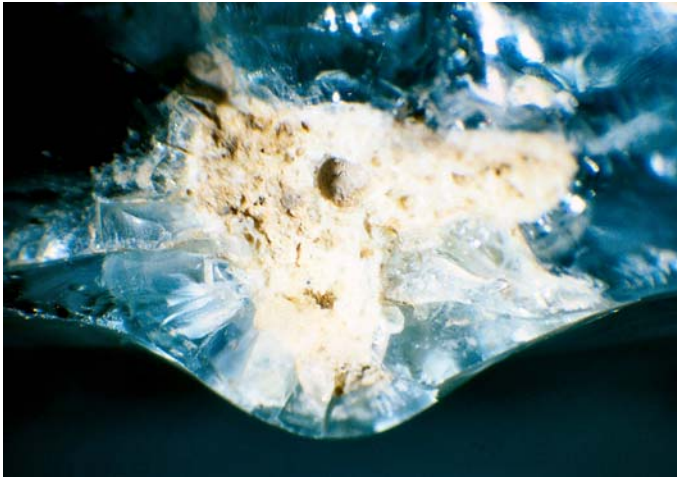
Along a break between two of the vessel fragments was a small nodule of whitish material, which appeared vitreous at X16 magnification. This may be a fragment of the crucible used for the glass melt (Prof J.Price, pers. comment). It was unfortunately not possible to remove any of the substance for analysis.

Fig 4 : Possible nodule of slag in the vessel wall (X16)

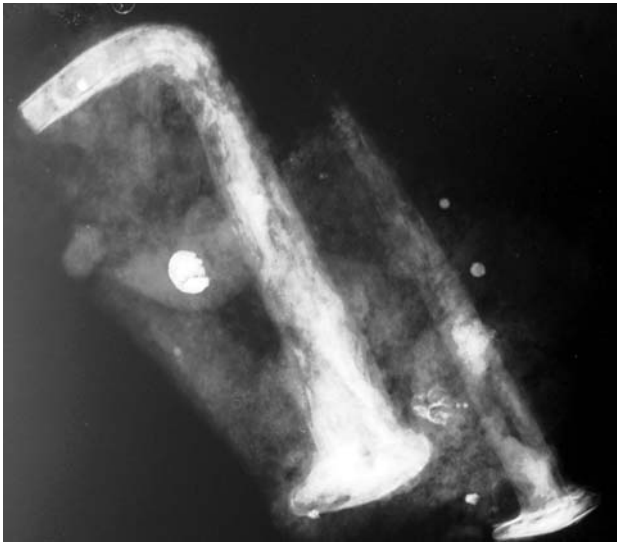
Several 'bright spots' of denser metal were observed on X-radiographs, eg on **1143Δ** a plate fragment and **1146Δ** a nail. Where this material could be detected visually among the iron corrosion products, it was analysed using EDXRF, and found to be (probably) leaded bronze.

Fig 5 : Melted CuA spots visible on XR of nails
