Specifications required by Stephen Green, Director of Bradwell Roman Villa Excavation (MK105,1976) regarding further investigation of the ironsbound lead(?) casket.

AM No	X-Ray No	Photo No	Description and Report	Ref No
765655			Working Report of the Lifting of the Iron- Bound <del>Lead (?)</del> Casket at Bradwell Roman Villa, Bucks.	
A.			Stage 1: Examination.  THAN NO 1 VIEWS  (1) — (3)  Fig:1  Shetohplan of Object on site.	
			A B	
			Fig:2 Section through AB to show position of Object.	
*			Fig.3 Sketch of Object.

THE "BRADEMLL VILLA" CHEST, SKCAVATION, CONSERVATION AND RECONSTRUCTION

Brief report for the purpose of exhibiting the casket at the May ballot of the Society of Antiquaries of London.

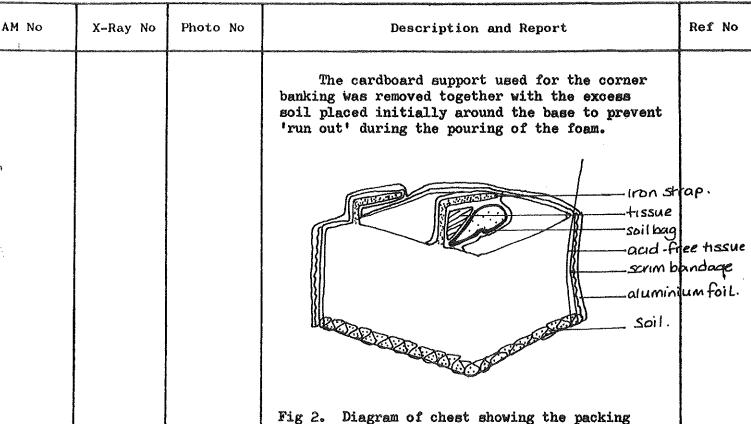
Fig 2. Diagram of chest showing the packing layers.

The aluminium foil, blue tissue paper same bandages, and soil bag supporting the iron top strap were then removed exposing the final layer of acid free tissue paper.

The final stage of unwrapping this layer was more delicate as protuding iron brackets, although held by a mixture of H MG (cellulose nitrate adhesive) in acetone were now not fully supported.

Wax blobs ie. Dental wax heated with an industrial hot air blower and worked into a putty-like consistency, were placed at the base of all the overhanging points eg corner brackets. This prevented any likely subsidence as the soil block had shrunk considerably on one side ie. the side that was nearest the baulk wall on site, and the metal fittings were left suspended by very little support. Also large fissures within the soil block were bridged with a polyamethacrylate ester ie. Bedacryl 122X. This consolidant has a viscous consistency and a rapid solvent evaporation point which permitted little wetting of the soil and thus prevented the likelihood of substantial

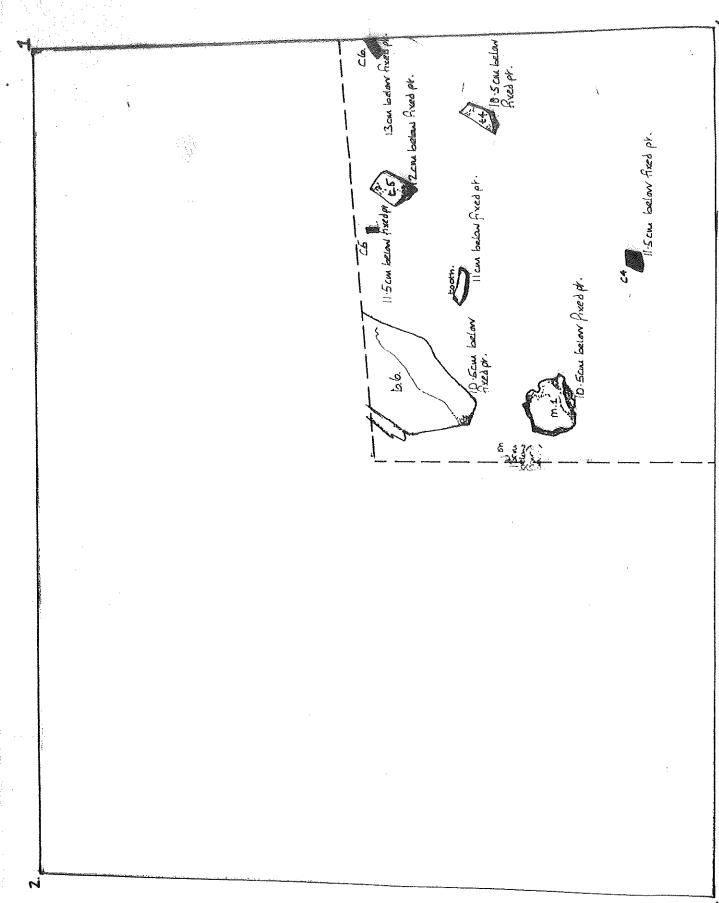
The rectangular block of soil defining the chest dimentions was found in situ to be distorted. The chest measured approximately 45cm wide x 37cm deep x 34cm high. There were eight decorative iron corner clamps and the chest had been partially bound with two parallel iron straps which were hinged at the top to permit lifting of the lid.

Visual inspection of the block suggested that the fittings had undergone slight movement after burial. The front straps were positioned above the level of the horizontal base line. Both front strap and back strap tilted backwards and the vertical distance between each pair of corner clamps was less on the front a) than that on the back b) of the chest. This suggests that the chest was slightly crushed downwards and inwards.

This was confirmed by the subsequent micro-excavation which revealed that the base straps sloped downwards towards the back of the chest. In addition the base strap 10 was found at a slightly lower depth to base strap 9 which presumably

attributed to the slight lean of the chest to the right. Both base straps had fractured towards their back ends and along the line of stress at the corners. Evidently there had been some downward movement of the back straps but there was no evidence to suggest that the back corner clamps had moved relative to each other. The iron straps supporting the lid had broken and were uncovered in their correct relative positions approximately one third of the way down the chest.

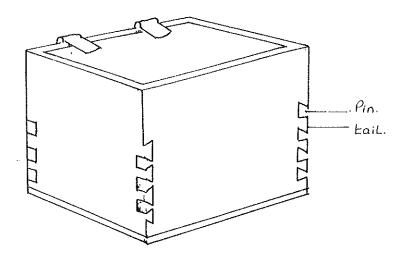
## Position of dovetails

All evidence seem to suggest that there are possibly four dovetails between the corner clamps.

The pins appear on the front and back of chest and the tails on the sides.

The base thickness is approximately  $\mathbf{1}^{\mathsf{H}}$ .

Distance from the base to the first dovetail is approximately 5cm.

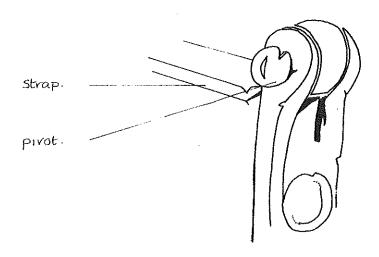
Detail of hinge on strap 10.

The hinges consisted of two plates on one strap, either side of a central plate on the top strap and held in place by a pivot ie. a strap hinge. (Frere, 1972)

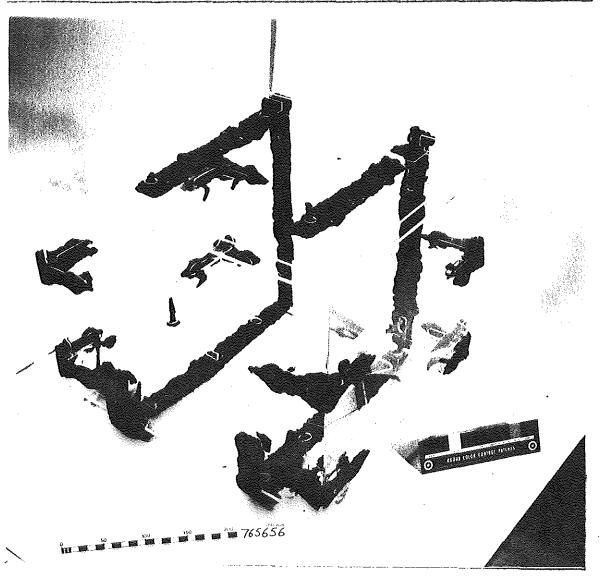
## A RECORD OF THE POSITION OF IRON FITTINGS ON THE RECONSTRUCTED PESPEX BOX

The above photograph BL(c)21 shows the position of all the iron fittings. Each fitting is clearly marked with white cyclo colour protected with a methacrylate resin (Bedacryl 1Z2X). The eight brackets are numbered 1-8 and the two parallel straps partially binding the chest are numbered 9 and 10. The long nails used to reinforce the sides, and base nails are marked by Roman numerals I-XVI, All numbers have been transferred to an inconspicuous corner ie on the inner surfaces of the brackets and on the shaft of the nails.
