ENGLISH HERITAGE

HERITAGE AT  
RISK  
REGISTER  
2012

NORTH EAST

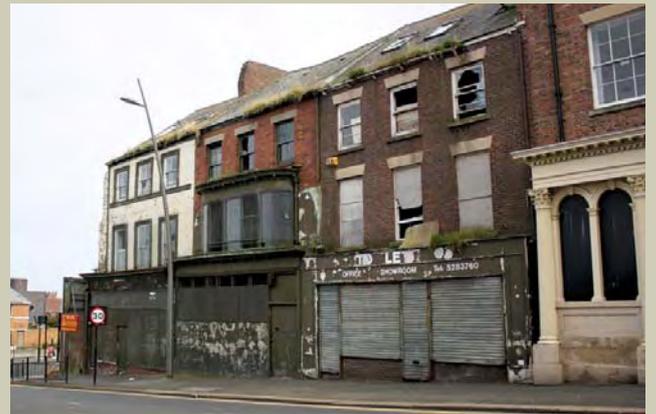
### OLD SUNDERLAND & OLD SUNDERLAND RIVERSIDE CONSERVATION AREAS, TYNE AND WEAR

Long-term economic decline has brought extreme deprivation and dereliction to this pair of neighbouring conservation areas. Townscape Heritage Initiative projects have been difficult to get off the ground and Sunderland Council is now processing applications to demolish a number of listed buildings in the area.
