# Heritage at **Risk**

Historic England

**Midlands Register** 2020

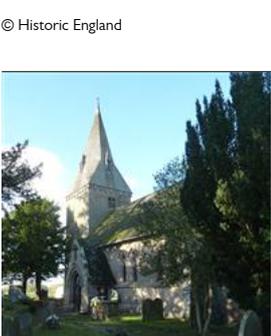
<p><b>SITE NAME:</b> Church of St Peter, B 4348, Peterchurch, Peterchurch</p> <p><b>DESIGNATION:</b> Listed Place of Worship grade I</p> <p><b>CONDITION:</b> Poor</p> <p><b>PRIORITY CATEGORY:</b> C (New entry)</p> <p><b>OWNER TYPE:</b> Religious organisation</p> <p><b>LIST ENTRY NUMBER:</b> 1296560</p>	<p>Large Norman church of nave, former tower base, chancel, and apse with some later medieval features. Tower of 13th century, with a fibreglass spire of 1972 replacing a stone spire removed in 1949. Interior remodelled for community use in 2009. The true condition of the spire is unknown, and options for its future repair need now to be considered. Other essential repairs remain outstanding from the 2016 QIR including replacing missing tiles, repair to roof flashings, urgent holding repair work to the tower parapet gutter, which is cracked and allowing water into the tower.</p> <p>Contact: Chris Miners 0121 625 6835</p>

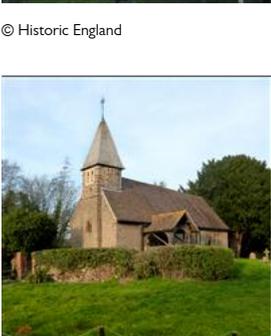
<p><b>SITE NAME:</b> Church of St Peter, Pipe and Lyde</p> <p><b>DESIGNATION:</b> Listed Place of Worship grade II*</p> <p><b>CONDITION:</b> Poor</p> <p><b>PRIORITY CATEGORY:</b> C (C)</p> <p><b>OWNER TYPE:</b> Religious organisation</p> <p><b>LIST ENTRY NUMBER:</b> 1172739</p>	<p>Small parish church set at the end of a village and facing the A49. Late C12 nave and C14 chancel largely rebuilt by F Kempson in 1874 who also added the broach spire to the C13 tower. The roof needs repair and work is also needed to the tower. A National Lottery Heritage Fund and Historic England Repair Grant for Places of Worship was awarded in 2012 but only development works were undertaken as there was no match funding to undertake the repairs.</p> <p>Contact: Chris Miners 0121 625 6835</p>
