# Heat Pumps in Historic Buildings

Air Source Heat Pump Case Studies – Small-scale Buildings

In 2021, we commissioned environmental building services engineers specialising in net zero technology, Max Fordham LLP to review the performance of ASHPs in 10 properties: homes, offices, shops and two small churches across England to inform our on-going advisory work. The key findings were:

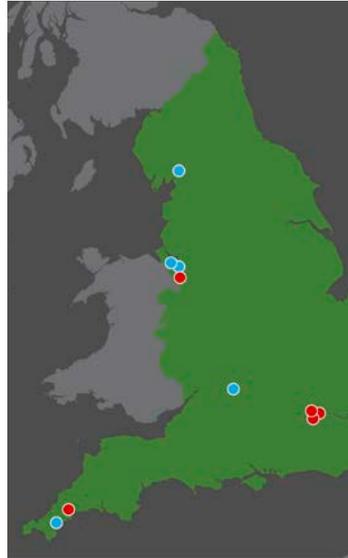
**Figure 1:**  
Location of the 10 case studies and types of ASHPs. Monobloc ASHPs are shown in blue. DX ASHPs are shown in red.

Ten case studies were commissioned to help understand factors underlying good or poor system performance in air source heat pumps (ASHPs). These case studies span homes, offices and shops, and churches in Cheshire, Cornwall, Cumbria, Gloucestershire and London. The case studies were mostly 18th and 19th century buildings and included a range of building construction types, and six were listed buildings. All of the properties had ASHPs installed as their primary space heating. Five of the properties use monobloc (air-to-water) ASHPs, and five had some type of direct expansion (air-to-air) ASHP.

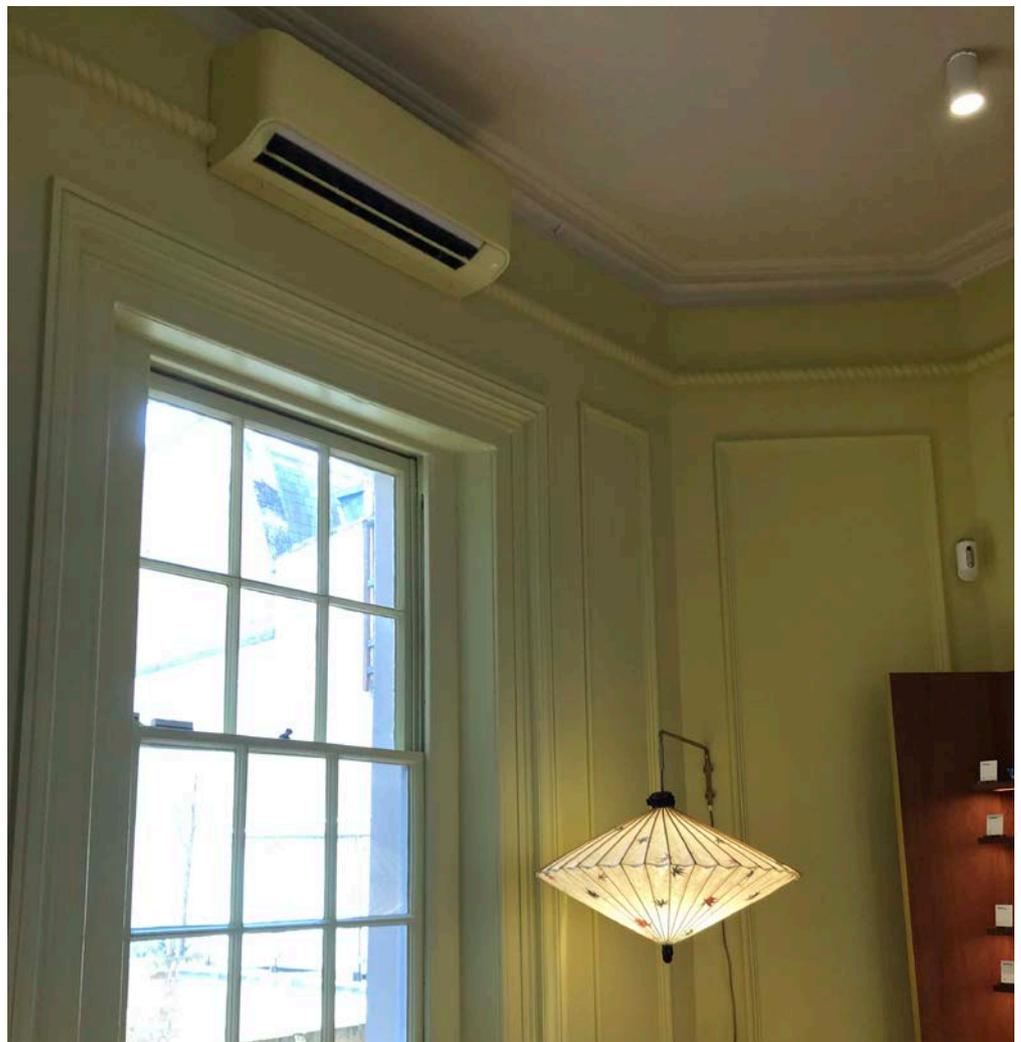
**Figure 2:**  
An example of a typical wall-mounted indoor condenser often used with DX ASHPs for both heating and cooling. The indoor condenser has been colour-matched to blend with the decor.

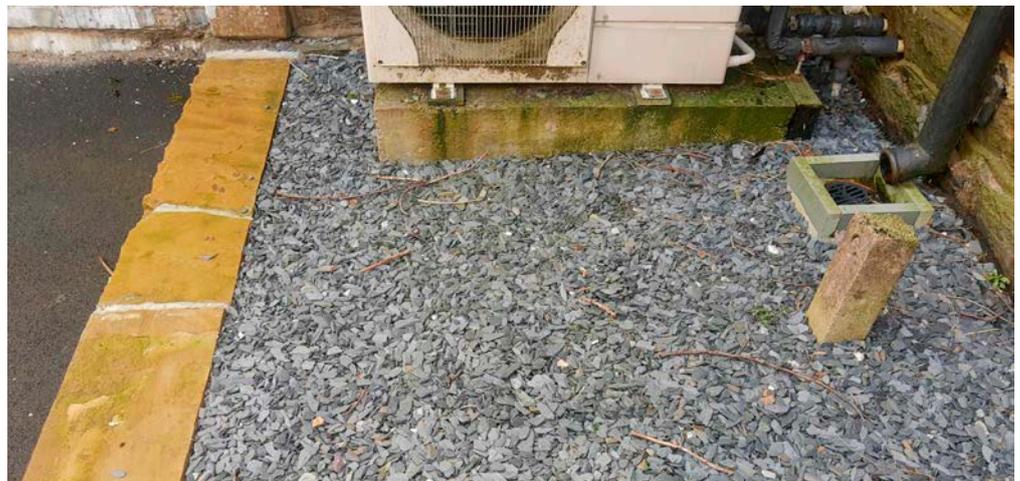
Generally, condensation water from external units is allowed to run over the ground to a nearby drain. This water will freeze in winter and become potentially hazardous. In all the studied properties, pedestrians did not need to walk between the ASHP and drain. Therefore, ice caused by condensate water was not reported as an issue by any participant, but it was noted as a potential slip hazard at some properties. In two properties, condensate water dissipated through a gravel/slate bed that surrounded the base of the external unit, thus eliminating any potential hazard.

Figure 5:  
A slate bed at the base of the ASHP allows condensate and defrost water to dissipate safely.

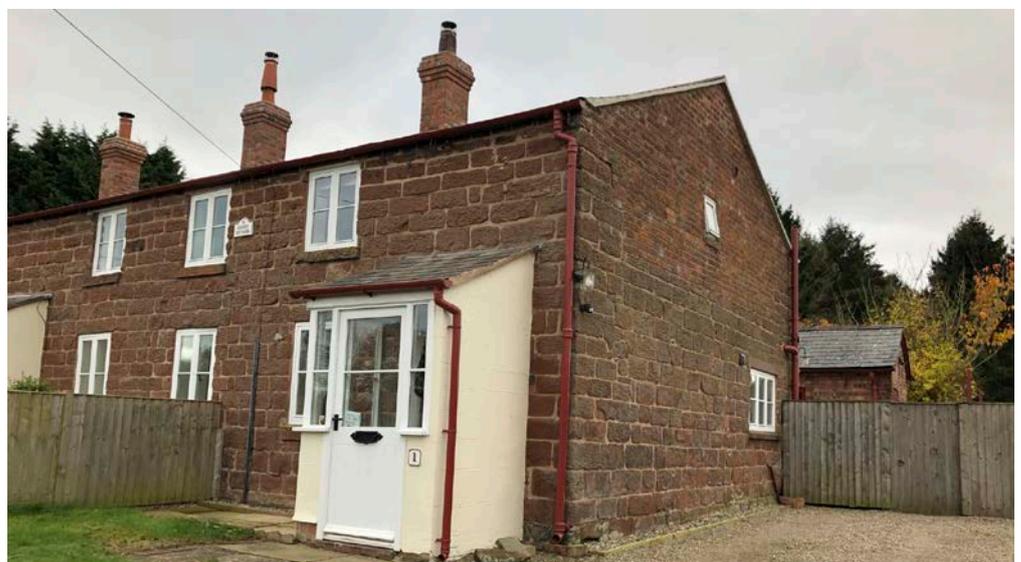
Figure 8:  
Site 1

Significant renovations were carried out in October 2020 to improve its energy efficiency. The works included adding internal mineral wool wall insulation to all external walls and installing a monobloc 8kW Hitachi RASM-3VRE ASHP that distributed heat through a radiator central heating system. The ASHP also provided all the domestic hot water for the property, which was stored in a hot water cylinder. There was a wood-burning stove in the living room, which serves as an additional or back-up heat source. Previously, the property was heated by electric storage heaters, which did not achieve comfortable temperatures.

<b>Technology choice</b>	★★	Monobloc heat pump is ideal for residential application where the unit can be located close to the domestic hot water cylinder.
<b>Thermal comfort</b>	★★	Comfort much improved over previous electric storage heaters.
<b>System design/ installation quality</b>	☆☆	Large heat pump capacity (132W/m <sup>2</sup> , expected range for a renovated property of this size 30–65W/m <sup>2</sup> ) coupled with low loss header and 10mm small heating system pipework size may be contributing to short cycle times and suboptimal heat pump efficiency. A low loss header is a means of hydraulically separating the primary side of a system from the secondary.

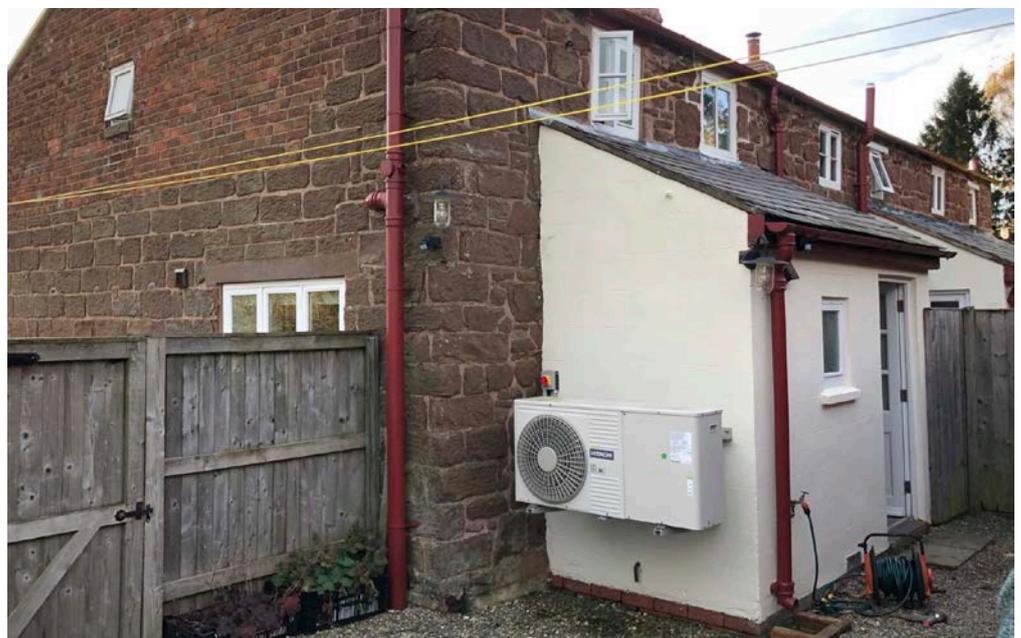
- The raised mounting provided sufficient clearance from heavy snowfall or flooding.
- The location met all the manufacturer's installation requirements for access and airflow.
- There are some small anti-vibration dampers between the ASHP and the mounting bracket, and between the mounting bracket and the wall.
- Condensate drainage had been addressed and there was no risk of freezing over walkways.
- Pipework was well insulated.
- During operation, noise levels were within the expected range.
- During operation, the air speed at the ASHP outlet was within the manufacturer's recommendations.

Figure 9:  
Site 1: ASHP installed at  
the rear of the house

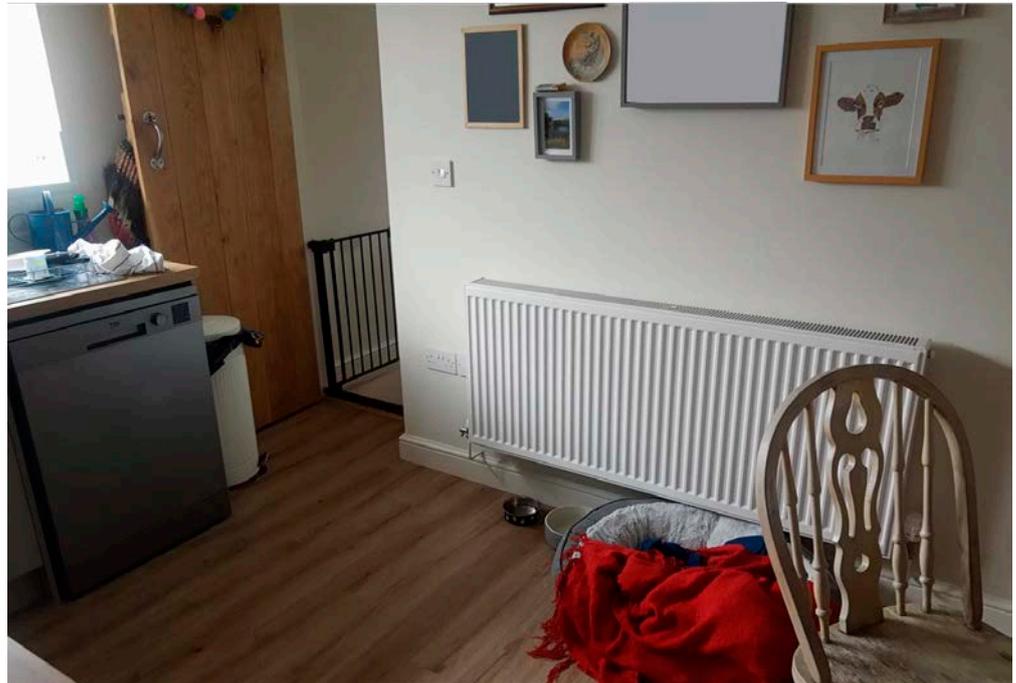
Figure 10:  
Site 1: Kitchen radiator  
with 10mm connecting  
pipework.

Installing 15mm pipework would have reduced the overall system costs and improved the system efficiency.

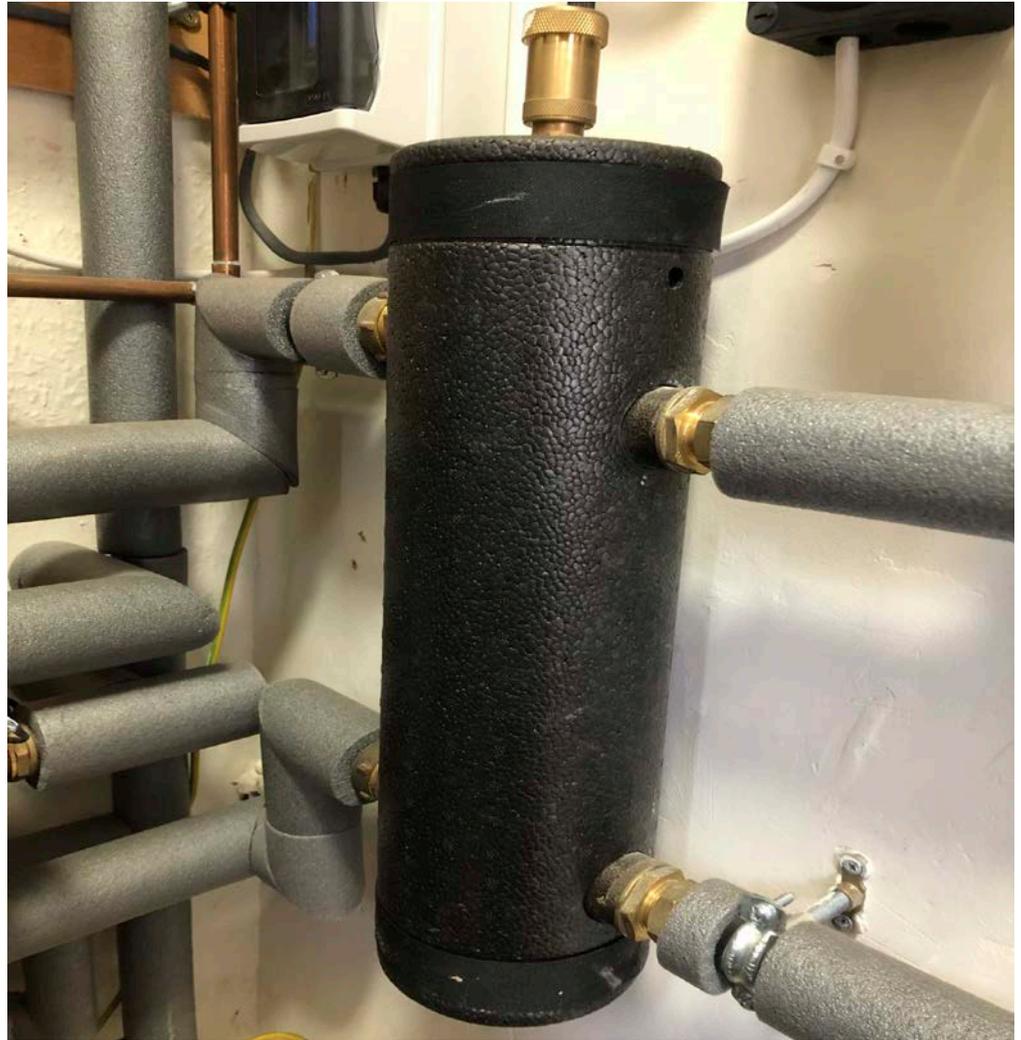
To guarantee minimum system flow rates, the installation at Site 1 incorporates a low loss header between the ASHP and the heating system, and a secondary pump on the radiator circuit. This arrangement adds additional costs and complexity to the system and, in this instance, may contribute to suboptimal ASHP performance.

During the site visit, the ASHP was running in short (sub 4-minute) cycles. The short cycling is probably caused by a discrepancy between the flow rates on the ASHP side of the low loss header and the heating system side. It should be noted that the site survey took place during mild weather, and this may have contributed to the very short cycle time.

Figure 11:  
Site 1: The low loss header was not felt to be necessary and was, in fact, detrimental to the efficiency of the ASHP system.

At Site 1, the minimum system volume recommended by the manufacturer is 28 litres. The estimated water volume of the installed heating system was 50 litres. If the system volume is too low, larger bore pipework could be installed, and a small buffer would help to increase the overall system volume.

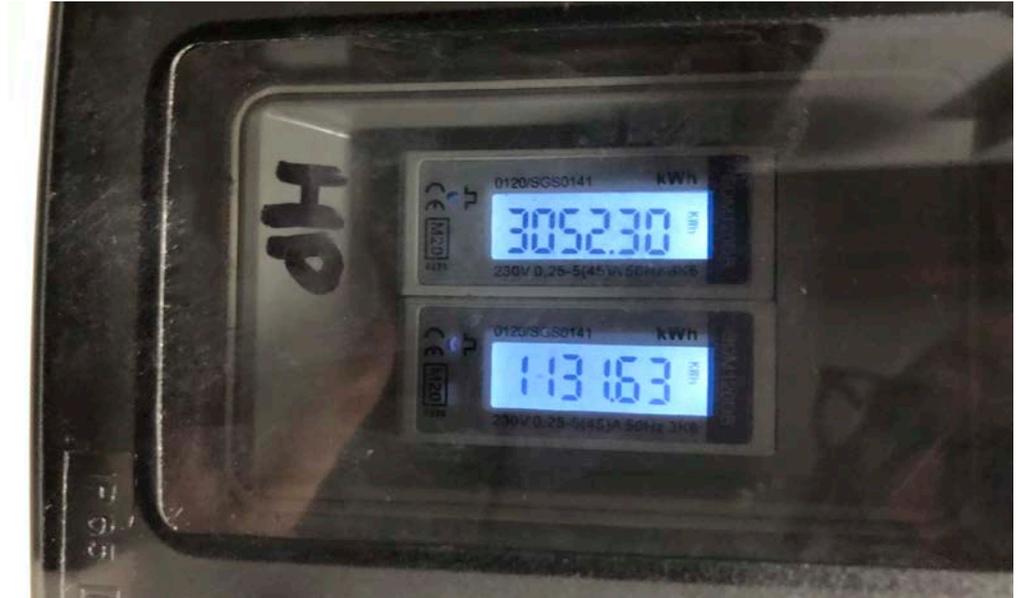
The ASHP was installed with a sub-meter. This allows the electrical consumption of the heating system to be measured separately from the rest of the electrical demand at the property. It is an important feature and allows the occupant to understand where their energy demand is coming from. Figure 12 shows the meter reading on 18 November 2021. The total demand of the property from October 2020 to November 2020 was 4183.6kWh. The ASHP accounts for 73% of the total. The bills provided by the occupant had significant time gaps so did not allow for an analysis of the real costs for this report.

Figure 12:  
Site 1: Electricity meter  
showing ASHP kWh in the  
top display.

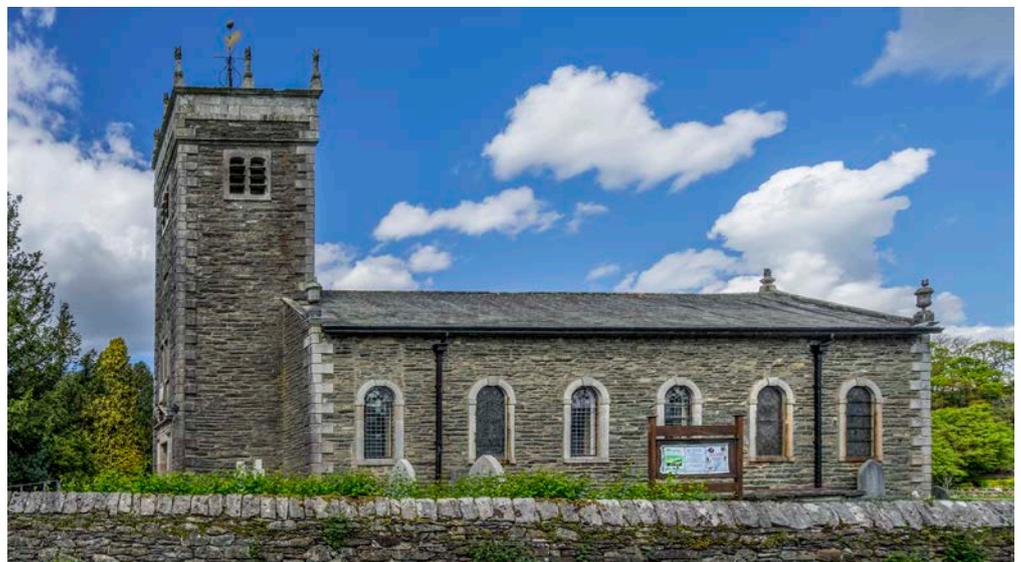
Figure 14:  
Site 4

Previously, the building was heated by direct electric under-pew heaters, which provided a comfortable heat for those sat in the pews. The heating was only switched on 24 hours prior to Sunday gatherings. This meant that the building fabric remained cold, which led to condensation and cold draughts. In 2012, the church underwent major renovations, including installing a 14kW underfloor heating monobloc ASHP system, with 13kW of back-up direct electric radiant wall panels. Fabric improvements were also made, adding floor and loft insulation and secondary glazing. Since these renovations, a small toilet extension had been built, but it was not connected to the underfloor heating circuit and, instead, was heated by a direct electric towel rail radiator.

<b>Property type</b>	Place of worship/multifunctional space
<b>Heat pump technology</b>	14kW monobloc
<b>Heating system</b>	Wet underfloor heating system
<b>Hot water system</b>	Direct electric
<b>Use pattern</b>	Occupied for one or two weekday evenings and church services on Sundays

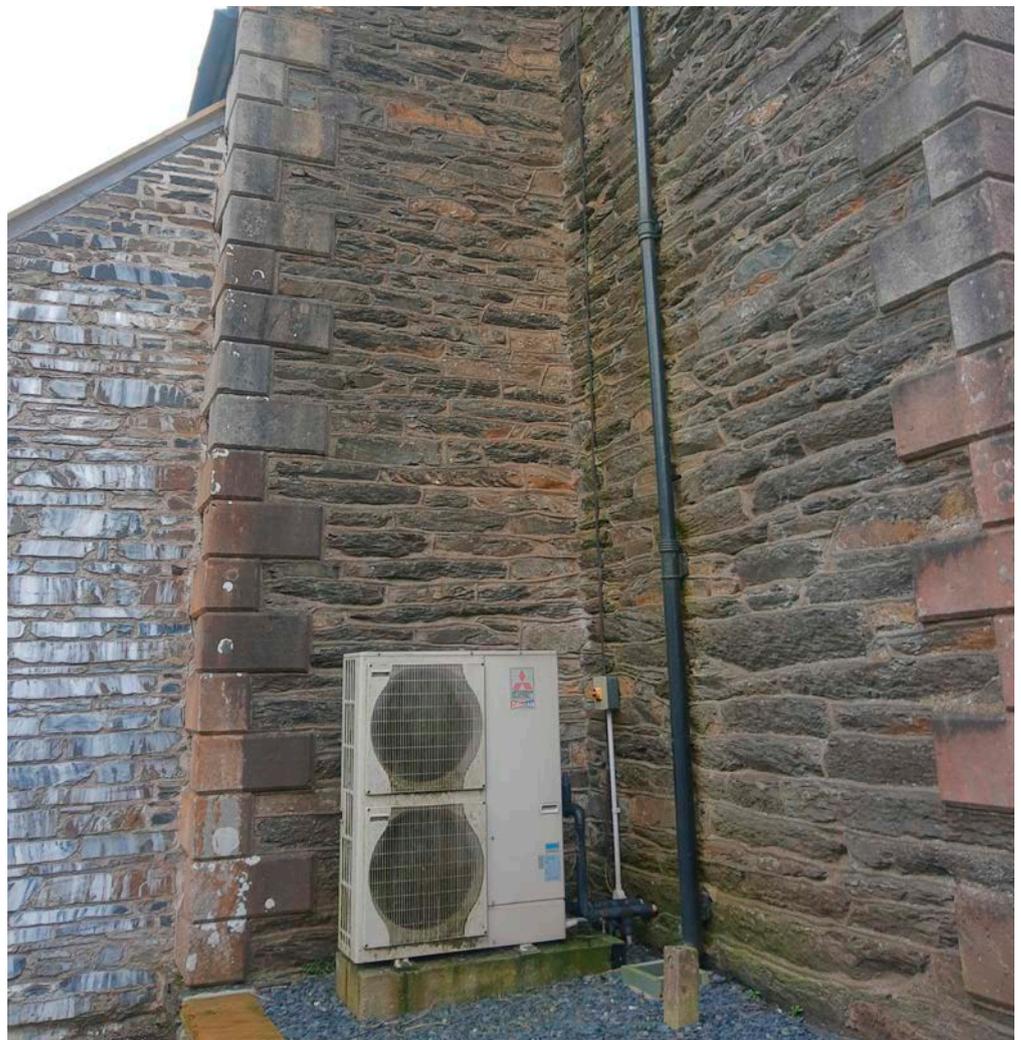
Figure 16:  
Site 4: The ASHP installed  
at the rear of the church.

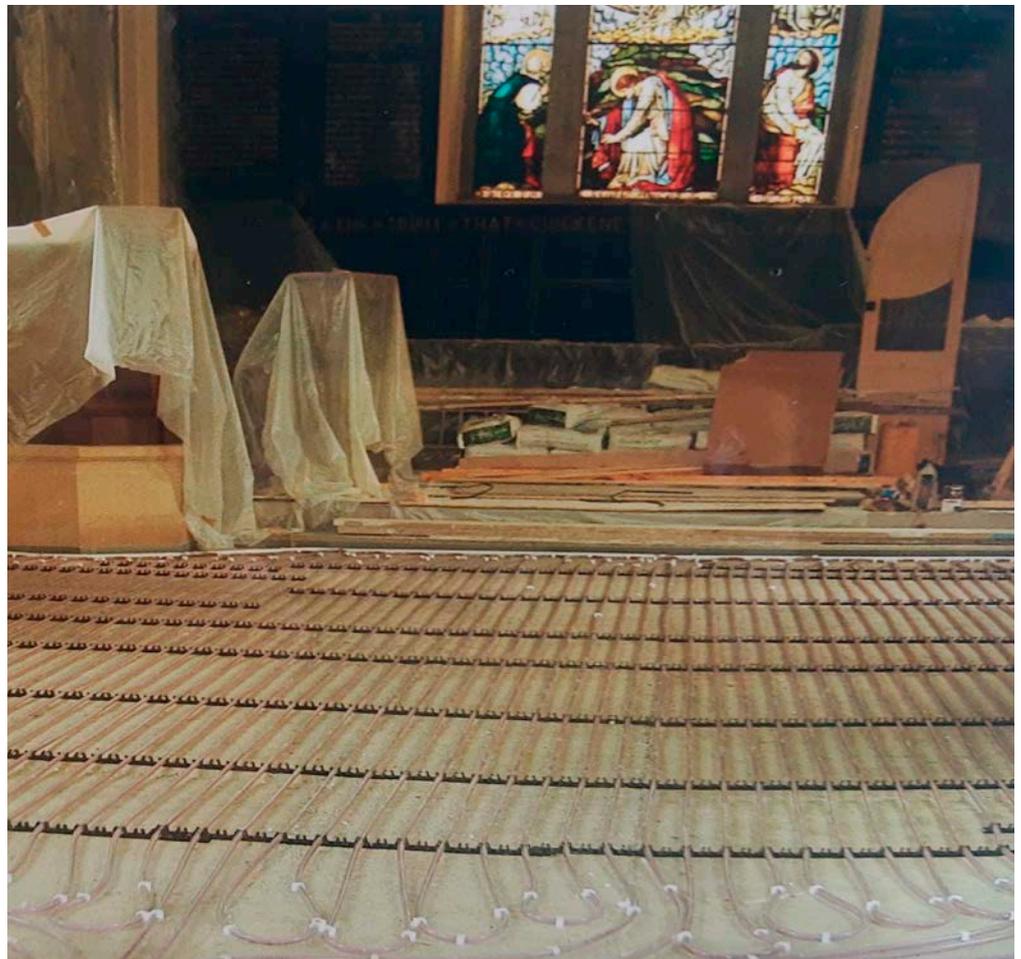
Figure 17:  
Site 4: Underfloor  
heating was laid during  
refurbishment works.

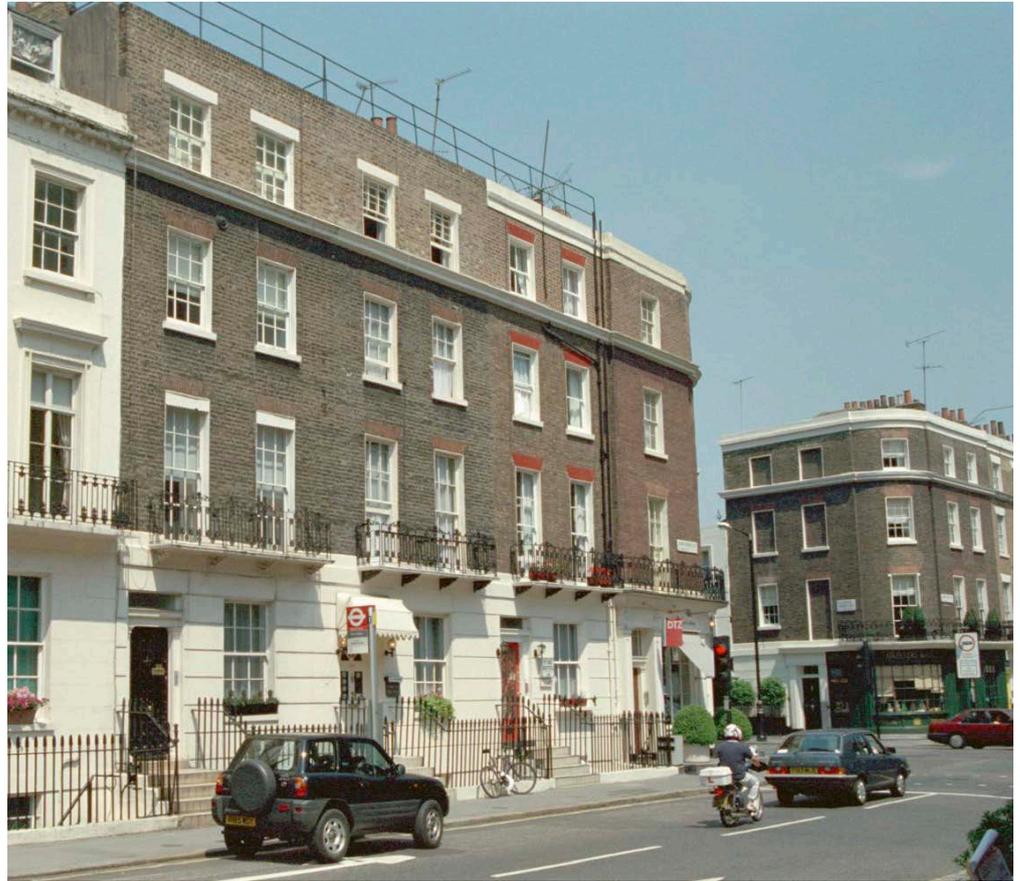
Figure 18:  
Site 5

- Two 5.4kW DX ASHPs installed.
- The ASHPs used R-32 refrigerant.
- The ASHPs were located in a 7.35m<sup>2</sup> outdoor courtyard, which complied with the maintenance space required by the manufacturer.
- The ASHPs were not running at the start of the visit.
- The external courtyard is surrounded by 3m-high walls on all sides.

- In winter, cold air expelled from the ASHPs would sink to the floor of the courtyard, where it would be drawn back into the units. As the temperature of the air in the courtyard drops, the ASHPs will become less efficient. Fortunately, a neighbouring property has also installed an ASHP in the courtyard. At the time of the visit, this ASHP was providing cooling and was, therefore, expelling hot air. As long as the neighbouring ASHP is operating in this manner, the issue with cold air recirculation may be mitigated.

- The ASHPs would benefit from being installed as high up the wall as possible. However, they would have to be accessible for maintenance.
- Condensate drainage was allowed to run freely from the external units across the courtyard to a yard gully drain. In winter, this could present a slip hazard.

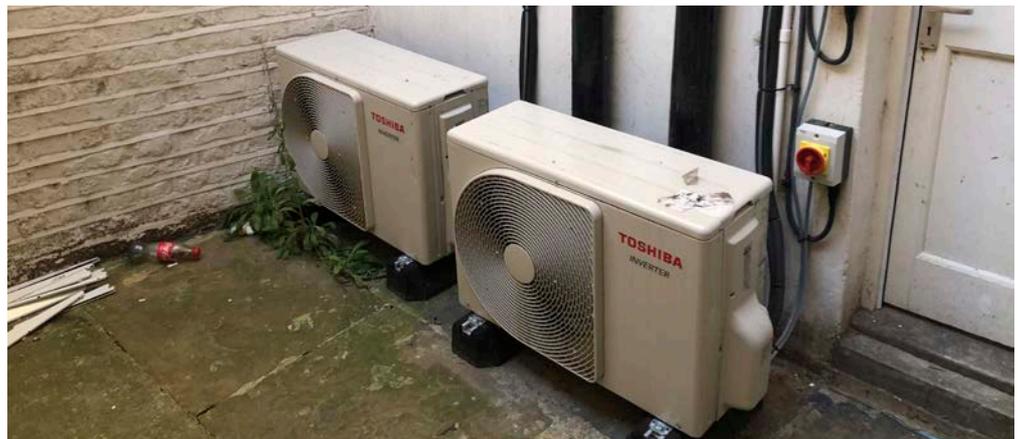
Figure 19:  
Site 5: The ASHPs in the  
courtyard.

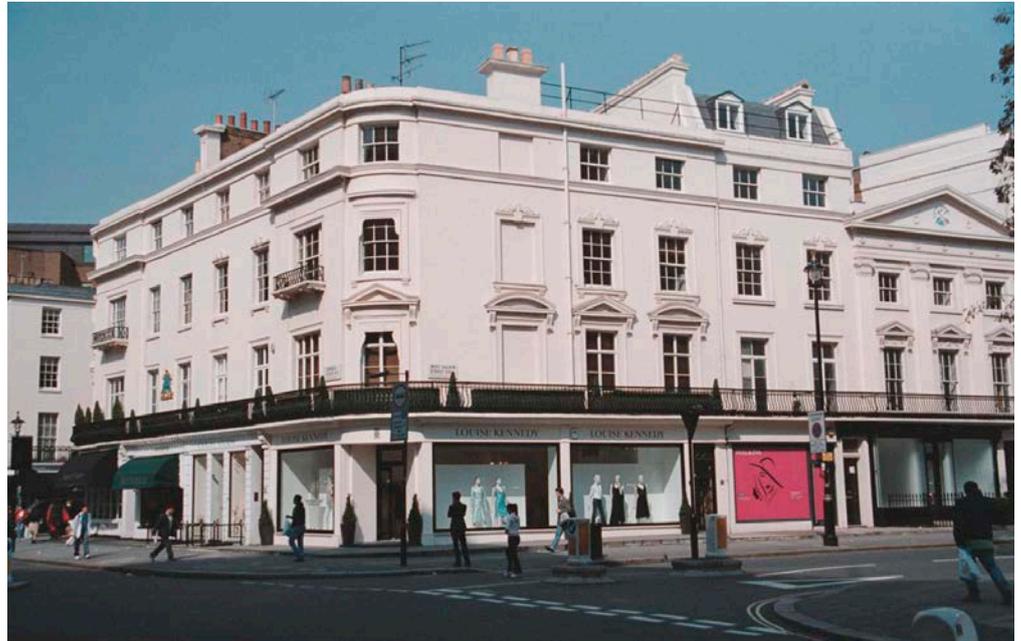
Figure 20:  
Site 6.

- Eight DX ASHPs had been installed.
- The ASHPs used R-32 refrigerant.
- The external pipework was well insulated.

- The rooftop location means that the units were hidden from neighbours.
- The nearest noise-sensitive location is more than 5m away. The rear courtyard is noticeably noisy from an ASHP belonging to a neighbouring property. There is a general background hum from external ASHP units, but the soundscape was dominated by a single kitchen extractor fan.
- The units had been installed in accordance with the manufacturer's requirements for access and airflow.
- There was no defined condensate drainage route, and water flowed directly across the flat roof to the nearest roof outlet. This could present a slip hazard when frozen for those accessing the roof.

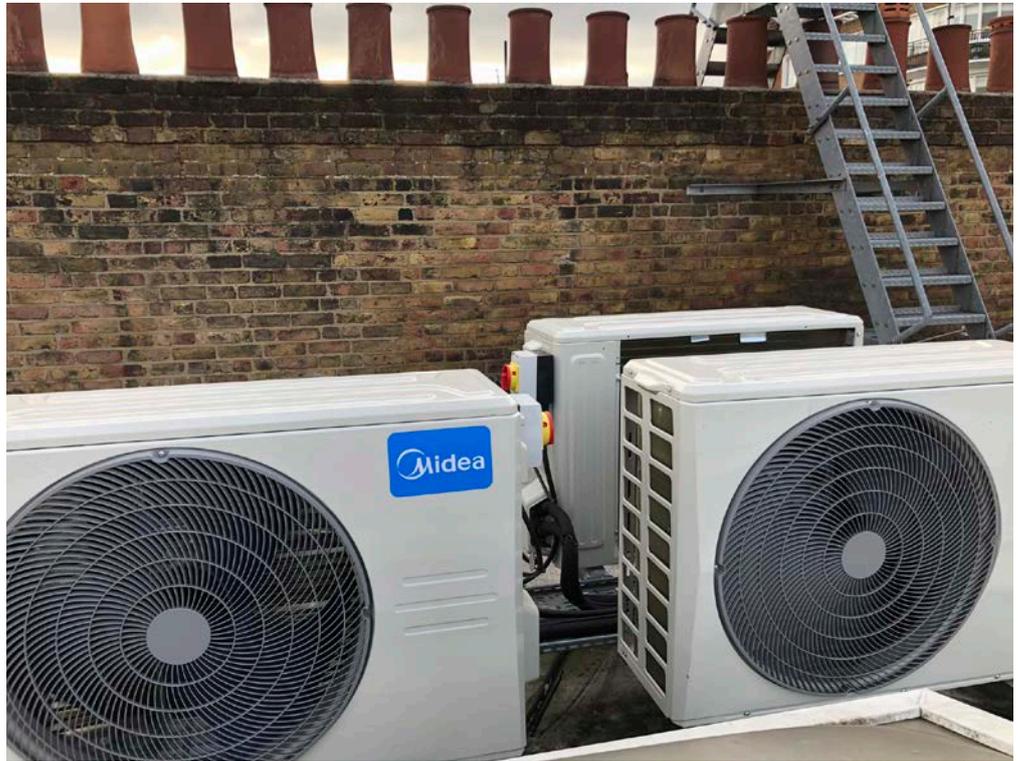
Figure 21:  
Site 6: ASHPs installed on  
the flat rooftop.

A variable refrigerant DX system to serve the shop and offices would provide a similar user experience and would need only one external unit. There is ample rooftop space to mount a single external unit.

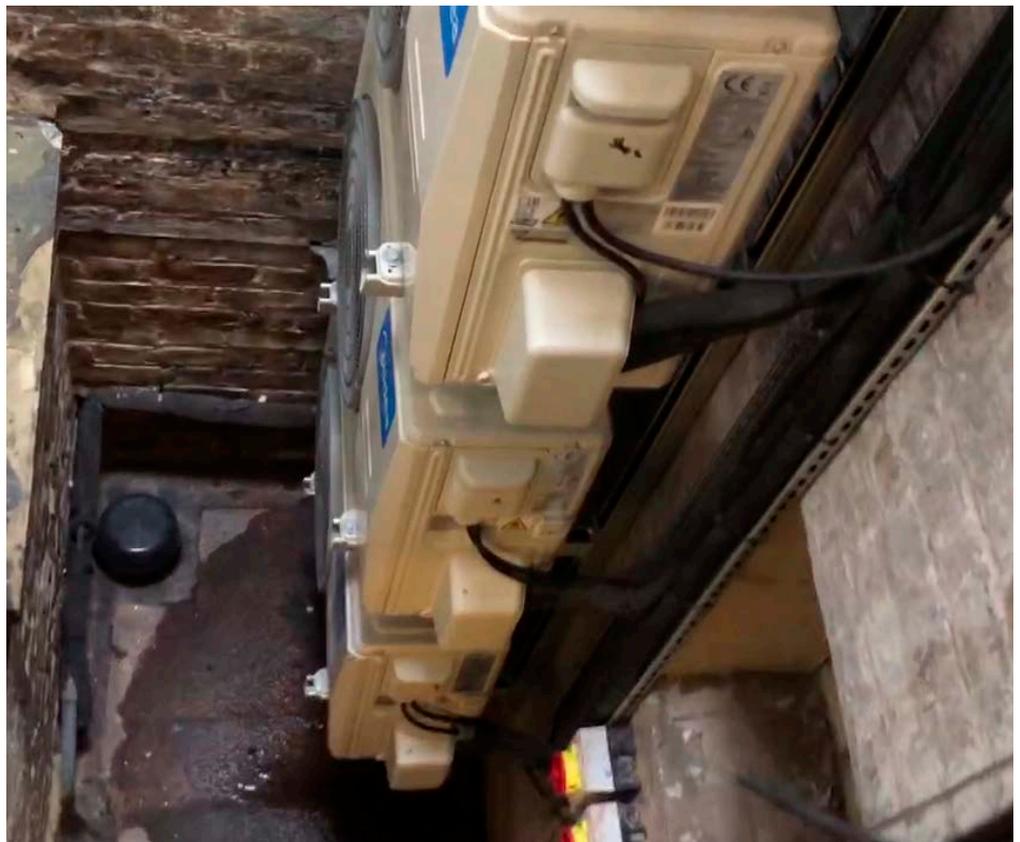
- These units were wall-mounted on brackets at the rear of the property.
- There was 1.8m between the face of the ASHPs and neighbouring single-glazed windows. It is likely that any noise from these four units would be masked by other noises in the vicinity. However, this is not a reason to place units where they may cause a noise problem.
- The neighbouring windows were obscured with an opaque window film. The ASHPs are, therefore, hidden from view.

Figure 22:  
Site 6: Wall-mounted  
ASHPs installed in the  
courtyard.

The courtyard units will be expensive to maintain because a scaffold is needed to provide safe access. This may discourage regular maintenance. Alternatively, maintenance personnel may have to use ladders, which presents unnecessary risks.

In areas with low background noise levels, it would not be appropriate to position external units in such close proximity to neighbouring windows. Given the high levels of background noise in this particular location, it was unlikely that the noise from the courtyard ASHP units would cause complaints.

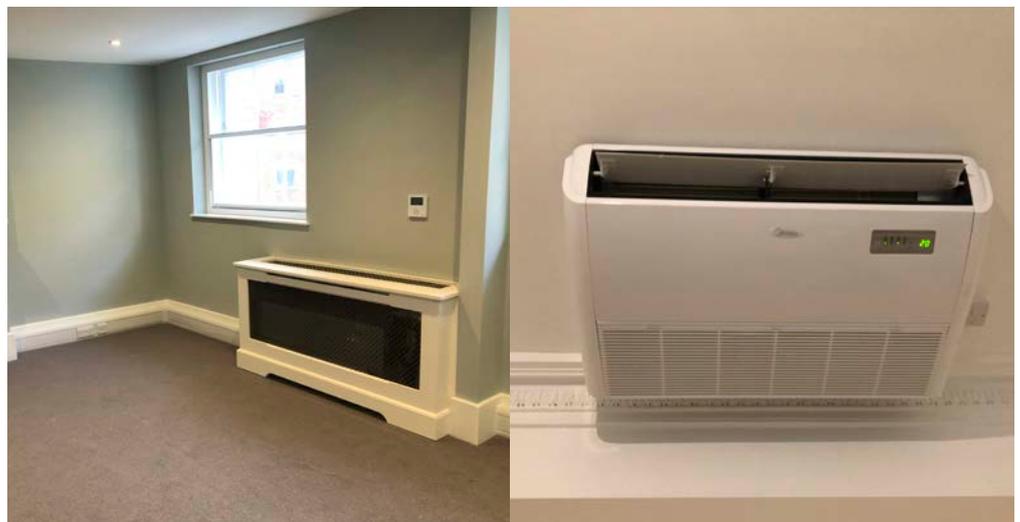
- The internal units were sympathetically installed, with concealed pipework and custom-made boxing around floor-standing units.
- The unit capacities could cope with the peak cooling demand of around 100W/m<sup>2</sup>.
- There was no integrated back-up system.
- The system design seemed robust. Open-plan spaces had at least two heat emitters powered by separate external units.
- It was assumed that the domestic hot water was provided by a hot water cylinder with a direct electric immersion coil. It was not possible to locate this because storage cupboards were locked at the time of the visit.
- There was no evidence of any gas appliances in the building.
- Hot water for showering was provided by an electric shower.

Figure 23:  
Site 6: A floor-standing condenser (left) and a ceiling-mounted condenser (right).

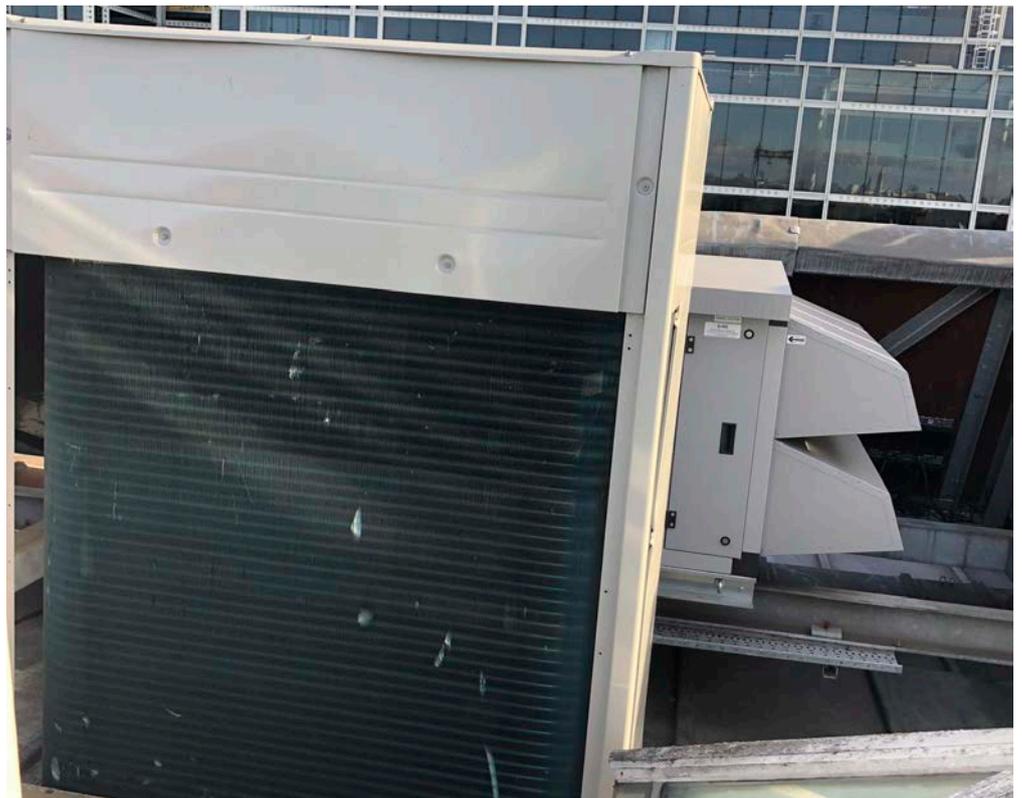
- A 23.2kW Daikin VRV ASHP had been installed.
- The refrigerant was R-410A, which is now being phased out.
- The ASHP was installed on an anti-vibration mount, and the work seemed to be of a high standard.
- Condensate drainage had not been addressed and condensate will flow across the roof to the nearest rainwater outlet.
- The ASHP had sufficient airflow.
- The pipework was insulated for outdoor conditions.
- The external ASHP was located discreetly on the roof, away from any noise-sensitive locations so any noise from the unit could not be heard from inside the building.

Figure 25:  
Site 7: ASHP installed on  
the roof.

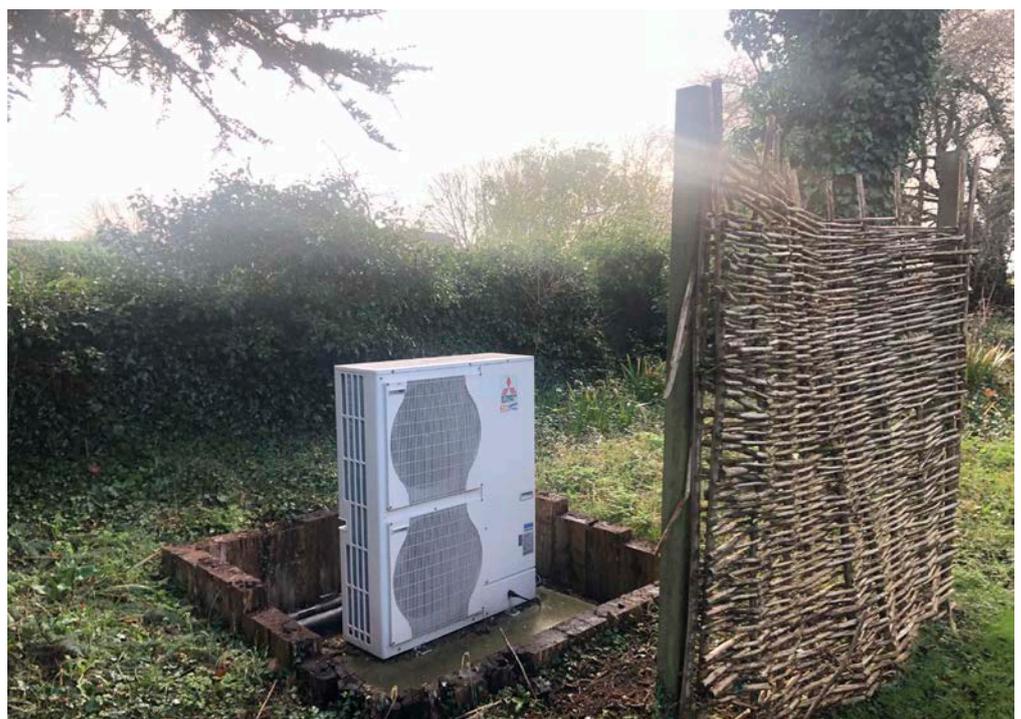
The only property that had attempted to conceal the ASHP external unit experienced unintended consequences. To reduce the visual impact of the unit, the base had been sunk 500mm below the ground level so that the top of the unit was below the level of the garden boundary wall. However, from the street, this slight drop in level made little difference. On the garden side, a hurdle fence had been erected to screen the unit although part of this screen had been blown down by winds. Dropping the level of the unit has caused issues with snow building-up around the ASHP in winter and leaf litter build-up in autumn. The snow and leaves must be removed manually for the ASHP to operate without fault. Although no issues were reported at this property, dropping the level in this way could also leave the ASHP vulnerable to damage from flooding.

Figure 28:  
Site 8: The sunken ASHP  
and the hurdle fence  
screen.

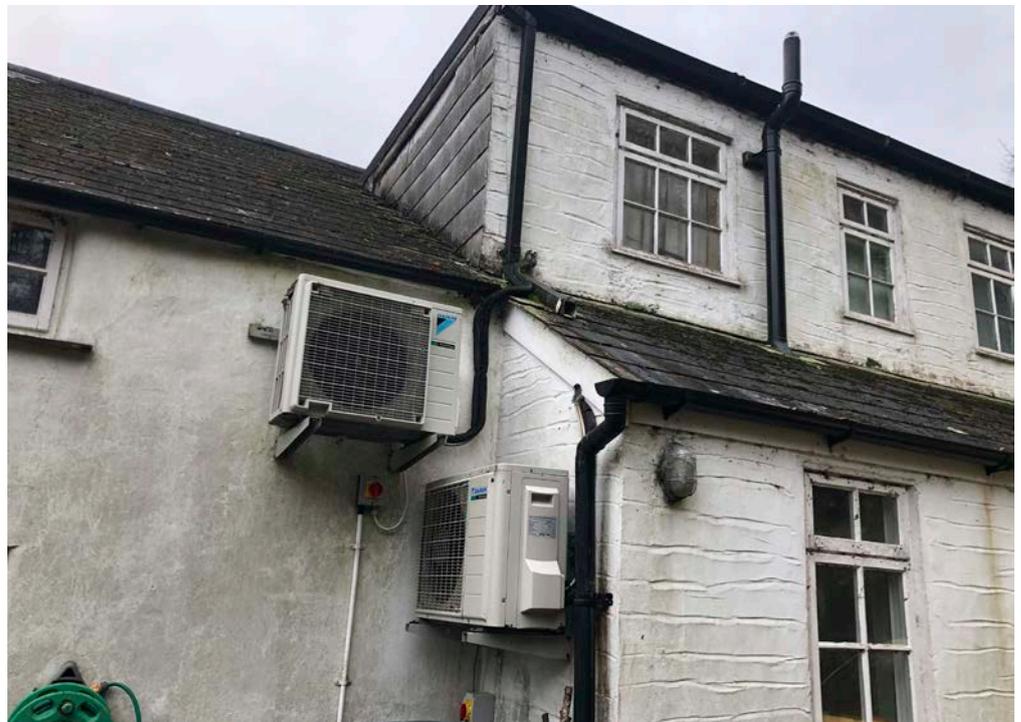
Figure 30:  
Site 9: The two ASHPs  
installed at the rear of the  
building.

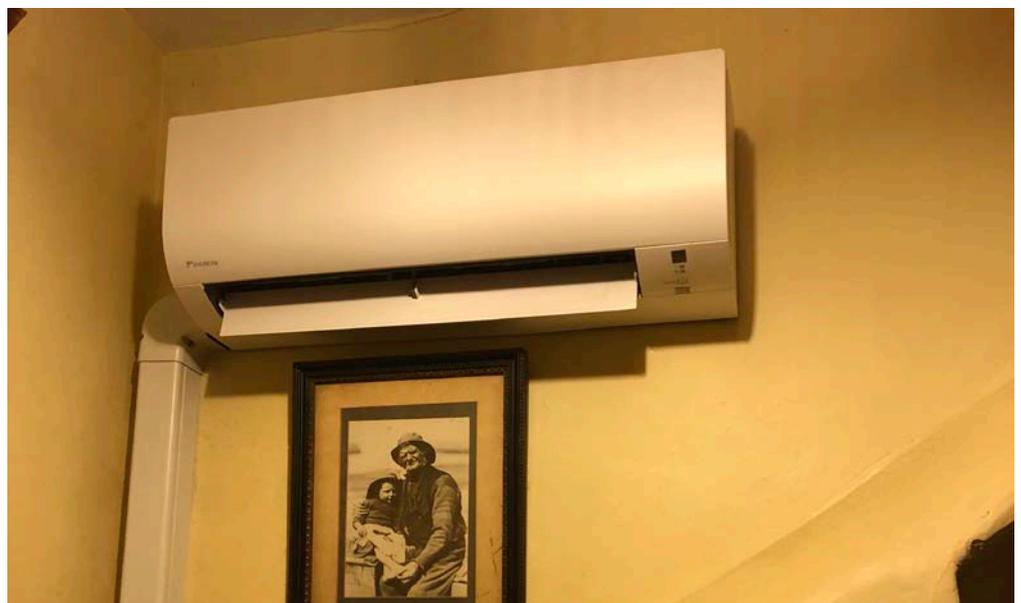
Figure 31:  
Site 9: A wall-mounted  
interior condenser unit.

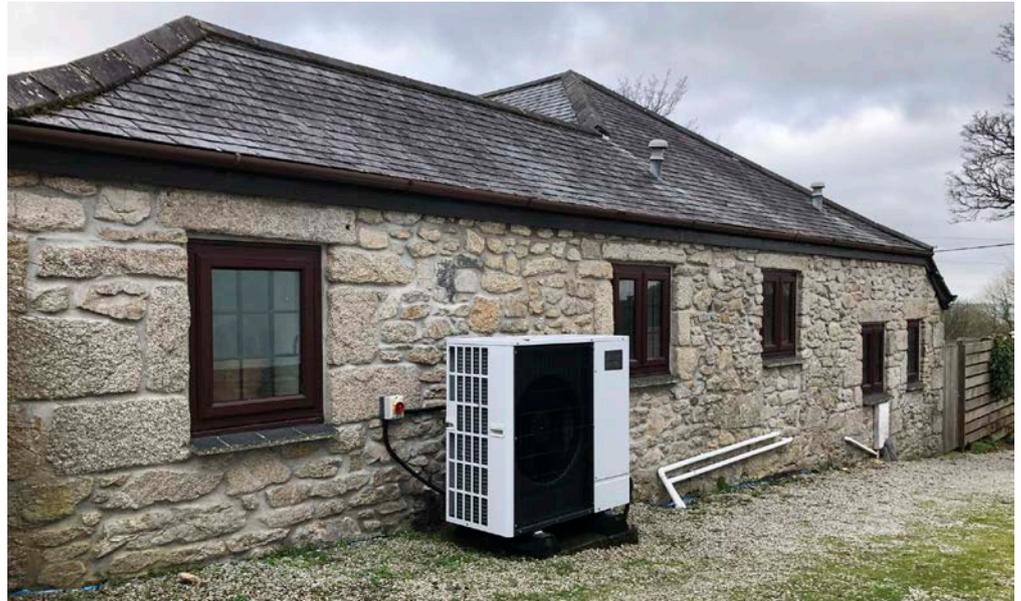
Figure 32:  
Site 10: The ASHP  
installed at the side of the  
converted barn.

- No system buffer vessel was installed.
- The ASHP was quiet, and the closest noise-sensitive point is 8m away.
- Pipework was well insulated, both externally and internally.
- Condensate drainage was allowed to disperse through the gravel driveway. No issues of freezing were reported.
- The ASHP was located around 2m from the interior hot water cylinder.
