# Conservation

*bulletin*

## Building Materials

# Editorial: Why Materials Matter

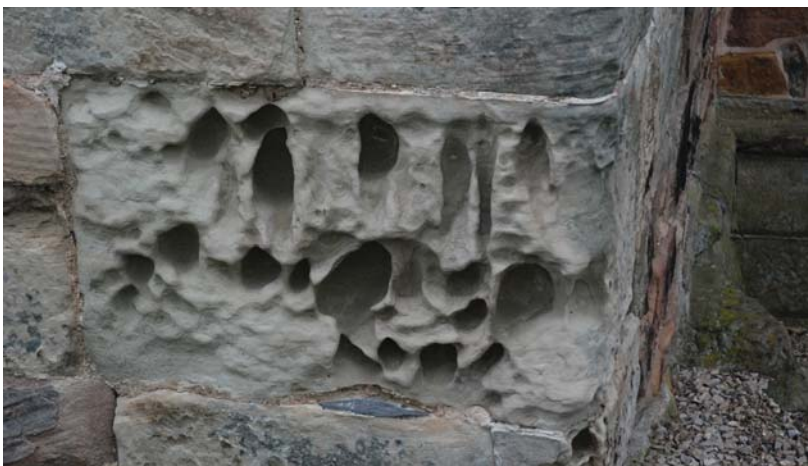
Cavernous decay of the 'white' Triassic sandstone used in the Priory church at Breedon on the Hill in Leicestershire.

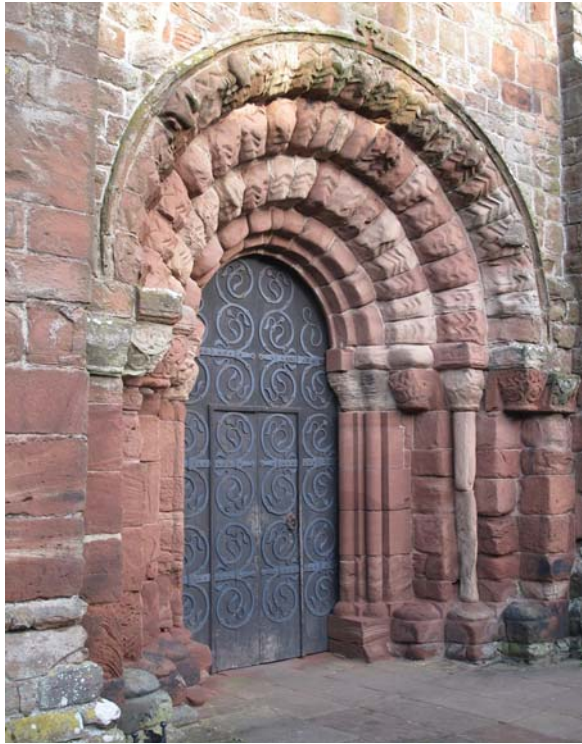
St Bees Priory, Cumbria, the Norman west door. Triassic St Bees Sandstone door mouldings, repaired using the local red St Bees Sandstone from recent production. The original stonework includes characteristically variegated St Bees sandstone, which should be a consideration in any further stone repair.  
© Graham Lott

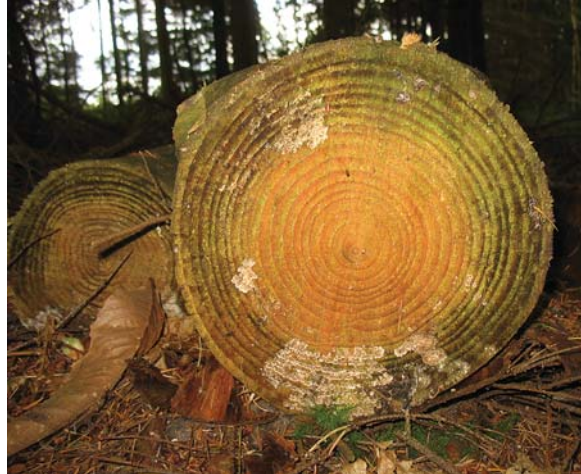
A pine log in the forest with fungus in the outer sapwood but not in the more durable red heartwood.

We now know that the poor durability of modern softwood is not caused by wide growth rings but by the outer band of sapwood that conducts sap from the roots of the tree to its crown. Unlike the heartwood into which it gradually converts over time, young sapwood lacks the chemicals that confer natural durability. It is the central core of heartwood that supports the tree, and it is its natural durability that we exploit for construction timbers. A growing tree generally maintains about 20 to 30 years of sapwood, which is a relatively small proportion of a 200-year old tree but a much larger percentage of one felled after only 45 years of growth.

All of the pathogens that attack softwood, from furniture beetle to dry rot, will rapidly destroy damp sapwood. When repairing historic buildings it is therefore important to select timbers that contain the minimum amount of sapwood.

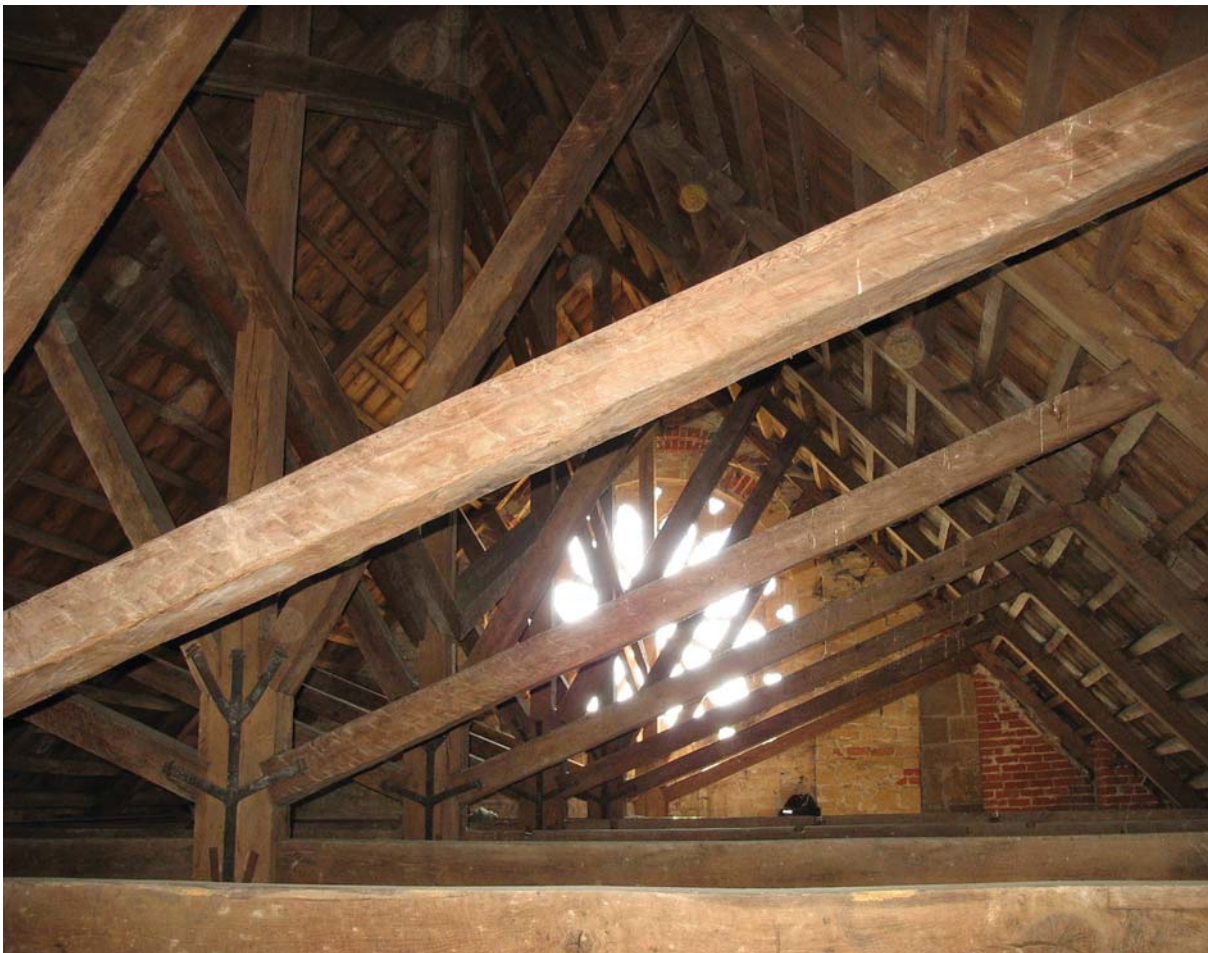
Slow-growing and thus durable Baltic pine was used for most of our historic buildings between 1750 and the end of the 19th century.

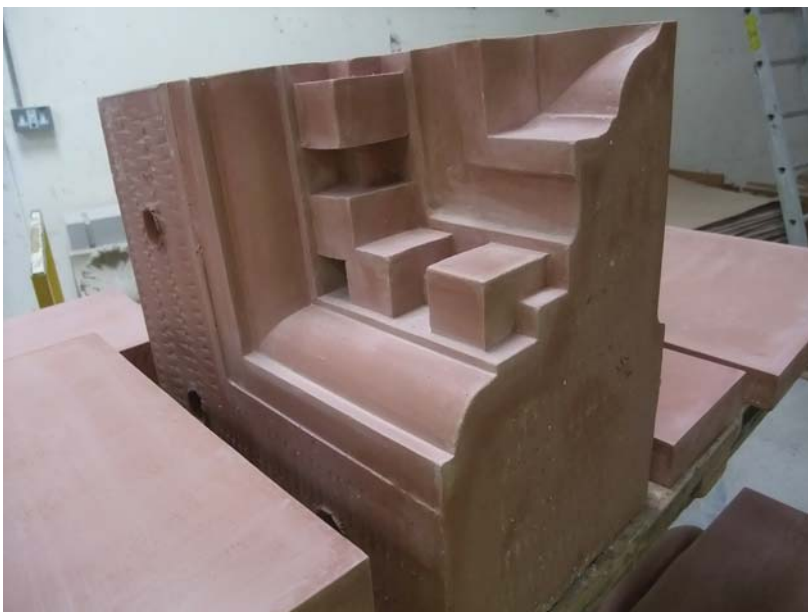
Replacement terracotta cornice block fabricated at Shaws of Darwen.  
© Alan Baxter & Associates

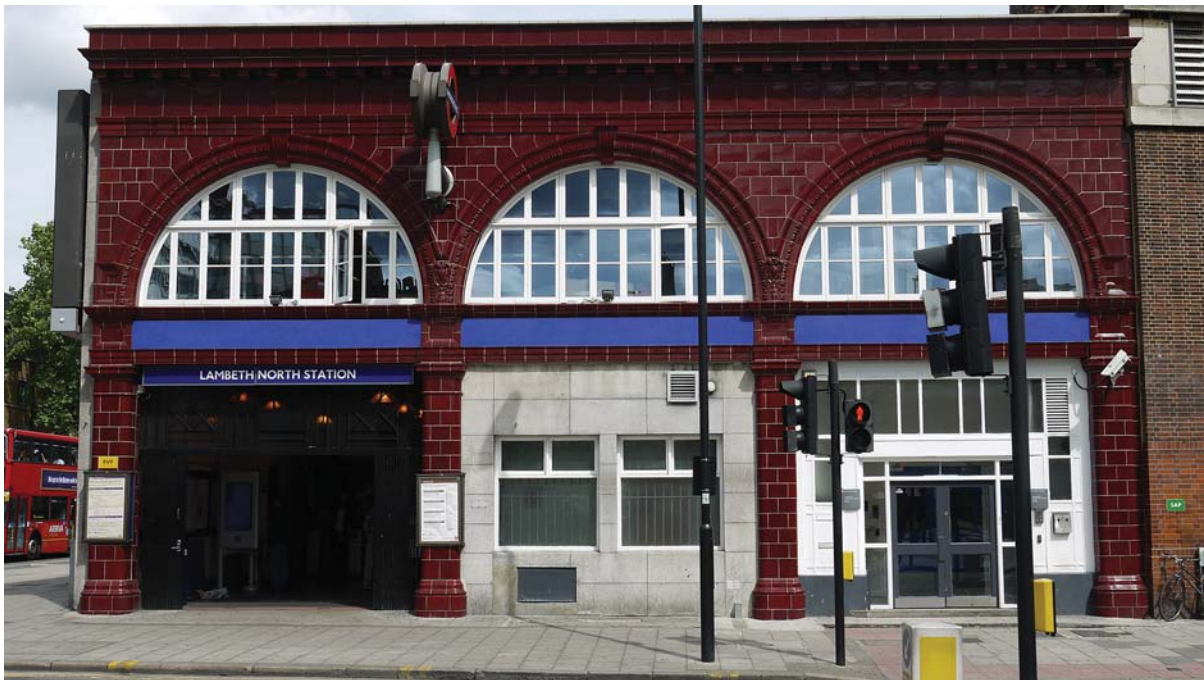
Lambeth North Underground Station (1906), repaired using slip-cast faience.  
© Alan Baxter & Associates

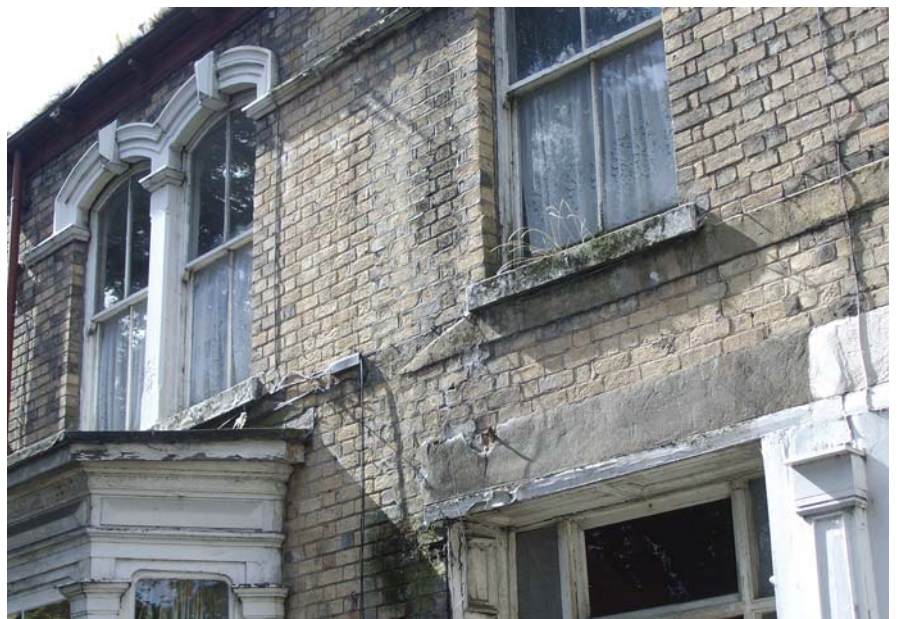
Neglecting simple tasks, such as gutter clearance or redecoration, leads to more work and greater expense in the long run.

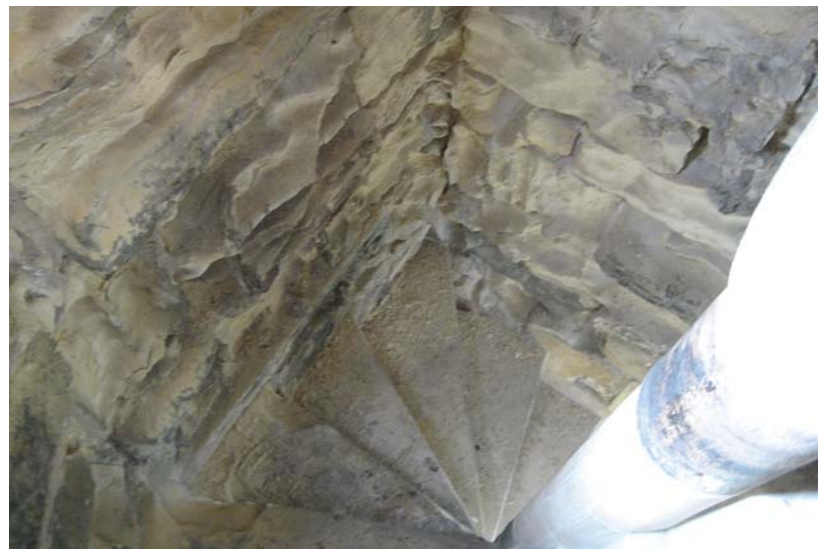
The staircase in the chapter house at Howden Minster exhibits particularly severe cavernous decay.

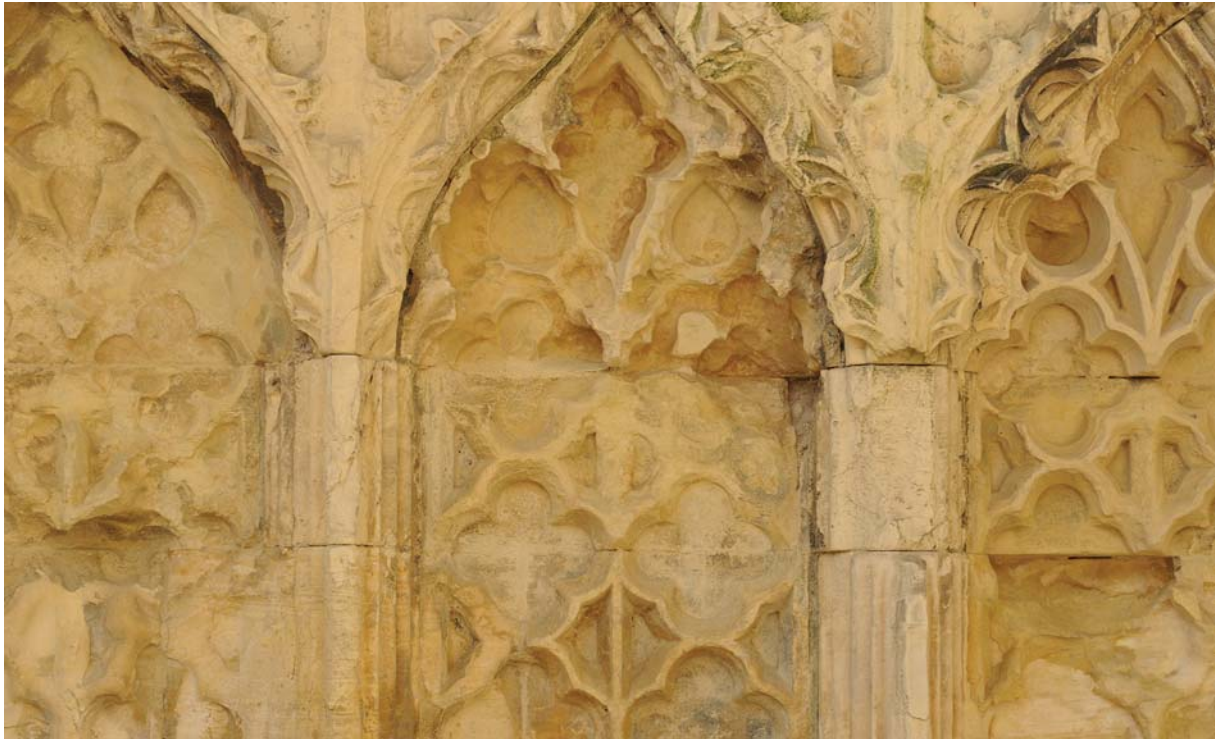
Protective shelter-coats have been tested to stabilise the flaking areas at Howden Minster.  
© Sarah Pinchin

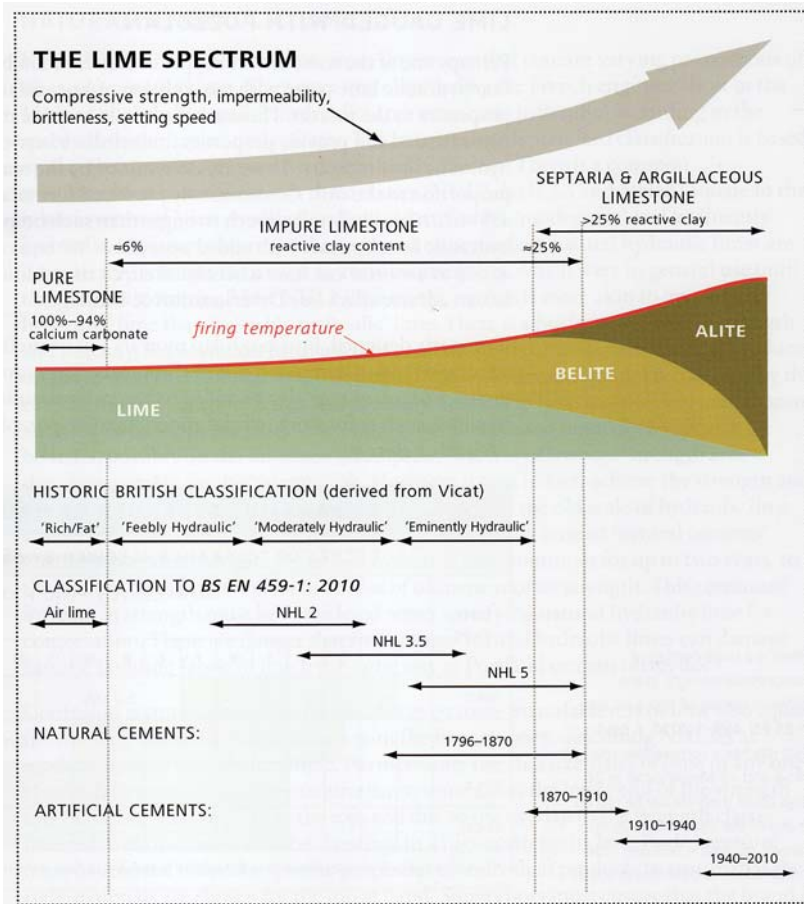
Diagram showing how the compressive strength, speed of set and permeability of historic and modern limes are related to the mineral content of the parent limestone and to burning temperature. There is a gap in the spectrum of modern limes that comply with BS EN 459, where feebly hydraulic lime used to sit. On the whole, the modern materials are significantly stronger than their historic counterparts.

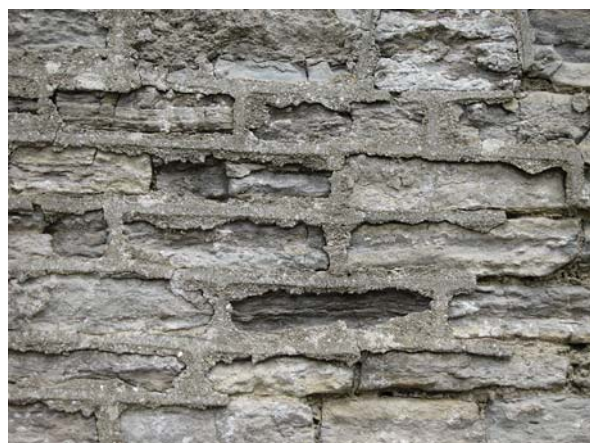
It is important to understand the properties of different binders in order to select appropriate materials for conservation of historic fabric. It has long been recognised that cement mortar can trap moisture in the stonework and lead to deterioration of the stone itself, as shown here, but strong hydraulic lime can also harm fragile stone and mortars.

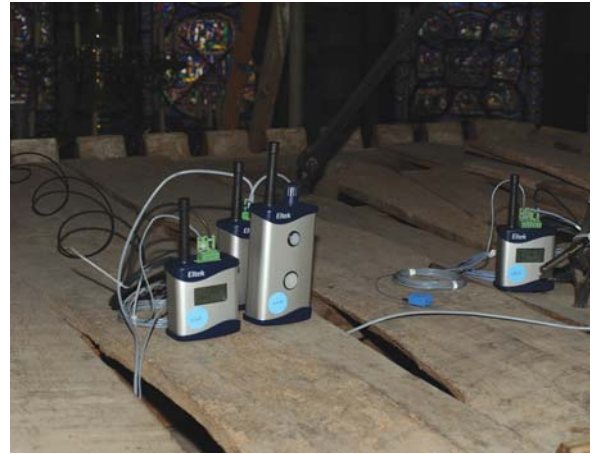
Sensors monitoring relative humidity, temperature, light, UV radiation and movement on the Black Prince's tomb at Canterbury Cathedral. ©Tobit Curteis

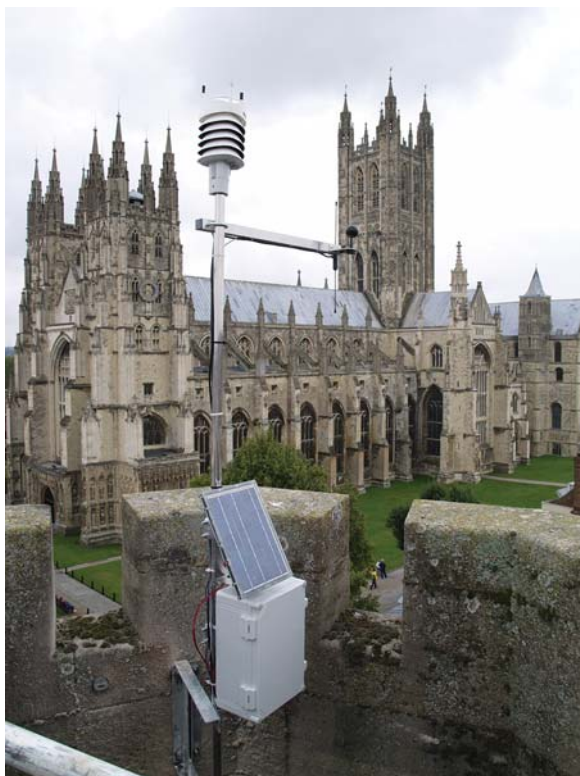
Weather station monitoring the external conditions at Canterbury Cathedral. ©Tobit Curteis

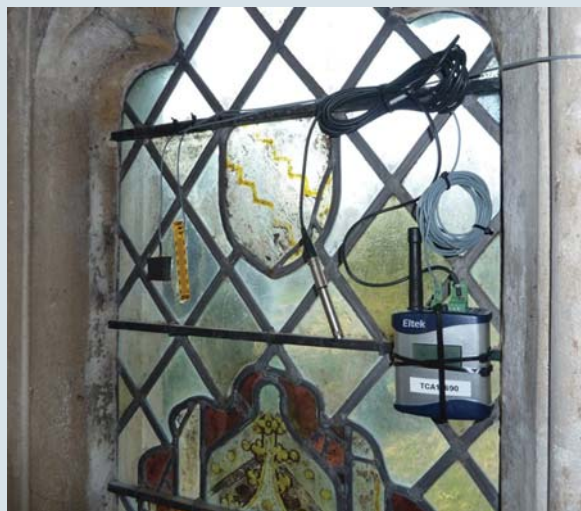
Monitoring the microclimate as part of a research project on protective glazing commissioned by English Heritage at Long Melford Church in Suffolk. Chris Wood © English Heritage

The Canterbury Cathedral Stained Glass Studio has constructed a number of test areas of protective glazing and environmental monitoring is being used to establish the current microclimate in the vicinity of the glass, the way in which the protective glazing alters this, and the efficacy of the different designs (including the depth of the air gap between the two layers of glass, and the design of the vents).

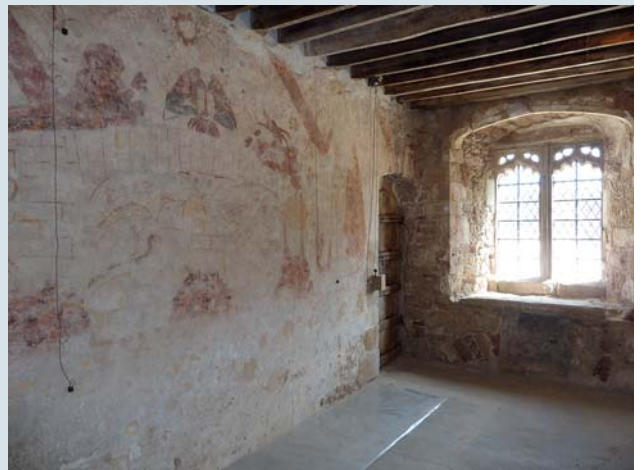
Light falling across the 15th-century wall painting at Cleeve Abbey.  
© Tobit Curteis

It was only when large-scale time-lapse imaging was used for a complete year that the cause was revealed: for a number of weeks in winter, the sun is low enough to penetrate the window of the chamber and strike the wall, and the pattern of exposure coincides with the pattern of damage. The problem can therefore be traced to solar radiant heating causing thermal expansion of the flint, and can now be controlled by covering the window for this period of the year.

The monitoring also revealed that the high level of air exchange with the adjacent passage (itself open to the exterior) causes highly unstable conditions that result in condensation and salt activity. It has therefore been possible to prevent further deterioration simply by installing clear panels in the openings to reduce air exchange.

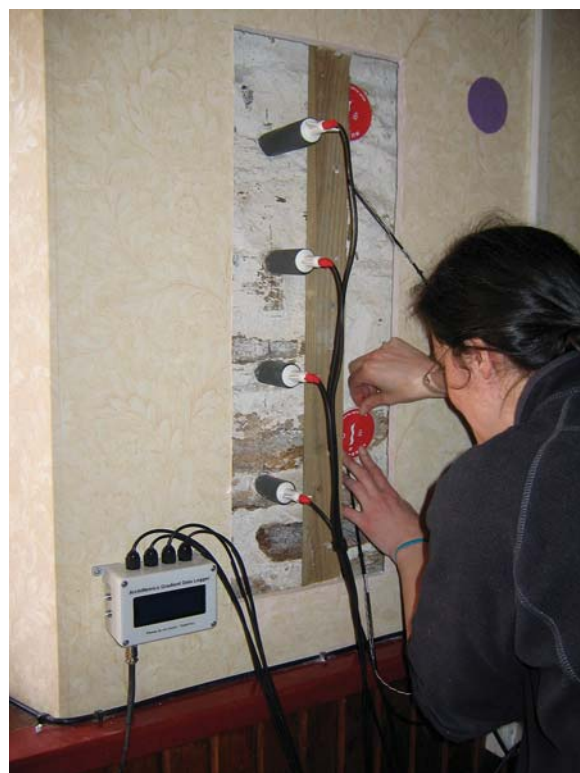
The author applying heat flux sensors to a wall to take an *in-situ* U-value measurement.  
© Caroline Rye, ArchiMetrics Ltd

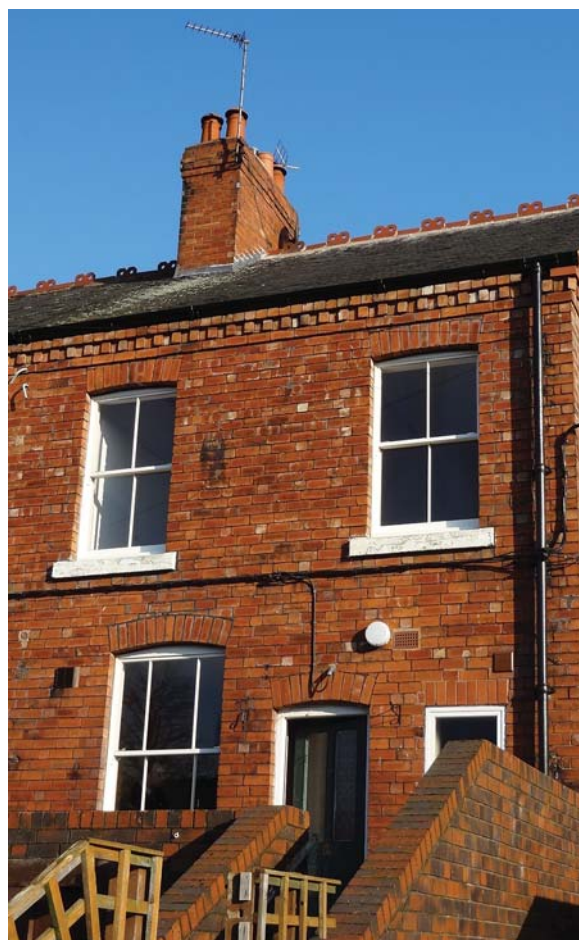
The front elevation of the New Bolsover test house showing the new single-glazed windows, which replicated the originals. Secondary glazing on the inside means that these windows are more efficient than most forms of double-glazing and are far more effective at reducing noise pollution.

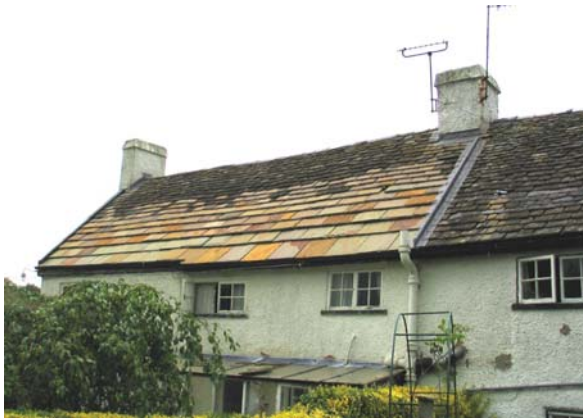
The rear elevation of this roof in Shropshire has been repaired with traditional local slate, but the left-hand side with imported Indian stone. Not only are the replacements the wrong colour and size but there is no evidence as to how they will match the host stones in terms of durability and performance.

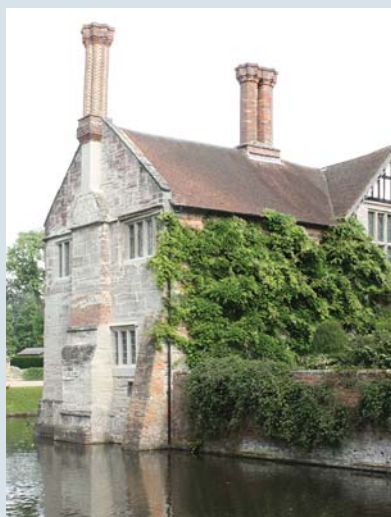
The repaired north-west gable.

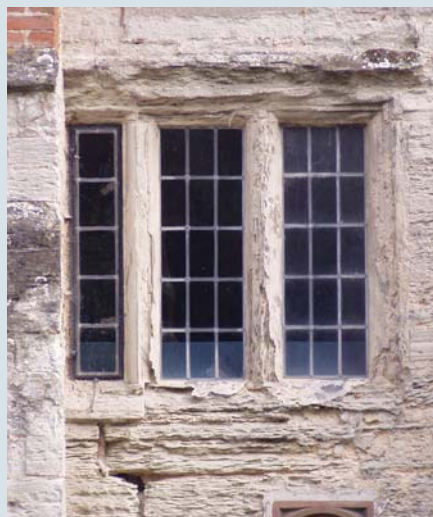
The coffin-room window before and after repair.

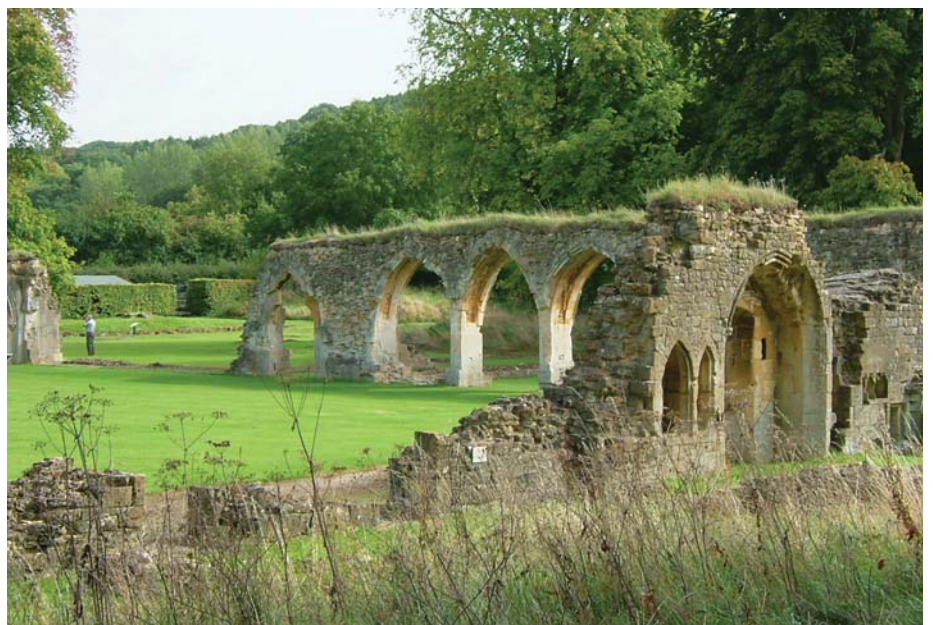
Turf-based soft capping on the cloister walls at Hailes Abbey, Gloucestershire, photographed four years after emplacement as part of the soft-capping research project.

at Byland Abbey in North Yorkshire, but also in a range of laboratory tests under realistic climatic cycles, and in field exposure trials in Oxford. Even a thin soft capping (5cm of soil) has been shown to be more effective than comparable hard caps in reducing temperature fluctuations on underlying stone. Untangling the effects of soft capping on moisture regimes has proved more difficult. Results from field monitoring of moisture levels in walls under soft capping (using the wooden dowel method) at Hailes Abbey in Gloucestershire, and at Byland Abbey in North Yorkshire came up with divergent results. However, one general trend we found was that moisture regimes in walls under soft capping are less variable over annual timescales than those under hard capping. Using our specially built test walls at Wytham Woods, we have been able to study moisture regimes under hard versus soft capping in a much more controlled way, but the findings are complex and not entirely clear cut. At Godstow Nunnery near Oxford, trials of turf and sedum-based soft capping show that sedum caps are more resilient in the face of harsh winters and dry summers.

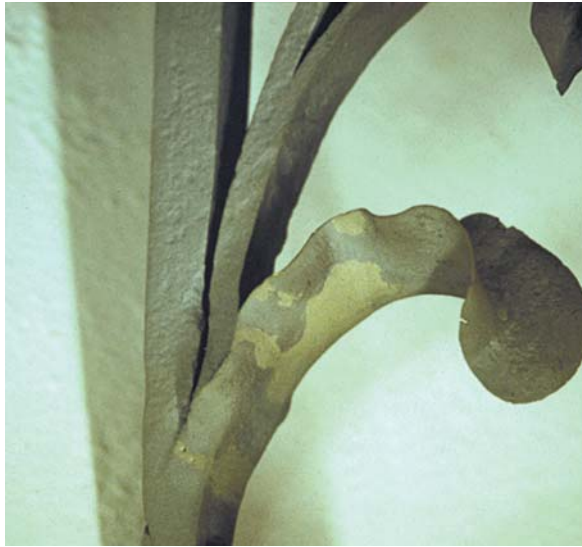
Small losses or dents in ferrous metals can be conserved and recoated as is, or filled with epoxy-based proprietary materials or using brazing materials and techniques. Decorative elements can be preserved instead of cut and replaced.

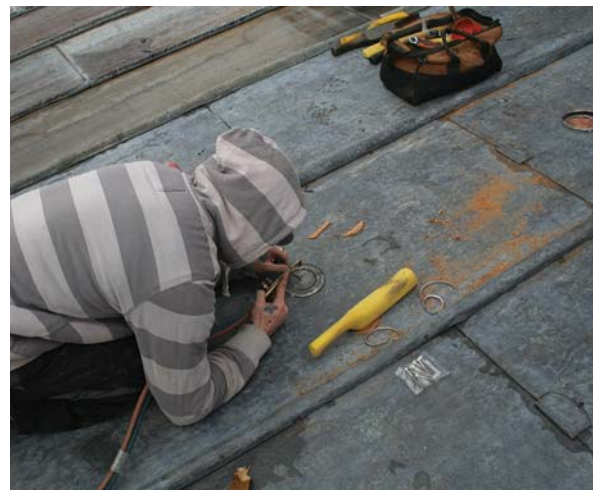
Ledlok being installed on an aisle roof in rural Norfolk following a theft. The roof is still safely in place and on another secluded church near by, which had also had Ledlok applied, thieves abandoned their attempts to steal the lead.

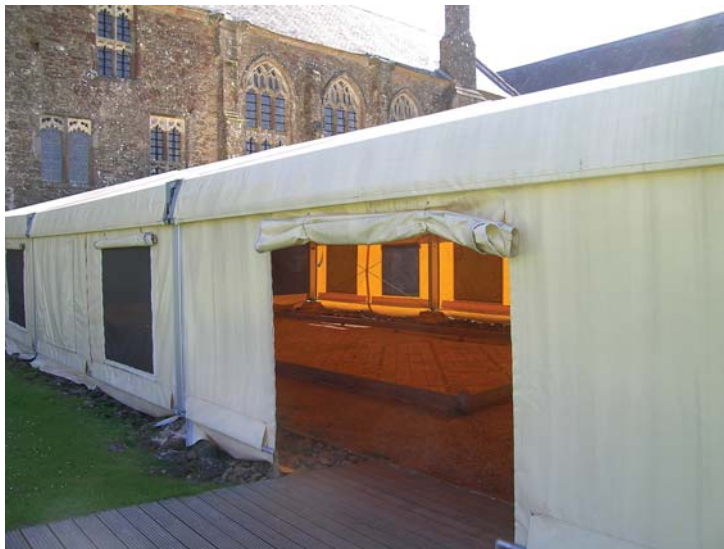
The Frater pavement at Cleeve Abbey protected under a temporary marquee. Its properties of ventilation and insulation were modified during the monitoring period.

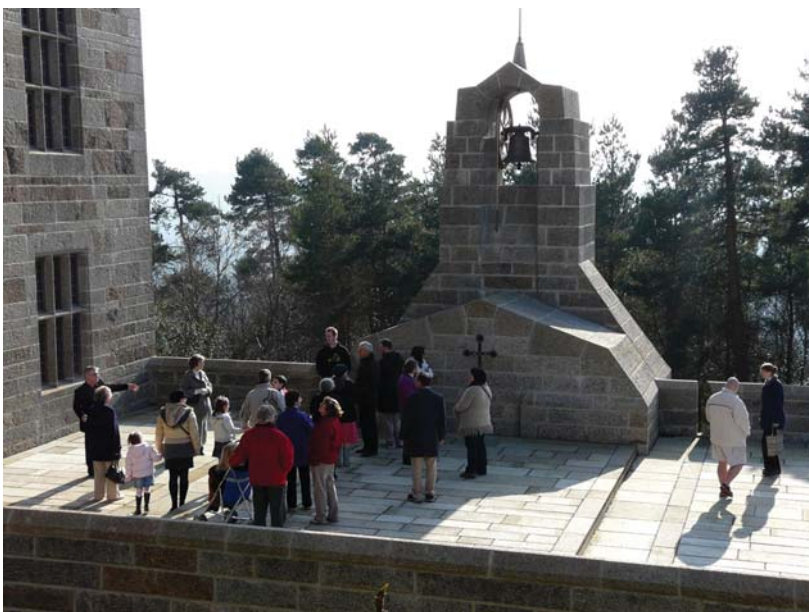
Castle Drogo, Devon: the application of 21st-century technical solutions has at last allowed the persistently leaking roof terrace to be restored to Lutyens's original design.

Castle Drogo was designed by (Sir) Edwin Lutyens in 1910 and its construction on a promontory overlooking Dartmoor continued until 1930. The house is essentially of one material: granite. Granite also extended as paving over the mastic asphalt roofing, transforming the complex roof terraces into a wonderful *promenade architecturale*. In addition to the roofing, asphalt was used within the walls and parapets as a vertical damp-proof membrane that was often continuous with the roofing asphalt. From the 1930s, the paving stones had to be lifted regularly to track down and patch defects in the asphalt below, and by the 1960s the complete paving, so important to Lutyens's design, had been permanently removed to allow easier access for roofing repairs.

With the roofing, it could be seen that the original build-up was technically deficient and the subsequent repair solutions over the years were ineffective. Asphalt was a comparatively modern material, but the problems of a 'cold roof' were not known at the time and the roofing was designed without insulation or ventilation. Not only was there no provision for accommodating thermal movement at abutments with concrete, steel and granite, but successive campaigns of repair had severed the continuity with the vertical damp-proof membrane and water was entrained below the roofing and into the fabric.

ingress. These had been replaced with new pointing in the 1980s using a Portland cement mortar with a waterproofing additive; it failed due to shrinkage relatively quickly, and a thermographic radar survey of the elevations revealed how water had built up within the masonry and how the mortars were hindering the evaporation of moisture through the jointing. The 'free lime' precipitate that had so disfigured the elevations was a direct result of water escaping when it eventually found a route.

Both the existing mortars and possible replacements were monitored in a series of trials on the elevation to help determine which was the most appropriate. The stonework was cleaned and the trial mortars were matched to the colour and texture of the original. The cement pointing of the area of wall that was being monitored was raked out and re-pointed with two different hydraulic lime binders of varying mixes, totalling four different combinations. Electronic probes were inserted into the pointing to form a grid of sensors wired to a data logger, from which information was downloaded every six weeks. The data logger was

also linked to a weather station that simultaneously recorded the specific weather conditions. Monitoring over 18 months indicated that the hydraulic lime mortars were reducing the moisture levels within the wall dramatically and that lime staining was also being arrested. This led to the selection of the appropriate repair mortar.

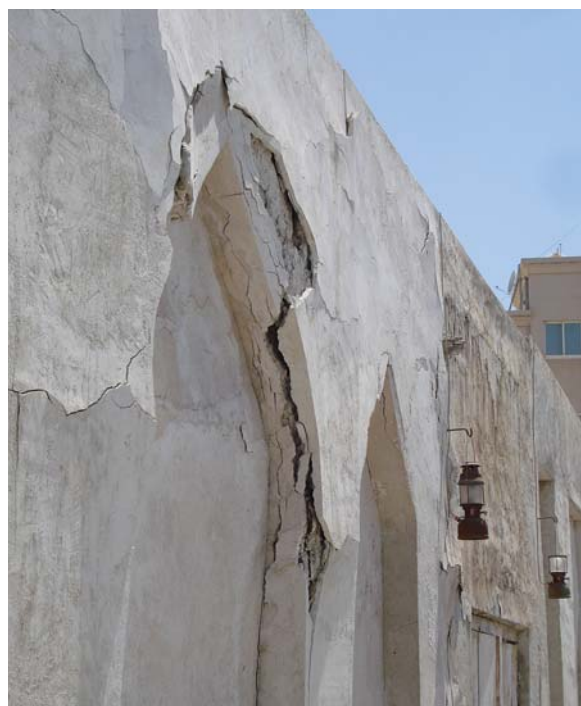
Sharjah – the problems of using cement and gypsum in a dry but humid environment.  
© David Odgers

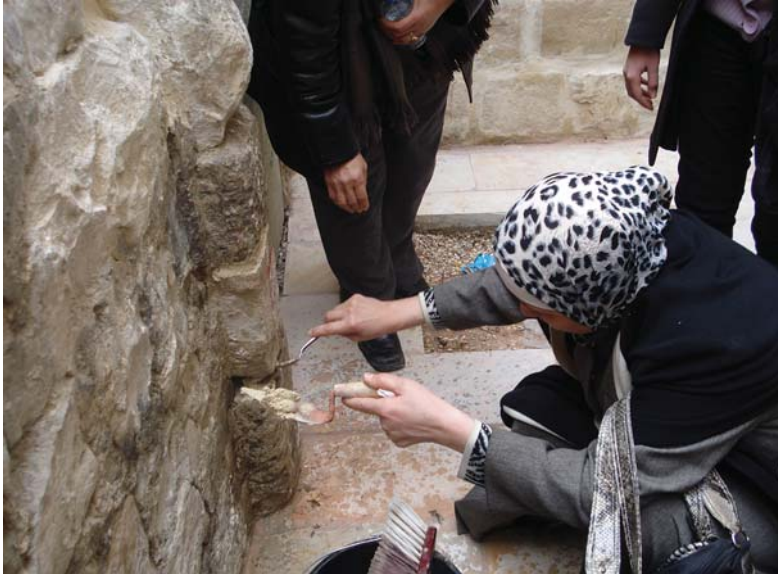
Nablus – pointing training in progress.  
© David Odgers

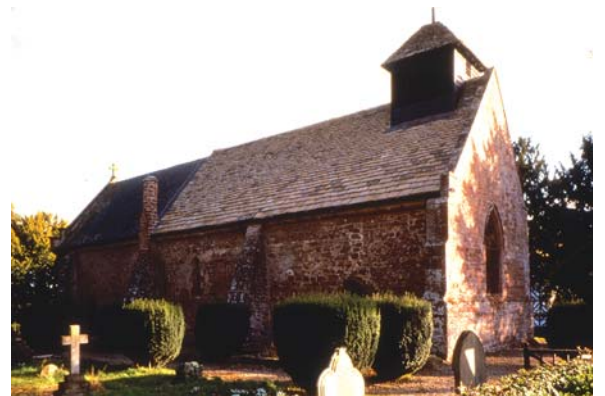
The nave roof of Pitchford Church in Shropshire (Grade I listed) is covered in Harnage stone slates. At the time of re-roofing in 1999, there were no sources of suitable new Harnage slates. Planning permission was obtained to extend a former small local quarry to enable extraction of sufficient stone for re-roofing the nave, plus a small surplus for future patch repair. The protection of such potential sources of building stone, even though they may not be needed now, is vital in order to help maintain the character of thousands of historic buildings and areas in the future.

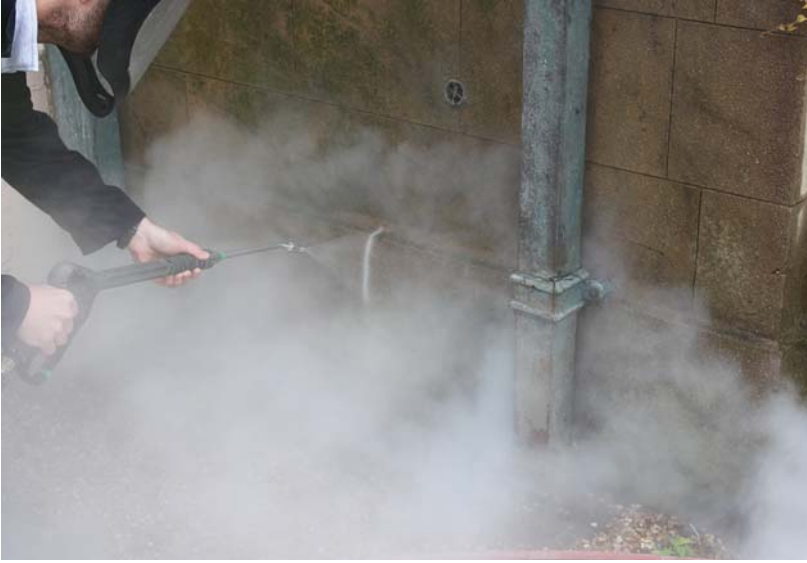
The decline in the use of sand blasting for cleaning buildings enabled more appropriate cleaning technologies, such as super-heated water, to become more competitive, and their use has increased in the last 15 years

the increased cost of abrasive cleaning meant that other cleaning technologies became more competitive, and this was one factor contributing to the development of super-heated water for building cleaning.

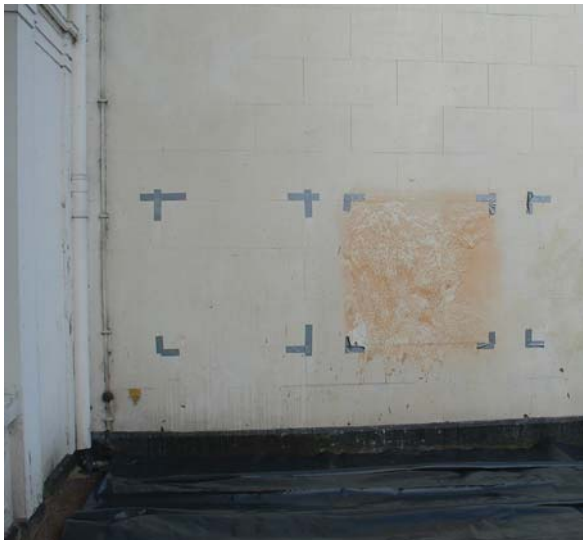
With the decline in the availability of DCM, paint and varnish removers have become more selective and it may be necessary to use different products to remove different paint layers. Trials are usually necessary to determine the appropriate materials to be used for removing multiple paint layers.

Similarly, DCM is much cheaper to produce than alternative paint-stripping chemicals. It works rapidly and indiscriminately, acting on a variety of coating types and removing multiple layers quickly. These properties propelled it to the forefront of the DIY paint-removal market and it was also widely used by professionals. However, apart from the health risk of inhaling DCM vapours, any rinsing water had to be treated as special waste (although in many cases this requirement was ignored), which added to the cost of using it correctly. Furthermore, when removing coatings from a porous substrate such as stone or plaster, there is a risk that paint residue may be carried below the surface, leading to staining. The banning of DCM has forced practitioners to look at alternative methods. Certain coatings, such as bitumen-based paints, waxes and some acrylic-based paints, can be removed effectively using super-heated water or steam without any risk of migration of the soiling, and without generating waste that requires special treatment, to the benefit of both the building and the environment.

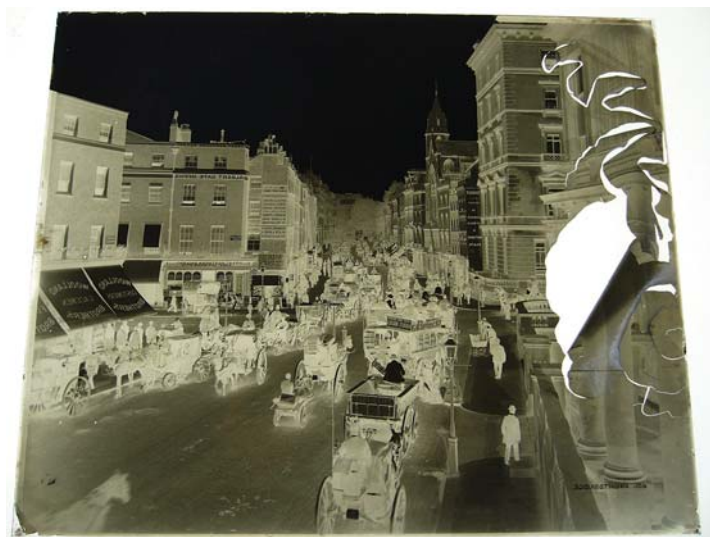
A glass negative with a peeling emulsion layer.  
© English Heritage
