Conserving War Memorials

Case Study: The Conservation of Mortar-Filled Inscriptions

First World War Memorial, Cheltenham,
Gloucestershire

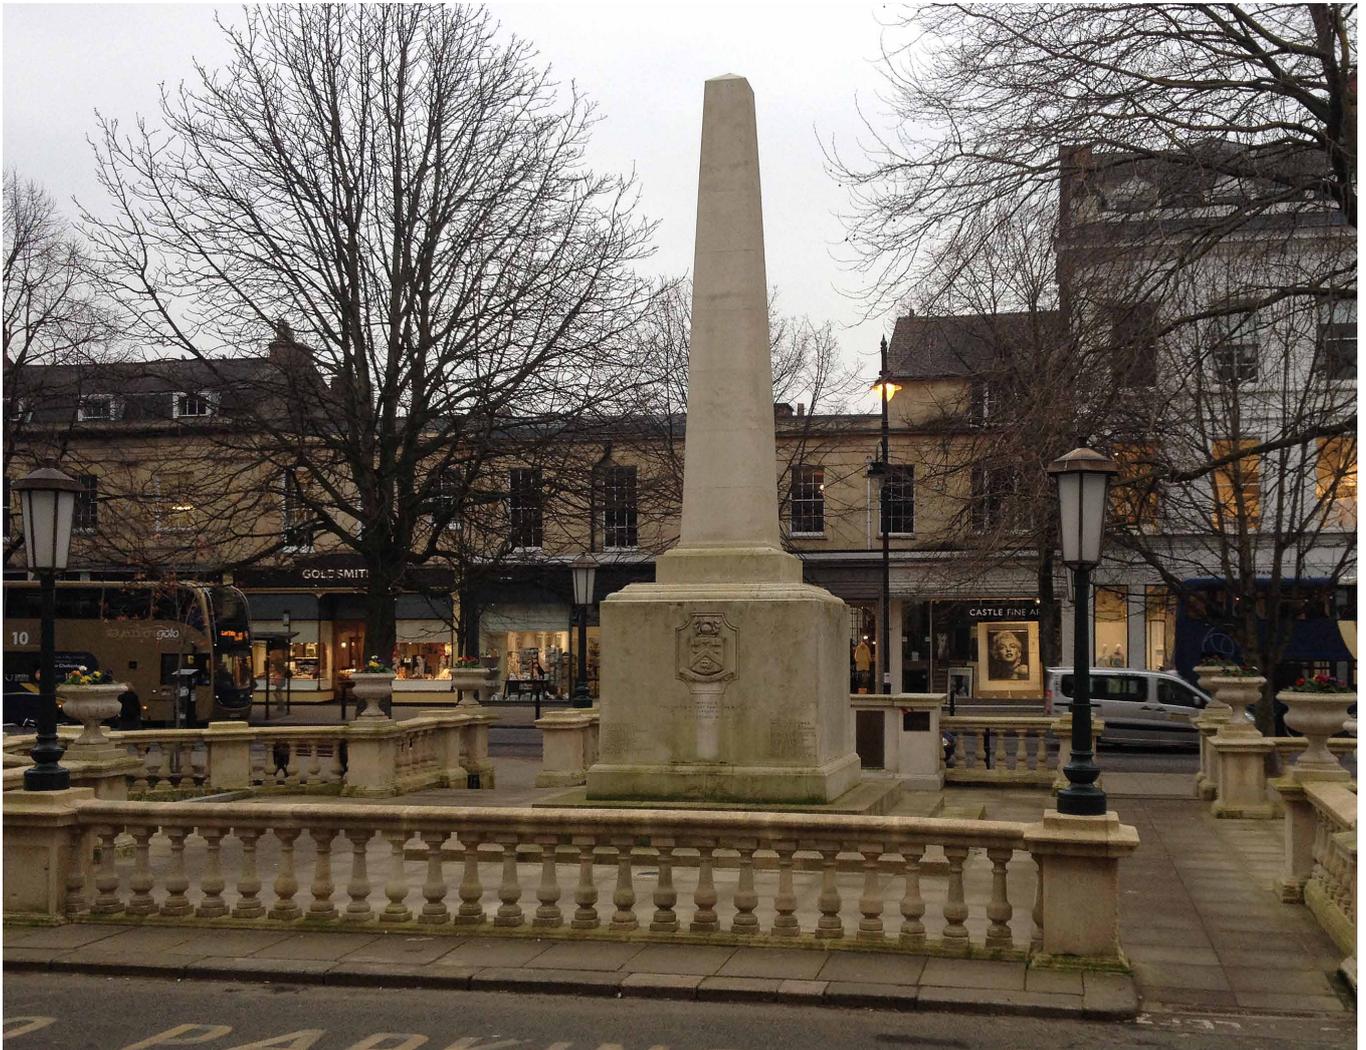
Front cover:

General view of the Cheltenham war memorial after conservation. © Odgers Conservation Consultants

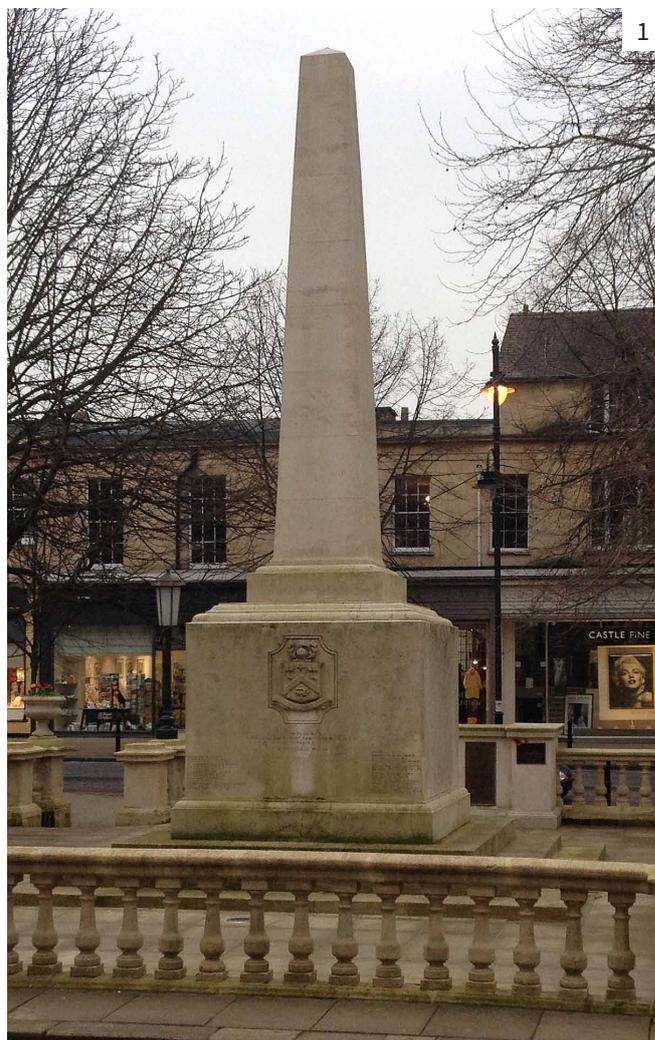
The memorial was constructed in 1921 and consists of a Portland stone obelisk on top of a large base set on a stepped plinth. The most notable element of the memorial is the extent and nature of the inscriptions: 1284 names are inscribed on three sides of the base. The letters were cut so as to receive lead fills but whether from cost or unavailability of craftsmen, the incisions were actually filled with coloured cement mortar with an oiled finish to simulate lead.

1 The Cheltenham War Memorial.

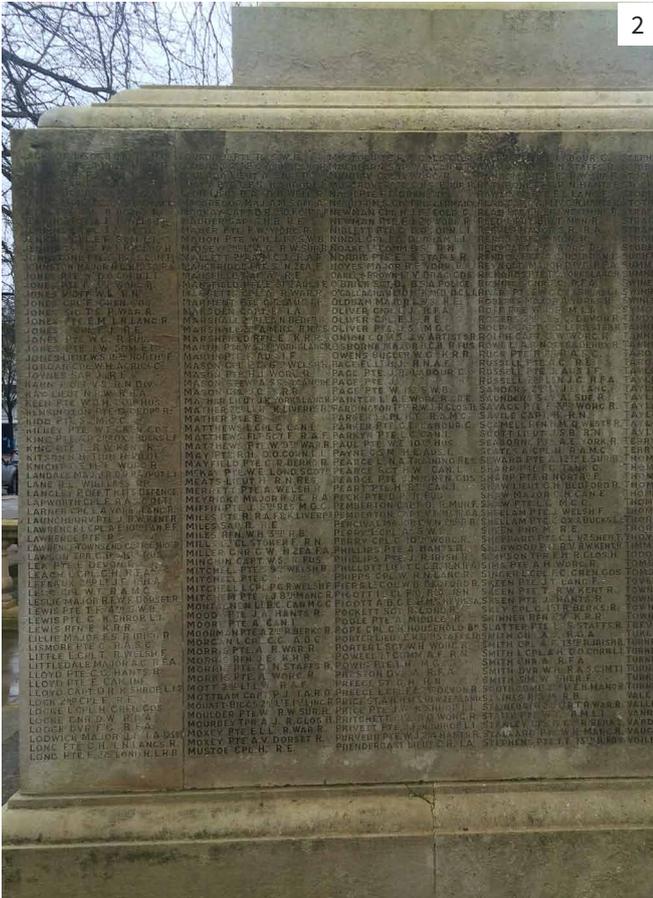
The original design allowed water to track down the obelisk and because there was no overhanging moulding this resulted in saturation of the top of the inscription panel. The combination of this design flaw, the local environment with overhanging trees and the porous nature of the stone meant that there existed ideal conditions for the growth of algae. As a result of this, inscriptions - particularly those in the upper parts of the panels - became obscured. In order for legibility to be restored, the memorial was therefore regularly cleaned, usually with pressurised water. Unfortunately this cleaning process caused the edges of the inscriptions to become worn and a consequent loss of some of the mortar infill. In places grey paint had been rather crudely applied as a replacement for missing infill.

- 2 Side panel showing extent of lettering and how it is obscured by microbiological growth
- 3 Typical area showing original technique of lettering and how the abrasion from regular cleaning has caused loss of mortar and reduced legibility.
- 4 Magnification (x50) showing the loss of mortar from a single letter. This also shows the fine aggregate in the mortar.

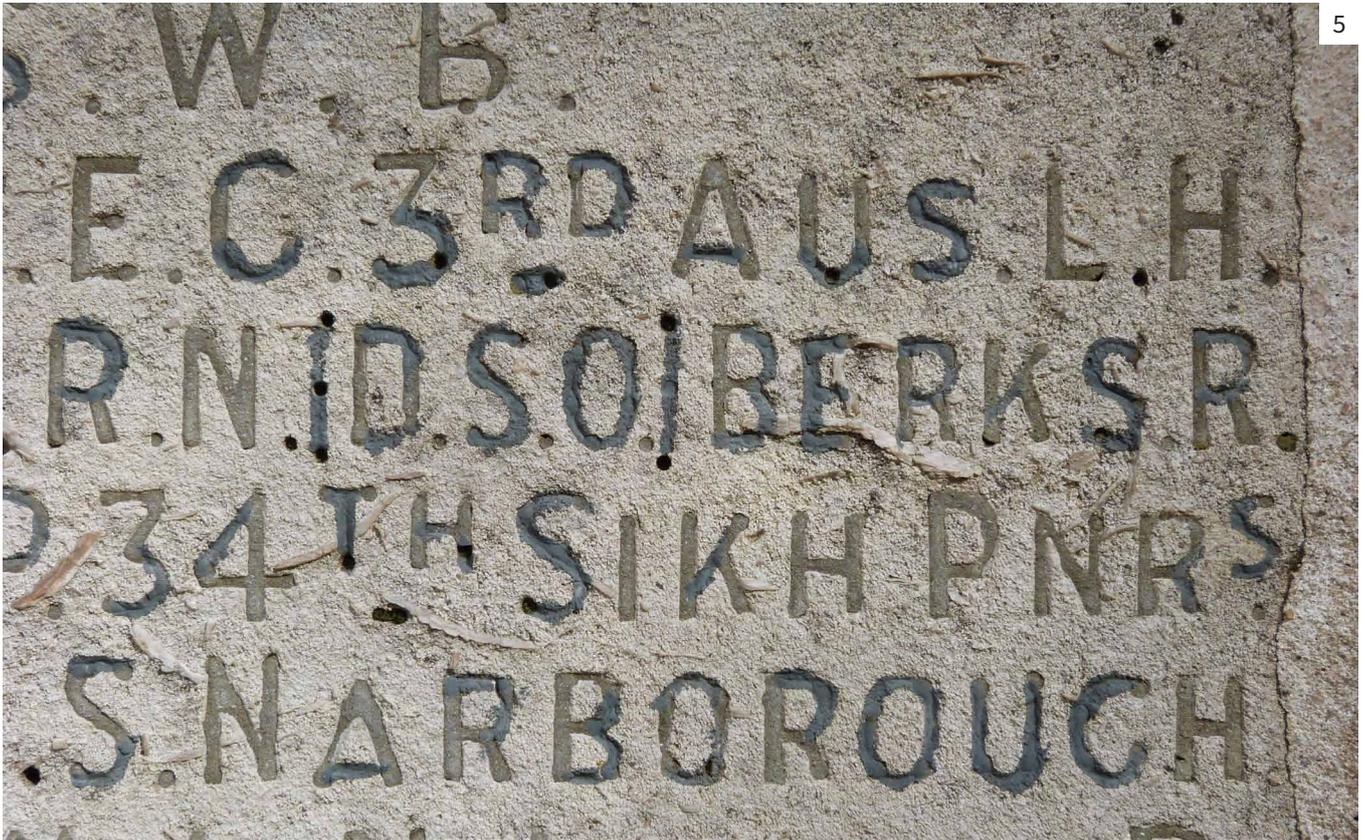
- 5 Lettering where mortar has fallen out and been replaced by crudely applied grey paint.
- 6 The extent of the work required can be seen in this typical example from a total of 1284 names.

The cleaning process (including the removal of the grey paint) revealed the full extent of decay and damage to the inscriptions. In general, although all of the names remained legible, much of the sharpness had gone and there were a significant number of letters where the mortar infill was wholly or partially absent. As an example, the erosion of fine detail meant that the letter 'C' and 'G' had become largely indistinguishable.

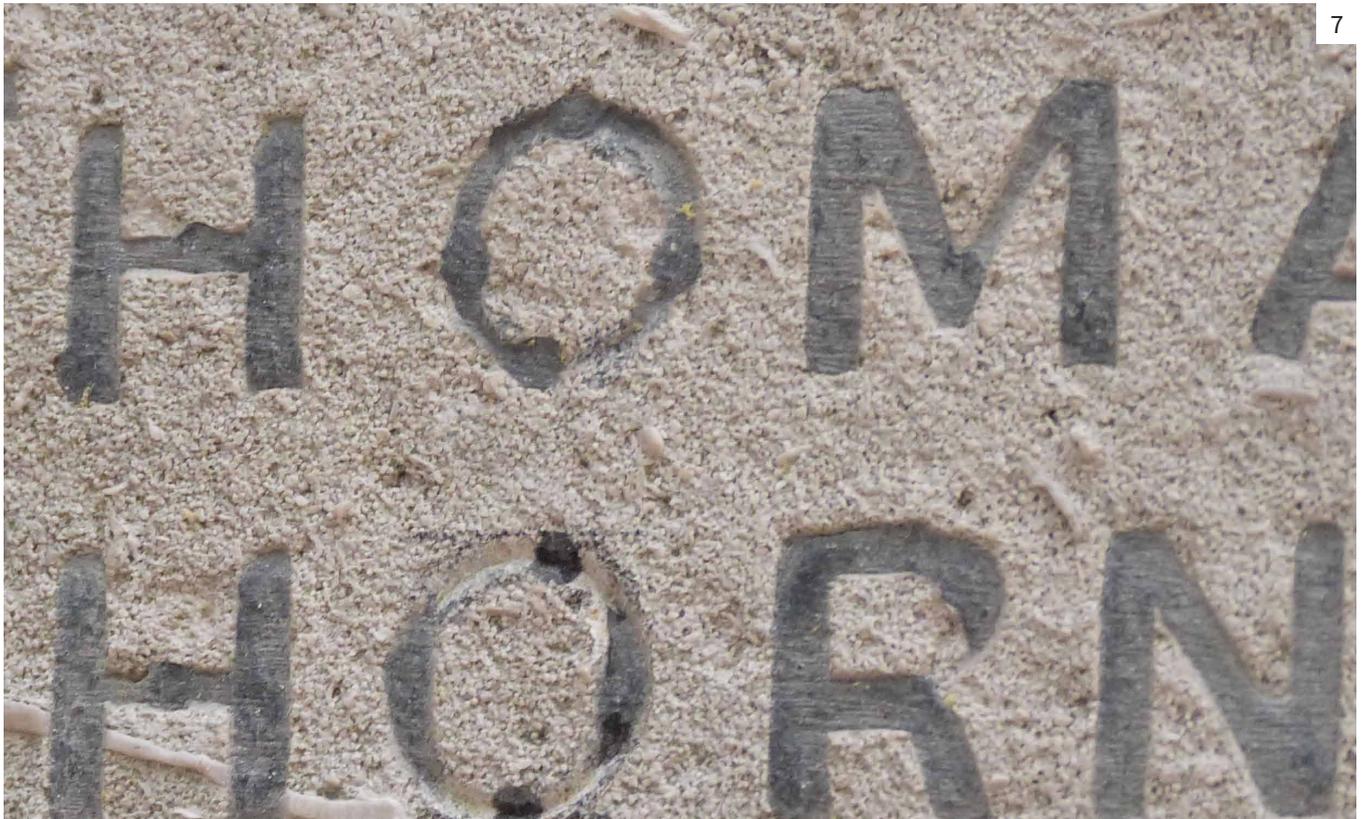
7 The skill of the letter cutter is in deciding how much of the letter needs to be cut, and then carrying out the work with great precision, using a very sharp chisel.

To reinstate the legibility it was necessary to replace the mortar infill. Before the mortar could be applied, it was necessary to ensure that there was a suitable incision to fill. This required delicate work of re-cutting, involving mostly only part letters. The letters were carefully incised to follow the weathered surface, rather than attempting to flatten the surrounding stone. The extent of this work could only be decided by the letter cutter on site.

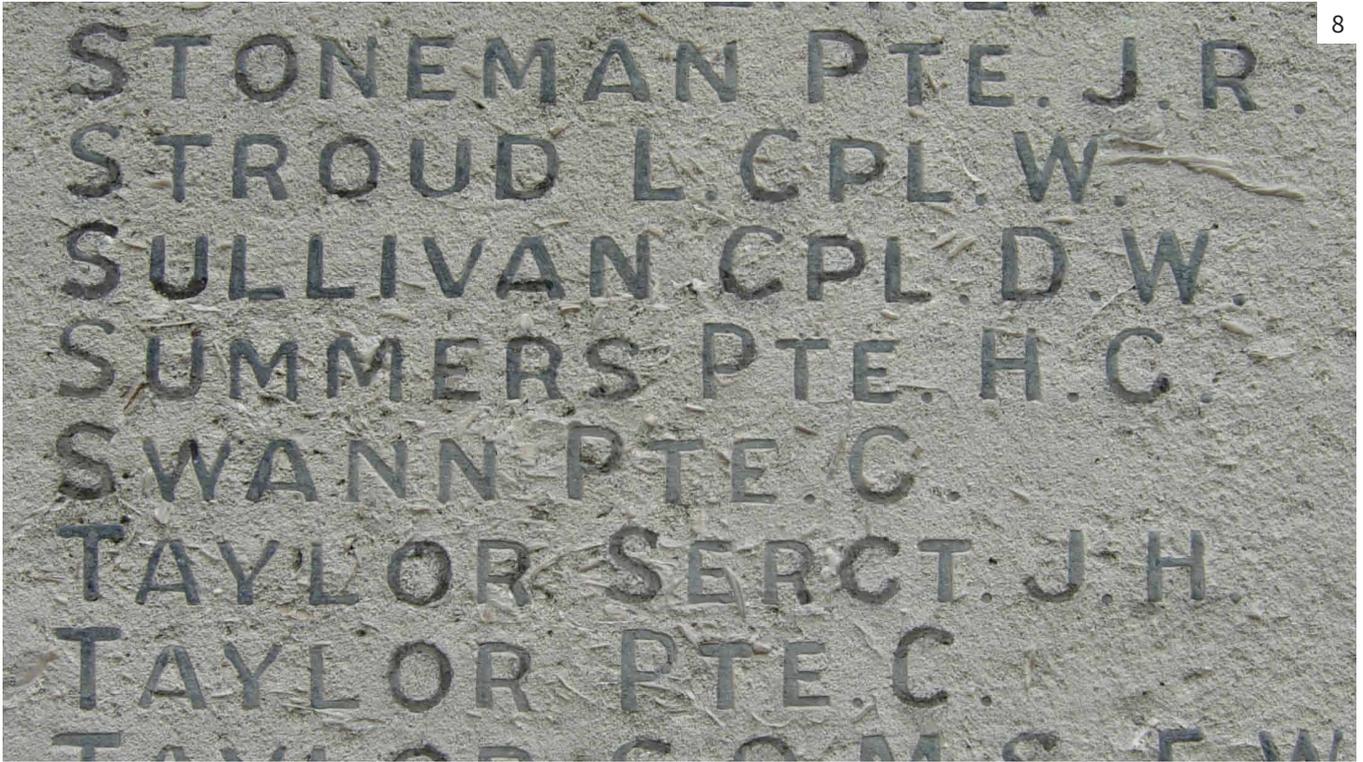
- 8 The fills were carefully placed and packed into the incisions and then scraped back flush with the surface when leather-hard.

Several trials of replacement mortar were made. This mortar needed to match the original, set quite quickly so that it could be modelled, but also be hard enough to set when only 2–3 mm thick. After trials the mortar selected was:

This mortar was applied to the pre-wetted surface and allowed to take on an initial set before being cut back to the right dimension. It was kept damp for several hours after application.

1 part	lime putty
2 part	rapid set cement
0.5 part	slate dust
0.5 part	sieved charcoal dust
0.03 part	black cement pigment
0.25 part	casein powder
0.03 part	citric acid (acting as a retardant for the set)
<i>All ingredients were measured by volume</i>

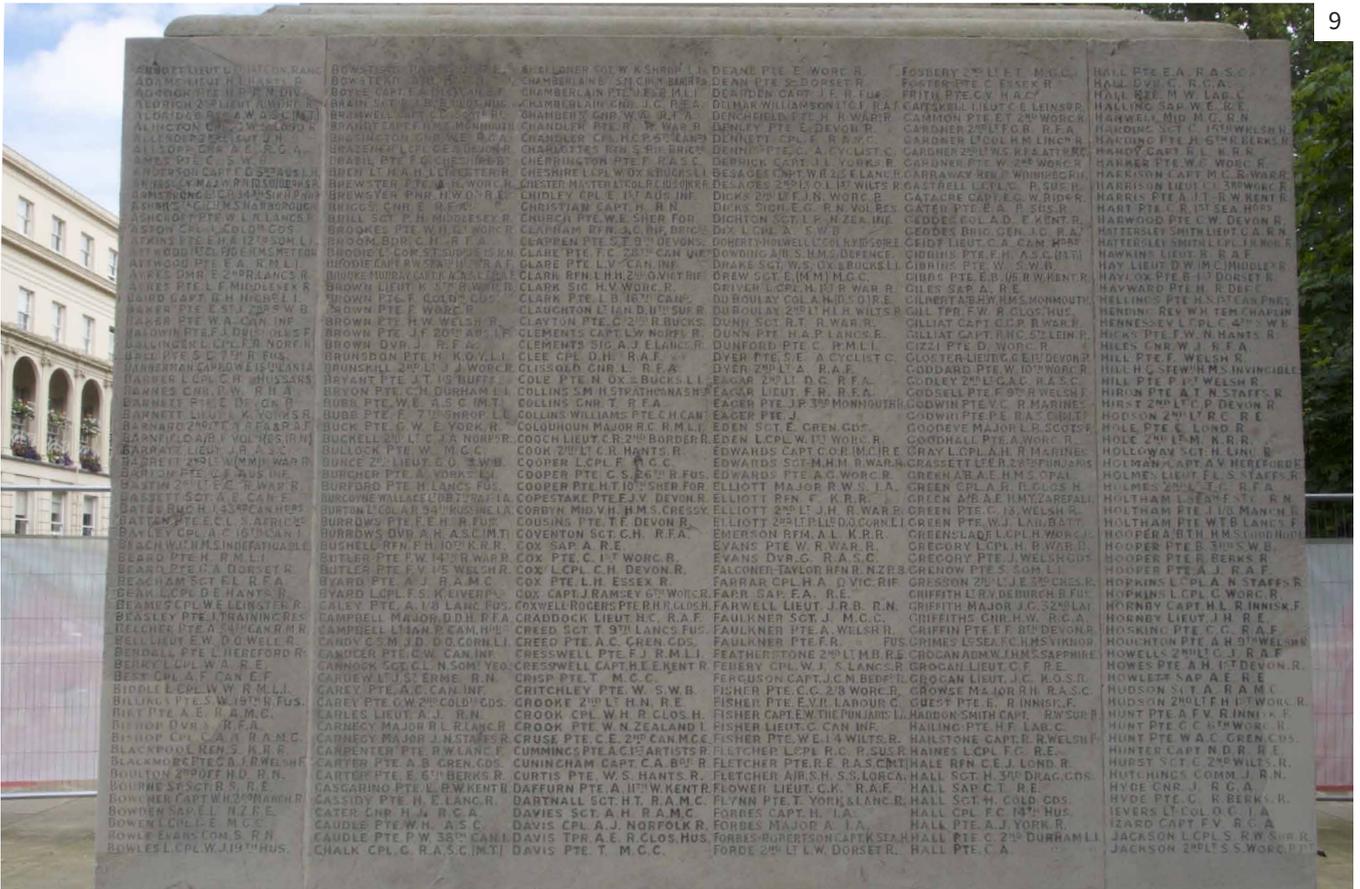
9 The extraordinary number and detail of the inscriptions is clear after completion of all the work; the challenge is to maintain it in this state.

Fortunately in this case, the intervention was carried out before legibility became substantially compromised. The challenge in the future is how to prevent the cycle of algae growth and regular cleaning being re-established.
