Conserving War Memorials

Case Study: The Replacement of Missing Bronze Elements

First and Second World Wars Memorial,
Bootle, Merseyside

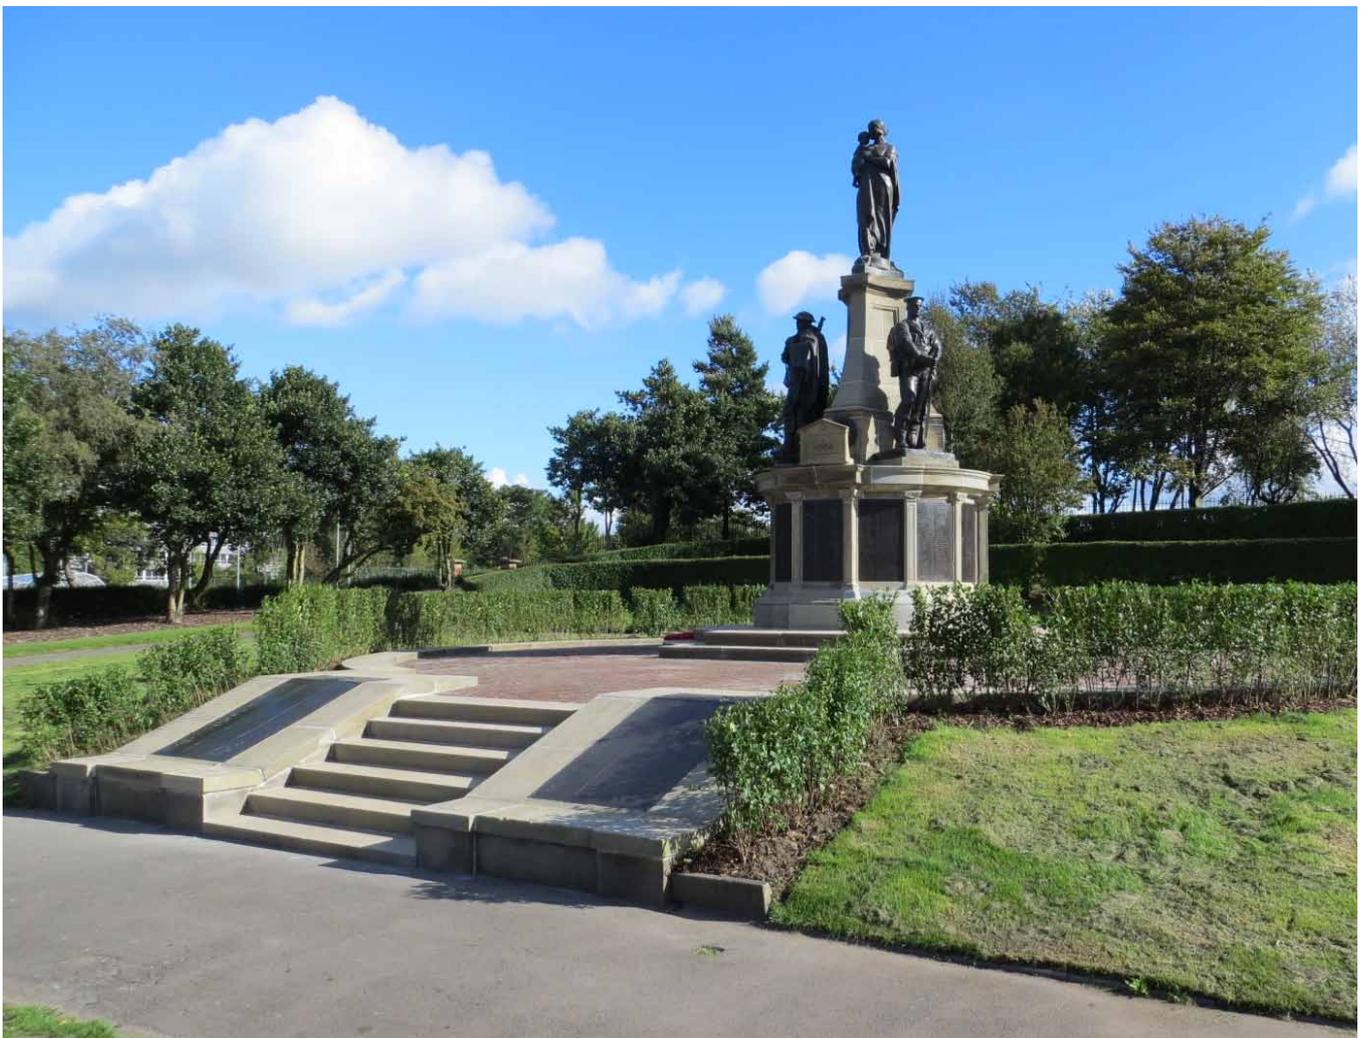
Front cover:

General view of the memorial after conservation work.

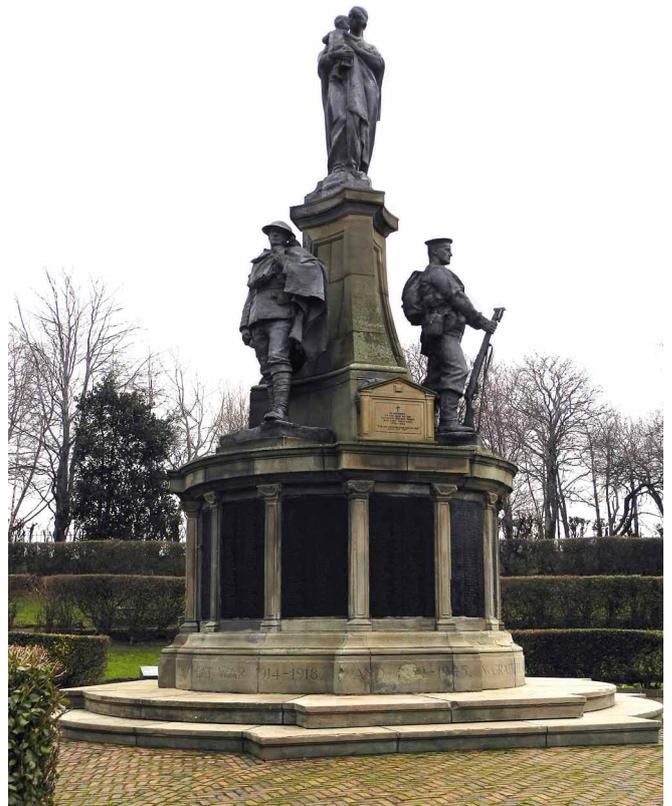
The Grade-II listed **Bootle War Memorial** (unveiled in 1922) is constructed from Forest of Dean sandstone and comprises a twelve-sided base on two circular steps, with bronze panels bearing the names of the First World War fallen. Above this base is a triangular, concave-sided obelisk that supports a bronze figure of a mother and child. Flanking the obelisk on three sides are over life-size bronze figures of an infantry soldier, a seaman and an airman. On the stonework separating the figures are three bronze wreaths; there is also a plaque on the west side commemorating the Liverpool Escort Force who were active in the Second World War. On the wide stone balustrade either side of the steps leading to the memorial are set two bronze memorial plates carrying the names of those who died in the 1939–1945 conflict, with additional names in lead lettering surrounding the bronze plates (as shown on the front cover image).

1 The Bootle War Memorial, before conservation.

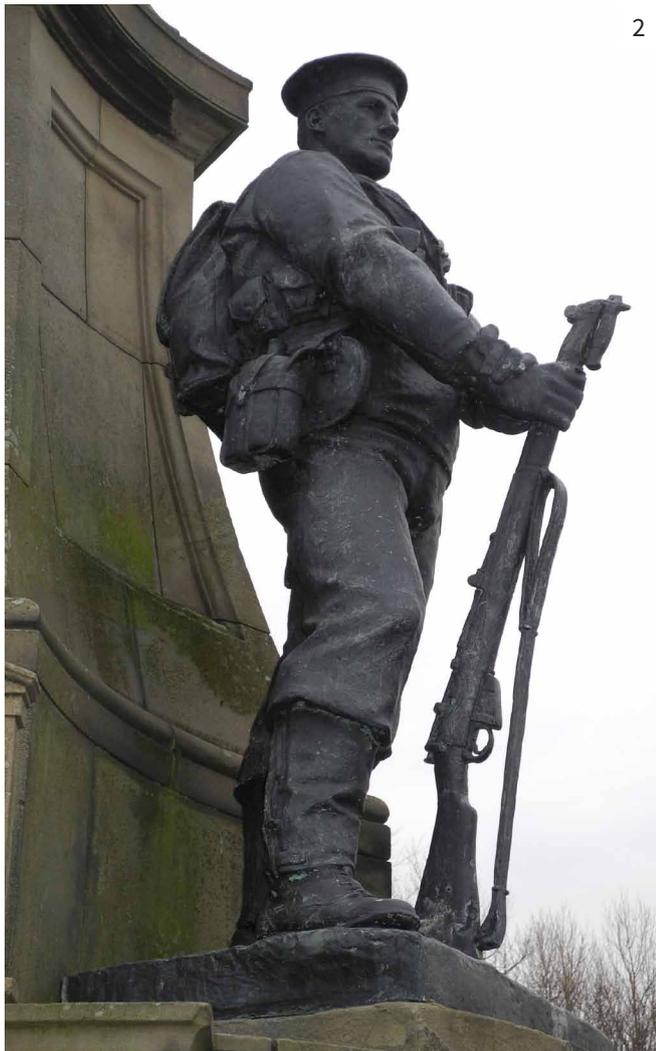
Despite poor surface condition, the overall physical condition of the bronzes was generally sound. However, the inherent weakness of the ferrous metal fixings that had been used originally to attach the Seaman's bayonet blade and the Infantryman's rifle strap had allowed the theft of those elements. The strap's upper and lower sling swivels were also damaged as a result of the theft.

- 2 The Seaman figure: note bayonet blade missing from the end of the rifle.
- 3 Detail showing bayonet blade missing from the end of the rifle.
- 4 The Infantryman figure: note the shoulder strap is missing from the rifle.

There was fracture damage and rust splitting in and around the bayonet handle. This required cleaning out and re-welding to fully repair the damage and to ensure that the socket into which the bayonet blade would fit was sound.

As the bayonet blade had been stolen in the past it was decided that this element was still vulnerable to theft, and so should be removable, so that it could be held for safekeeping and installed for ceremonial occasions. The bayonet handle was carefully cut off the gun, to enable it to be attached to a new blade at the workshop. A wooden pattern matching the correct form for the bayonet blade used on this rifle was made. This was used to sand-cast a replacement blade in bronze, which was welded onto the original bayonet handle. Both elements were patinated and waxed, using the same materials and techniques as for the rifle strap, to match the surrounding bronze surface of the statue. Pin and slot fixings were engineered in bronze to allow the bayonet to be correctly positioned onto the statue's rifle, with the joints invisible from the ground. A small bronze 'cap' was also engineered to finish and seal the rifle when the bayonet blade is not fitted.

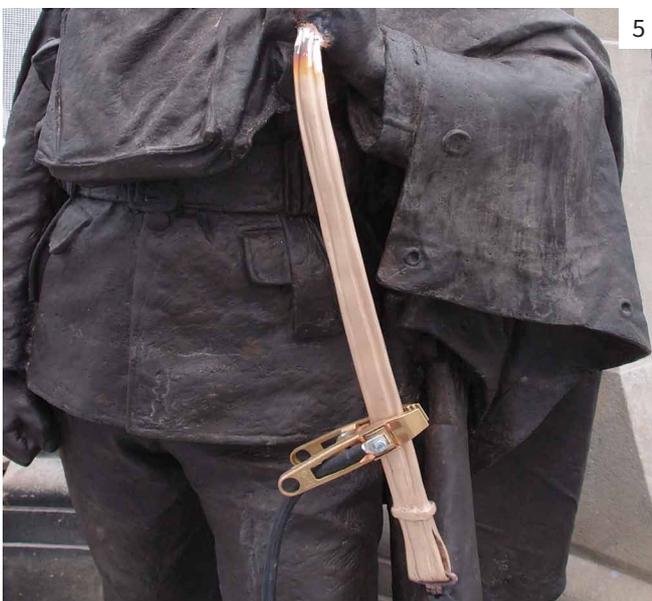
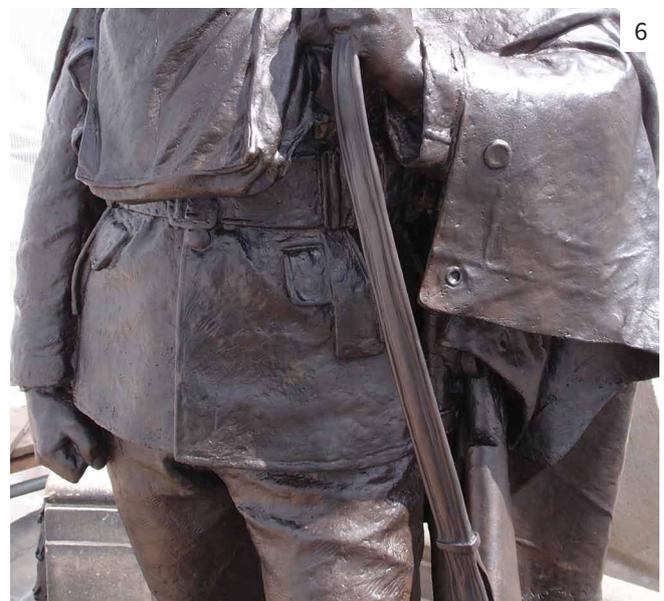
-
- 5 The Infantryman's new bronze strap attached to the rifle.
 - 6 The new strap after patination and waxing.

The two sling swivels on the Infantryman's rifle were repaired and a new sling strap was modelled by hand from historic photographs to make a casting pattern, which was then sand-cast in bronze. The sling strap was made to follow the contour of the figure and to have an open return loop from the fore sling swivel. This was fitted to the statue by tungsten inert gas (TIG) welding, and it was then patinated to match the surrounding bronze surface, using a weak dilution of potassium sulphide, augmented with a weak

solution of ferric nitrate, in order to achieve the desired colour. Heat supplied by large propane torches was used, to aid the reaction of the chemicals. The bronze surface was then warmed again to drive off any residual moisture in the patina layer. The bronzes were then waxed with microcrystalline wax, using the 'hot wax' process to ensure the wax coating was fully absorbed into the porous patina coating.
