# Conserving War Memorials

Timber Lych Gates, Shelters and Calvary Crosses

HEAG324

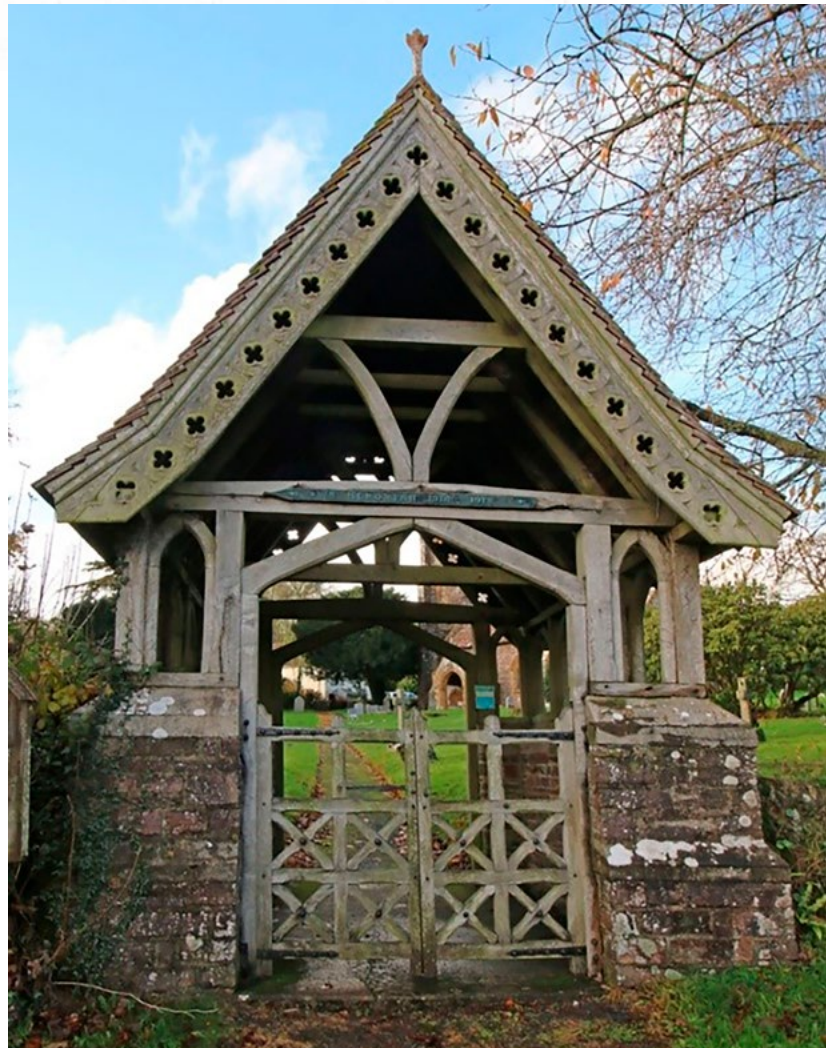
**Figure 2.2:** This Grade II World War memorial oak lychgate at Chipstable, Somerset ([WMO/99221](https://www.gov.uk/monuments-and-buildings/wmo/99221)) exemplifies the decorative qualities of work of this period. Note, in particular, the contribution made by the gates themselves. An iron inscription plate above the gates commemorates the fallen of 1914–18.

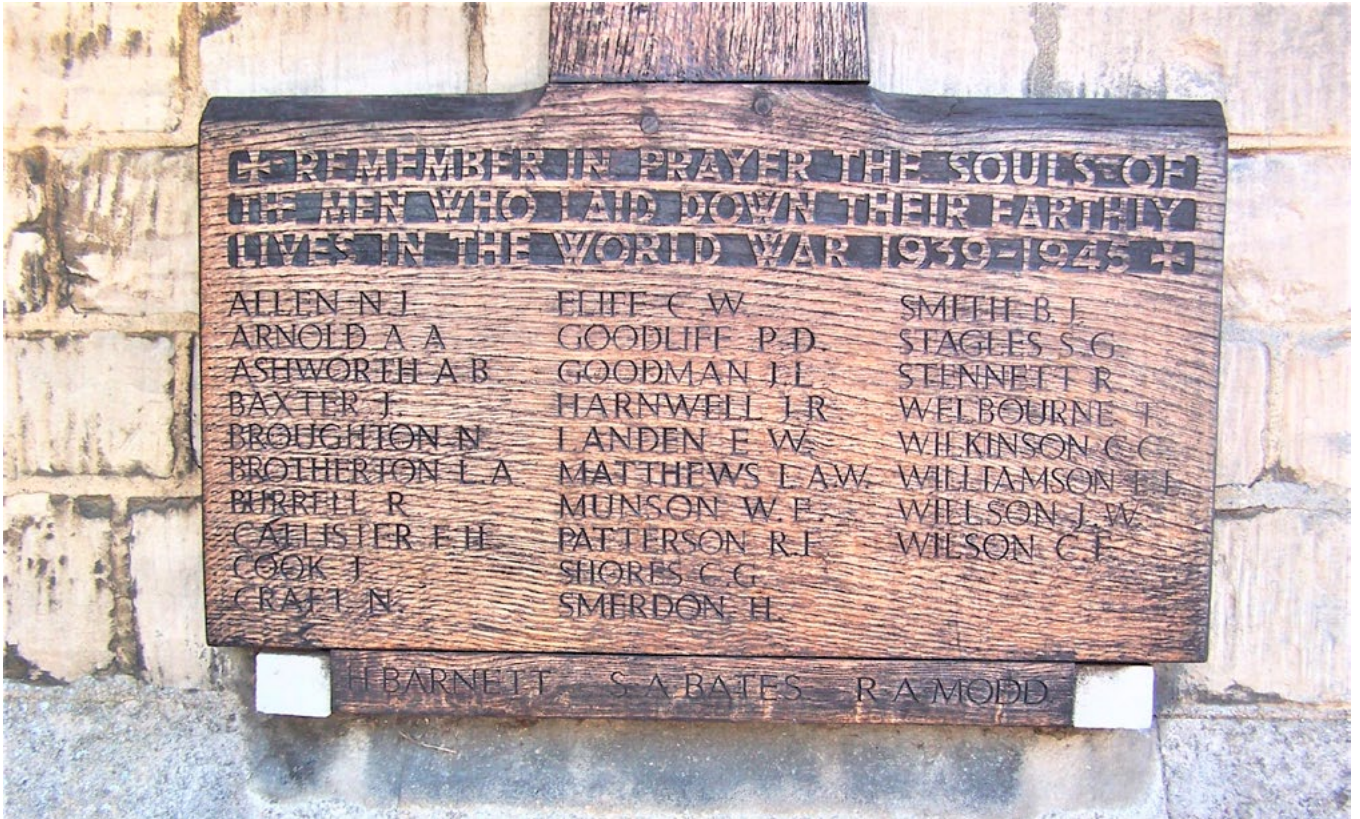
**Figure 2.5:** St John the Baptist Church, Spalding, Lincolnshire ([WMO/189589](#)). A timber inscription panel with raised and incised lettering.

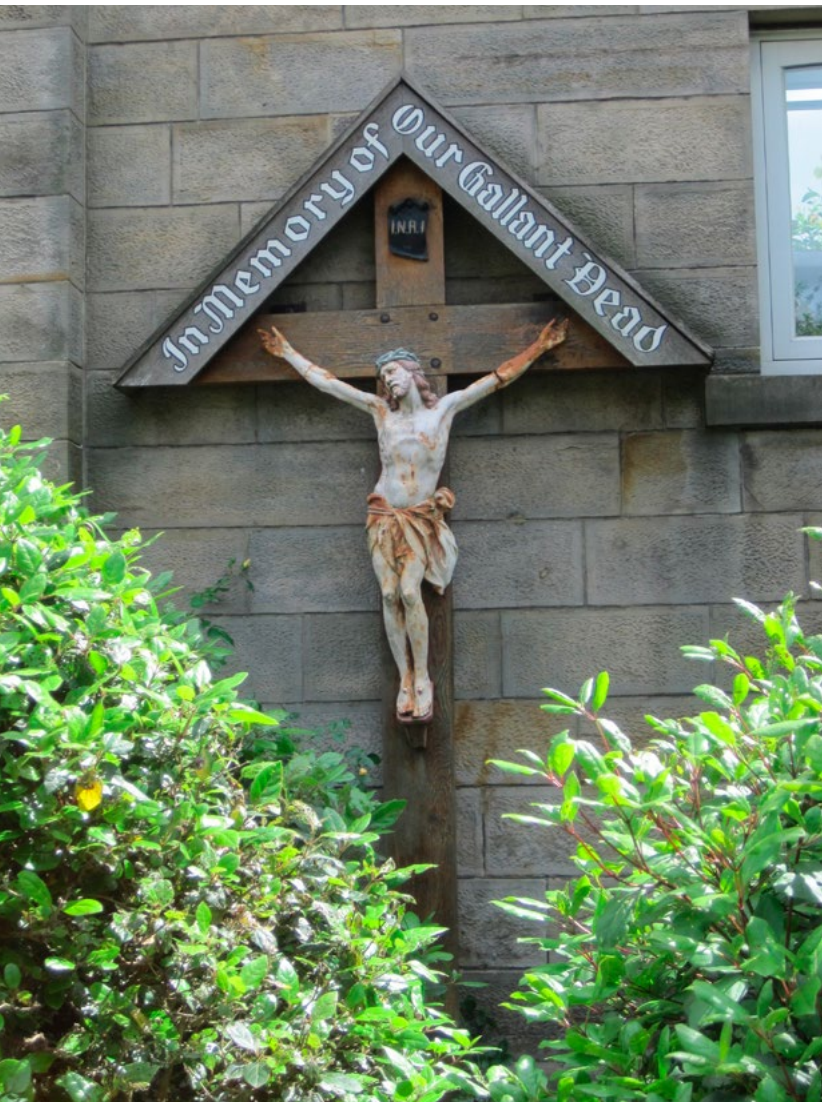
**Figure 2.6:** St Mary's Church, Knaresborough, North Yorkshire ([WMO/301432](#)). The painted cast iron corpus has some corrosion in localised areas. The inscription to the canopy bargeboard is clear and has likely been repainted in the recent past.

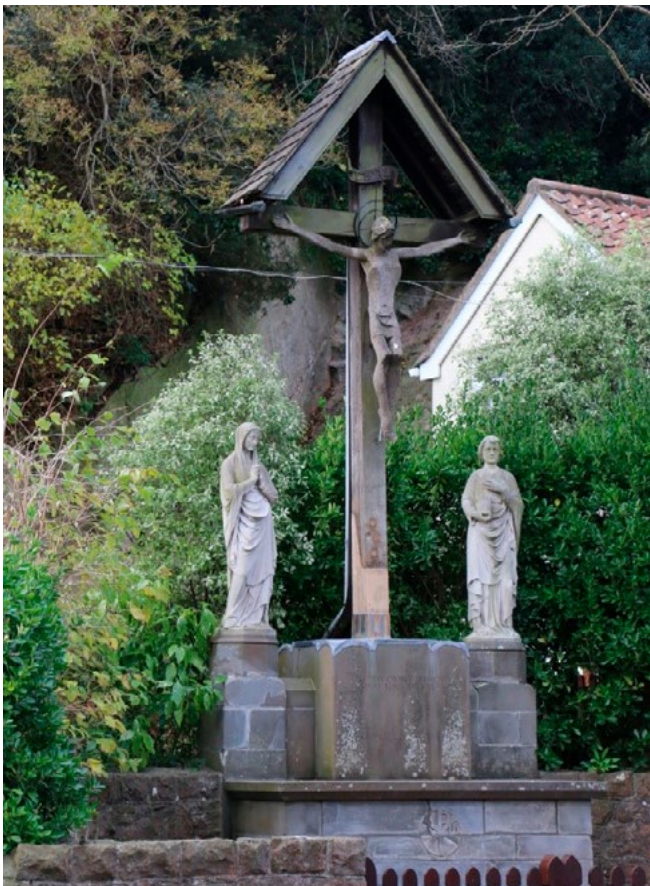
**Figures 3.1a and 3.1b:** Calvary and war shrine, East Clevedon, Somerset ([WMO/158421](#)), designed by John Ninian Comper and dedicated in August 1918. Commemoration of a casualty of the Second World War was added to the memorial in 1948. These photographs, taken in June 1930 and November 2018, show several significant changes to this memorial. All three figures have been replaced with different materials, and the side figures of Mary and John no longer look up at the crucified Christ, obscuring the message conveyed by the original assembly of the group. The detail at the base of the cross shaft has been lost, and the design and spacing of the palings at the front of the enclosure have been altered. An extension to the house behind impacts the setting of the memorial. Note that the lead cap to the central plinth stone is concentrating the staining below.

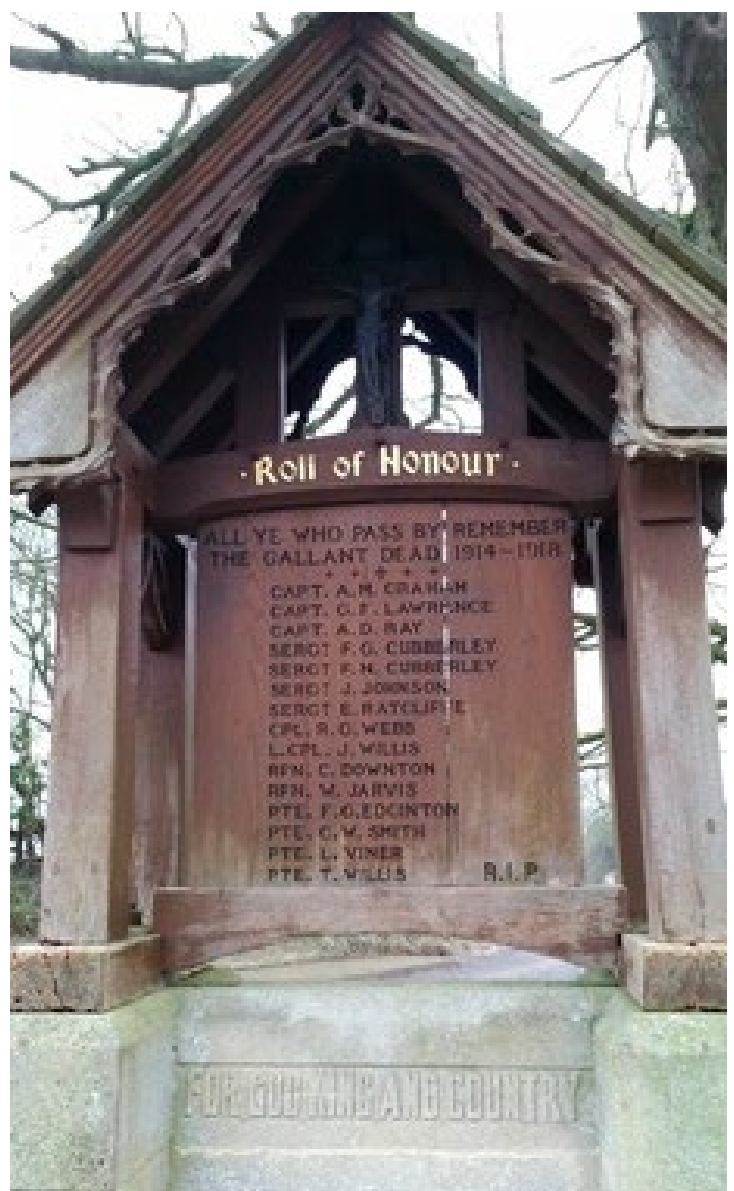
**Figure 3.2:** Norton Juxta Kempsey war memorial, Norton, Worcestershire ([WM/233441](#)). Over time, the weather has eroded the surface finish to the more exposed elements of the memorial.

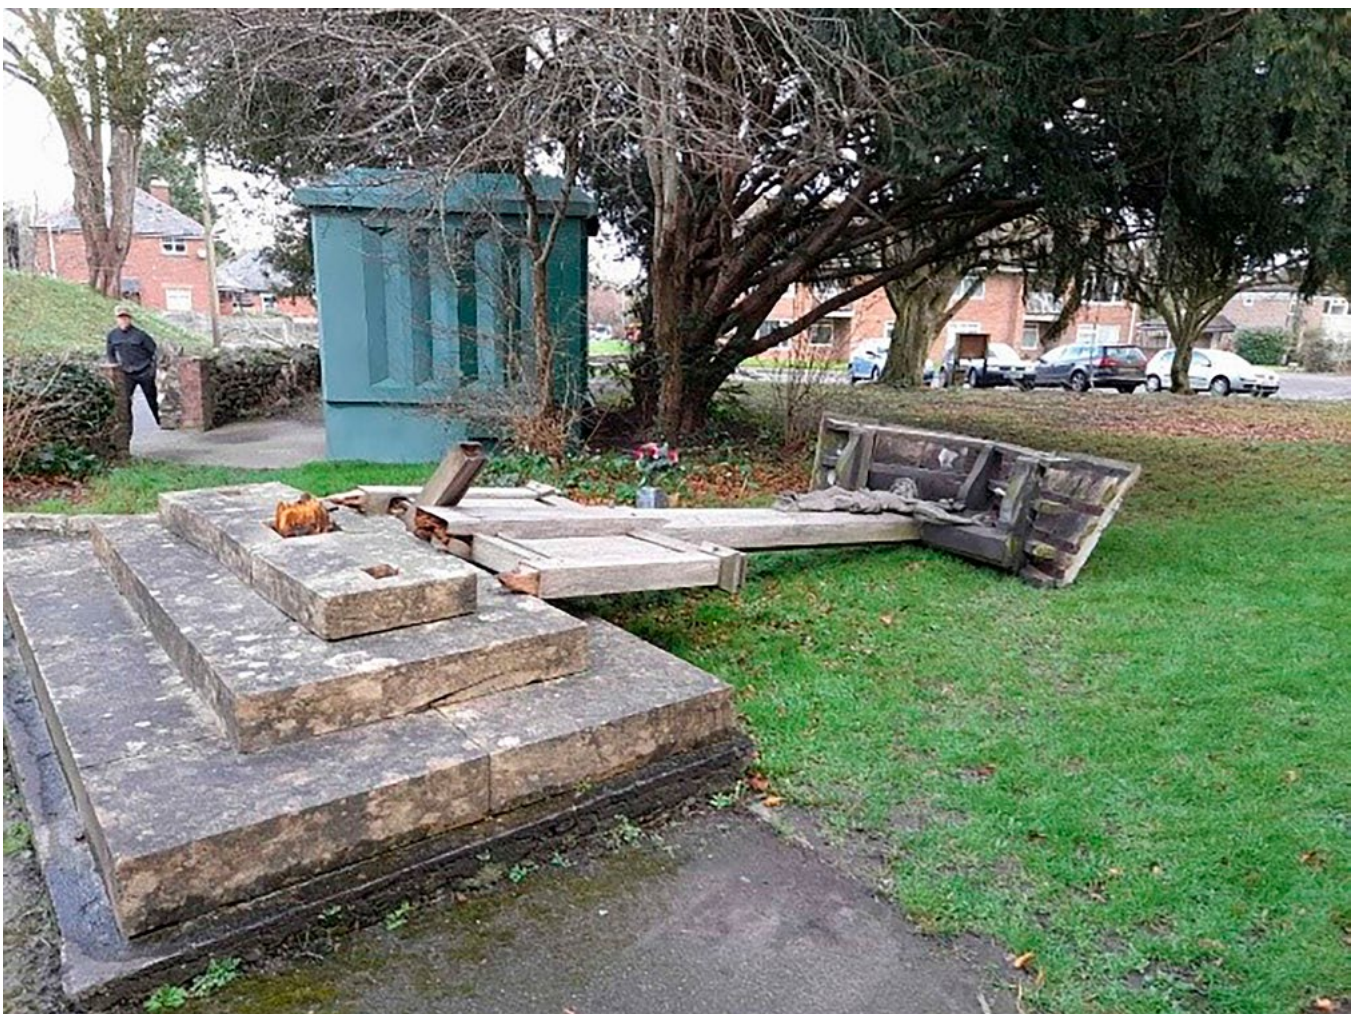
**Figure 3.3:** Here, the timber base of the cross has rotted within the masonry socket and strong winds have pushed the Calvary cross over.

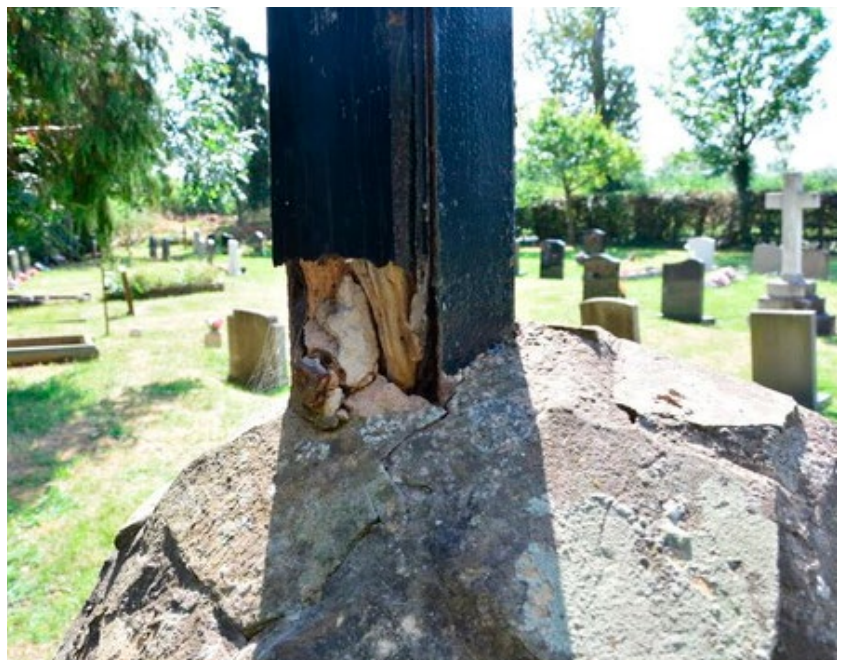
**Figure 3.4:** Decay of the timber post is visible where it enters the socket in the stone base. The shrinkage of the timber has created a substantial gap between the post and the stone on one side. This will allow water in, thereby causing further timber decay.

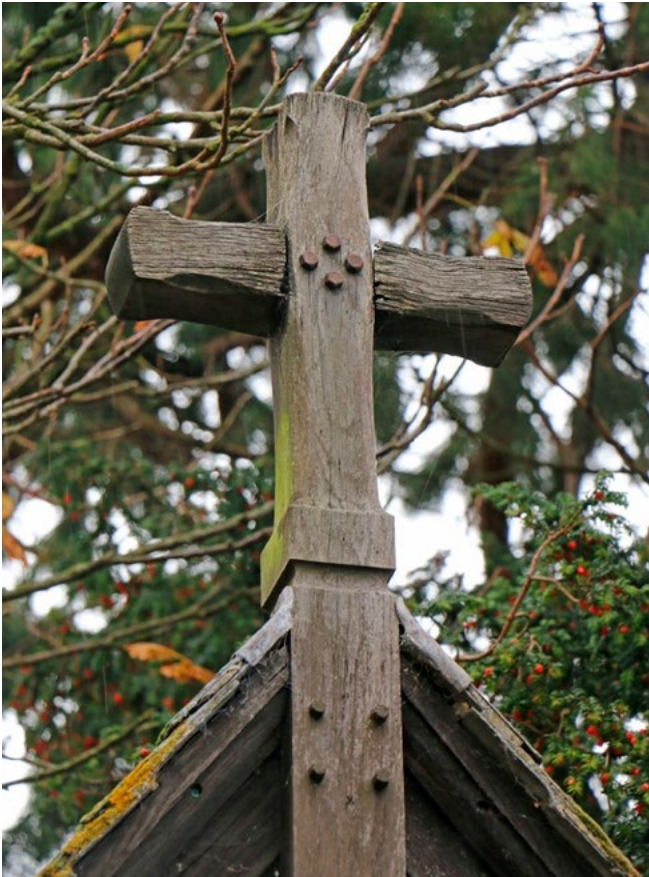
**Figure 3.5:** This cross is situated at high level at the apex of the lychgate roof. Decay is evident in the cross where the end grain is exposed to moisture at the junctions between the cross bar and the shaft.

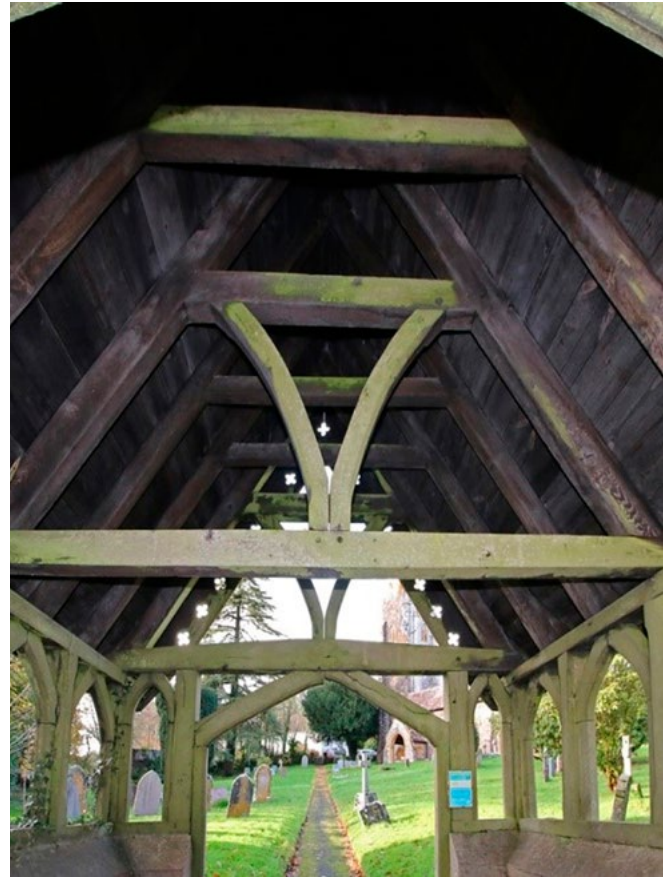
**Figure 3.6:** Algal growth on lychgate timbers indicates persistent dampness, the cause of which needs to be investigated.

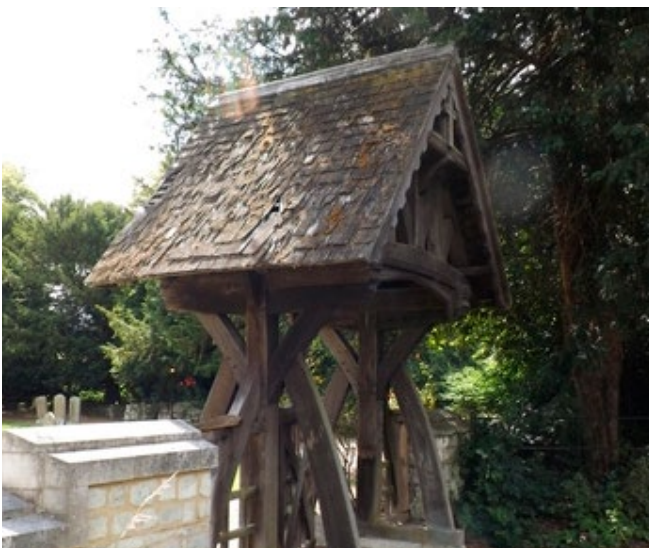
**Figure 3.7:** The shingles on this lychgate have deteriorated over time to the extent that they need to be replaced.

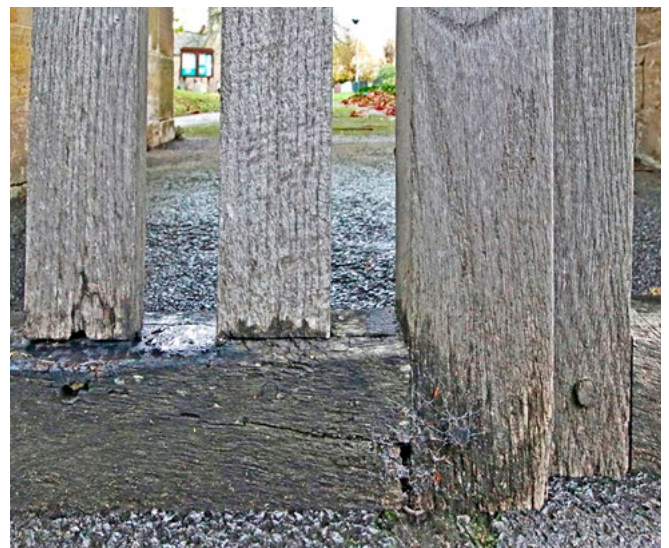
**Figure 3.8:** Decay in the bottom rail of this gate is the result of its exposure to the elements, as it is farthest away from the protection of the lychgate roof and within the 'splashback zone' from groundwater.

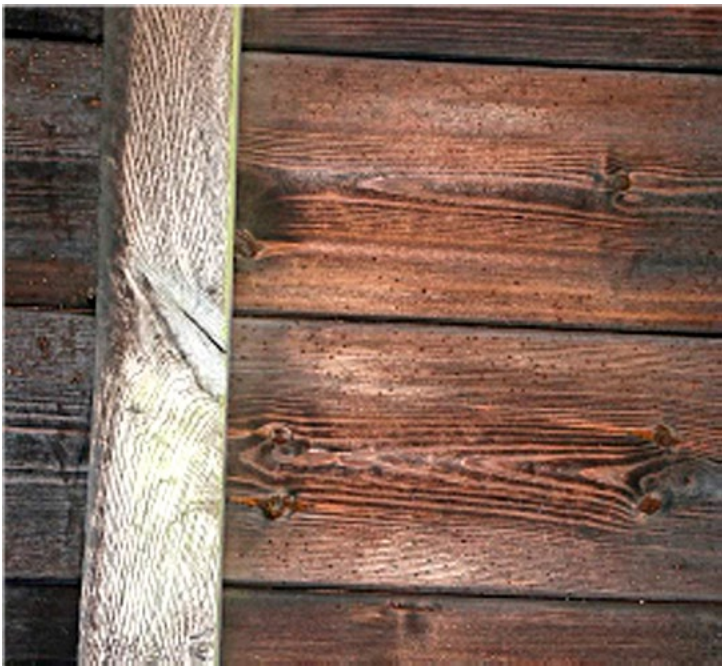
**Figure 3.9:** A common furniture beetle infestation can be seen in the cover boards on the underside of this lychgate roof. Damage is generally restricted to sapwood. Active beetle infestations usually only occur where the timber is damp.

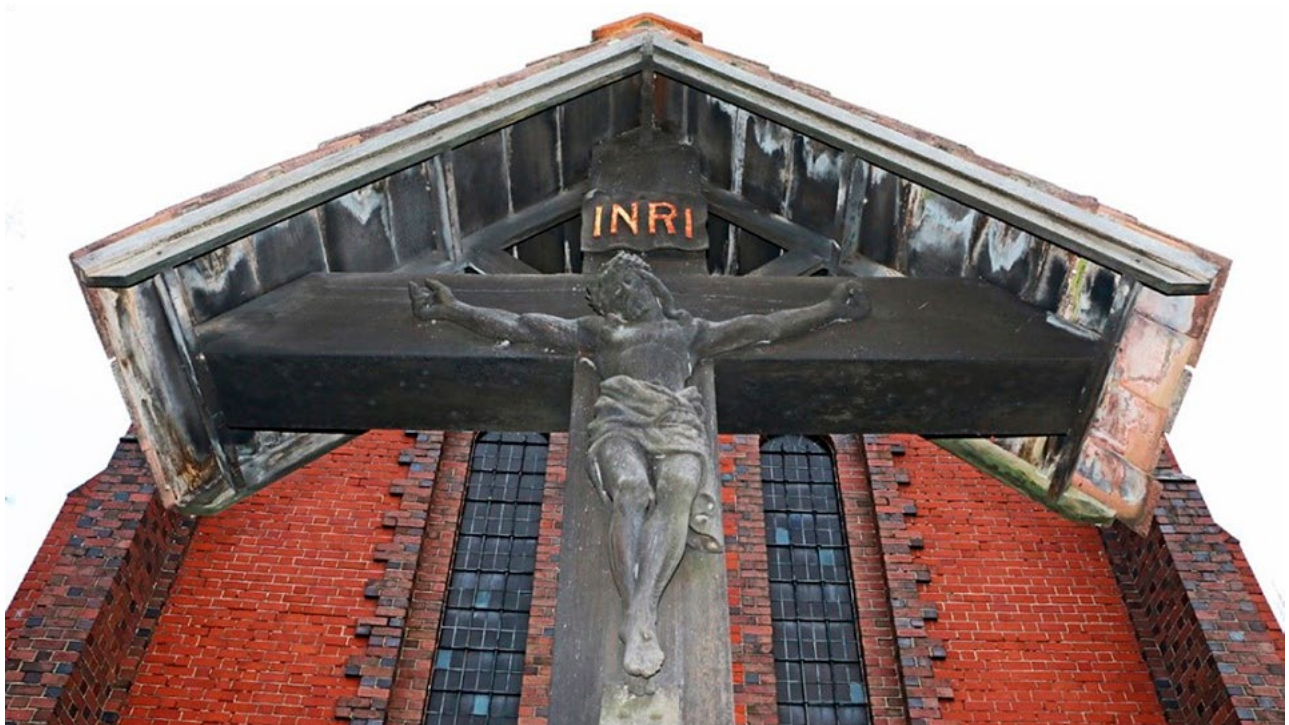
**Figure 3.10:** The underside of this Calvary roof shows staining and decay from water ingress caused by pointing failure below the edges of the tiles.

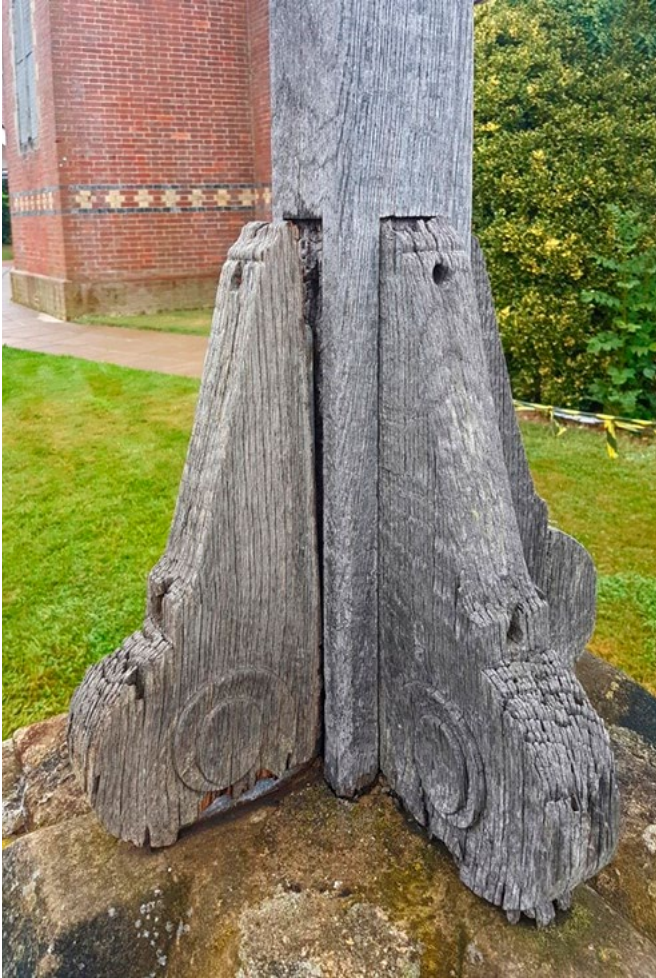
**Figure 3.11:** The junction of this cross shaft and stone base is supported by carved brackets. They have now decayed as a result of absorbing water from the masonry plinth below, and because of weathering damage to the exposed end grain on the top surface. General exposure to moisture has destroyed the fixings of the brackets, which are now loose.

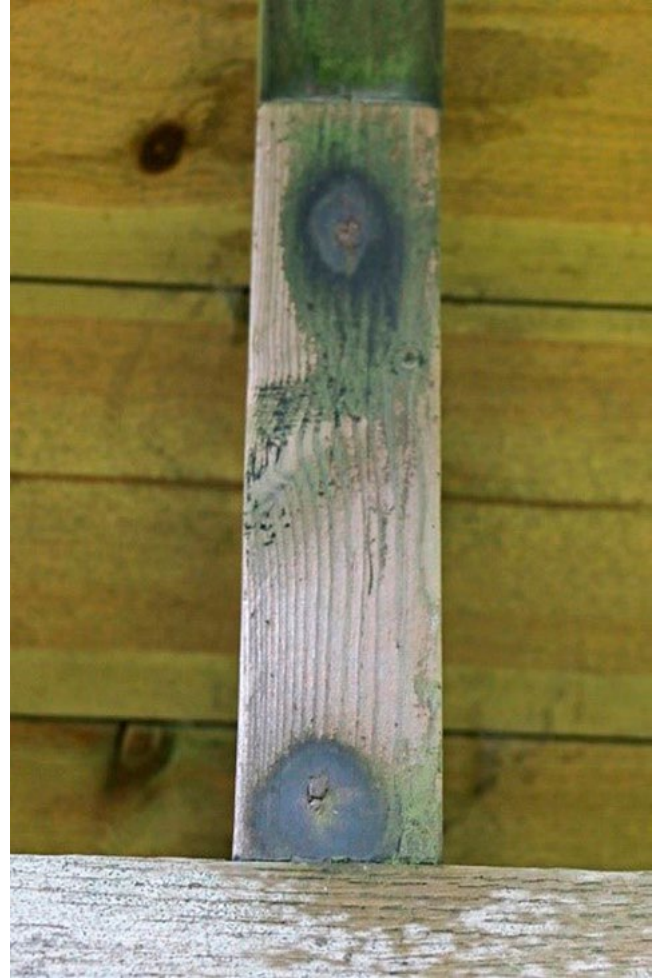
**Figure 3.12:** Disfiguring staining from steel nails. These should be painted with anti-corrosive paint and the gaps filled to prevent moisture coming into contact with the shaft of the nail.

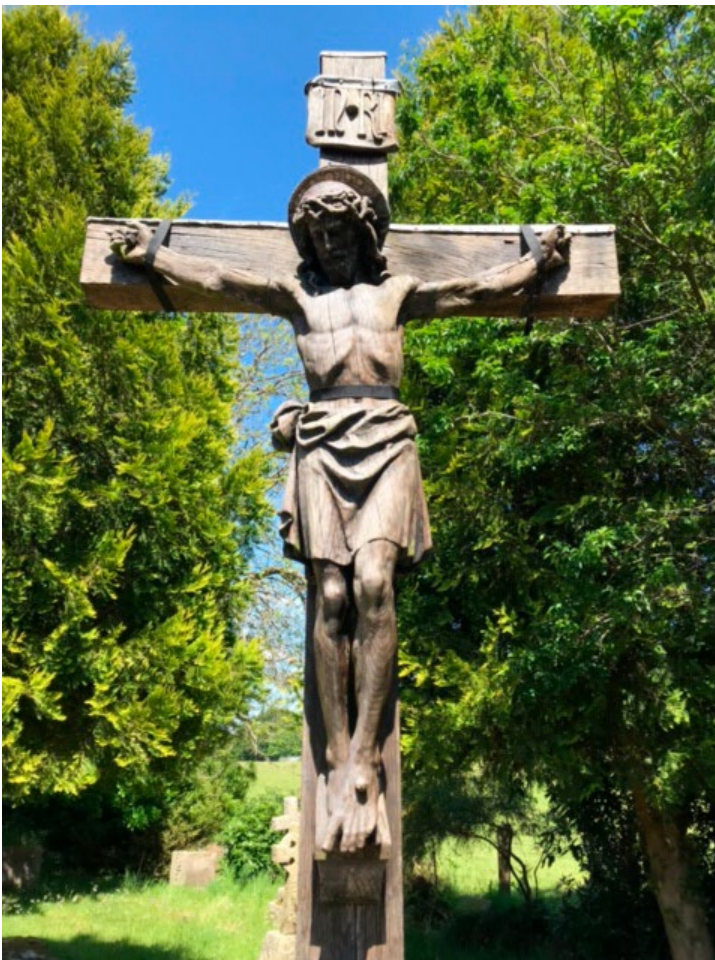
**Figure 4.1:** Calvary cross, St Michael and All Angels' Church, Pirbright, Surrey ([WMO/100753](#)). Although the supports holding the corpus to the cross are temporary, they are barely noticeable.

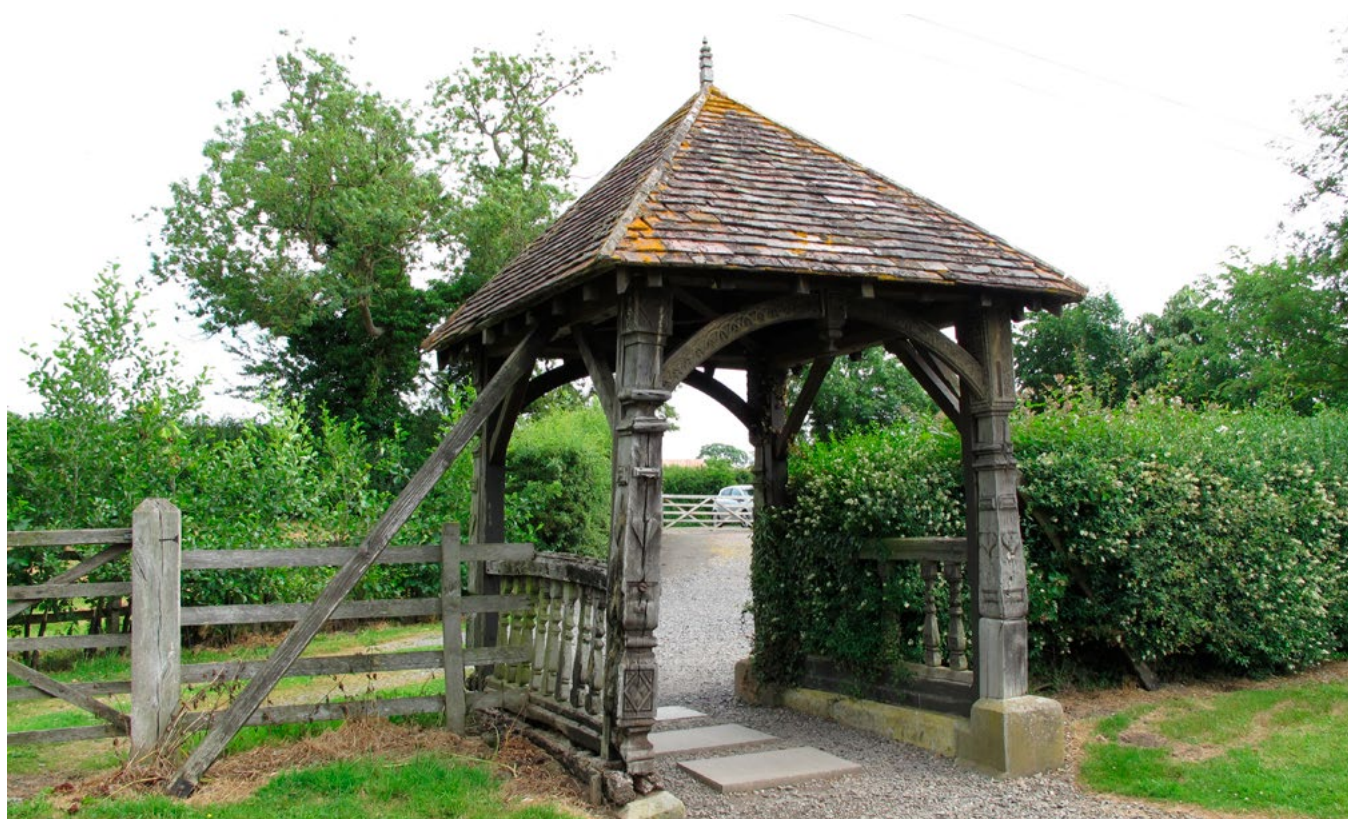
**Figure 4.2:** Emergency intervention is sometimes needed to prevent further deterioration until more permanent repairs can be carried out. Here, two raking shores have been installed to stabilise the structure.

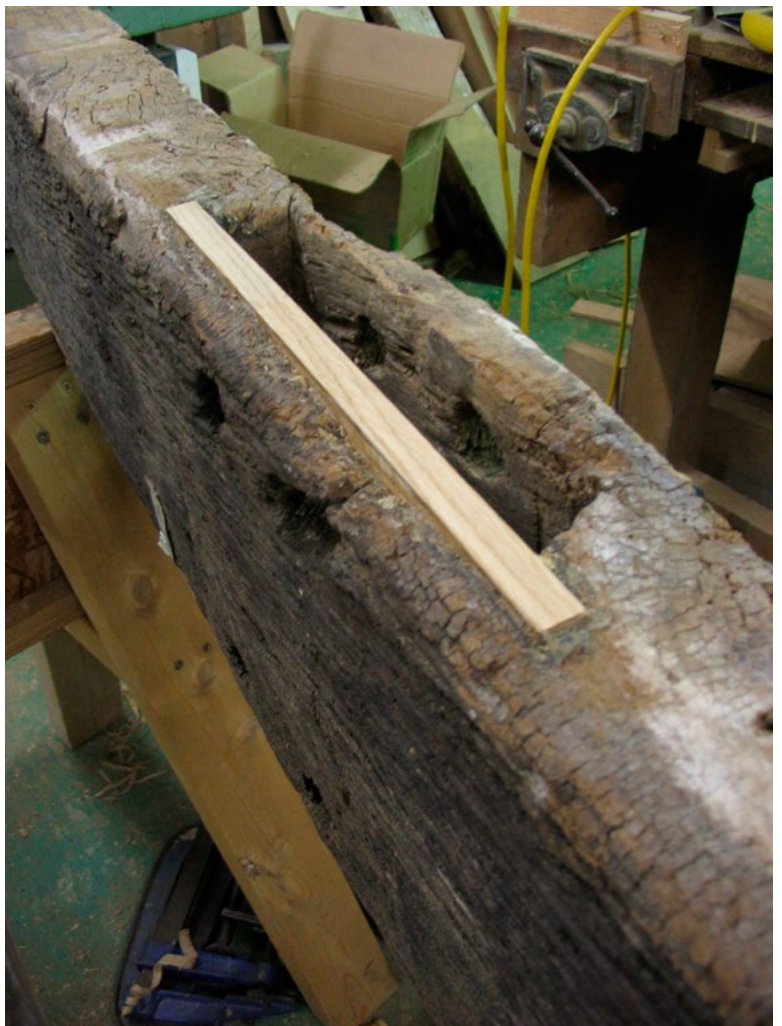
c) Repair of a decayed mortice and tenon joint.

d) Completed repair.

Timber-to-timber repairs are comparatively invasive, as historic fabric has to be cut away to receive new inserted timber. Also, some dismantling of the structure may be required where whole section repairs are needed. As an alternative, adding metal straps or brackets to strengthen and stabilise the structure could be considered in some cases. This method has been employed for centuries, and could, therefore, be said to be more ‘traditional’ than timber-to-timber repairs. It eliminates the need for dismantling the structure and minimises the loss of historic fabric. Furthermore, such repairs are reversible. This method can, therefore, be an efficient cost-effective treatment. The suitability of this type of repair will depend on its location, visibility and vulnerability to rain penetration and water trapping. Consideration should also be given to whether stainless steel or painted galvanised mild steel could be used. Careful design and good workmanship are required. In some instances, specially crafted metalwork may be used to enhance the visual quality of the repair.

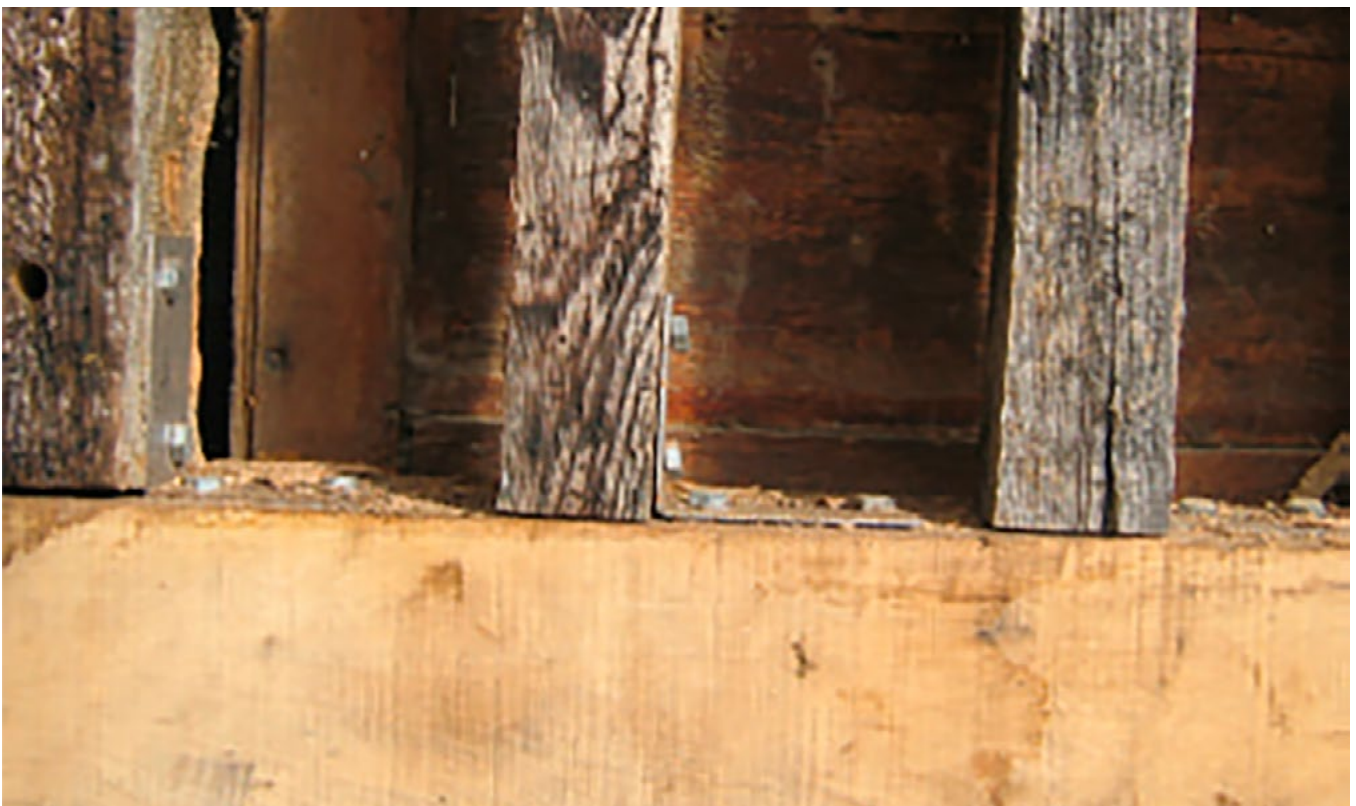
**Figure 4.5:** Steel angle cleats take the place of decayed tenons to fix studs to a newly inserted rail.

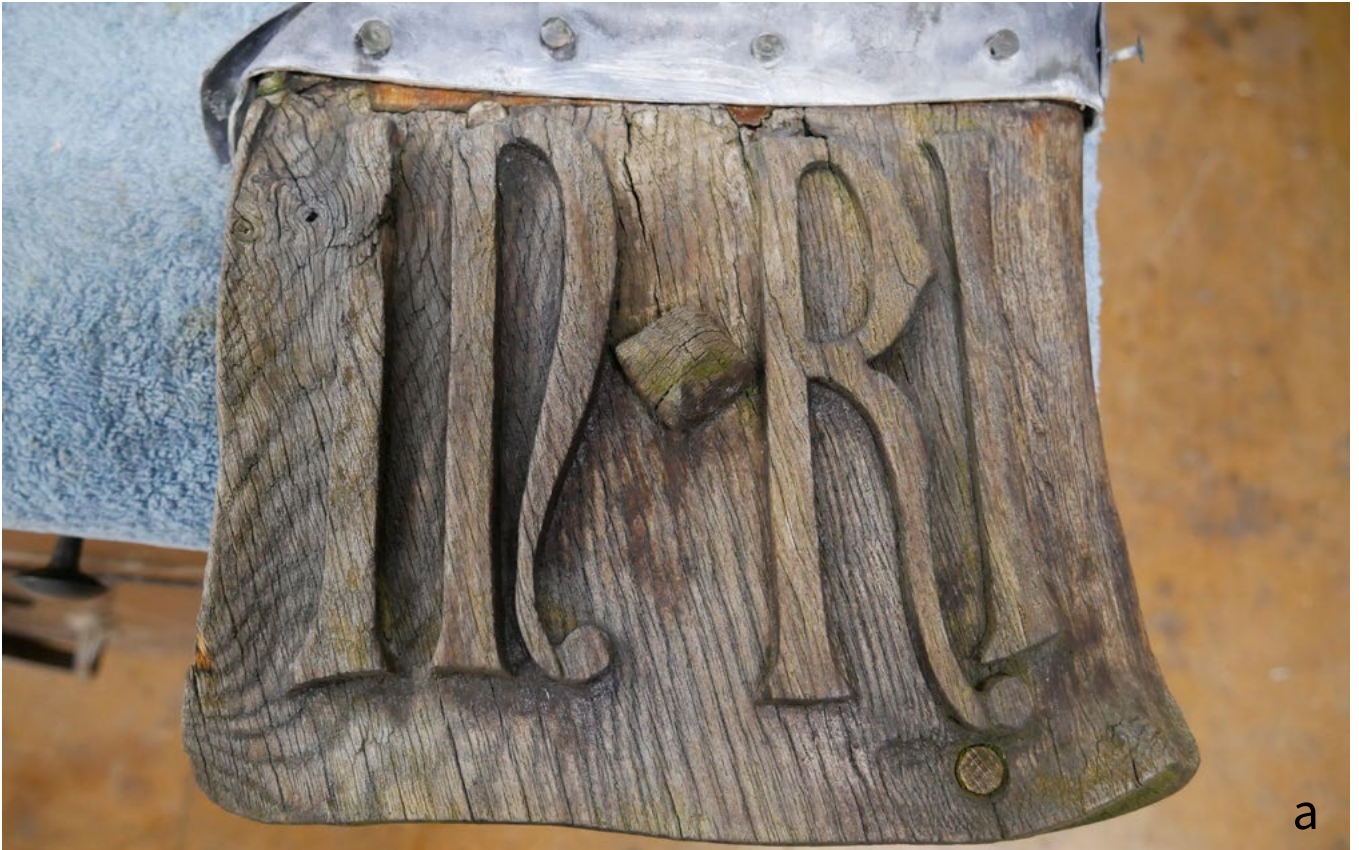
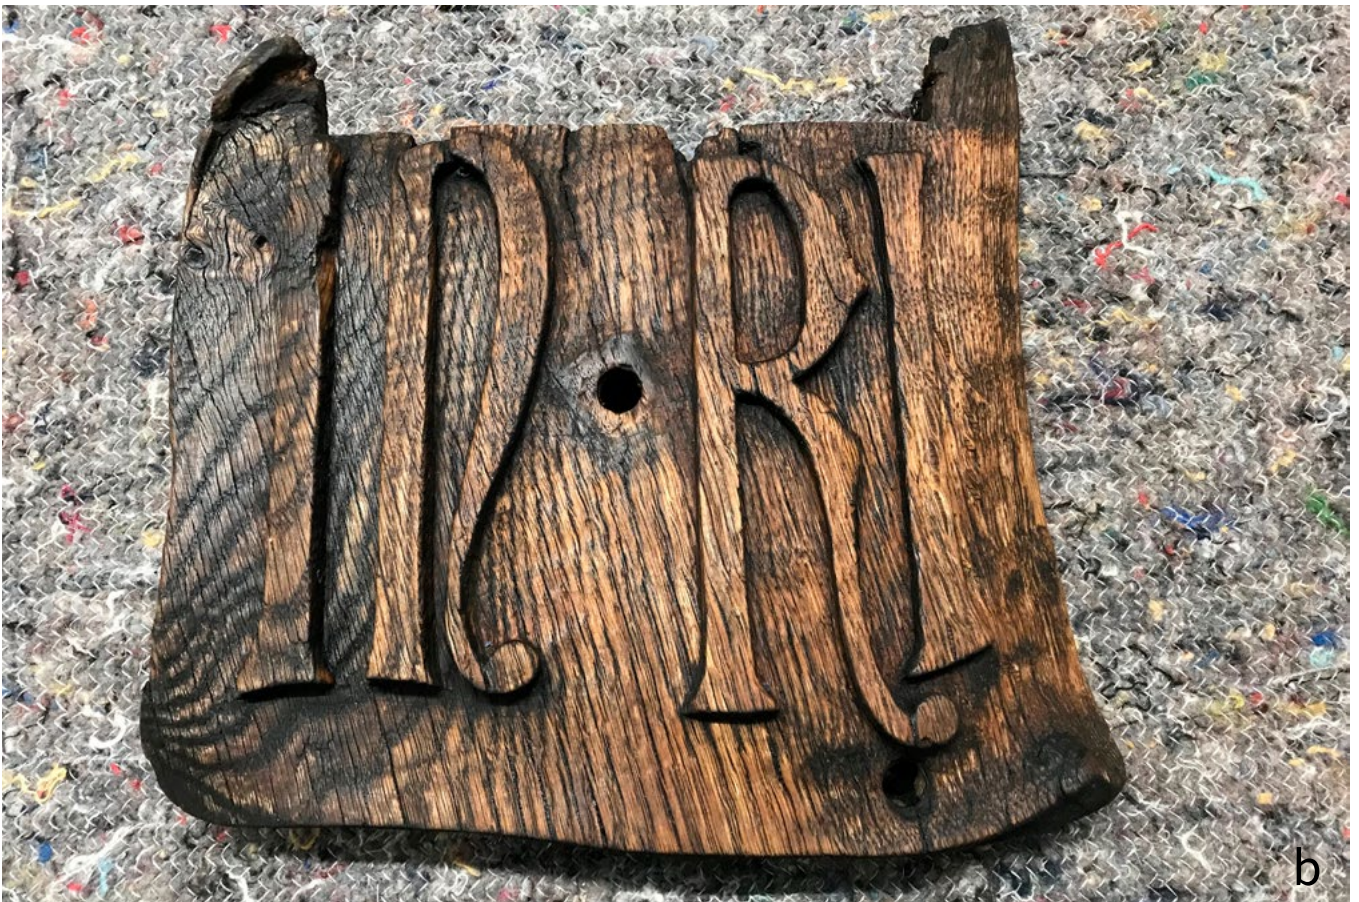
**Figures 4.6a and 4.6b:** An oak inscription panel before and after consolidation with an epoxy resin. There is some darkening in appearance, but the consolidation will increase the lifespan of the carved element.

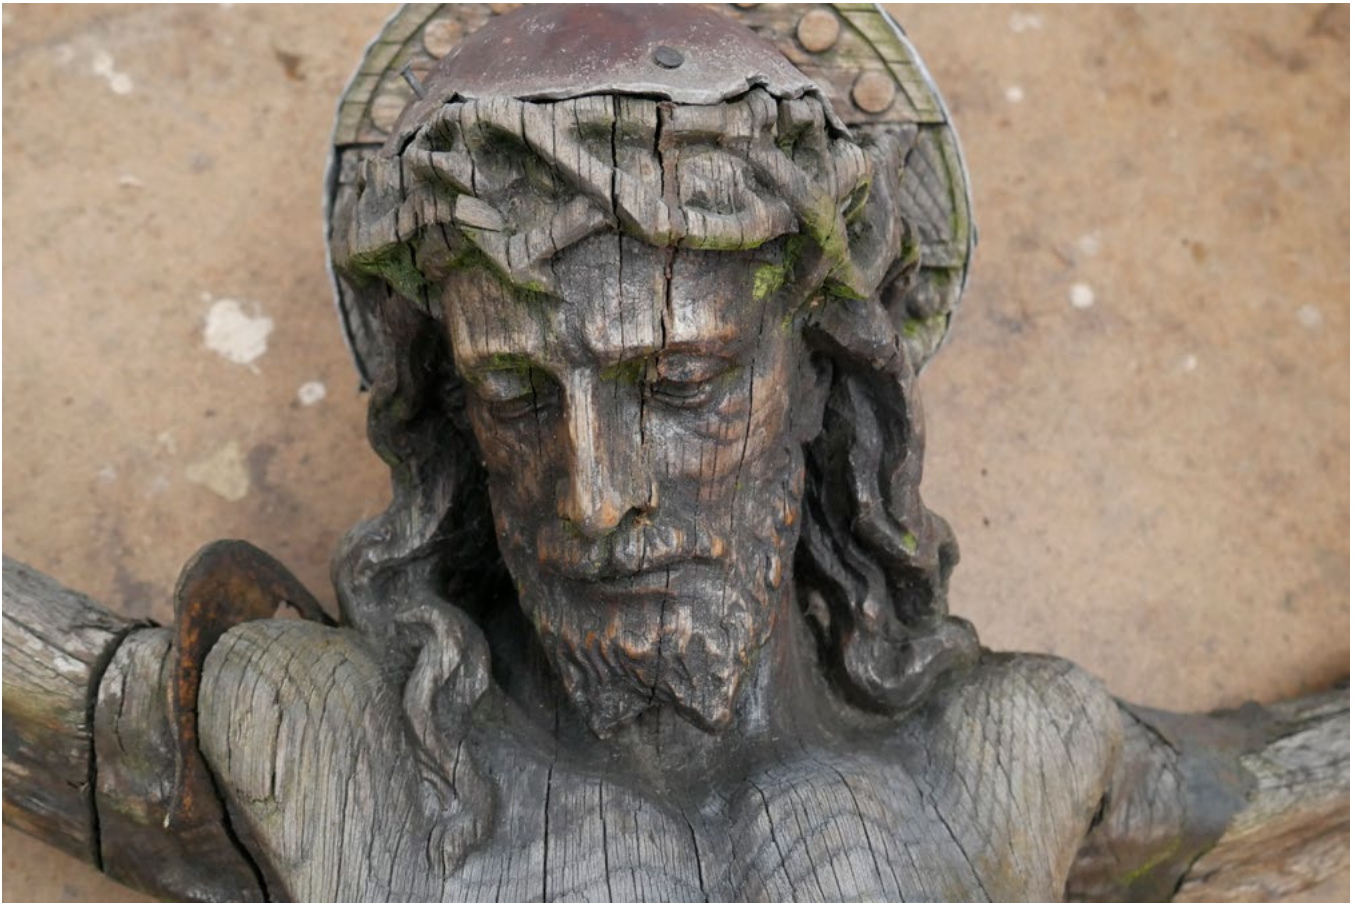
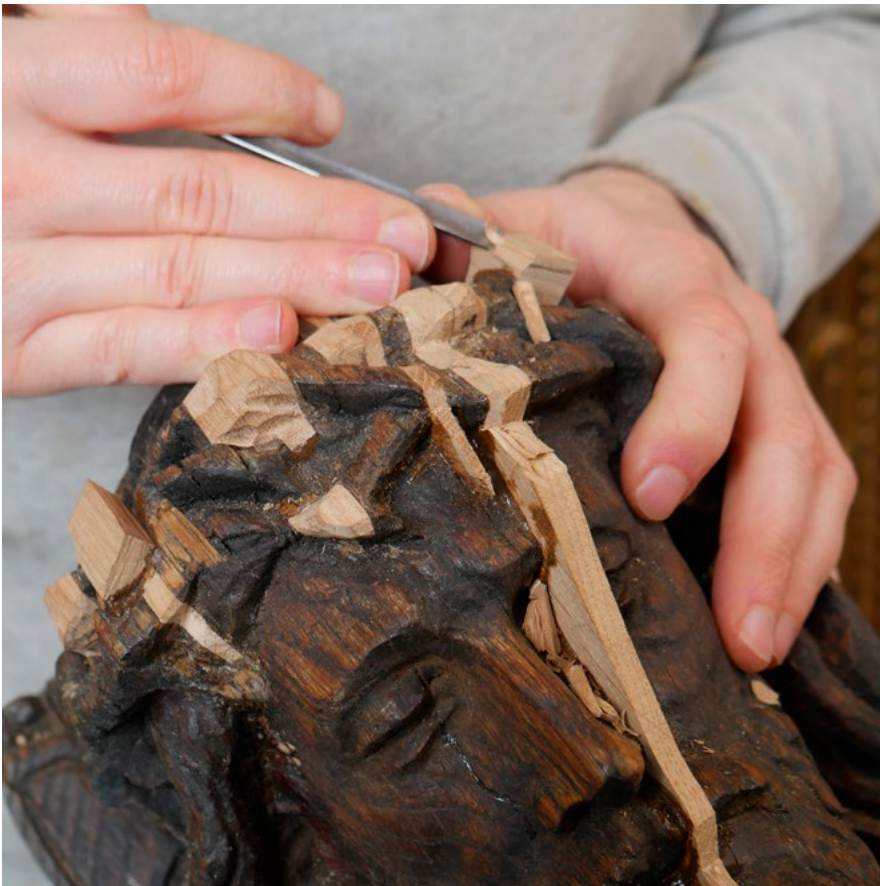
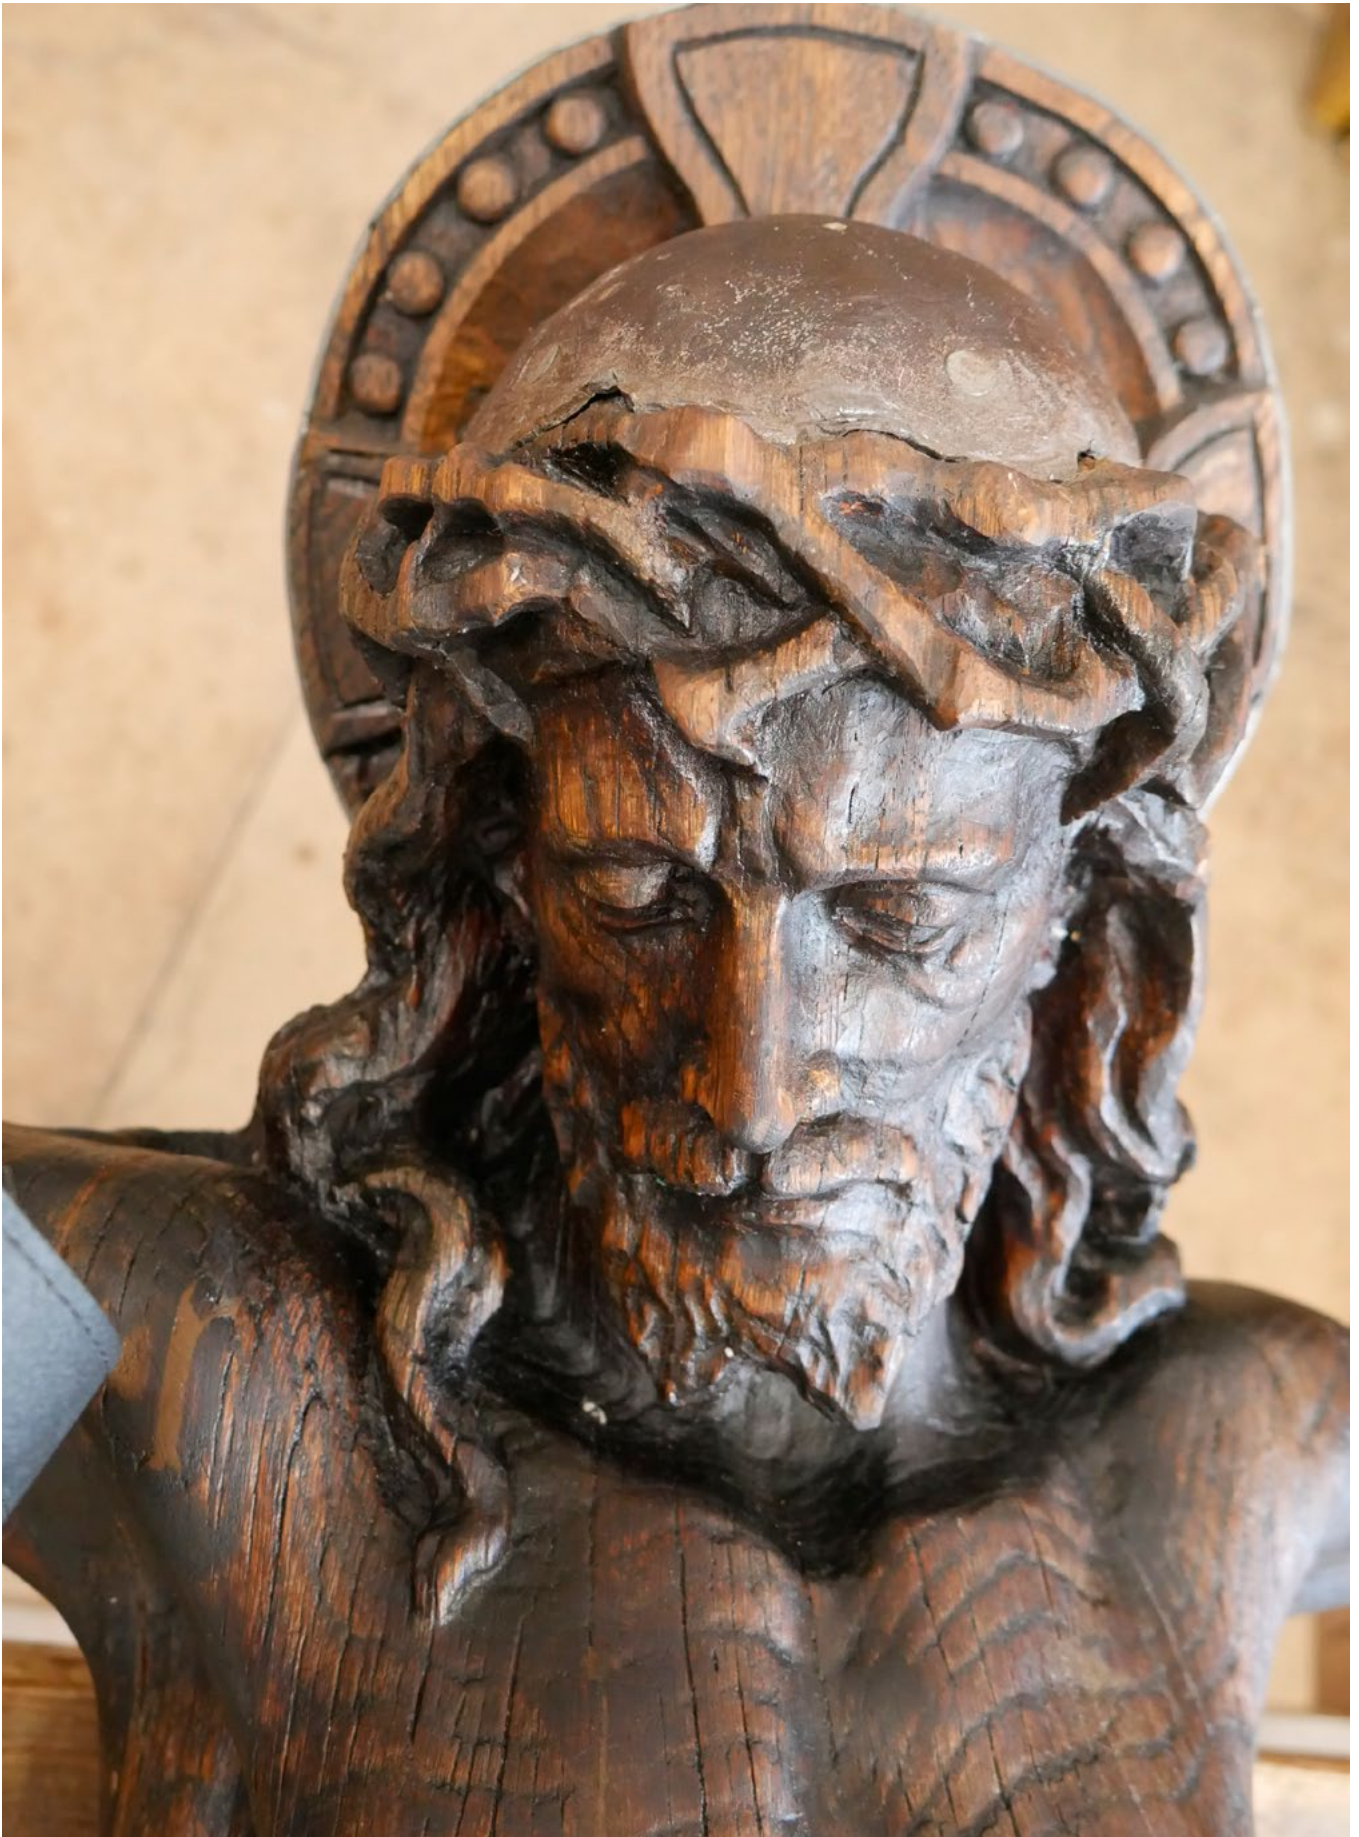
Figure 4.7 a, b and c Head of Christ before, during and after conservation:

a) The cracks in the head are wide enough to receive seasoned timber slips which are fixed with epoxy resin.

b) They are then trimmed and carved.

c) The surface of the completed piece finished with tung oil.
