# Conserving War Memorials

Timber Lych Gates, Shelters and Calvary Crosses

HEAG324

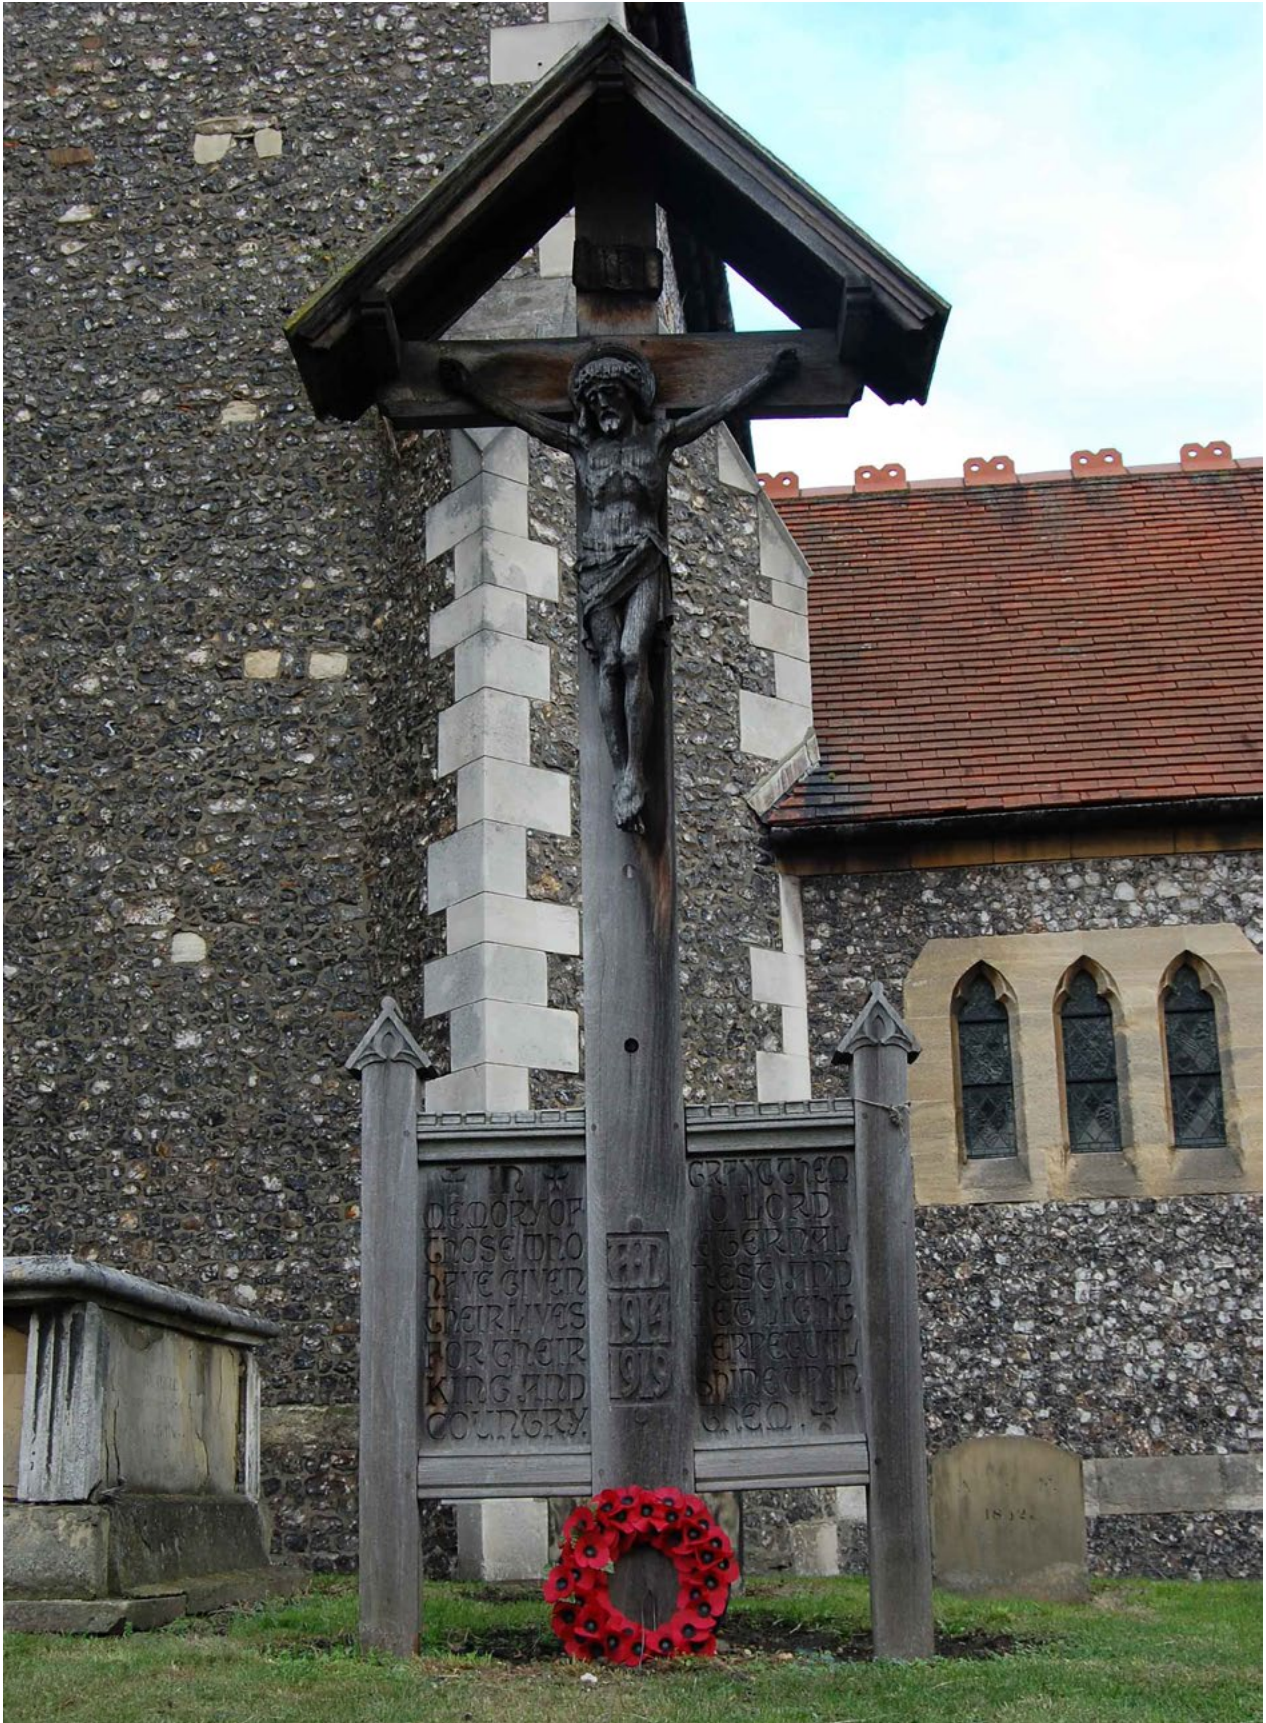
**Figure 4.8:** Calvary cross at St Giles' Church, Reading, Berkshire ([WMO/253679](#)). Commemorative names and text are integral to the significance of a war memorial and should, therefore, be legible. Here, the incised inscription could be made more legible if it was gently cleaned by hand.

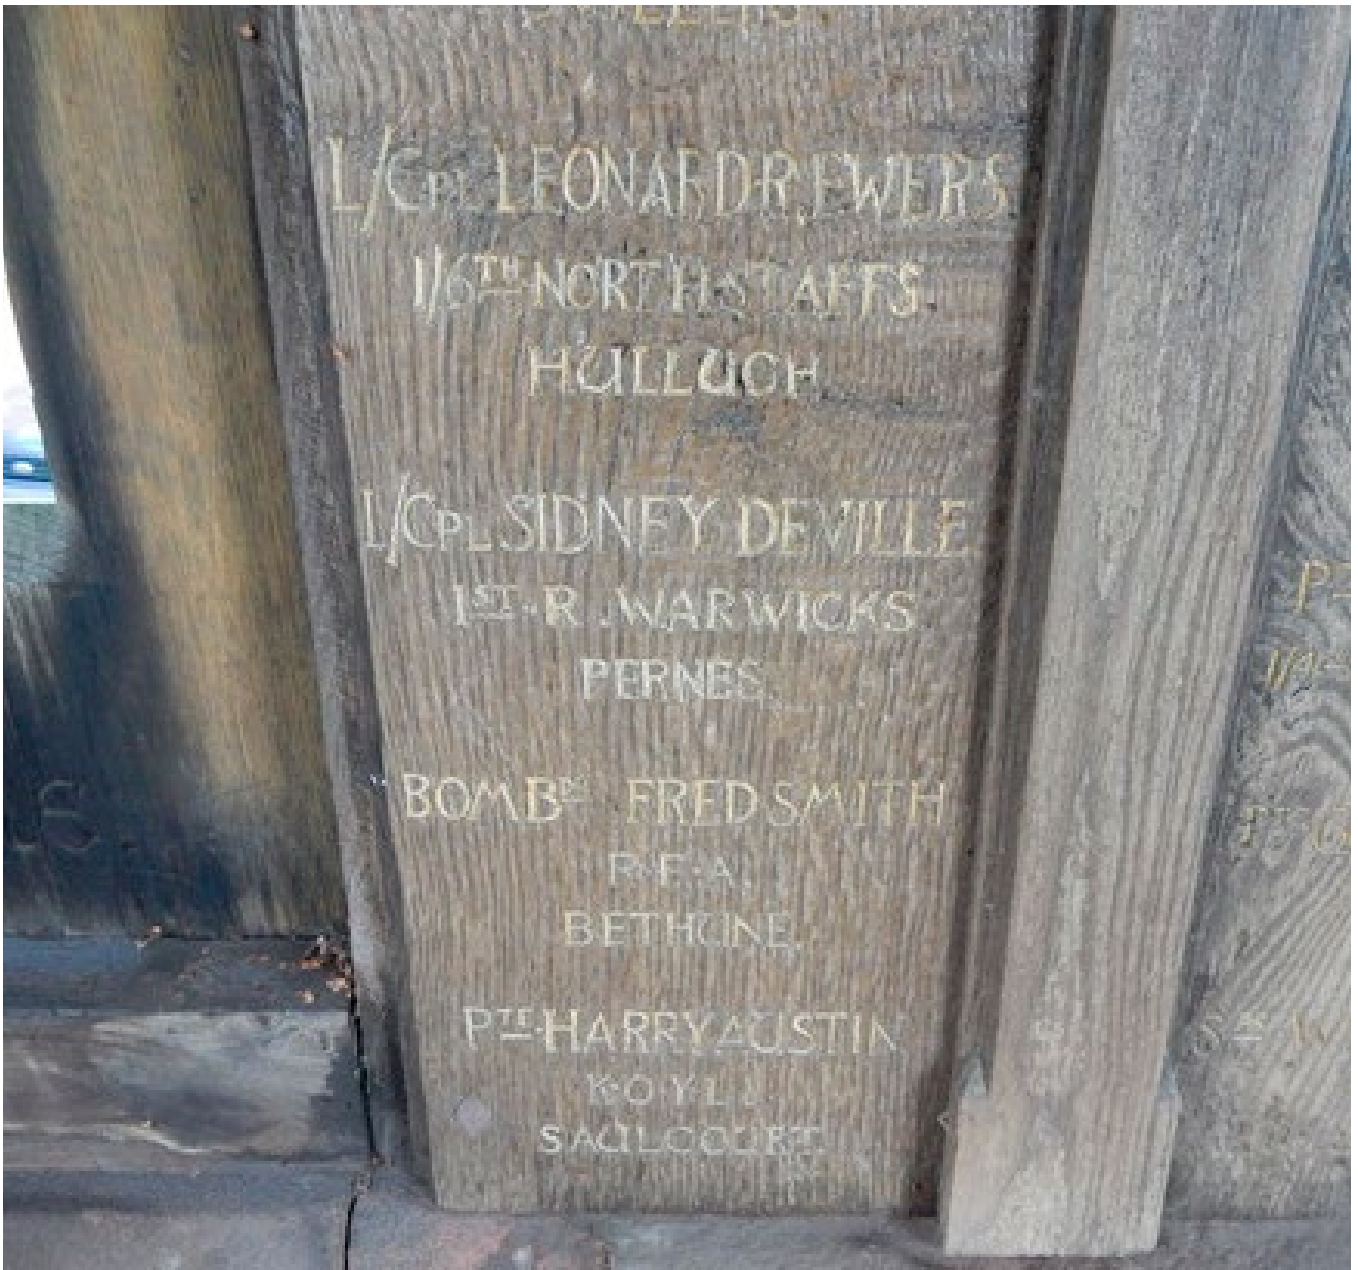
**Figure 4.9:** The incised names are legible even though the gilt has weathered away. Some maintenance of the surface would help preserve the timber and improve legibility. Re-gilding the letters may be an option.

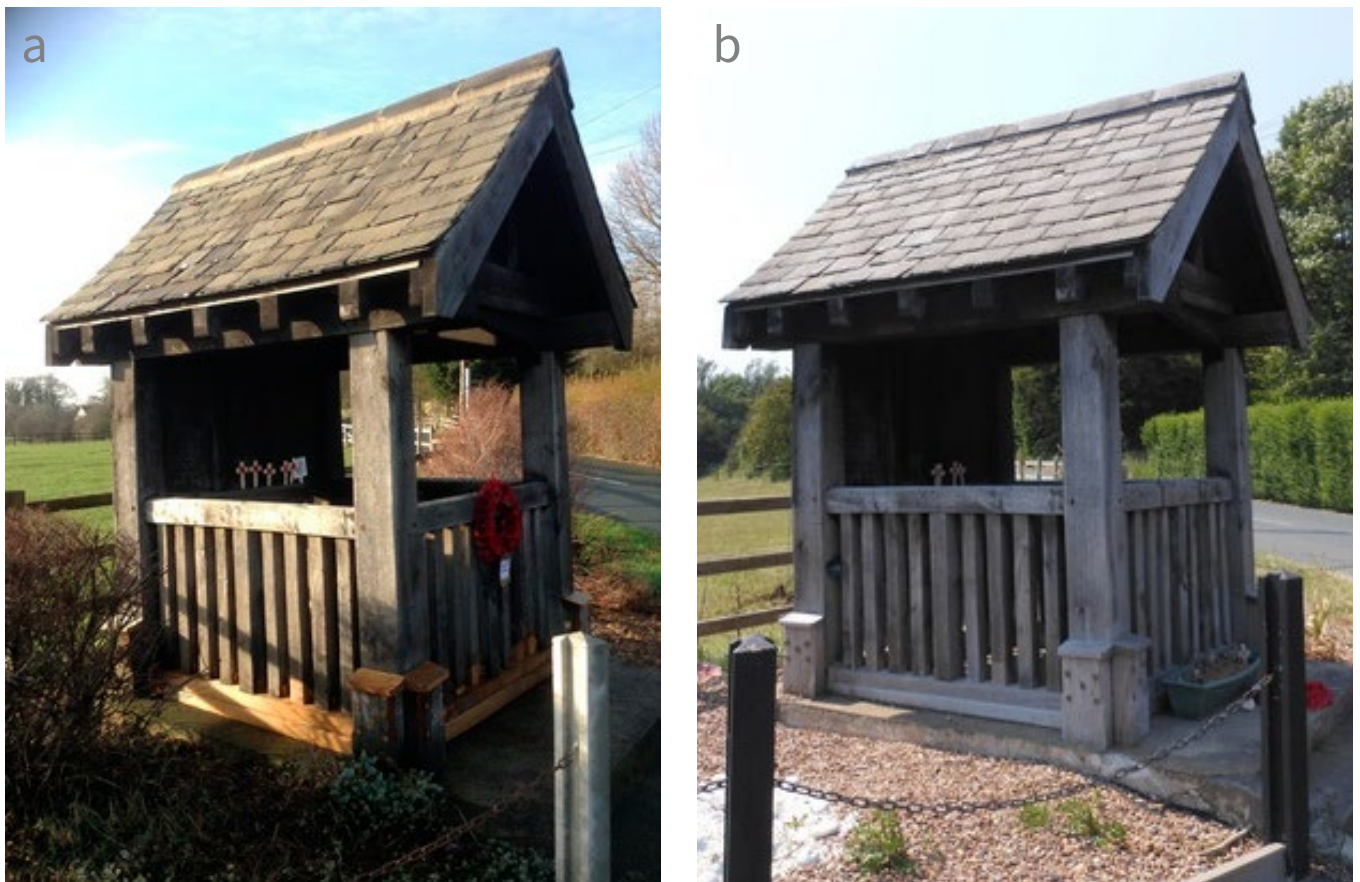
**Figures 4.10a and 4.10b:** Roll of honour and shrine, Burton Salmon, North Yorkshire (WMO/231096). Here, the sill beam and rails have been replaced with oak (a). Over a few years, these have weathered to closely match the originals (b).

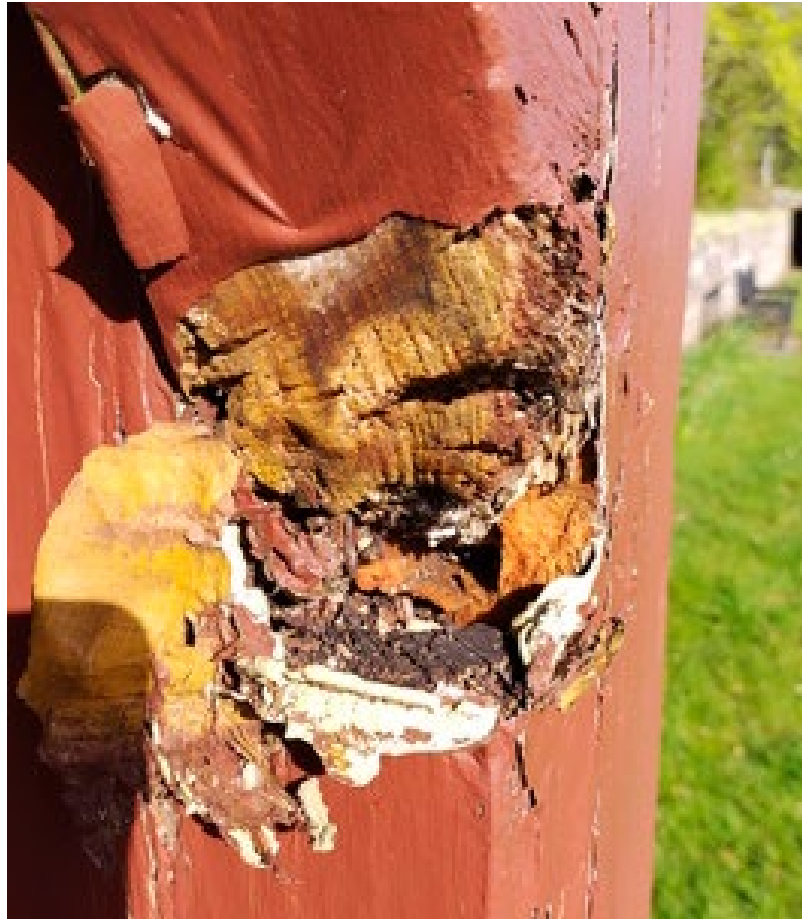
**Figure 4.11:** An impermeable paint has trapped moisture beneath it, causing the paint to peel and the wood to decay.

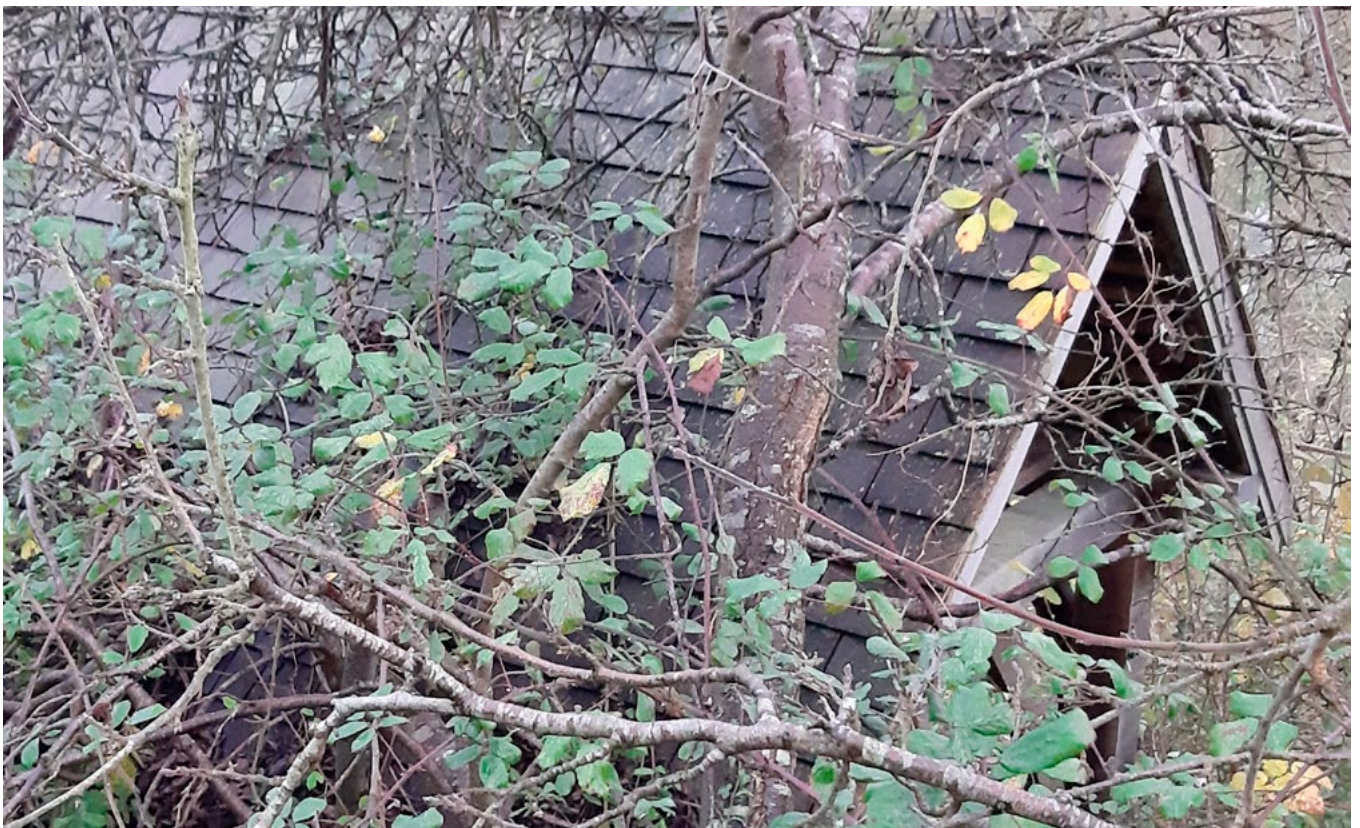
**Figure 4.12:** The branches of nearby trees have been allowed to encroach on the roof of this lychgate. They will increase moisture run-off and could cause structural damage if any of them were to break and fall.
