# Environmental Management Performance Standards

*Guidelines for historic buildings*

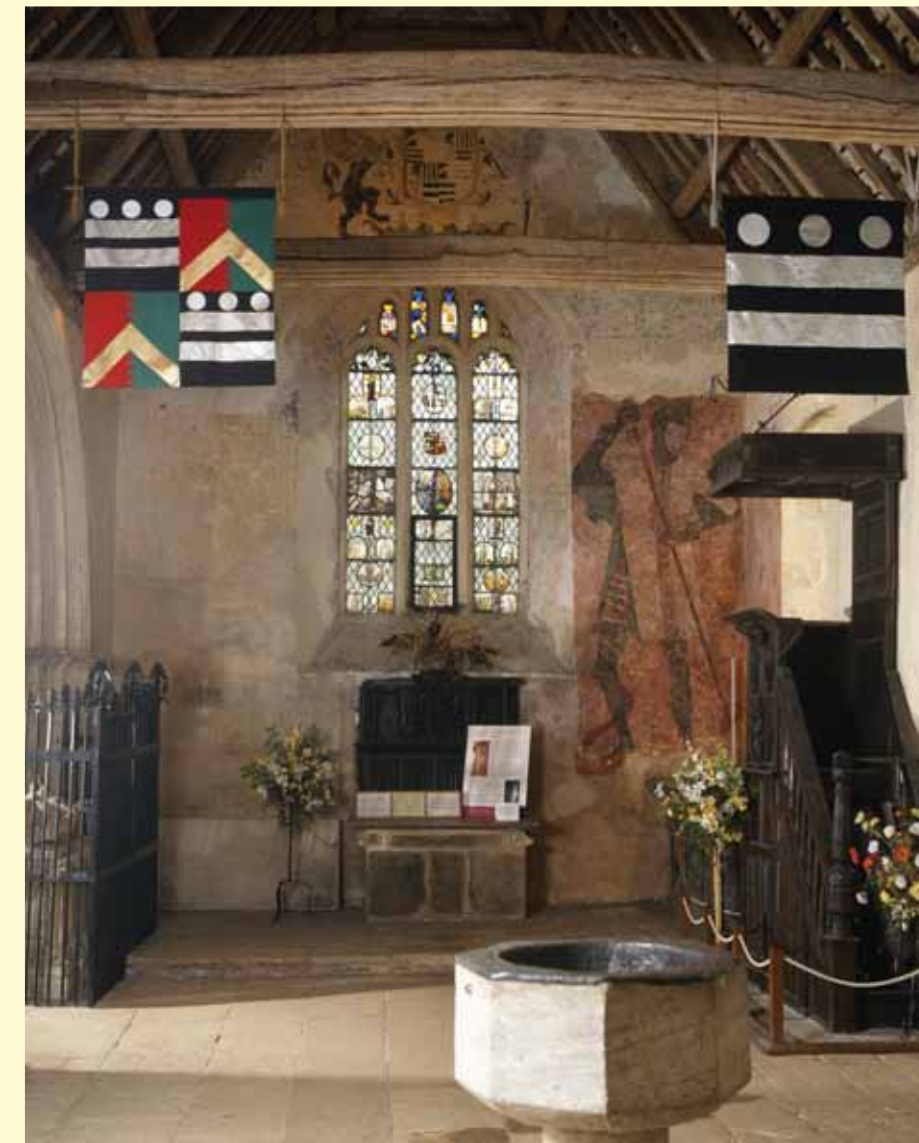
Fig 2 East end of the chapel including wall painting of St George.

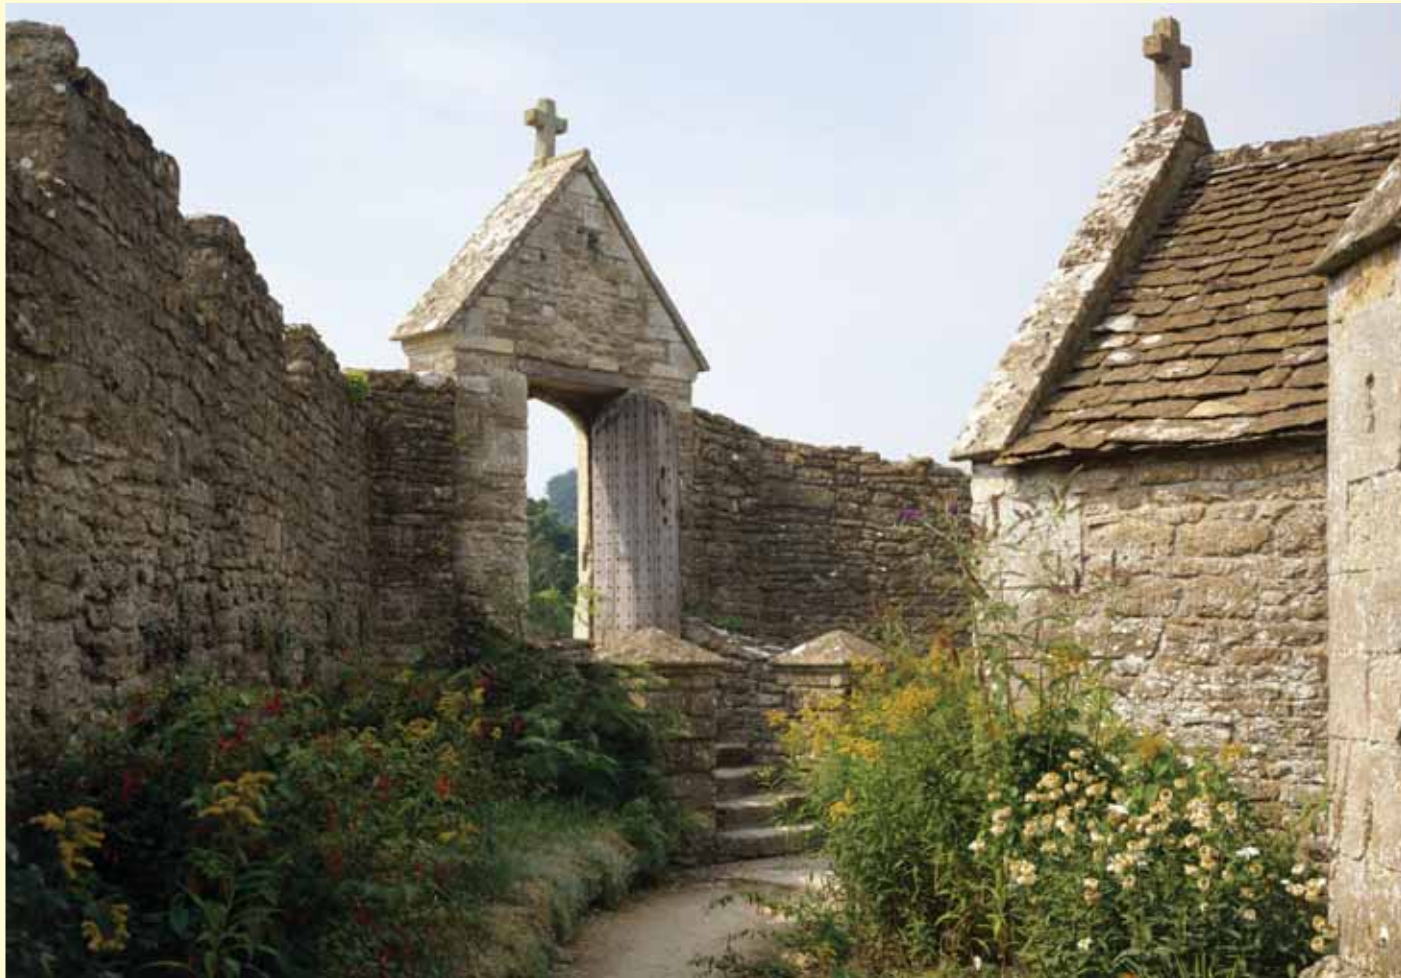
Fig 3 Enclosure around Chapel of St Leonard, showing ground sloping towards the chapel.

*Maintenance in context:* Maintenance of the chapel cannot be restricted to just the visible structure when the condition of the land around it and the underground drainage are so critical to its well-being. The chapel is situated in a hollow surrounded by a battlemented retaining wall. This creates a local context for the building. Vegetation and silting of the drains are critical issues for the chapel's maintenance. A regular programme of preventive maintenance is necessary to reduce water ingress into the walls. Gullies must be kept clean and free from vegetation if they are not to retain liquid moisture and cause damp penetration. This building has a gully along the west wall.

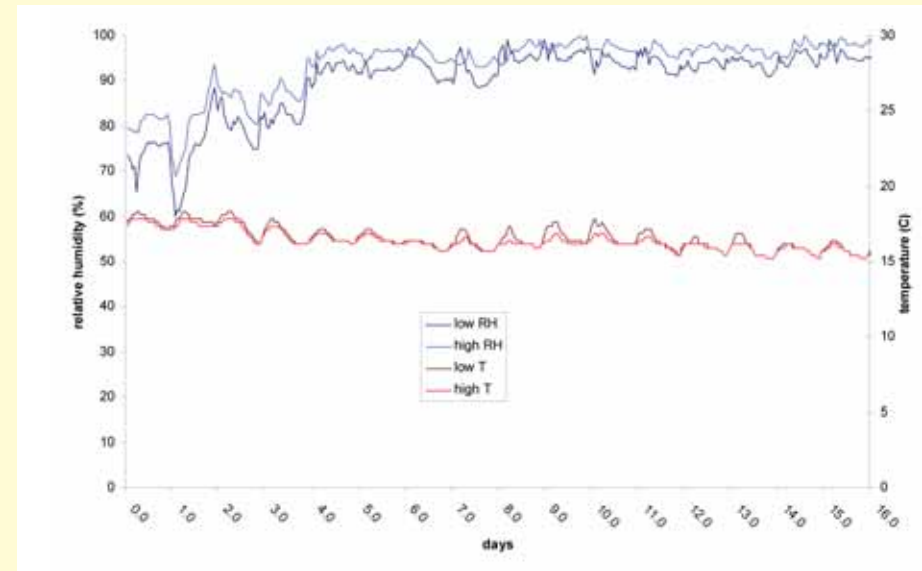
Fig 4 Relative humidity (RH) and temperature at low and high level at the wall-painting surface.

Diagnostic monitoring is continuing at St Leonard Chapel with the purpose of understanding the effectiveness of the new insulated roof of the chapel. Vertical profiles of conditions are being recorded at intervals from the roof to the ground in the south-east corner of the chapel in which the St George and the Dragon wall painting is located. Dependent on the results of these records, monitoring decisions will be made on the need and design of any permanent system of monitoring.

At St Leonard Chapel, the diagnostic investigations identified that rapid exchange of moisture-laden external air through gaps in the roof, exacerbated through keeping the west door open throughout the day, resulted in periods of prolonged condensation as the air came in contact with cold internal surfaces. Immediate improvements were achieved

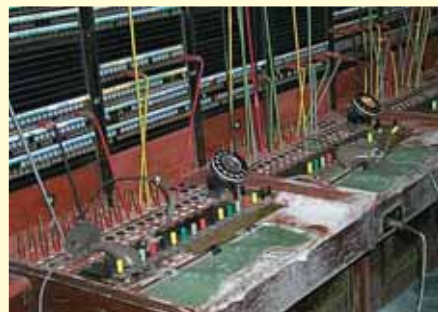
Fig 10 (above) Mould growth on telephone exchanges and under plotting table.

turn off the fans in the Casemate level and to rely on natural ventilation, prompted by the continued mechanical failure of that plant. In 2001 a spectacular outbreak of mould growth in those tunnels occurred, which appeared to be the result of this action. Investigations were undertaken to understand and solve the environmental problems.

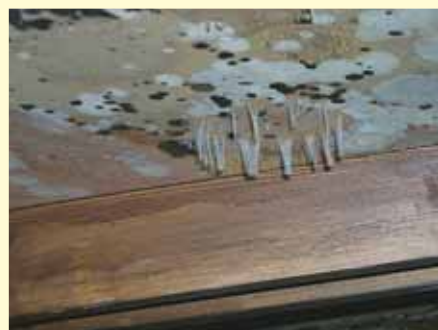
Fig 11 (right) Mould growth on telephone exchanges and under plotting table.

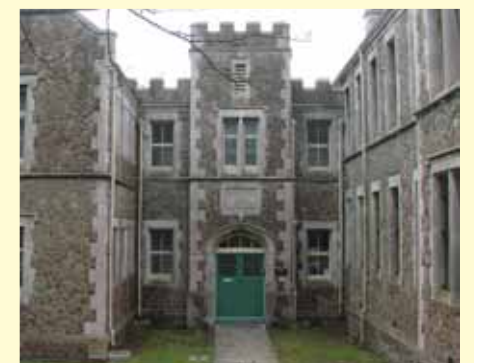
Fig 14 (left) The Royal Garrison store at Dover Castle. Fig 15 (above) The enclosed entrance at the barracks creates a wind vortex, which deposits wind-driven rain onto these walls. Therefore, no collections are stored inside (on the opposite side) directly against these damp walls.

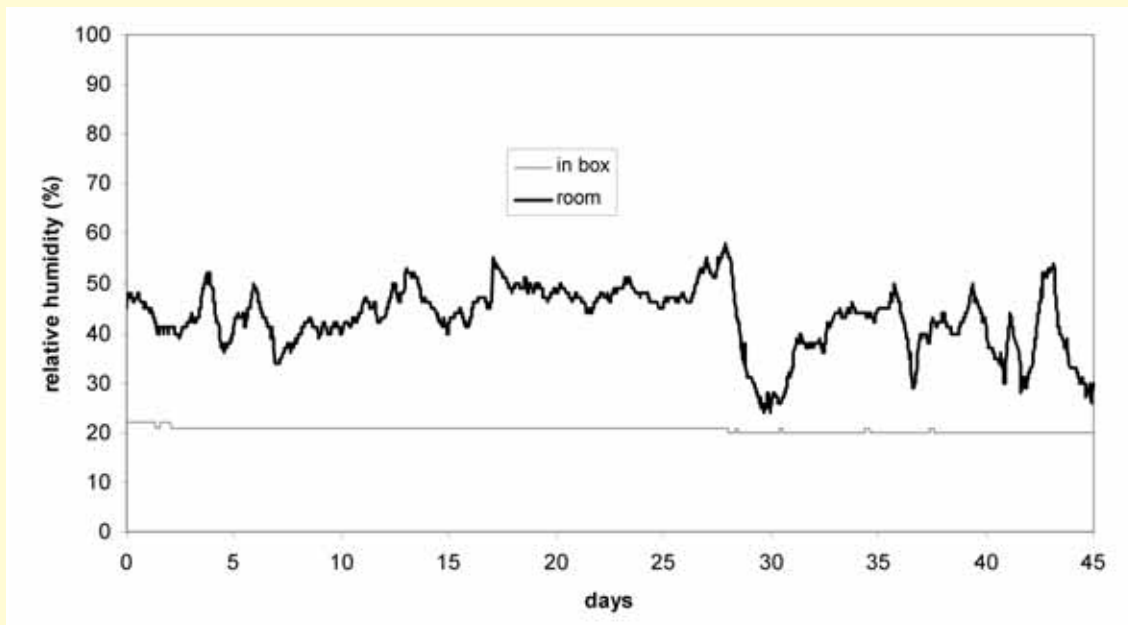
**Fig 16** The relative humidity (RH) inside polypropylene boxes is reduced to below 30% by the addition of sufficient dried silica gel. The room RH is kept below 50% with a dehumidifier, which significantly extends the period between changes of the silica gel.

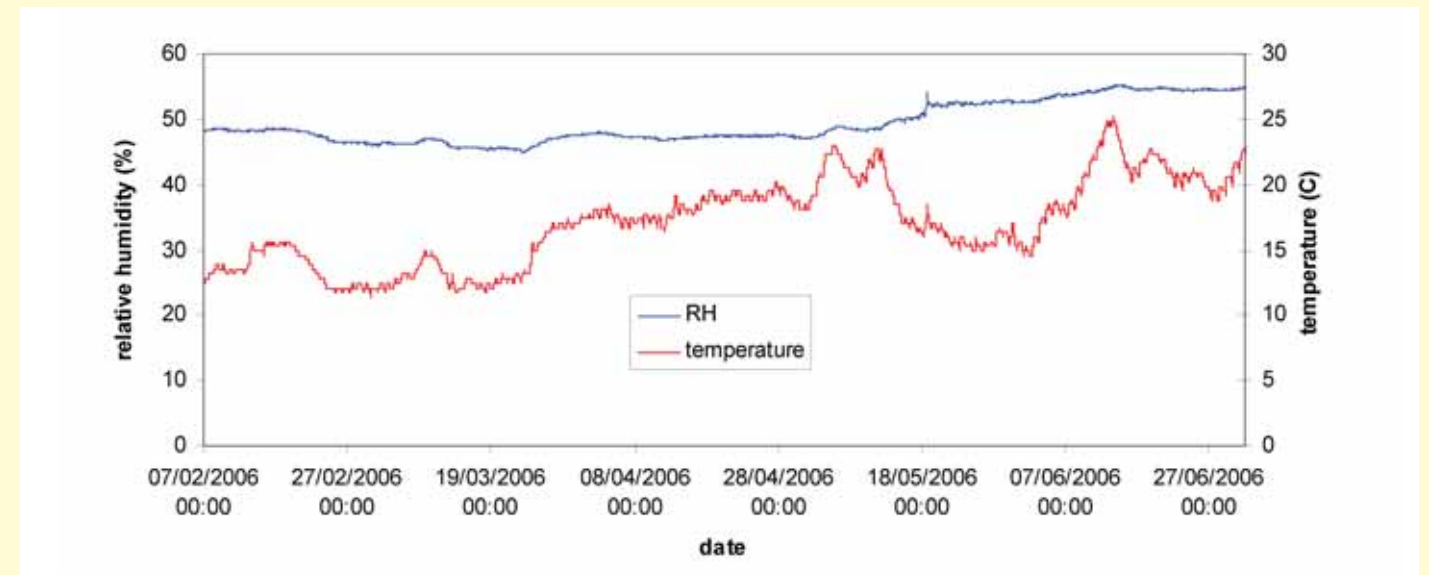
**Fig 17** The relative humidity (RH) in the archive room is adequately controlled with a manually adjusted radiator, turning it up or down depending on the reading from the radio-telemetry monitoring system, the silica gel.

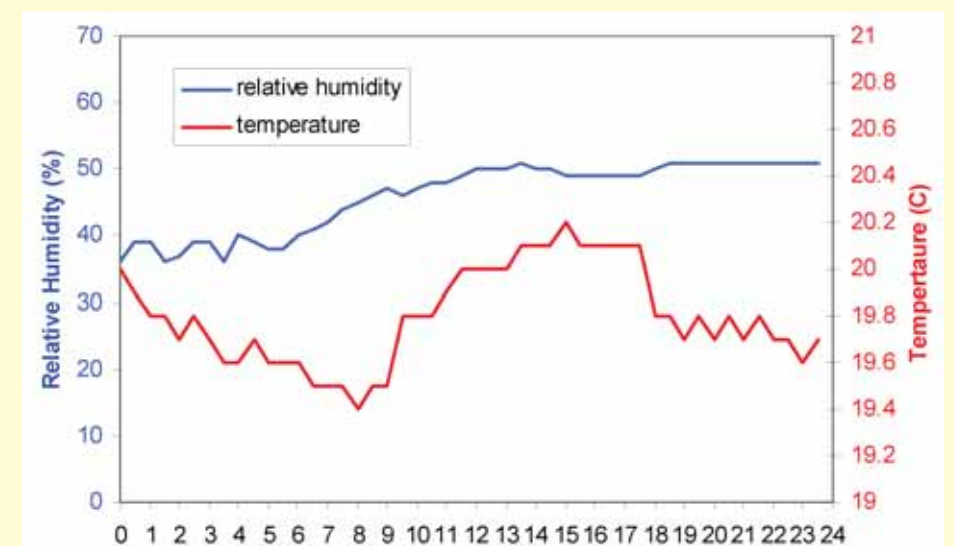
Fig 21 (bottom) A day at Chiswick House with normal opening for comparison.

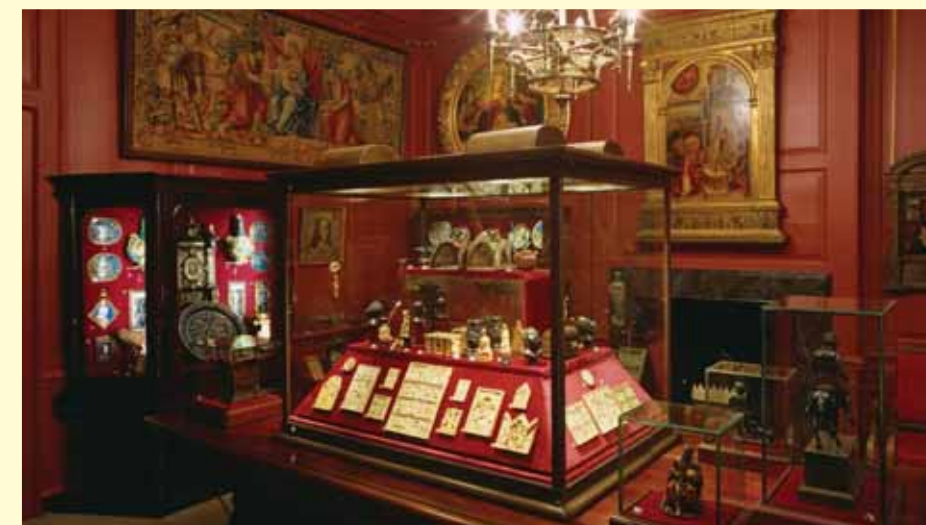
Fig 24 Showcases at Ranger's House. The design is based on the showcases originally commissioned by Julius Wernher for his collections.

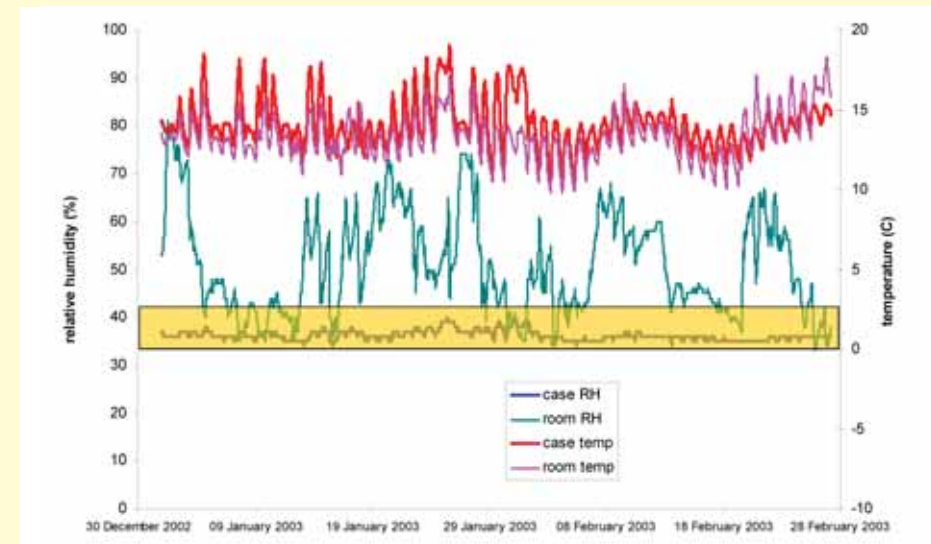
Fig 26 Conditions in a showcase with Limoge Enamels and in the room.
