Groundwell Ridge Villa Analysis Project.
Pr 3641

December 2007 (Update 5)

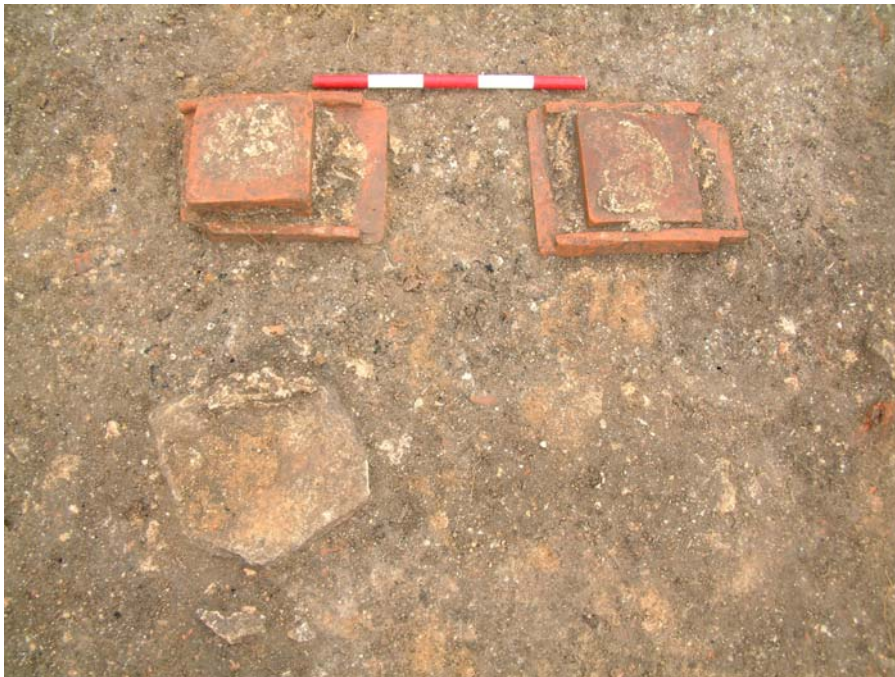
Tegulae, Bessales and a stone tile *in-situ* in Room 4

The first job was to assess the type and quantity of the ceramic building materials and then to look for any defining maker's marks which can indicate such things as the date and place of production and even the manufacturers names. Unfortunately nothing so helpful has been found, so fragments are being studied to see if the place of production can be ascertained from the type of clay and pieces of stone within it and whether the date can be judged from the style of the tiles.

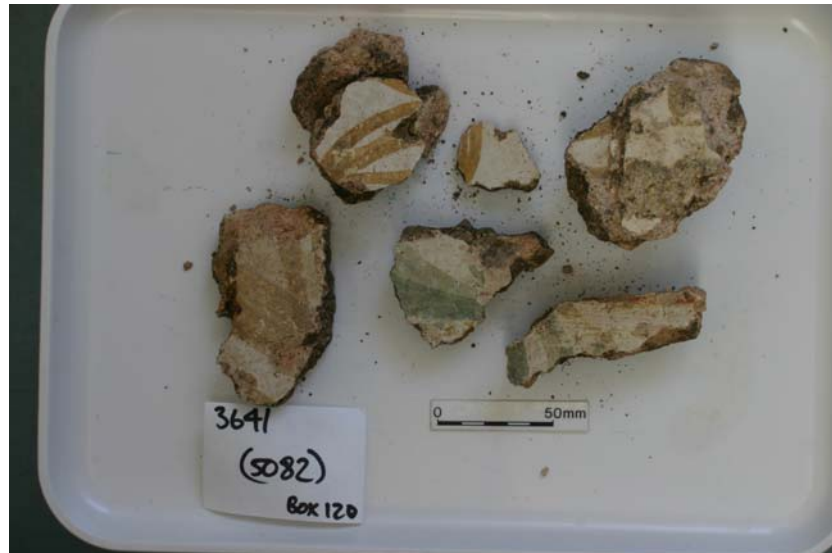
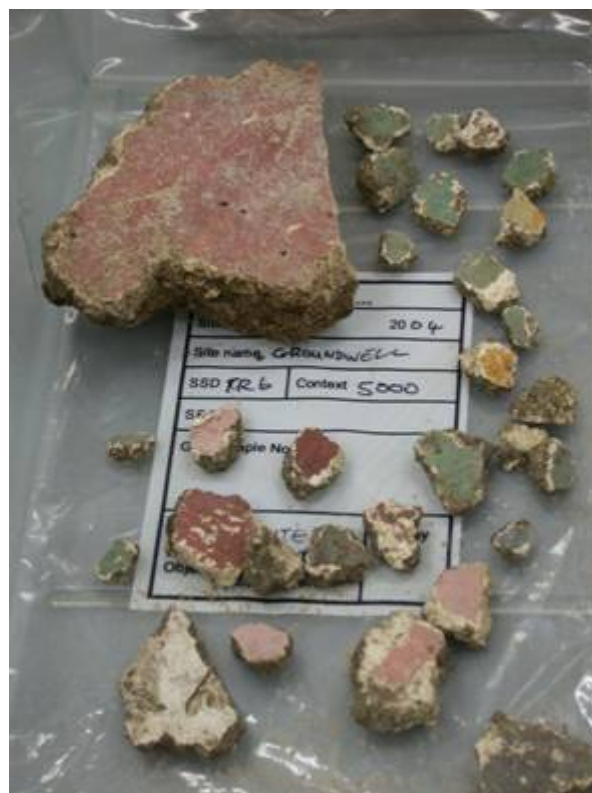
Two images showing part of the range of colours of wall plaster found on the Groundwell Ridge site.

Much wall plaster has also been found from the building which is made up of at least seven different colours. Not many of the fragments are of any real size, and most are

plain white or white and red, but some possible patterns of flowers in yellow and green and geometrical shapes, which may be the borders of panels of colour, have been discerned on some. It is hoped that by plotting the prevalence of the different coloured fragments of plaster by where they were found some idea may be gained of the internal colour schemes of the villa.
