# The Hadrian’s Wall Milecastles Project: 1999–2000

by Tony Wilmott

### The numbering and structure of the milecastles

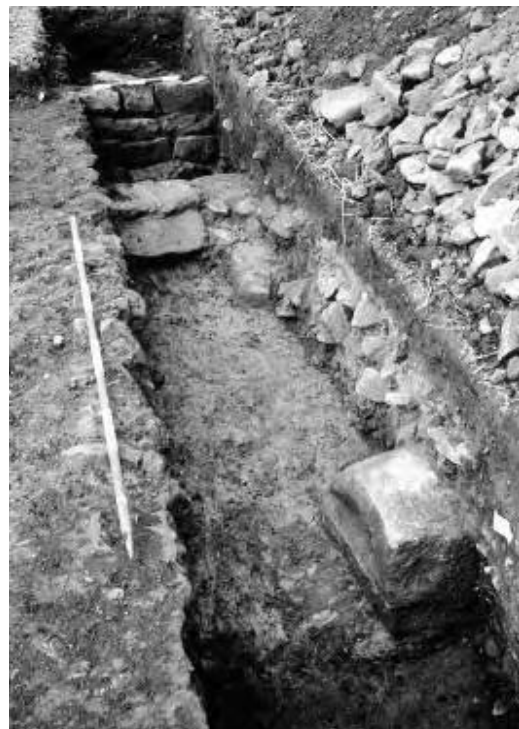
Fig 240  
Milecastle 9: view west  
along trench showing  
exterior milecastle wall,  
and wall of internal building.

The wall of an interior building was found 1.02m west of the east face of the east wall of the milecastle (Fig 240). This building was clearly the primary stone structure found by Birley in 1929. The wall (1218) survived to a height of three courses (880mm). It was built of clay-bonded coursed rubble, with a clay core, and was 540mm wide.

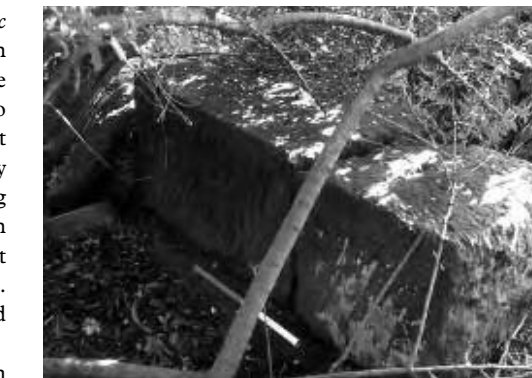
Fig 245  
Milecastle 10: photograph of the north-west pier of the north gate in its present state (photograph by P Hill).

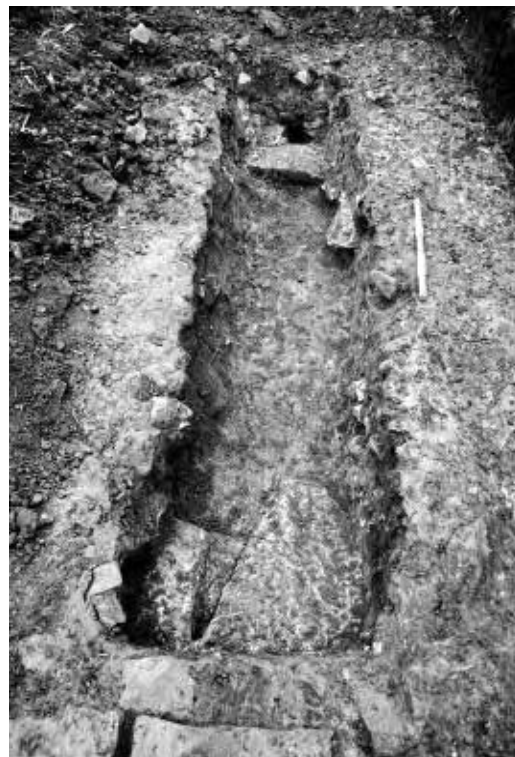
Fig 248  
Milecastle 10: photo of  
Trench 1 showing section  
through robber trench and  
surviving wall face.

Within Trench 1 a north-south linear feature (410, fill 411) proved to comprise a robber trench 2.98m wide for the external western wall of the milecastle (Fig 248). On the eastern side of the trench the bottom course of facing stones for the interior face of the wall were found *in situ*, while on the western side similar stones, albeit disturbed, might have comprised the remains of core work. The trench did not extend far enough to reveal the facing stones of the outer face. The construction trench for the wall

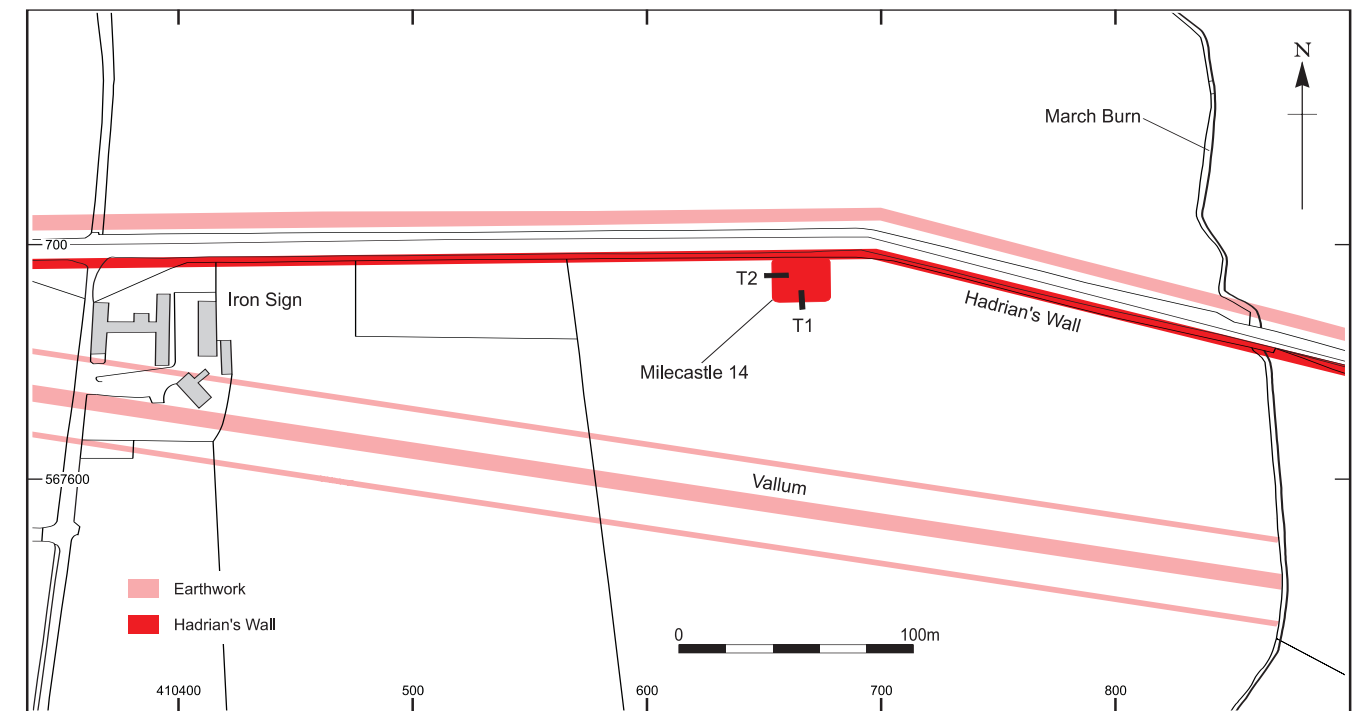
Fig 252  
Milecastle 14: Mc14 and  
excavation trenches shown  
against modern mapping.

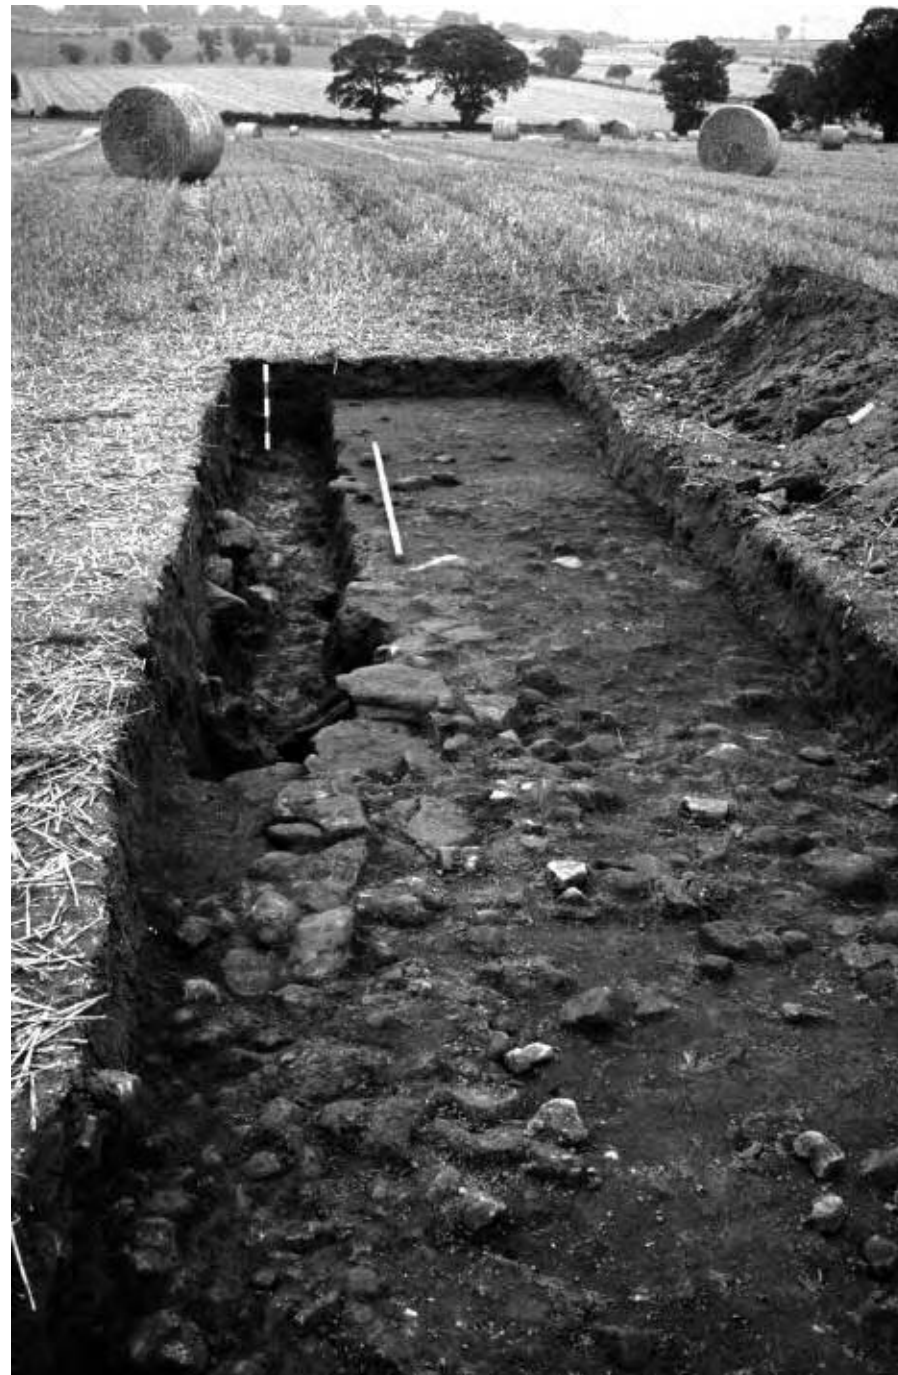
Fig 254 (above, right)  
Milecastle 14: trench 1  
showing section through  
robber trench.

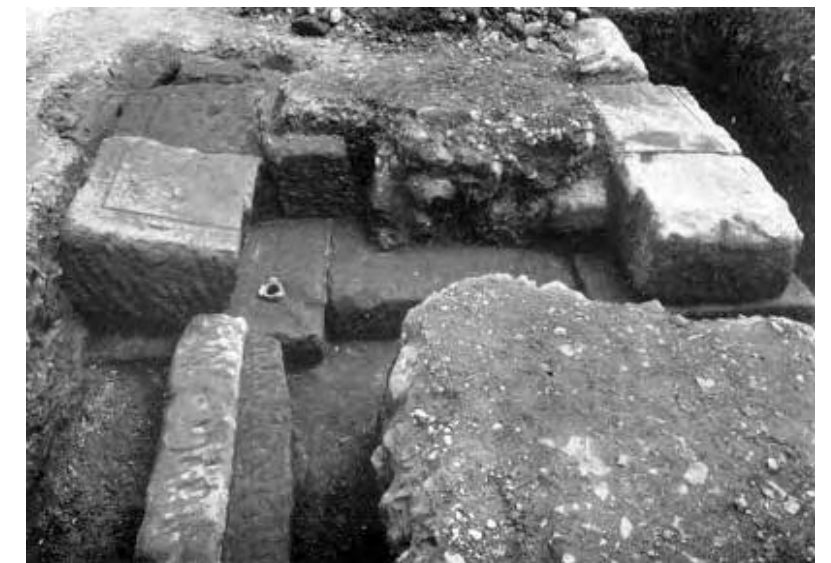
Fig 259  
Milecastle 17: photograph of north gate excavated in 1931 (Birley *et al* 1932).

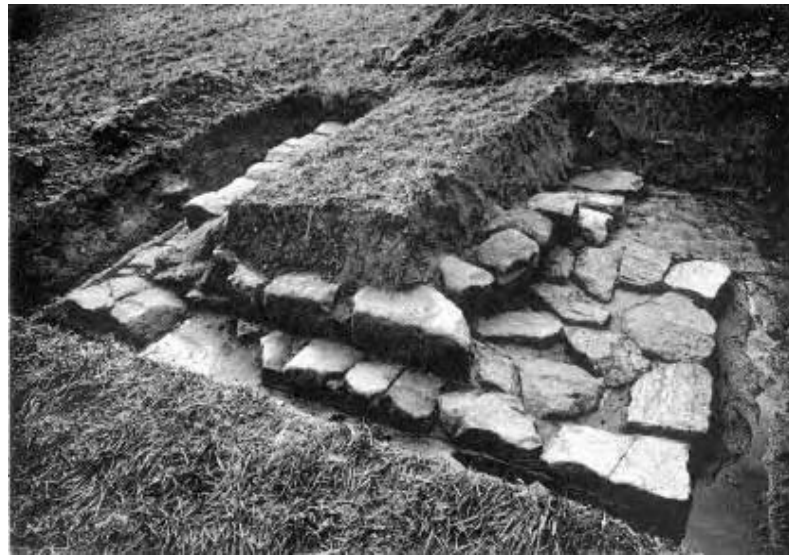
Fig 264  
Milecastle 19: photograph of south gate excavated in 1935 (Simpson et al 1936b).

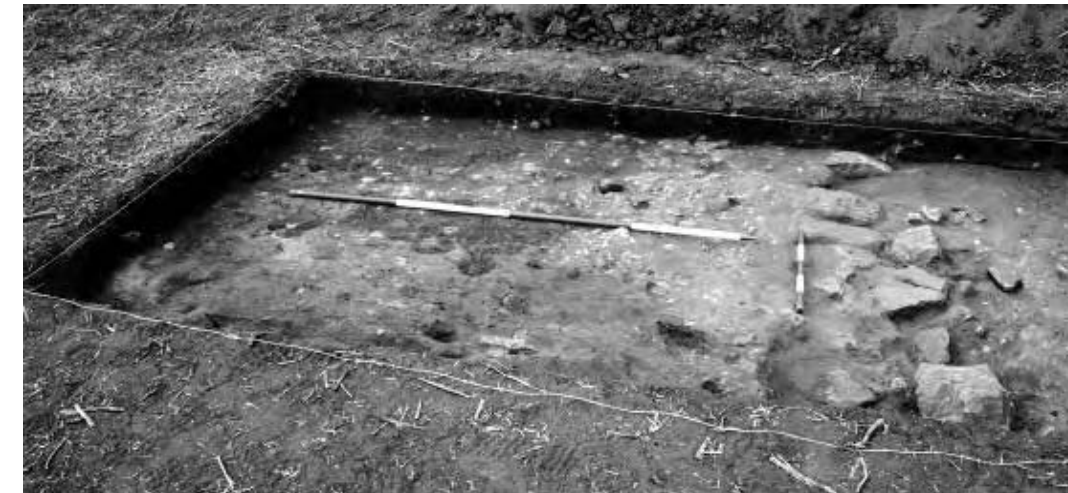
Fig 266  
Milecastle 19: Trench 1 from south showing floor surfaces and wall of internal building.

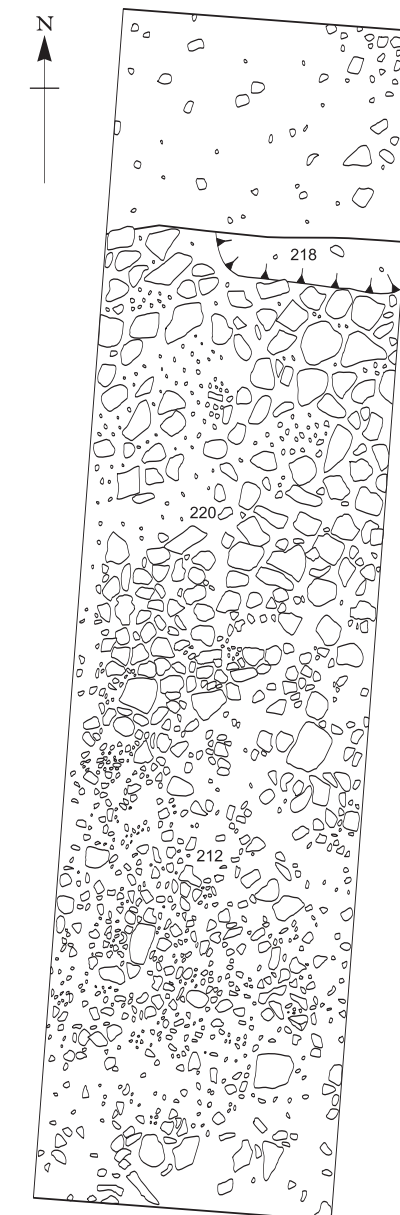
Fig 268  
Milecastle 19: rubble  
surface in Trench 2.

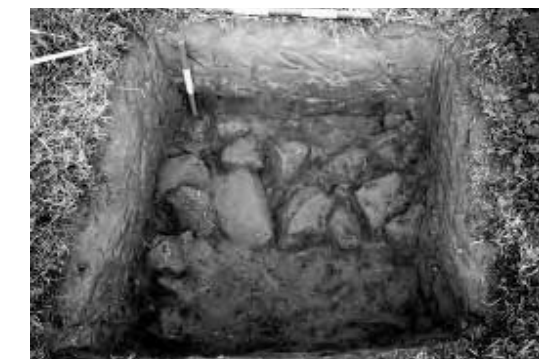
Fig 273  
Milecastle 62: wall footing  
in test pit 1.

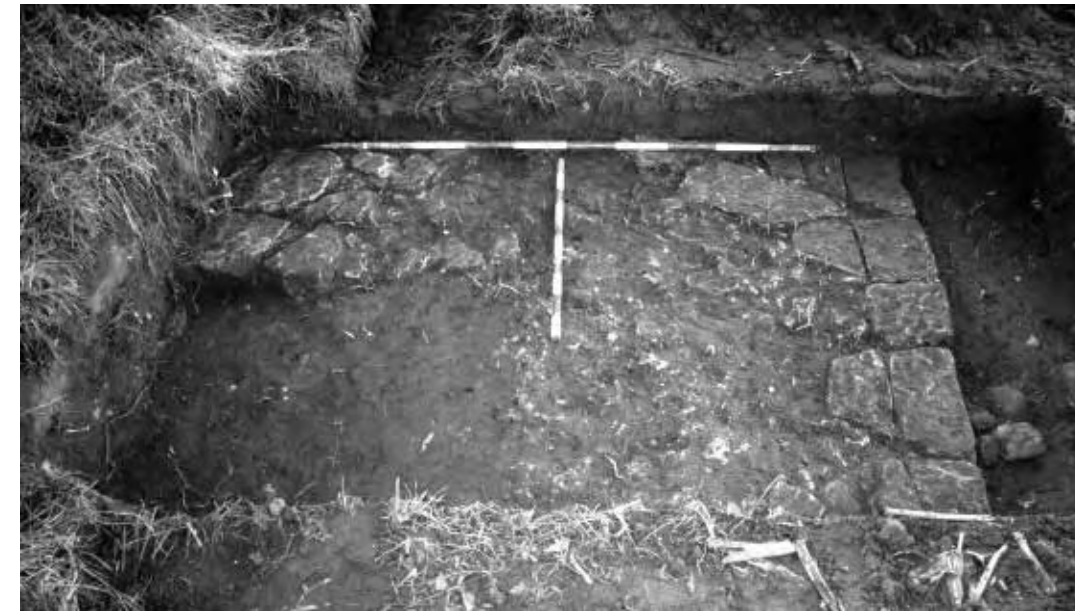
Fig 276  
Milecastle 63: flagstone foundation course of Hadrian's Wall in trench. Note the linear crack marking the offset of the north wall face with the flag foundation course.

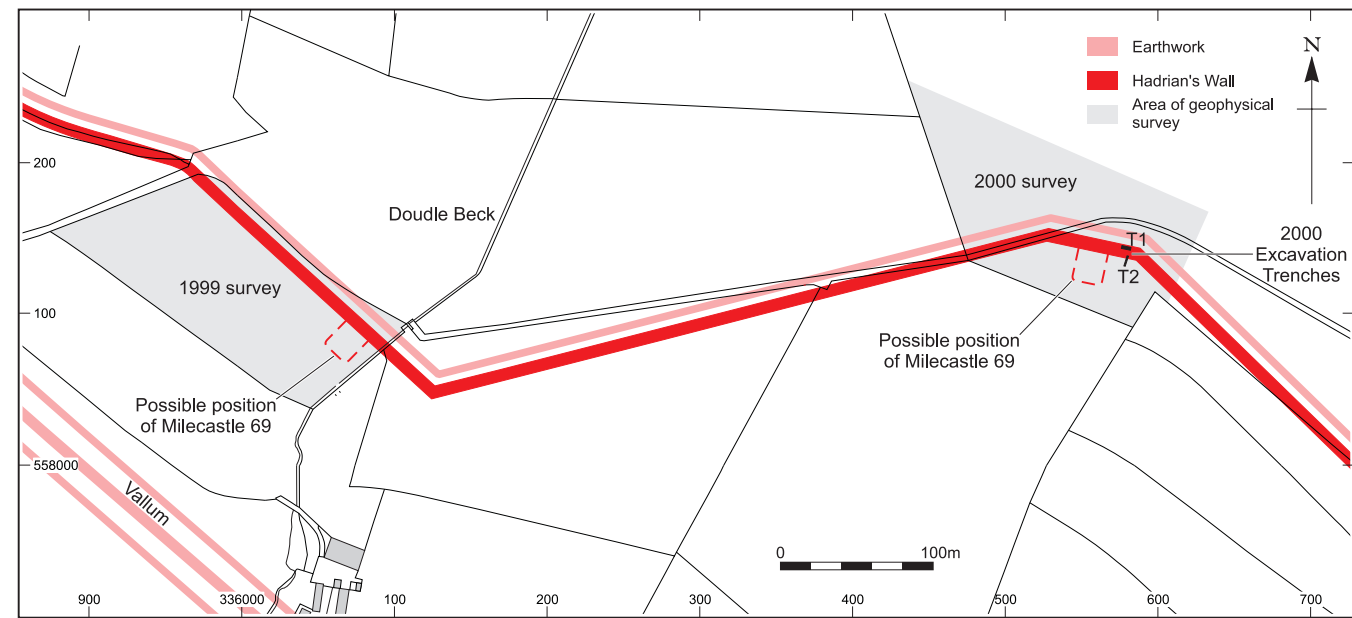
Fig 278 (above)  
Milecastle 69: alternative sites for Mc69, showing the extent of geophysical survey and the location of evaluation trenches.

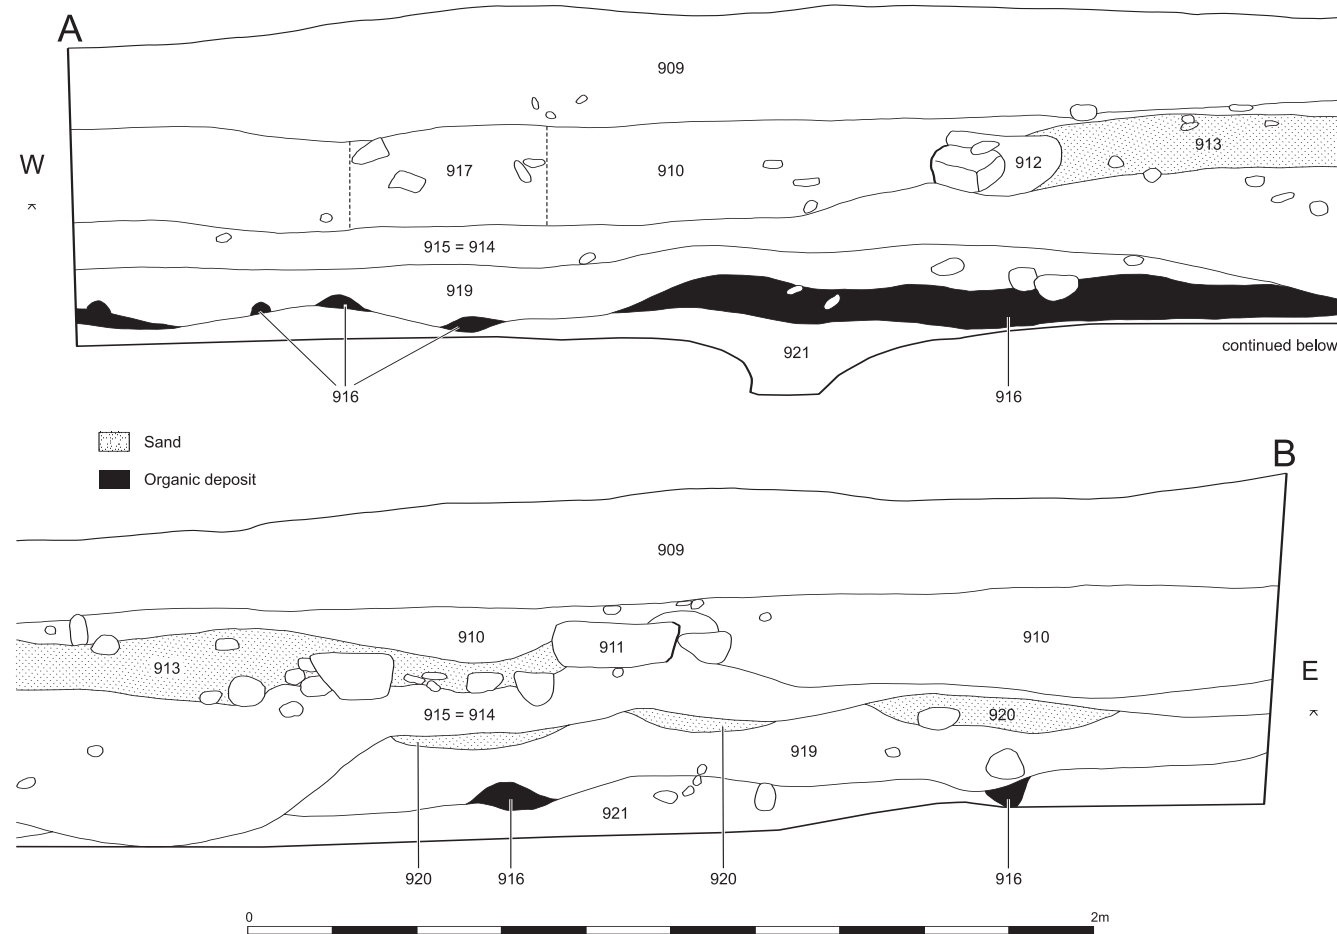
Fig 287 (top)  
Milecastle 71: south-facing section of Trench 5.

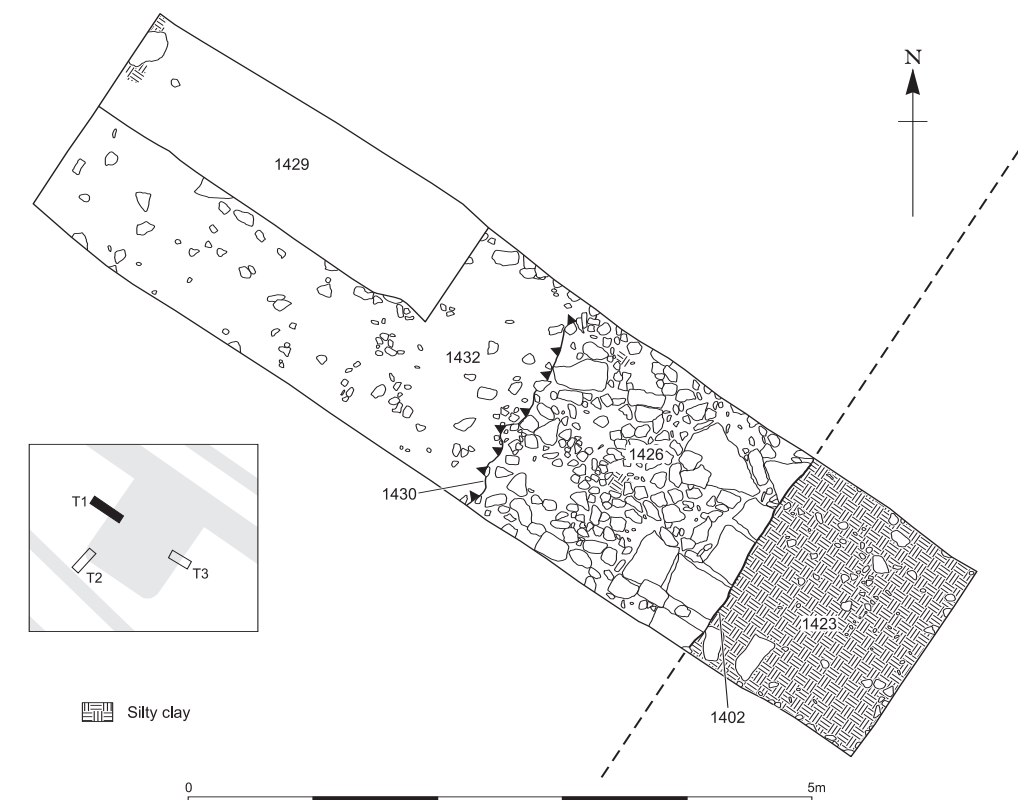
Fig 292 Milecastle 78: plan of Trench 1.

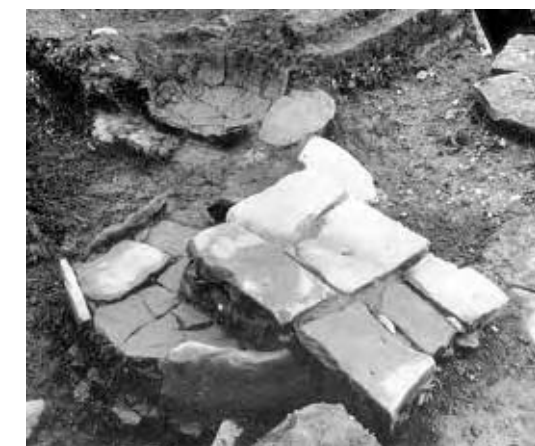
Fig 301  
Milecastle 79: hearths H2 and H4 excavated in 1949.

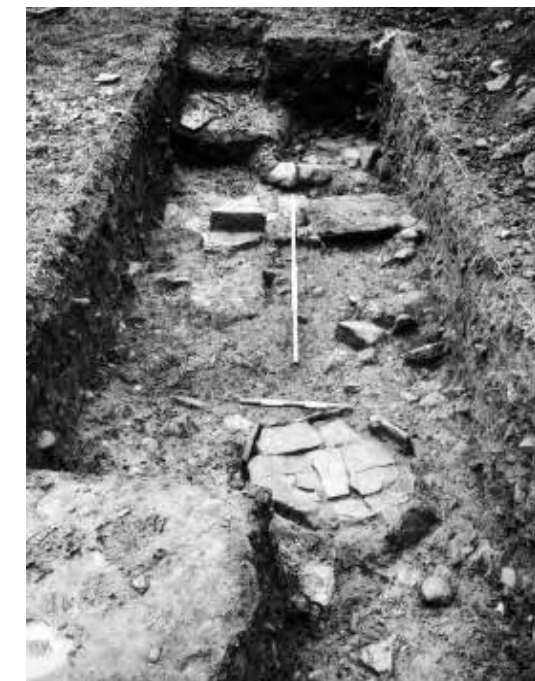
Fig 305  
Milecastle 79: photo of Trench 2 showing hearth 303, which is the same as the 1949 hearth H2 (compare Fig 301).
