# Hadrian's Wall

Archaeological Research by  
English Heritage 1976–2000

*edited by Tony Wilmott*

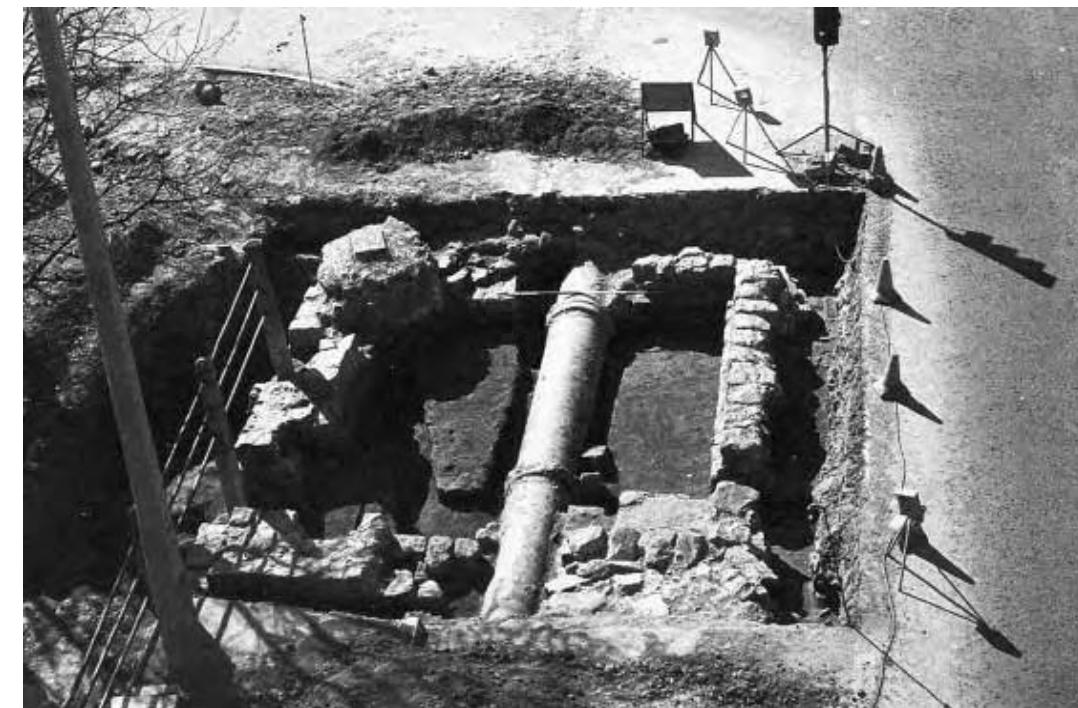
Fig 2  
Excavation of T10a at Throckley in advance of renewal of services.

The earliest of these larger works was undertaken at Tarraby, east of Carlisle in 1978 (Smith 1978), where a pre-Roman cultivation system was found beneath the Vallum and Wall. Evidence of a similar nature was found at T10a in Throckley (Fig 2), where the Roman structure sealed pre-Wall ard-marks (Bennett 1983). Excavations on two sites were necessitated by the laying of major gas pipe-lines. At Crosby-on-Eden in 1981 (this volume, pp 120–8) (Fig 3) a complete cross-section of the linear elements of the Wall was recorded, while at Wallhouses in the same year (Bennett and Turner 1983) a Vallum crossing was located.

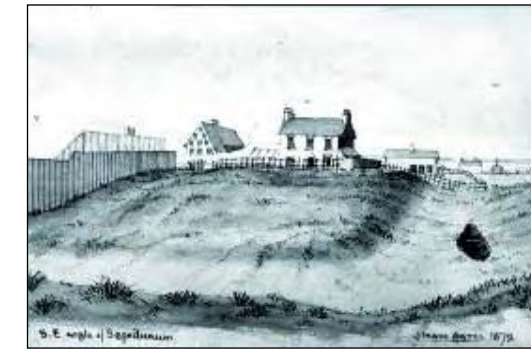
### 1 S.E. angle of Segedunum. 1879 (Fig 9)

The drawing shows a number of buildings, perhaps associated with the Wallsend colliery, within the confines of the fort. One is a two-storey structure with chimneys at both gable ends and a centrally placed arched doorway, above which are three upper floor windows. This may be the house at one time occupied by Mr Reay (Bruce 1863, 39). Another building appears to be four storeys high. The ditch at the south-east angle of the fort is well defined.

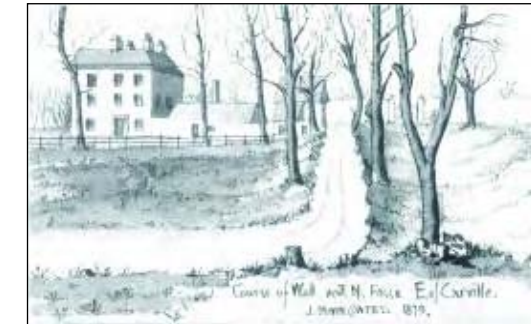
### 2 Course of Wall and N. Fosse E. of Carville. 1879 (Fig 10)

A three-storey house with an associated outbuilding is depicted adjacent to the south side of the Wall. A tree-lined path or bridle way lies on top of the Wall and the north Ditch is defined. This building is part of Carville Hall (previously known as Cousins House and rebuilt c1750) and is shown on the 1st edition of the Ordnance Survey map within the boundary of the Hall.

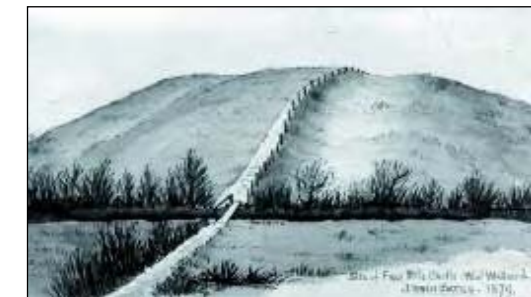
### 3 Site of First Mile Castle. W. of Wallsend. 1879 (Fig 11)

A footpath is shown following the line of the Wall with a small footbridge over a stream called Stotts Pow, between Stotts House and Old Walker. The outline of the north Ditch is shown. Mc1 was located just west of the stream (Bruce 1863, 42). The church of St Francis now covers the site.

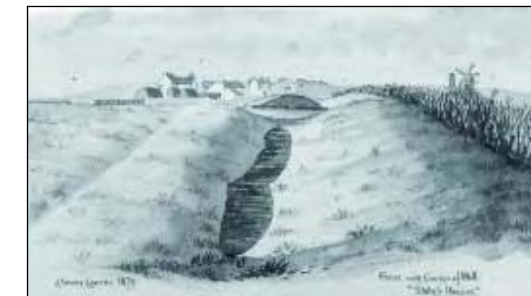
### 4 Fosse and Course of Wall, 'Stote's House'. 1879 (Fig 12)

A footpath runs adjacent to the Wall towards the Stote's Houses buildings, called the Beehouses by Horsley in 1732 (Bruce 1863, 42). The north Ditch is partially filled with water and forms two ponds. A hedgerow grows on the north lip of the Ditch. North of the Wall is the Walker corn mill, which is powered with four sails and in the distance is the village of Old Walker.

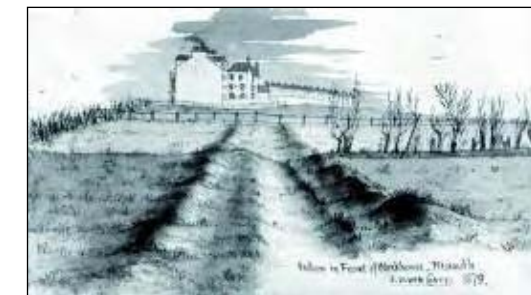
### 5 Vallum in Front of Workhouse, Newcastle. 1879 (Fig 13)

The shallow outline of the Vallum and its associated mounds is visible with the buildings of the Union Workhouse adjacent to or covering the Wall on the line of the Westgate Road on the east side of Elswick Grange. It is marked as the Poor House on MacLauchlan's map of 1852–4. Bruce (1863, 52) also says that the Vallum is well seen opposite the Union Work-house.

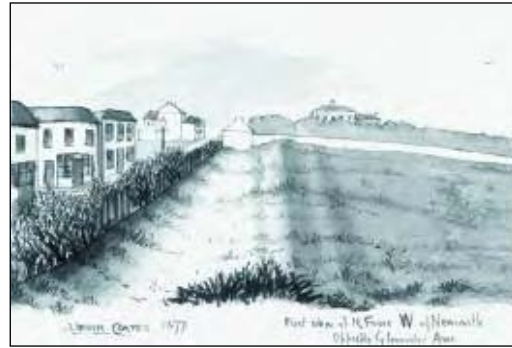
**6** First view of N. Fosse W. of Newcastle. Opposite Gloucester Arms. 1879 (Fig 14)

The view, looking west, shows the north Ditch of the Wall in a field on the north side of the Westgate turnpike. A single gas lamp stands opposite the Gloucester Arms. The public house was situated close to where the present Gloucester Road joins the Westgate Road. According to Bruce (1863, 52), the mounds and Ditch appeared the moment the last row of houses in the town, Gloucester Road, was passed.

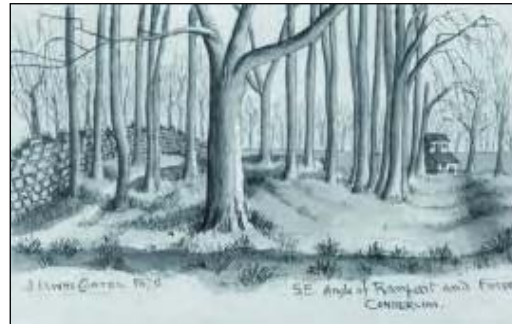
**7** S.E. Angle of Rampart and Fosse. Condercum. 1879 (Fig 15)

The fort ditch is visible, as well as a stone wall (presumably of re-used Roman material) and footpath running parallel to the ditch. A two-storey house (Benwell Hills?) is depicted close to the north-east corner of the fort on the first edition OS map of 1854. A stand of mature trees grows along the line of the east ditch. A map of Benwell in 1790–1808 shows a similar line of trees along the east side of the fort (Graham 1984). Bruce (1863, 52) says that the east rampart and south-east angle stood in the grounds of G W Rendel Esq, who had recently excavated one of the suburban buildings on the east side of the fort.

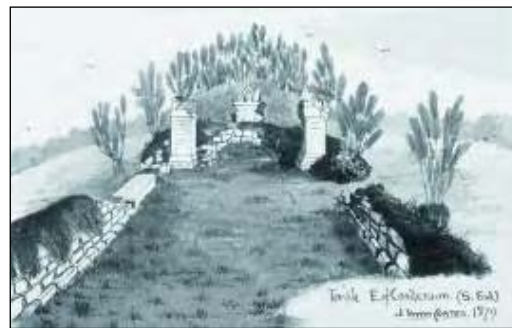
**8** Temple E. of Condercum (S. End). 1879 (Fig 16)

The depiction, looking south towards the apse, shows the surviving low walls of the Temple of Antenociticus, located in 1862, standing at least four courses high above the offset. The two original altars (RIB 1327, 1328) are in place and the statue base of Antenociticus (RIB 1329), together with several pieces of sculpture, lies on top of the apse end. The door threshold block in the east wall is visible. No other buildings are visible and small trees or scrub on top of a small mound surrounds the south end. Grass capping covers most of the tops of the temple walls.

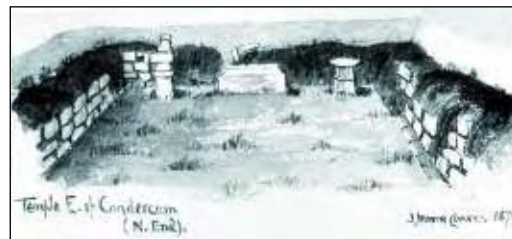
**9** Temple E. of Condercum (N. End). 1879 (Fig 17)

A large stone plinth is at the north end of the temple flanked by several pieces of moulded masonry. The grass-capped walls stand at least four courses high. The wall at the north end of the temple is only partially exposed.

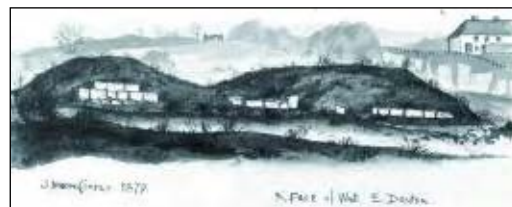
**10** N. face of Wall. E. Denton. 1879 (Fig 18)

Up to three courses of wall facing stones are exposed with an earth mound covering the surviving core. A depiction in the mid-19th century (Bruce 1863, 54) shows the trunk of an apple tree on top of the west mound of the Wall. Two houses are depicted south of the Wall. The rock face of the Denton Burn is shown on the south-west side of the Wall.

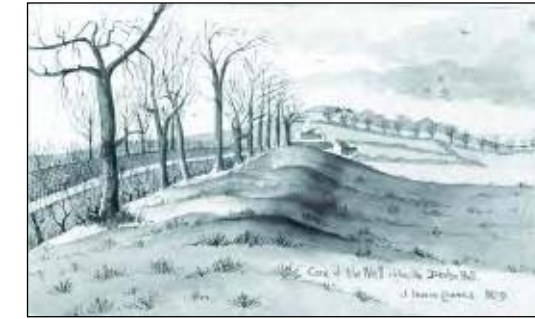
**11** Core of the Wall opposite Denton Hall. 1879 (Fig 19)

The view, looking east, shows the site of the, as then undiscovered, T7b. The raised mound covering the Wall shows no visible stonework. The Westgate turnpike is depicted together with a stone boundary wall, probably that of Denton Hall. A line of trees is growing on the north side of the Wall and within the north Ditch. The houses of East Denton are depicted and another house is situated farther east. The surrounding fields south of the Wall are divided by hedgerows and a line of trees.

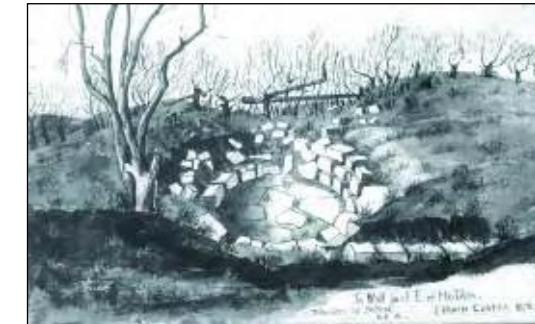
**12** In Wall just E. of Heddon. Diameter at bottom 6' 4". 1879 (Fig 20)

The depiction is of a circular-shaped medieval kiln (excavated by Clayton in the mid/late 1870s) built into the south face and core of the Wall at Heddon-on-the-Wall. The mound of the Wall was covered in trees and bushes with three courses of the kiln stonework surviving above the flagged-stone floor.

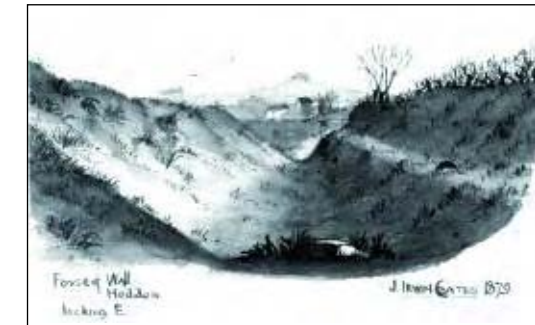
**13** Fosse of Wall. Heddon. Looking E. 1879 (Fig 21)

The view shows the well defined cut of the Fosse (north Ditch). Two buildings, one of which appears to be a row of terraced cottages, are depicted in the distance. A hedgerow forms a fence line on the south side of the Ditch. Bruce commented on the depth of the Ditch at this point (Bruce 1863, 57).

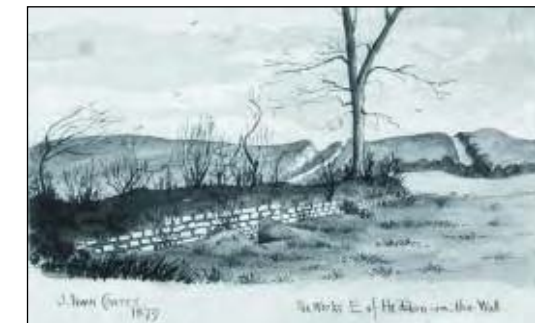
**14** The Works E. of Heddon-on-the-Wall. 1879 (Fig 22)

The Newcastle–Carlisle turnpike is shown, as is the well defined Vallum coming down Great Hill. The south face of the Wall is at least seven courses high, with a small trench (possibly Clayton's) against the face of the Wall exposing several courses of Wall below ground level. Bushes and a large tree grow on top of the Wall.

Anderson, by now a foreman, together with two labourers began exposing and consolidating the 300m length of Wall at Heddon-on-the-Wall in 1938 completing the work in May of that year. At this time a line of trees was growing along the line of the Wall and a fence ran along the top as a boundary between two fields. At the west end of the Wall there was a medieval kiln, which had been exposed by 1879 (or possibly earlier). A drawing done in the same year shows the kiln (Fig 20) and some of the exposed facing stones on the south face of the Wall. Anderson said the tools used to carry out the work consisted of picks, shovels and wheelbarrows. The cement and lime mortar was mixed by hand shovels in the farmyard west of the site and delivered to the site in wheelbarrows. Water for the work was delivered in the same manner. Anderson notes that the east end of the site was flooded by water coming from the Vallum down the steep hill. The site was visited by Professor Sir Ian Richmond, who thought there was some evidence of puddled clay in the core of the Wall. Evidence is cited for a clay-bonded core at or near Heddon by Daniels (1978, 75) and also at Denton (Bidwell 1996, 32). Anderson says he found a short section of clay bonding of the core during the consolidation but that this was the only place that he saw it while re-building the Wall. This was probably because many of the sections of the Wall that he uncovered did not require dismantling to below the offset level.

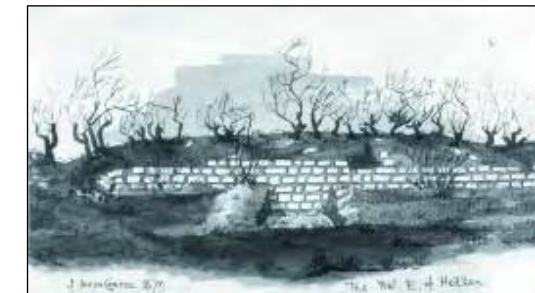
**15** The Wall: E. of Heddon. 1879 (Fig 23)

A detail of the previous drawing (Fig 21), showing the trench against the south face of the Wall. Seven courses are depicted, three of which are below ground level. The length of Wall sketched is approximately 9.5m.

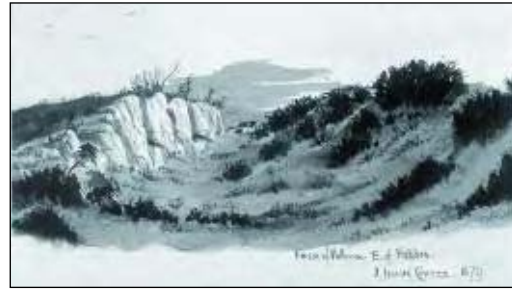
**16 Fosse of Vallum, E. of Heddon.** 1879 (Fig 24)  
The south side of the Vallum is sharply scarp-ed and rock faced, the north face is sloping and covered in vegetation. A building in the distance in line with the Vallum appears to be the church of St Philip and St James in Heddon.

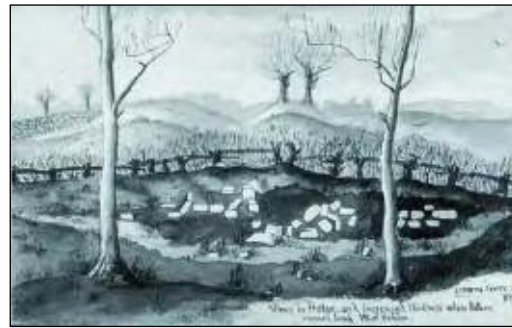
**17 Stones in Hedge and increased thickness where Vallum crosses brook W. of Heddon.** 1879 (Fig 25)  
The view shows the Vallum at a point where the present A69 (Carlisle–Newcastle) road crosses the line of the Wall, slightly east of Mc13. A wood railing fence crosses the Vallum at right angles. The Rudchester Burn flows across the line of the Wall and Vallum. The stonework exposed in the banks of the Burn is most likely the remains of the Roman culvert built to channel the water through the Vallum. A similar culvert through the Wall is shown in Bruce (1863, 55). The Newcastle–Carlisle turnpike road is depicted flanked by a stone wall.

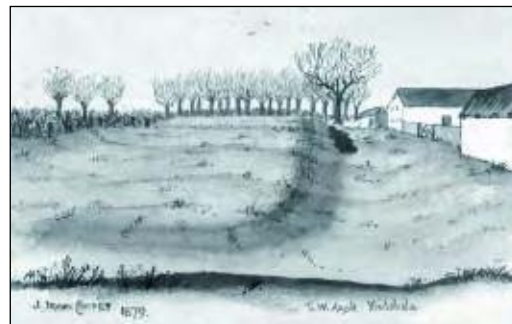
**19 S.W. Angle: Vindobala.** 1879 (Fig 27)  
The outline of Rudchester (*Vindobala*) fort Ditch is clearly indicated, including a pool of standing water. Adjacent to the south edge of the Ditch are some of the buildings of Rudchester Farm. A line of trees is shown at the east end of the site and a hedgerow, including several trees, is depicted in an east–west direction, bisecting the southern half of the fort.

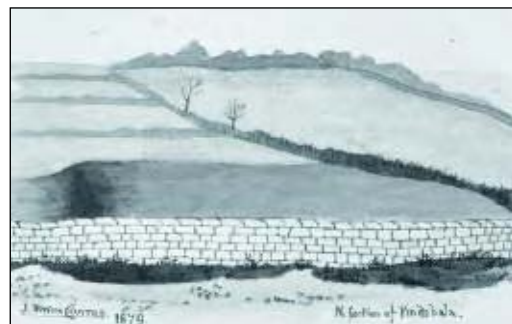
**20 N. portion of Vindobala.** 1879 (Fig 28)  
The view, north from the Military road, shows the slope of the west Ditch of the fort to where it turns for the north-west corner. A stone field wall has been built on the north side and parallel to the turnpike road. On the east side of the fort is a hedge line indicating the line of the road running north from the Rudchester junction.

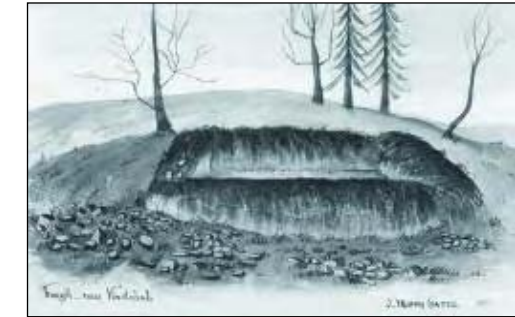
**21 Trough near Vindobala.** 1879 (Fig 29)  
The top is turf-covered. The masonry partition in the trough, when it was discovered, has been removed. A quantity of irregular-shaped stones is lying adjacent to the cistern.

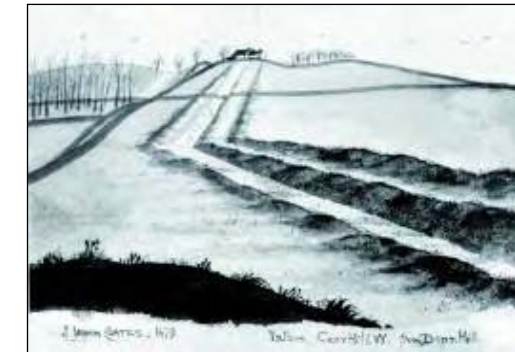
**22 Vallum, Carr Hill, W. from Down Hill.** 1879 (Fig 30)  
The view, looking east, shows the well defined Vallum and associated mounds in wall mile 20/21. Carr Hill Farm is on the east horizon. A similar view from the same position was made in 1848 by H B Richardson (Birley 1961, pl iv). The outline of the north Ditch is visible on the north side of the Military Road. A (19th century?) field wall bisects the line of the Wall and Vallum. A clump of trees is on the north side of the Military Road.

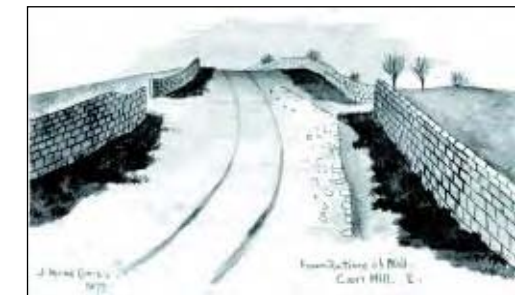
**23 Foundations of Wall, Carr Hill, E.** 1879 (Fig 31)  
The line of the north face of the Wall is visible in the road surface. A stone boundary wall, probably incorporating Roman material, runs parallel to Hadrian's Wall and to the road. The slope of the north Ditch is discernable. The view is close to the position of T20a.

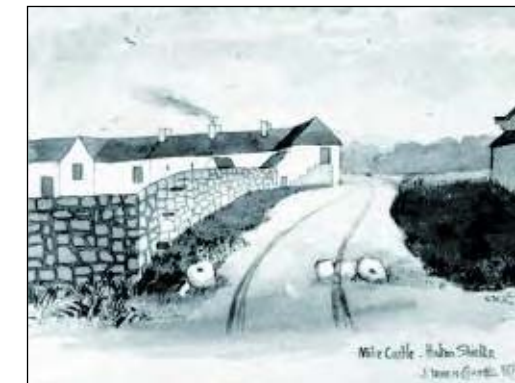
**24 Mile Castle, Halton Shields.** 1879 (Fig 32)  
The view, from the Military Road shows the entrance to Halton Shields Farm (the site of Mc20). Within the road surface are several large stone blocks, two of which appear to be the pivot stones for the milecastle gateway, together with two threshold blocks. The field wall appears to be built of re-used Roman stone.

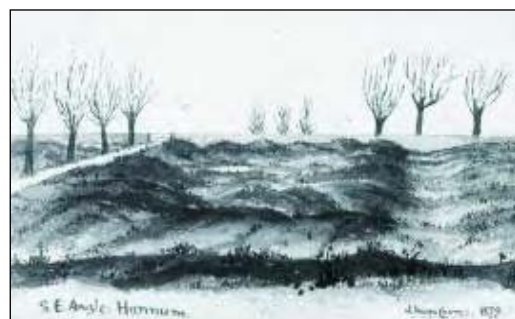
**26 S.E. Angle: Hunnum.** 1879 (Fig 34)  
The Ditch and mound of the east wall of Halton Chesters fort are discernable, as well as the tree-lined road through the middle of the fort leading from the Newcastle-Carlisle turnpike to Halton. This road presumably lies above the original Roman road within the fort. A stone(?) wall crosses the fort on the south side of the Newcastle-Carlisle turnpike road. Numerous humps and bumps in the south-east quadrant of the fort indicate the extent of buried buildings within the fort.

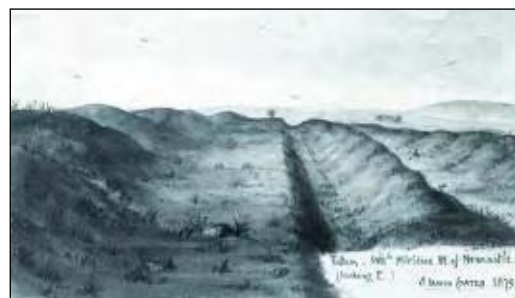
**28 Vallum. XVIIth Mile Stone. W. of Newcastle (looking E.).** 1879 (Fig 36)  
Probably close to Mc23, west of Dere Street. The north, south and marginal mounds of the Vallum and the Vallum Ditch are all well defined.

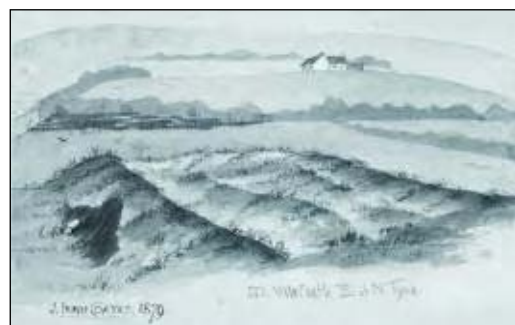
**29 IVth Mile Castle E. of N. Tyne.** 1879 (Fig 37)  
This is Mc24 (Wall Fell) opposite Errington Hill Head farm. The grass covered sides and platform of the milecastle are distinct and the Vallum appears to be water filled. A farmhouse is depicted to the south-west of the Vallum.

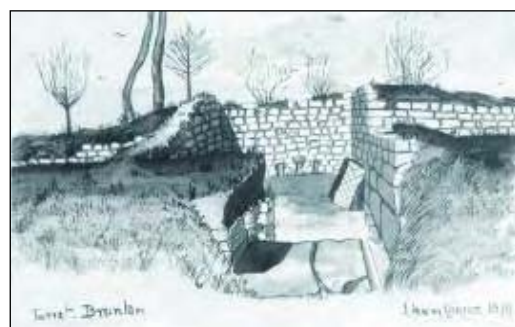
**30 Turret. Brunton.** 1879 (Fig 38)  
This turret (T26b) had been excavated by Clayton in 1873. The drawing shows the emptied turret, with three small altars against the north wall and a larger block with diamond broaching against the east wall. The threshold block shows the pivot slot and door jamb. The east wall stands 11 courses above the offset.

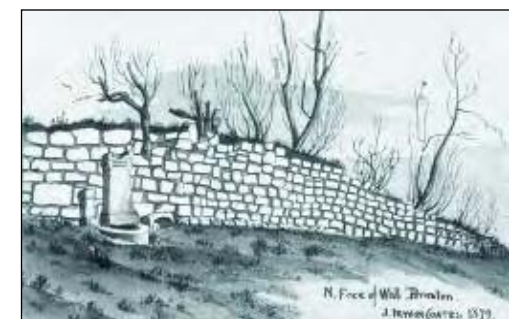
**31 N. face of Wall. Brunton.** 1879 (Fig 39)  
The sketch is of the uncovered north face of the Wall. Lying against the Wall are two altars, part of a window head and a circular stone block. Trees are growing out of the Wall face and on top of the Wall. The large altar appears to be the one (Coulson and Phillips 1988, no. 279) that was removed from outside St Oswald-in-Lee church (Heavenfields) and placed here by the owners of Brunton House in the early/mid-19th century. The altar was placed back in the nave of the church by the Ministry of Works c1948. The location of the second altar is unknown.

Anderson noted a Roman altar on the north side of the turret. The vicar of St Oswald's Church, the Reverend F G Westgarth, visited the site and said the altar had been removed from in front of the church to the grounds of Brunton House and then to its position on the north side of the Wall more than 100 years ago. After discussions among Mrs Selby Woods of Brunton House, Mr P Hedley of Corbridge, Mr Charlton (the assistant Inspector of Ancient Monuments) and Dr Richmond it was agreed that it would be better to have the altar placed back in the church (EH file AM 10348/01). The necessary Faculty was obtained and the altar is now in the nave of the church (Coulston and Phillips 1988, no 279). A drawing made in 1879 of the north face of the Wall at Brunton by James Irwin Coates (Fig 38) shows two altars on the north side of the Wall, the larger of which is presumably the one noted by Anderson and returned to the church.

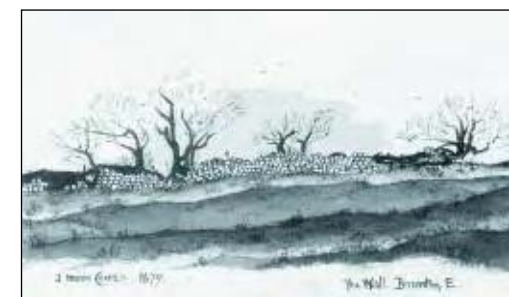
**32 The Wall. Brunton. E.** 1879 (Fig 40)  
This length of the exposed (north?) face of the Wall, up to six courses high, is at Planetrees situated to the east of T26b. A number of large trees grow adjacent to and on top of the Wall.

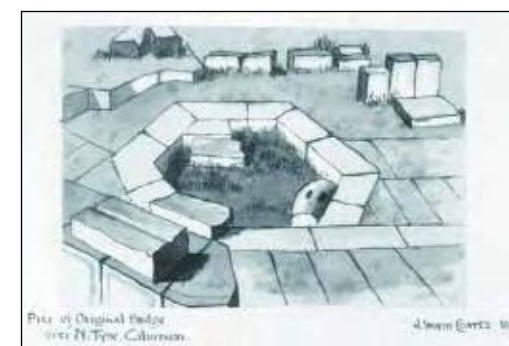
**34 Pier of Original Bridge over N. Tyne, Cilurnum.** 1879 (Fig 42)  
The drawing is of a detail of the pier of the first bridge enclosed by the masonry of bridge two. Lying within the pier is a socketed counterweight stone.

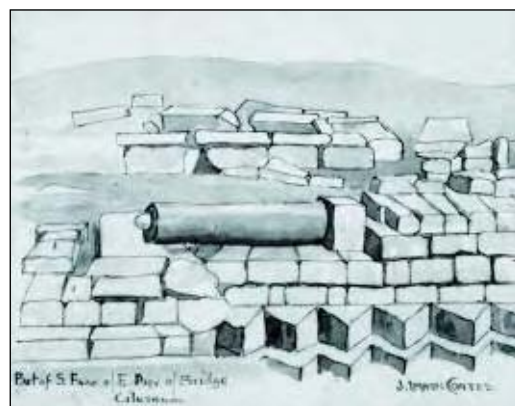
**35 Part of S. Face of E. Pier of Bridge. Cilurnum.** no date (Fig 43)  
Presumably made at the same time as Figs 41 and 42, the sketch depicts a cylindrical column, with an oval boss at one end and a square base at the other, lying on the masonry of bridge two. The lower blocks of the abutment have been laid at an angle of 45 degrees to those above to form a series of dogtooth courses. A number of blocks forming the stone millrace are in the background.

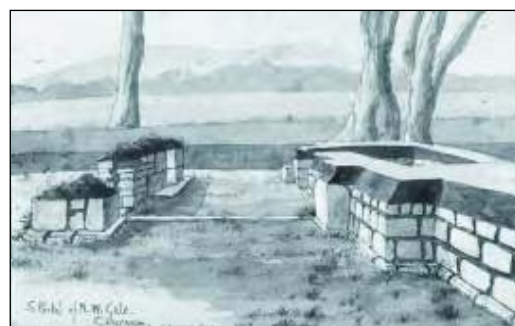
**36 S. Portal of N.W. Gate. Cilurnum.** 1882 (Fig 44)  
The view, from the west, shows the south portal, gate threshold and central *spina* of the West gate. Hadrian's Wall is bonded with the south guard chamber, which stands three courses above the offset course. Several mature trees grow adjacent to the gate.

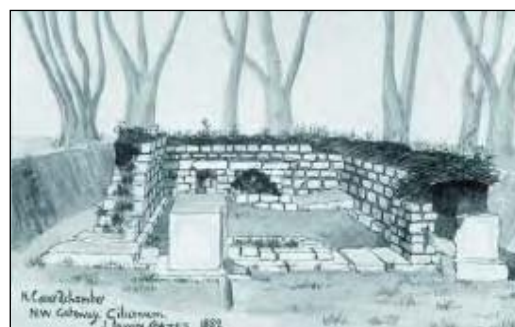
**37 N. Guardchamber, N.W. Gateway. Cilurnum.** 1882 (Fig 45)  
The sketch, looking north, shows the internal view of the guardroom, including the pivot block and slot for the gate. At the north end is a stone water channel and a stone platform to support a tank for the water supply. The west wall of the guard chamber is seven courses above the offset course. The guard chamber door threshold is in place. A clump of mature trees, north of the chamber, extends across the Ditch and fort wall.

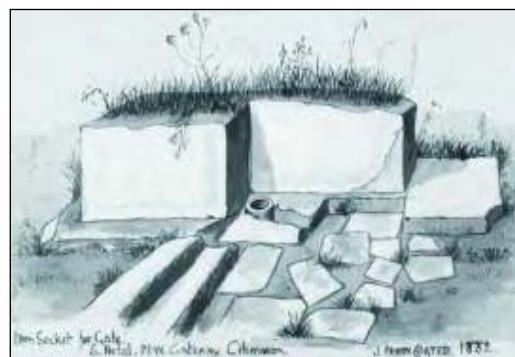
**38 Iron Socket for Gate. S. Portal. N.W. Gateway. Cilurnum.** 1882 (Fig 46)  
This shows a detail of the surviving iron collar in the pivot block to hold the door as well as the south portal threshold block.

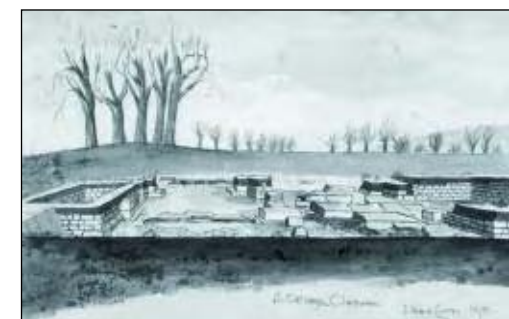
**39 S. Gateway. Cilurnum.** 1879 (Fig 47)  
The drawing, looking north, shows the east and west guard chambers, central *spina* and gate portals. The sill and threshold of the east portal have been uncovered, while the east portal retains the large blocks of a later road. Within the fort are a large number of mature trees.

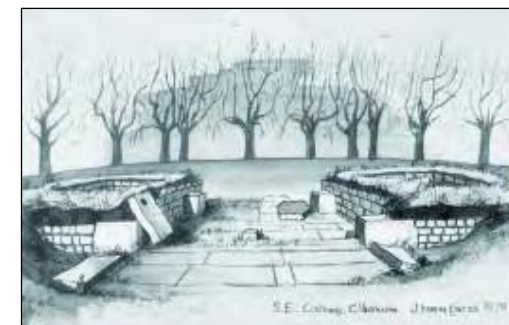
**40 S.E. Gateway. Cilurnum.** 1879 (Fig 48)  
The first gate to have been excavated, perhaps in 1854, but before 1863 (Bidwell and Snape 1993, 13); the sketch shows the two guard chambers and the paving slabs of the single passage portal in the east wall. The outer face of the fort wall is partially excavated. The north pivot block is in place and a large block with a pivot hole rests against the north wall of the south guard chamber. Irwin Coates clearly depicts guard chambers on either side of the gate. These are not evident on the ground or indicated on any of the site plans, and no doors are visible in the side walls of the portal, the entrance perhaps being at the back of the guardrooms. Mature trees are growing within the fort.

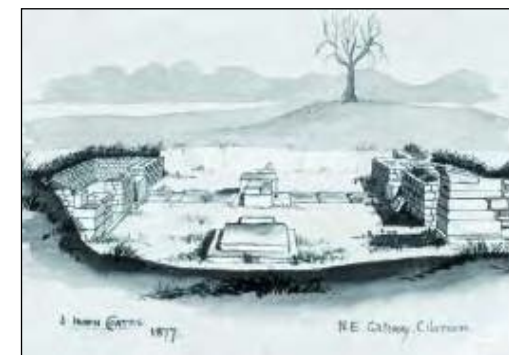
**41 N.E. Gateway. Cilurnum.** 1877 (Fig 49)  
The view of the main East gate shows the north and south guardrooms, the central *spina* and portals as well as the gate thresholds. The pivot slots for the gates are visible as is the section of Hadrian's Wall and its junction with the south guardroom. The impost-mould of the south rear pier is depicted.

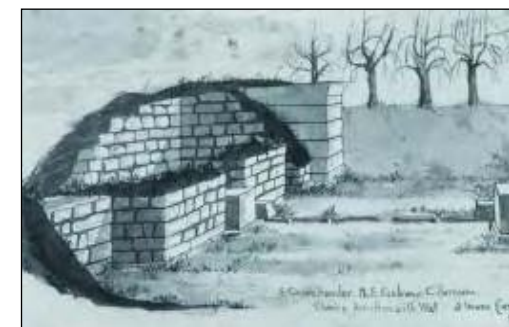
**42 S. Guardchamber, N.E. Gateway. Cilurnum. Showing junction with Wall.** 1877 (Fig 50)  
The view, from the east, shows the excavated south guard chamber, the gate portal and threshold, central *spina* and north face of Hadrian's Wall at its junction with the east face of the south guardroom. The impost block at the rear of the gate is in place. Four mature trees are inside the fort.

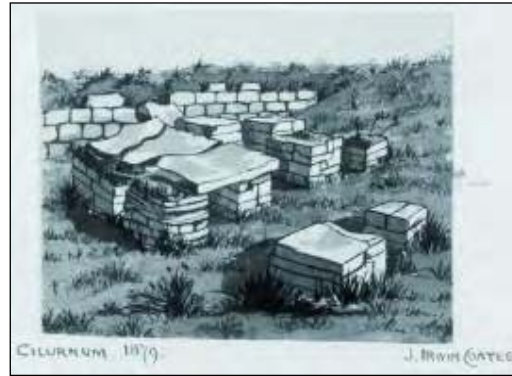
**43 Cilurnum. 1879 (Fig 51)**  
The drawing depicts a section of the hypocaust system within the central part of the Commander's House. Three large stone slabs rest upon raised stone pillars with another slab in the background resting against five courses of walling.

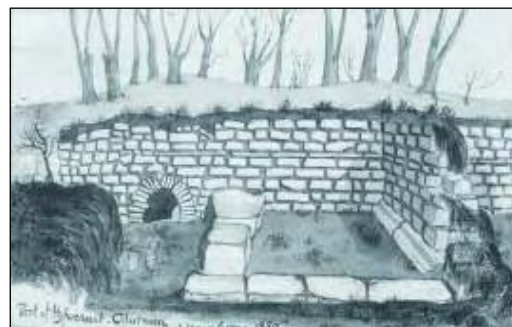
**46 Part of Hypocaust. Cilurnum. 1882 (Fig 54)**  
This is the east wall of the Commanding Officer's House at the south-east corner showing the brick arch of the furnace through the wall. A string course extends the length of the east wall. Large foundation blocks and the north wall of eight courses (above a moulded plinth) of a small room abut the east wall. The top of the east wall is turf capped and a clump of a dozen mature trees is situated within the fort.

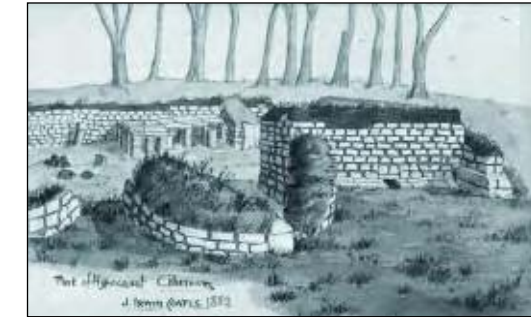
**47 Part of Hypocaust Cilurnum. 1882 (Fig 55)**  
The view shows the raised floor and hypocaust of the Commanding Officer's House together with the apsidal ends of the hot room and the moulded base course on the external face of the east wall. A squared-topped column rests against the wall close to the hypocaust. All of the walls are turf capped. A clump of eleven mature trees is depicted within the fort.

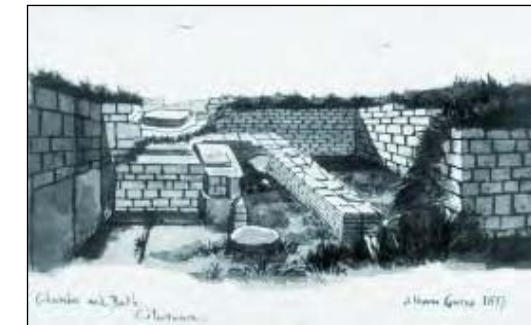
**49 Chamber and Bath. Cilurnum. 1877 (Fig 57)**  
The view is of the north-east corner of the Commanding Officer's House, showing the area of the cold baths, including the wall of brick tiles up to six courses high and a door threshold slab leading into the dressing room. The surviving walls stand to 11 courses high.

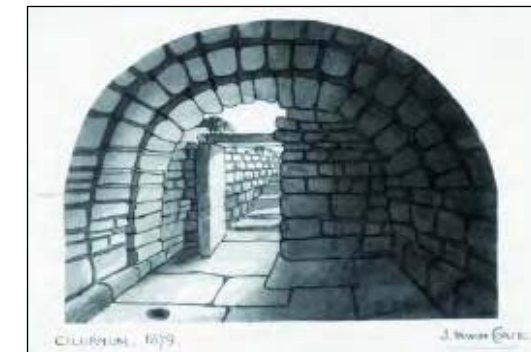
**50 Cilurnum. 1879 (Fig 58)**  
The internal view of the underground strong room in the *principia* shows the arch-ribbed vaulting and entrance with its monolithic door jam and a stone slab over the passage steps. The walls of the vault are built on a stone plinth. On one of the floor slabs is what appears to be a circular drain hole.

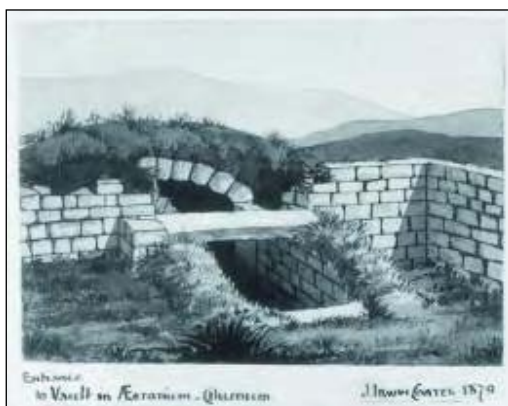
51 Entrance to Vault in *Aeararium* ~ *Cilurnum*. 1879 (Fig 59)

An external view of the entrance to the underground strong room. The top is still covered in turf. A stone slab is laying above the passage steps. The wall on the south side of the steps contains eight courses of masonry.

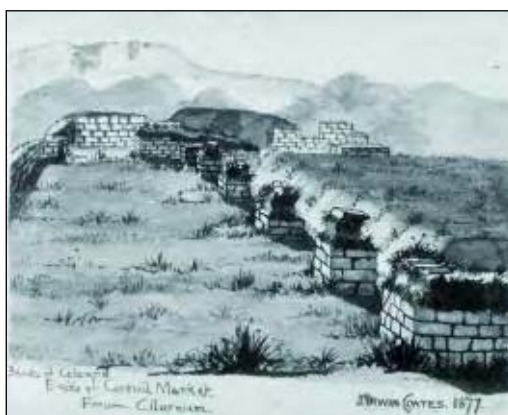
53 Bases of Columns. E. side of Covered Market. Forum. *Cilurnum*. 1877 (Fig 61)

The *principia* was exposed between 1870 and 1875. The view depicts the east portico of the *principia* courtyard with a line of column bases on plinths, the east entrance to the *principia* and the mound of earth covering the as yet unexcavated underground strongroom. The interior of the courtyard area had also not yet been uncovered.

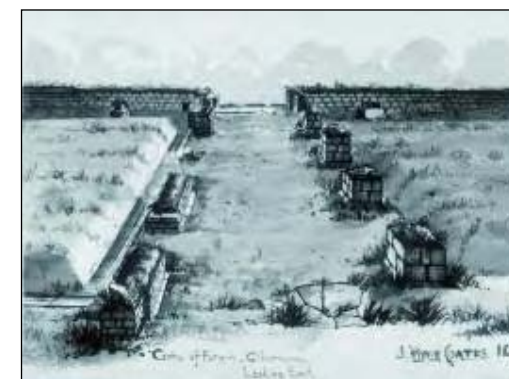
55 Centre of Forum. *Cilurnum*. Looking East. 1877 (Fig 63)

The view shows the cross-passage of the basilica looking towards the east entrance. Four column plinths, with between two and three courses above, occupy the south side while the north side has the courtyard gutter and three arch supports. The eastern support arch for the entrance from the courtyard to the basilica passage has been robbed out and only a pivot stone is in place. A small section of cross-passage paving is at the west end of the passage. The central area of the courtyard and the basilica is unexcavated.

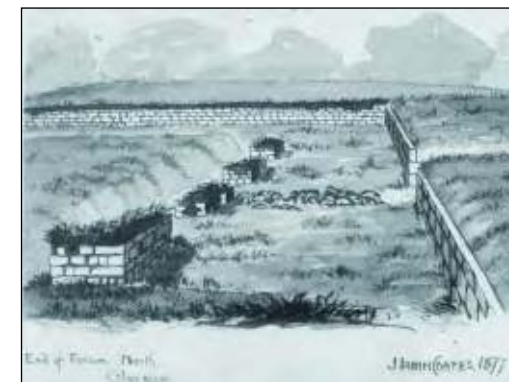
56 End of Forum. North. *Cilurnum*. 1877 (Fig 64)

Four arch supports and associated masonry (which are still capped with turf) are exposed as are the west and north portico walls. The north entrance into the courtyard is exposed. The courtyard and the area north of the *principia* entrance are unexcavated.

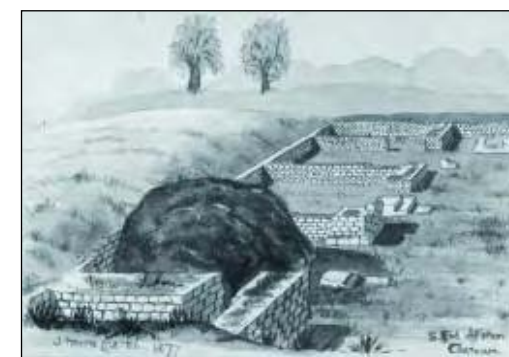
The drawing, from the south-east, shows the southern end of the *principia* including the chapel (*aedes*), regimental records room and pay room with the earth mound covering the vault of the underground strongroom. The tribunal foundations are at the west end of the hall. Up to six courses of masonry are surviving in some of the walls. Two mature trees with foliage are shown to the west.

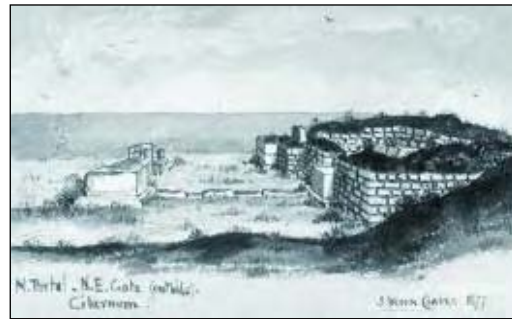
**59 N. Portal. N.E. Gate (outside). Cilurnum. 1877 (Fig 67)**

The gate was excavated in 1867. The depiction shows the central *spina*, the north portal and threshold as well as the north guard chamber standing to at least seven courses. Turf covers the tops of the guard chamber walls.

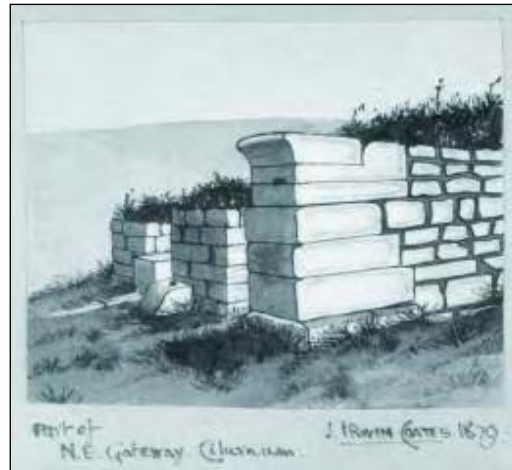
**60 Part of N.E. Gateway. Cilurnum. 1879 (Fig 68)**

The depiction shows a detail of the south guard chamber of the east gate including the impost on the rear south pier and nine courses of the fort walls inner face, the guardroom entrance, the pivot block on the south side of the gate and a section of the gate threshold. The pivot block shown is probably the one from the upper part of the gate superstructure.

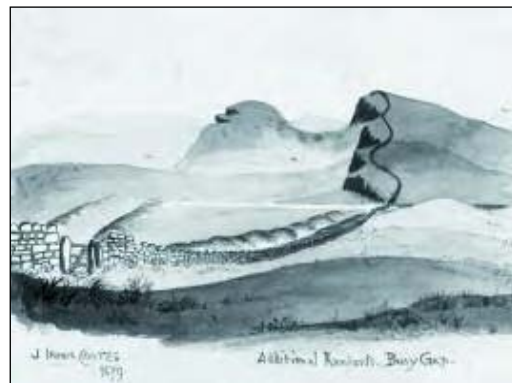
**61 Additional Ramparts. Busy Gap. 1879 (Fig 69)**

A stone field wall of re-used Roman stone, built on top of the line of Hadrian's Wall stretches eastwards towards Sewingshields. A wooden gate, attached to stone pillars is built into the west end of the field wall. The outline of the north Ditch (east of Mc36) is shown crossing the level ground in front of Busy Gap. The Ditch and banks of a post-Roman enclosure on the north side of the Wall is depicted.

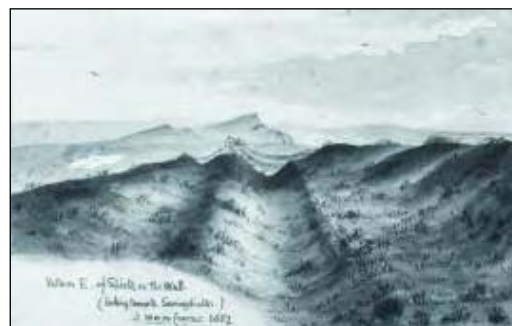
**62 Vallum E. of Shield on the Wall. (looking towards Sewingshields.). 1882 (Fig 70)**

Shield-on-the-Wall is situated close to and south of Mc33. The mounds and Vallum Ditch are clearly outlined. South of the Vallum is a reservoir now known as Shield-on-the-Wall Dam. Shield-on-the-Wall cottage (previously known as Tipplehall) is depicted on the Vallum mound and Sewingshields Farm is shown farther westwards.

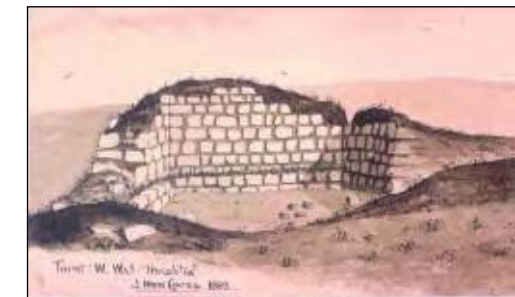
**66 Turret: W Wall. Procolitia. 1882 (Fig 74)**

This must be the interval tower south of the west gate of the fort excavated by Clayton in 1871 (Snape 1994, 17). Eight courses of the inner face are depicted built on top of two offset courses. All of the walls have a turf capping.

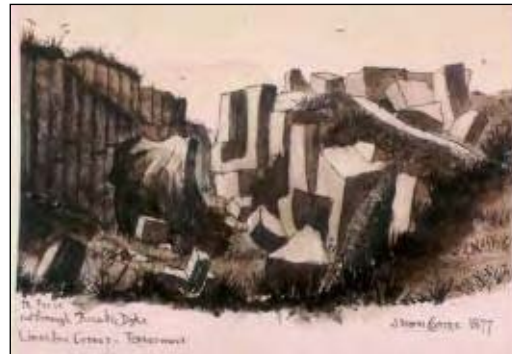
**69** N. Fosse cut through Basaltic Dyke. Limestone Corner. Teppermoor. 1877 (Fig 77)  
The drawing, looking west, shows the jumbled mass of stonework left lying in the north Ditch.

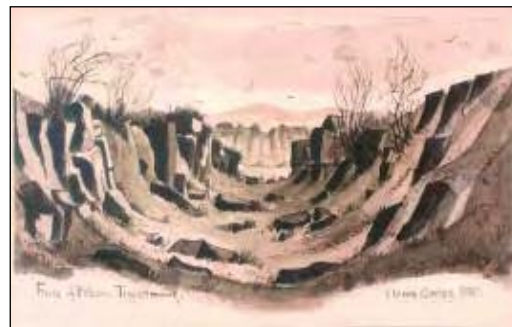
**70** Fosse of Vallum. Teppermoor. 1882 (Fig 78)  
The view depicts the top of Limestone Corner looking west towards Carrawburgh fort with the distinct shape of the Vallum cut through the outcrop of basalt rock. In the distance is the faint outline of a building (Carrawburgh Farm) on the south mound of the Vallum.

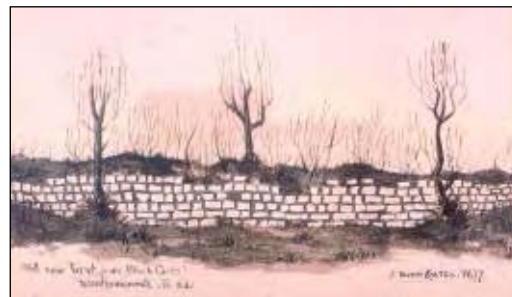
**71** Wall near Turret (near Black Carts) recently uncovered – S. side. 1877 (Fig 79)  
Excavated in 1873 by Clayton, the Wall stands at least six courses high. Vegetation and trees are on top of and adjacent to the Wall.

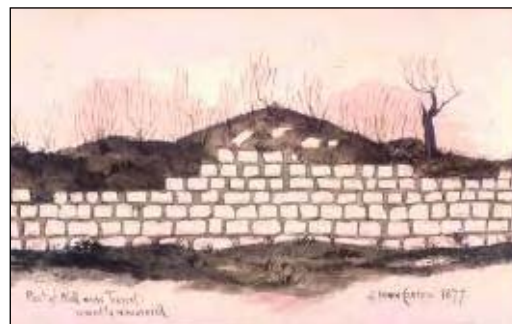
**72** Part of Wall near Turret recently uncovered. 1877 (Fig 80)  
Seven courses of the Wall are visible. Small bushes and a tree grow on top of the Wall.

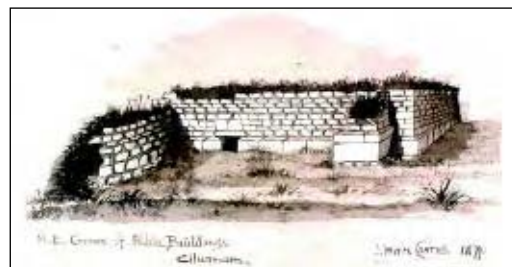
78 *N.E. Corner of Public Buildings, Cilurnum. 1877 (Fig 86)*  
The drawing is of the north-east corner of the Commanding Officer's House showing the moulded plinth, the buttress and the curve of the apse end of the bathhouse. The east wall has an outlet at plinth course level. The walls survive up to eight courses above the plinth.

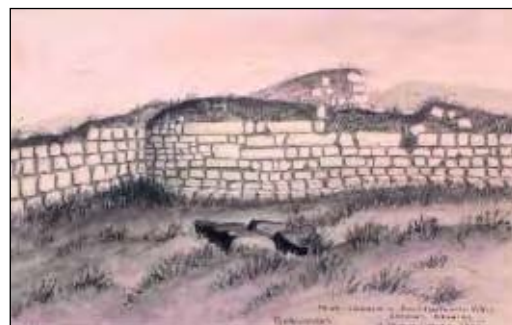
80 *N.W. Corner & Junction with Wall showing repairs, Borcovicus. 1883 (Fig 88)*  
Five courses of the south face of Hadrian's Wall are depicted at the north-west corner of Housesteads fort. The fort wall itself is built on top of the offset course. A number of large blocks in the external face of the north wall of the fort indicate Roman repairs. Within the fort some of the west wall of the north-west angle tower is visible. Both the fort wall and the Curtain Wall are turf capped. Three large pieces of masonry lay outside the fort.

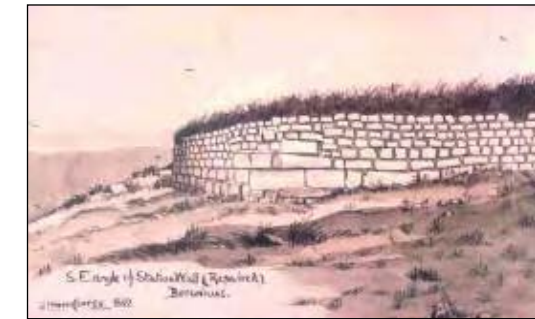
81 *S.E. angle of Station Wall (Repaired), Borcovicus. 1882 (Fig 89)*

This external view shows the turf capped fort wall standing ten courses high with large blocks, indicating repair work, at the position of the south-east angle tower.

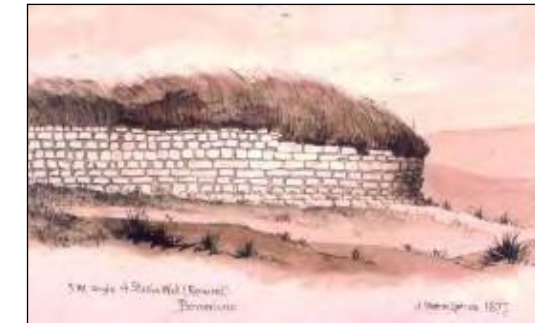
82 *S.W. angle of Station Wall (Repaired), Borcovicus. 1877 (Fig 90)*

The turf-capped external face of the fort wall stands ten courses high. Larger stones denote the position of the internal angle tower and areas of repair work and rebuilding. The late-18th-century farmhouse situated near the south-west corner of the fort (Bruce, 1863, 126) had been demolished by this time.

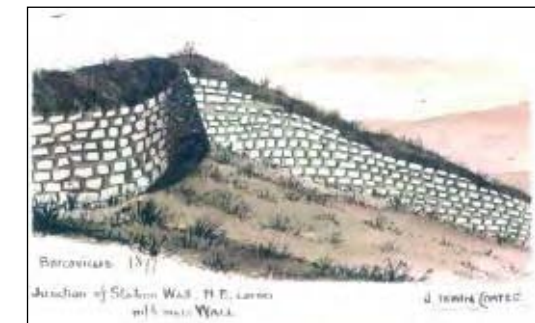
84 *Junction of Station Wall, N.E. corner with main Wall, Borcovicus. 1877 (Fig 92)*

Nine courses of fort wall are depicted at the junction of the north-east corner and the south face of the Wall, which slopes eastwards to the Knag Burn. Both the fort wall and curtain wall are turf-capped.

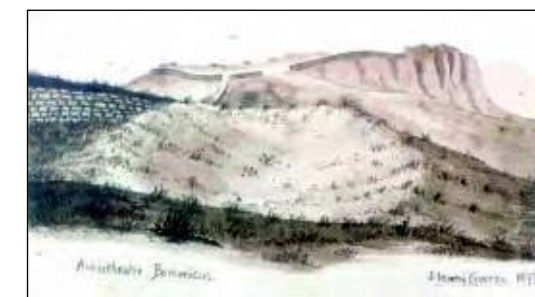
85 *Amphitheatre ~ Borcovicus. 1877 (Fig 93)*

The view, from the north side of the Wall looking towards the fort, shows the circular depression in the foreground referred to by Bruce (1863, 116) as an amphitheatre but now known to be a Roman quarry (Crow 1994, 16). At least six courses of the north face of the Wall adjacent to the quarry are depicted. The east and north walls of the fort are shown as is the gap in the north wall used as a farm entrance/exit. Housesteads crags and the woods to the west of the fort are depicted. The outlines of the walls of buildings are shown inside the fort.

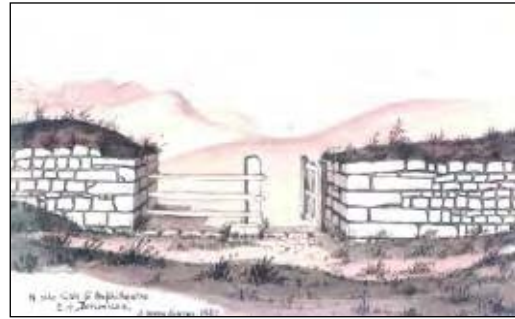
**86** *N. side Gate to Amphitheatre E. of Borcovicus.* 1882 (Fig 94)  
The view, from the north side of the Knag Burn gateway, shows the large blocks of the Knag Burn gate entrance with the gate threshold and stop block in position. The gate had been opened up by Clayton in 1856. A wooden three rail fence is in the east portal and a three-bar gate in the west portal. The north face of the Wall stands up to eight courses high. For the Housesteads 'amphitheatre' see Wilmott (forthcoming)

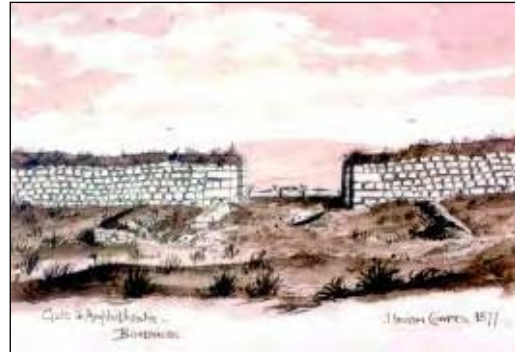
**87** *Gate to Amphitheatre ~ Borcovicus.* 1877 (Fig 95)  
The depiction of the south face of the Wall at Knag Burn shows the Wall to be standing up to seven courses high. The outline of the gateway is depicted showing the partially exposed walls of the two guard chambers. The gate stop block and threshold are visible as is the pivot block of the west guard chamber. A slab with a pivot hole is on the ground surface in the centre of the passage way.

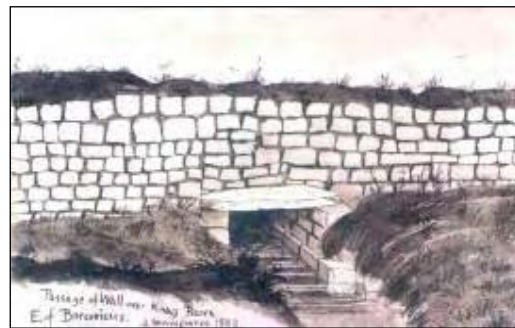
**88** *Passage of Wall over Knag Burn E. of Borcovicus.* 1882 (Fig 96)  
A detail of the south face of the Knag Burn culvert with eight courses of Wall visible. A large stone slab covers the culvert, the east side of which has three courses of large blocks above an offset course. The top of the Wall is turf-covered.

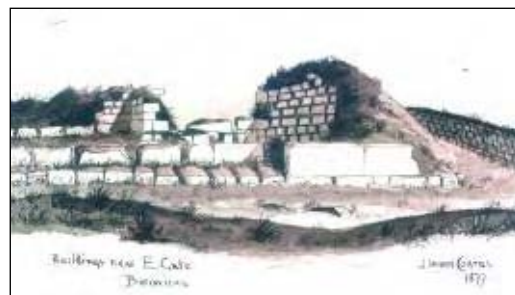
**90** *Building near E. Gate. Borcovicus.* 1877 (Fig 98)  
This drawing, from the south, is of the east end of Building XV opened by Hodgson in 1831 and identified as a bath suite. At the south-east corner of the building are two massive stone blocks with 'diamond broaching' and the internal face of the east wall standing eight courses high. A section of the internal face of the east wall of the fort, north of the east gate, is shown.

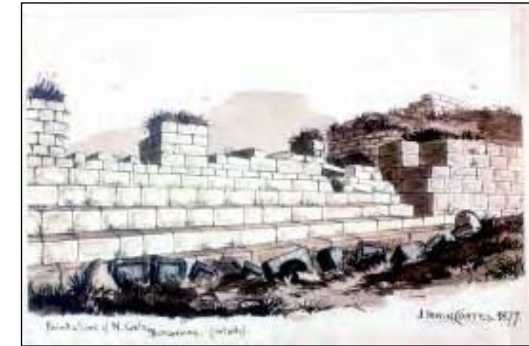
**91** *Foundations of N. Gate. Borcovicus. (outside).* 1877 (Fig 99)

The north gate including a section of the external face of the north wall of the fort had been exposed in 1852. The drawing shows both portals of the gate and the large foundation blocks below, the north-west corner of the east guard chamber, the central *spina* and the east wall of the west guard chamber. At the base of the gate are a number of partially exposed fallen blocks containing a (moulded?) border and one block, which appears to be the upper part of an arched window head.

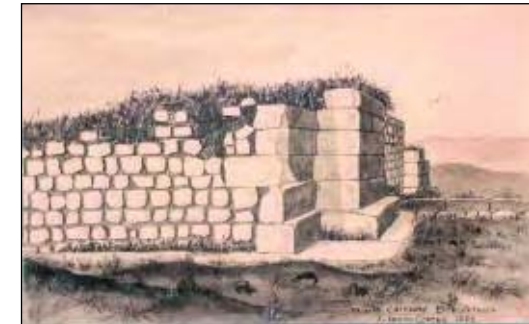
**92** *N. of W. Gateway. Borcovicus.* 1882 (Fig 100)

The view from outside the north portal of the west gate, shows the junction of the fort wall with the piers of the north portal. Five courses of masonry above an offset are standing on the foundation slab. The door and south wall of the north guard chamber is visible as are the north portal threshold blocks.

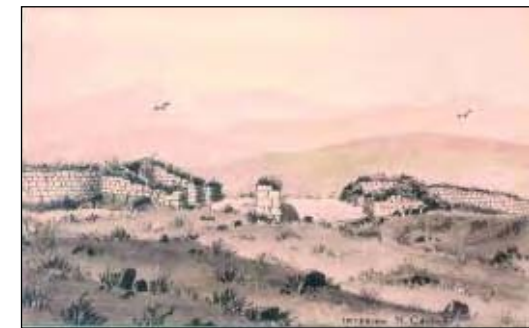
**93** *INTERIOR N. Gateway. Borcovicus.* 1877 (Fig 101)

This interior view of the north gate shows both guard chambers, the central *spina*, the inner face of the fort wall and the water tank on the south side of the west guard chamber, all of which had been cleared prior to 1857 (Crow and Rushworth 1994, 30). Several large blocks are close to the south wall of the east chamber and in the foreground a number of blocks are protruding through the ground surface.

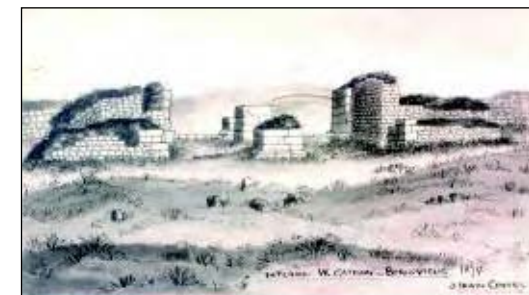
**95** *INTERIOR W. Gateway ~ Borcovicus.* 1879 (Fig 103)

The view of inside of the west gate shows both guard chambers, the central *spina* and portal thresholds as well as the inner face of the west wall of the fort. The south face of the north guard chamber stands seventeen courses high. A number of blocks protrude through the ground surface in the foreground. The top of the gate and fort walls are turf capped.

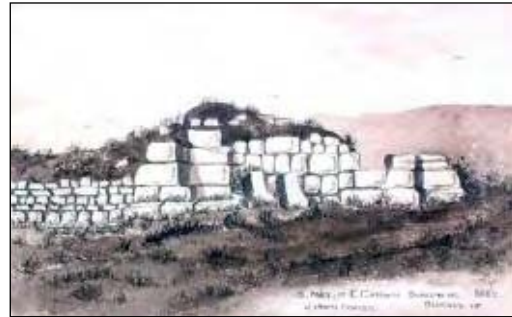
**96 S. Part of E. Gateway. Borcovicus. Blocked up. 1882 (Fig 104)**

The view, from the exterior of the fort, shows the blocked south portal of the gateway with the adjoining piers and central *spina* as well as the exterior face of the east wall of the fort south of the gate. Two sections of window arch, one of which has a moulding, rest against the portal blocking. The gateway blocking and wall top is turf-capped.

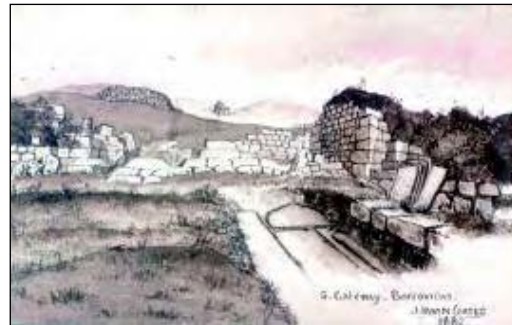
**97 S. Gateway ~ Borcovicus. 1882 (Fig 105)**

By 1852 Hodgson and Clayton had fully excavated the gateway. The drawing, from the south, shows the two gateway portals and thresholds, both of which show wear marks from the passage of wagons. In the east portal the stop-block is in position. Outside the gate passage are a number of stone slabs forming the Roman road and in the foreground are more slabs. Above these, but separated by a layer of material, is another set of stone slabs. The west wall of the medieval bastle is partially seen, resting against which are several large flag stones. The west wall of the east guard chamber retains its blocked door while the west guard chamber has a column and base resting on it and a window arch together with what appears to be a column are on the south side of the chamber. The blocking of the inner end of the east portal (Bruce 1863, 125) seems still to have been in place at this date. Within the fort is a wall belonging to the east wing of the Commanding Officer's House, exposed in 1858, (Crow and Rushworth 1994, 30) and to the east, on the *via principalis*, is what appears to be either a partially buried altar or column base.
