# Hadrian's Wall

Archaeological Research by  
English Heritage 1976–2000

*edited by Tony Wilmott*

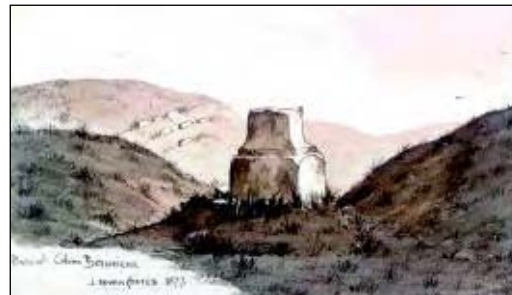
**98 Base of Column. Borcovicus. 1877 (Fig 106)**

The detail shows a broken column shaft, square in outline with the edges tapering at the bottom, sitting on top of a square base. On the left side of the drawing are the edges of three rows of stones protruding from the earth, possibly relating to the granary. This depiction appears to be of the column base still *in situ* on the *via principalis* at the south end of the *principia*.

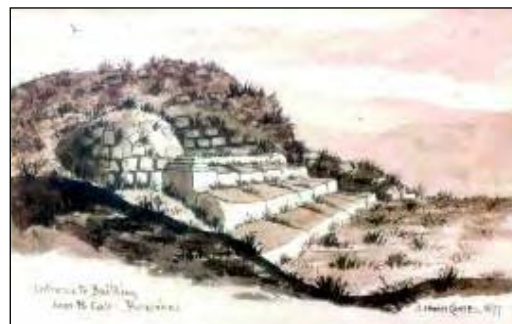
**99 Entrance to Building near N. Gate – Borcovicus. 1877 (Fig 107)**

Three rows of stone steps lead to the unexcavated entrance of the east door of the south granary. A moulded column plinth is situated on the third step up on the south side.

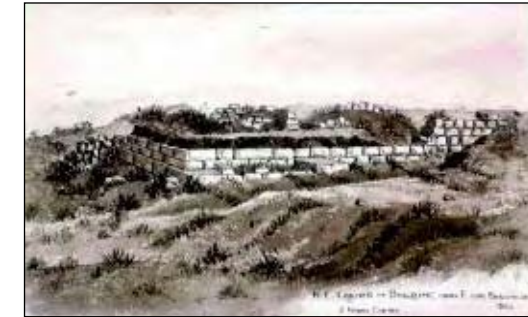
**100 N.E. Corner of Building: near E. Gate. Borcovicus. 1882 (Fig 108)**

This is the north-east corner of Building XV, the south end of which has a bath suite inserted. Some of the walls of the bath suite are visible within the building. The remains of a buttress on the north wall of the building can be seen, the wall of which stands up to six courses. The barrack block (XIV) and its associated alleyway to the north of the building are still covered in overburden.

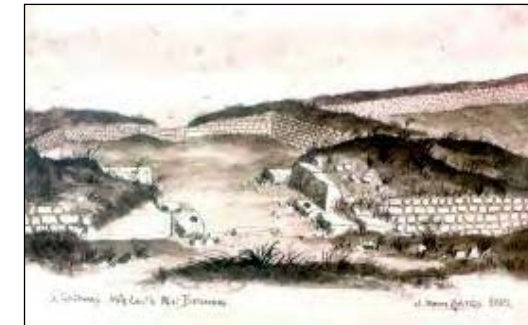
**101 S. Gateway. Mile Castle W. of Borcovicus. 1882 (Fig 109)**

The view, from outside the south gate of Mc37, shows the visible internal and external walls and the south face of the Wall east of the milecastle. Within the south gate are the two lower pivot blocks as well as a pivot slab from the top of the gate. Part of the gate threshold as well as the stop block is visible. The west side of the south gate has been robbed down to the foundation slab. An arch voussoir is visible on the west side of the north gate although the voussoir shown in Fig 109 (1879) on the east side is no longer there. The later blocking of the north gateway is exposed and a wooden fence had been erected since Coates was there in 1879. The Wall and milecastle tops are covered in turf.

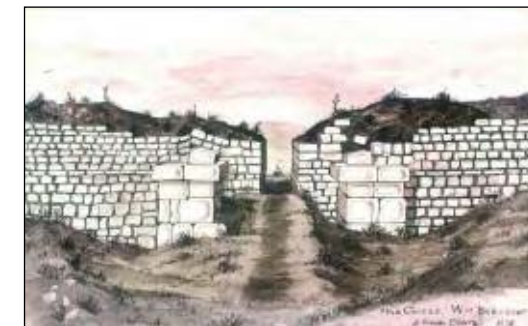
**102 Mile Castle. W. of Borcovicus. 1879 (Fig 110)**

The milecastle was excavated in 1853. The view is of the internal face of the north gate and the later blocking in the entrance passage. A single voussoir is on top of both of the gate piers. The string course within the internal face of the north wall is visible, above which are seven courses of masonry and seven below. The internal building in the north-east corner is not uncovered.

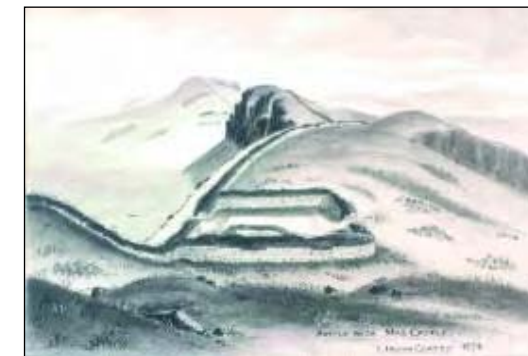
**103 Castle Nick Mile Castle. 1879 (Fig 111)**

The view is of Mc39 from the west. The Curtain Wall had been exposed as had the walls, gates and internal building of the milecastle. The rounded external corners and square internal corners of the milecastle are evident. In the distance is Hotbank Farmhouse with Highshield Crags overlooking Crag Lough. The line of the Wall continues eastwards over Hotbank Crags. The outlines of field boundaries and drainage ditches are visible on the ground north of the Wall. A similar view is depicted in Bruce, (1863, 152).

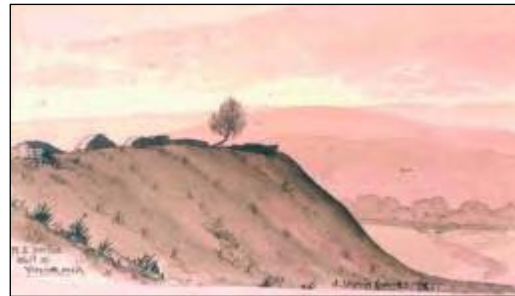
**105** *N.E. portion of Wall of Vindolanda.* 1877 (Fig 113)

The partial remains of the east wall of the fort, north of the east gate, are depicted and the sloping ground to the east. A tree grows in the north-east corner of the fort and an arch or culvert of a small bridge to the north indicates the course of Brackies Burn as it crosses the Stanegate. The roof outline of an unidentified building can be seen behind the arched culvert.

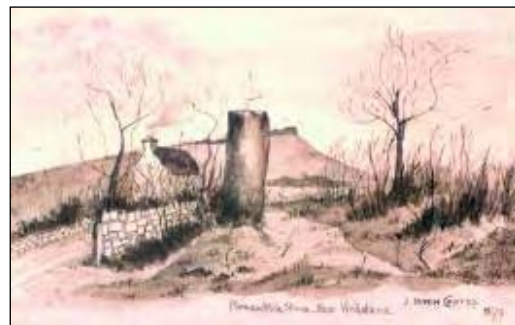
**106** *Roman Mile Stone. Near Vindolanda.* 1879 (Fig 114)

The milestone is situated on the Stanegate to the north-east of the fort, the wall of which is visible. A stone wall lines the road as it passes Codley Gate Farm. The building has a chimney at the east end and appears to have a thatched roof.

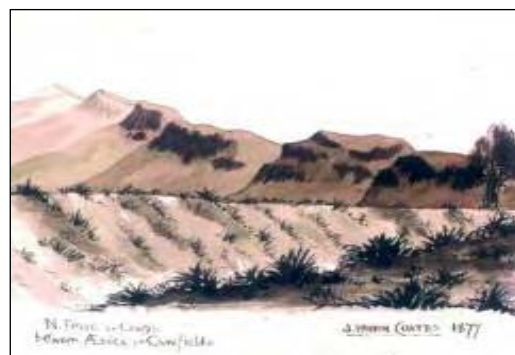
**108** *N. Fosse & Crags between Aesica & Cawfields.* 1877 (Fig 116)

The north slope of the Wall Ditch and its southern lip is shown with the crags of Cawfields and Winshields in the distance. The drawing appears to have been made slightly west of Burnhead Farm and east of T42b.

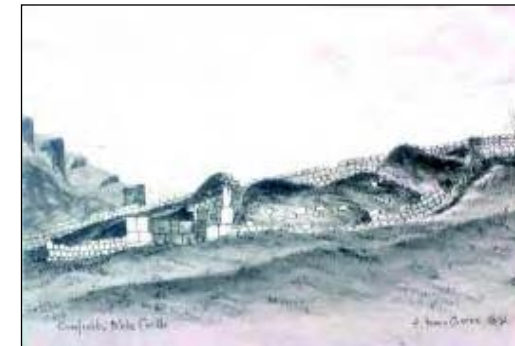
**109** *Cawfields Mile Castle.* 1891 (Fig 117)

This was the first of the milecastles on the Wall to be excavated, the work being done by Clayton in 1848 (Clayton 1848, 54–9). The view shows the rounded south-east corner, the south gate with its massive piers and the external face of the milecastle west of the south gate. Hadrian's Wall joins the north-east and north-west corners. The depiction appears to show a stone wall running through the northern end of the milecastle. This field wall, presumably made with re-used Roman material blocks the view of the north gate while the passage of the south gate also appears to be partially(?) blocked with a stone wall. Both of these were probably erected after the Clayton excavations. The face of the quarry at Cawfields is seen to the west of the site.

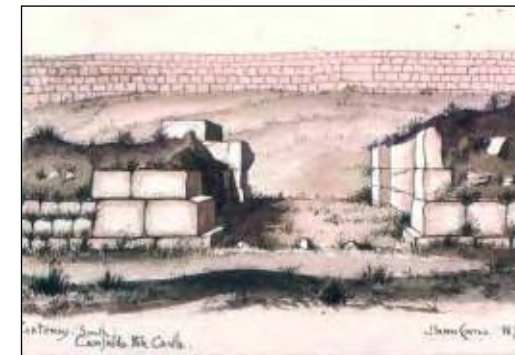
**110** *Gateway: (South). Cawfields Mile Castle.* 1877 (Fig 118)

The view shows the excavated entrance of the south gate of the milecastle (Mc42) showing the large blocks forming the gate piers and a section of the external face of the south wall. Within the gateway portal is the stop block and stone threshold. A field wall of reused Roman stone standing up to seven courses high is in the northern quarter of the milecastle crossing in front of the north gate. Several large blocks in this wall appear to be reused north gate piers.

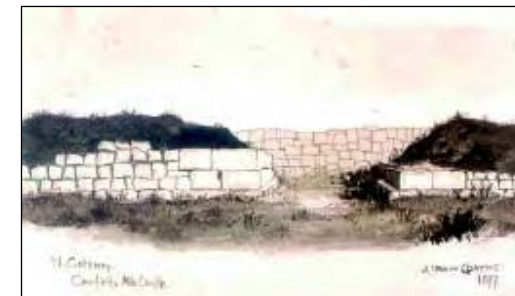
**111** *N. Gateway, Cawfields Mile Castle.* 1877 (Fig 119)

The view of the excavated north gate shows the stone piers and foundations as well as five courses of external Wall face east of the gate. Within the milecastle is the previously noted 'No 109' (Fig 117) field wall of reused Roman material. The date of the removal of this wall is not known.

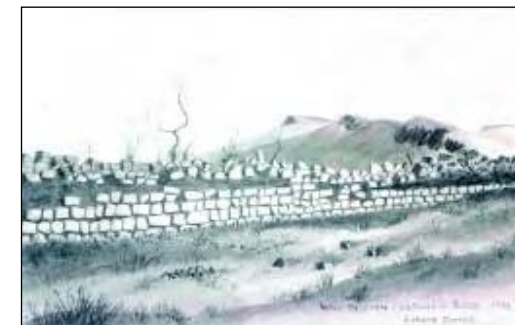
**112** *Wall between Caw Burn & Aesica.* 1891 (Fig 120)

Looking east towards Cawfield Crags, the drawing shows the south face of the Wall standing at least four courses high with the remains of a field wall on top. This section of Wall is probably close to T42b.

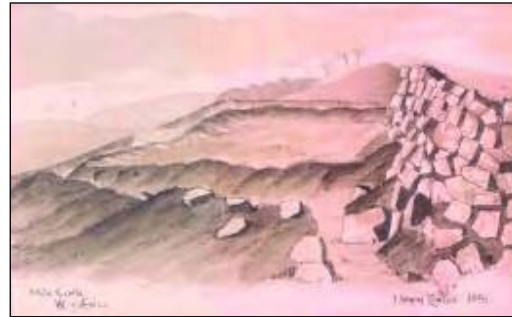
**113 Mile Castle W. of Æsica. 1891 (Fig 121)**  
This is Mc44 (Allolee). The outline of the walls and ditches are distinct and this was noted by Bruce (1863, 162). A gap in the south wall indicates the position of the gateway, while a field wall built of Roman stone lies on top of the line of the north wall.

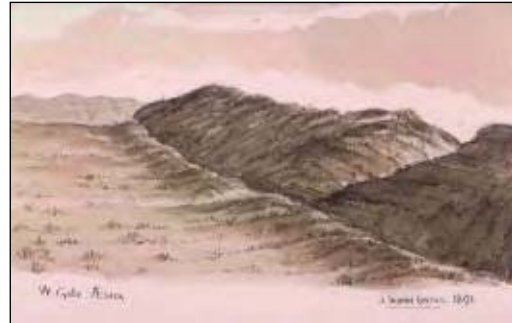
**114 W. Gate Æsica. 1891 (Fig 122)**  
The drawing depicts the external face of the west wall of the fort covered in earth and turf. The outline of the inner ditch outside the west gate is discernable. A slight gap in the wall indicates the position of the gateway. The inner face of the west wall was not cleared until 1895. The fort wall continues northwards to where it meets the Roman Wall at the north-west corner. The line of the Wall west of the fort appears to be indicated by a covered mound.

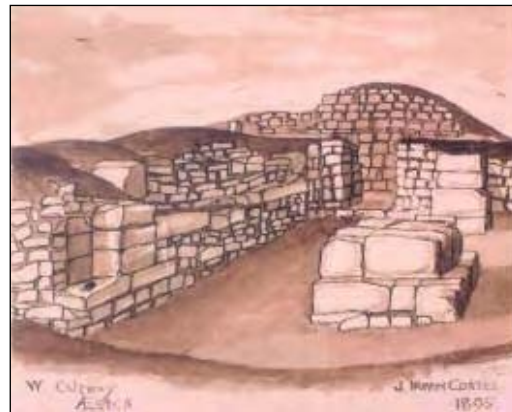
**115 W. Gateway. Æsica. 1885 (Fig 123)**  
The internal view from the south-east shows the blocking in the north portal of the west gate, the *spina* blocks and the north guard chamber with its doorway (seven courses high), all of which had been uncovered in June of that year by J P Gibson (1903, 26). Within the blocking of the north portal are the two pivot blocks for a later raised Roman road surface. The north pivot block of the south portal is in place including three of the pier blocks above the portal blocking. In the internal north wall of the guard chamber there are five courses below the string course and five courses above. The gateway blocking and the walls of the guard chambers are turf-covered.

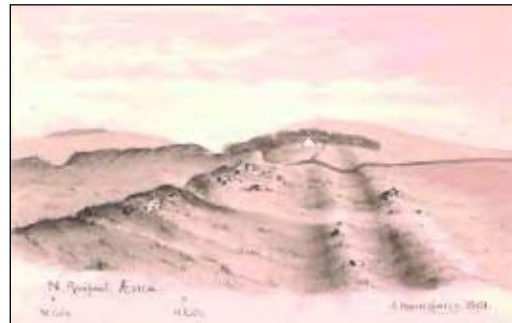
**116 N. Rampart; Æsica. 1891 (Fig 124)**  
Looking westwards, the view shows the turf-covered north rampart of the fort with the position of the north gate indicated by an arrow and exposed masonry. The mound of the west wall leads to a gap, indicated by an arrow showing the position of the west gate. The outline of the Ditch on the north side of the fort is clearly indicated leading towards Cockmount Hill Farmhouse and Cockmount Wood. A number of fallen blocks of masonry are on the mounds of the north Ditch. A field wall crosses the line of the Roman Wall and Ditch west of the fort.

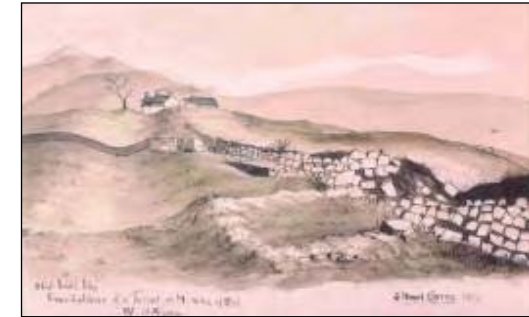
**117 What looks like Foundations of a Turret on N. side of Wall. W. of Æsica. 1891 (Fig 125)**

This drawing is approximately 250m west of Great Chesters fort (*Æsica*). The farmhouse and buildings of Great Chesters in the north-east corner of the fort are depicted. The distinct outline of the north Ditch has a field wall crossing it with a wooden gate situated on the Wall berm. A mound of stonework consisting of a field wall built on top of Roman material indicates the line of the Wall. On the north side of the line of the Wall is an oblong platform with slightly raised sides indicating buried walls on the east, north and west sides. This is likely to be the site of a medieval shieling or shelter rather than a turret. To the south is the outline of a road, which is straddled by a wooden gate attached to stone uprights. This road may either be the one still situated on the south mound of the Vallum or perhaps be a track laying on top of the Military Road, which exited from the west gateway of the fort.

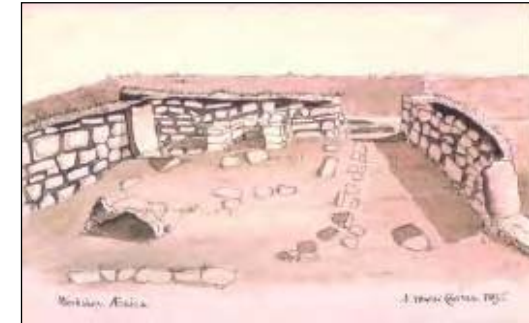
**118 Workshop. Æsica 1895 (Fig 126)**

The position of this building within the fort is uncertain. It may relate to either one of the barrack buildings excavated in 1894 (Gibson 1903, 22) or one of the buildings erected against the inner face of the west wall north of the west gate excavated in 1895 (Gibson 1903, 33). The view is from inside the building showing a doorway and stone threshold on the right side. The walls of the building survive up to five courses. The line of what appears to be a stone-capped drain leads from the middle of the room towards the door. A large stone slab, which may be a threshold block, is resting in the left-hand corner of the building. Close to this is a small semicircular structure three or four courses high, which may be the smithy referred to by Gibson. Another stone slab lies against the right hand side wall of the building.

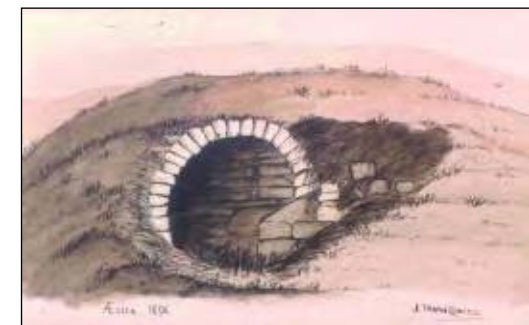
**119 Æsica. 1896 (Fig 127)**

The drawing is of the east end of the vaulted underground chamber, first opened by Dr Lingard in 1800 (Hodgson 1840, 203) and re-examined in 1894 (Northumberland Excav Comm 1895). The vault had been fully emptied by this time and 23 of the voussoirs are visible as are several large blocks in the entrance. The top of the chamber is covered in turf.

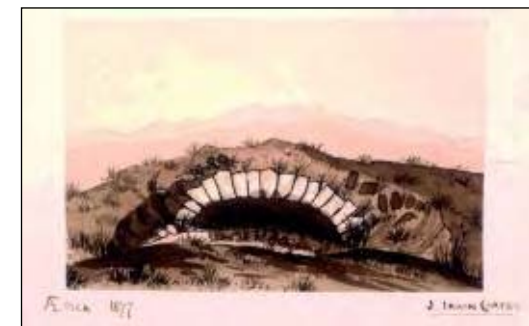
**120 Æsica. 1877 (Fig 128)**

This view of the west end of the chamber was made prior to the clearance of the rubble and earth filling in the chamber. The arch is clearly visible with 18 of the voussoirs depicted. Earth, turf and loose stones partially block the entrance and cover the top of the chamber.

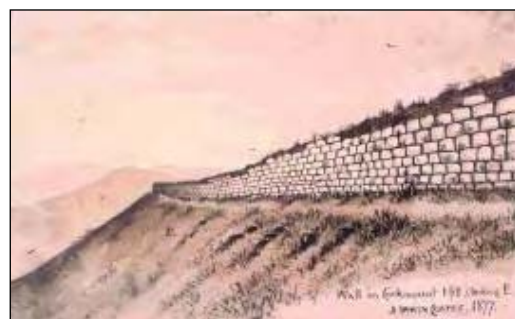
**121 Wall on Cockmount Hill. (looking E.). 1877 (Fig 129)**

The view, looking eastwards, is of the north side of the Wall, close to Mc44, showing an extensive length of Wall standing up to eleven courses high with a turf capping. On the north side of the Wall the ground slopes steeply away.

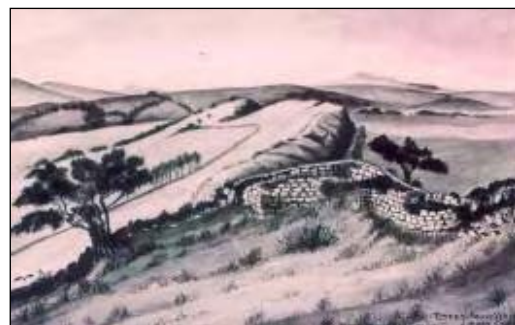
**122 Turret Above Walton. Nine Nicks of Thirkwall. no date (Fig 130)**

The drawing must have been made during either the 1895 or 1896 trip as the site was not excavated until 1892 (Gibson 1902, 13) although it had been discovered in 1883. The view, from the east side of T44b (Mucklebank), shows the right-angled turn of the Wall, the turret with the door in the southwest corner and a length of Wall on the east side. A line of stone south of the turret indicates the line of the Wall towards Walltown Nick. The line of the Wall heading west along Walltown Crags is outlined. On the south-facing slope is a field wall and a small stand of trees close to the line of the Military Way as it passes near Mc45.

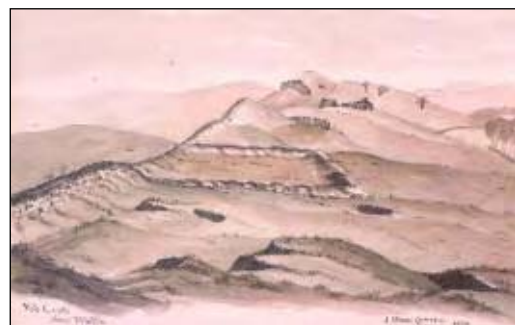
**123 Mile Castle above Walton. 1891 (Fig 131)**

This is Mc45 (Walltown) viewed from the west. The mounds outlining the walls are visible as is the Wall itself, which contains exposed rubble and facing stones. The line of the Wall is indicated following the Crag edge eastwards.

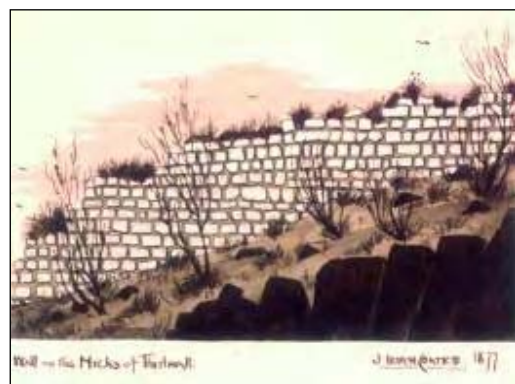
**124 Wall on the Nicks of Thirkwall. 1877 (Fig 132)**

This view of the south face of the Wall west of T45a shows up to 16 courses of facing stones surviving. Horsley commented on it (Birley 1961, 82) and a depiction of an adjacent section of Wall appears in Bruce (1863, 165).

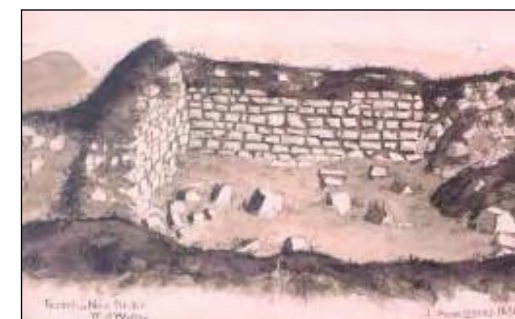
**125 Turret on Nine Nicks. W. of Walton. 1891 (Fig 133)**

This is T45a, partly exposed in 1886 by Clayton in advance of the second Pilgrimage, cleared and planned in 1912 and re-examined in 1959 prior to consolidation. The view is of the exposed north and west walls with collapsed rubble and facing stones to the east. Up to nine courses are visible in both the north wall and west walls of the turret with facing stones and core lying on the surface within. To the west are several blocks forming the south face of the Wall. The tops of the turret walls are turf-covered.

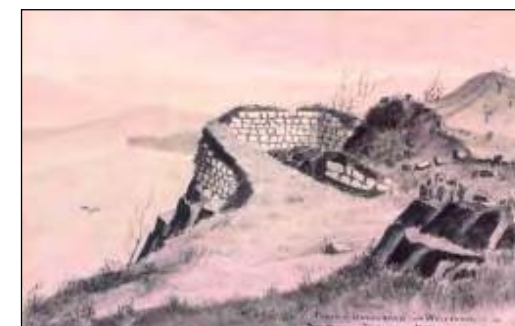
**126 Turret Uncovered on Westernmost of Nine Nicks of Thirkwall. 1883 (Fig 134)**

T45b was located in 1883 by Clayton, but was subsequently destroyed soon after by the operations of the Greenhead quarry (Birley 1961, 28). The view, from the west, shows the turret perched on the crag edge showing the exposed external west face and the internal north and east faces. A mound of earth indicates the position of the south wall, of which two courses of the east jamb of the door are visible. Within the turret is a mass of fallen material and outside the south wall sits a pivot block. The outline of the course of the Wall eastwards towards T45a is visible. A similar view is published by Bruce (1885, 57).

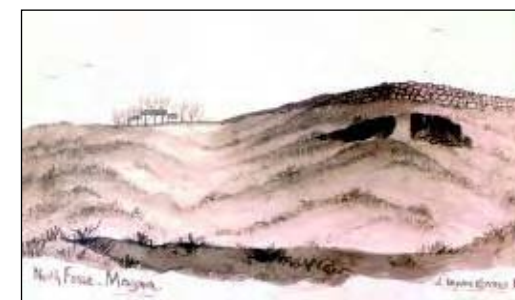
**128 North Fosse ~ Magna. 1883 (Fig 135)**

The view is of the north Ditch of the fort looking east towards Carvoran Farmhouse, which is surrounded by trees. Bruce (1863, 167) noted the distinct profile of the north fosse. A stone field wall is built on top of the line of the north-west angle of the fort, which was uncovered three years later (1886) by Clayton in time for the second Pilgrimage in 1886 (Birley 1998, 80). Fallen fort material has been exposed on the slope below the north-west corner.

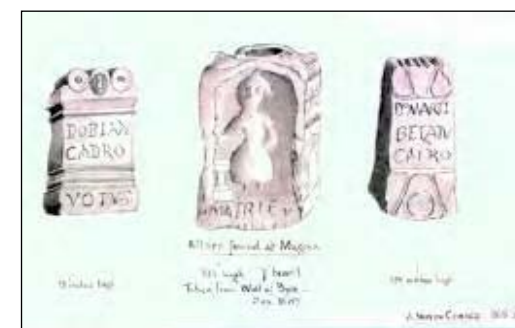
**129 Altars found at Magna. 1883 (Fig 136)**

The depiction is of three altars found at Carvoran. The left-hand one is RIB 1776, the middle is RIB 1785 and that on the right is RIB 1784. The text under the depiction of RIB 1785 says 'Taken from Wall of Byre Sept 1883', whereas the Roman Inscriptions in Britain (Collingwood 1965, 556) says that it was re-discovered in 1886 built into the farmhouse. RIB 1776 and RIB 1784 are now in the Museum of Antiquities, Newcastle and RIB 1785 is in Chesters Museum.

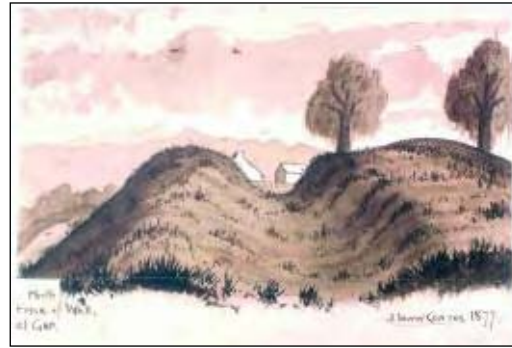
**130 North Fosse of Wall at GAP.** 1877 (Fig 137)  
The drawing, looking east, shows the profile of the steep sided north Ditch with a sharp drop on the north side. Two buildings of Gap Farm are seen straddling the line of the Ditch and in front of these is a stone wall crossing the line of the Ditch. A stone built field wall and two mature trees are seen on the south side of the Ditch. In the background is the outline of Walltown Crag. The drawing is just west of T47b.

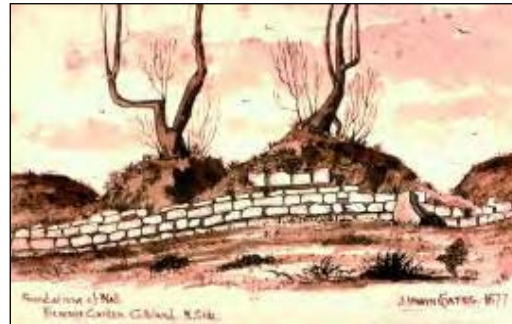
**131 Foundations of Wall. Vicarage Garden. Gilsland. N. Side.** 1877 (Fig 138)  
Up to five courses of Wall face are visible, the top of the Wall being covered in turf with two trees growing from the mound. Three cuttings have been made across the width of the Wall and in front are four small piles of Wall core. This section of Wall had been exposed not long prior to this by the vicar of Gilsland, Rev A Wright (Ferguson 1877-8, 24).

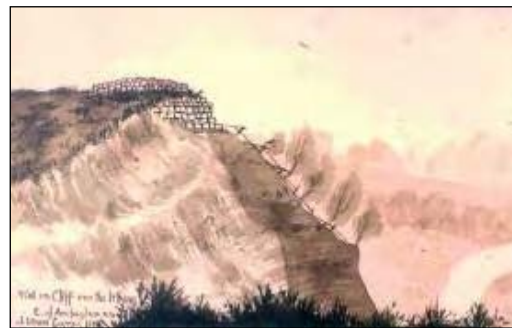
**132 Wall on Cliff over the Irthing E. of Amboglanna.** 1879 (Fig 139)  
This shows the section of Wall east of Mc49 (Harrow's Scar) overlooking the steep west bank of the Irthing river. At least nine courses of facing stones are visible above two courses of foundations, the rest of the Wall having been taken away by land slips. The bare slope above the curve of the river has a wooden fence and a line of five trees. An 1848 watercolour by H B Richardson (Bidwell 1989, pl 6) shows the Wall perched on top of the river escarpment and evidence of the river undermining the Wall.

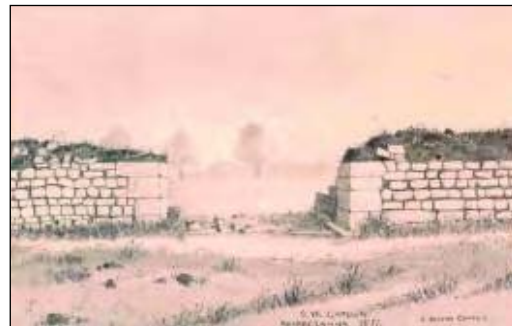
**133 S.W. Gateway. Amboglanna.** 1877 (Fig 140)  
This single portal gate had been exposed in 1850 (Birley 1961, 199) The drawing, from the west, shows the pier blocks on both sides of the gateway with up to eight courses of facing stones in place as well as the portal threshold within which are blocks of fallen masonry. The top of the fort wall is turf covered. Several mature trees are depicted inside of the fort.

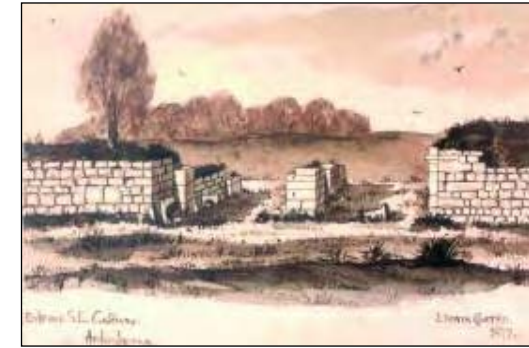
**134 Exterior S.E. Gateway. Amboglanna.** 1877 (Fig 141)

This gate, excavated in 1852, shows both of the gate portals, central pier and a short section of the external face of the east wall of the fort flanking the gateway. On the north side of the south portal is a pivot block and on the south side are two arched window heads. A possible voussoir for the gate arch is lying within the north portal. An engraving of the gateway in 1852 (Wilmott 1997a, 5) shows the portals fully excavated and the window heads lying outside the gateway. By 1877 vegetation is growing within the portals and the window heads moved to the position shown in the drawing. The window heads have now been incorporated in the new visitor and education centre. A mature tree is growing in the fort close to the east wall and a large mass of trees grows on the west side of the fort.

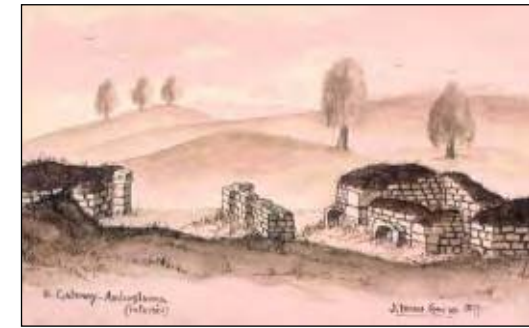
**135 E. Gateway ~ Amboglanna (interior).** 1877 (Fig 142)

The view from inside the east gateway shows the two portals, the central pier as well as the walls of the guard chambers, the southern one having been excavated, the northern one seemingly only partly exposed. Two arched window heads are depicted partly buried within the southern portal. The wall tops of the guard chambers are turf covered.

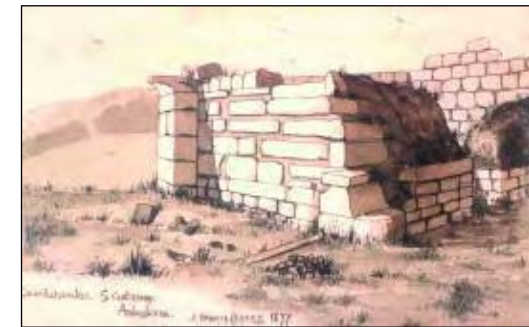
**136 Guardchamber. S. Gateway Amboglanna.** 1877 (Fig 143)

This was excavated in 1851 by H G and W S Potter when Henry Norman was owner of the site. This is a detailed view of the west portal of the south gate showing the gate pier blocks and the impost block to carry the arch. The door of the west guard chamber and the internal face of the west wall are depicted. A voussoir is exposed within the gate portal and the threshold at the rear of the gate is partially visible.

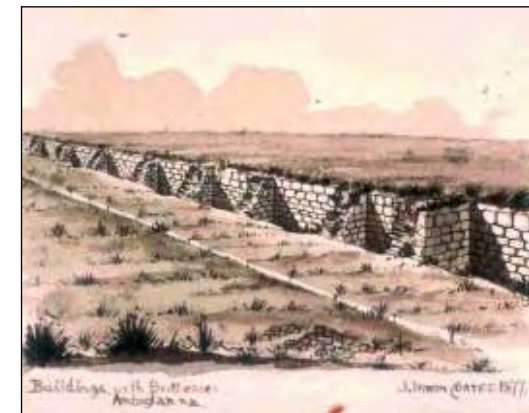
**137 Buildings with Buttresses. Amboglanna.** 1877 (Fig 144)

This view is of the south wall of the south granary, excavated in 1859, and used as a ha-ha (retaining wall) for the garden in front of the farmhouse. The granary was subsequently excavated between 1987-91 (Wilmott 1997a, 8). Eight of the buttresses are depicted with the walls standing seven courses high. A line of partially covered stone slabs indicates the flooring level of an adjacent building south of the granary.

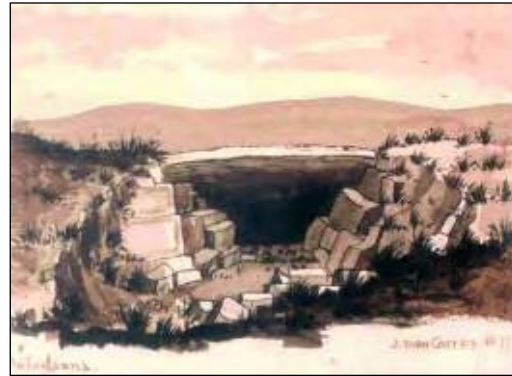
**138 Amboglanna. 1877 (Fig 145)**  
This drawing shows the eastern *porta quintana* of the fort, which was excavated by WG Potter in 1850 (Potter 1855a). The excavation has clearly been left open for the 27 years between excavation and Coates' visit (Compare images of the gate from 1855 and the 1992 re-excavation in Wilmott 1997a, fig 40).

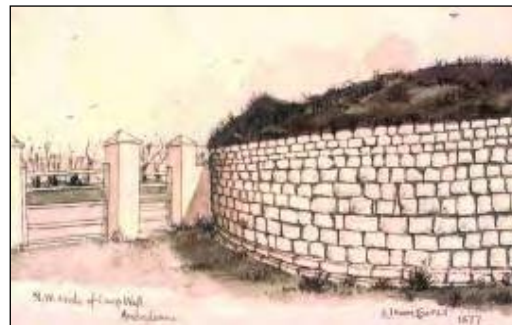
**139 N.W. angle of Camp Wall. Amboglanna. 1877 (Fig 146)**  
The angle tower wall was exposed in 1831 by the proprietor Thomas Crawhall (Hodgson 1840, 207). The drawing shows the turf-topped north-west angle of the fort wall standing ten courses above two foundation courses. A two-part gate is erected on the line of the Wall. The three large gate pillars are each topped with a chamfered capstone. The pedestrian entrance, on the east side, has a six-bar gate and the carriage entrance a five-bar gate. A line of bushes grows on the north side of the road outside the fort. Bruce (1863, 177) depicts the gateway with a section of Wall joining on to the angle of the fort but comments that this portion of the Wall had recently been removed to allow for a new entrance to the house.

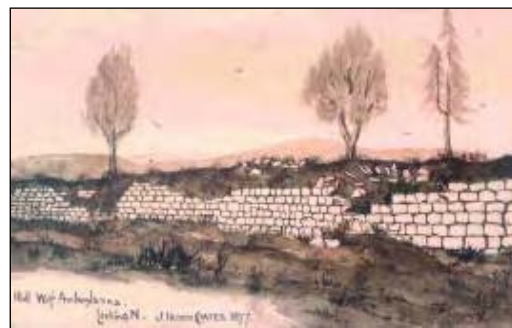
**140 Wall W. of Amboglanna. Looking N. 1877 (Fig 147)**  
The south face of the Wall west of Birdoswald stands at least seven courses high, the earth capping containing core work. Sections of the Wall face show evidence of either collapse or robbing of the stone work. Three mature trees are shown on the north side of the Wall. In the distance to the north-west is the outline of the only remaining wall of Triermain Castle, which had been built with re-used Roman Wall stone.

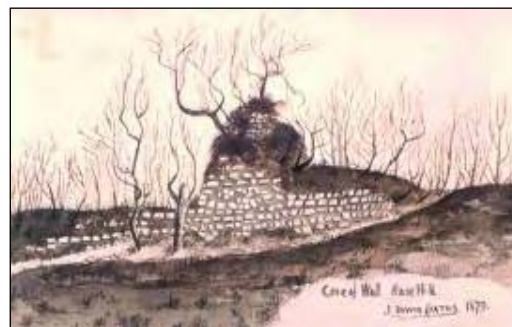
**141 Core of Wall. Hare Hill. 1879 (Fig 148)**  
This depiction, possibly of the north face, shows the original core work laid horizontally and a large amount of scrub and small bushes cover the surviving Wall. The north face of the Wall, including a centurial stone found to the west of T53a (RIB 1958) was re-built in the 19th century by Mr Marshall, the Earl of Carlisle's architect (Bruce 1933, 182).

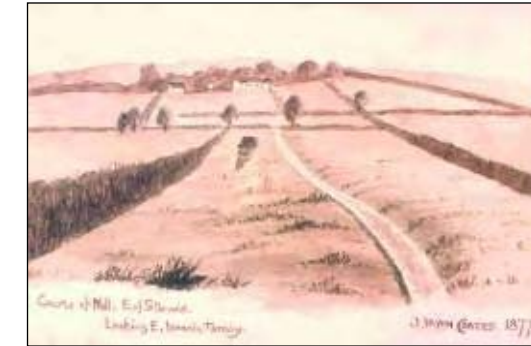
**142 Course of Wall. E. of Stanwix. Looking E. towards Tarraby. 1877 (Fig 149)**

This drawing, made from close to the crest of Wall Knowe and east of Mc65, shows Tarraby Lane on the line of the Wall with a shallow depression, partially water-filled, indicating the position of the Ditch. A hedgerow grows along the north edge of the Ditch and another is on the south side of the Wall enclosing a field system. Two hedgerows in the middle distance cross the line of the Wall. In the distance are several buildings in the village of Tarraby.

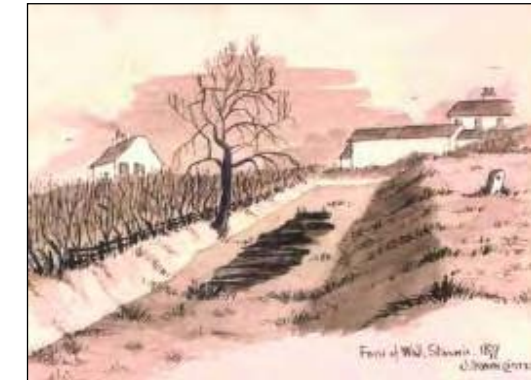
**143 Fosse of Wall. Stanwix. 1877 (Fig 150)**

The position of this drawing appears to be looking eastwards between the river Eden and the fort of *Petriana*. Well defined slopes indicate the line of the partially filled north Ditch which has a pool of water in the bottom. A mature tree grows on the north slope, behind which is a wooden fence and a hedge-line parallel to the Ditch. In the background the Ditch has been filled in and a wooden building with vertical planking erected across it. Behind this is a two-storey house with three upper windows and centrally placed chimney stack. On the north side of the Ditch is a two-storey building with two windows at one end and a chimney stack at the other. In the area of the berm between the south side of the Ditch and the Wall is an upright stone possibly used as a sheep or cattle rub.

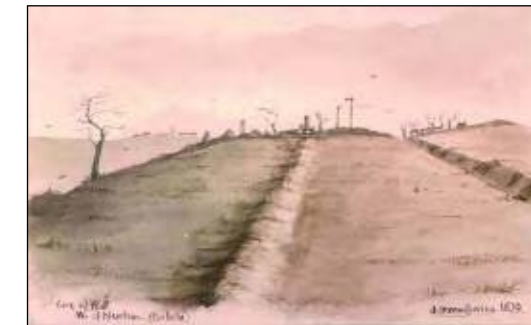
**144 Core of Wall. W. of Newtown ~ (Carlisle.) 1879 (Fig 151)**

The drawing is east of Knockupworth Gill in the vicinity of T67a. A low covered mound marks the line of the Wall, south of which is the outline of the Vallum at Davidson's Bank. The ground to the north of the Wall slopes down to the River Eden. The drawing depicts the distant view of Stanwix, in Carlisle, with its church, the two chimney stacks of the Bone Manure and the Varnish Works at Primrose Bank as well as the engine shed of the North British Railway on the Carlisle-Silloth line (Ordnance Survey map, 1865, sheets 23/2&3). A tall railway signal is evident and south of the Vallum are five houses surrounded by trees in the vicinity of the Newtown area.

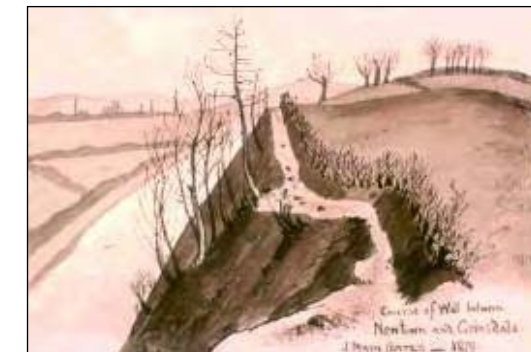
**145 Course of Wall between Newtown and Grinsdale. 1879 (Fig 152)**

The Wall, situated on the steeply sloping south bank above the River Eden, is shown as a raised mound surmounted by a hedgerow in front of which is a footpath. The Wall makes a dogleg turn at this point. In the distance is the outline of several large chimneys and Carlisle Cathedral.

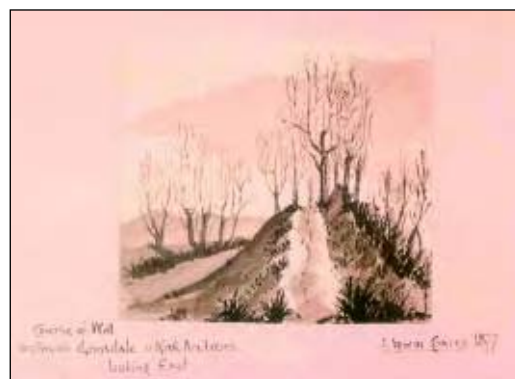
**146** *Course of Wall between Grinsdale & Kirk Andrews, looking East.* 1877 (Fig 153)  
The depiction is of Long Bank between Ladylands Lane and Kirkandrews. The earth-covered mound of the Wall has a hedgerow growing on top as well as a group of mature trees. A footpath is on the berm with the ground sloping away to the north Ditch.

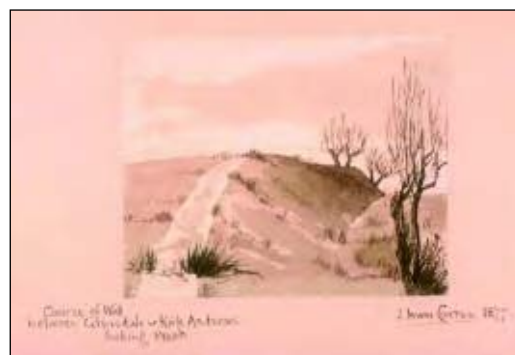
**147** *Course of Wall between Grinsdale & Kirk Andrews, looking West.* 1877 (Fig 154)  
The drawing is in a similar position to Fig 153. Although there is no discernable trace of the Wall itself the drawing shows a path on the position of the Wall berm. The ground slopes away to the north.

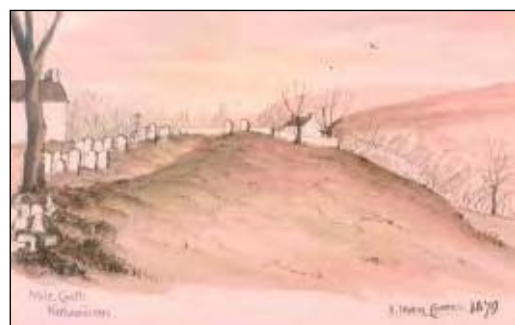
**148** *Mile Castle, Kirkandrews.* 1879 (Fig 155)  
The view shows the graveyard of (the now demolished) Kirkandrews-upon-Eden church. An earlier 12th century church, dedicated to St Andrew, had been built on the line of the Wall (Whitworth 2000, 55). Mc70 (Brae Lees) is now thought to be further north (p 181) but Coates was following the information supplied by Bruce who said there was a milecastle here (Bruce 1863, 210). Two buildings are depicted adjacent to the graveyard, one of which is probably related to Eden Farm. A stone pile, perhaps of re-used Wall material from the earlier church, lies next to a tree within the graveyard.

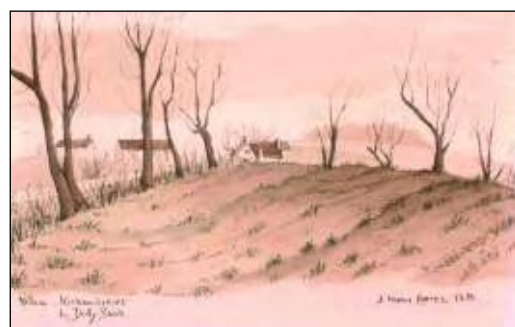
**149** *Vallum, Kirkandrews by Dolly Bank.* 1881 (Fig 156)  
The view, looking west, shows the Vallum mound surmounted by a number of trees with the road from Carlisle to Bowness on the left. Several buildings in Kirkandrews are depicted. The drawing seems to be on the east side of the Carlisle-Silloth section of the North British Railway as it passes through Kirkandrews.

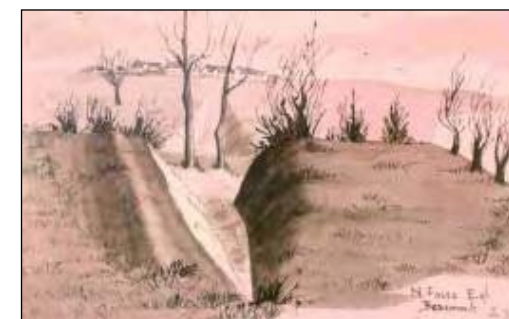
**150** *N. Fosse E. of Beaumont.* 1879 (Fig 157)  
The view shows the low mound of the Wall, the well defined north Ditch and the bank of the Eden river. The drawing is west of Mc70 and overlooks the Monkhill Beck. At least eight buildings in the village of Beaumont are depicted as well as the church of St Mary

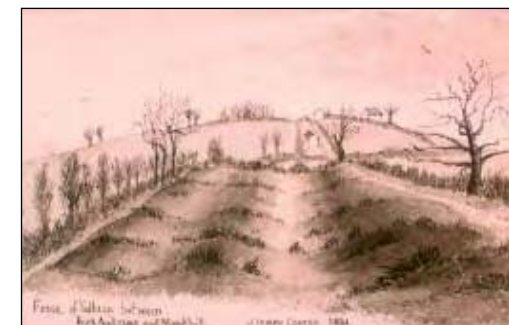
**151** *Fosse of Vallum between Kirk Andrews and Monkhill.* 1881 (Fig 158)  
Looking west, the drawing shows the hedge-lined Carlisle to Bowness road as it approaches Monkhill with the line of the Vallum on the south side. A number of fields are outlined by hedgerows and trees. Three buildings at Monkhill are depicted one of which is on the north mound of the Vallum. The building adjacent to the road may be the Drovers Rest Public House.

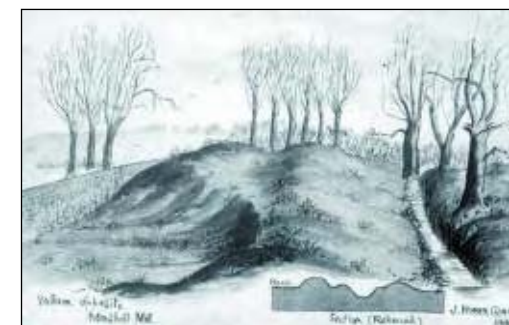
**152** *Vallum opposite Monkhill Mill.* 1881 (Fig 159)  
The depiction, looking west, is of the Vallum at the west end of Monkhill, on the west side of the crossroads and the Mill Race. The outline of the Vallum and mounds on both sides are distinct and the bottom of the cutting is water-filled. Several large trees grow within the Vallum and a line of five mature trees and a hedgerow cross the line of the Vallum. In the foreground the south face of the Vallum has been partially removed. A stone wall follows the line of the Carlisle-Bowness road. A cross section of the Vallum showing the road, mounds and Ditch has been included. In the background is a building with a chimney stack on the north gable.

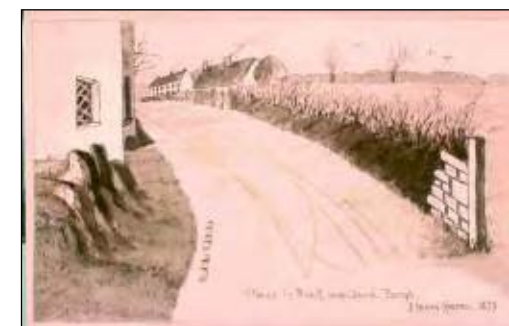
**153** *Stones in Road near Church, Burgh.* 1879 (Fig 160)  
The drawing, looking west from the east end of the village, shows the corner of the old vicarage with a lattice window, on the south side of the road leading into Burgh-by-Sands. A line of seven stones on the south shoulder of the road is depicted which is most likely the north face of the Wall (see comments on Fig 161), which had also been noted in 1877 (Daniels 1978, 247). A row of cottages with a haystack at the east end is on the north side of the road adjacent to the two storey Lowther Arms Inn (now the farmhouse of Demesne Farm). A hedgerow on an earth bank is on the north side of the road ending in a gate post with an associated short section of stone walling.

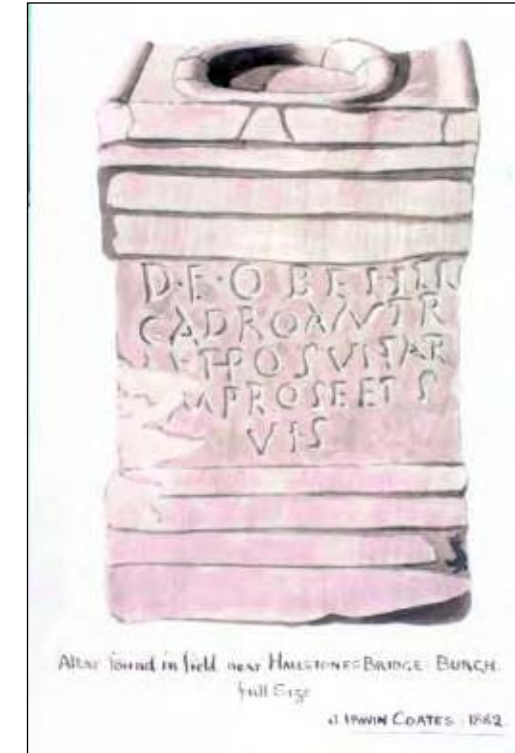
**156 Altar found in field near HALLSTONES BRIDGE: BURGH.** full Size. 1882 (Fig 163)  
 This altar (RIB 2039), dedicated to the god Belatocadrus Antronius Aufidianus, was found in 1792. A depiction of it is in Bruce (1863, 213). Collingwood gives the location of the altar as Rindle House, Burgh-by-Sands. Its present location is not known to the author.

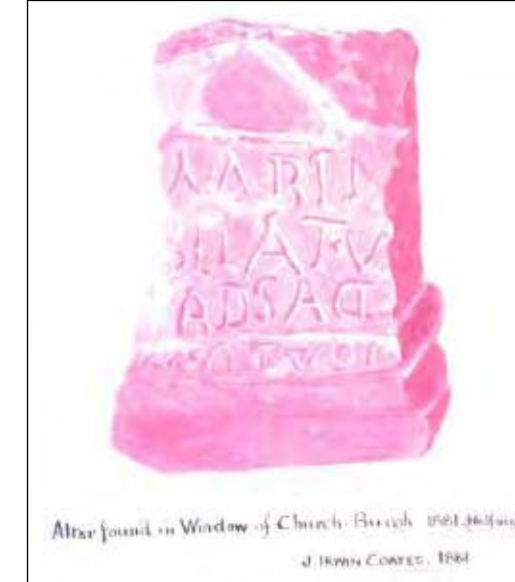
**157 Altar found in Window of Church: Burgh.** 1881 (Half Size). 1881 (Fig 164)  
 The sandstone altar, 6in × 9in (152.4mm × 228.6mm) (RIB 2044), was found in 1881. It is dedicated to Mars Belatucadrus, and now in Tullie House Museum, Carlisle.

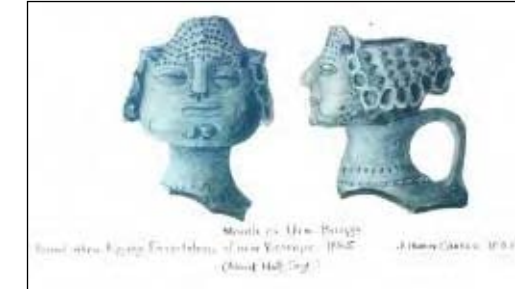
**158 Mouth of Urn: Burgh.** Found when digging Foundations of new Vicarage. 1885 (About Half-Size). 1885 (Fig 165)  
 The drawing depicts a female face and neck forming the top of a pottery urn. The figure has hair in ringlets and the forehead is decorated with a stippling which may be some form of body decoration. Of Roman origin it dates to the 3rd–4th century. This urn was shown to the members of the 1886 pilgrimage on 3rd July (CWAAS 1880, 150) and is now on public display in Tullie House Museum, Carlisle.

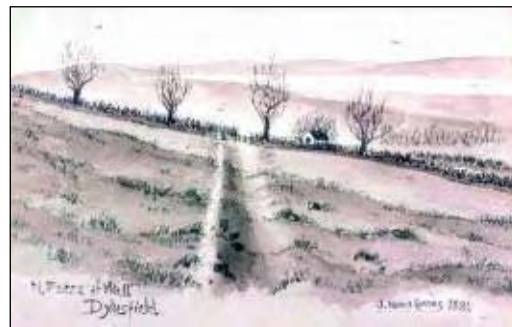
**160 N. Fosse of Wall. Dykesfield.** 1881 (Fig 167)  
The depiction, looking west, is in the vicinity of T72b and Mc73, on the west slope of Watch Hill. The line of the north Ditch is distinct with some stonework exposed within it and on the north side. The Wall itself is discernable as a slight raise. A line of trees and a hedgerow with a wooden gate entrance cross the line of the Wall at right-angles indicating the line of the road north from Dykesfield. A small cottage is close to the road on the north side of the Wall. In the background Ridding Sough flows across Burgh Marsh towards the Solway.

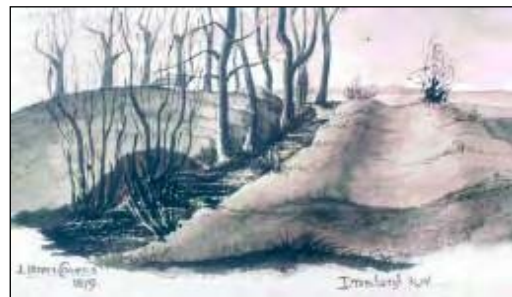
**161 Drumburgh N.W.** 1879 (Fig 168)  
The depiction shows a water-filled, tree-lined ditch, which must be that of the right-angled medieval grange enclosure which crossed the north-west angle of the fort (Daniels 1978, 251). The top of a farm building can be seen which must be situated in the south-west quadrant of the fort. Coates must have mistaken the medieval ditch and banks for those of the fort, as there are no surface traces and excavations did not begin until 1899 (Haverfield 1900–1, 81).

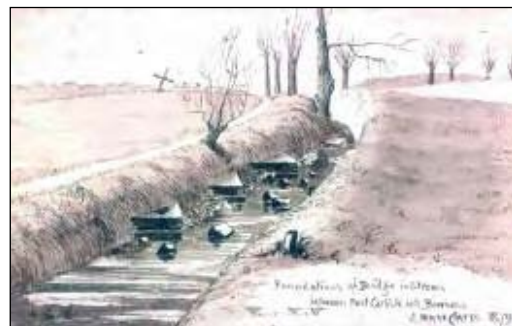
**162 Foundations of Bridge in Stream between Port Carlisle and Bowness.** 1879 (Fig 169)  
The depiction shows three large wedge-shaped blocks, which must have been associated with a Roman culvert through the Wall, partly exposed in the bank of a watercourse, which flows in a northerly direction into the Solway Firth. The Wall crosses the stream close to the estimated position of T79a. The nearest block seems to have a recessed hole in the top. A number of blocks and stones are in the bottom of the stream. A small sketch gives the measurements between the blocks: 3ft (0.9m) between the north and central blocks and 6ft (1.8m) between the central and southern blocks. The sketch shows a similar shaped block in the east bank of the stream. No discernable traces of the Wall or Ditch remain but a path or track follows the line of the stream and this indicates the line of the Wall. In the distance are the roofs of two buildings and a four-sailed windmill in Bowness village.

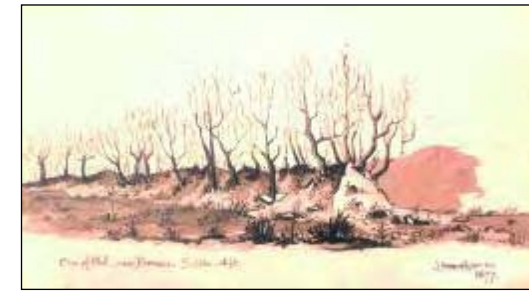
**163 Core of Wall ~ near Bowness: S. side.** 4ft. 1877 (Fig 170)  
The mound of the Wall is covered in small trees and bushes, with little evidence of the facing stones which have been robbed out. Horsley (1732, 157) had reported it to be 10ft (3.05m) high half a mile east of Bowness, and that gunpowder was used to bring it down (Daniels 1978, 253).

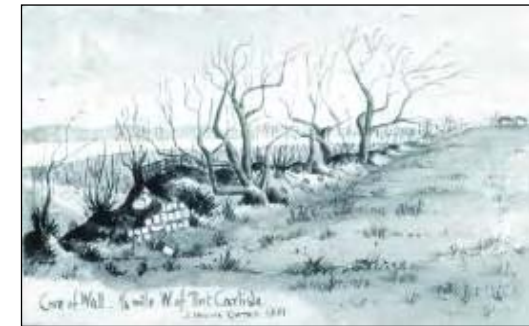
**164 Core of Wall ~ 1/4 mile W. of Port Carlisle.** 1881 (Fig 171)  
The site is west of Mc79. The view, looking east, shows the line of the Wall although it is covered in trees and bushes and a wooden fence has been erected on top. Three courses of the south face of the Wall are visible at the west end but much has been robbed (Jenkinson 1875, 187). In the background several houses in Port Carlisle are depicted.

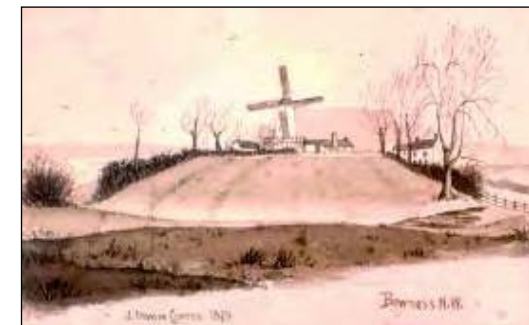
**165 Bowness N.W.** 1879 (Fig 172)  
The depiction shows a windmill with four sails or 'sweeps' and wooden cantilevered gantry situated in the north-west corner of the fort together with the kiln and associated buildings (Hughes 1973, 355). The windmill, owned by Sarah Lawson, was demolished between 1880–85 (Hughes 1972, 126). A section of the water-filled west Ditch of the fort is outlined. Ridge and furrow are evident in the field in the north-west corner of the fort. Mill Cottages are seen on the south side of the Bowness-Silloth road.

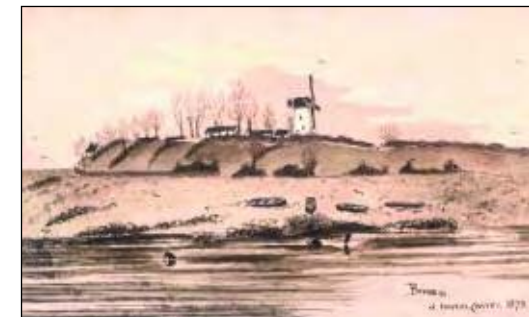
**166 Bowness.** 1879 (Fig 173)  
The view is of the shore of the Solway Firth at low tide with the ground rising towards Bowness. Four small boats are depicted on the shoreline. The Bowness windmill is situated in the north-west corner of the fort, as are several other buildings associated with the mill. A hedgerow on the headland indicates the line of the north wall of the fort. Running towards the shore at right angles from the fort are a number of hedgerows.

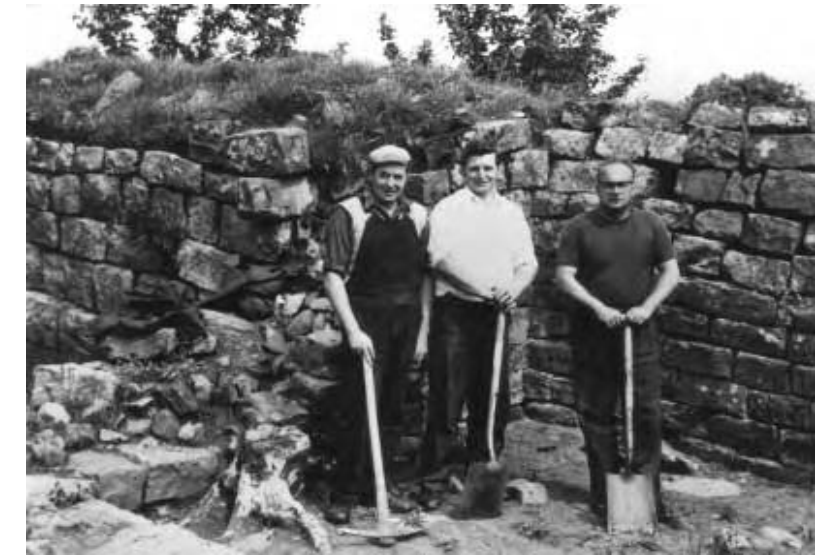
Fig 175  
Consolidation team at  
Black Carts (T29a).

The site of Black Carts, taken into guardianship in 1970, was covered with a line of trees and scrub, although some of the south face of the Wall and T29a had been exposed by John Clayton in 1873. After removing the trees and scrub the masons exposed and consolidated the north face of the Wall as well as T29a (Fig 175). A series of photographs taken by Mr Anderson showed the Wall as left by Clayton and its subsequent re-building, as well as work in progress and the finished work. Anderson, in a taped transcript of the photographs he took of this section of Wall, made some comments and observations. "I think Clayton must have been a very thoughtful fellow; he also appears to have the public in mind, or visitors to the Wall. When he exposed any Wall section, it was always an easy section to reach."

He took a couple of photographs to show the difference between Clayton core packing and Roman core within the Wall, and also how the Roman core work and lime mortar was built in layers, making a tie across the Wall each time, for strength. He notes that there were "no chamfered stones at Black Carts but what we did find in position were three centurial stones (Charlesworth 1973, 97); one on the south face west of the turret, on the lower courses, and two in position on the north face, which is supposed to be unusual, as an expert told us they were only found on the south face." Another centurial stone was located fallen on the north side of the Wall 82m west of the turret (Wright and Hassall 1972, 354, 12).

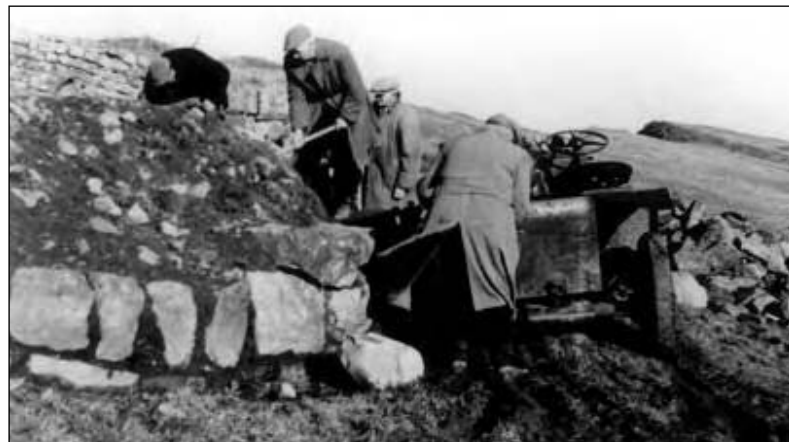
Fig 178  
Consolidation team at work  
at Mc42, Cawfields.

The Cawfields section of Wall stretches for a distance of 1.2km. Within this sector are T41a, T41b and Mc42 (Fig 178). The milecastle was exposed by Clayton in 1847–8 and the turrets located in 1912 by F G Simpson (Simpson 1976, 108). Consolidation work first began here in 1960, the year it came into guardianship, and continued through until 1973. Anderson noted that the milecastle had "become mostly covered again with soil and turf" and that the south face of the Wall had also been exposed, perhaps at the same time as the milecastle, from the field entrance gate west of the milecastle as far as Thorny Doors. He said that there were a few courses of original or undisturbed face work.

"I lime pointed the face joints of the original work, but Clayton work I left 'angry' with outline pointing. The north face of the Wall

was covered with soil and shrubbery and well hidden from view with the exception of the top course or so in the milecastle area. To the east of Thorny Doors the Wall was below ground level and for the majority of the distance there was a dry-stone wall built along top."
