# Hadrian's Wall

Archaeological Research by  
English Heritage 1976–2000

*edited by Tony Wilmott*

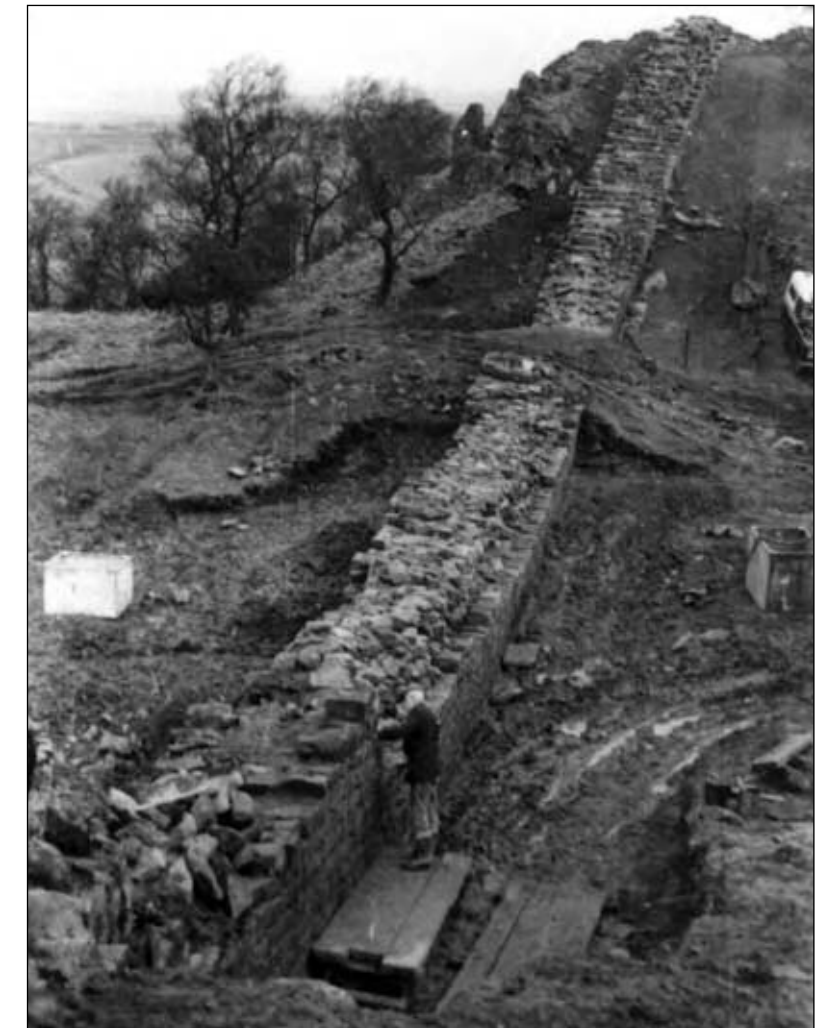
Fig 179  
Consolidation on the south  
face of the Wall at  
Walltown.

Of all of the sections of Wall that Anderson helped expose, his favourite was at Walltown Crags (Fig 179). He said:

“Walltown is one of the best and most interesting of all the sections of the Wall I have had the pleasure to expose. There had been no modern interference; even Clayton worked in the area, but for a change he failed to leave his trademark. All the curtain Wall we exposed was original and in an excellent state of preservation and in most cases, it was only necessary to remove the top course or two and the top layer of core for re-setting and waterproofing, and the remainder of the face joints were raked out, removing soil and perished mortar, washing out with water and re-pointed with new lime mortar.”

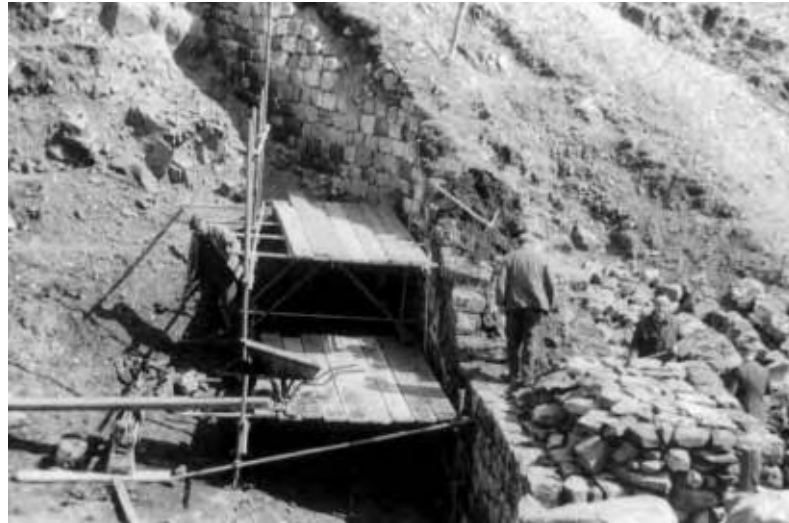
Fig 180  
Consolidation on the north face of the Wall at Thorny Doors, where the original Wall face was 10ft (3.05m) high.

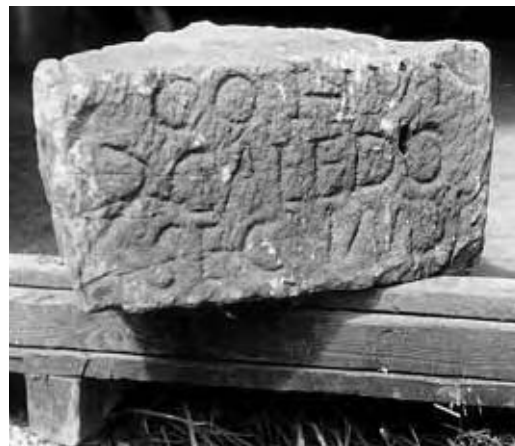
Fig 182  
Centurial stone (COH VI >CALEDO SECUNDI) found at Walltown.

The photographs of this section of Wall show how much was visible prior to work commencing, and there are numerous photographs of the Wall as work progressed, uncovering and consolidating the remains. At least 11 centurial stones were found in material fallen from the Wall as well as one *in situ*

built upside down in the north face of the Wall and their locations noted in the *Journal of Roman Studies* for 1960, 1961 and 1962 (Fig 182).

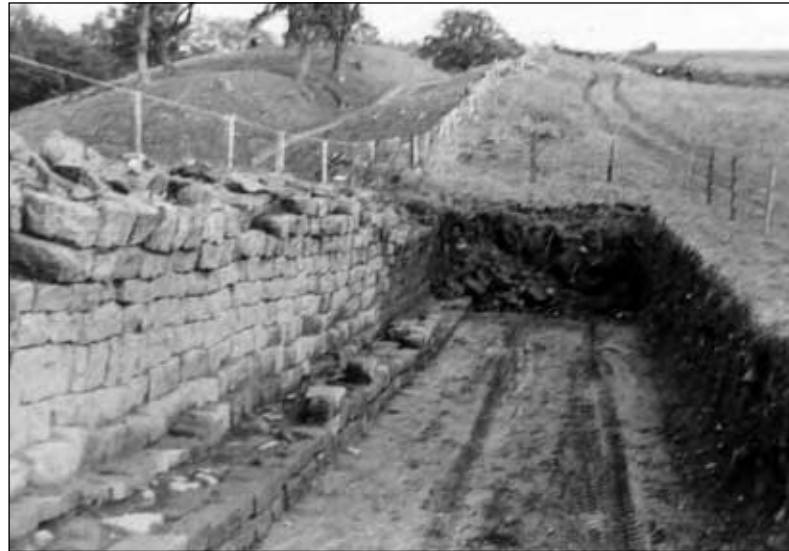
Fig 183 (top)  
The wall face excavated at Willowford, east of the farm.

Willowford and found the Wall with ten courses of ashlar and standing in several places' 8ft or 9ft (2.4-2.7m) high and any amount of stone along the side of the Wall to raise it another course or two.

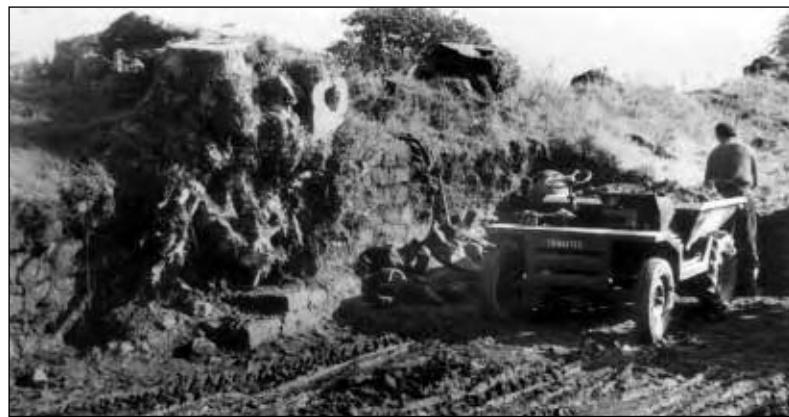
Fig 184 (above)  
Clearance of debris and tree roots from the Wall at Willowford.

As the Wall was being opened up, by pick and shovel, the soil and rubble lying next to and covering the Wall was moved by small dumper trucks and scattered around the farm fields (Fig 184). In parts of the Wall there were more than seven courses of original Roman facing stones *in situ*. He noted the three offset courses at the bottom of the Wall on the north face and the 2in (50.8mm) offset above and related this to the Broad Wall foundations.

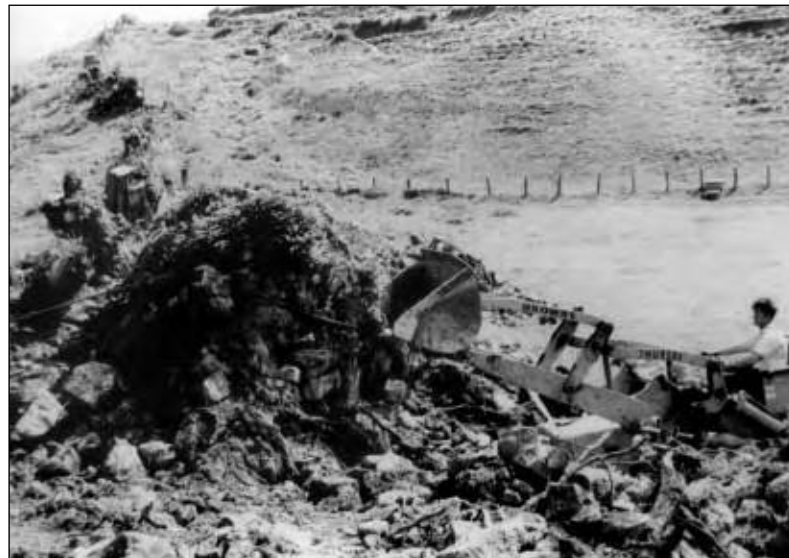
Fig 185 (below)  
Mechanical clearance of rubble near Willowford Bridge.

At the west end of the Willowford section, from the farm to the bridge abutment, a line of mature oak trees was growing on top of the Wall and a field wall had been constructed with re-used facing stones. Anderson said this was the worst section for trees. Once the trees had been felled, the removal of the stumps required the use of heavy machinery on the site so a bulldozer, supplied by Browns of Thursby, was used to ease the root remains free of the Wall and also to move the tree trunks away from the Wall face. A number of photographs show this operation taking place (Fig 185). This was the only time that such a large piece of equipment was used by the workmen along the Wall.

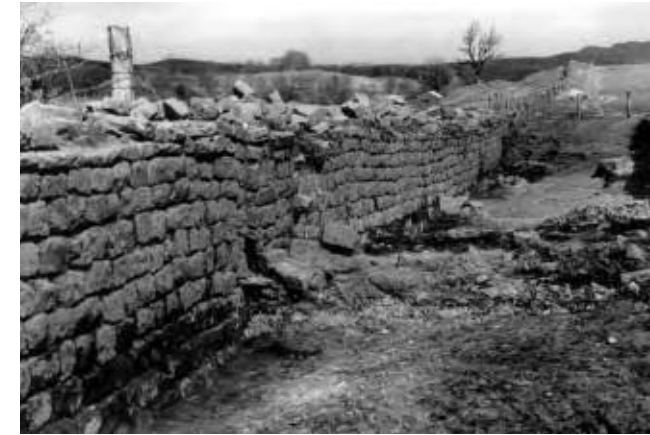
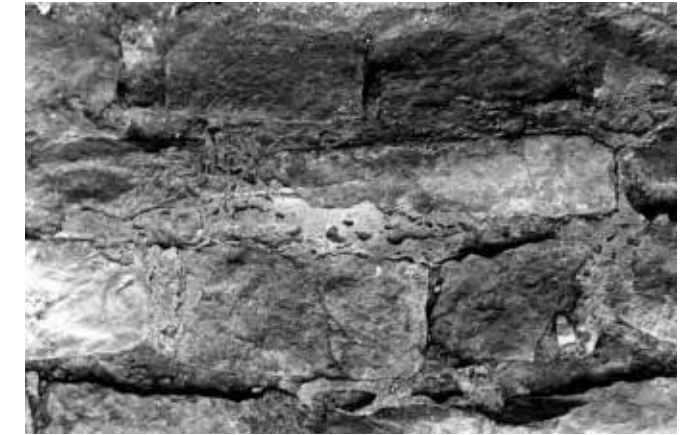
On the north face of the Wall east of the fort Anderson photographed another section of Roman mortar spread, which had partly covered the outline of the individual blocks (Figs 186–7). This method of pointing the facing block joints was applied, as an experiment, to a section of the south wall of the south granary when consolidation was carried out at Birdoswald after the 1992 excavations (Wilmott 1997, 119). This method, as applied by the Romans, may have resulted in the idea that the Wall was white washed or plastered. Anderson notes that once the frost got at it the mortar did not survive very long and soon needed to be replaced with a modern mortar.

Fig 186  
South face of the Wall newly exposed to the east of Birdoswald.
