# HERITAGE A YORKSHIRE & BER

## CASTLE HOWARD MAUSOLEUM

Contact: Susan Daniels, Business Manager, English Heritage, Yorkshire and the Humber Region, Tanner Row, York YO1 6WP Telephone: 01904 601979 Fax: 01904 601999 E-mail: **susan.daniels@english-heritage.org.uk**  HERITAGE AT RISK 2008 / YORKSHIRE AND THE HUMBER / EAST RIDING OF YORKSHIRE (UA)

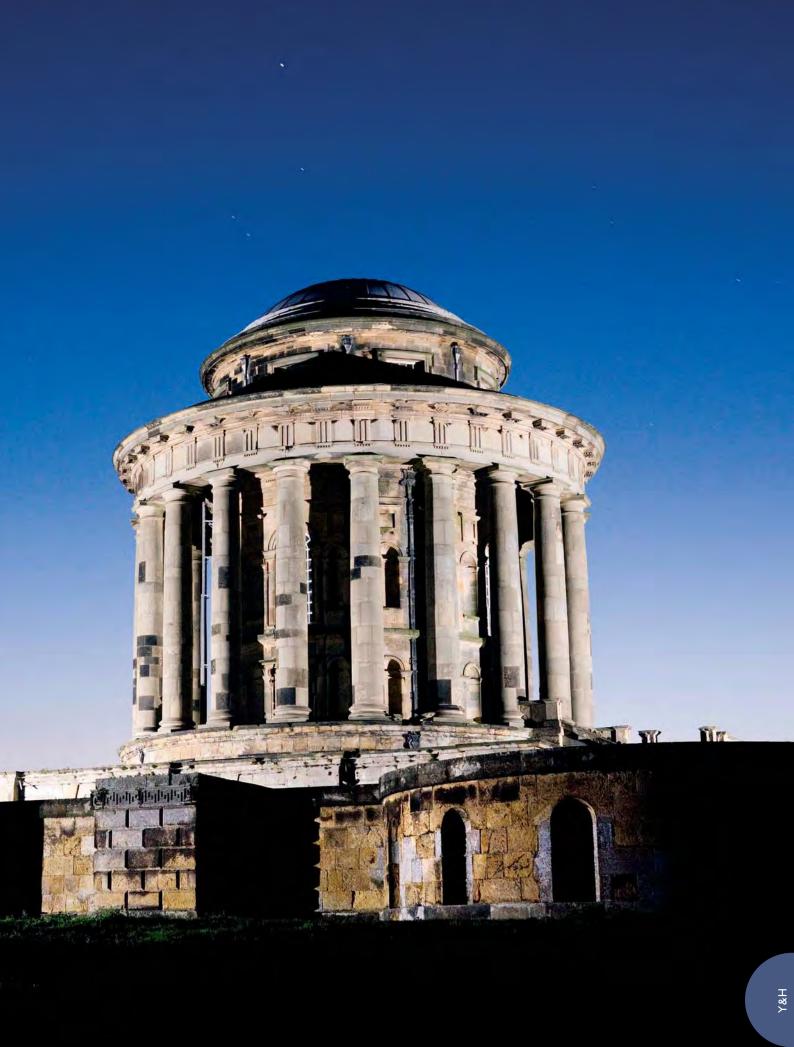
**Castle Howard Estate, Ryedale, North Yorkshire** The Mausoleum, by Hawksmoor, 1729-42, and modelled on the tomb of Metella, is a major feature of the Howardian Hills. Situated on a bluff east of Castle Howard. The columns were repaired with a grant in the 1980s. The entablature and bastions continue to decay. Much of the damage is due to rusting cramps. The staircase balustrade is collapsing.
