Discovery, Innovation and Science in the Historic Environment

Historic England

ISSUE 8 • SPRING 2018

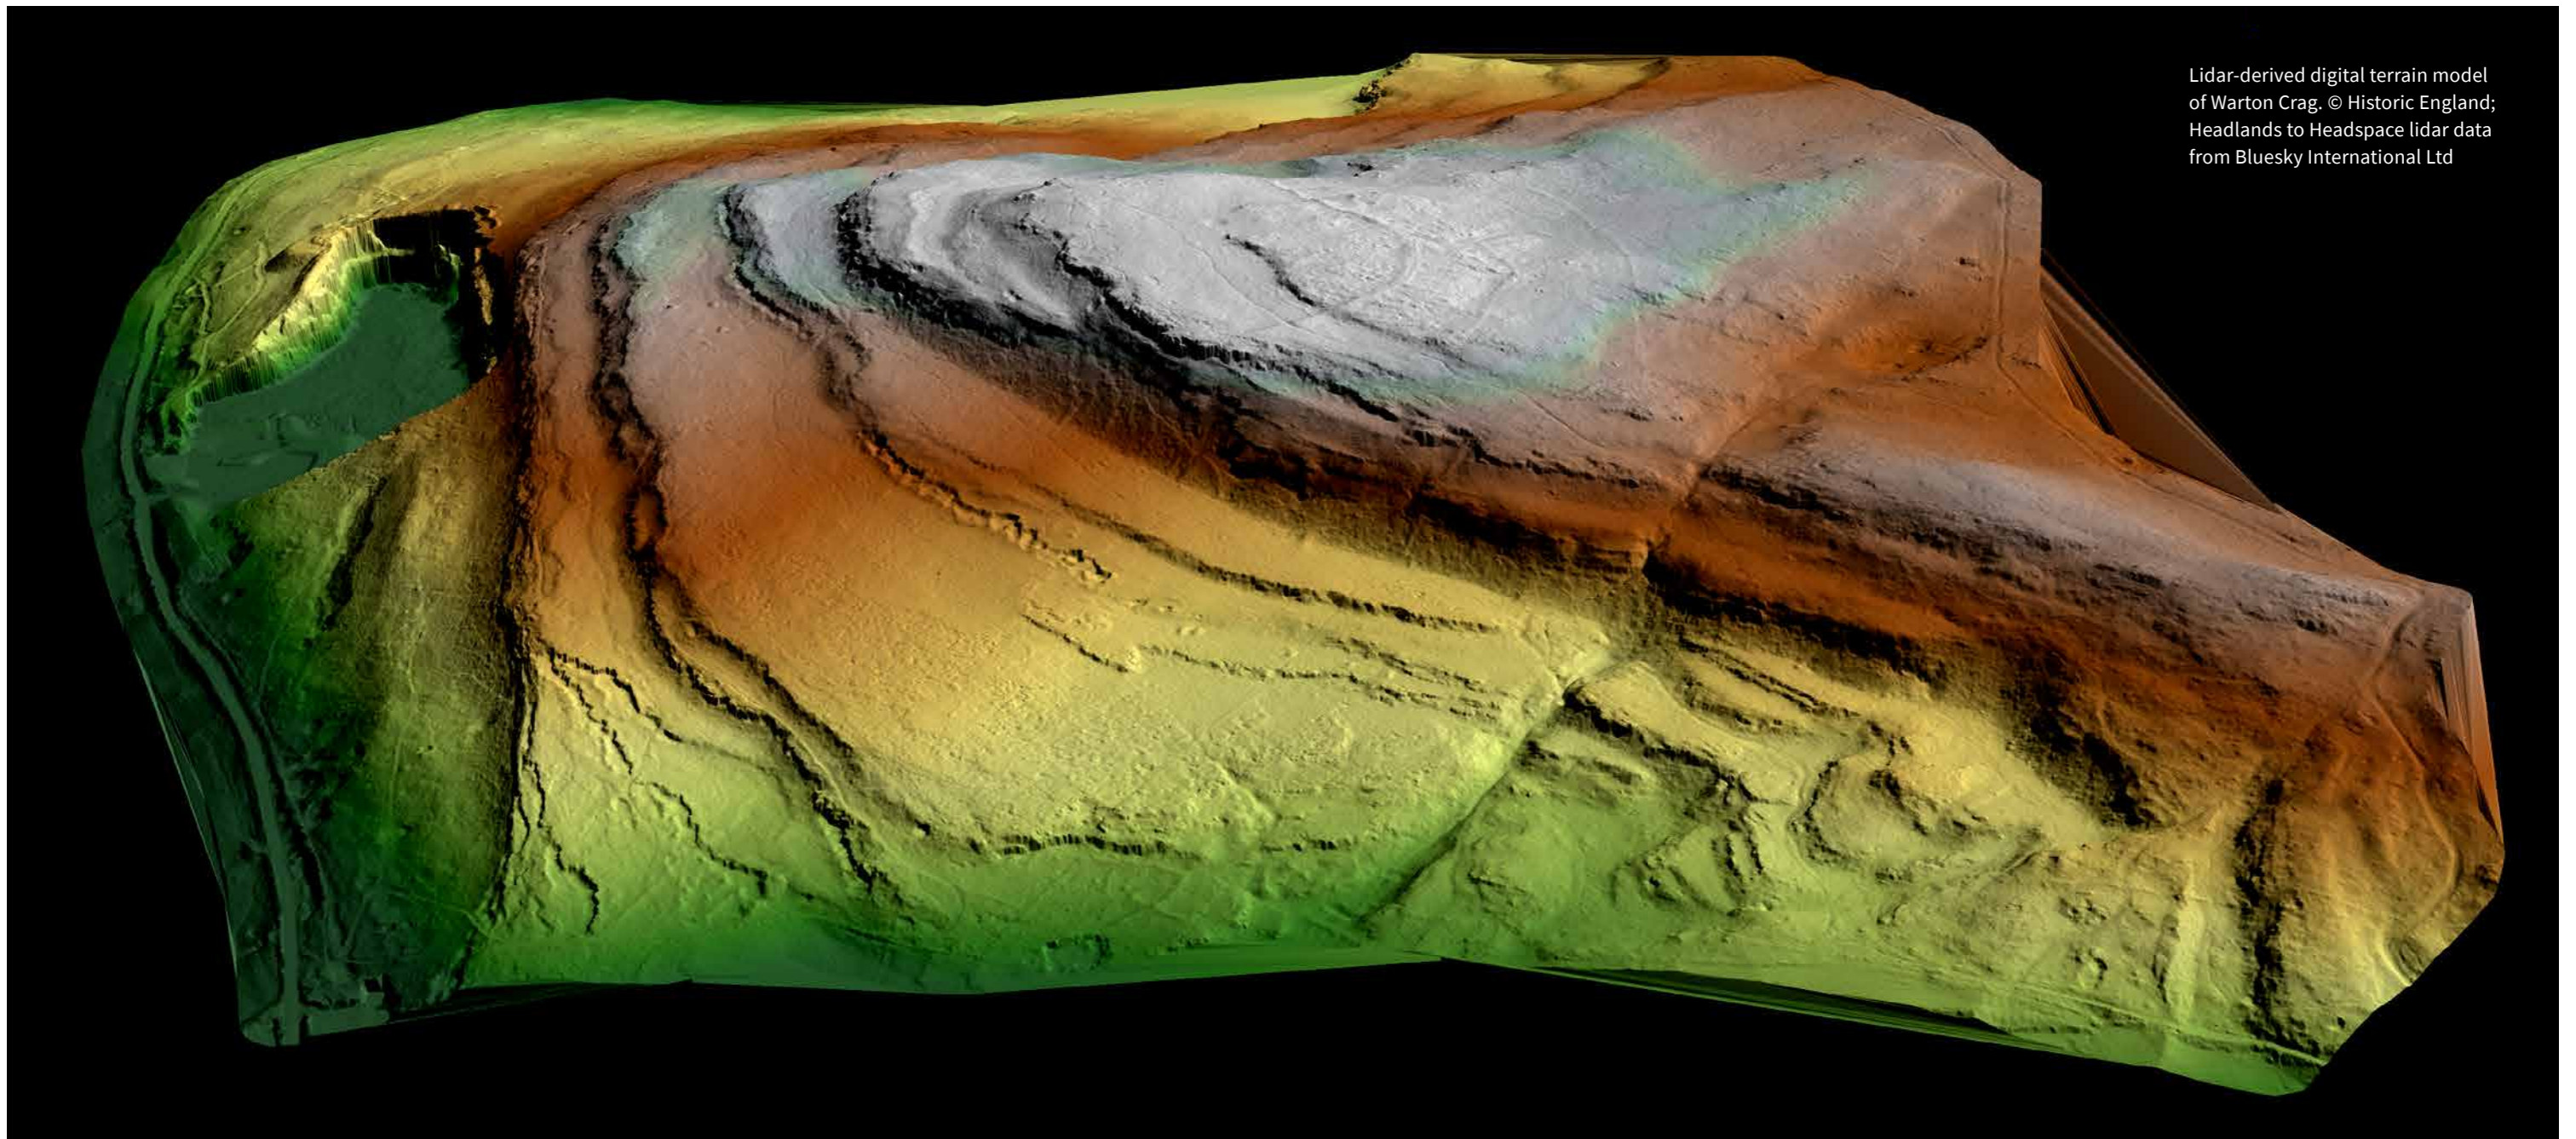
Lidar-derived digital terrain model of Warton Crag. © Historic England; Headlands to Headspace lidar data from Bluesky International Ltd

resolution, the technique can even 'see' through tree canopies to record the terrain beneath. The mapping of the new data, in combination with ground observation, has resulted in a much more detailed and nuanced understanding of the monument, and thrown in to question its hitherto accepted identification as a hillfort >>

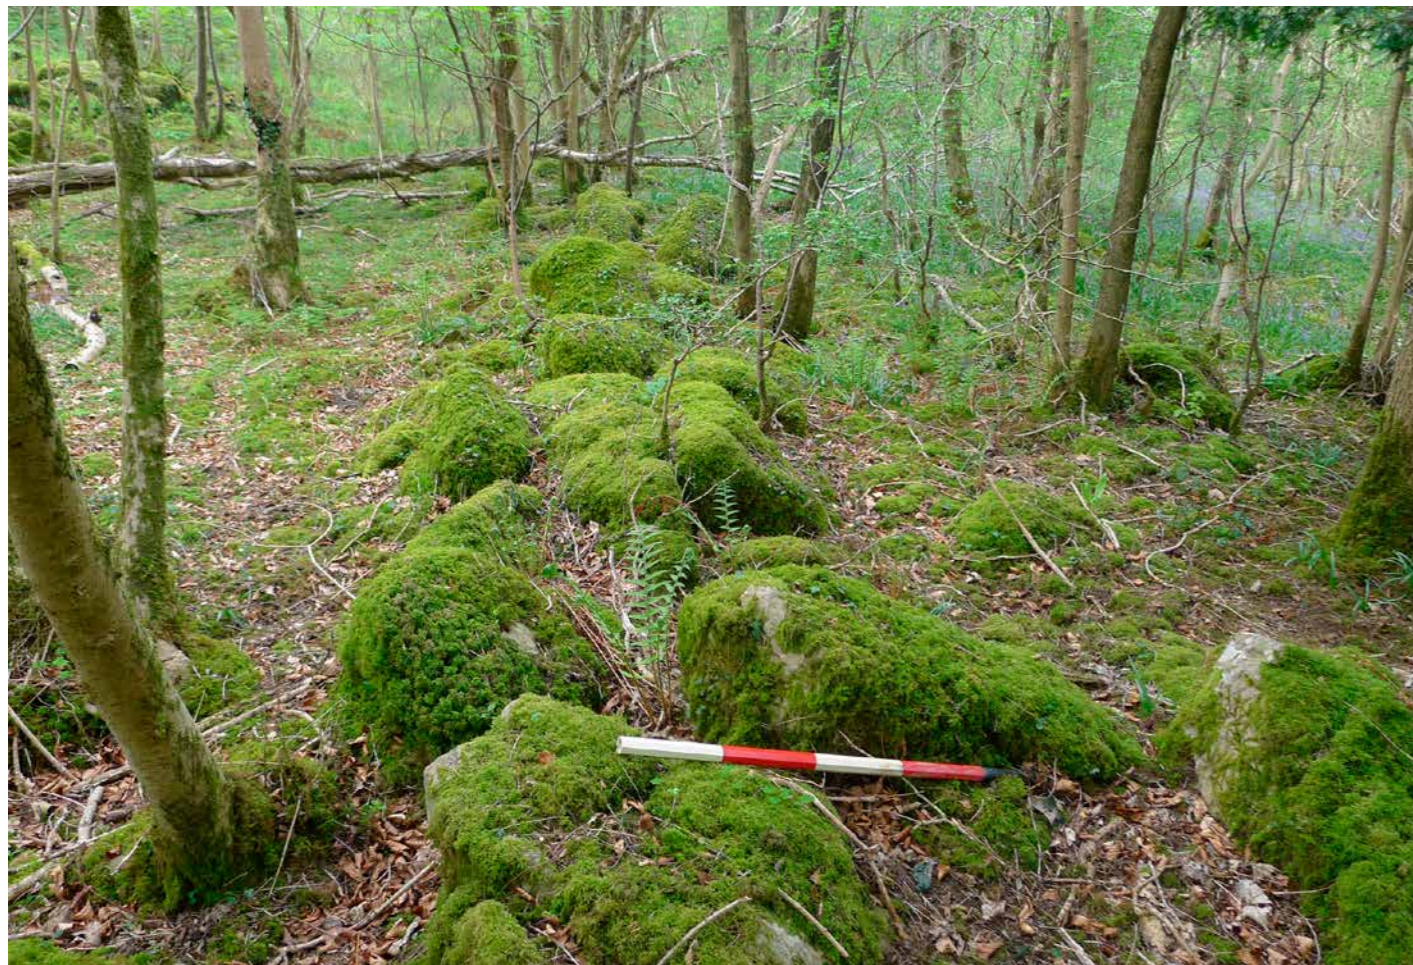
**Left:** Part of the middle circuit of walls, illustrating the scale of the 'defences' and the nature of the obscuring vegetation. © Historic England, Marcus Jecock

containing large areas of exposed limestone pavement – is the most massive. There is no evidence that this inner wall ever continued above the main, steep southern scarp-edge known as Beacon Breast. The lidar survey revealed no surviving internal structures contemporary with the enclosure – indeed the fractured and irregular nature of the bare limestone pavement makes permanent occupation unlikely. The walls of a number of small 'pens' are, however, visible against a low limestone scar just back from Beacon Breast, and a circular depression can be seen towards the centre of the monument. These are almost certainly post-medieval stock enclosures and a dewpond (the latter probably to be equated with Hutchinson's reservoir) for grazing cattle. The visualisations also suggested a number of gaps in each of the three circuits although from the lidar alone it was impossible to ascertain whether these are original entrances or later breaks.

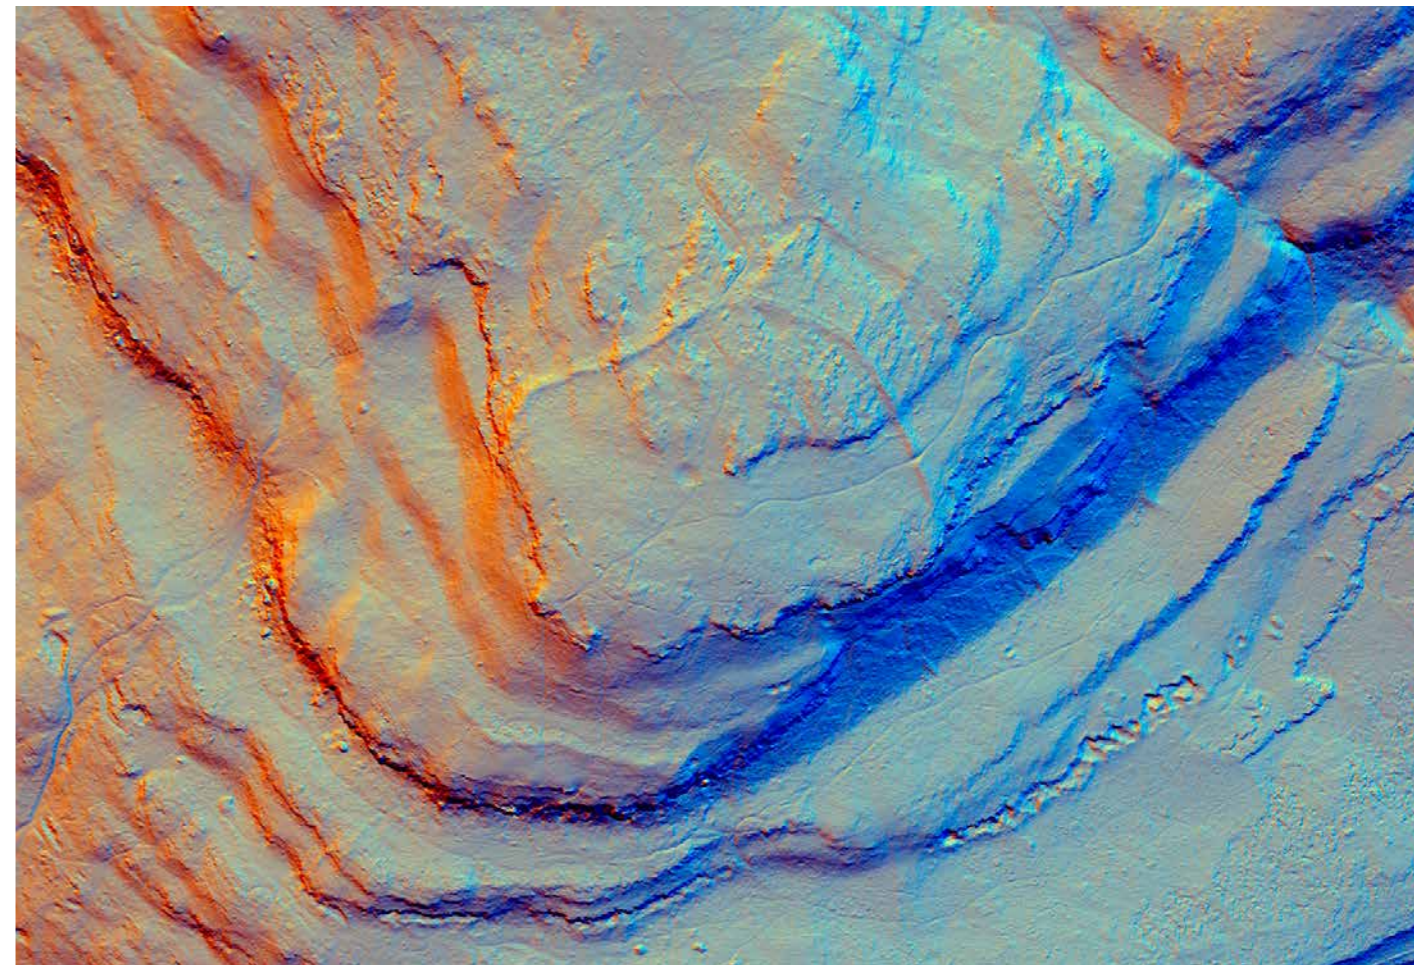
**Right:** Plan view of the circuits of the Warton Crag hilltop enclosure, as revealed by a 16-direction hillshade visualisation of the lidar data. © Historic England; Headlands to Headspace lidar data from Bluesky International Ltd.

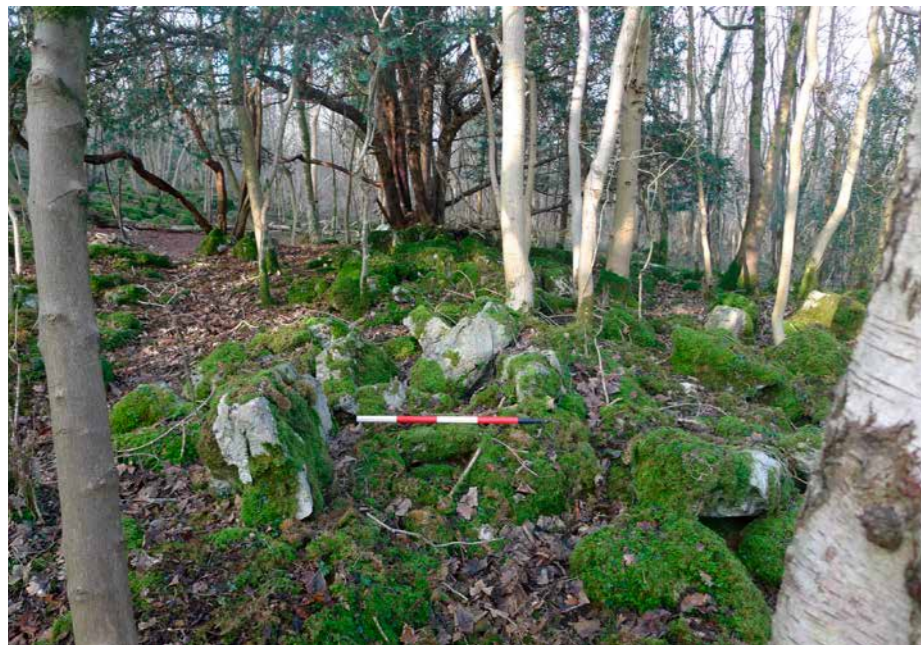
**Left:** Part of the middle wall-circuit showing wall faces formed by *in situ* orthostats.  
© Historic England, Marcus Jecock

The field survey demonstrated that the walls are all similar in build, consisting of rubble infill between faces of orthostatic construction (that is, formed of stones set on end); they are, therefore, as far as we can say based on surface evidence, probably all contemporary. Survey was even able to identify individual *in-situ* surviving orthostats and confirm that the walls were originally up to 3m wide, as reported by Hutchinson. The survey also revealed that the southern end of the middle wall extended 30m further than plotted from the lidar, all the way to the crest of Beacon Breast, and identified a number of additional stock enclosures. These features were all invisible on the lidar because the vegetation was exceptionally dense in particular areas. Finally, the field survey confirmed that a number of >>

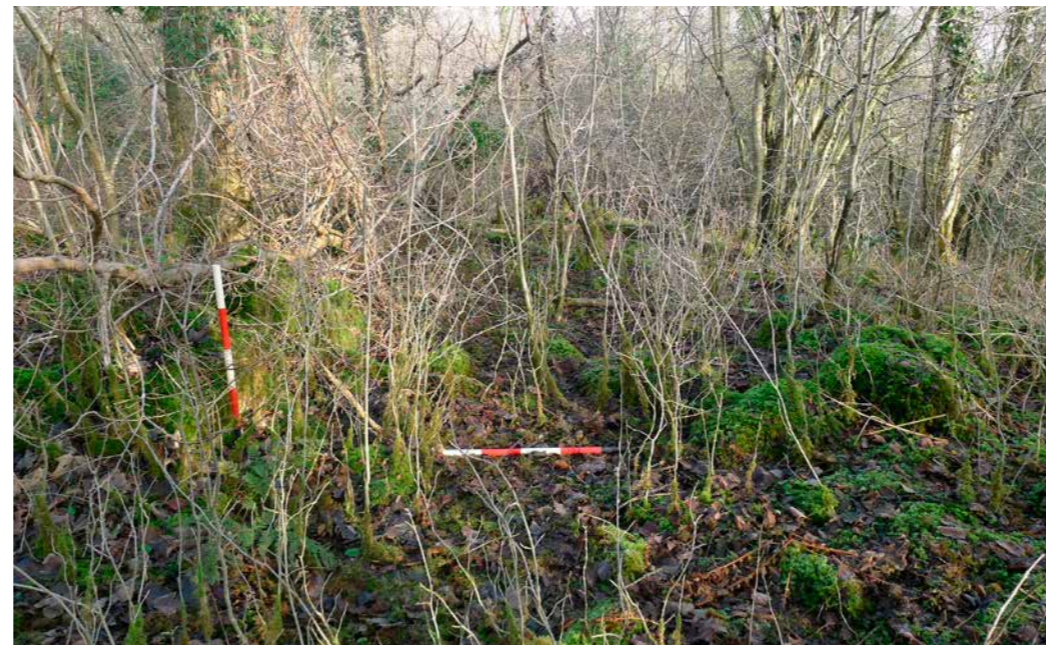
**Middle:** The additional section of the middle wall identified by field survey immediately above Beacon Edge. The ranging rods indicate the site of a newly recognised entrance through the wall.  
© Historic England, Marcus Jecock

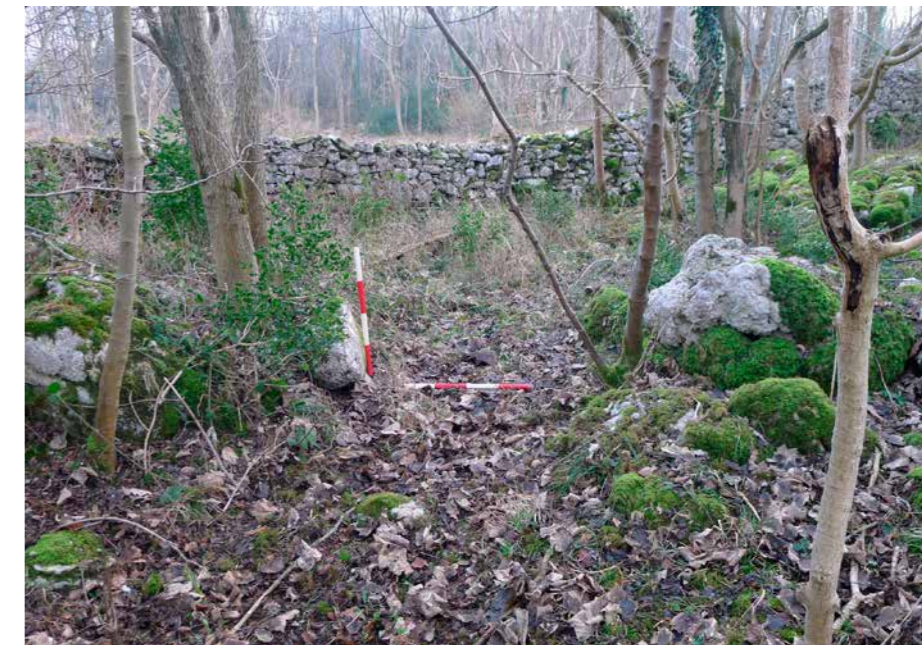
**Right:** The western entrance in the outer rampart, flanked by transverse orthostats.  
© Historic England, Marcus Jecock

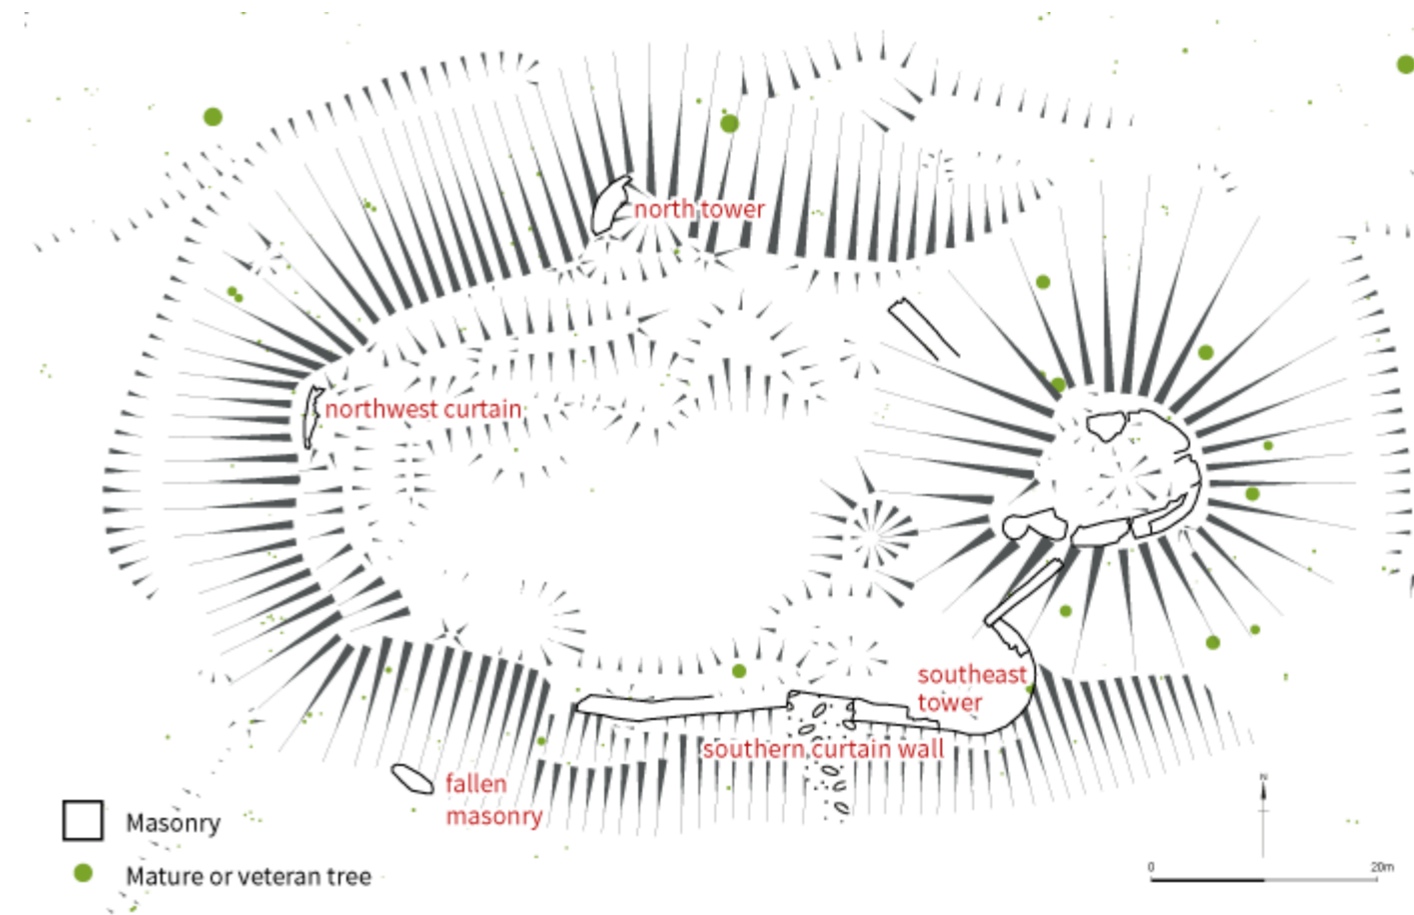
**Below right:** Plan of Snodhill Castle. © Historic England, Sharon Soutar

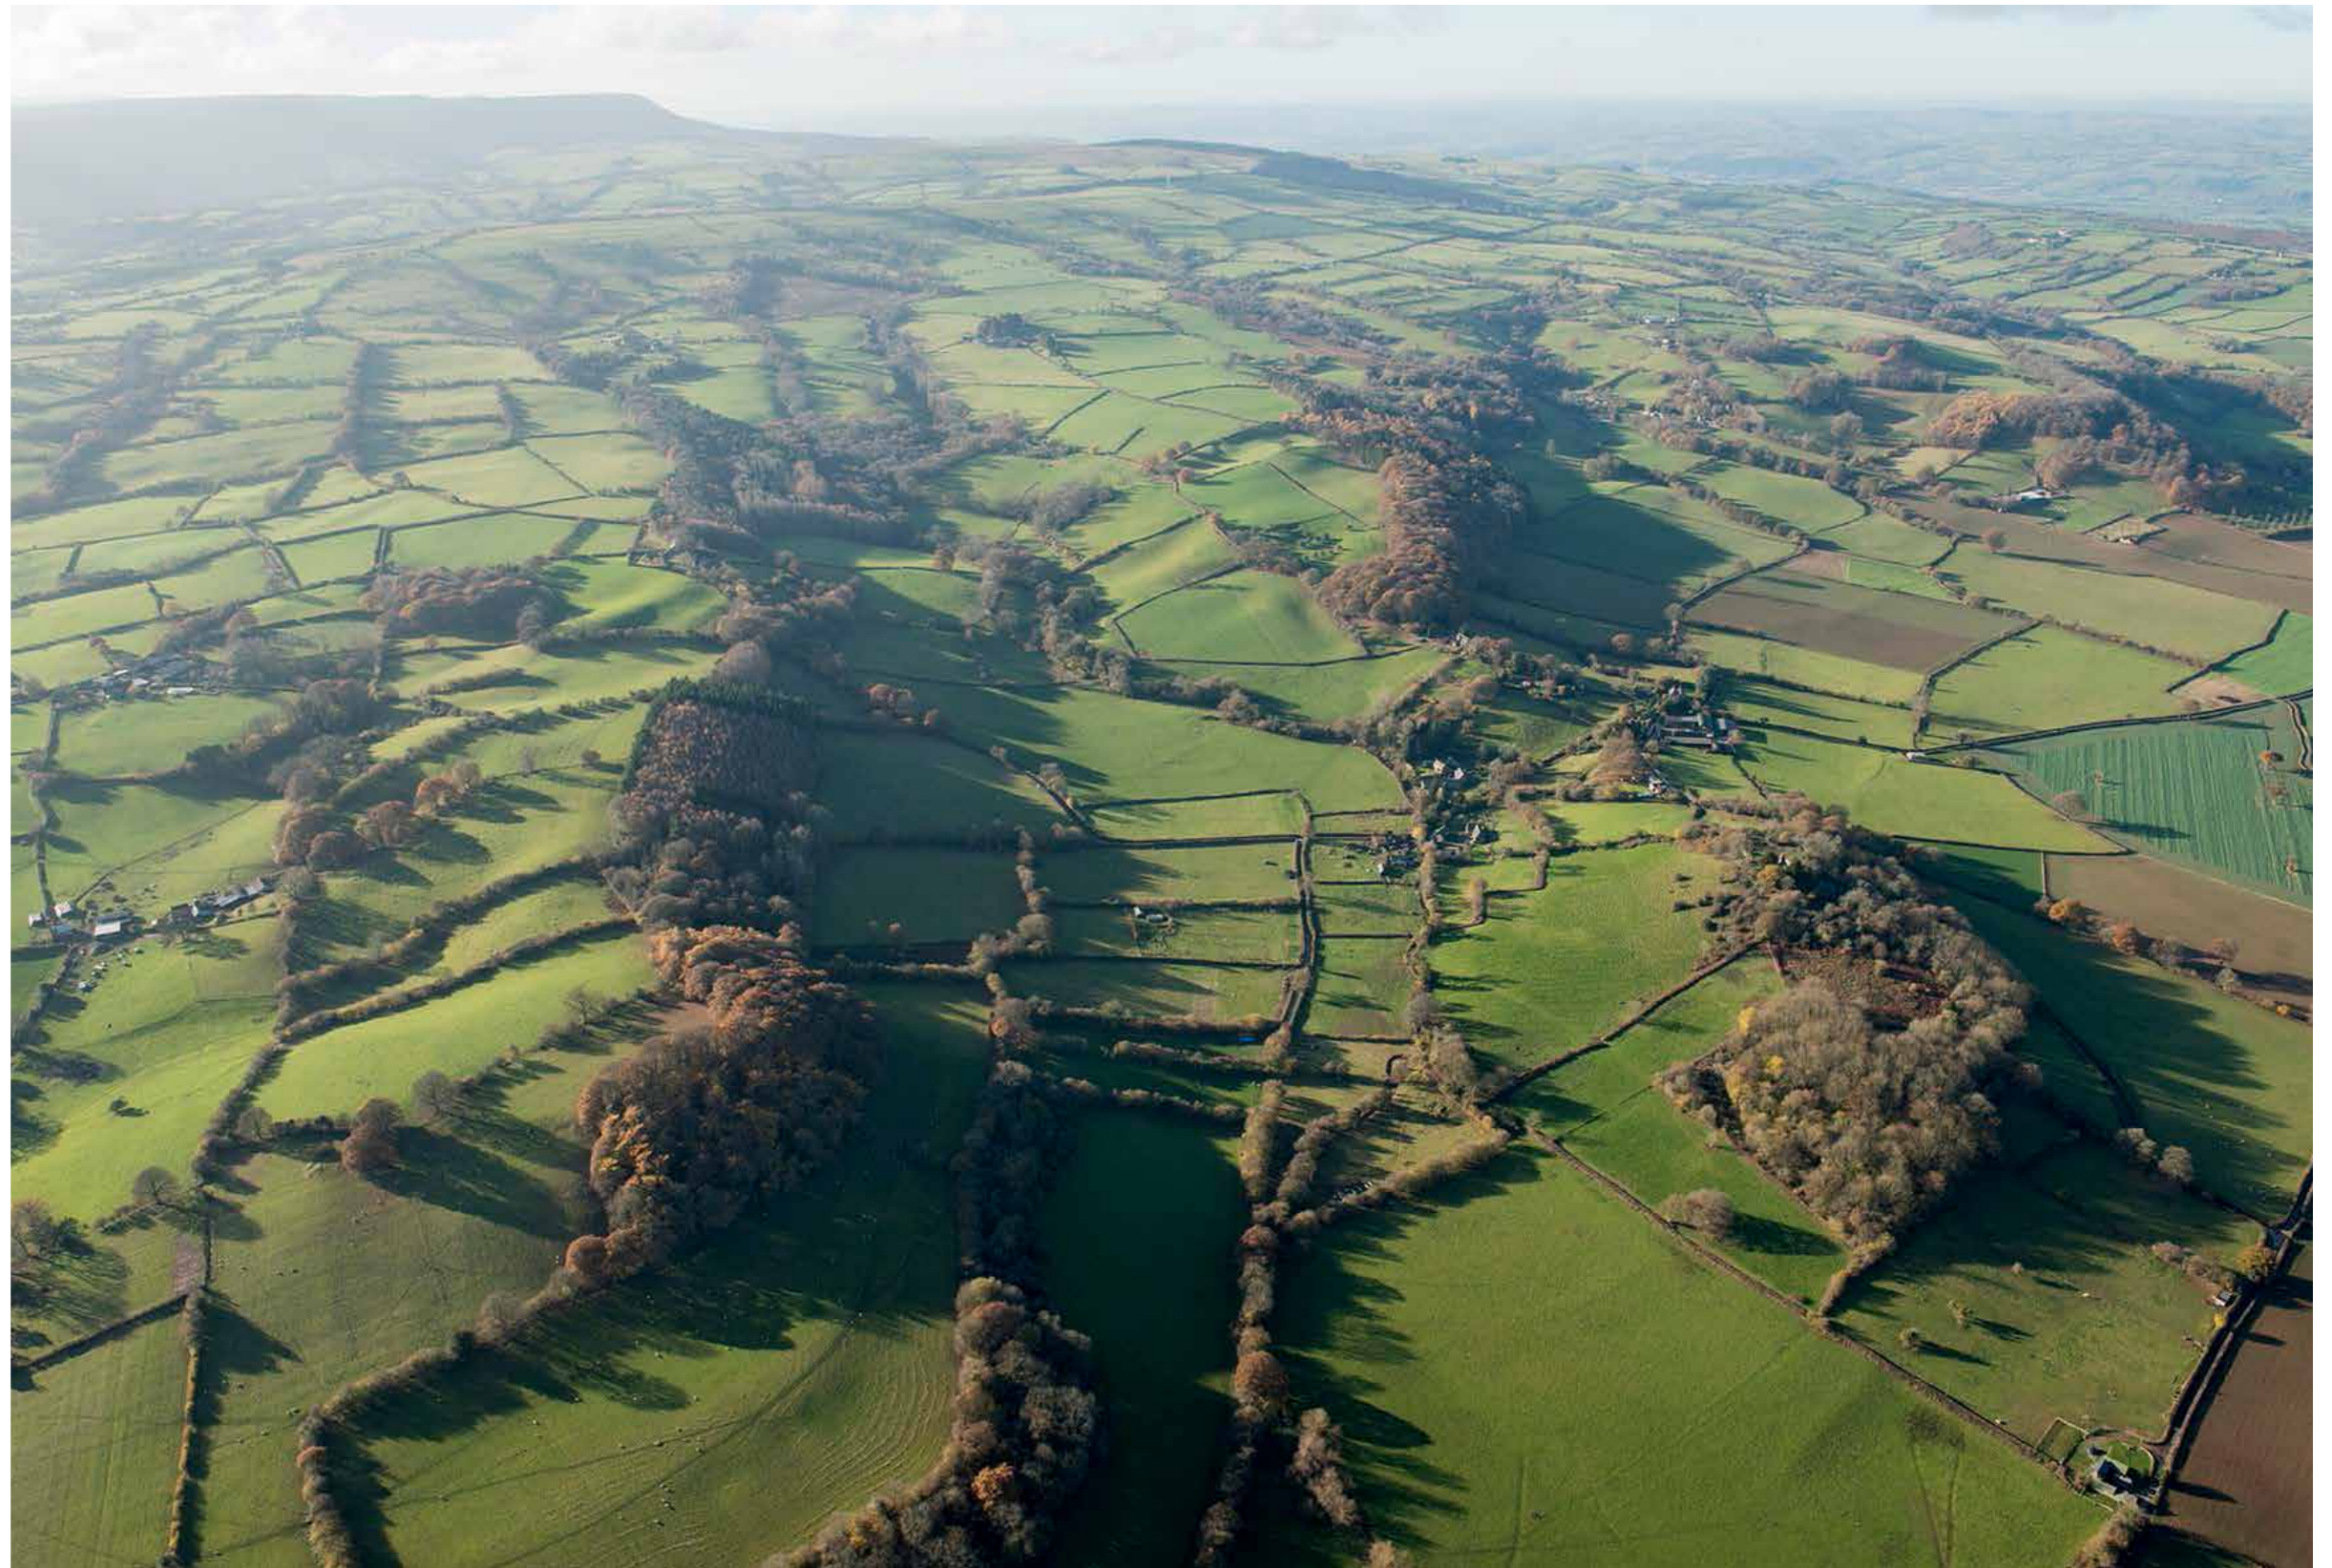
**Below:** Snodhill from the air: the castle is within the wooded area at bottom right and the deer park occupies much of the landscape above and to the left. © Historic England, Damian Grady, HEA 29993/008, 25 November 2016

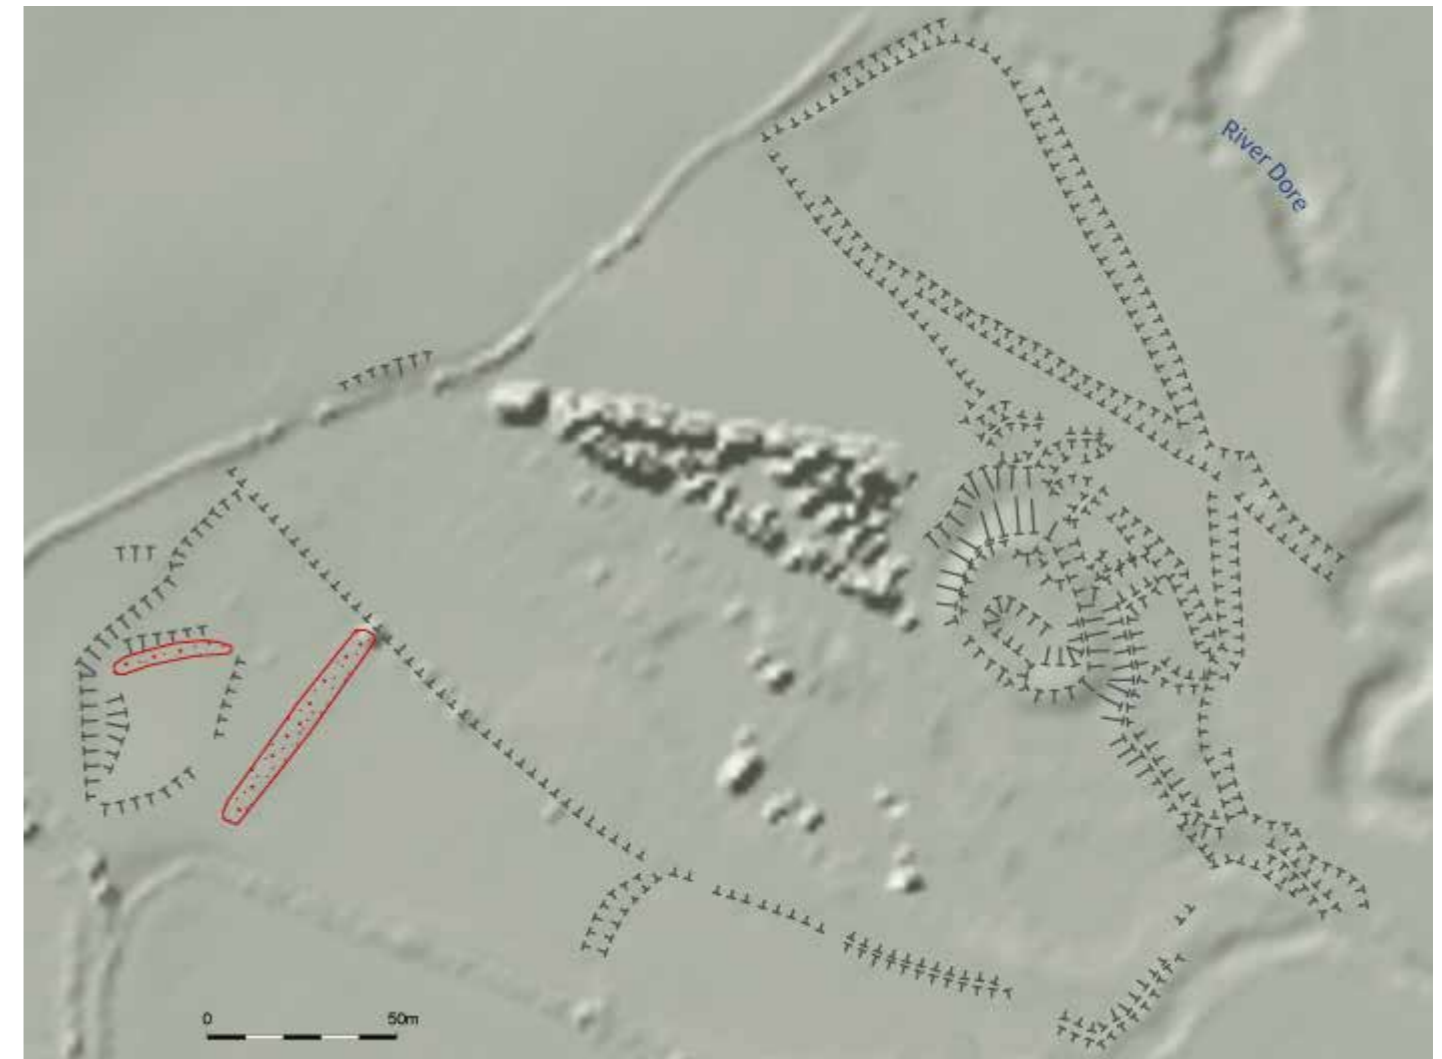
**Above right:** Earthworks at The Splashes, with the moated site towards the right; details from aerial photography, superimposed on Environment Agency lidar plot. Lidar © Environment Agency 2006. All rights reserved

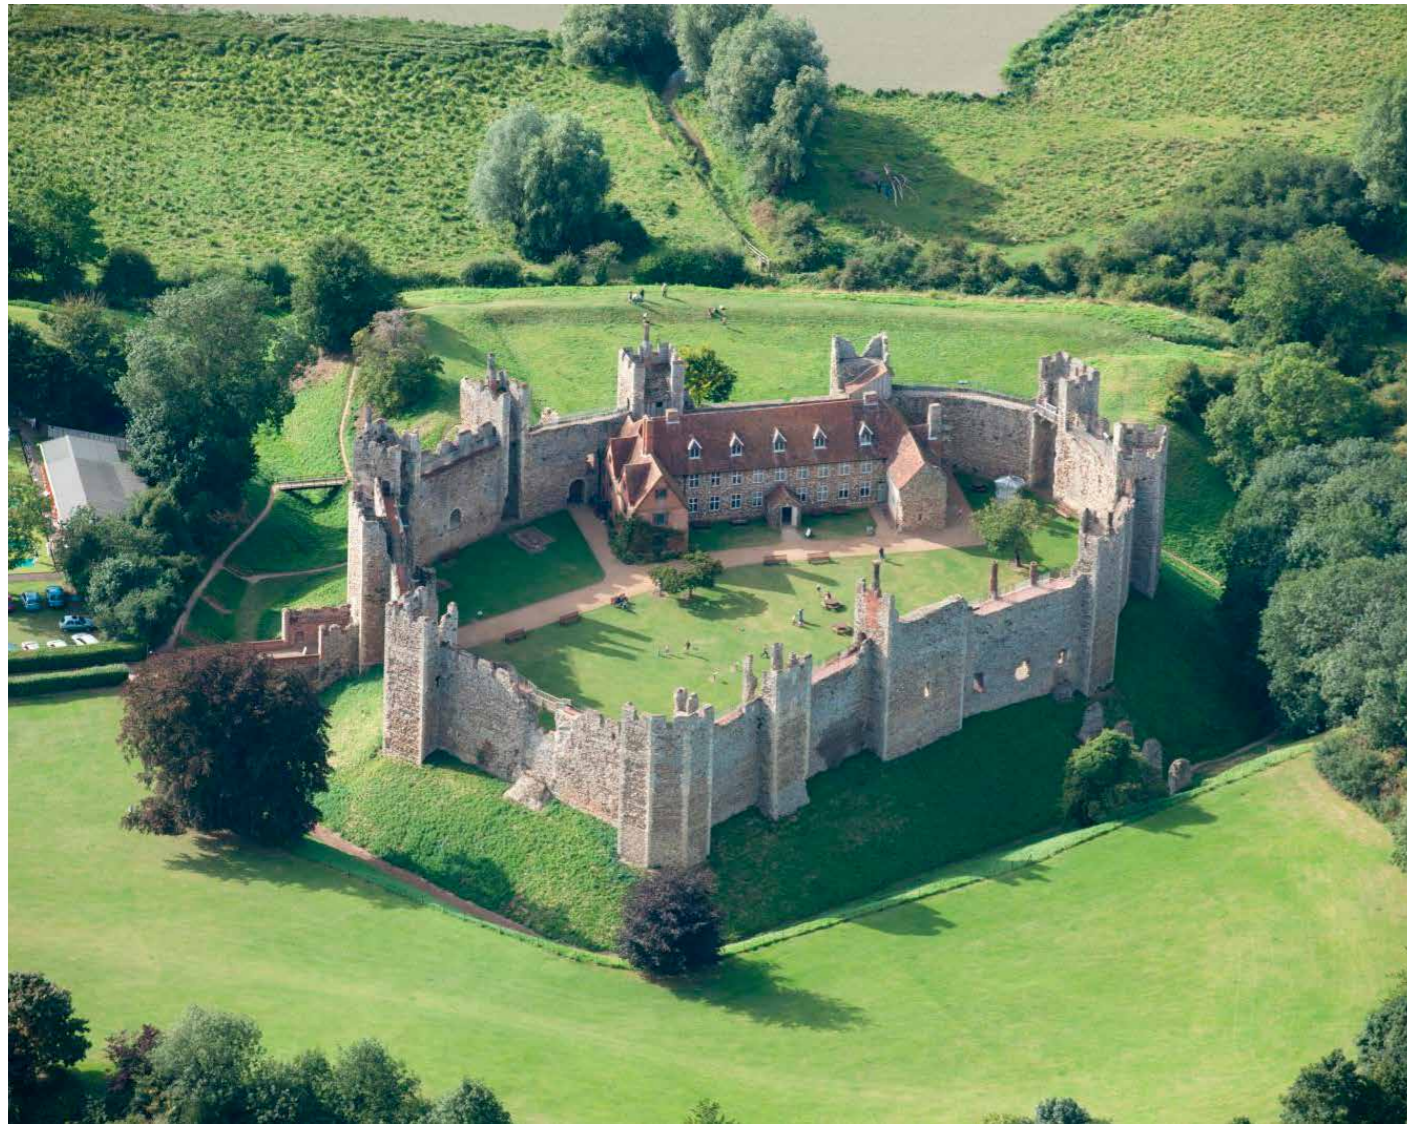
**Above:** Aerial view of Framlingham Castle, taken by Damian Grady in September 2012. © Historic England, 2758/015

The fairy-tale silhouette of Framlingham Castle – with its wall-walk, turrets and decorative Tudor chimneys – draws visitors from far and wide. Until the 17th century the inner bailey was filled with stone structures, including a great hall, lodgings and a kitchen. Today, however, this area contains just one two-storeyed building, abutting the west wall. This structure clearly did not form part of the medieval castle complex, although several carved heads have been reset on its façade and some old fabric is buried in its walls.

The building comprises a central range flanked by north and south ranges, forming a U-shape which is open to the east. In order to access the wall-walk, visitors are directed through a shop and café in the central range. The gabled 'Red House', lying to its south, served as a private dwelling after Framlingham Castle entered guardianship in 1913, but was altered to provide a catering kitchen and offices in 2017. It is not currently open to the public. The range to the north, known at one time as the 'White House', has accommodated the Lanman Museum, a local collection, since 1984. Visitors thus pass through the building on their way up and down from the wall-walk, but few pay it the attention it deserves >>

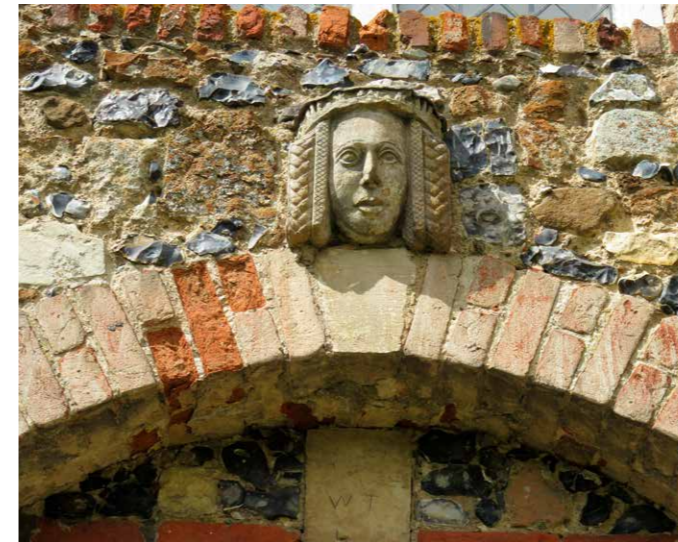
**Top:** Medieval carved head, reset on workhouse façade.  
© Kathryn Morrison

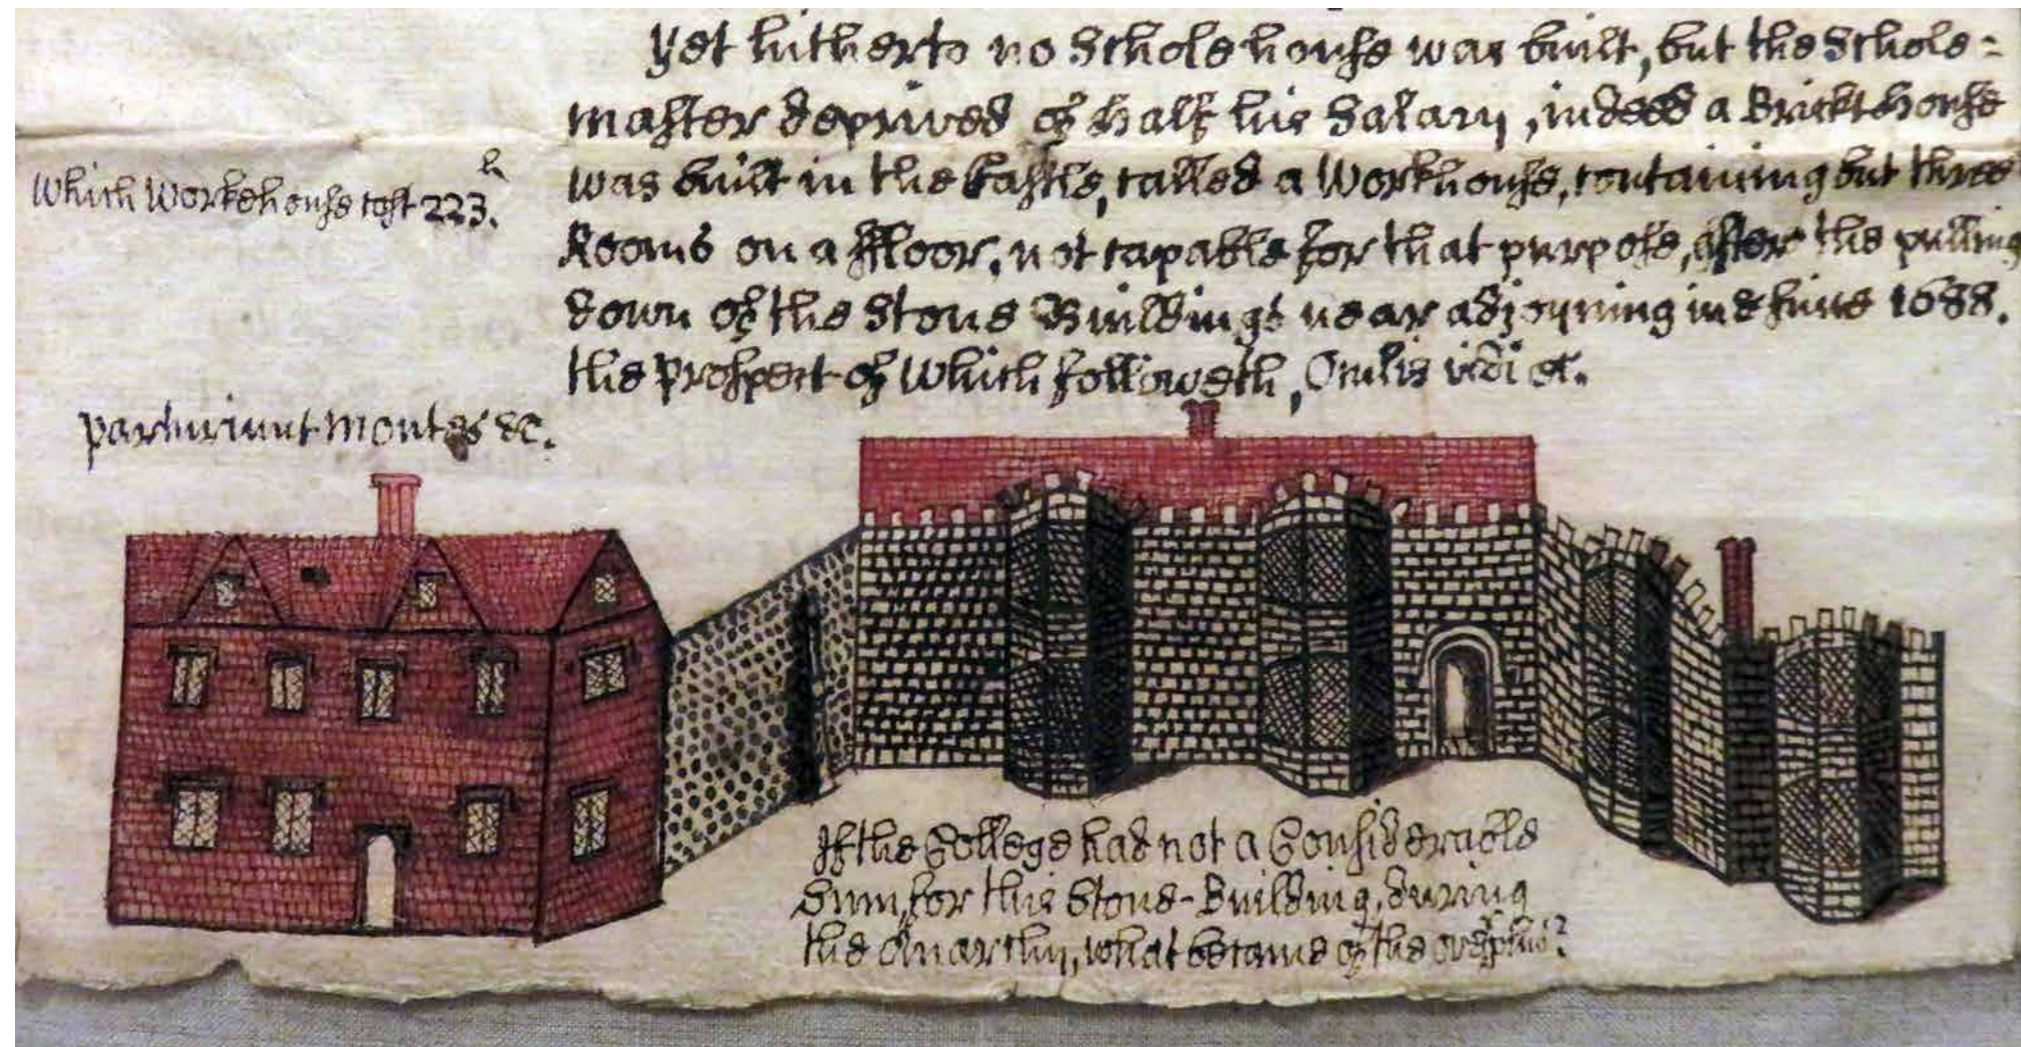
Above: A drawing by Robert Hawes of the north range of Framlingham Castle, as it stood prior to its demolition in 1700. The Red House is shown to the left. © by permission of the Master and Fellows of Pembroke College, Cambridge, Pembroke College N5

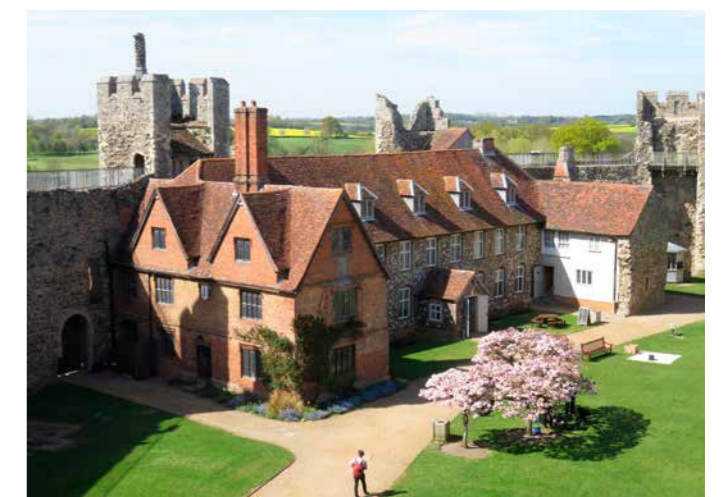
Right bottom: The new workhouse, photographed here in 2006, was built between the Red House and the White House in 1729. © Kathryn Morrison

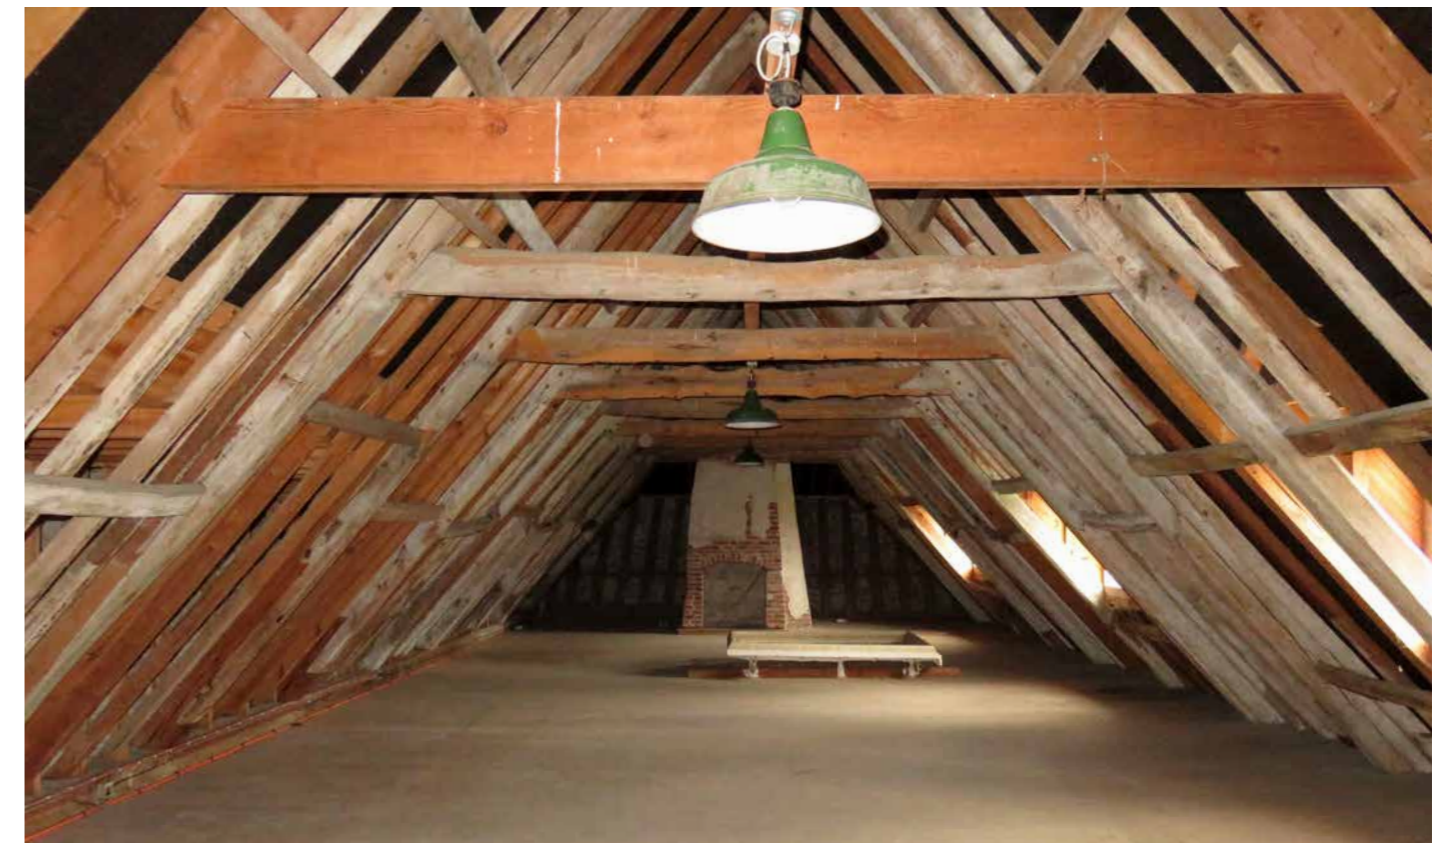
**Below:** The attic of the 1729 workhouse. © Kathryn Morrison

After its inmates moved out, the centre of Framlingham Workhouse was gutted to create a ‘Town Hall’ or ‘Castle Hall’, with a gallery at its south end. The hall was put to various uses: for public gatherings, as a court house, and as a drill hall. The attic was retained – possibly, initially, as a dormitory for a girl’s school that occupied the upper floor of the White House. Beneath this, next to the former bakery, was a fire engine house. As for the Red House, it became home to the master of Hitcham’s school until 1882, when the schoolmaster Samuel Lane died and it was taken over by the drill instructor and his family >>

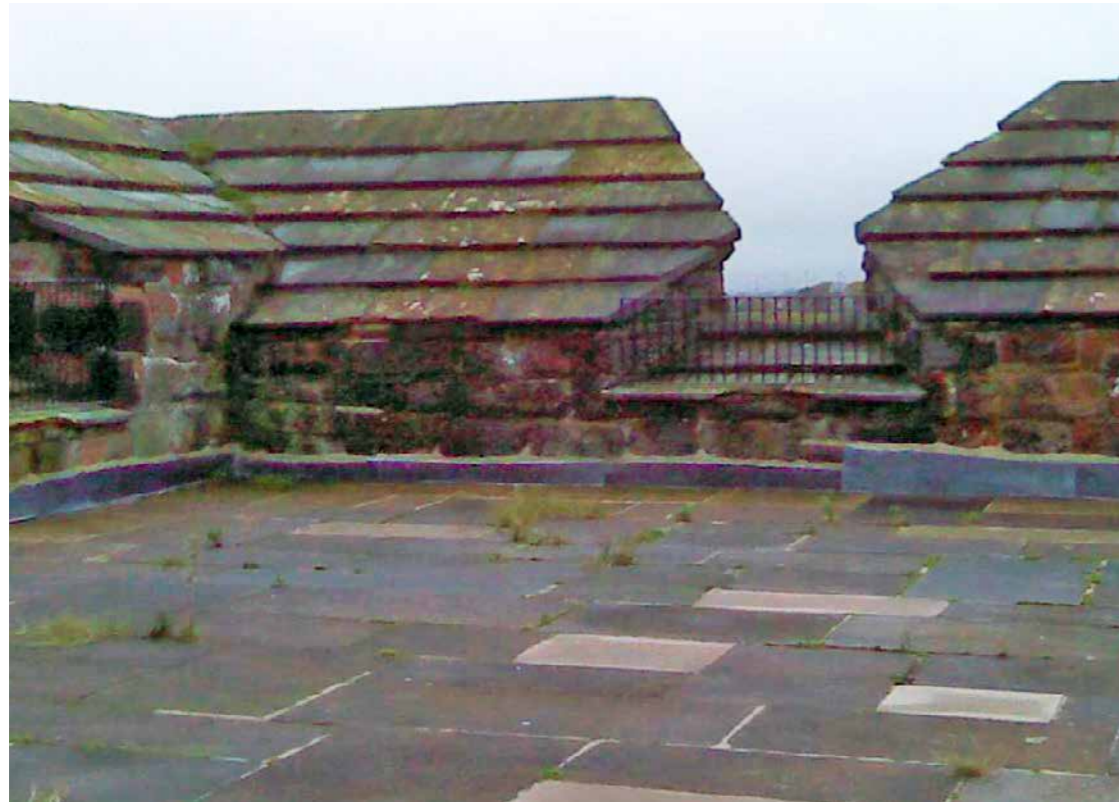
**Top:** South-east corner of the roof of the keep, Carlisle Castle. © Historic England, Soki Rhee-Duverne

**Bottom:** Blue areas at Carlisle are colder, indicating damp masonry; faint yellow ones are warmer, indicating voids. © Historic England, Soki Rhee-Duverne

The keep of Carlisle Castle has a history of penetrating dampness. Considerable remedial work has been carried out over the years, including the insertion of a damp-proof membrane in its flagstone roof. The problems have not gone away, and an infrared thermography survey was carried out as part of preparatory work for planned interventions to manage the moisture ingress. The survey highlighted areas of condensation risk in the interior of the keep, as well as damp masonry on the lower parts of the parapets, corners, and flagstone joints of the roof. Possible voids between the membrane and the flagstone roof were also identified.
