Discovery, Innovation and Science in the Historic Environment

Historic England

ISSUE 8 • SPRING 2018

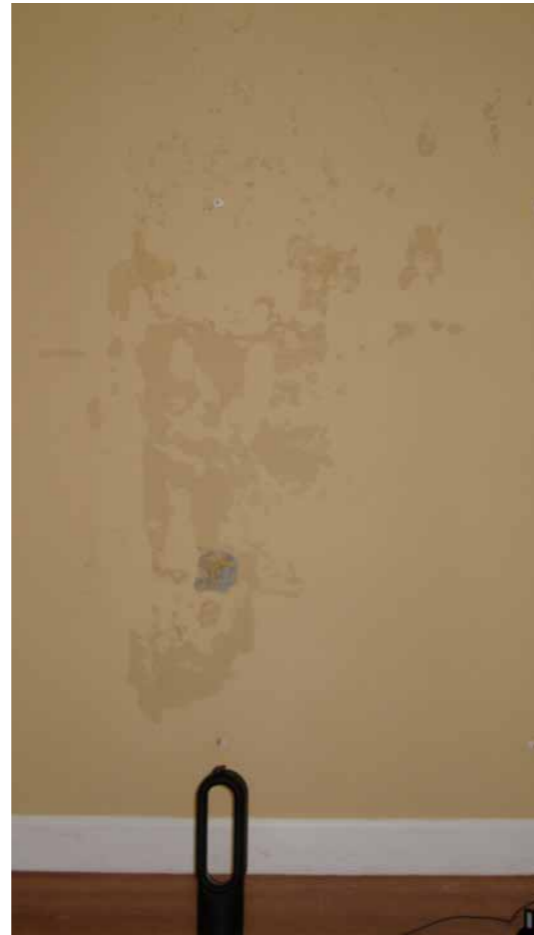
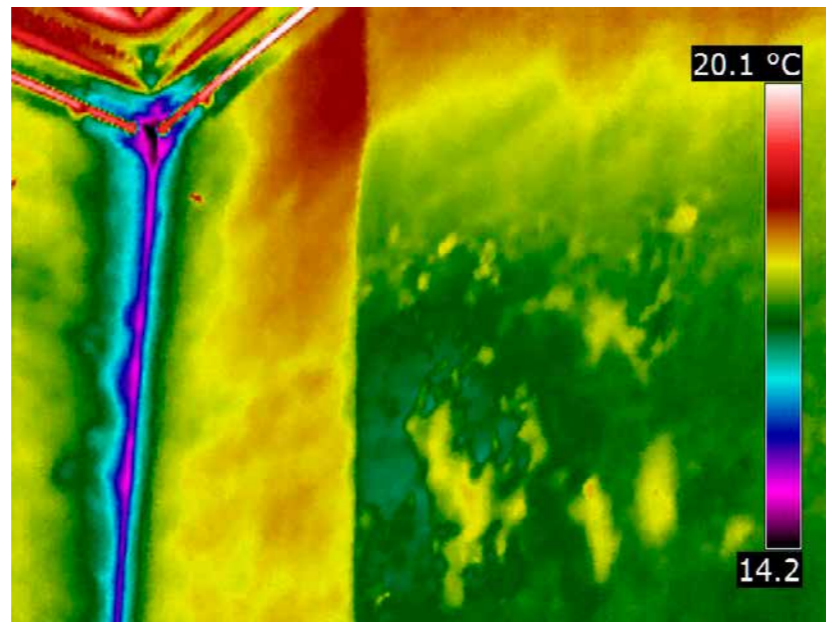
**Right:** North wall of the Orangery at Kenwood, showing delaminated and blistered paint caused by damp. The area is to the right of the suspected impermeable membrane shown in the accompanying infrared image. photograph. © Historic England, Soki Rhee-Duverne

**Below:** The large rectangular area to the left indicates the location of the possible impermeable membrane beneath the paintwork. The yellow patches are possibly voids, or the areas of damp on the wall in the companion photograph. © Historic England, Soki Rhee-Duverne

Thermal imaging was also employed to determine the cause of moisture ingress in the north elevation of the Orangery at Kenwood House, London. Heaters helped to increase local temperature in order to reveal information from the depth of the wall. Water has a higher heat capacity than most materials; it also retains heat longer. Damp areas thus appear warmer than their surroundings and can be identified by thermography.

The survey at Kenwood revealed an unexpected and distinct difference in the pattern of moisture ingress beneath the paint. The apparent difference may be the result of a previous intervention in the fabric: an impermeable membrane that is trapping water leaking from defective rainwater goods. Possible voids or damp areas also became more visible.

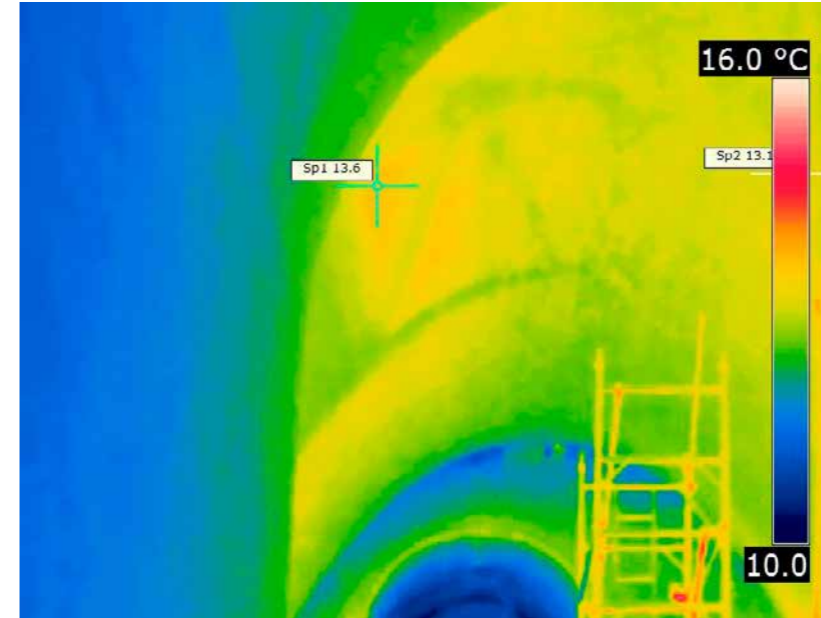
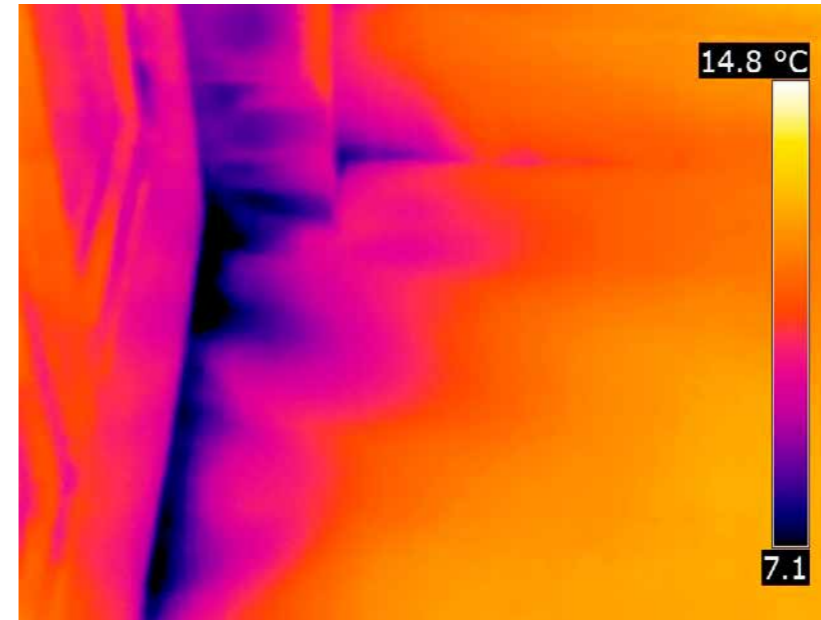
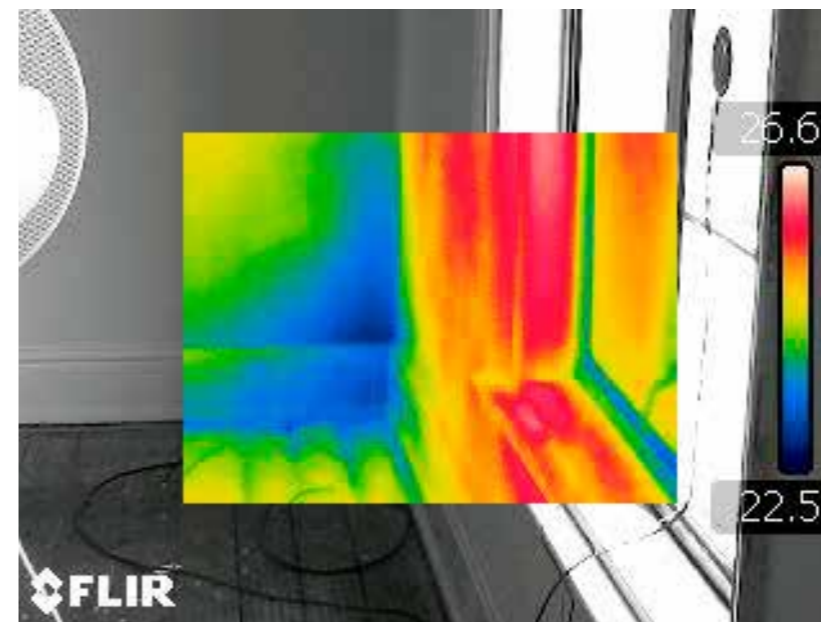
**Opposite top:** Dover Castle: after the fire was extinguished, a 1°C surface difference was revealed on the right- and left-hand sides of the bedchamber. © Historic England, Soki Rhee-Duverne

**Opposite bottom:** Thermal bridging in the corner and round the window frame of the house at Bolsover. © Historic England, Soki Rhee-Duverne

A trial was conducted with and without the fire being lit. A small surface temperature difference was noticed, caused by convection in the area immediately above the fire – and surprisingly, also on the wall and ceiling opposite it. It is possible that this slight rise in temperature, in combination with the continued exposure of the fabric to sea salts, is sufficient to exacerbate the delamination process.

The survey also helped assess the effectiveness of the house's insulation, revealing areas of missing insulation in the loft and significant areas of heat loss through window frames and as a result of thermal bridging, the result of changes of the qualities of the walls at corners and junctions >>

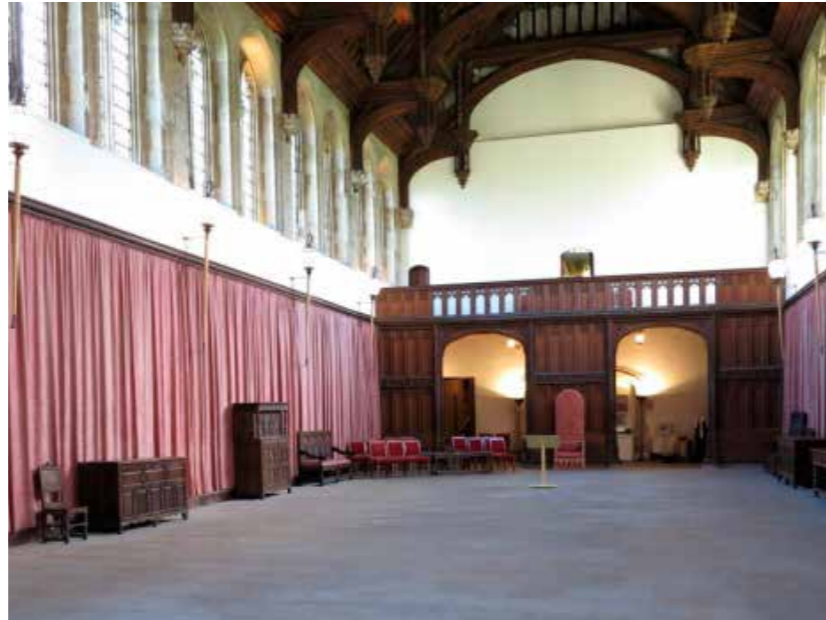
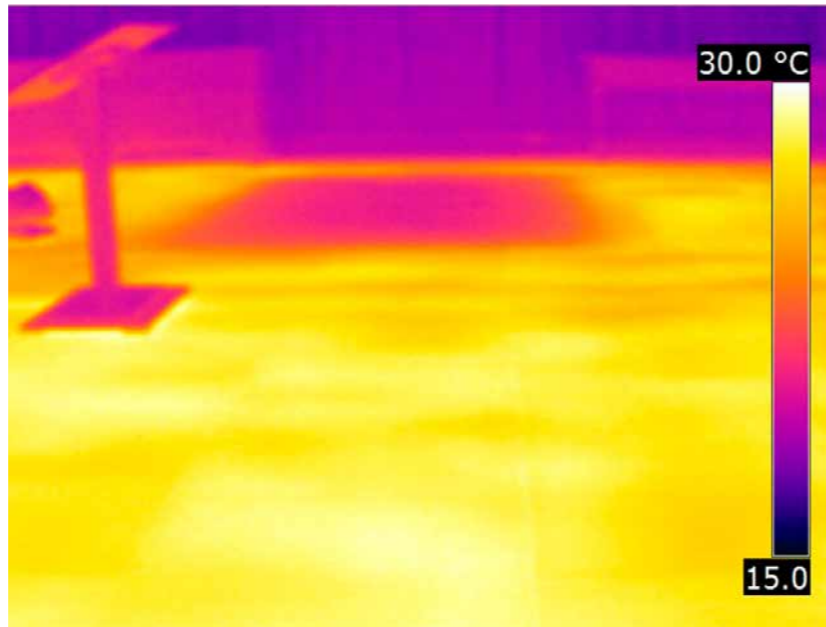
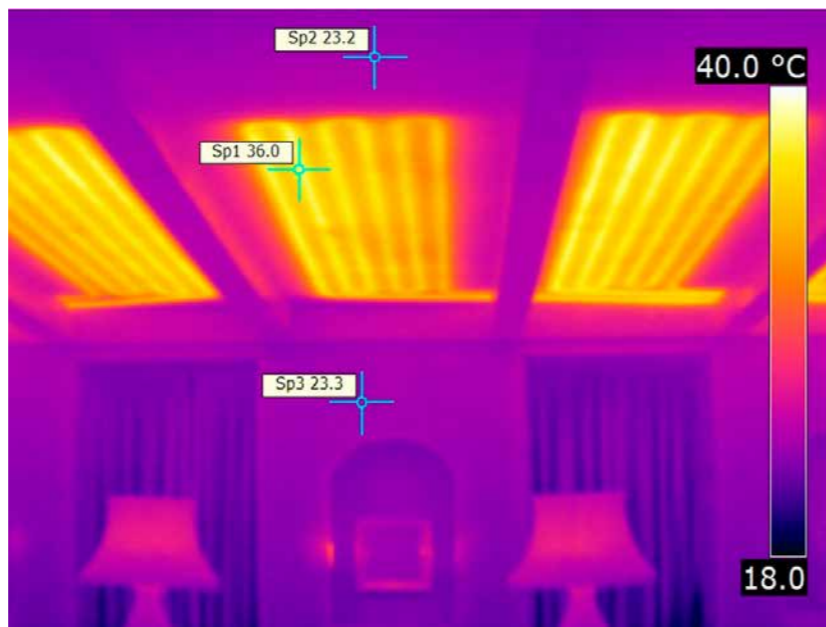
**Opposite middle:** Thermal image of part of the great hall floor at Eltham Palace. The square area of coolness indicates where one of the underfloor heating coils has failed.  
© Historic England, Caroline Cattini

The heating system has been in use for some 70 years, and by 2008 it was beginning to fail. There were numerous leaks, and little control of the system itself. The lack of an effective water treatment regime was the main cause: over time, the system became blocked with residue.

The decision was made to replace the heating system. Very little information had been recorded about the location of the pipework and thermal imaging was thus used to map out the layout of the system and identify any defects in it.

This process was successful. It also helped to find the cause of damage to gold leaf and veneers in the historic interior, caused by their continued exposure to excessive amounts of heat.

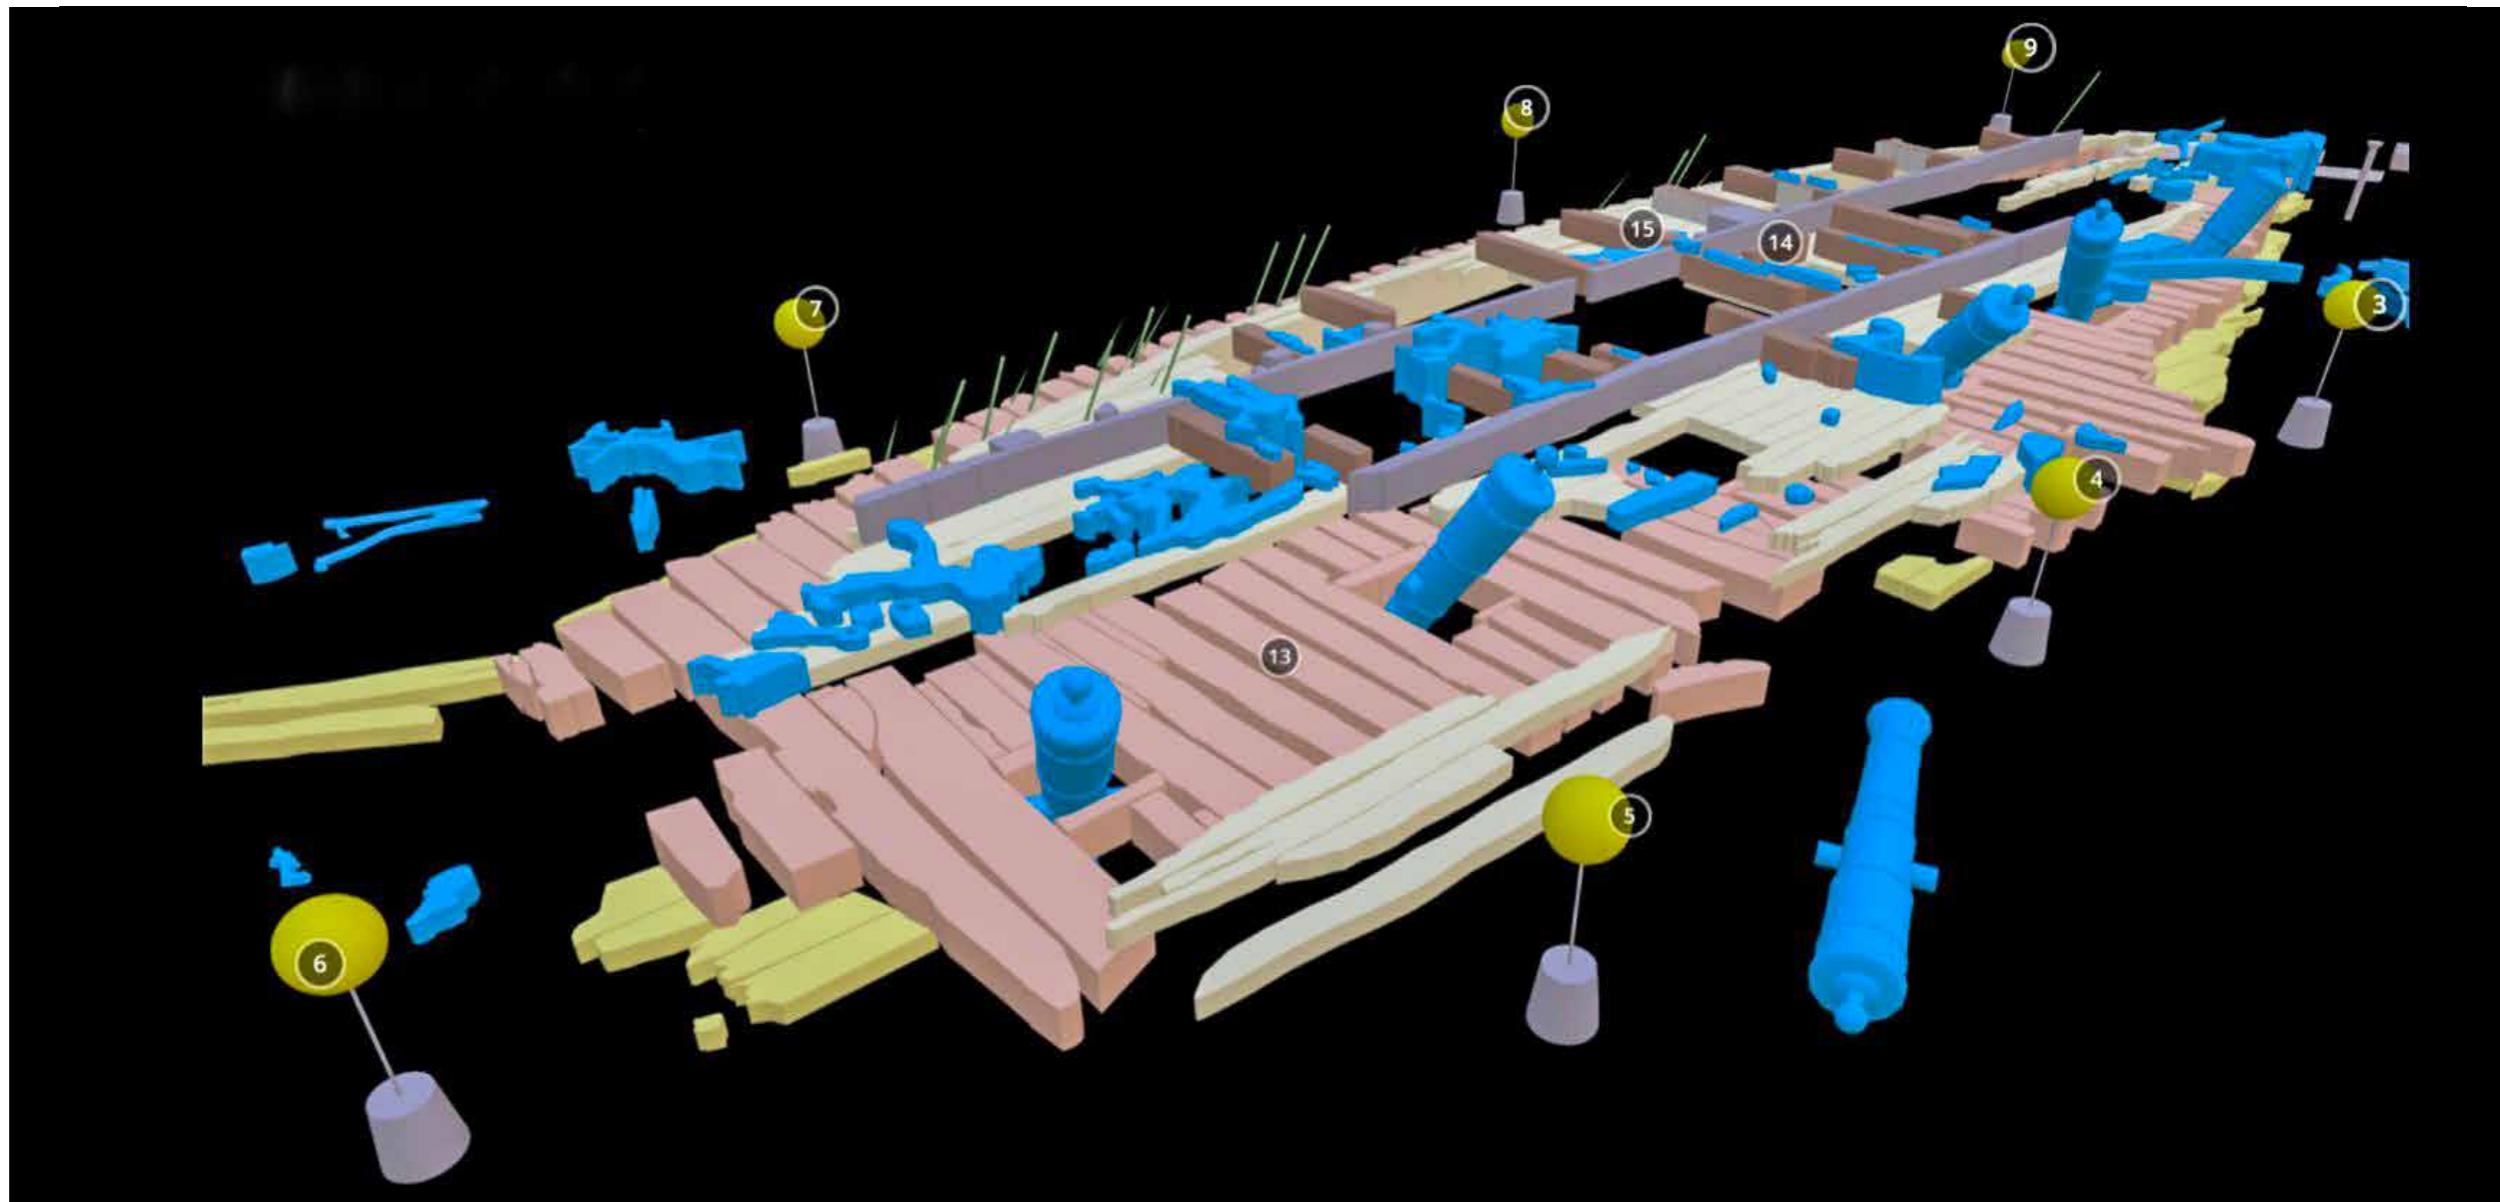
**Above:** A three-dimensional representation of the stern site-plan for HMS *Colossus*. Note how the upper deck guns sit upright in their gunports. © CISMAS

One of the abiding enigmas of the stern site was how the five upper deck cannons came to rest in their unusual positions. In the conventional wrecking scenario, the ship foundered at Southard Well and a section of the stern then drifted east to its current position. The problem with this is that we know the ship fell onto her beam-ends (side) within hours of her abandonment. It is hard to see how the upper deck guns could have stayed in place throughout such a process. As she rolled over onto

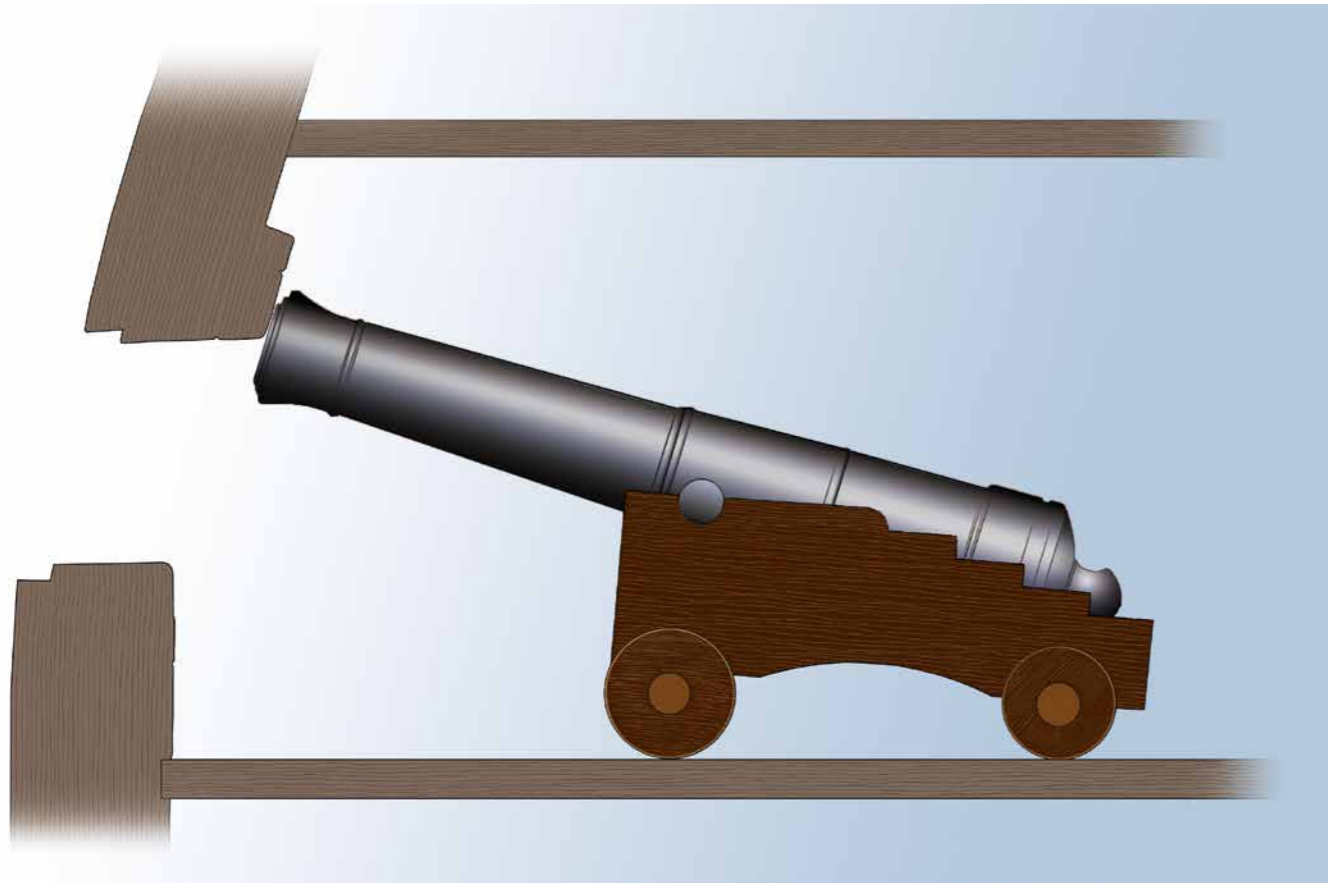
**Above:** The guns on 18th-century warships were lashed with their muzzles up against the upper gun-port sill when not in use. It is easy to see how they would end up falling through the gun-ports when the ship fell over onto her side. © CISMAS / Historic England, Vincent Griffin

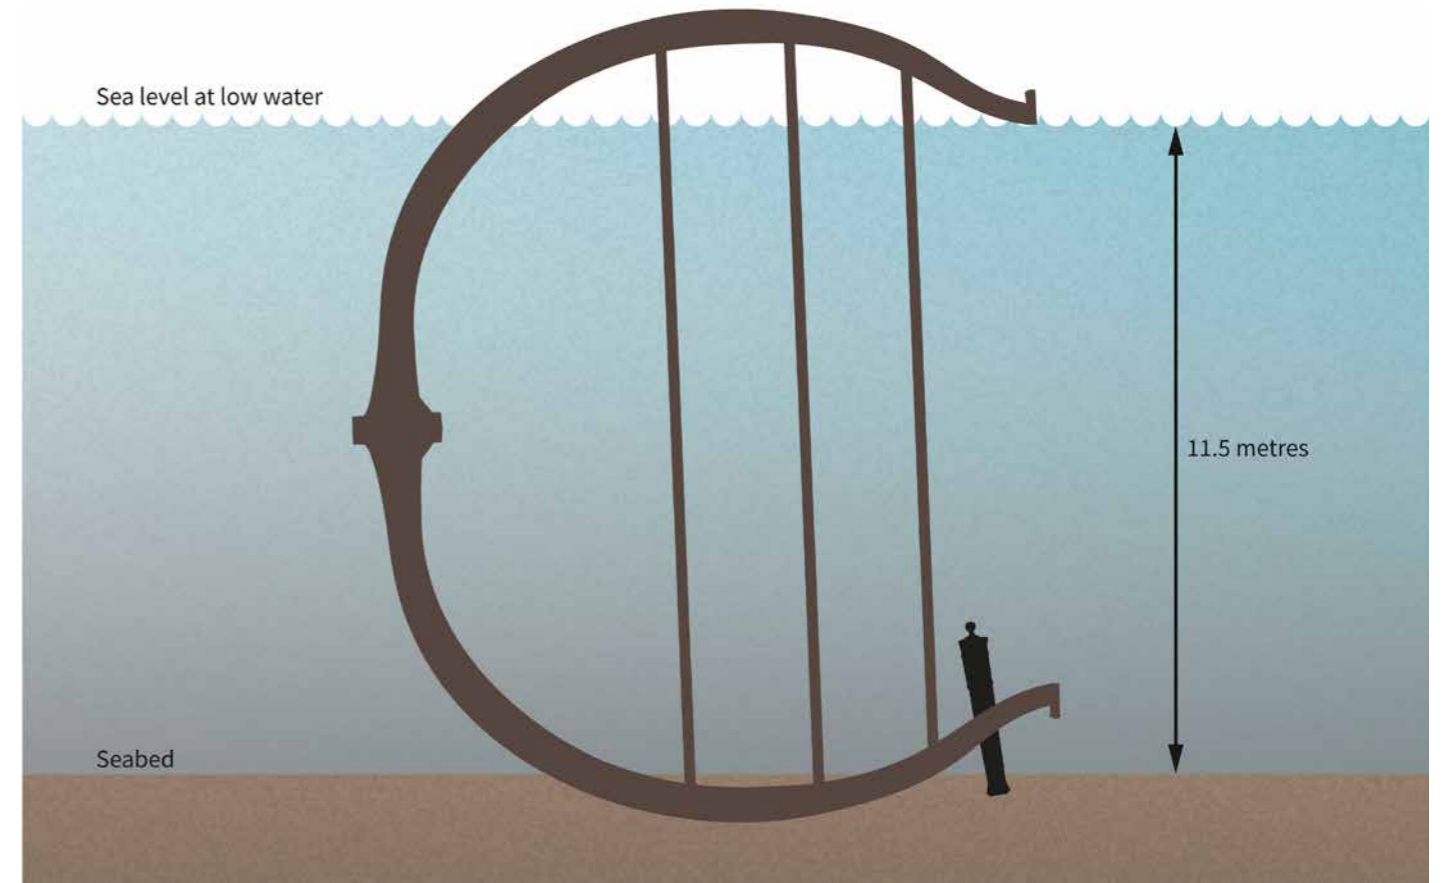
**Above:** With the ship on her beam-ends (side) it is clear that the curve of the upper hull tumblehome allows the upper gun-deck guns to protrude through the gun-ports – which also help hold them upright. It is then easy to imagine how they became buried muzzle down in the seabed. However, it is difficult to see how the hull could then travel over 300m along the seabed without shedding the guns. © CISMAS / Historic England, Vincent Griffin

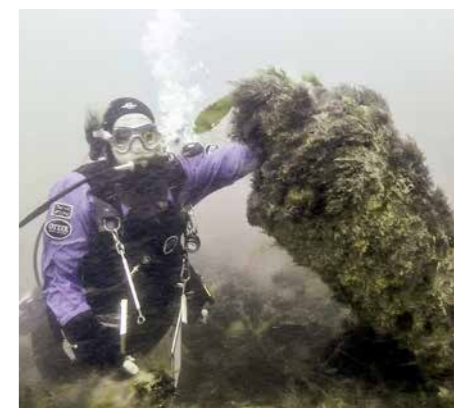
**Above:** One of the upper gun-deck ‘upstanding’ guns on the stern site. These are 18lb guns, which are 9ft (2.75m) long; roughly half the length of the gun is buried in the seabed. © CISMAS

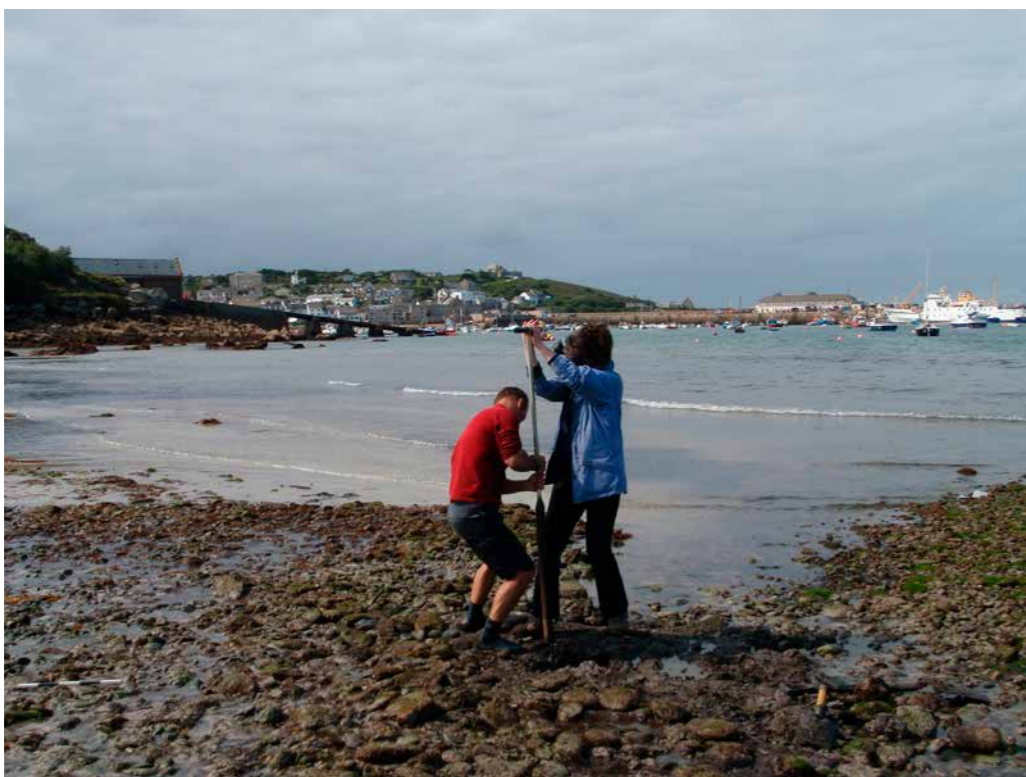
Above: Augering at Porth Mellon, St Mary's.  
© Cornwall County Council

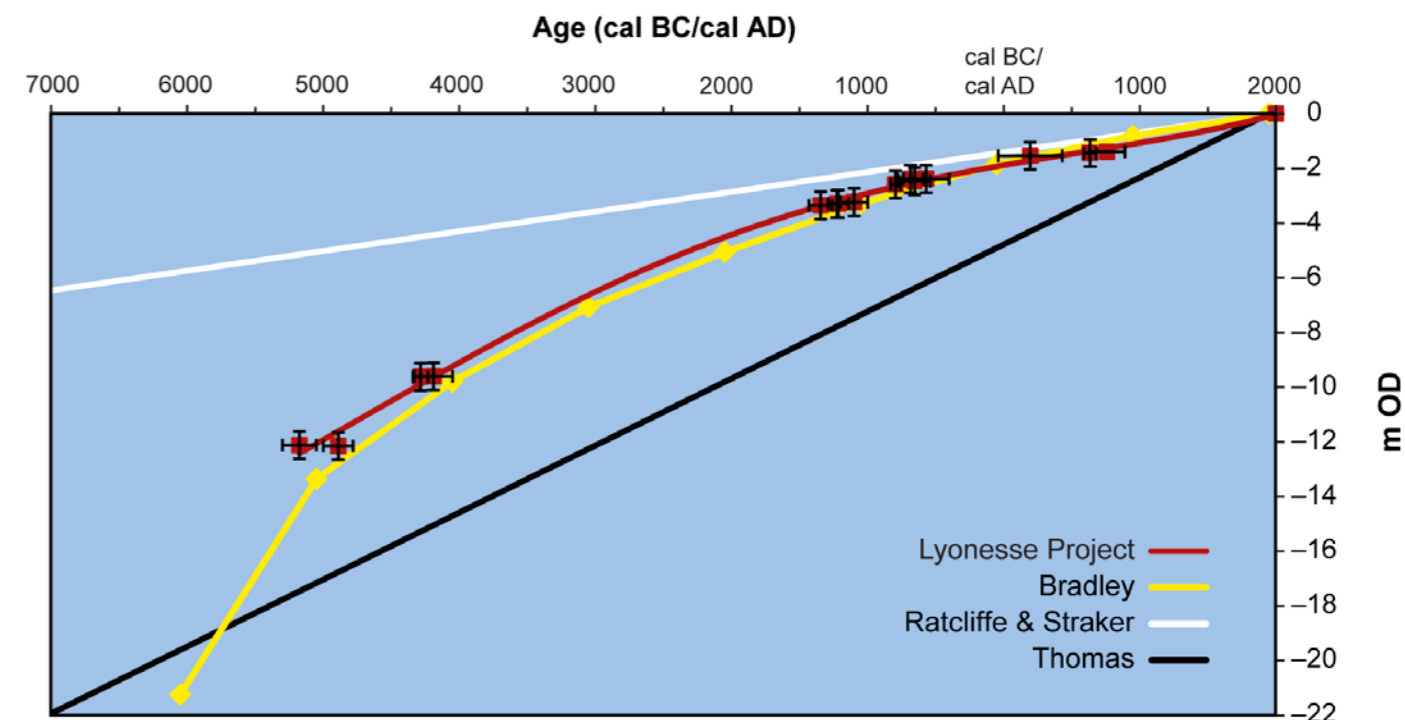
Above: Sea-level curves for the Isles of Scilly.  
© Historic England, Peter Marshall / Vincent Griffin

In order to build a record of sea-level change for the Isles of Scilly, samples were identified from which an accurate palaeo-elevation above sea-level (an 'indicative meaning') could be established. Foraminifera secrete tiny shells (tests) that survive as fossils, and these can pinpoint the elevation of the deposit in which they are found relative to the sea-level at the time of their formation. Sea-level index points were therefore derived from samples in cores containing foraminifera that were indicative of environmental conditions different to those of the present day.

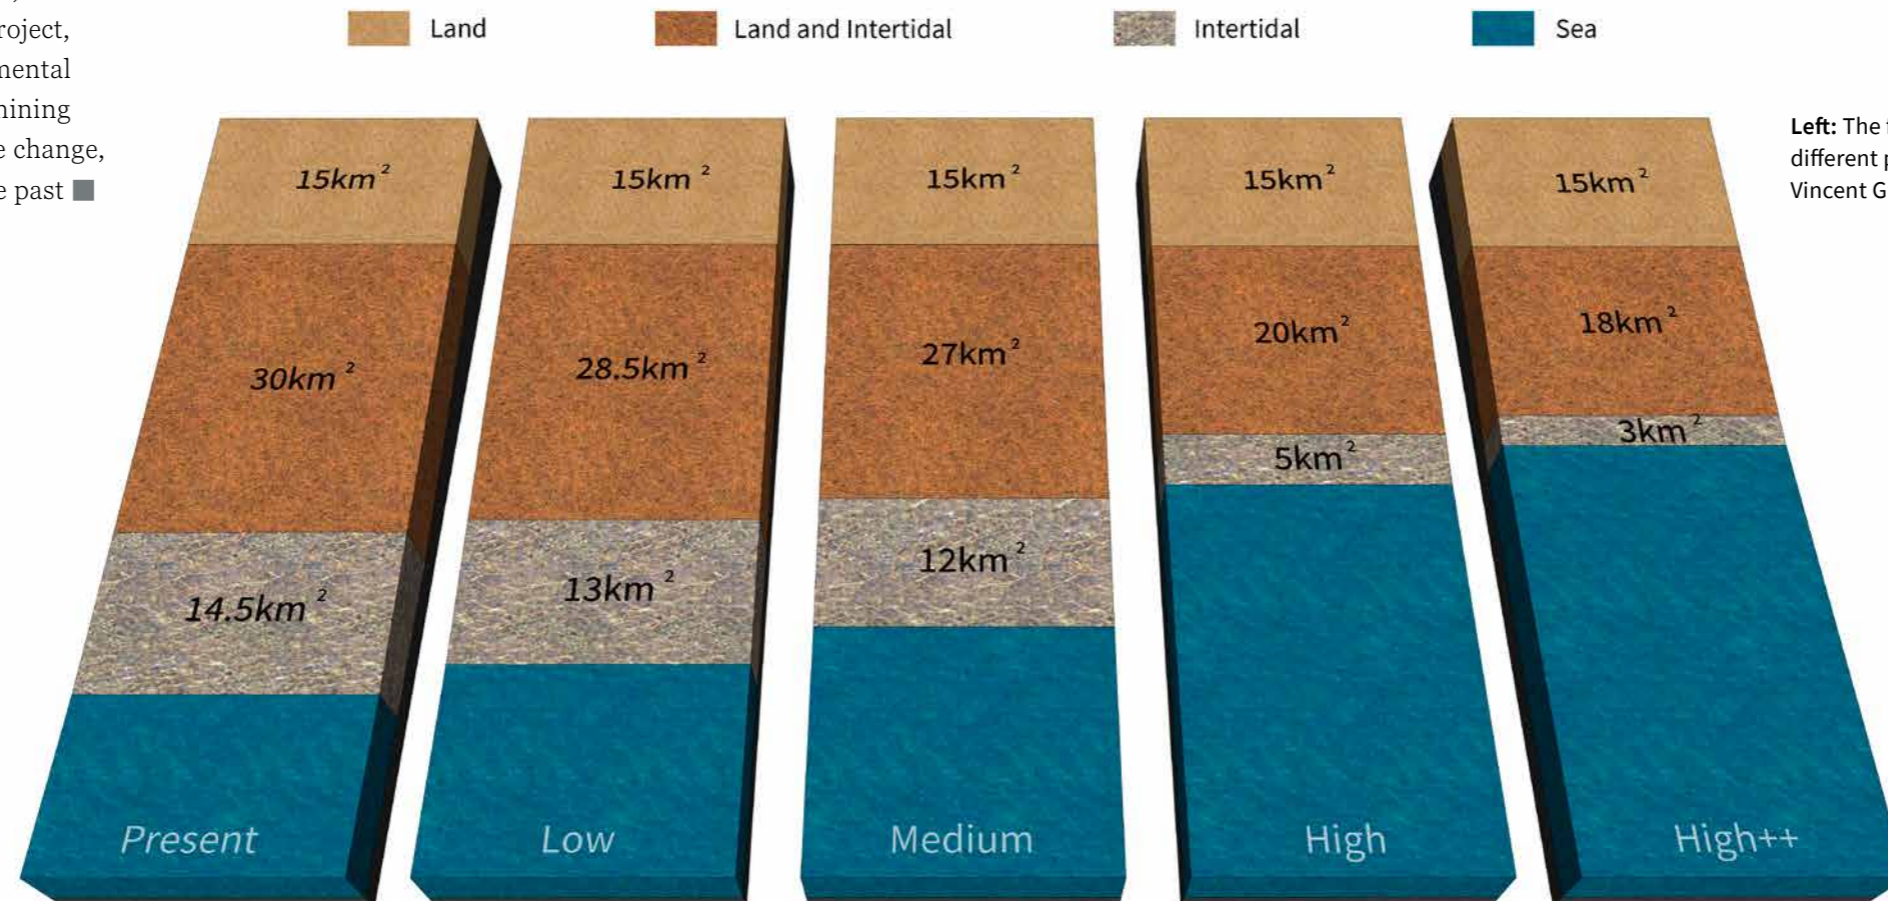
Left: The future extent of land and intertidal area under four different projections for sea-level rise by 2100. © Historic England, Vincent Griffin
