Historic England

Prehistoric and Romano-British Settlements with Structures

Introductions to Heritage Assets

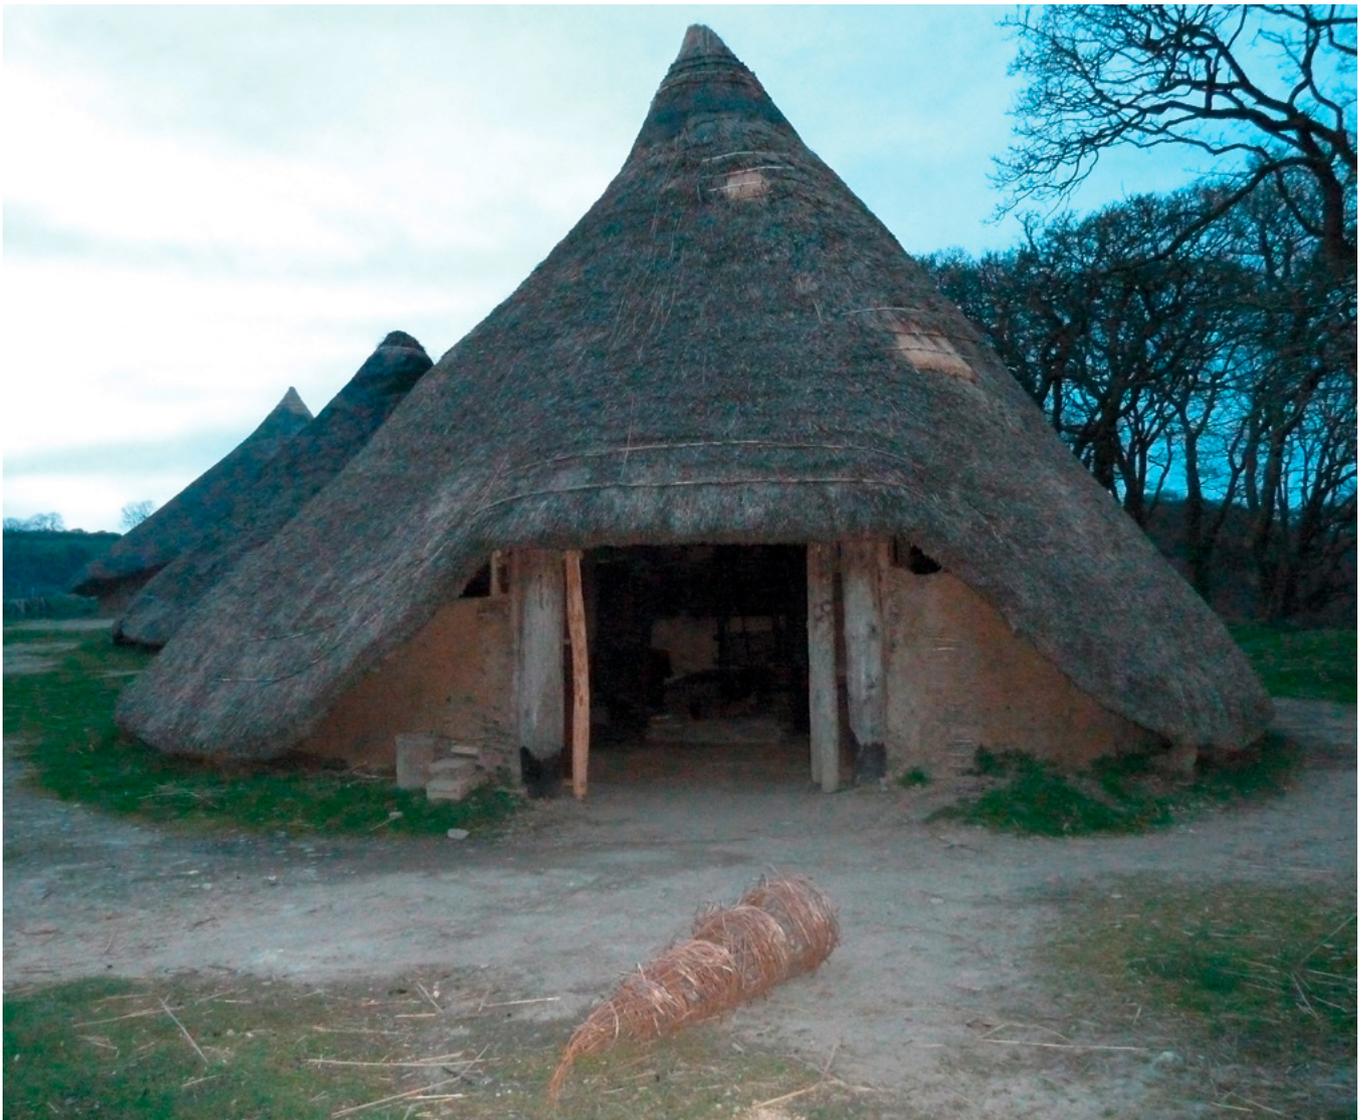
Front cover

Reconstruction of Roundhouse 1 (the "Cook House"), excavated 1981, built on the site of the original structure. It has since been rebuilt (in 2016).

Front Cover: Reconstruction of Roundhouse 1 (the “Cook House”), excavated 1981, built on the site of the original structure. It has since been rebuilt (in 2016). (© Lisa Brown).

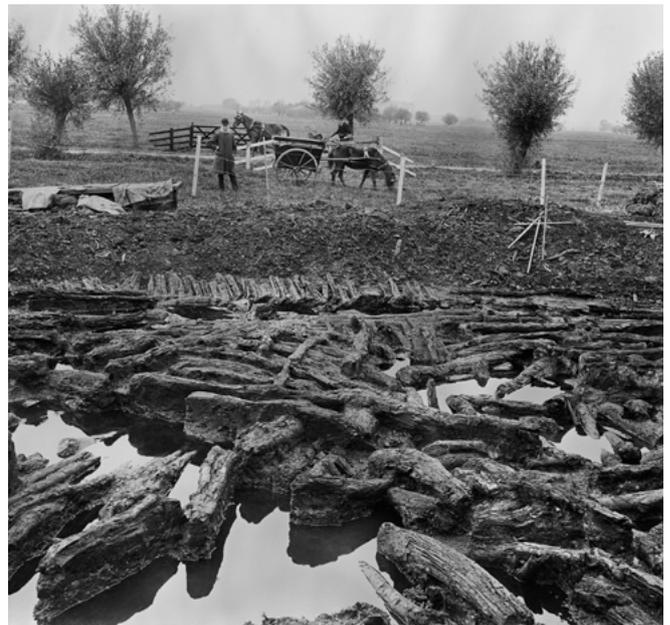
Figure 1
Glastonbury Lake Village work commenced in 1892 and extended until 1907. Excavation showed that this lake village, dating to the middle centuries of the 1st millennium BC, consisted of about 80 individual circular timber buildings built on top of a massive platform composed of timber and brushwood.

The excavation and research into Somerset's wetland sites, including the famous work at Glastonbury Lake Village which was initiated in 1892 (Figure 1), and investigations at Meare in 1910, has remained instrumental in understanding Iron Age settlements in this area and beyond.

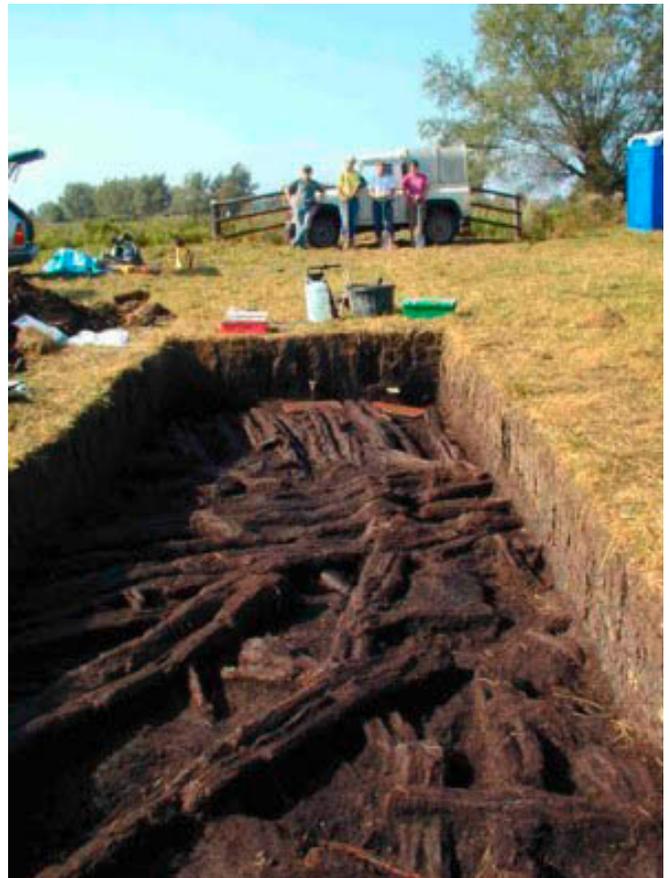
Figure 2

Re-excavation of one of the timber platforms at Glastonbury, Somerset, highlighted not only the incredible levels of preservation at the site, but also the threats to it from desiccation in a landscape rapidly drying out.

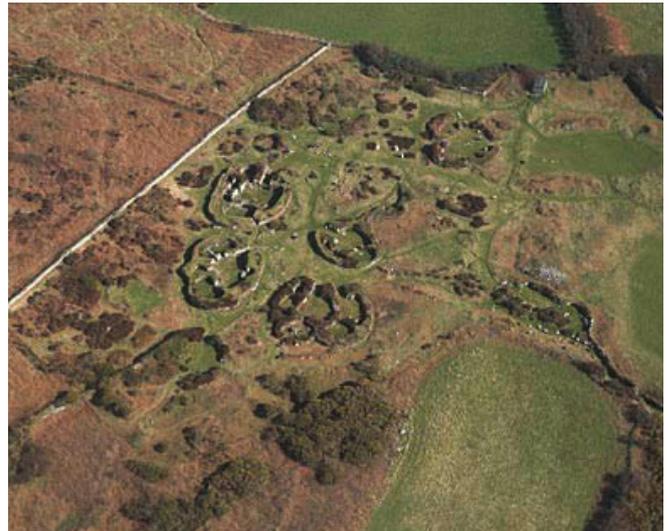
Figure 3

This aerial photograph shows the complex layout of the courtyard house settlement at Chysauster, Cornwall. At least ten houses have been recorded, articulated along a central street and surrounded by an earlier and contemporary field system. The village was built in the first centuries AD.

Courtyard houses and their settlements, consist predominantly, of a small oval or sub-circular compound with a maximum overall diameter of 30 m defined by a strong, thick, wall. This wall, normally composed of earth and rubble and revetted in locally obtained stone, stands to a height of about 1.5 m and is punctured by a single entrance passageway which leads to an interior open area, or courtyard (Figure 3).

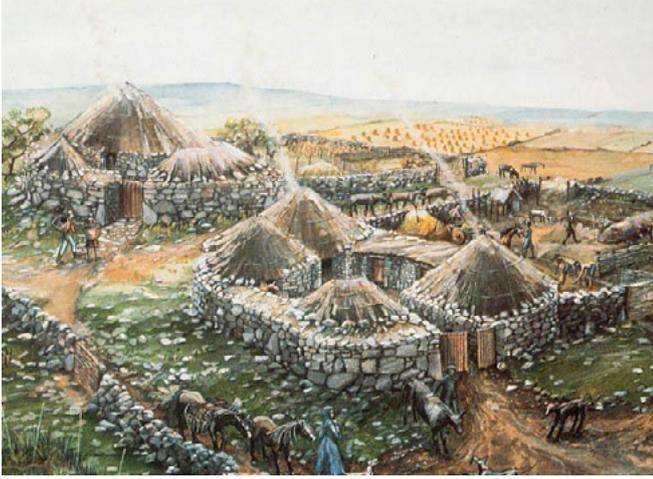
Figure 4
Courtyard house settlement, Chysauster, Cornwall. Reconstruction drawing of courtyard house settlement. The information for the main elements including the farmyard compounds and surrounding fields is drawn from survey and excavation.

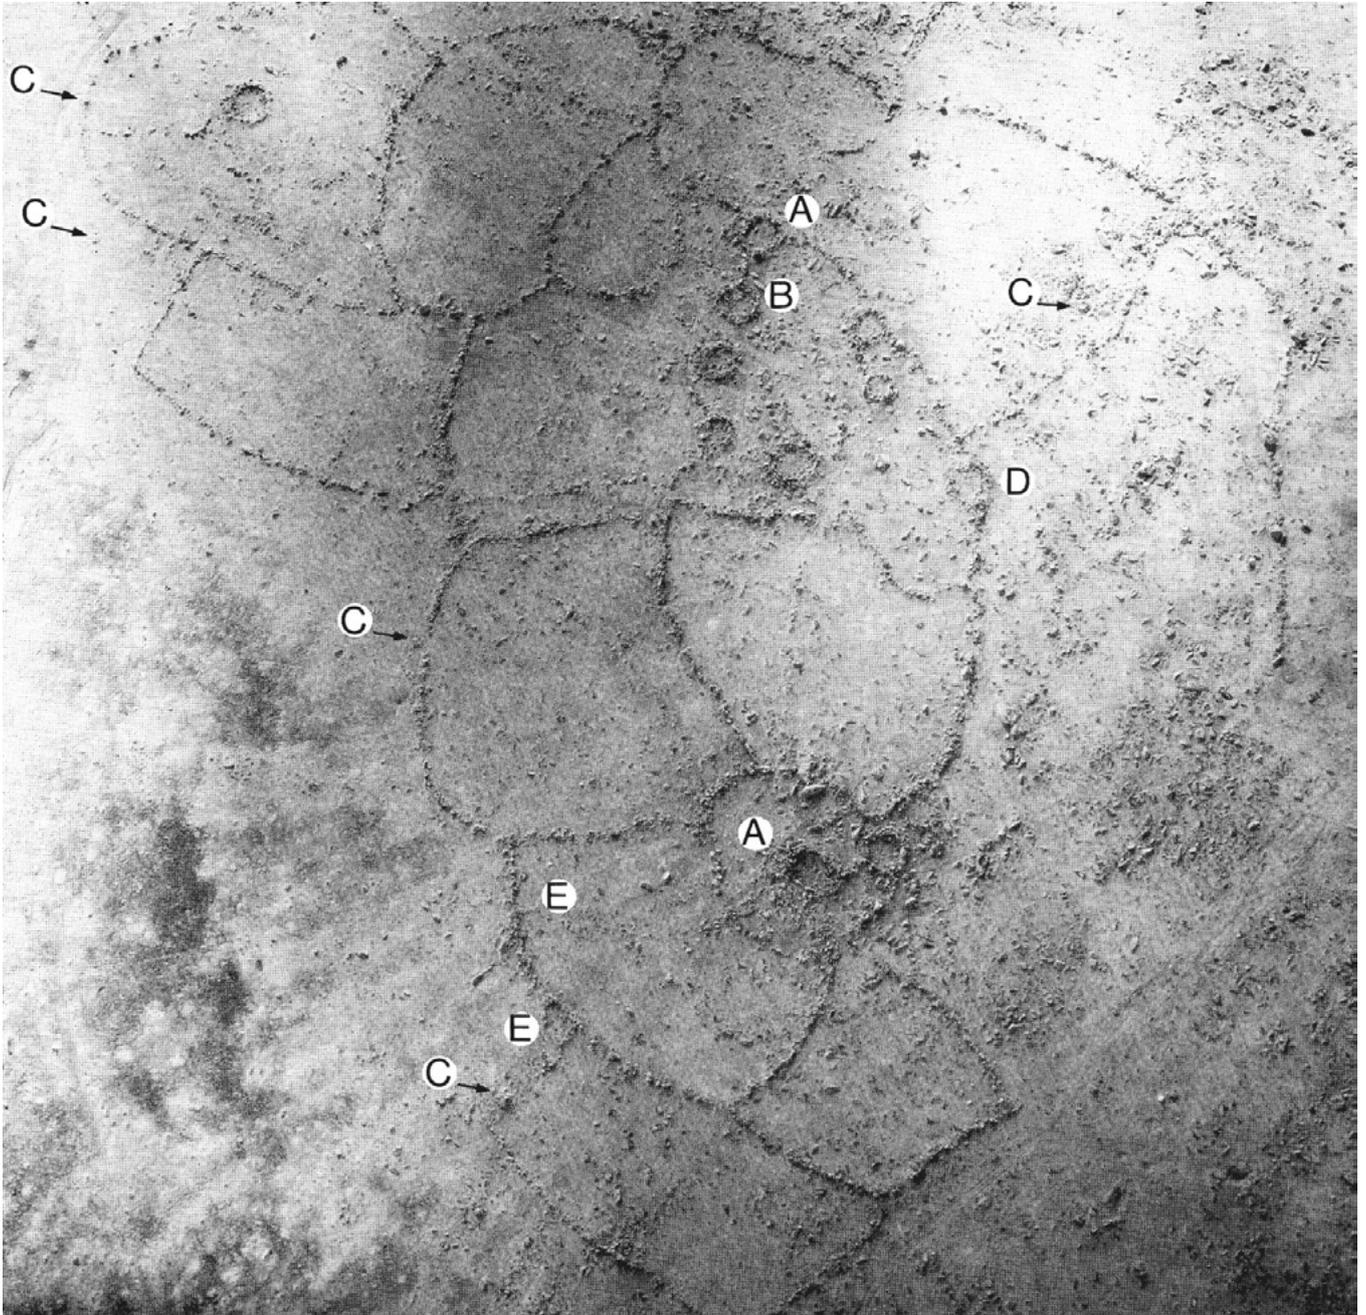
Figure 6

Settlement and field system at Leskernick, Cornwall. The walls of an irregular accreted field system show clearly on the aerial photograph, as do the cluster of stone hut circles. Those at 'A' on the photograph consist of low circular walls with entrance porches; others are less well defined such as the dispersed cluster of huts at 'B'.

Stone hut circles are frequently found in association with a wide range of monuments including regular and irregular accreted field systems, coaxial field systems, as well as different forms of enclosure (Figure 6).

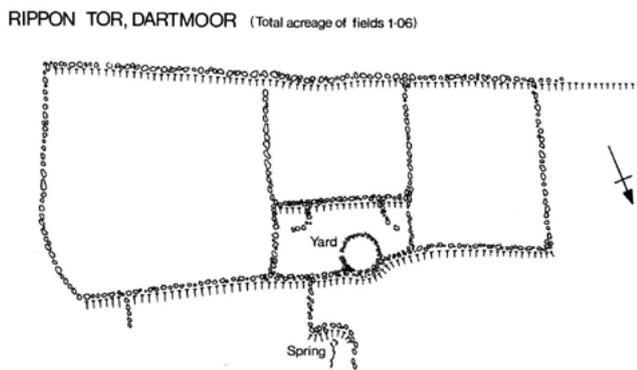
Figure 7
Settlement, Rippon Tor, Dartmoor, Devon. Single stone hut and fields. The interlocking of the settlement and its fields is shown clearly in this basic field survey. The close proximity of a fresh water supply is notable too, and is a pattern repeated at a large number of contemporary sites.

Stone hut circles are ubiquitous in upland areas, particularly, moorland. It has been stated that there are perhaps as many as 1,700 examples on Dartmoor alone, as at Rippon Tor (Figure 7), but it is likely that this, and neighbouring Bodmin Moor, represent the densest concentrations in the country. A national figure in excess of 2,500 is probable.

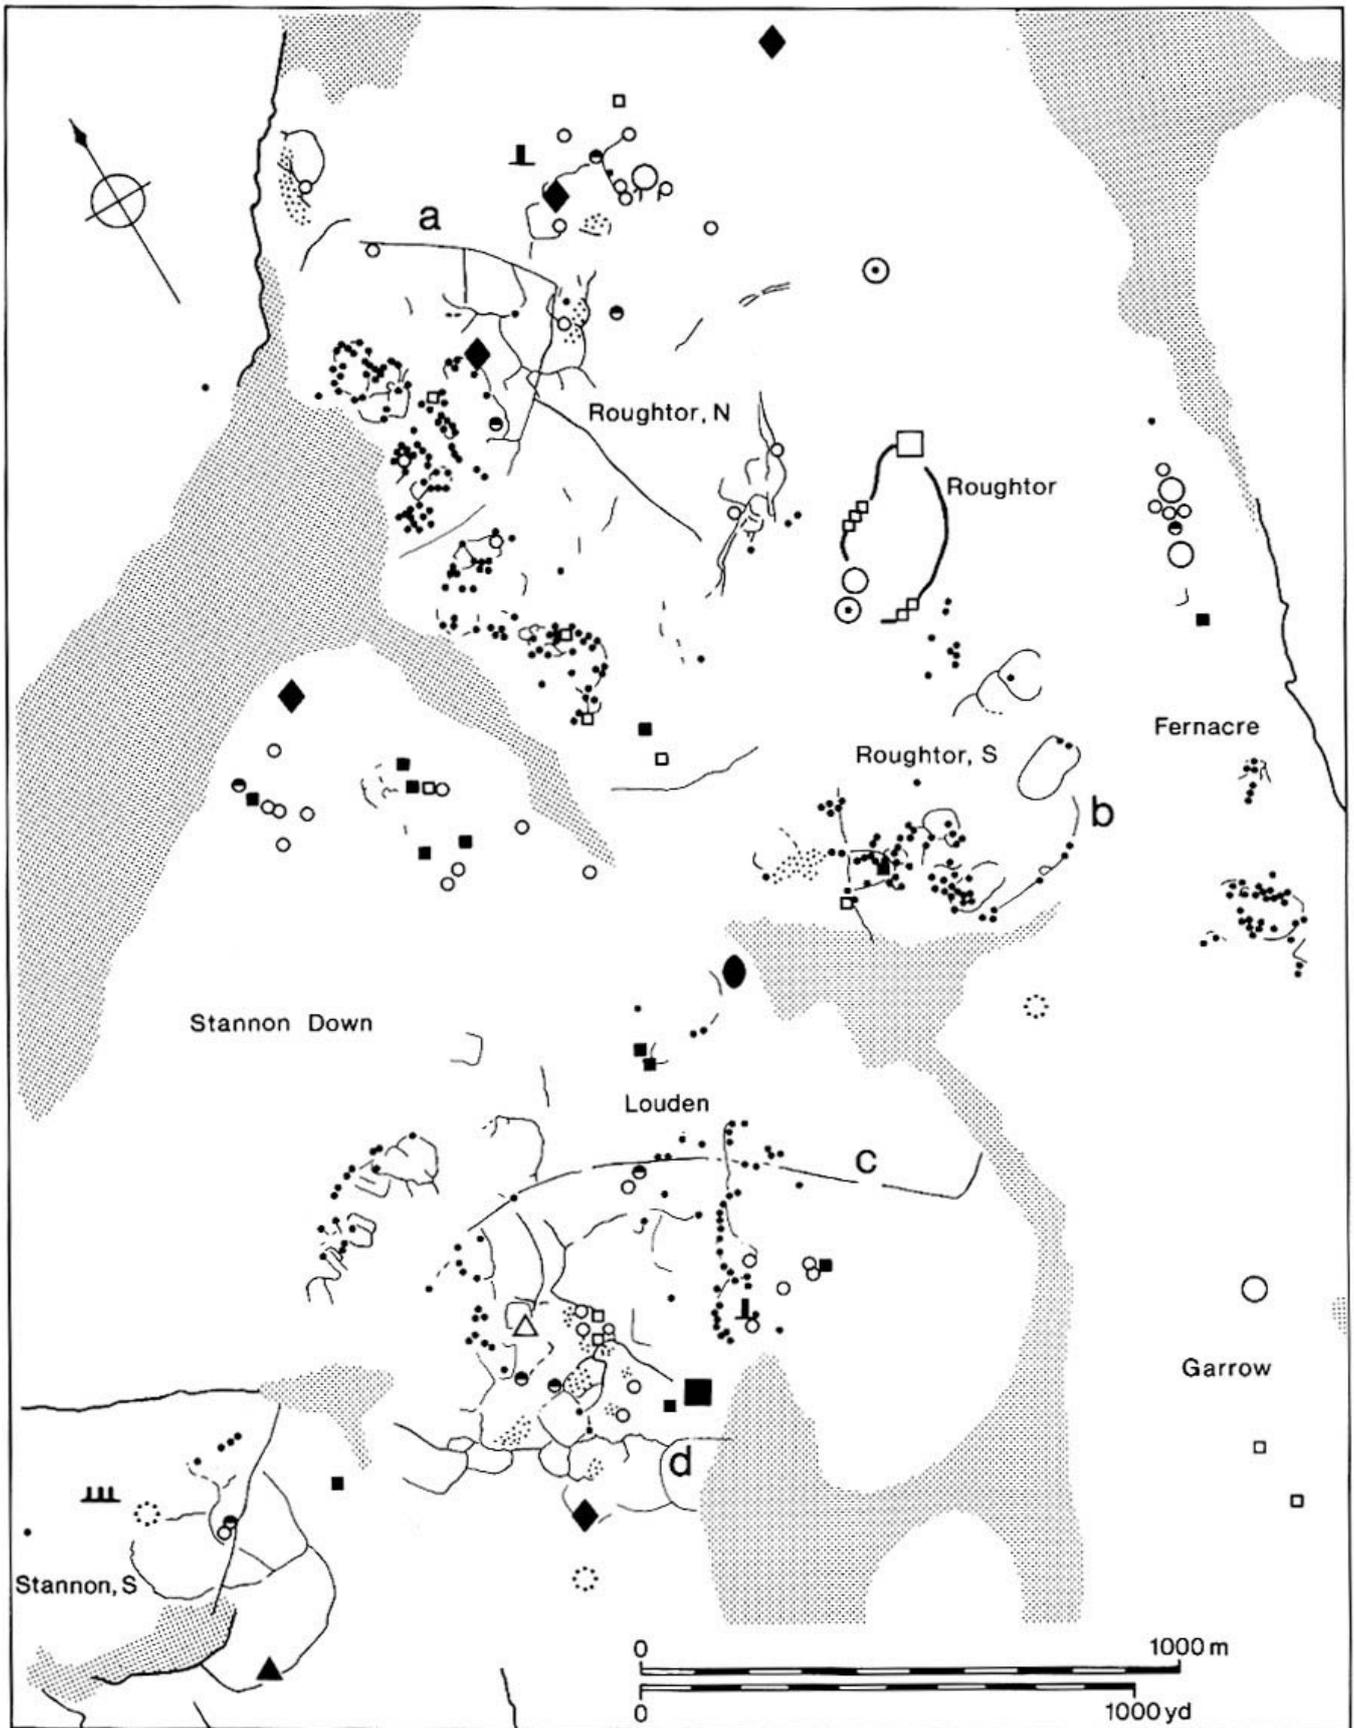
Figure 8
 Bodmin Moor, Cornwall. Landscape of fields and settlement. The landscape around the tor enclosure at Rough Tor is dominated by clusters of stone built huts, either individually or within small clusters. Contemporary fields and trackways are visible too.

Based on an assessment of the density of hut sites in these settlements, it is apparent that some can be characterised as ‘nucleated’, where density is greatest, such as Roughtor North and South, Bodmin Moor and Stanton Down, Dartmoor (Figure 8), whilst others can be more ‘dispersed’, where there is greater space between each constituent hut site, for instance at Holne Moor on Dartmoor. It is clear, too, that in the majority of cases, both nucleated and dispersed, that the layout of huts is random or without clear pattern. In a smaller number of cases the huts within the settlement are arranged in a linear, sometimes multiple and tiered, layout, as seen clearly at Loudon Hill on Bodmin Moor.
