Lead roofs on historic buildings

An advisory note on underside corrosion

ENGLISH HERITAGE
LEAD SHEET ASSOCIATION

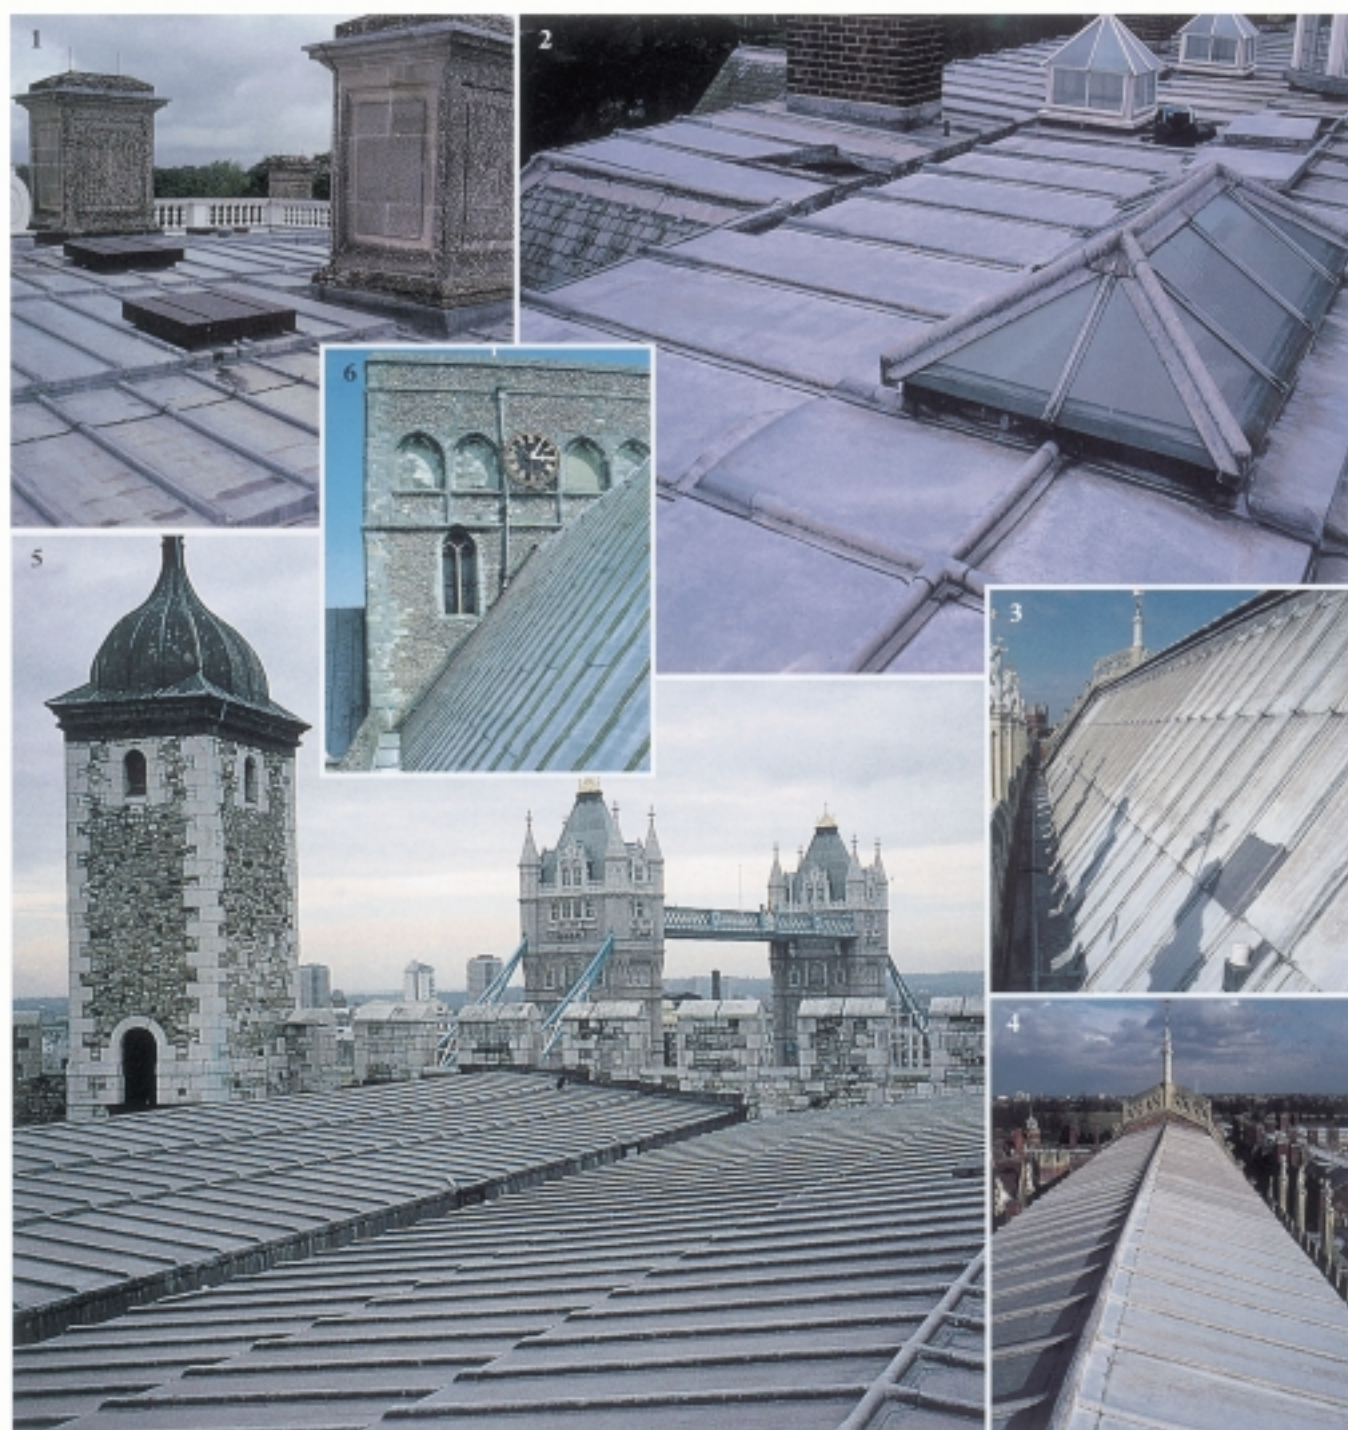
Lead has been used for centuries to cover roofs and as a result of its excellent performance record, it continues to be widely used – particularly on historic buildings. These photographs show lead roofs at (1) Kingston Lacy, (2) Wittington House, (3 and 4) Hampton Court, (5) the White Tower, Tower of London, and (6) St Cross, Winchester

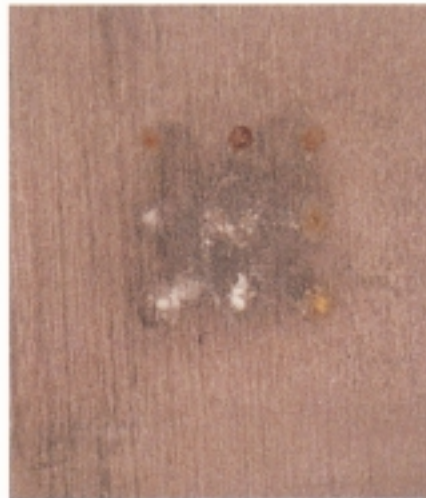
Figure 1 The corrosion behaviour of lead is markedly affected by small changes in environmental conditions. This test specimen, near actual size, was placed on a sheet of polythene-backed building paper on softwood and subjected to evaporation / condensation cycles for two weeks. The paper had nine pinholes in it: above these, dots of corrosion product vary in colour from white through yellow to brown. In the square around them, a dark 'passive' layer has developed which has some resistance to ULC. At the outer perimeter, the lead is bright and virtually unaffected. This mechanism of spontaneous passivation in conditions verging upon the corrosive has helped lead roofs in some historic buildings to perform well, even in damp situations.

Many lead roofs in historic buildings often become damp but show little ULC owing to the development of passive protective films in vulnerable areas. Sometimes these form spontaneously in warm, moist (but not wet) conditions - as in the darkened area around the nine corroded dots in the photograph above. Paradoxically, additional ventilation can sometimes suppress this mechanism.

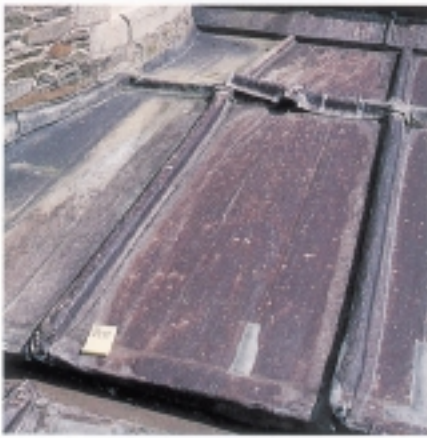
Figure 2 This 1850s roof has eventually failed owing to fatigue cracks caused by thermal stresses in large sheets subject to constant thermal movement. A small amount of ULC was also visible under the sheets: this is perfectly normal, and has not contributed significantly to the failure.

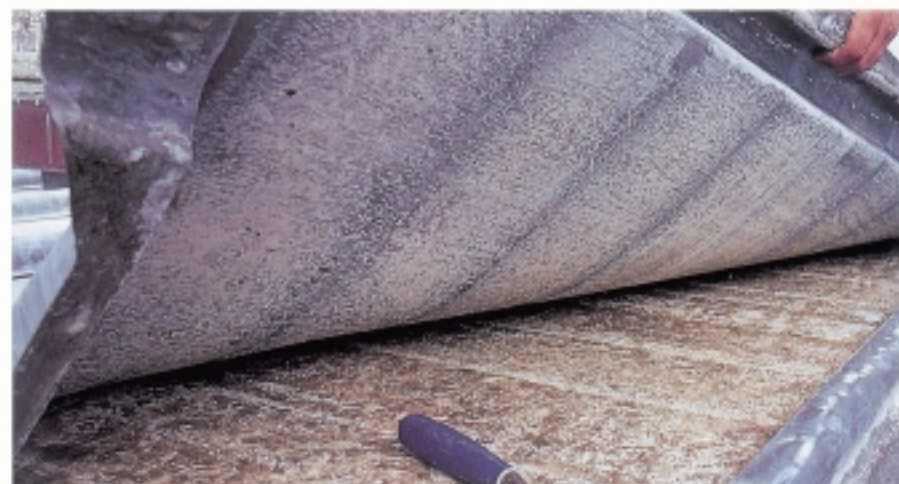
Figure 5 A quinquennial inspection found a compact layer of white corrosion product under this roof on a historic house in Dorset. Over most of the roof, lead which was wire-brushed clean did not corrode again. It was concluded that most of the corrosion had occurred during or shortly after re-roofing, when the lead was vulnerable and the substrate timbers were damp. Coatings of various kinds can help to protect fresh lead from this initial corrosion: see Section 6. At the bottom right, note also the mild corrosion originating from the distillation of rainwater trapped in the splashlap by capillary action. This is discussed further in Section 3.
