Ancient Monuments Laboratory
Report 32/97

WALL PAINTING CONDITION AUDIT,
BYLAND ABBEY, NORTH YORKSHIRE

Remains of decoration, east end, south chapel

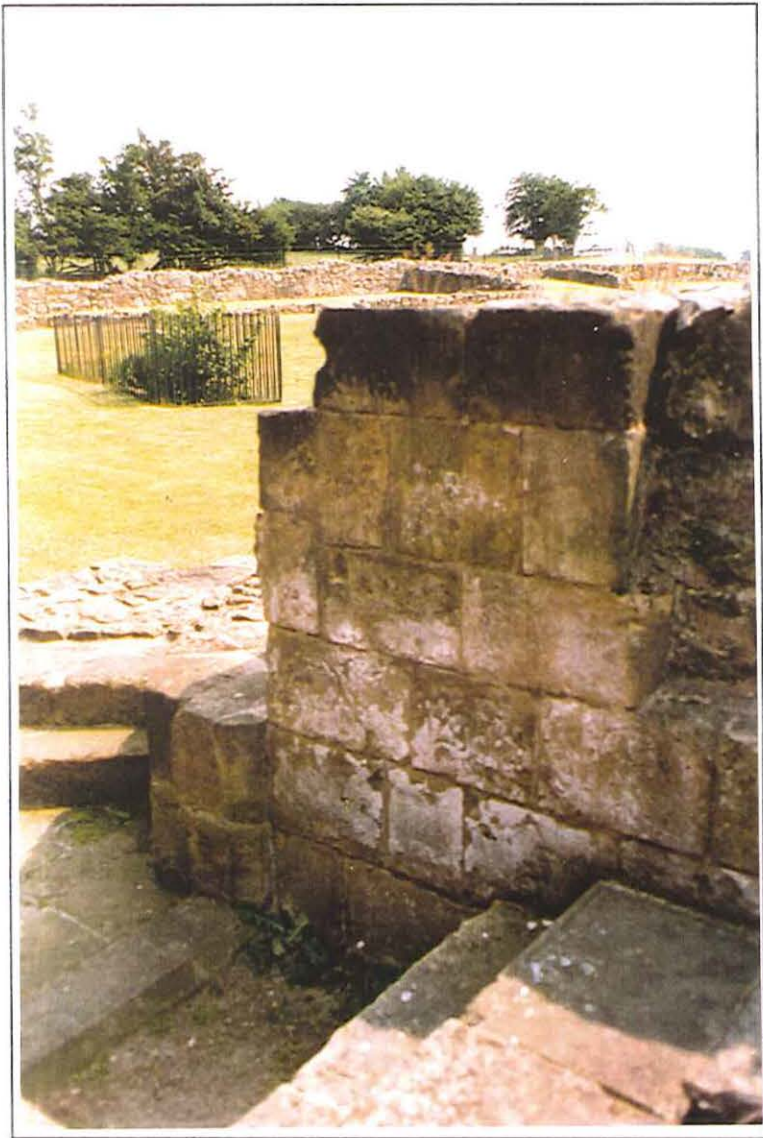
The fragments of paint audited in 1995 appear to be the remnants of a rosette and scrollwork design, in red on a limewash ground. These remains can be seen at the east end of the church, in the southern chapel on the east and south wall.

The paint layer consists of thinly applied red paint. In places, where it appears preferential erosion of paint and ground layers has occurred, 'ghosts' of scrollwork pattern can be seen. A red rosette is visible to the eastern end of the south wall.

East end, south chapel, southeast corner

Comments The painting should be fully photographed and documented as it appears to be the only remains of once extensive decoration within the Abbey.

It may not be possible to conserve the surviving fragments as they are severely eroded and it would prove difficult to successfully carry out any conservation treatment of the paint layer. However, consolidation of the stone and/or removal of the black crust over the surface may be considered desirable.

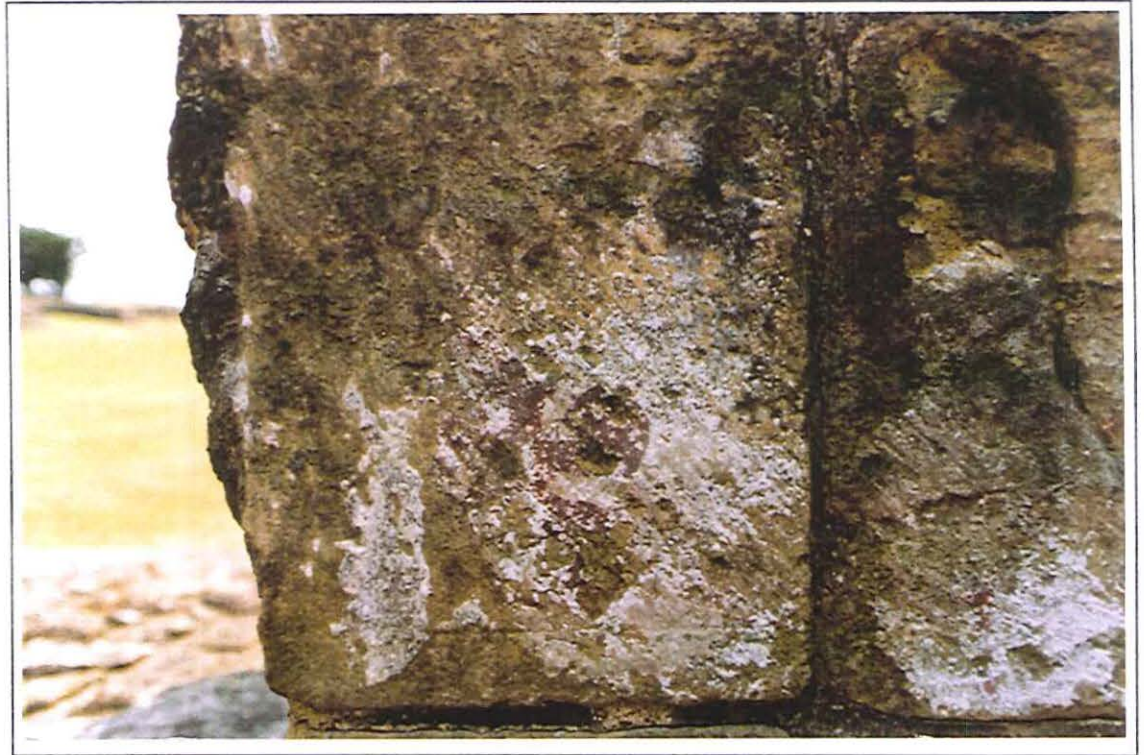
Detail, painted rosette on south wall
