Ancient Monuments Laboratory  
Report 12/99

DENDROCHRONOLOGICAL ANALYSIS  
OF HALL I' TH' WOOD, BOLTON,  
GREATER MANCHESTER

Summary

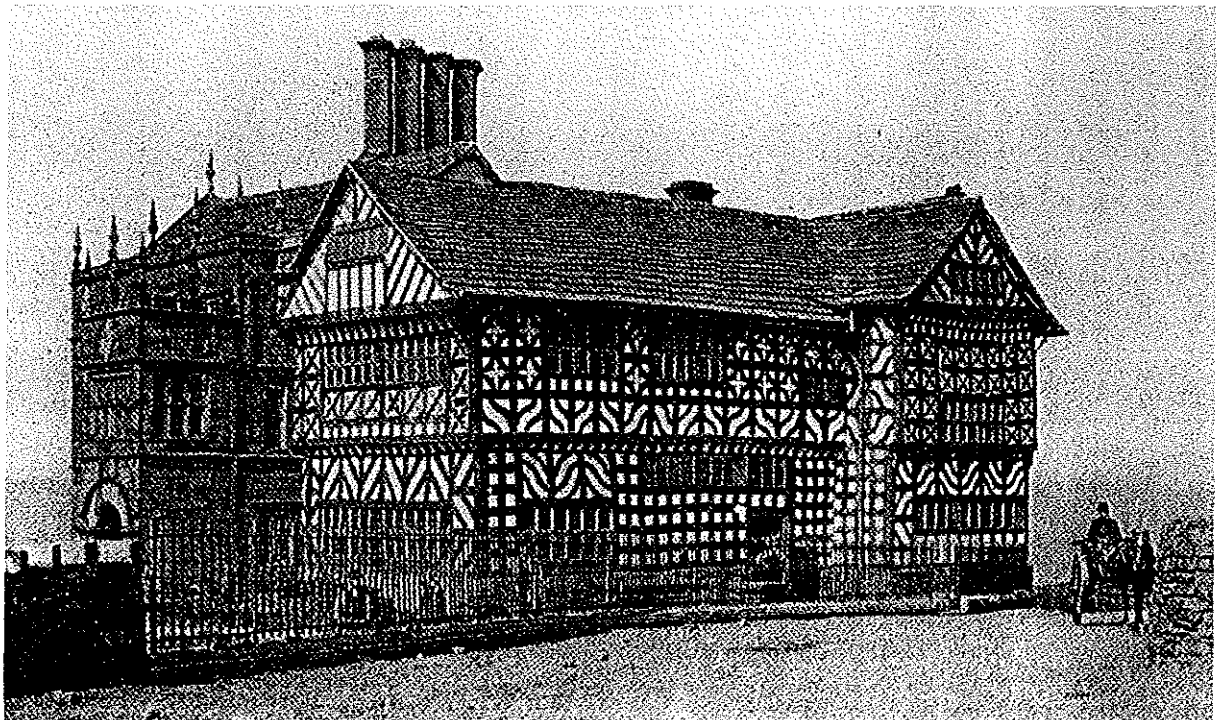
Figure 4: Hall I' Th' Wood, *circa* AD 1900, viewed from the south-east, reproduced from Mills 1992.
