The Museum

Contents of Show Cases

Environment of Museum Building

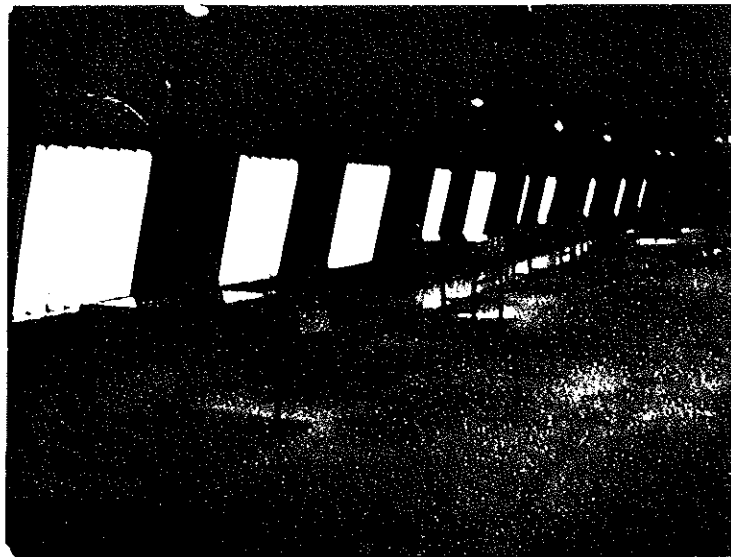
The show cases are arranged in 2 galleries, an upper and lower which are situated on the higher side of the museum building. The show-cases in the lower gallery are 'top viewing cabinet type' (photograph 4) with one additional large custom made glass case that houses a lead coffin containing a skeleton. Above each of these cases is a spot light (not on on day of survey), but the distance is sufficient that no significant change of environment within the cases should take place when they are in use. However behind a number of these cases is a large glass fibre window which allows the sunlight to fall across the glass tops of the show cases. This could be

detrimental to objects of an organic nature.

photograph 4. Cases in lower gallery showing windows and spot lights.

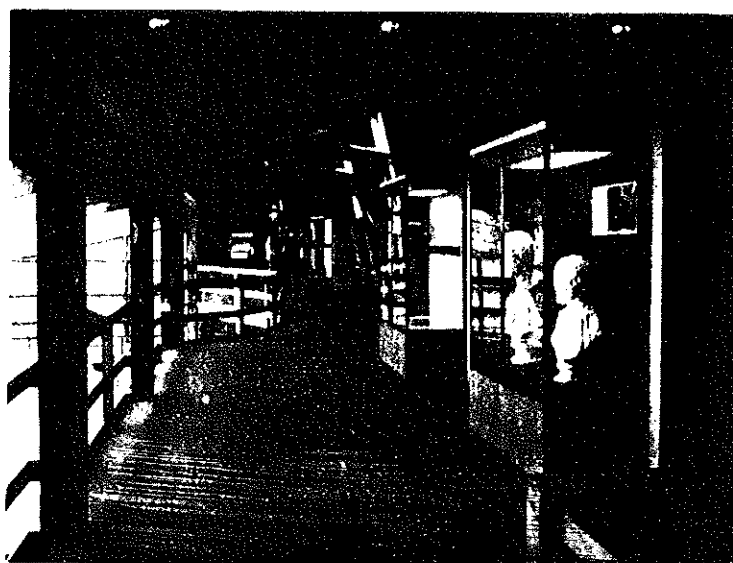
The show cases in the upper gallery are the large free- standing type lit through a light diffuser at the top. It is in this upper gallery that the opening windows are situated, and the two air fans are situated on top of two of these cases. This is satisfactory during the summer months but could possibly cause some trouble during the winter when the heating elements are in use.

photograph 6. Upper gallery showing show cases, opening windows and air fans.
