Ancient Monuments Laboratory  
Report 55/1999

TREE RING ANALYSIS OF TIMBERS  
FROM HILL HALL, THEYDON MOUNT,  
ESSEX

M C Bridge

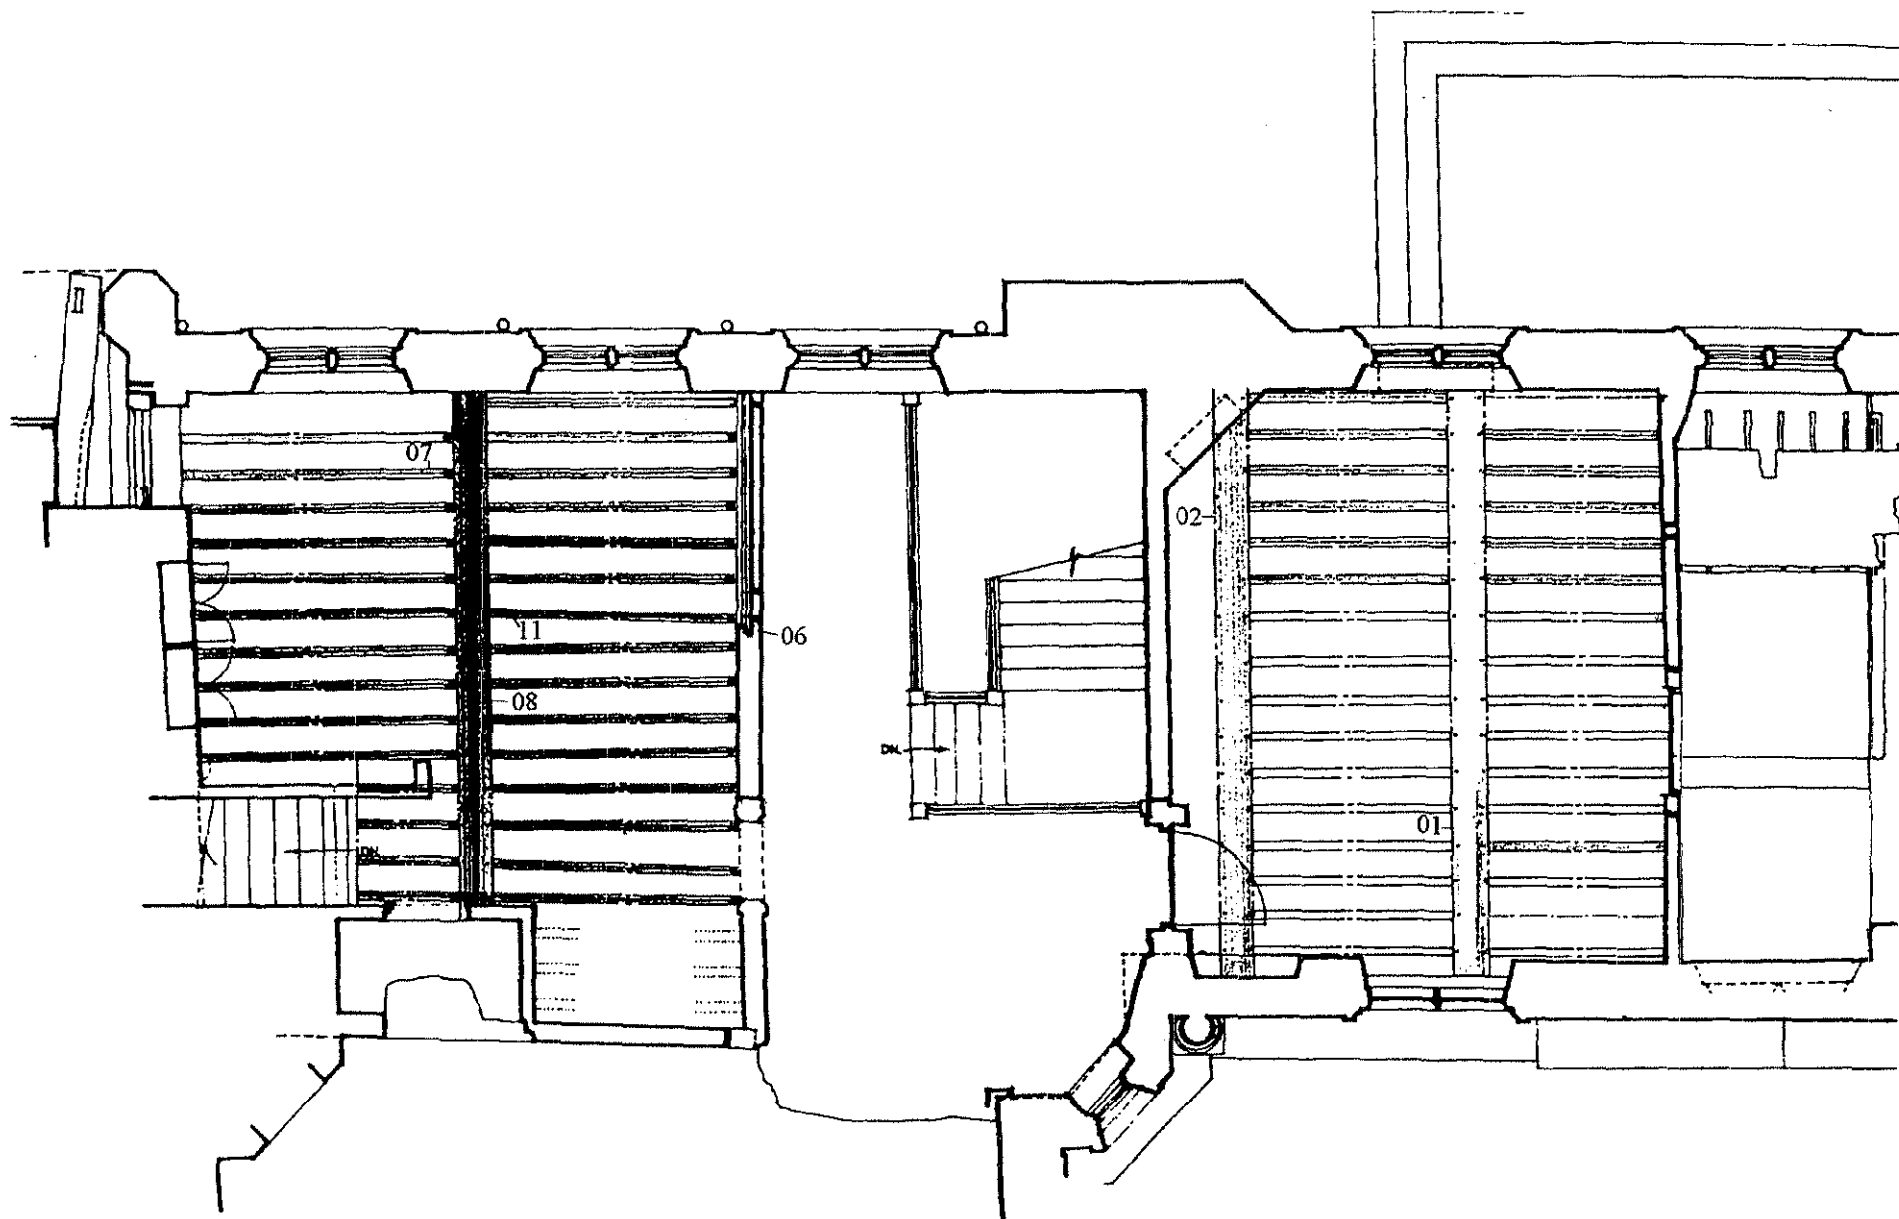
**Figure 1:** Plan of the north range, Hill Hall, Essex, showing locations of samples taken for dendrochronology

Timbers in both the north range and the north-west wing were sampled, the locations of those timbers sampled, are shown Figures 1-5, and described in Tables 1 and 2. Although not many timbers in either the north or north-west ranges had extensive sapwood surviving, enough timbers had some traces of sapwood that it was felt that the information they might yield justified the sampling done.

The oak ring series from the north range, samples HHT01 - HHT11 (Table 1, Figs 1 - 3) did not match each other, and therefore individual series were matched against a range of regional and site chronologies. Consistent significant matches were found for six of the timbers and the dates subsequently allotted to them are shown in Table 1, with the evidence for their dating in Table 3. The six series were combined into a site chronology Hill Hall 1 (Fig 6), which gave very good matches against a number of chronologies (see Table 4).

The first point of interest is that many of the timbers which survive in the north range (Figs 1 - 3) are of relatively poor quality, being full of knots, and are not finished to a high degree. The main beam from which sample HHT08 was taken for example, has no chamfers and a rough exterior. Many of the joists have rough rounded edges where the outside of the tree has been left. This seems like rather poor workmanship when compared to nearby properties such as the earlier Gosfield Hall (Bridge 1998c). The nature of the knotty timbers, coupled with the lack of internal matching between the components of this range, suggests that the timber may have come from hedgerow-like environments, possibly from scattered sites, although probably from the local region, given the nature of the crossmatching with reference material. The number of timbers with bands of varying width annual rings, showing sudden changes in the rate of growth, suggests that some lopping of the trees had taken place during their lifetime, though other causes, such as disease, cannot be entirely ruled out. Nevertheless, it was felt that these trees may represent typical growth over a wide area and although they did not crossmatch well statistically, the site master derived from them has been demonstrated to give strong matches against a range of reference chronologies (Table 4). The much earlier date derived for the outermost ring of HHT08 (AD 1546), which had no obvious signs of reuse, suggests that the tree had either been standing dead for many years prior to felling, or that this timber had been stored for many years before being used.

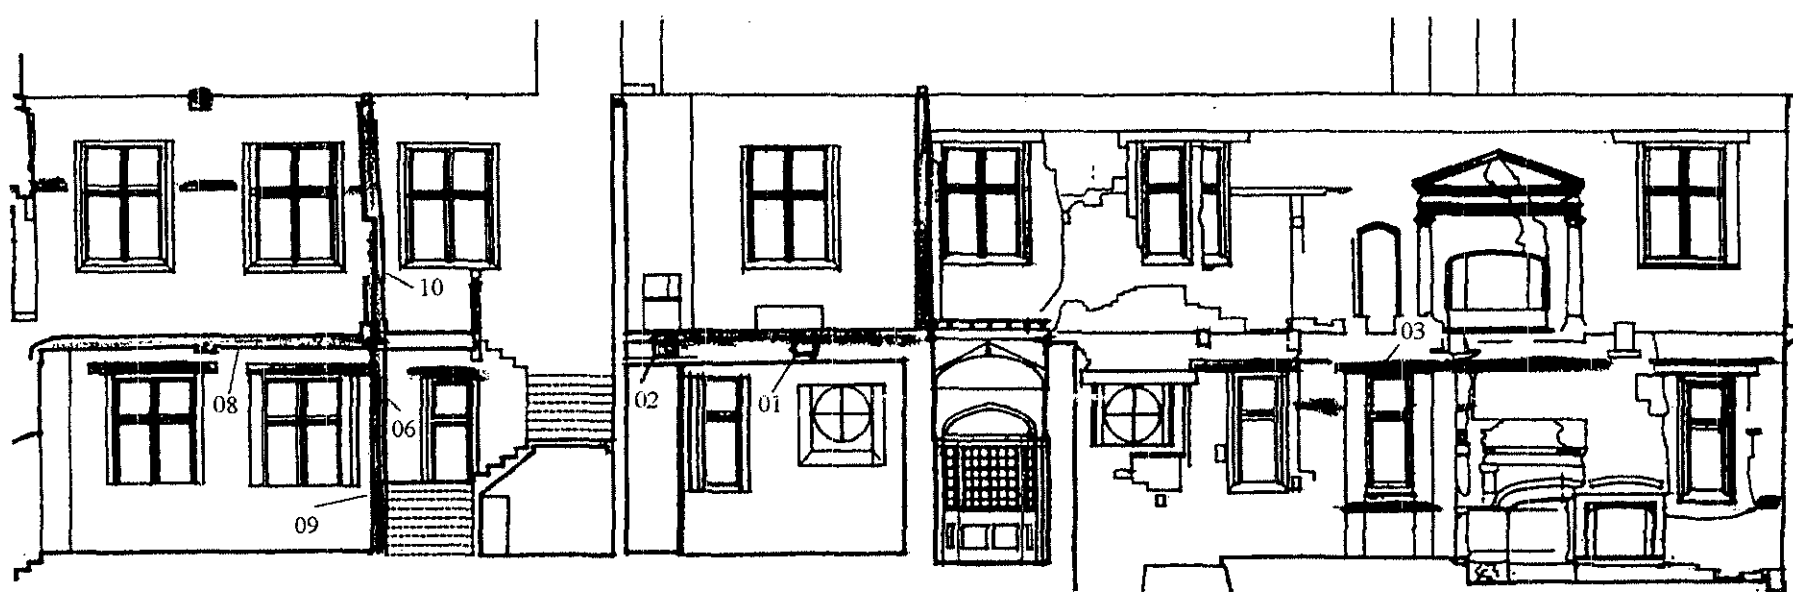
Figure 2: Drawing of the north wall of the north range, Hill Hall, Essex, showing locations of samples taken for dendrochronology

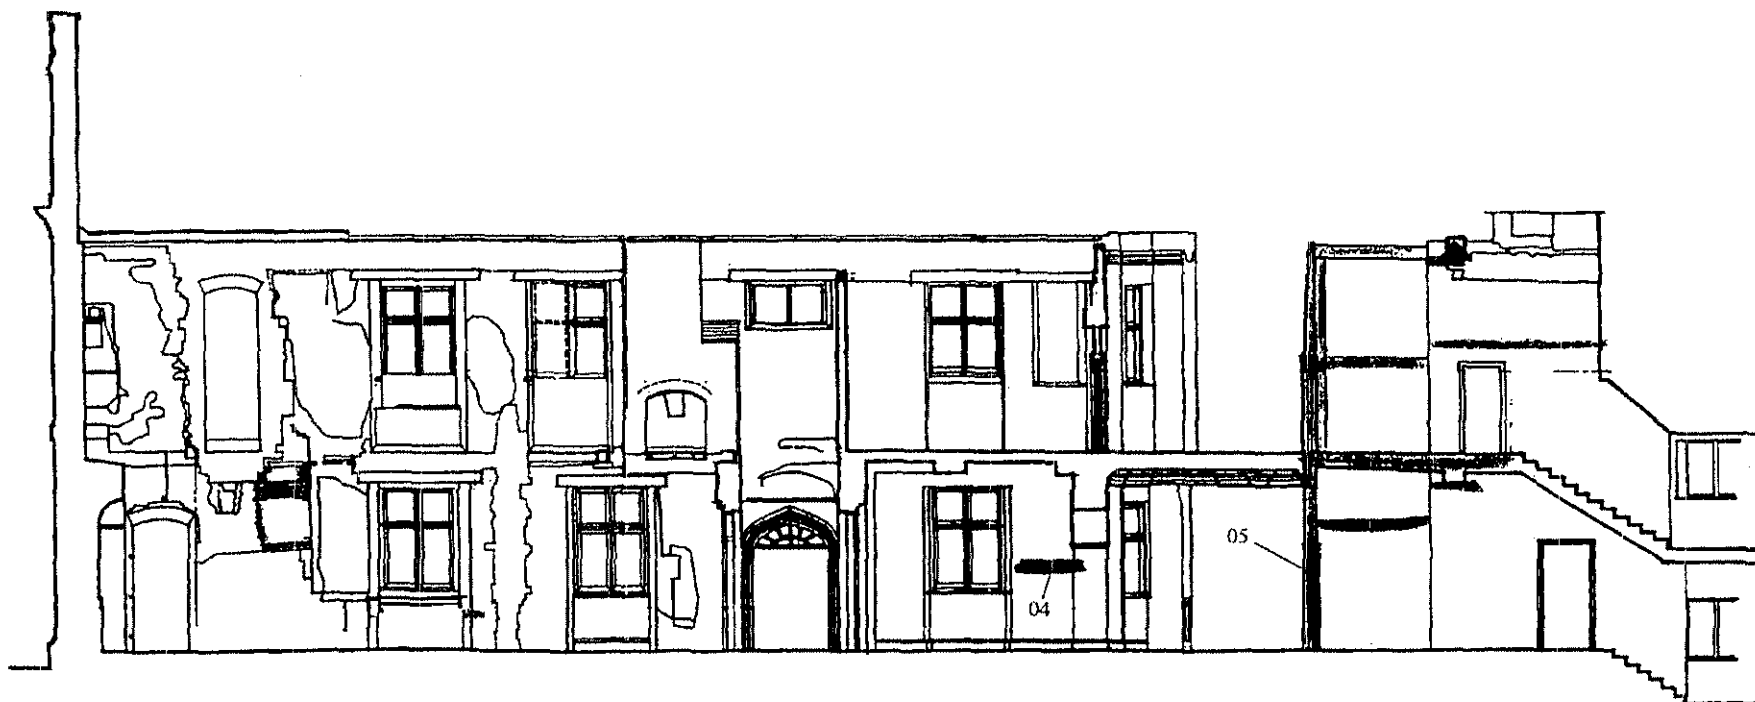
**Figure 3:** Drawing of the south wall of the north range, Hill Hall, Essex, showing locations of samples taken for dendrochronology

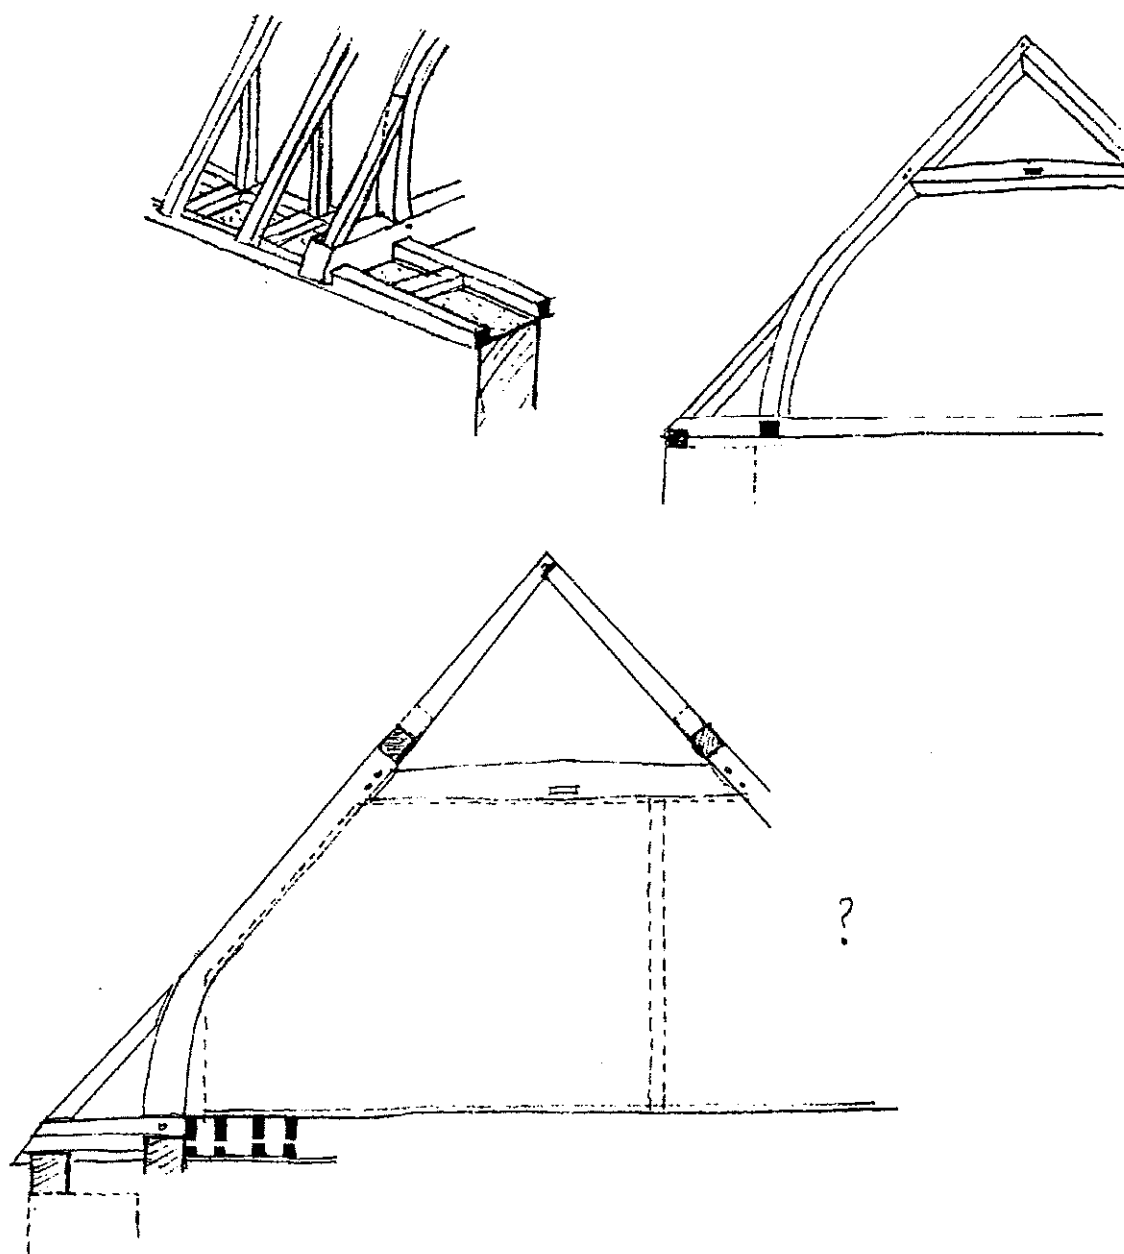
**Figure 4:** Sketches of the roof of the north west wing, Hill Hall, Essex, showing the general form of the trusses. Based on originals by Andy Wittrick (English Heritage)

The timbers in the north-west range (samples HHT12-HHT28, Table 2, Figs 4 and 5) had had their sapwood crudely removed, making it more difficult to find useful timbers with extensive

By contrast, the roof of the north-west wing (Figs 4 and 5), thought to have been built as servants' quarters, at least on the ground floor, has well-finished, refined carpentry. The sapwood appears to have been hacked off rather crudely, though this may well have been done many years later, probably when the wing was remodelled by Blomfield in the early-twentieth century (Drury pers comm). However, the presence of pit saw marks on many of the timbers, indicated that they were likely to be older than Blomfield's time. Many of the principal rafter pairs have made use of very fast-grown oak, and these may have been selected for strength. Many of the floor timbers (Fig 5), including joists and tie beams were cored. Several were found to have a high moisture content and the cores were difficult to extract.

structure in this wing. The unusual curved principal rafters have been likened to upper crucks, but this much later date further removes this roof from that tradition.

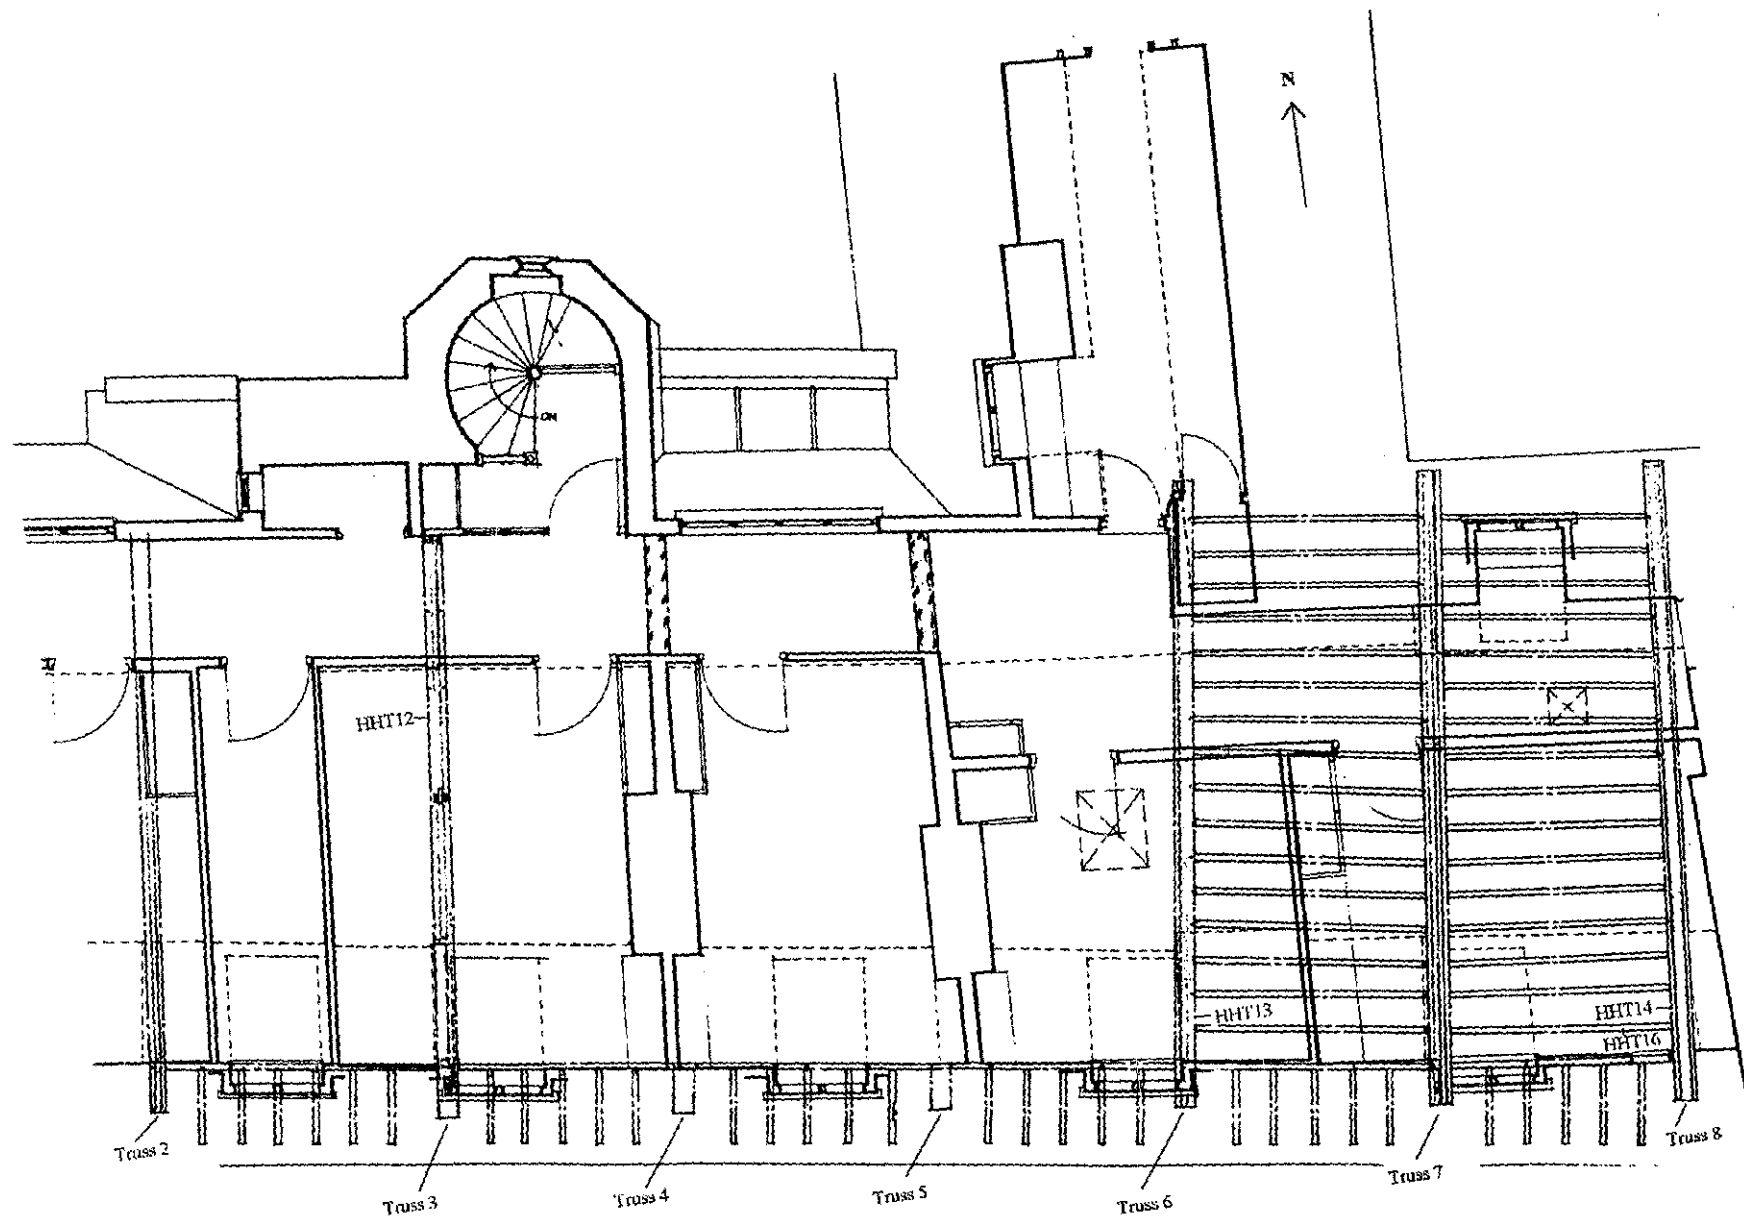
Figure 5: Plan of the first floor of the north west wing, Hill Hall, Essex, showing the truss numbering, and locations of samples taken for dendrochronology

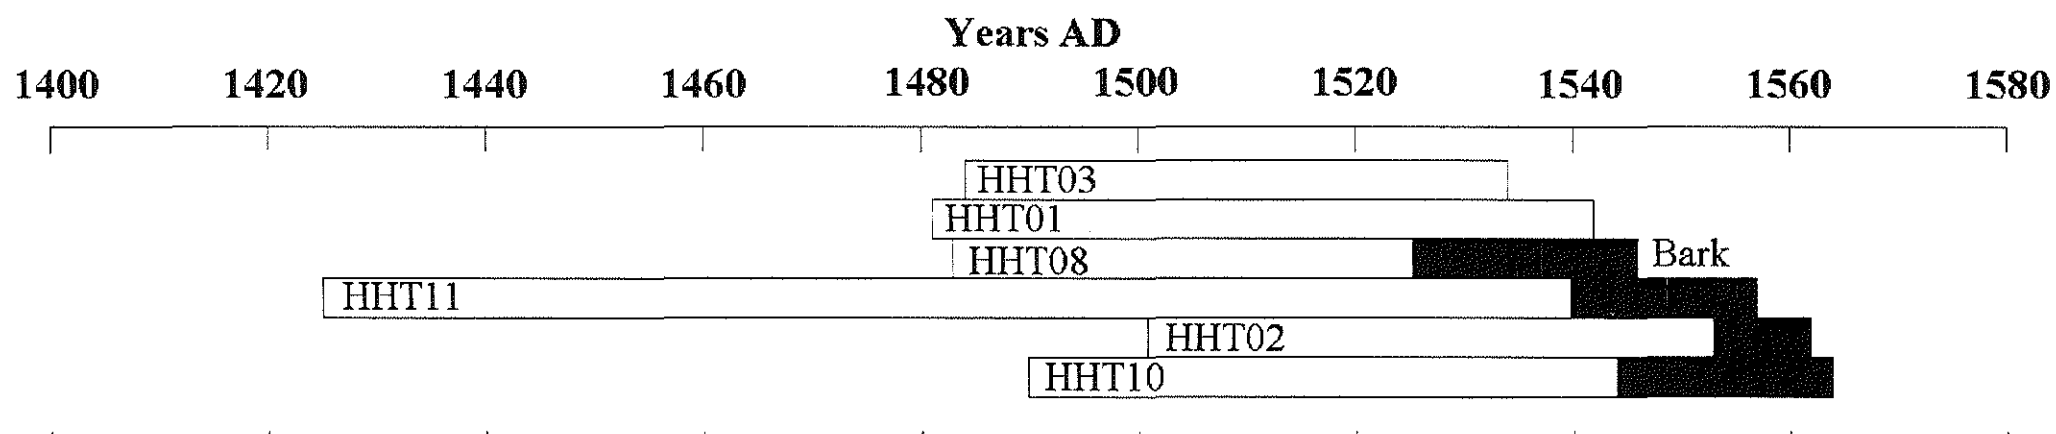
**Figure 6:** Bar diagram showing the relative positions of overlap of the dated timbers used in the site chronology HillHall 1. The shaded areas represent sapwood

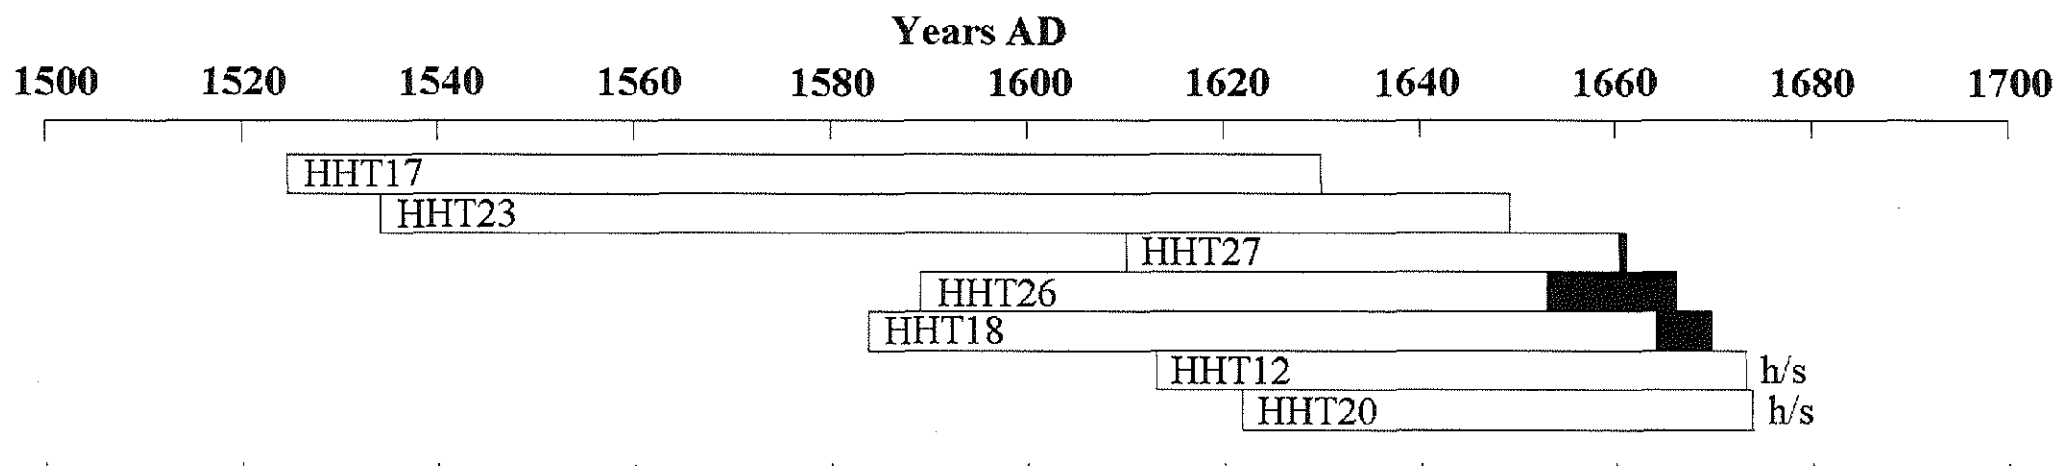
**Figure 7:** Bar diagram showing the relative positions of overlap of the dated timbers from the north-west range used in the site chronology HillHall 2. The shaded areas represent sapwood, h/s = heartwood-sapwood boundary

sapwood for dating. Individual truss drawings were not available and exact locations above tie beam level are not therefore indicated. Good crossmatching was found between seven of these timbers (Table 5) and their series were combined to form a second site chronology Hill Hall 2 (Fig 7), which was subsequently dated (see Table 6).
