Ancient Monuments Laboratory  
Report 46/2000

TREE-RING ANALYSIS OF OAK  
TIMBERS FROM THE PRIOR'S HOUSE,  
CASTLE ACRE, NORFOLK

I Tyers

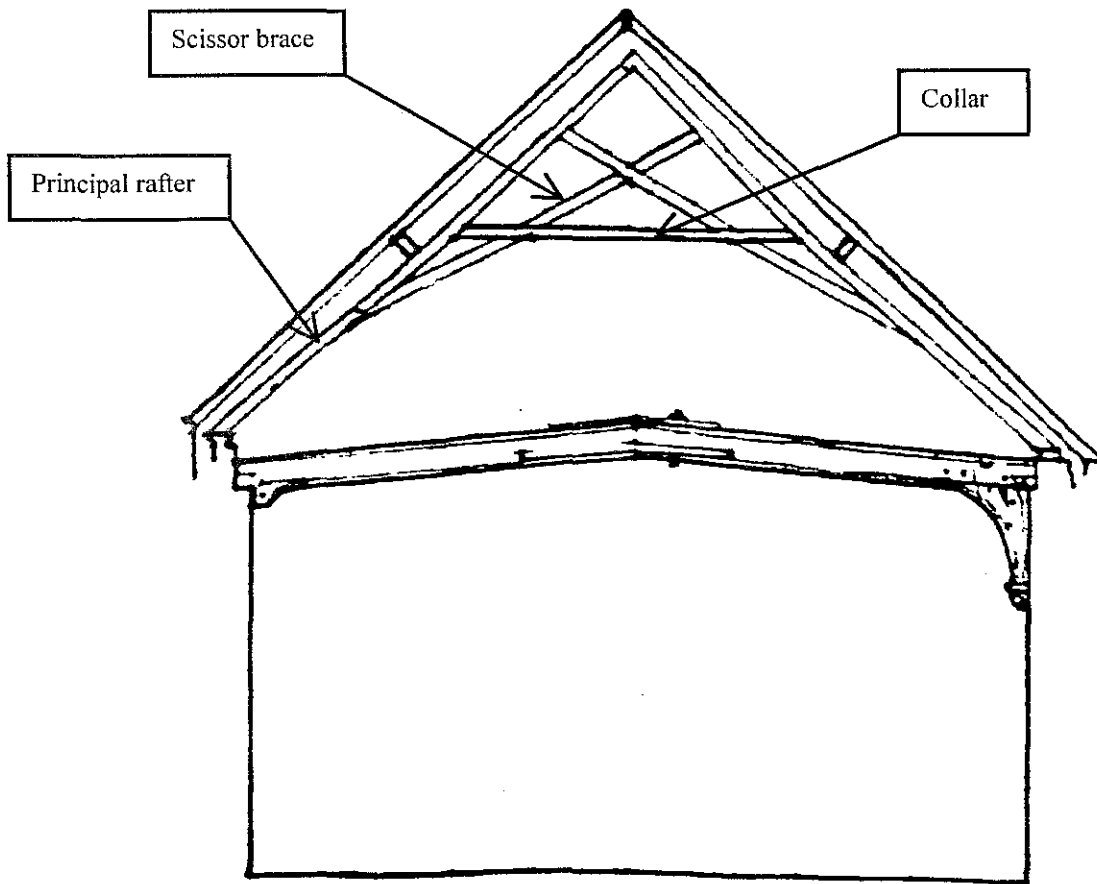
**Figure 3**

A typical scissor braced truss from the upper roof as seen in trusses 1, 2, 4-14, and 16-36 inclusive, showing the nomenclature used for the timber elements, based on an original by the Ministry of Public Buildings and Works, this figure also shows one of the cranked tiebeams forming the present ceiling

The correct nomenclature to use for the parts of the lower roof or inserted ceiling is a problem, the nomenclature followed here is as if it were a cranked tiebeam roof with central ridge and rafters. This is not meant to pre-judge the correct interpretation of the structure. During sampling no original truss numbers were identified that formed a coherent sequence. The lower roof was therefore assigned truss letters A-E from the east (Table 1; Fig 6). Unfortunately it was subsequently found that there were modern chalked numbers on the upper roof from 1-36 running from the west, these are possibly from the recent survey work. This upper roof numbering sequence was followed for the sampling records in this area (Table 1; Fig 6).

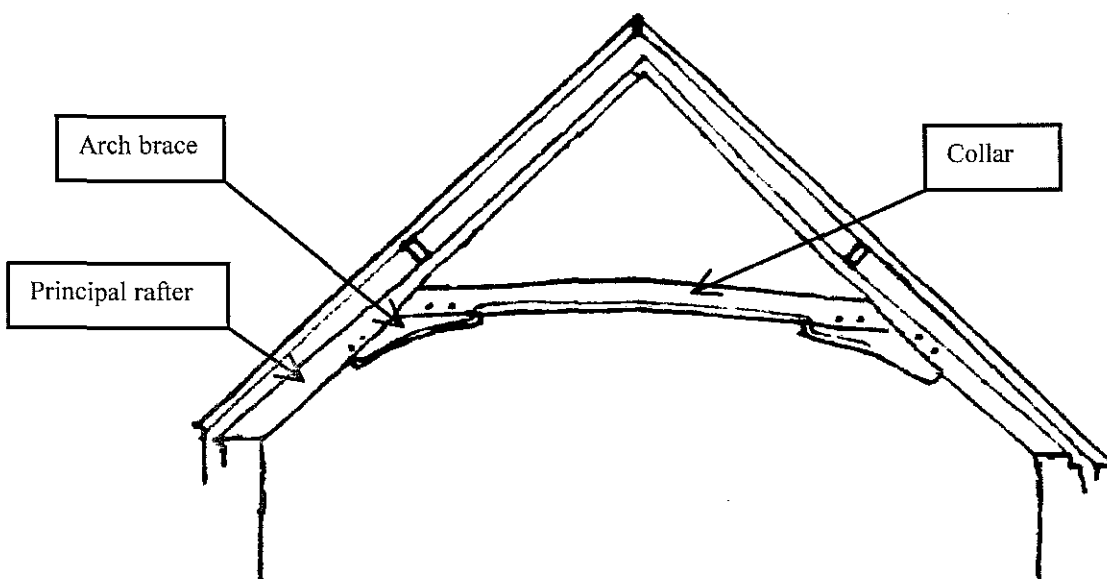
**Figure 4**

An arch braced truss from the upper roof, trusses 3 and 15, showing the nomenclature used for the timber elements, based on an original by the Ministry of Public Buildings and Works

In contrast the upper roof contains fewer timbers suitable for dendrochronology. Sample selection was more difficult and, compared with the lower roof, the timbers in it appeared to have fewer rings and faster average growth rates. These impressions are supported by the samples obtained from it, with six of the 23 samples having fewer than 50 rings, and only one sample having more than 100 rings, by comparison only one of the 12 lower roof samples was too short to measure and six have more than 100 rings (Table 1). The dated samples from the upper roof combine to give an original felling date for these timbers of between AD 1396 and AD 1419 which suggests this structure is made of timber felled around 30 years later than those of the lower roof. The dendrochronological results indicate the two structures are not contemporaneous and there are redundant joints in some of the unsampled upper roof timbers which, if these are the same date as the rest, would imply this roof is somewhat later than the dendrochronological dating evidence obtained for it. There is, in addition, the unresolved issue of the date of the two arch-braced trusses in the upper roof (trusses 3 and 15; Figs 4 and 6). Three of the five samples from these two trusses are combined to form the CAP\_ARCH sequence but this is hopelessly short at 54-years length and not surprisingly remains undated (Table 10). The longer individual sequence obtained from the truss 15 collar (sample 33) which includes sapwood and bark-edge (Table 11) also has proven undatable by current reference data. None of the other timbers in these two trusses appeared suitable for sampling.

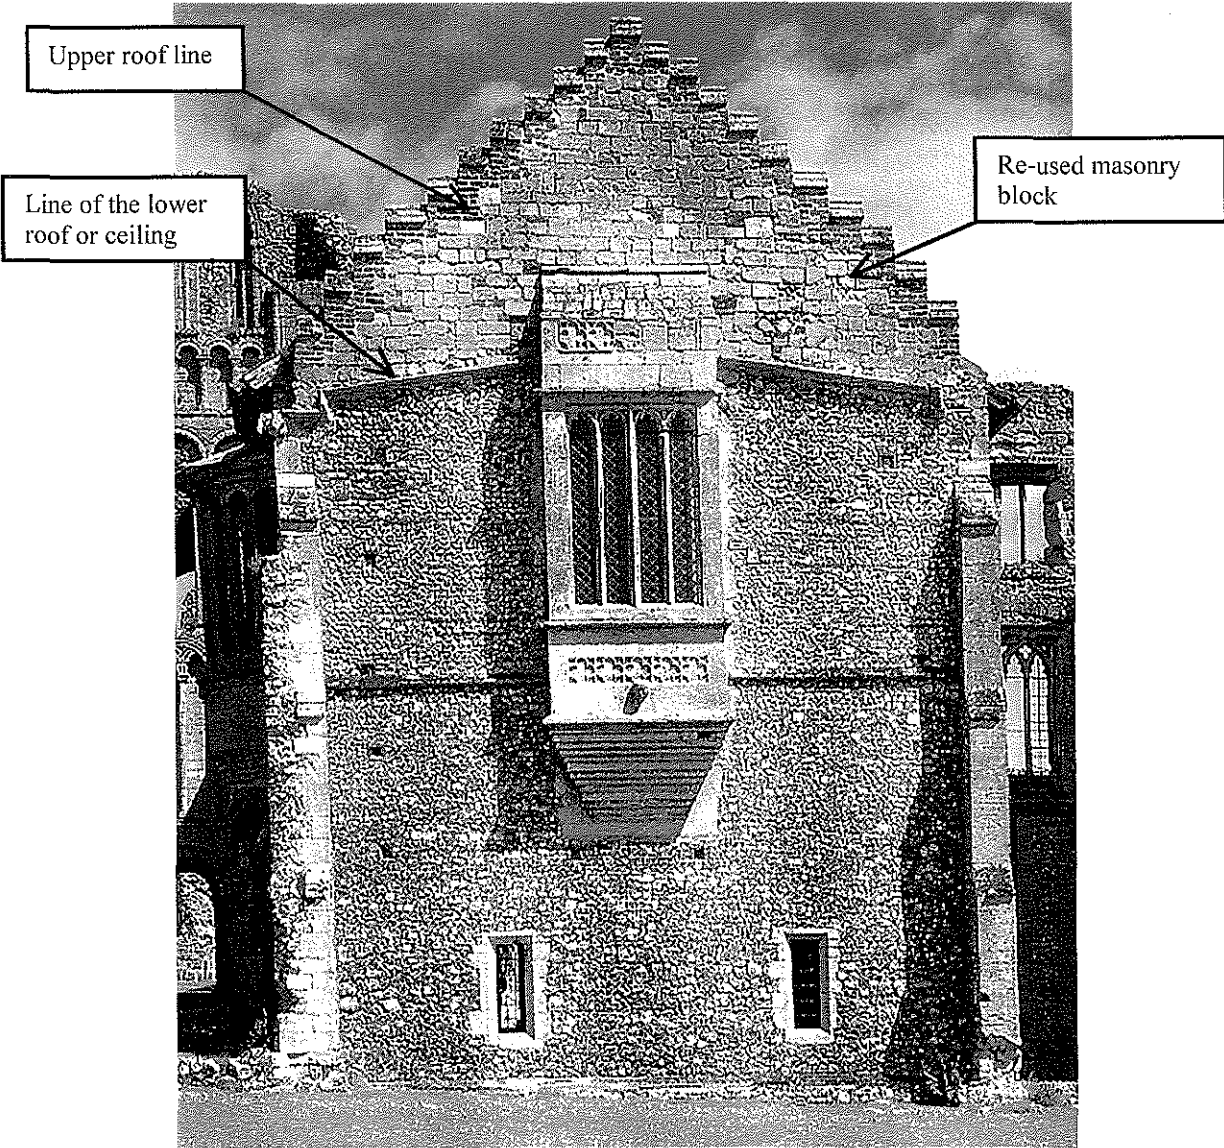
**Figure 5**

Photograph of the west end of the Prior's House. This shows the drip courses associated with the lower ceiling, the different masonry above these, and also highlights at least one piece of re-used masonry. Photograph English Heritage Photographic Unit © English Heritage

The presence of two different but undatable trusses in the upper roof and the likely presence of datable but re-used timbers that are already later than those in the lower roof indicates the upper roof is later than the lower roof and thus replaces it. Further supporting evidence for this conclusion is provided by two other observations: firstly that there is widespread water damage on the upper surfaces of the lower roof that is absent from the roof above it, and secondly that there is the inclusion of re-used masonry on the stone gable ends only above the drip courses. Since these drip lines are an expression of the lower roof line the alternative suggestion requires these to have been added later to the outside of the walls simply to reflect the location of an inserted ceiling.

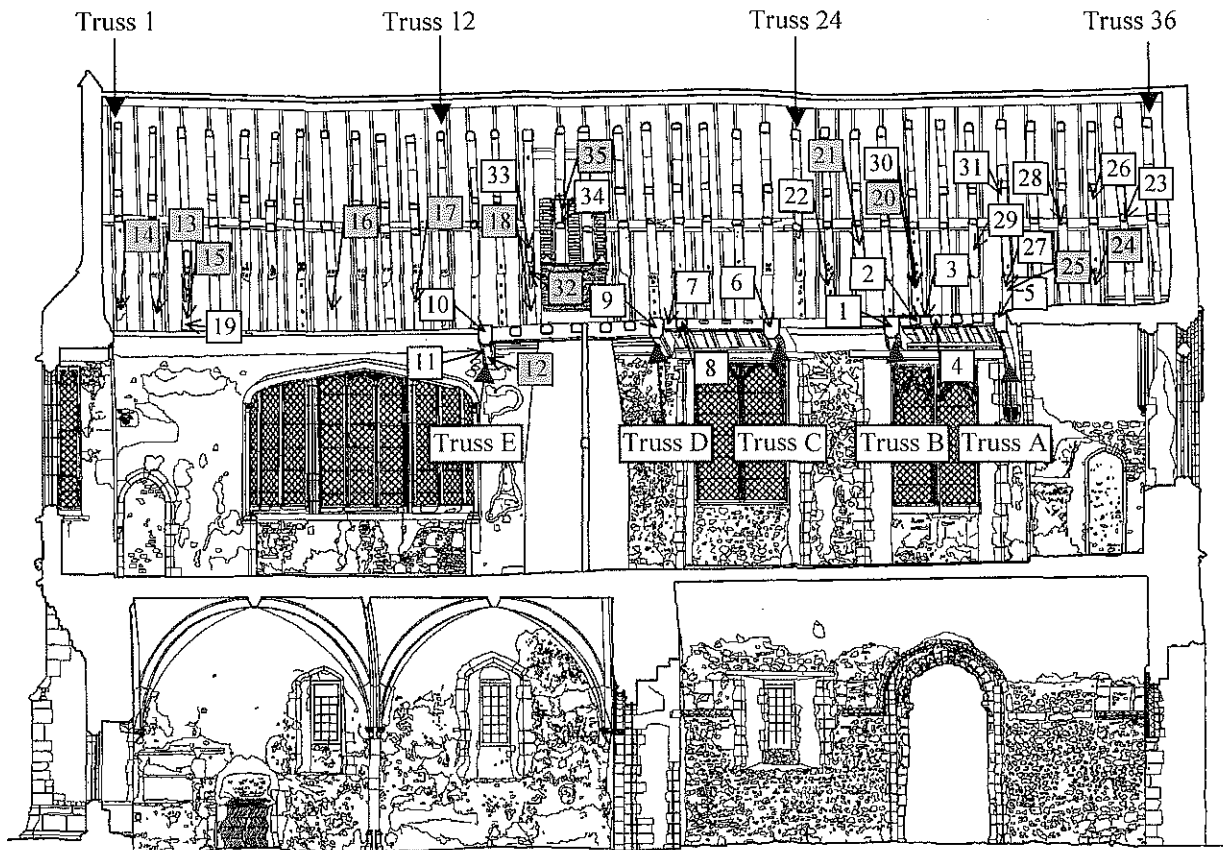
**Figure 6**

Section of the Prior's House looking north, showing both roofs, the truss numbering scheme adopted, and approximate location of samples 1-35, based on an English Heritage Survey Services diagram © English Heritage. The timbers from the unseen, but identical southern half of the roof are shown in yellow boxes, those in the northern half are in white boxes

A total of 35 timbers were selected as most suitable for sampling (Table 1; Fig 6). There was an almost complete lack of sapwood throughout the building. The samples were numbered **1-35** inclusive: samples **1-12** are from the lower roof, samples **13-35** from the upper roof.

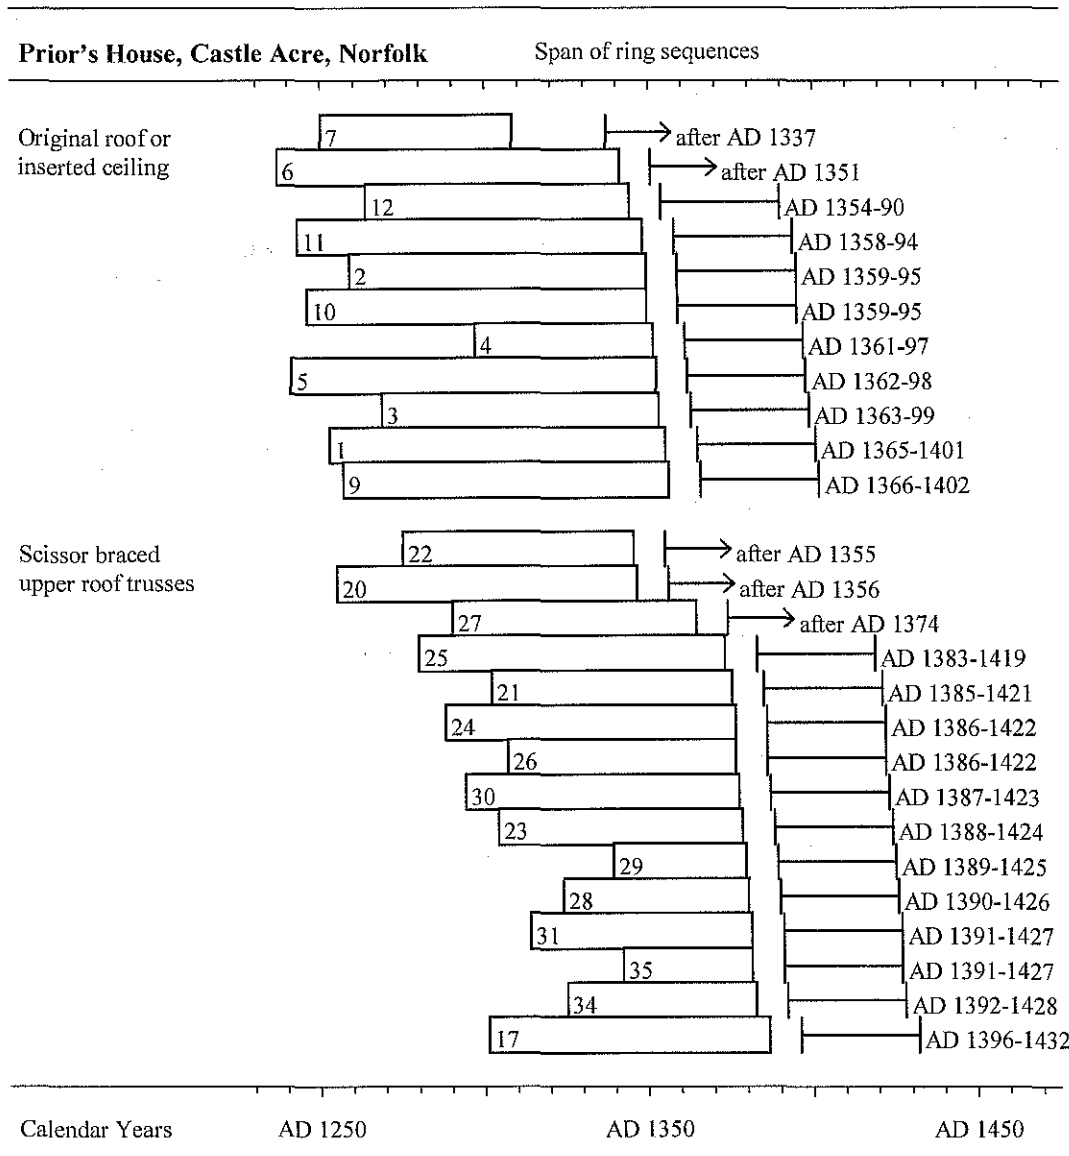
**Figure 7**

Bar diagram showing the chronological positions of the 26 dated timbers. The felling period for each sequence is also shown

The 120-year chronology CAP\_LOW is dated AD 1237 to 1356 inclusive. It was created from eleven timbers. None of the dated samples were complete to bark-edge, but all except two of them are definitely or probably complete to the heartwood/sapwood boundary (Table 1). Inspection of the bar diagram (Fig 7) suggests they are derived from a single felling period. Combining the interpretation of these samples suggests they were all felled between AD 1366 and AD 1390 inclusive. The 132-year chronology CAP\_HIGH is dated AD 1255 to 1386 inclusive. It was created from fifteen timbers. None of the dated samples were complete to bark-edge, but all but four of them are definitely or probably complete to the heartwood/sapwood boundary (Table 1). Inspection of the bar diagram (Fig 7) suggests they are derived from a single felling period. Combining the interpretation of these samples suggests they were all felled between AD 1396 and AD 1419 inclusive.

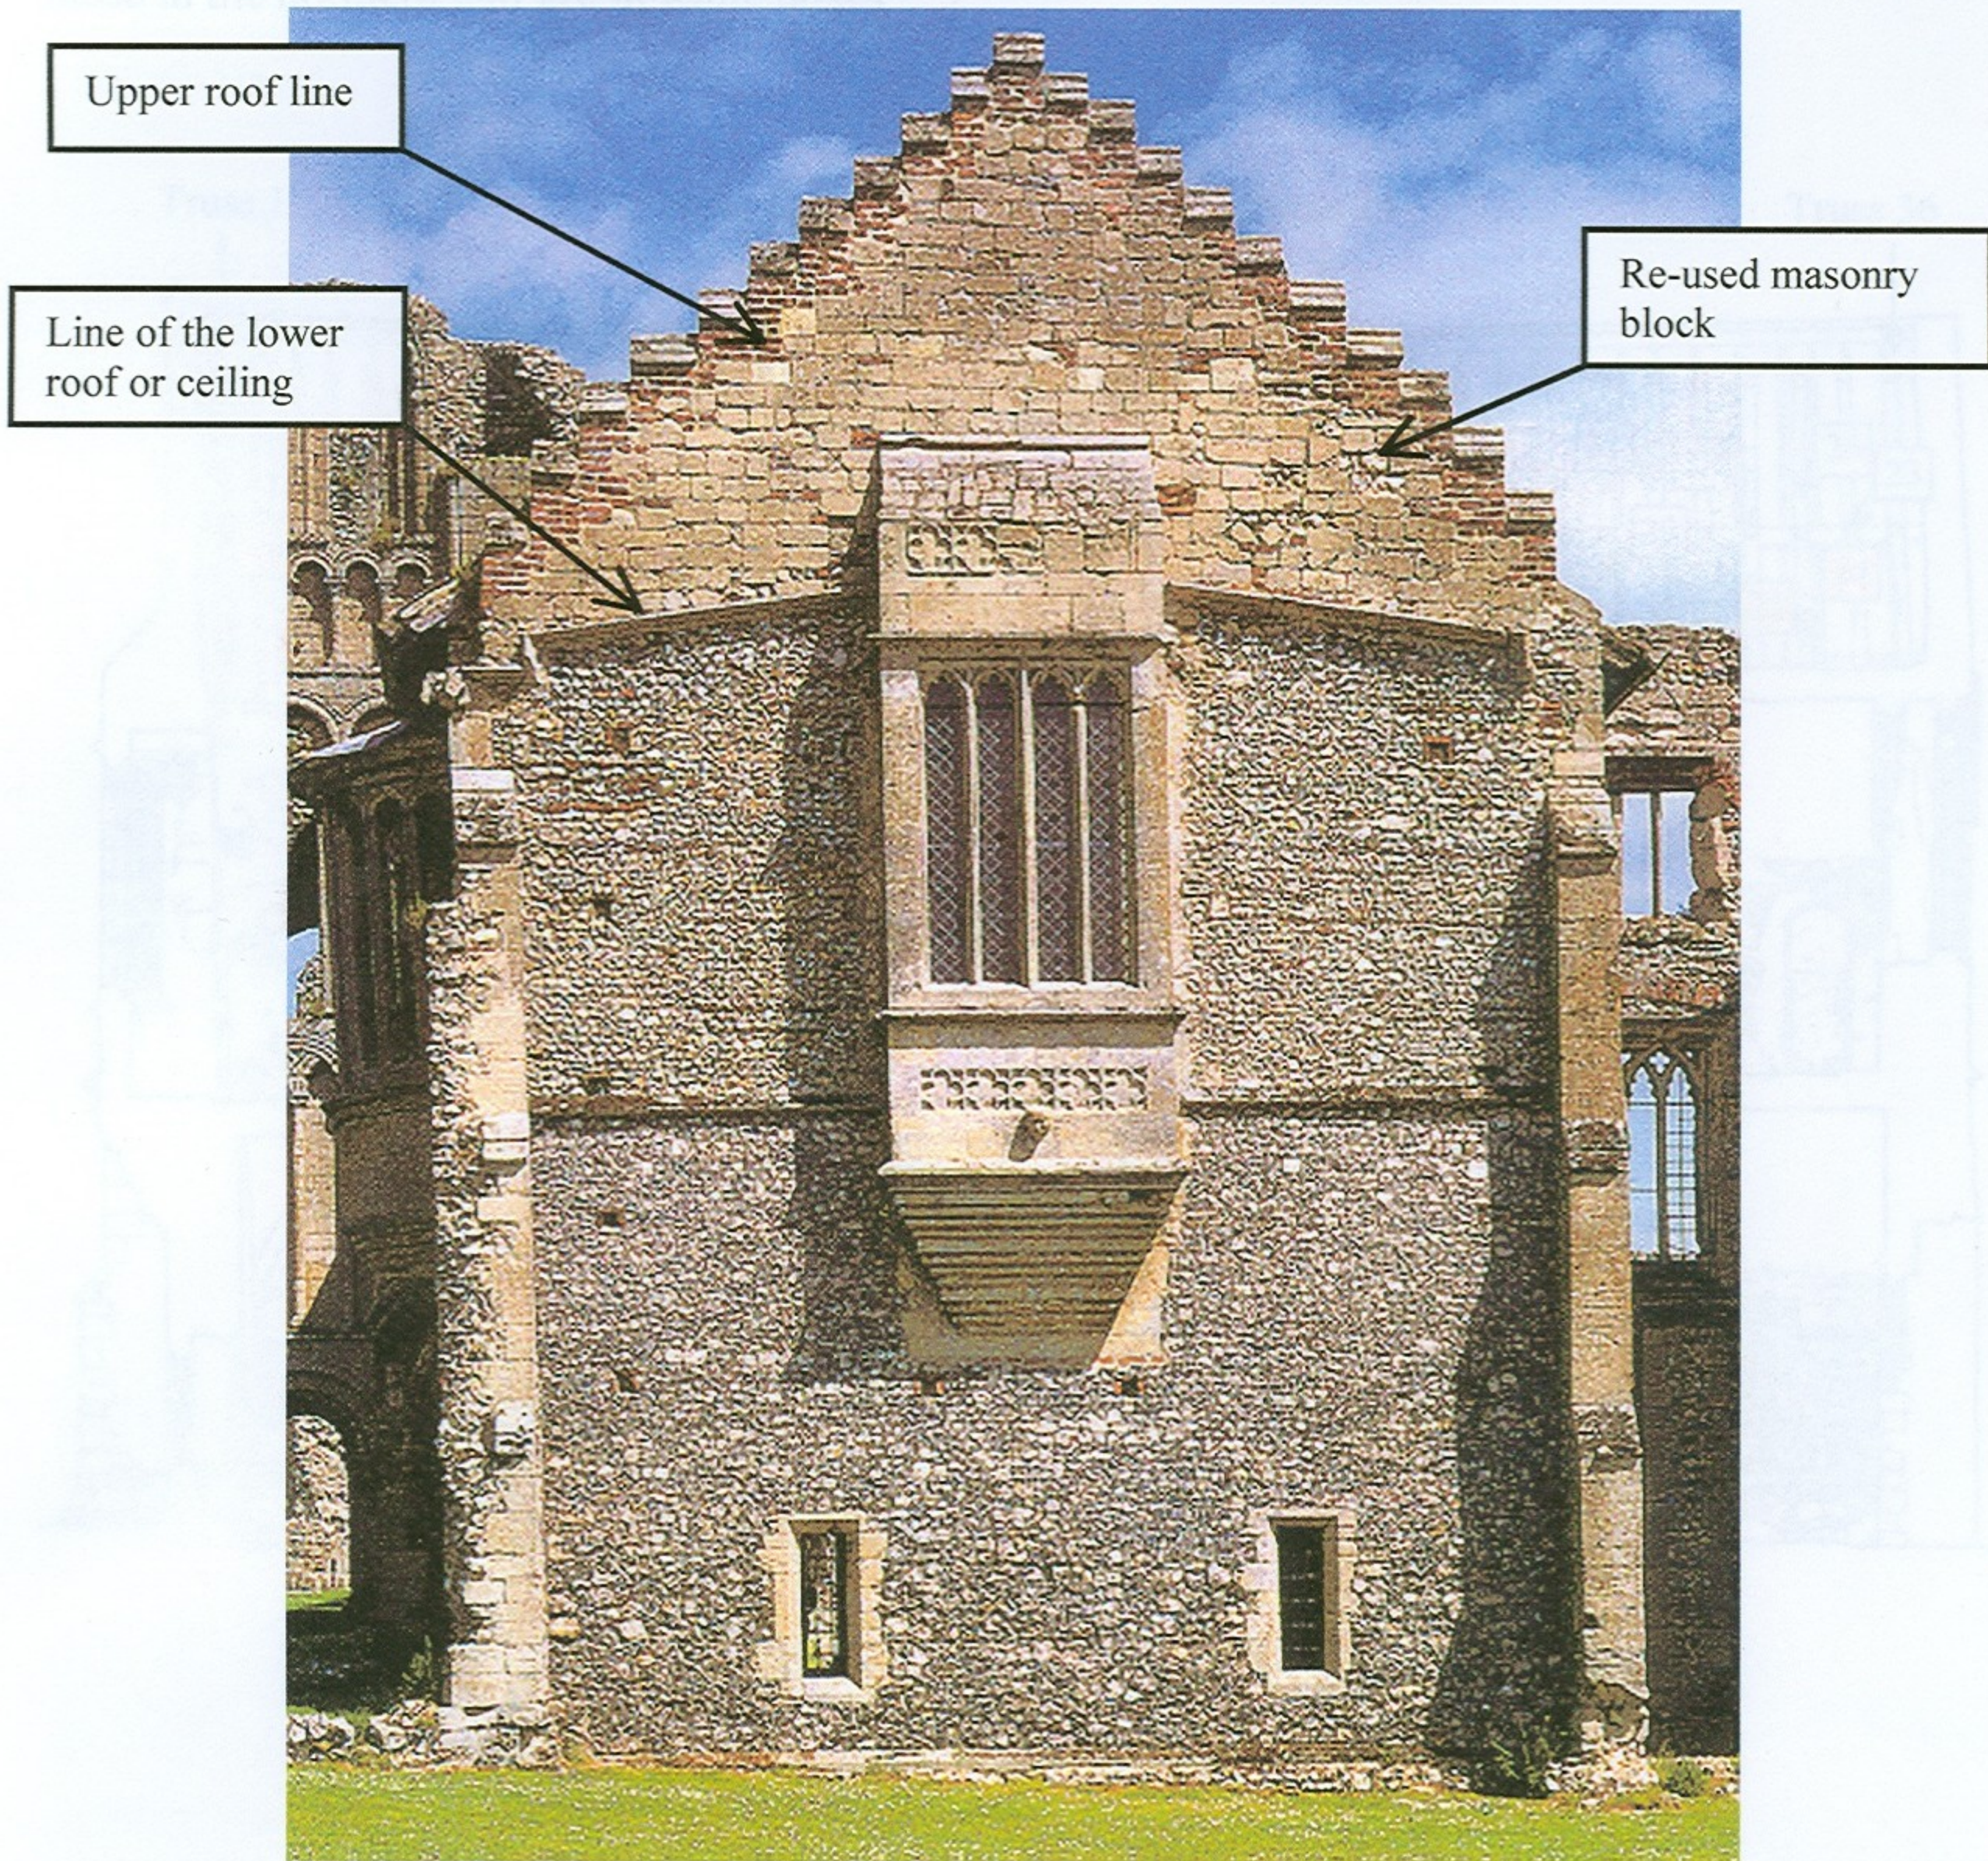
**Figure 5**

Photograph of the west end of the Prior's House. This shows the drip courses associated with the lower ceiling, the different masonry above these, and also highlights at least one piece of re-used masonry. Photograph English Heritage Photographic Unit © English Heritage

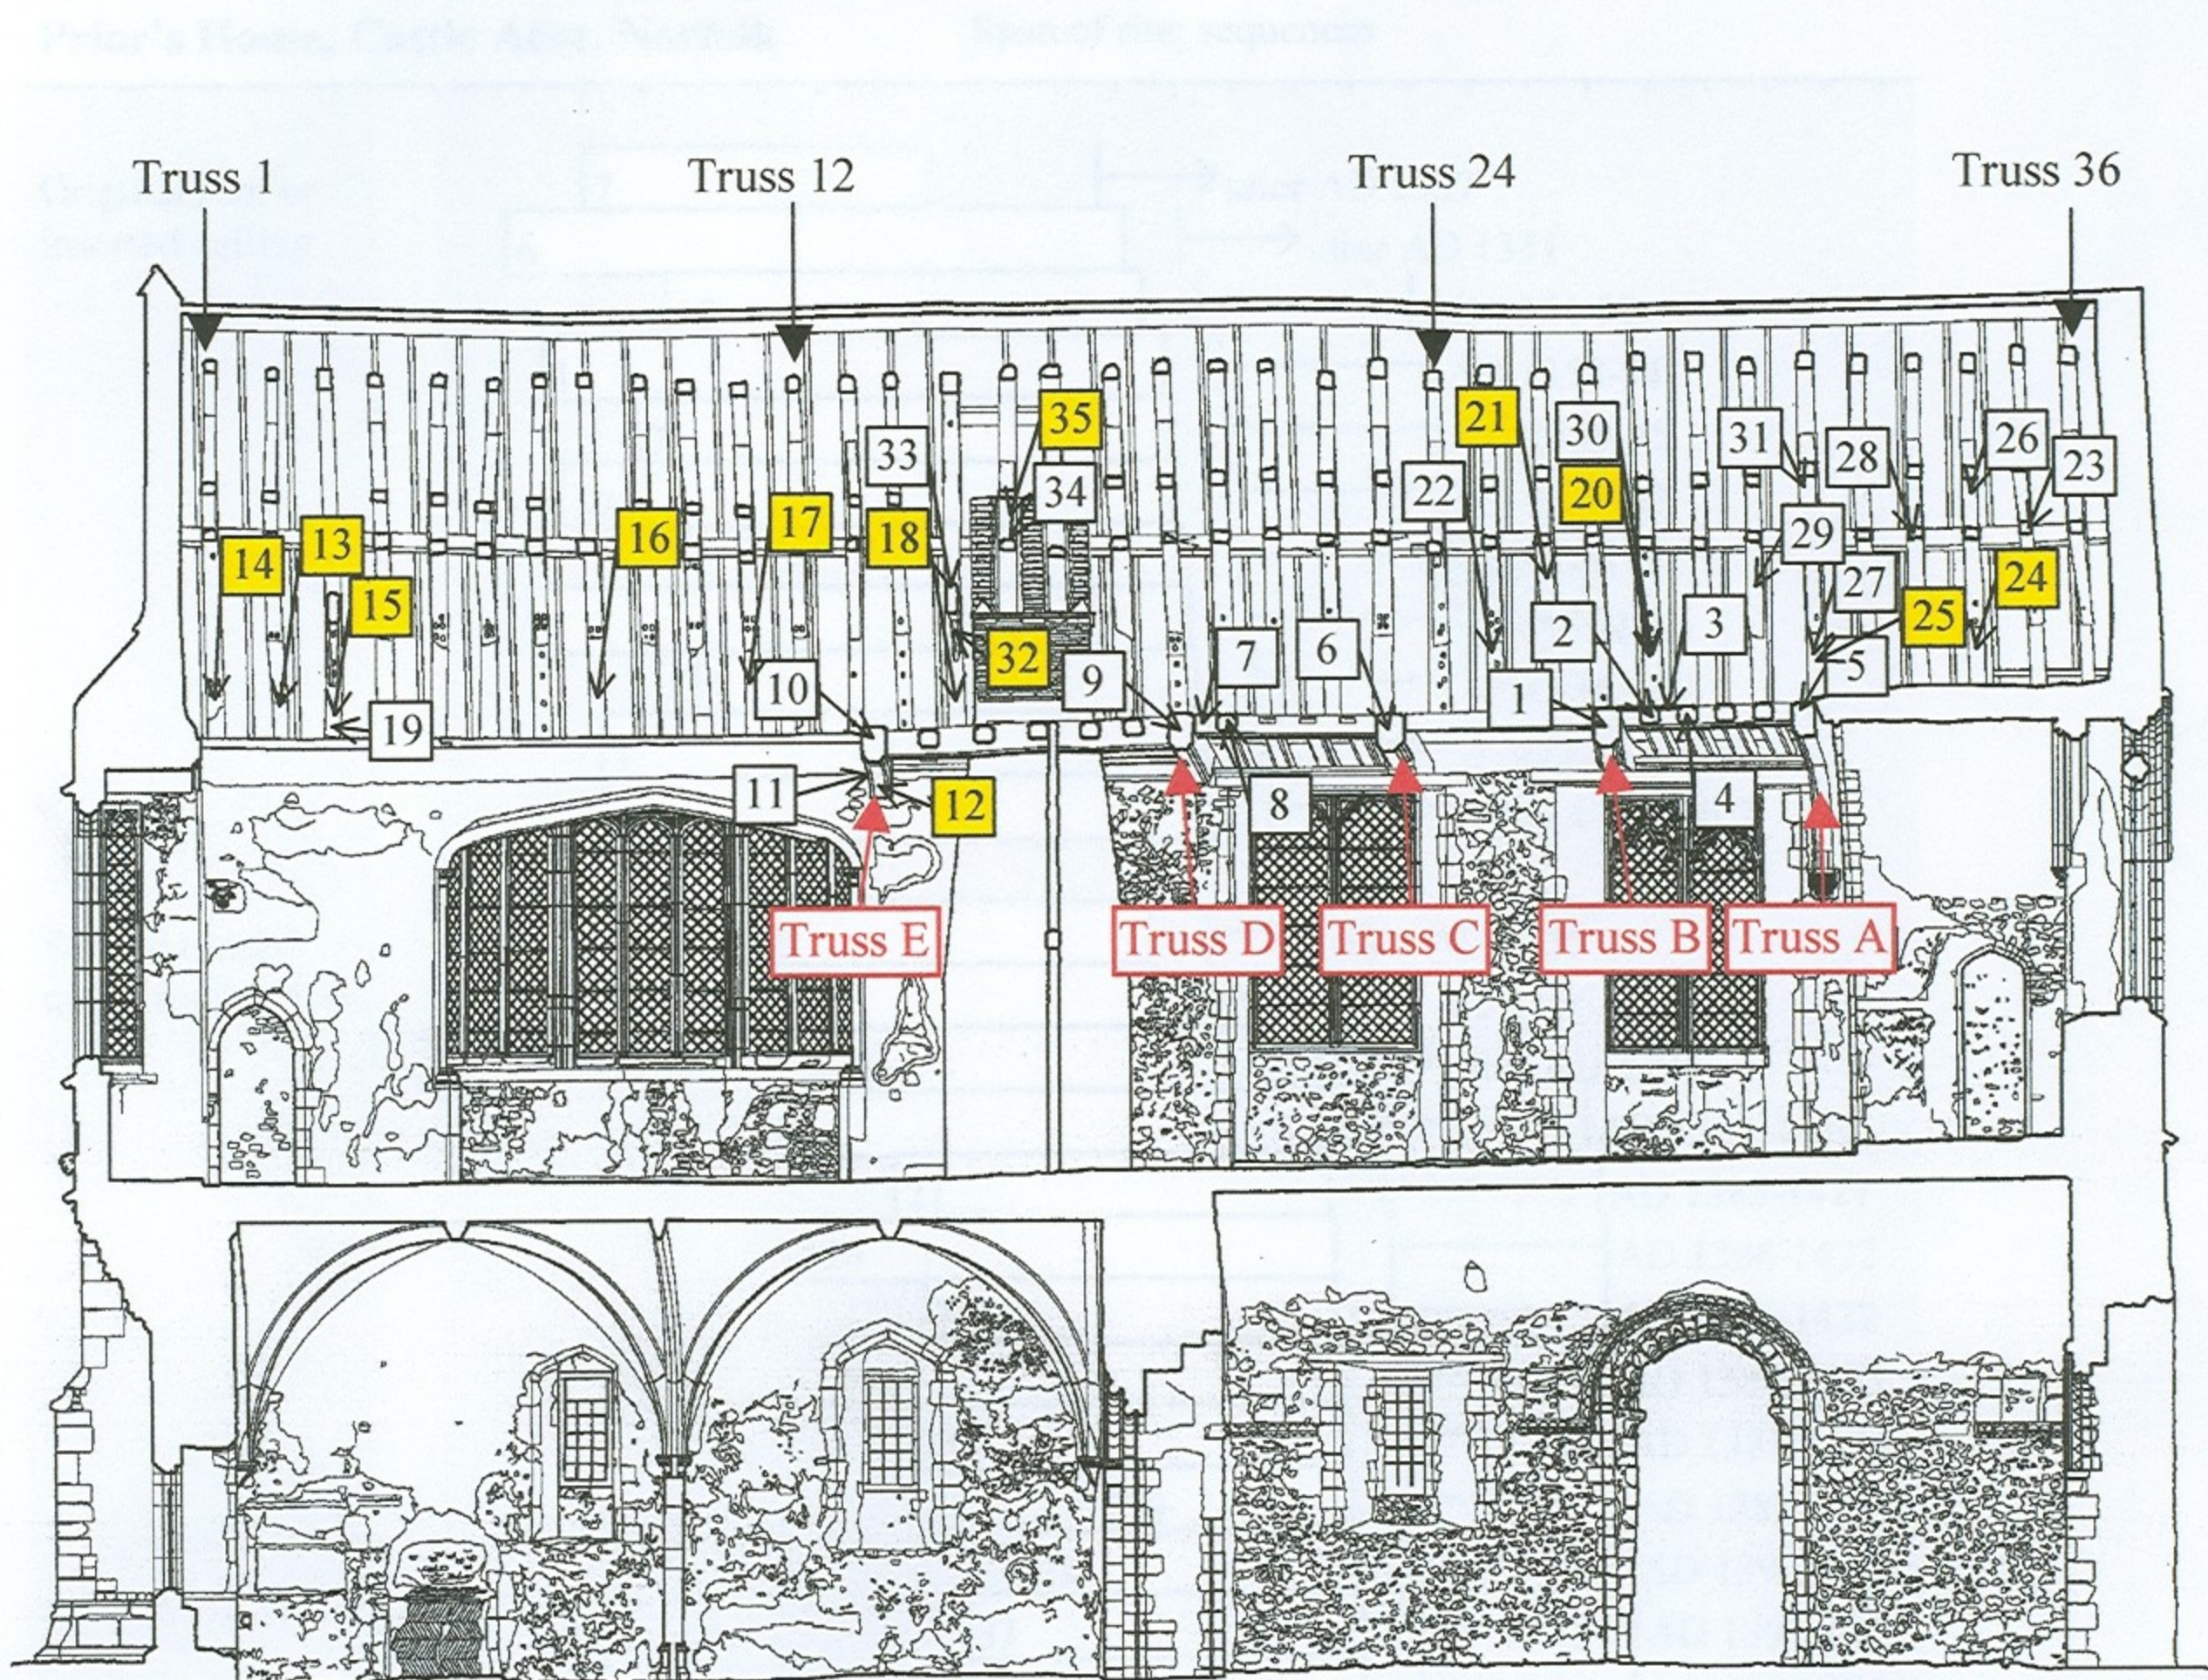
**Figure 6**

Section of the Prior's House looking north, showing both roofs, the truss numbering scheme adopted, and approximate location of samples 1-35, based on an English Heritage Survey Services diagram © English Heritage. The timbers from the unseen, but identical southern half of the roof are shown in yellow boxes, those in the northern half are in white boxes
