Centre for Archaeology Report 43/2001

**Tree-Ring Analysis of Timbers from the Church of St Mary
Magdalene, Debenham, Suffolk**

Dr Martin Bridge

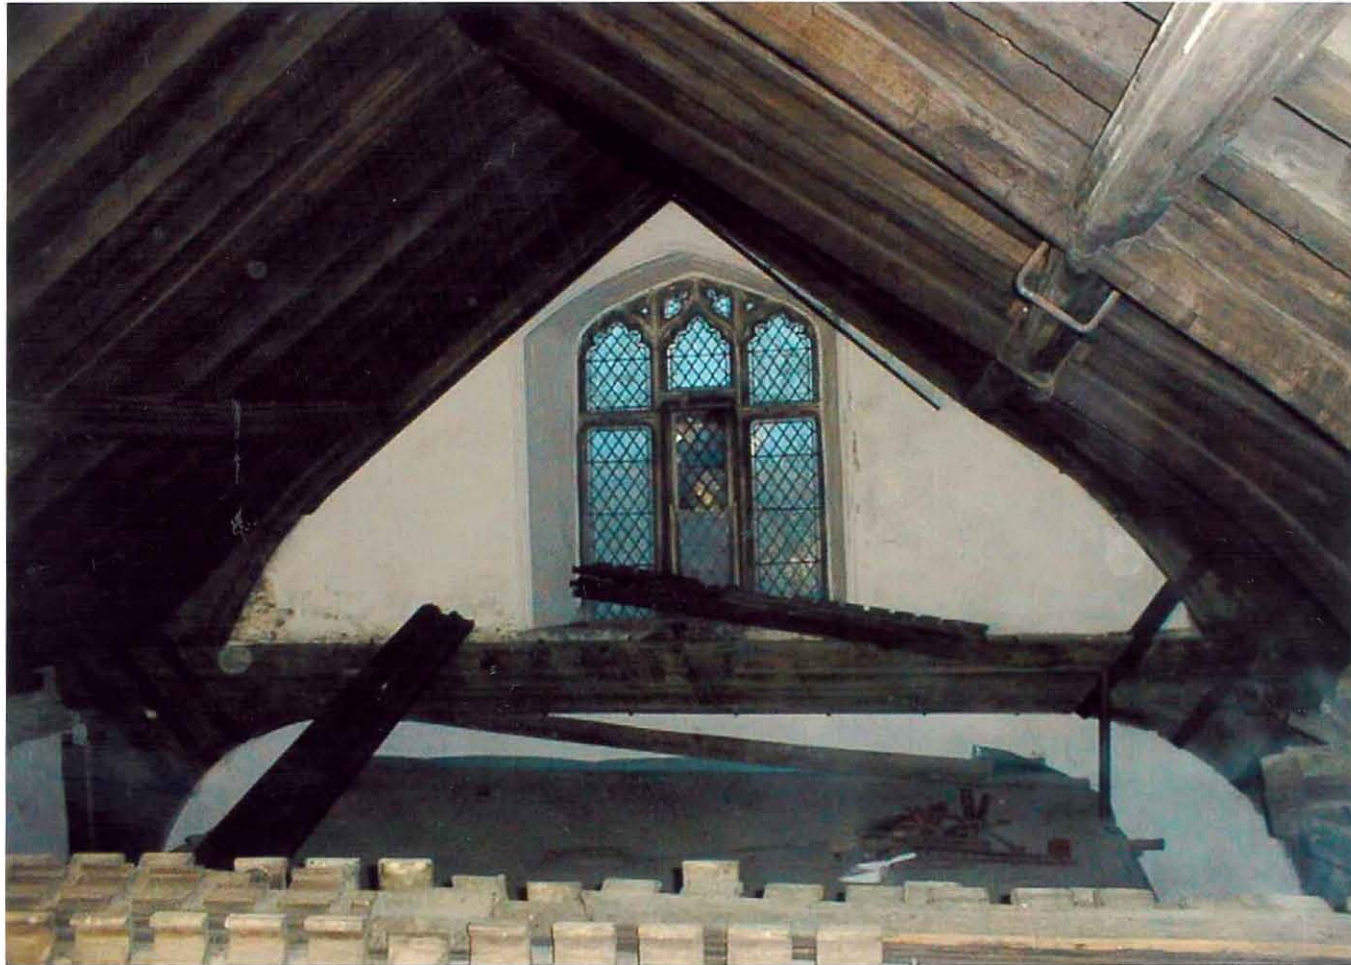
Figure 2: View of the nave roof showing moulded purlins and principal rafter and embattled tie beam (photo A F Knight Builders of Debenham)

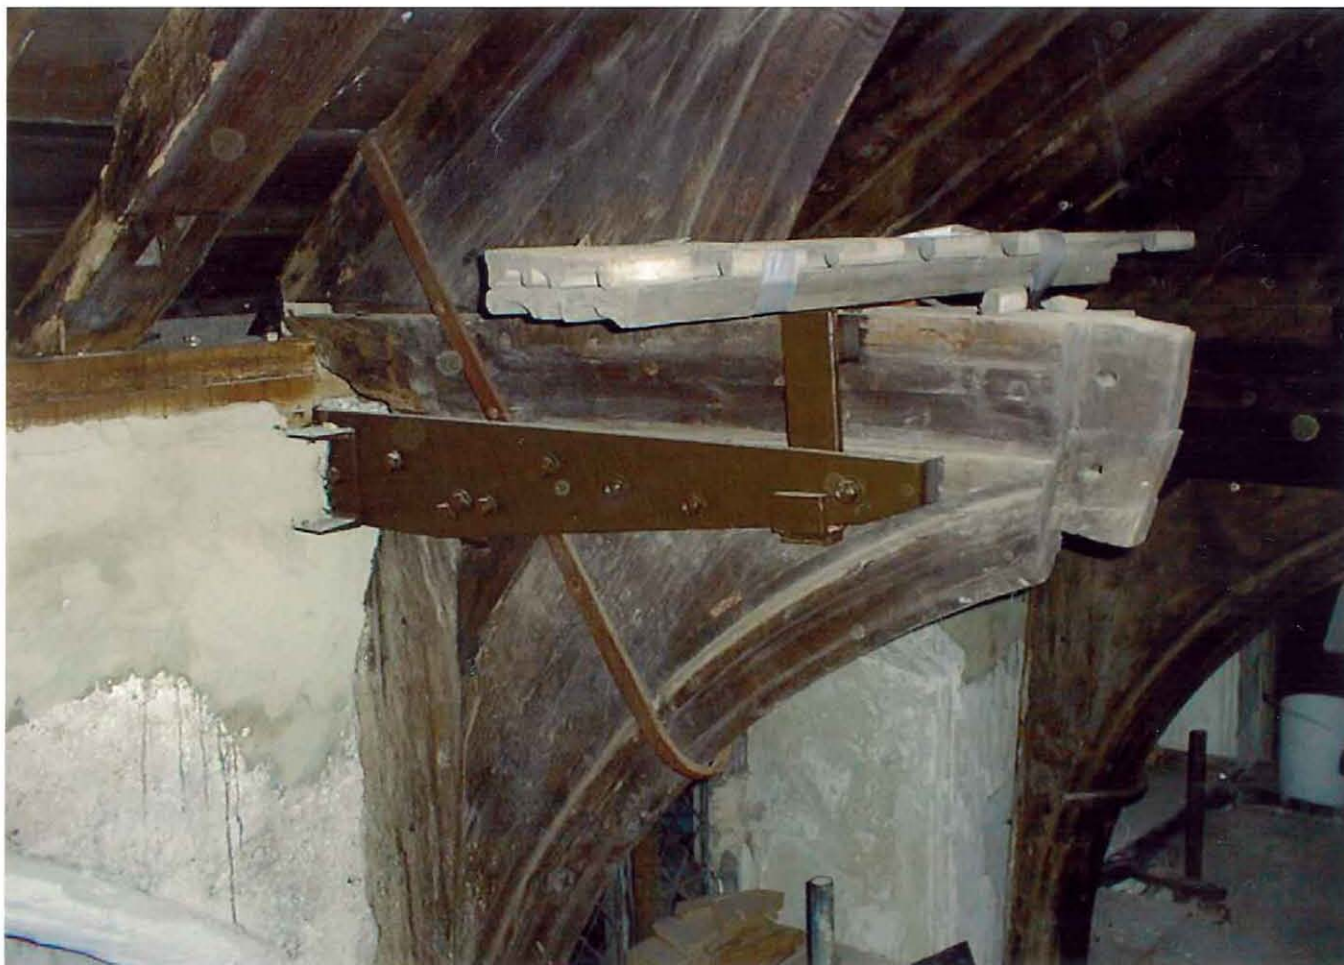
Figure 3: View of the nave roof showing arch brace and hammerbeam under repair (photo A F Knight Builders of Debenham)

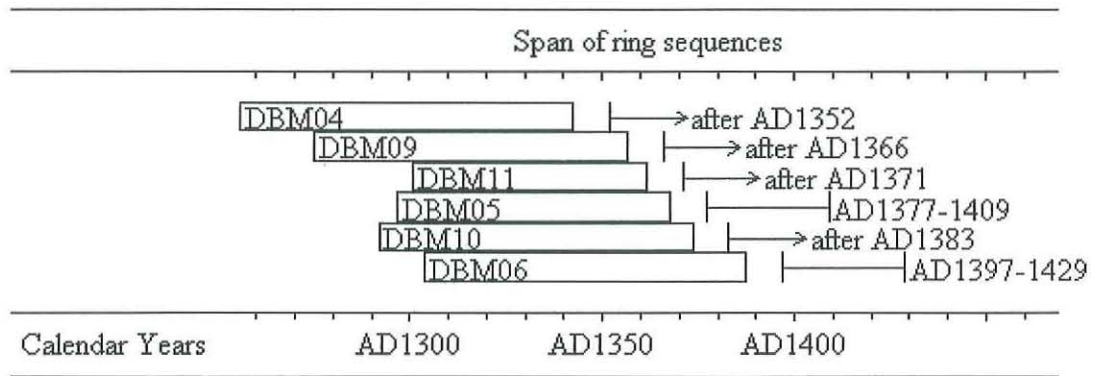
Figure 4: Bar diagram showing the relative positions of overlap of the dated samples in site chronology DEBENHAM1, along with the interpreted dates of felling.

All the timbers sampled were oak (*Quercus* spp.). Details of each sample are given in Table 1. The year-to-year variation in ring-width was greater than is often encountered in historic oak timbers (their sequences are said to be 'sensitive'), and the levels of crossmatching within the samples were in most cases quite low, though timbers DBM 07, 12, and 14 crossmatched well (Tables 2 and 3). Individual samples were crossmatched with a range of reference series in order to confirm the internal crossmatching found (Table 4). Whilst the shortest sequence (DBM11) did not match so well with the reference material, it matched well against a combined series made from DBM 04, 05, 06, 09, and 10. Two site chronologies were eventually formed, DEBENHAM1 (comprising samples DBM 04, 05, 06, 09, 10, and 11) and DEBENHAM2 (comprising samples DBM 07, 12, and 14). Both were compared with available reference chronologies from both regional and site chronologies, with the result that DEBENHAM1 was dated to the period AD 1256-1388 (Table 5) and DEBENHAM2 (Figure 6) remains undated. Possible crossmatches in the late fourteenth-century were found both for DEBENHAM2 and some of the other undated individual sample ring-width series, though these were neither strong enough, nor sufficiently consistent to be considered as having been dated. The relative positions of overlap of the sequences in each site chronology are shown in Figures 4 and 5. The data for the two site chronologies are given in Table 6.

The lack of sapwood and bark edge makes interpretation of the felling date of the timbers used more difficult. If the timbers really are from a single batch, then the combined felling dates from the dated timbers would suggest a felling date range of **AD 1397 – 1409**. This date is rather earlier than had previously been proposed on stylistic grounds, and would suggest that this church roof may not be the work of the architect Hawes. The four timbers DBM A-D were thought possibly to represent later repairs to the roof. Sadly none of these sequences dated and therefore they do not add any further information at present.

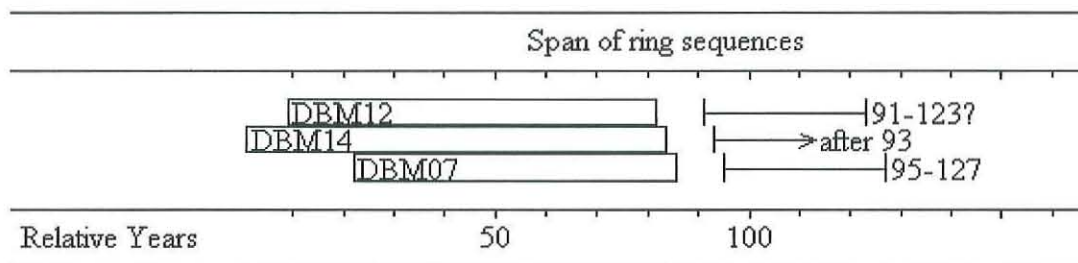
Figure 5: Bar diagram showing the relative positions of overlap of the samples included in site chronology DEBENHAM2

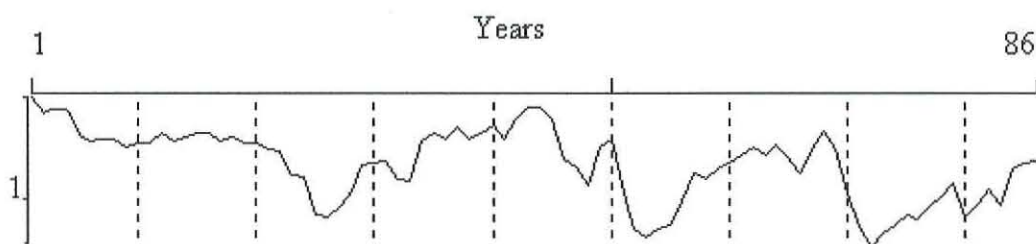
Figure 6: Plot of DEBENHAM2, showing the 'sensitive' nature of the series with its pronounced changes in ring width

from a wide geographical area. The sensitivity of the data, exemplified by the plot in Figure 6, may result from micro-site peculiarities or management of the trees, and these unusual sudden growth changes render the series less likely to date.
