Centre for Archaeology Report 51/2001

**The Tree-Ring Analysis of the Timbers from the Church of St
Peter, Barton on Humber, North Lincolnshire**

Ian Tyers

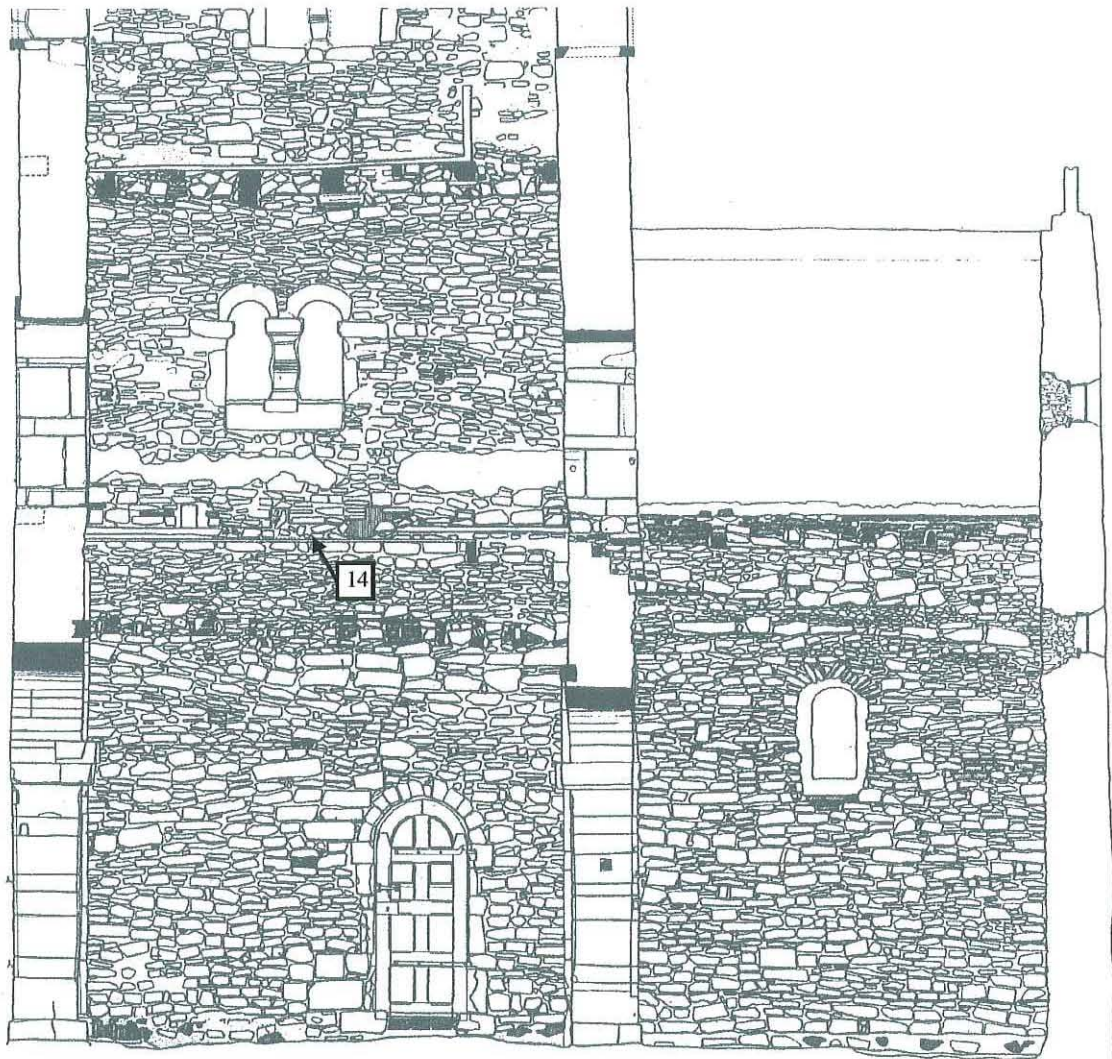
Figure 5 Internal elevation of the south walls of the lower part of the tower and baptistry (after Atkins and Rodwell pers comm), showing approximate location of samples from this area

The tenth-century stone tower includes four timber plates within the stonework, these are presumed to be part of the original construction. The top of the baptistry retains some complete and some stub-ends of horizontal beams also thought to be part of this phase. Access to these timbers was by ladder for the tower plates, and an *ad hoc* arrangement of scaffold boarding laid over the various joists at the top of the baptistry gave access to the joists that could not be reached from the normal access ladders. Three of the tower plates and three of the baptistry joists were selected for sampling (Table 1; Figs 4 and 5). In the case of the tower plates the minimal visual cues provided by the exposed face meant that optimal sampling directions were not always achieved. In the event during sampling it became clear that in each case only the outer few centimetres of these plates survived, and that there were voids and/or later masonry behind them. Two plates were cored more than once at different locations to ensure this was not an isolated problem. The joist ends could be more reliably assessed and the sampling directions more readily achieved. There was no survival of sapwood in this area, which is not especially surprising given the presumed age of the material, curving surfaces thought to be equivalent to the original heartwood/sapwood boundary were present on most. The samples were numbered **5, 6, 8-10** inclusive, and **14**. One of the samples (number **14**) when examined in the laboratory was rejected due to it having too few rings for reliable analysis. In total therefore five samples were measured from this area and the resultant series were then compared with each other. All were short sequences and several of the cores produced series shorter than would normally be considered acceptable. Perhaps inevitably given the available material, but to great disappointment, none were found that matched together to form internally consistent groups.

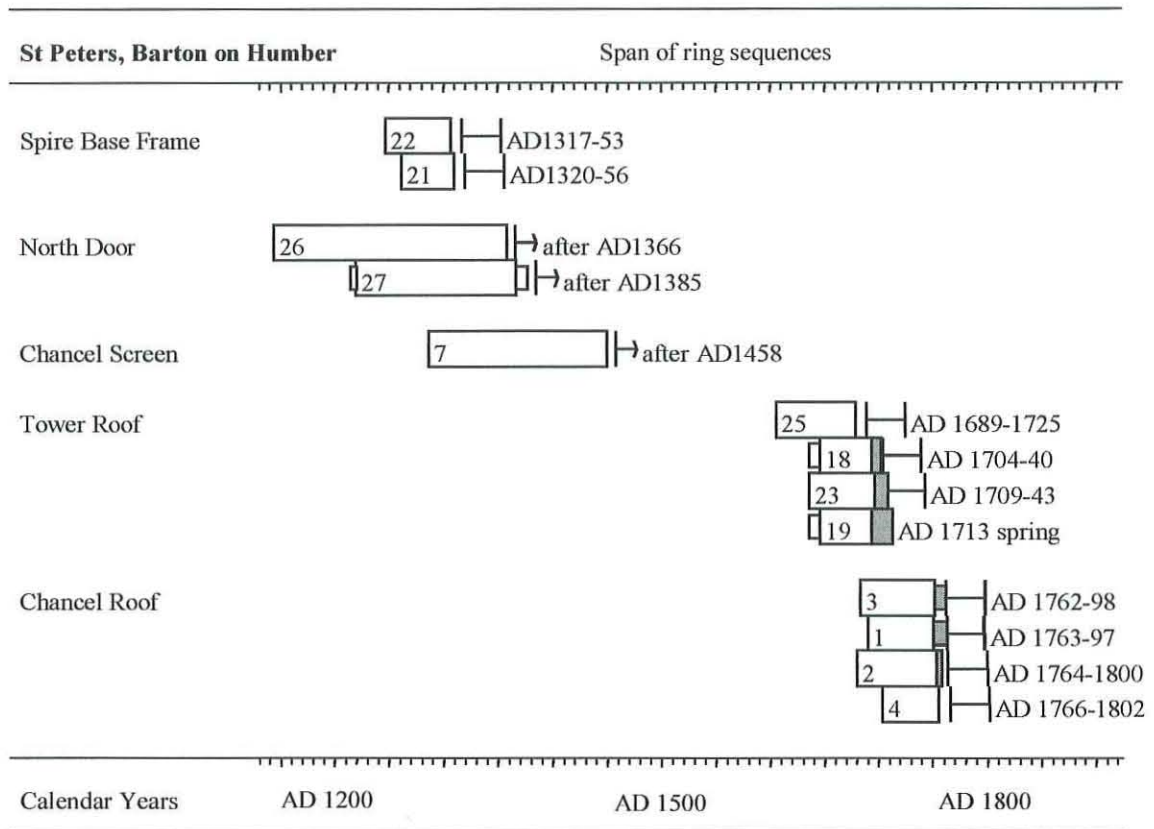
Figure 11 Bar diagram showing the chronological positions of the dated timbers from the church of St Peter, Barton on Humber. The felling period for each sequence is also shown
