Centre for Archaeology Report 72/2001

**Evaluation of the Footings of the Western Chimney Stack at
Headstone Manor, Harrow**

David Fellows

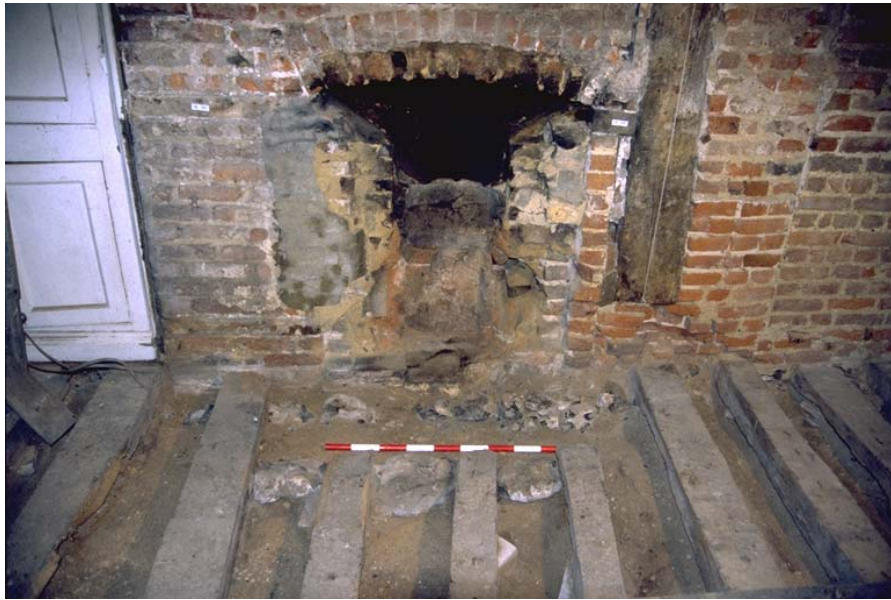
Figure 11: Southern face of western chimney stack showing shortened joists and flints from hearth -1m scale

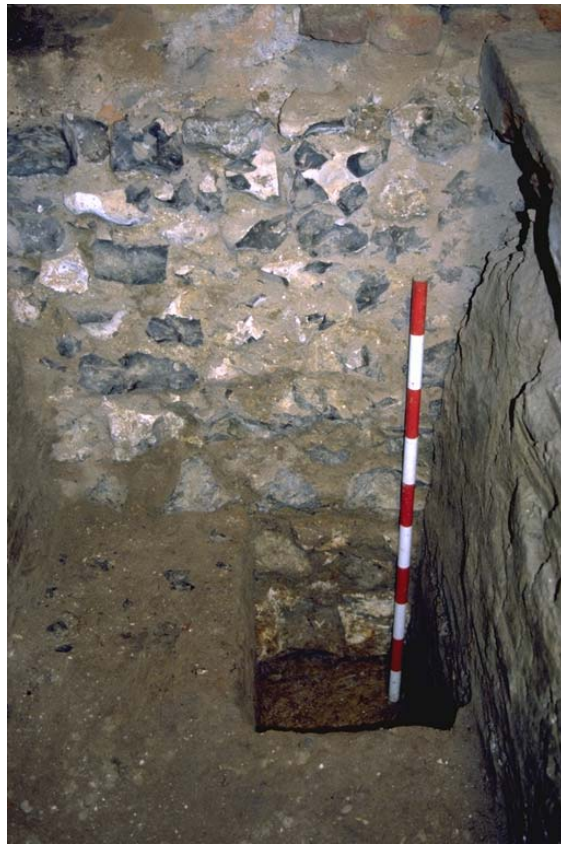
Figure 12: Trench P1 North section of chimney stack excavation showing flint walling 272 -1m scale

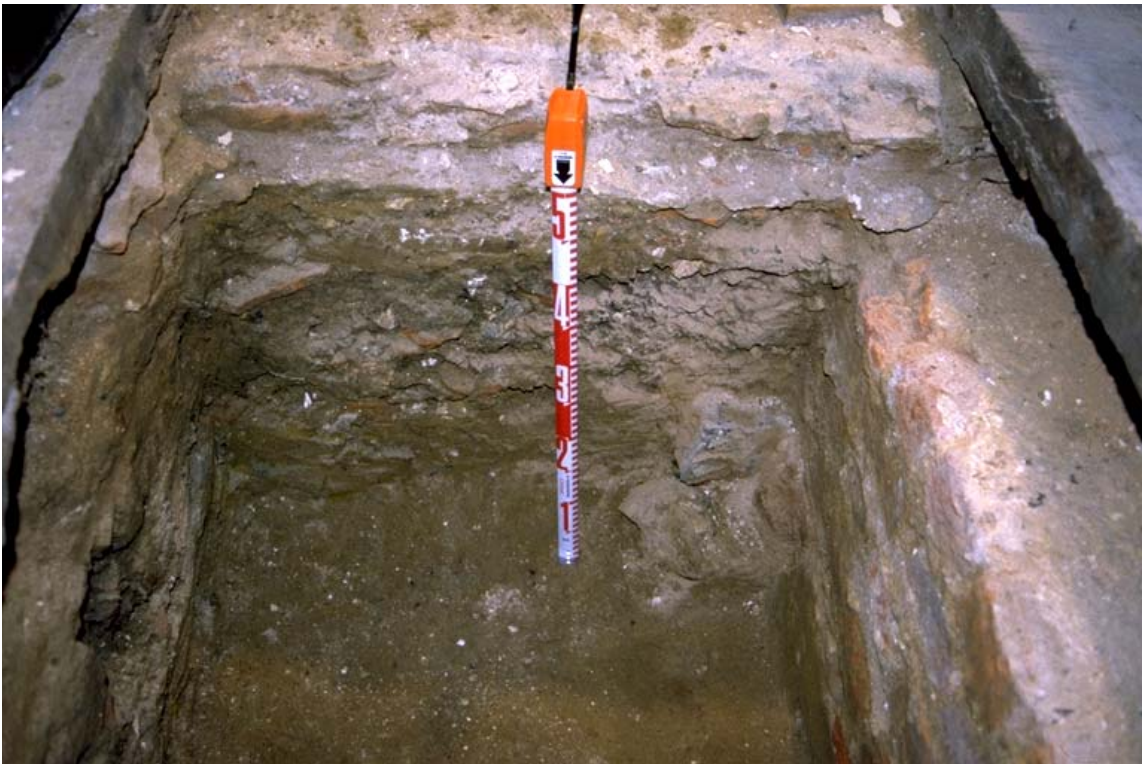
Figure 9: Photograph of north section of museum excavation, 0.5m scale

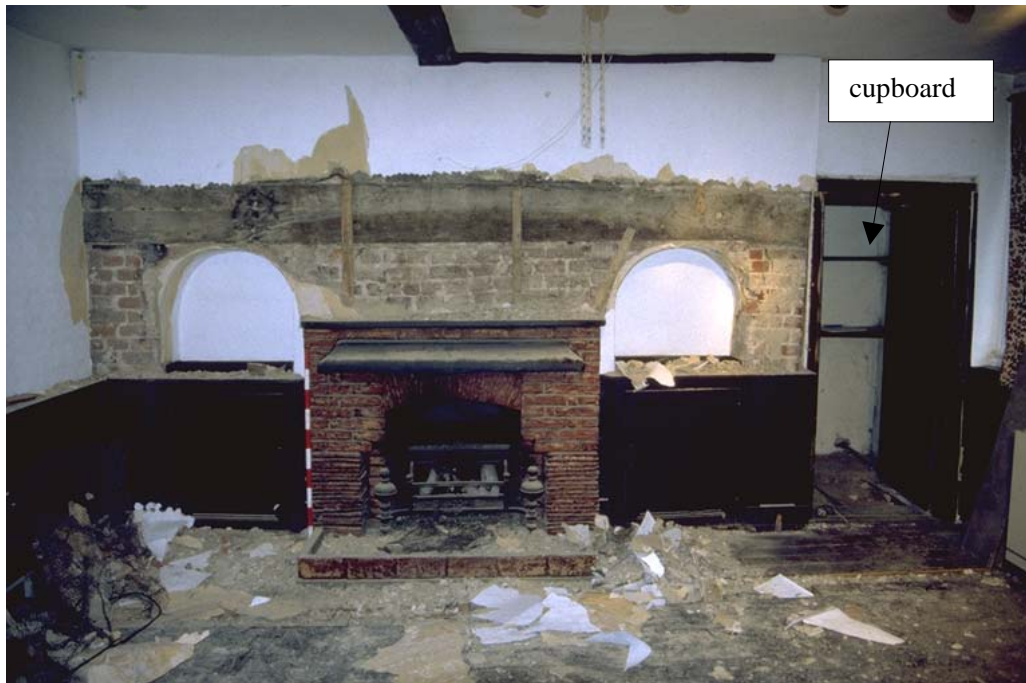
Figure 5: Southern elevation of the Museum (northern face of chimney stack) - 1m scale

The excavation in the museum was located in the cupboard to the west of the brick chimney stack under investigation. **Figure 5** is a photograph of the southern elevation of the museum. It shows the 17th-century fireplace range with the substantial timber lintel supported on brick jambs, and the later fireplace with alcoves either side inserted into the original fireplace opening.

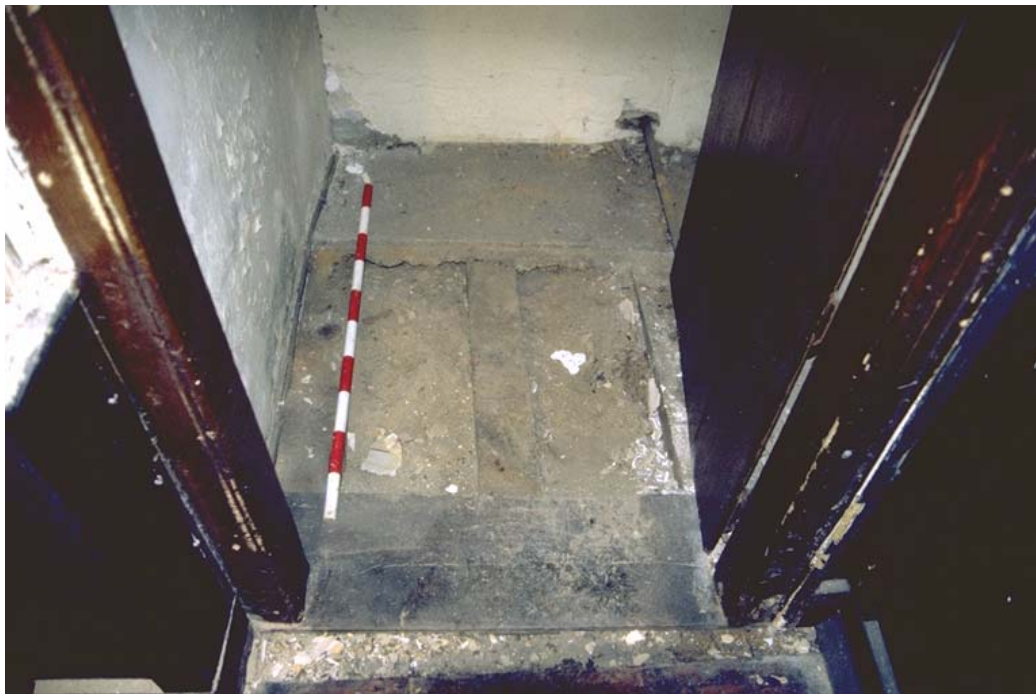
Figure 6: The base of the cupboard following removal of floorboards - 1m scale

Following the removal of the timber floor boards and joists (289) from the cupboard, the size of the excavation was limited by the space available. Eventually an area 1.00 x 0.95 x 0.75m was excavated, and **figure 6** shows the floor of the cupboard in its pre-excavation state.

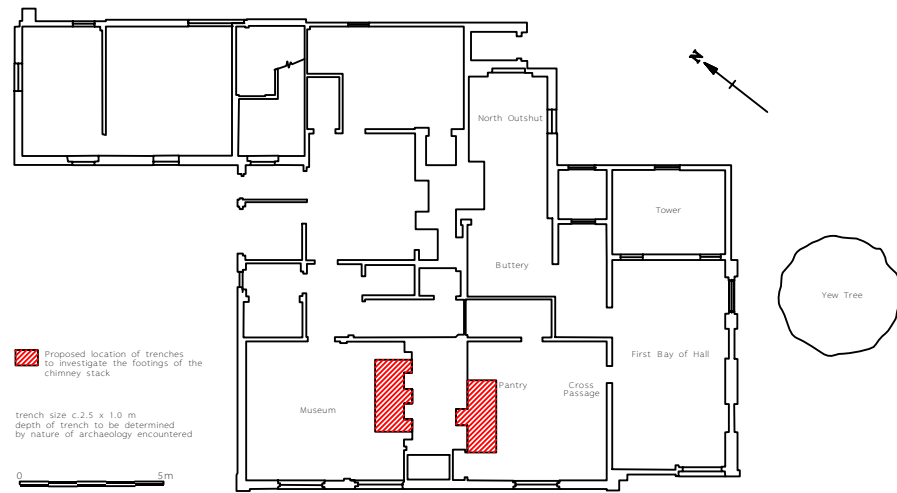
Figure 3: Location of archaeological excavation trenches to investigate the footings of the western chimney stack

The locations of the three excavations that were undertaken in the medieval pantry at Headstone are shown on *figure 3*. These smaller interventions took the place of the single excavation measuring 2.5 x 1m in front of the fireplace that was originally planned (*see figure 2*). This had the advantage of minimising the disturbance to the surviving below ground archaeology and of the floor joists, and also enabled the excavations to be targeted to answer additional questions about the development of the manor house that came to light

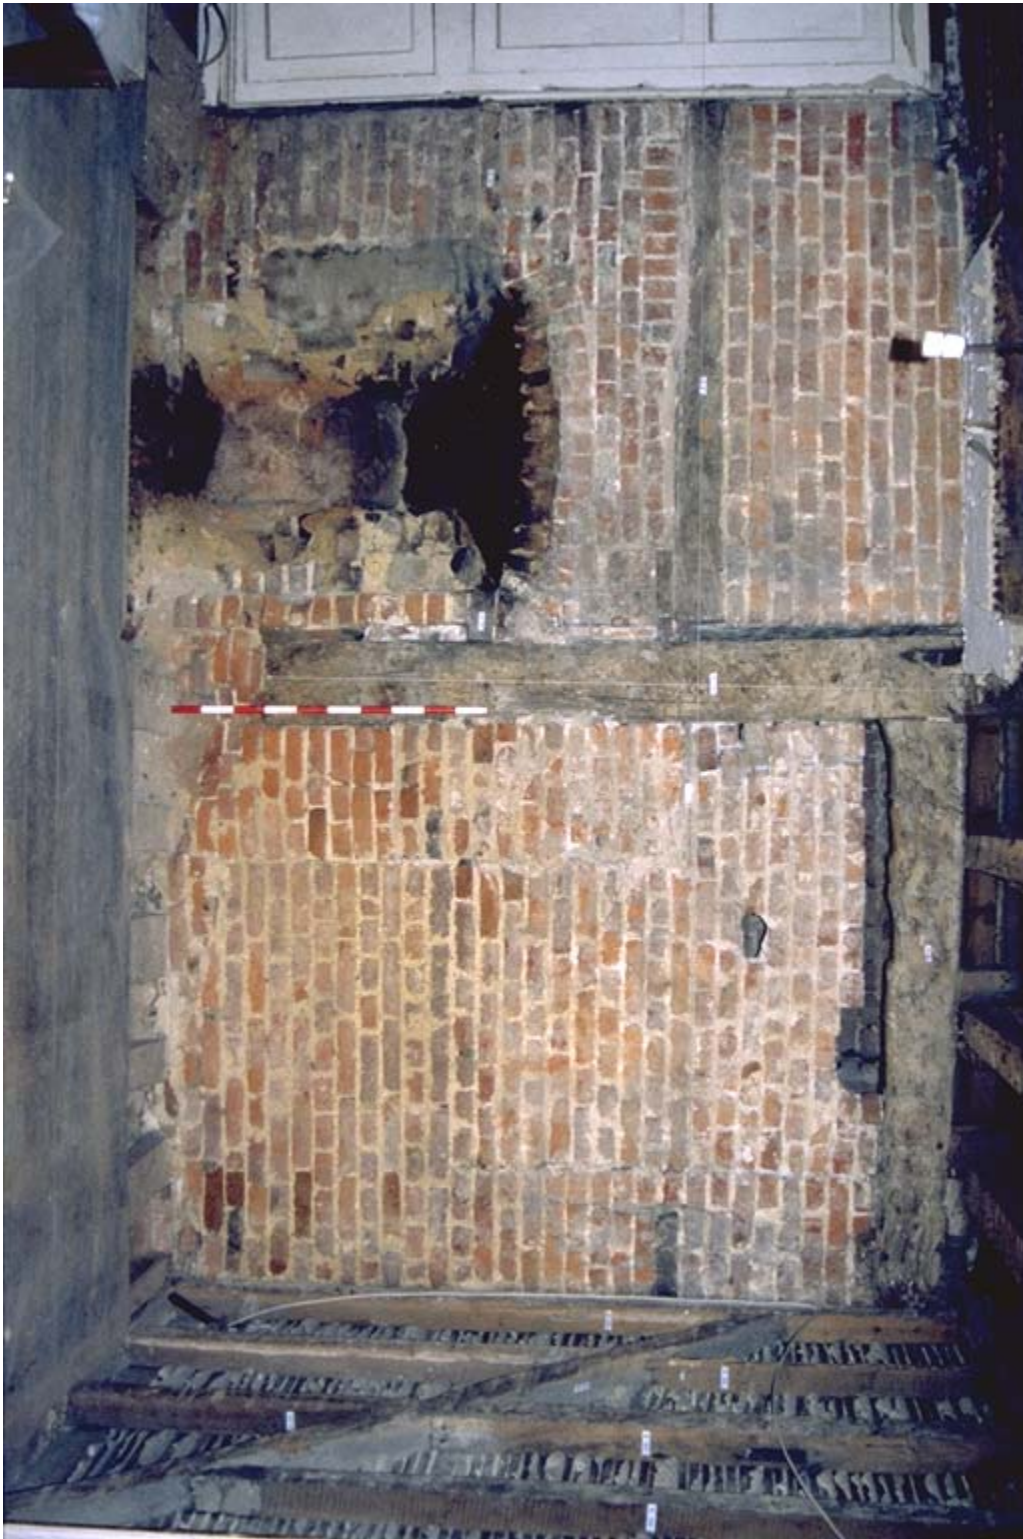
Figure 4: Southern elevation of the western chimney stack prior to investigation works (1m scale)

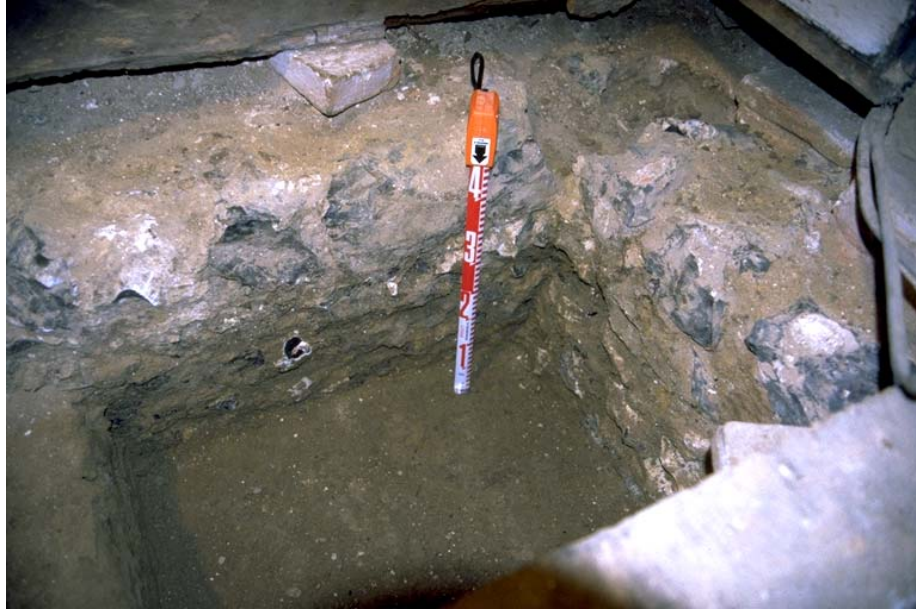
Figure 14: Trench P2 Junction between the north wall of the crosswing and the footings of the jettied western front of the house - 0.4m scale

At this point the wall met the north-south aligned flint wall footings of the jettied west front of the crosswing (wall 278). A further excavation 1.10 x 0.45m in size was undertaken at this junction to establish the relationship between the two, and it was found that they were bonded together and were thus contemporary (14th century) – *see figure 14*.

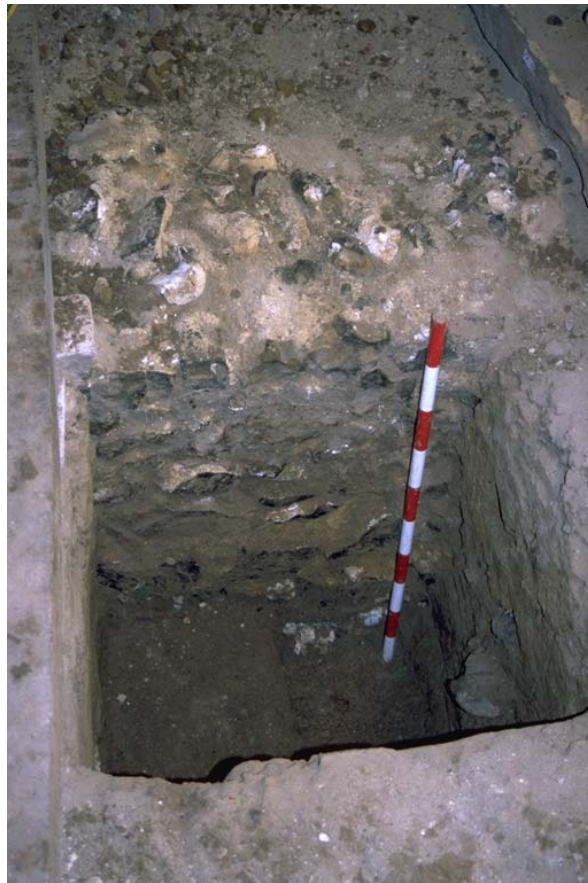
Figure 15: Trench P3 - Flint wall of cross passage with chalk footings – 1m scale

One of the trenches exposed the flint sleeper wall of the north partition of the cross passage and this surprisingly showed that the internal wall foundations were as substantial as those used for the external elevations. They were also constructed in the same manner with a combination of chalk, dressed and undressed flint, and had the construction surface described above.
