Centre for Archaeology Report 105/2001

**Hadrian's Wall Milecastle 78 (Kirkland), Cumbria: Interim
Report on Archaeological Evaluation, September 2000**

HADRIAN'S WALL MILECASTLE 78 (KIRKLAND), CUMBRIA

Interim Report on Archaeological Evaluation, September 2000

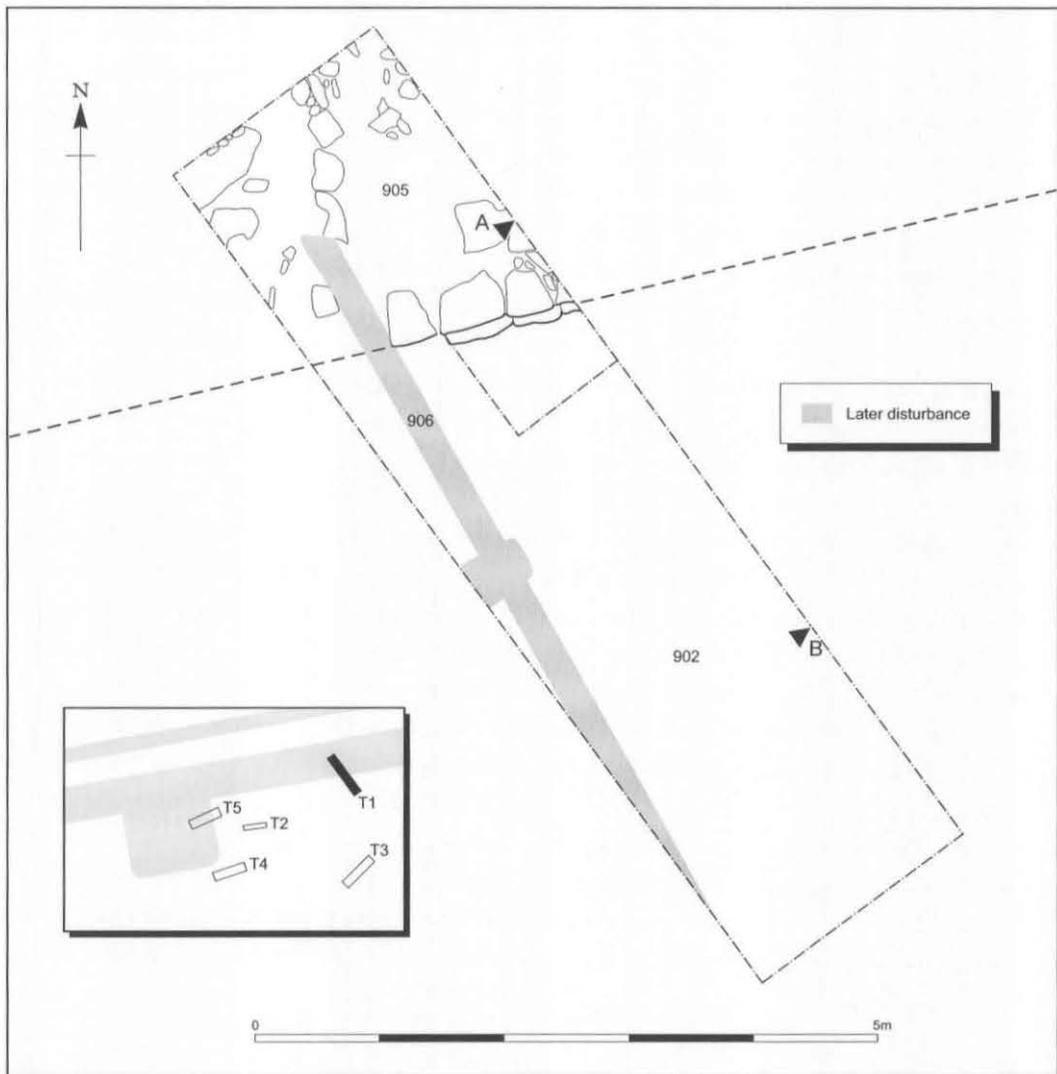
The topsoil (1407) in Trench 2 was very shallow at 0.17m thick, and directly below this archaeological deposits were observed. The trench was fortuitously located on the south western corner of the milecastle, and a continuous robber trench following the alignments of the western and southern walls along with the curved playing card shape of the corner of the milecastle was visible. A water pipe trench (1419) truncated the robber trench

The robber trench (1408=1413) had vertical sides, and followed almost exactly the line of the original walls. The fill (1409=1410) was a mid reddish brown sandy silt with frequent angular sandstones which are likely to have derived from the rubble core of the wall as it was being robbed and demolished. This fill was very similar to that recorded from the robber trench in Trench 1. Presumably the robbing of the walls of the milecastle was one contemporaneous event, and all the trenches were backfilled together. No finds were recovered from any of the robber trench fills, so it is difficult to say at what date the robbing of the milecastle took place. The depth of the robber trench (1408) was approximately 0.40m, and the visible width within the trench was 1m. The depth of the robber trench for the southern wall was 0.25m, and it was 2.40m wide.

Below the robber trench fill (1409=1410) the foundations of the corner of the milecastle survived intact, with facing stones in situ. The core of the wall was composed of red sandstone rubble bonded together with a blue-grey clay. The southern wall curved round at the western side of the trench to form the playing-card shape typical of Roman forts, though the interior corner was squared and did not mirror the outer curve.

On the eastern side of the western wall a grey silty clay surface (1412) survived which was banked up over the facing stones of the western wall. This is very similar to the surface that survived in trench 1 (1423), and was probably constructed at the same time as the milecastle wall. Pottery was recovered from this surface, and a patch of burning was also recorded which may be the remains of a hearth. The surface was 0.30m deep and 0.90m x 1.72m of it was visible in the trench.

On the southern edge of the trench, immediately behind the southern wall of the milecastle, a pale blue-grey clay deposit (1427) was banked up over the facing stones of the wall. It was thickest closest to the wall at 0.18m, tapering to 0.05m to the south. Immediately above this layer was a thin deposit of small whitish-grey pebbles and silty sand (1424) which was 1.40m wide and 0.16m thick. This deposit may have been a laid as a layer above the clay so that there would have been a dry, firm surface upon which to work to construct the superstructure of the wall. This interpretation is supported by the fact that a shallow posthole (1405) was excavated through this surface. It was half moon shaped in plan, and was very shallow at 0.05m deep, and may have been a posthole for scaffolding to construct the wall. Above the fill of this post-hole was a deposit of rubble identified as collapse from the wall (1434)

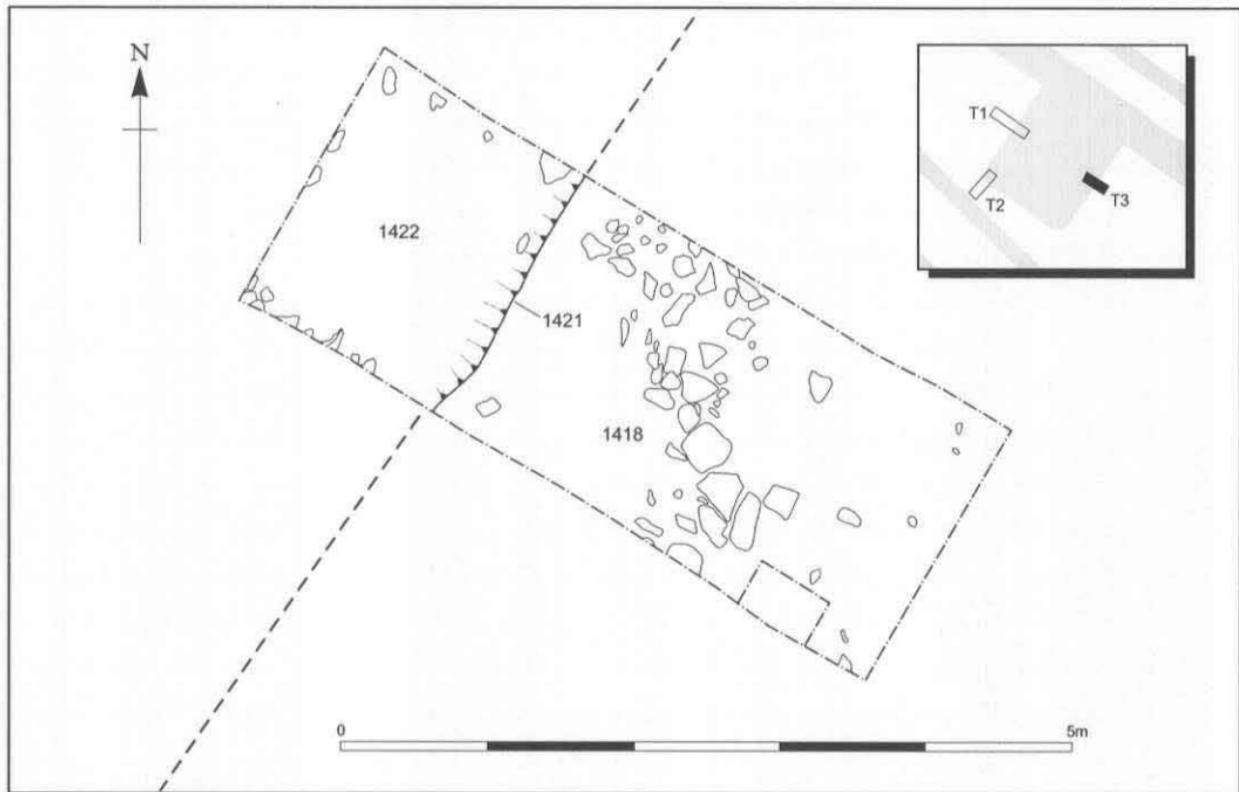
Figure 5
Plan of Trench 3

The topsoil above Trench 3 was 0.25m thick, and directly below this archaeology was encountered.

On the eastern side of the trench, a robber trench (1421) which was presumably following the line of the eastern wall of the milecastle was recorded. The far eastern edge of it was not visible as it was beyond the limits of the trench to the east. It was 1.60m wide, but was not completely excavated due to site conditions and the trench rapidly filling with water. It was filled with red sandstone rubble similar to that found as robber trench fills in Trenches 1 and 2.

This robber trench was cut through a layer of mid grey-brown clayey silt (1418) which contained some large pieces of sandstone rubble. These were randomly spaced and are likely to have been disturbed by ploughing. This is probably an early ploughsoil layer which formed above the milecastle and has been moved around by the action of the plough for a considerable time. A number of finds were recovered during cleaning of this layer, including a fibula brooch and a coin. This layer was not excavated, except in a very small slot, which revealed a grey clay surface beneath it which may be similar to the surfaces (1423) in Trench 1 and (1412) in Trench 2.

Trench 3 was not excavated fully, but the presence of the robber trench for the eastern wall within the trench, fulfilled the aim of establishing the overall dimensions of the milecastle.

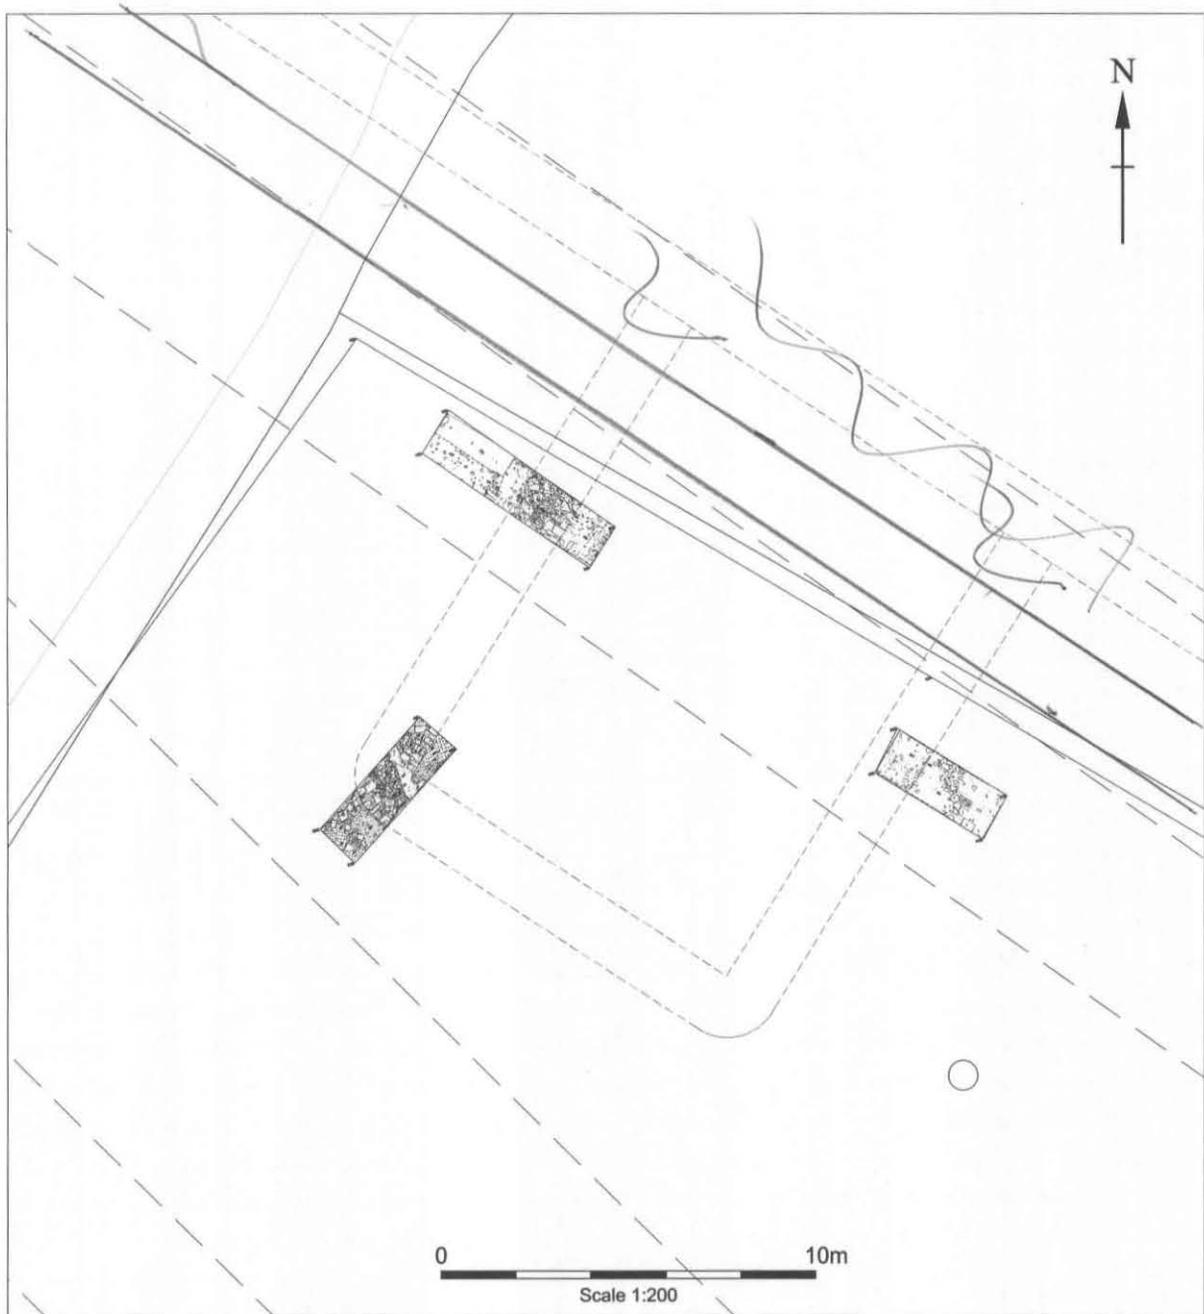
Figure 6 Trenches 1,2 & 3 and reconstructed outline of Milecastle 78

Immediately to the west of the site of milecastle 78 is a small, deep north-south drainage dyke, which has been canalised for drainage, and seems formerly to have been stone lined. It is probable that robbed Roman stone has been used for this as many sandstone blocks within the bed, both up- and down-stream of the milecastle have the typical tapered shape of Roman facing stones. Given that this dyke transected the line of the Wall, it was decided to attempt to locate it in section. Undergrowth was cleared, and part of the eastern edge was cleaned back slightly. This revealed the foundations of the stone Wall, comprising two large flagstones, of which the north facing stone was 90mm thick and 710mm deep. Above this was a mass of beach cobbles and sandstone pieces, which clearly comprised either intact core work or robber trench filling. The importance of this observation was that it enabled the true line of the Wall, and thus the north wall of the milecastle, to be established (Fig 6).

The milecastle is similar in shape to milecastle 79 (Richmond and Gillam 1952), though the dimensions differ slightly. The interpretation advanced for 79, that it was a long axis milecastle, is even more applicable here, as 79 measured 22.09m square externally, whereas milecastle 78 measures approximately 20m east-west and 25m north-south (Fig 6: the approximation is within 0.5m each way and is due to uncertainty in the absence of some wall faces). The similarity in the form of the corners, which are rounded on the outside and square on the inside, may suggest that the milecastles 78 and 79 may have been built by the same legion, and the similarity in corner form to milecastles 37 (Housesteads), 39 (Castle Nick), and 42 (Cawfields) may tentatively indicate that the
