Centre for Archaeology Report 71/2002

**Report on the excavations resulting from improvements to the
paths and lighting at Fort Cumberland**

Report on the excavations resulting from improvements to the paths and lighting at Fort Cumberland

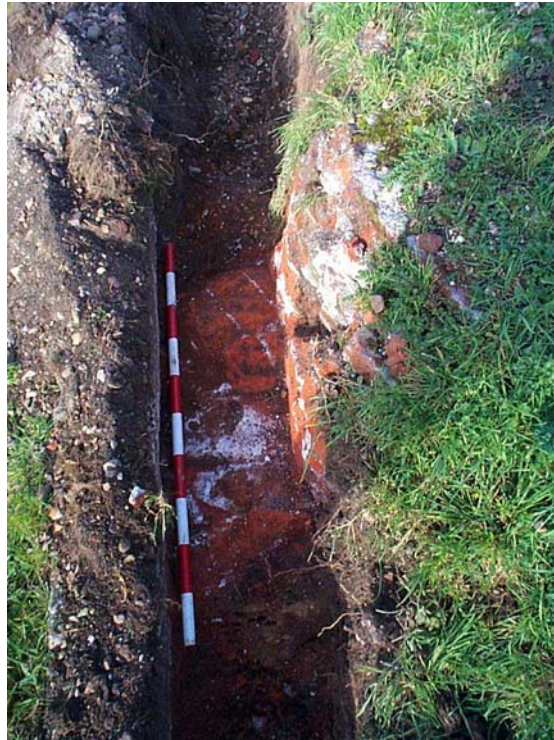
This trench exposed the breached brick counterscarp wall of the dry ditch (see *figure 3*). This wall had been partially dismantled when the access route was altered and the road from the north west constructed. This followed the damage to the land curtain during the bombing raid of 1940, after which the main entrance moved from its position in the left curtain wall to the breach in the land curtain wall. Also seen during the excavation were the general build up of gravel and soil deposits

Figure 3 - Photograph showing remains of breached dry ditch counterscarp wall exposed during excavations

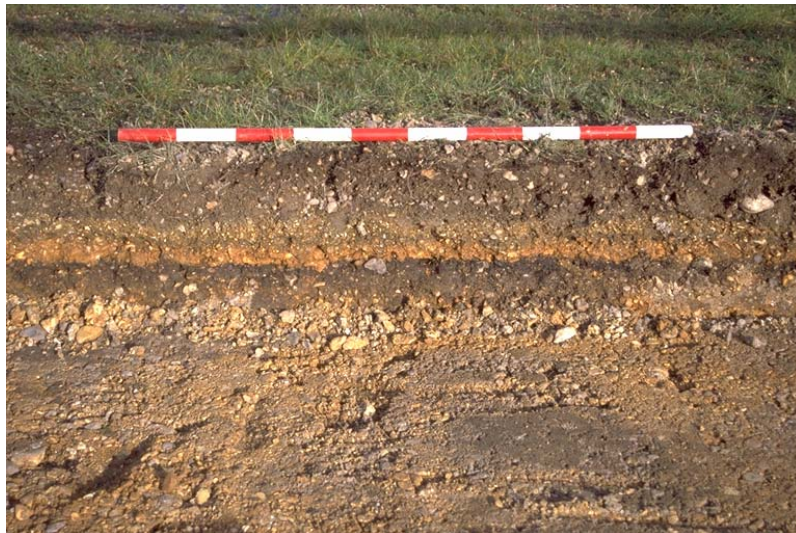
The trench cut through the build-up layers of gravel used to surface the parade ground. In section, seven distinct layers of gravel were recorded. These consisted of alternating light and dark gravel bands – presumably resulting from the periodic refreshing of the gravel parade ground surface (see *figure 4*).

It is possible that the layering may represent, in part, the levelling of the earthworks from the first fort. Previous excavations on the parade ground to the north and west revealed an extent to the lower layers that was thought to reflect the glacis of the first fort (J.B.Kerr, pers. comm.).

Figure 4 - Photograph of the banded gravel horizons that make up the parade ground (1m scale)

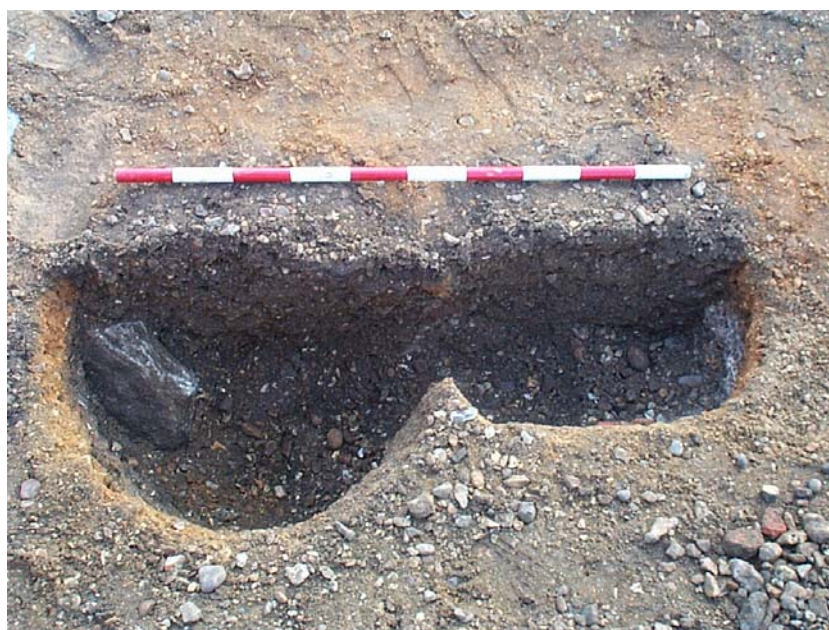
The northern of the two pits was circular in plan, with a diameter of 0.66m. The southern pit was rectangular measuring 0.55 x 0.54m. The pits were half-sectioned – see *figure 5*.

Figure 5 - South-east facing photograph showing the two pit features half-sectioned during the excavation (1m scale)

Both pits were filled with a dark greyish brown sandy fill with numerous gravel fragments, although with no other finds.

It was interesting to note the layers the pits had cut through. The upper level was an orange brown sandy gravel – one of the spreads of beach gravel presumably used to build up the parade ground levels. Beneath this was a 0.07m thick layer of mortar containing brick fragments – probably indicative of a demolition debris layer. Beneath the brick and mortar layer was a fairly deep (>0.25m) layer of mixed grey sandy gravel (10YR 5/3).

As the pits cut through the brick and mortar demolition debris layer from the original brick building, they post-date its early 20th-century demolition, but a more closely defined date is not known.

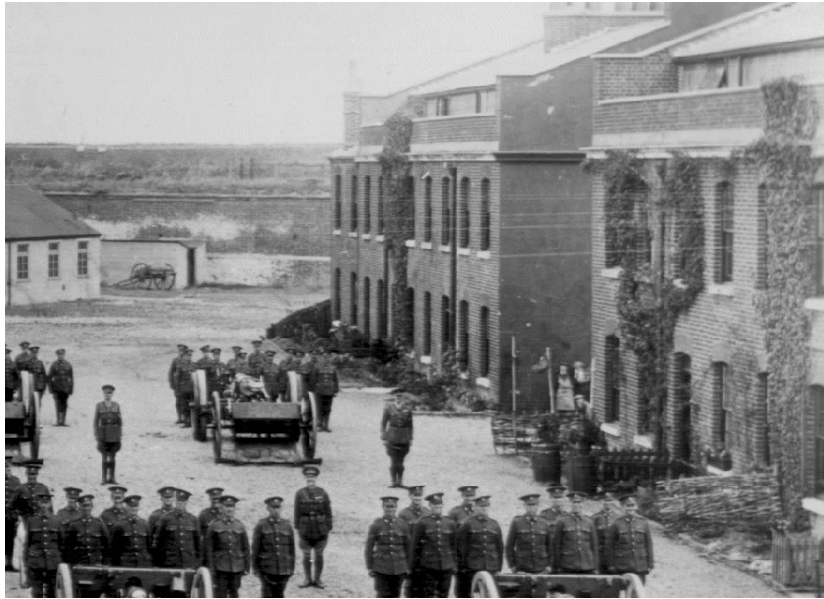
Figure 6 - Photograph showing the gardens in front of the Officers' Blocks
©Royal Marines Museum

The trench cut through various parade ground gravel make-up layers and buried surfaces, as well as some mixed garden soil layers and layers containing varying amounts of brick hardcore. The dark soil layers were presumably from the beds that were laid in front of the officers' blocks. Photographs taken early in the 20th century (c.1920) show the gardens in front of the houses bounded by picket and hurdle fences – see **figure 6**. The beds were subsequently grassed over, although by the early 1990s the present gravel beds in front of the houses had replaced the earlier lawns.
