Centre for Archaeology Report 117/2002

Tree-Ring Analysis of Timbers from 10-14 Churchgate, Hallaton, Leicestershire

R E Howard, Dr R R Laxton, and Dr C D Litton

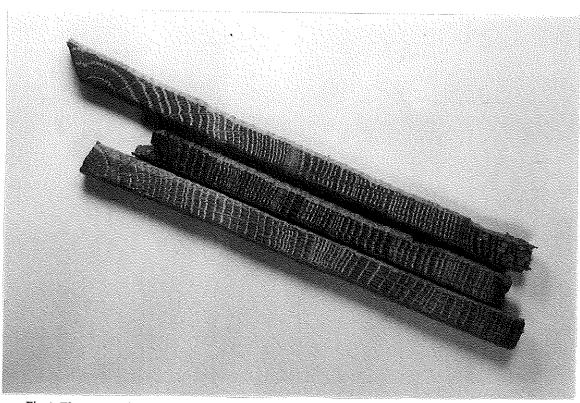
Fig 4. Three cores from timbers in a building. They come from trees growing at the same time. Notice that, although the sequences of widths look similar, they are not identical. This is typical.
