Centre for Archaeology Report 69/2002

Dendrochronological Analysis of Conifer Timbers from Danson House and Danson Stables, Bexley, Kent

Cathy Groves

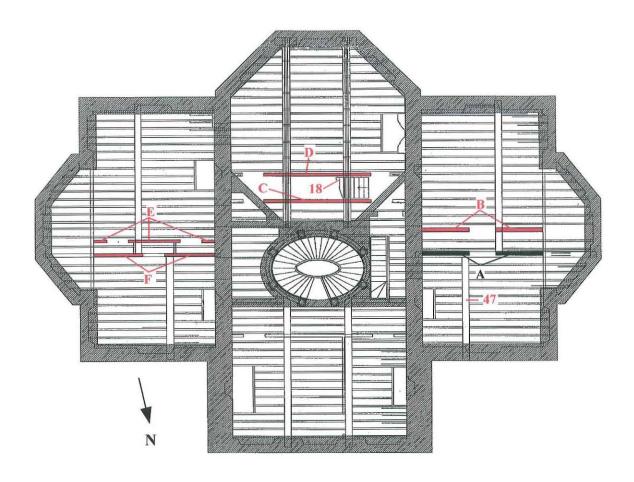
Figure 4: Plan of bedroom level floor (after Purcell, Miller, Tritton, and Partners 1994) showing the location of the partitions (C, D, E, and F) and the other sampled timbers. Dated timbers or partitions with dated elements are indicated in red

The sampling strategy for the house was adapted as necessary during the sampling visits to make allowances for areas that remained inaccessible. A series of 50 in situ timbers were selected, the locations of which are indicated in Figures 4-12 and Table 1. Sampling was concentrated at the bedroom level as the ceiling beams (attic-level floor), partition wall framing, and bay roofs were exposed and accessible. Of the three canted bays only the east bay roof was suitable for coring as the other bays contained modern replacement timbers. No timbers were exposed at the principal level, though it was possible to access one of the major ceiling beams from above where an area of floor boarding had been lifted. The only exposed timbers at ground level were replacement ceiling beams. The roof proved equally problematic as safe access was severely restricted and the scantling of many of the rafters was such that sampling using standard coring equipment could have affected structural integrity. In addition the small scantling meant that these timbers would generally contain fewer growth rings. It had been hoped that a whole series of samples could be obtained from the principal level floorboards, thought to be original to the building, as these had been lifted. However in view of these proving entirely sound, unlike some of their supporting beams, the decision to relay them precluded the possibility of removing even thin cross-sectional slices from their ends. A series of 19 cross-sectional slices were however removed from various ex situ timbers. Richard Lea was able to identify the likely function and location within the building for several of these timbers (Table 1).

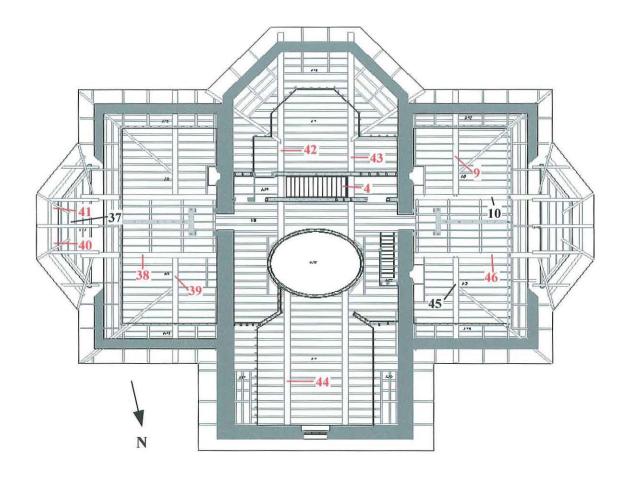
Figure 5: Plan of attic level floor (after Purcell, Miller, Tritton, and Partners 1994, Lea pers comm) showing the location of the sampled timbers. Dated timbers are indicated in **red**

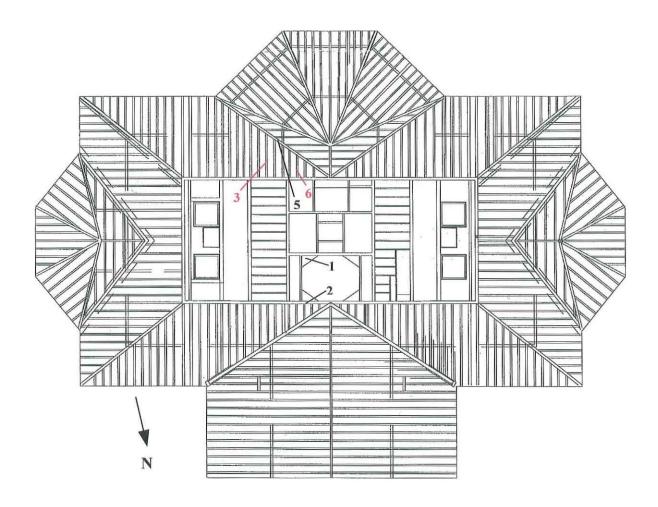
Figure 6: Plan of the roof (after Purcell, Miller, Tritton, and Partners 1994) showing the location of the sampled timbers. Dated timbers are indicated in red

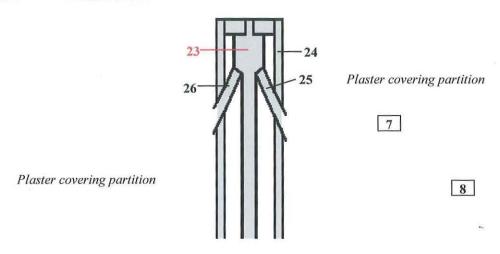
Figure 7: Schematic diagram of the north face of partition C on the bedroom level showing the location of the sampled timbers. Samples 7 and 8 were taken from the south face where some additional elements of partition C were exposed but the precise location of each element is not known. Dated timbers are indicated in red

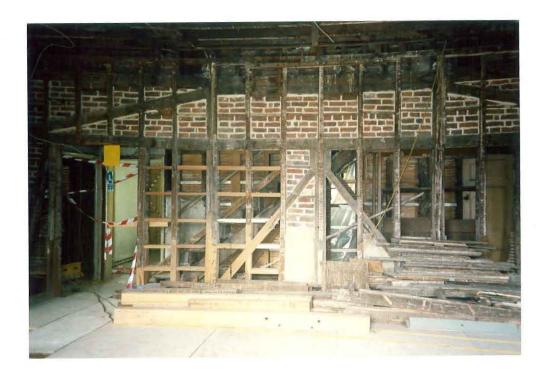
Figure 8: Photograph of south face of partition D on the bedroom level (C Groves)

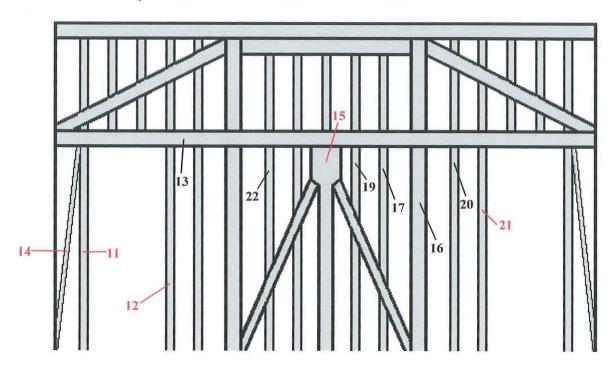
Figure 9: Schematic diagram of the south face of partition D on the bedroom level showing the location of the sampled timbers. Dated timbers are indicated in **red**

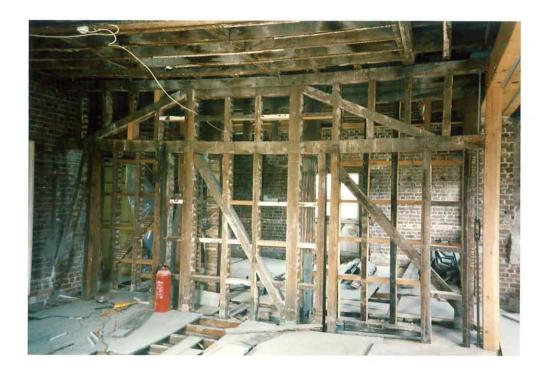
Figure 10: Photograph of south face of partition E, with partition F behind on the bedroom level (C Groves)

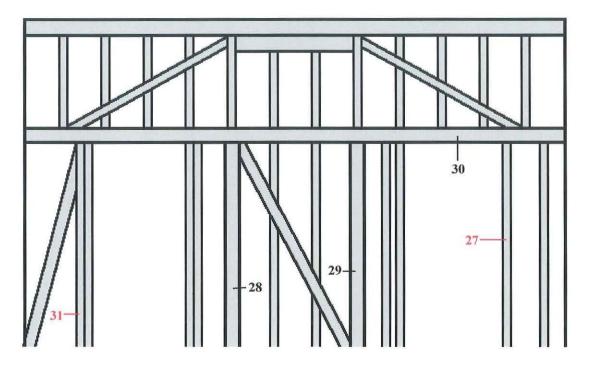
Figure 11: Schematic diagram the south face of partition E on the bedroom level showing the location of the sampled timbers. Dated timbers are indicated in red

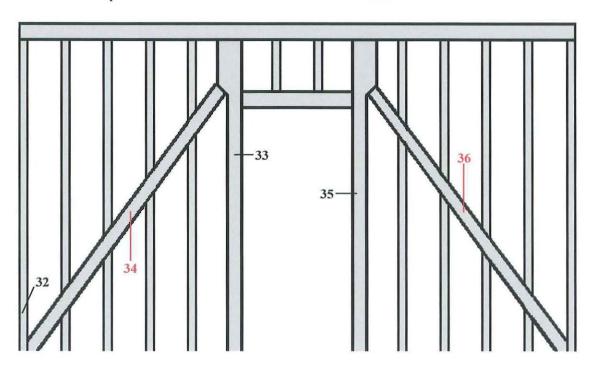
Figure 12: Schematic diagram of the north face of Partition F on the bedroom level showing the location of the sampled timbers. Dated timbers are indicated in red

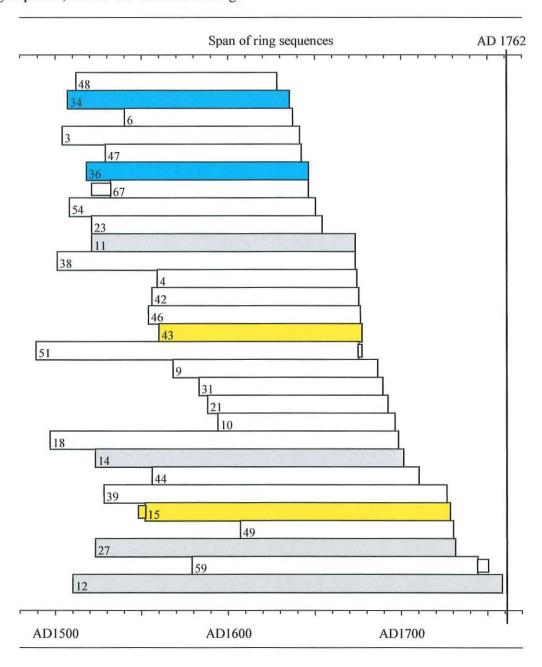
Figure 13: Bar diagram showing the relative positions of the matched ring sequences included in the site master chronology DANSON1. Possible same-tree groups are highlighted. Wide bar is measured ring sequence; narrow bar unmeasured rings

All 69 samples were suitable for measurement. The ring sequences of 29 samples crossmatched, including a number of possible 'same-tree' groups (Table 2; Fig 13). The 'same-tree' groups were combined to produce single-tree sequences before being incorporated into the 270-year site master chronology, Danson1 (Table 3), so as to ensure that the master chronology was not biased towards individual timbers or trees. The ring sequences of a further four timbers were found to match, including a possible 'same-tree' pair (Table 4; Fig 14). These were combined to produce a 223-year site master chronology, Danson2 (Table 5).

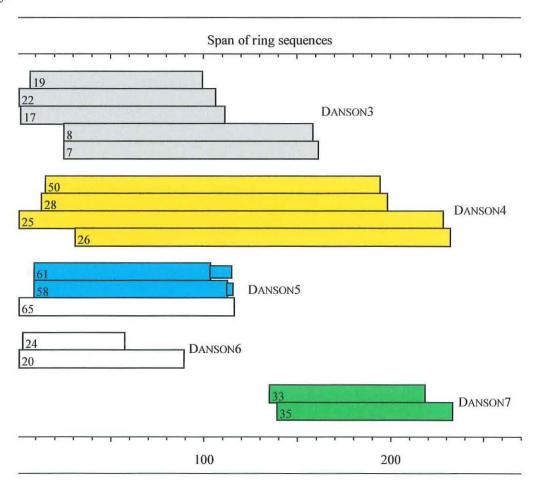
Figure 15: Bar diagram showing the relative positions of the matched ring sequences included in the site master chronologies DANSON3-DANSON7. Possible same-tree groups are highlighted. Note there is <u>no</u> matching between the groups. Wide bar is measured ring sequence; narrow bar unmeasured rings

A further 16 samples formed five groups of matching ring sequences, some of which included possible same-tree pairs or groups (Fig 15; Tables 6-10). Each group of matched samples was combined to produce a site master chronology, DANSON3 – DANSON7 (Tables 11-15).

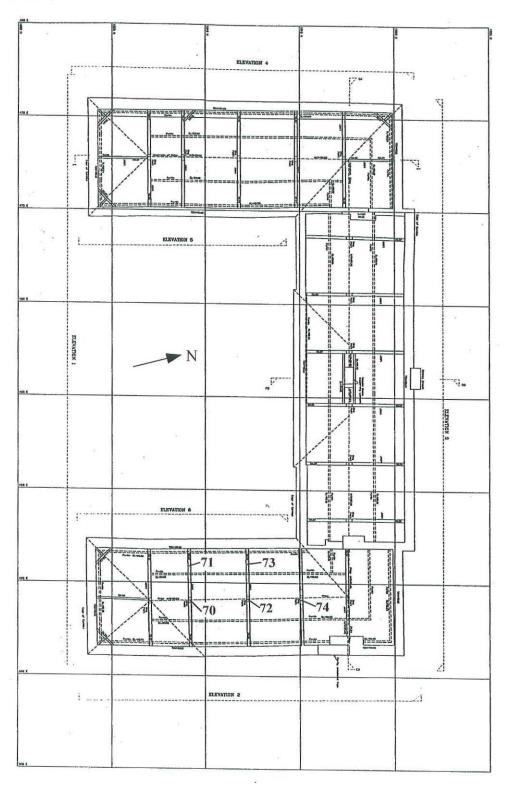
Figure 16: Plan of Danson Stables loft showing the location of the sampled timbers (after ELS Land Consultants 1994)

The five most promising timbers in the east range were selected and sampled (Fig 16; Table 1). All others clearly contained too few rings for dating purposes. The samples were identified as above as likely to be *Pinus sylvestris* L.. Prior to measurement two of the cores were also rejected as they contained less than the acceptable minimum number of rings. No matches were found between the three measured ring sequences so all were compared to DANSON1, DANSON2, and the undated material from Danson House. Neither this nor their comparison to the available European and North American reference chronologies produced any consistent results. Thus no timbers from Danson Stables have been successfully dated.

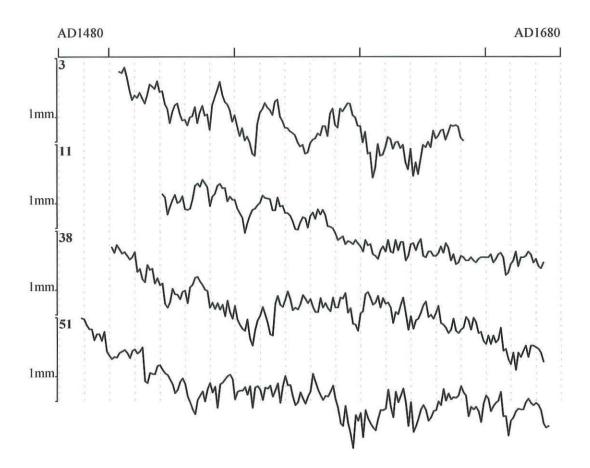
Figure 17: Diagram showing the ring sequences from four dated samples

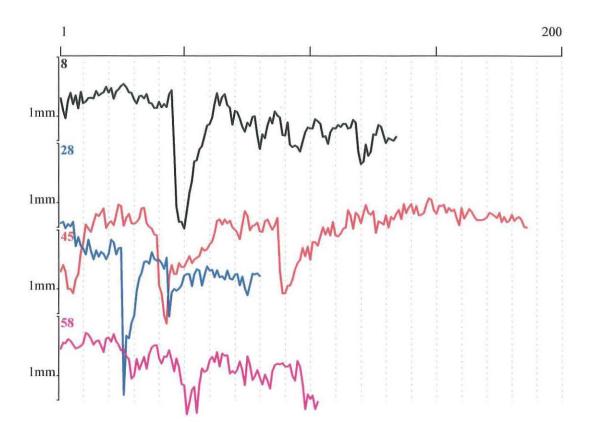
Figure 18: Diagram showing the ring sequences from four undated samples showing severe growth retardation events. Note there is <u>no</u> matching between the ring sequences shown

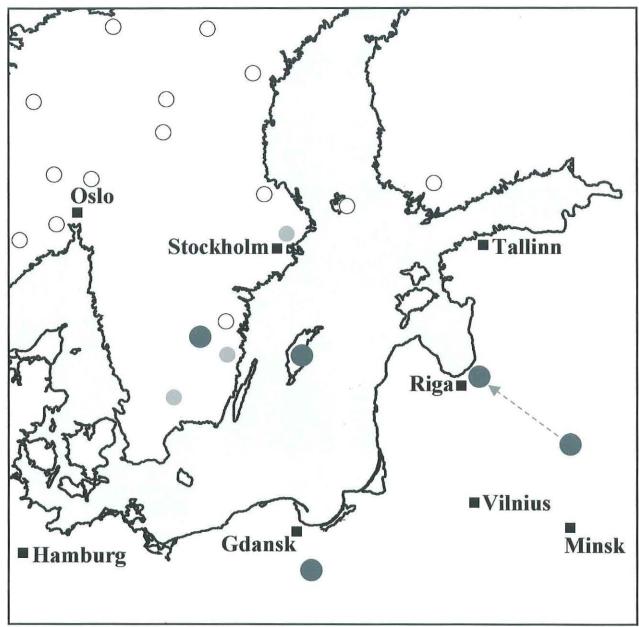
Figure 19: Geographical location of the reference chronologies with which DANSON2 matches indicating approximate source of the timbers used in the raising of the bays

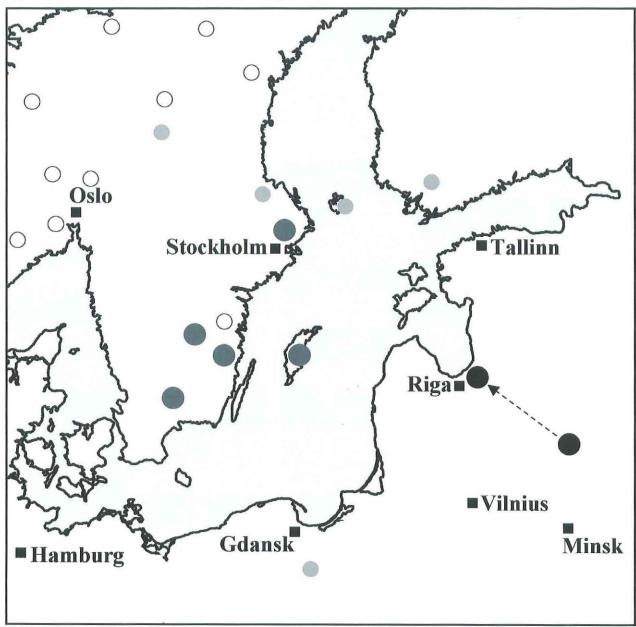
Figure 20: Geographical location of the reference chronologies with which DANSON1 matches indicating approximate source of the timbers used in the primary construction phase

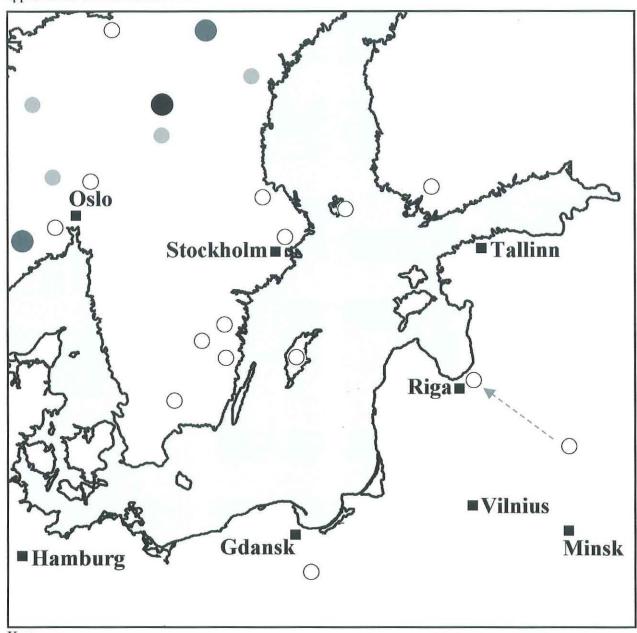
Figure 21: Geographical location of the reference chronologies with which **55** matches indicating approximate source of the roofboard

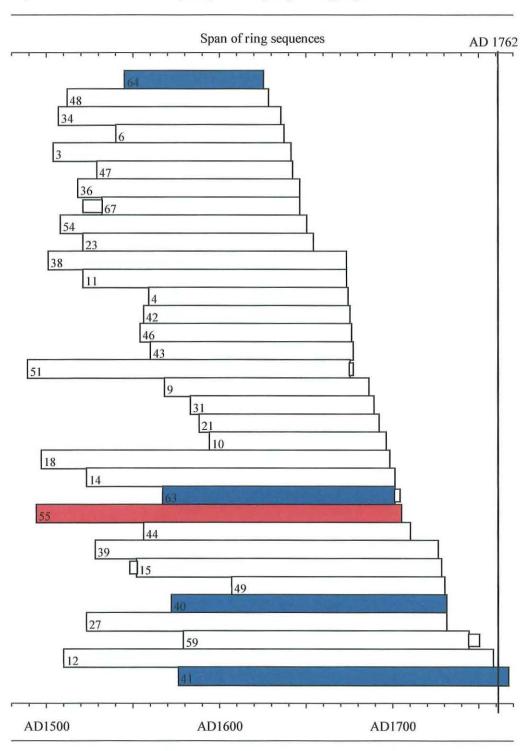
Figure 22: Bar diagram showing the relative positions of all dated ring sequences sorted by end date. The components of and DANSON2 (blue) and 55 (red) are highlighted

The wide range of dates of the outermost rings is quite wide spanning over 125 years (Fig 22). However this can perhaps be expected as these pines are generally long lived and the growth trend in pines is much more marked with the growth rate slowing down significantly. The majority of the average ring widths vary between 0.6–1.3 mm, though the growth trend means that the outermost rings are frequently narrower than this. Documentary evidence suggests that the timbers undergo initial conversion at the export point with planks, boards, and baulks being referred to in documentary sources. Planks and boards may well be used as they are but baulks could be either used whole as major structural timbers or converted into timbers suitable for lesser structural elements such as partitioning. The trimming of 50mm would result in the loss of at least 45-85 rings and if is perfectly feasible that the smaller structural elements may represent only the inner or outer sections of a larger baulk.

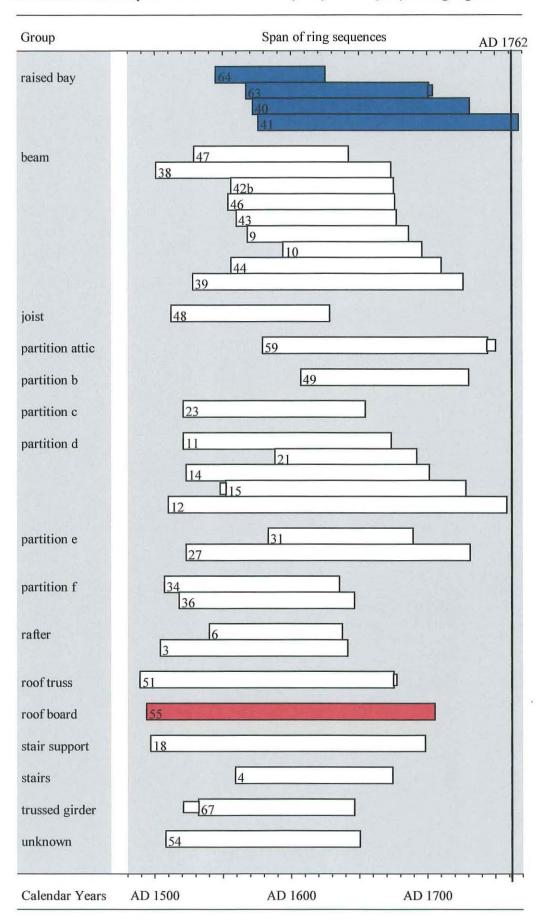
Figure 23: Bar diagram showing the relative positions of all dated ring sequences sorted by function or location. The components of and DANSON2 (blue) and 55 (red) are highlighted
