Centre for Archaeology Report 39/2004

Kenilworth Castle Gallery Tower evaluation 2004  
Archive Summary Report

An evaluation trench was excavated at the Gallery Tower to assess the nature of deposits in advance of proposals to place a new building on the site. This report outlines the results.

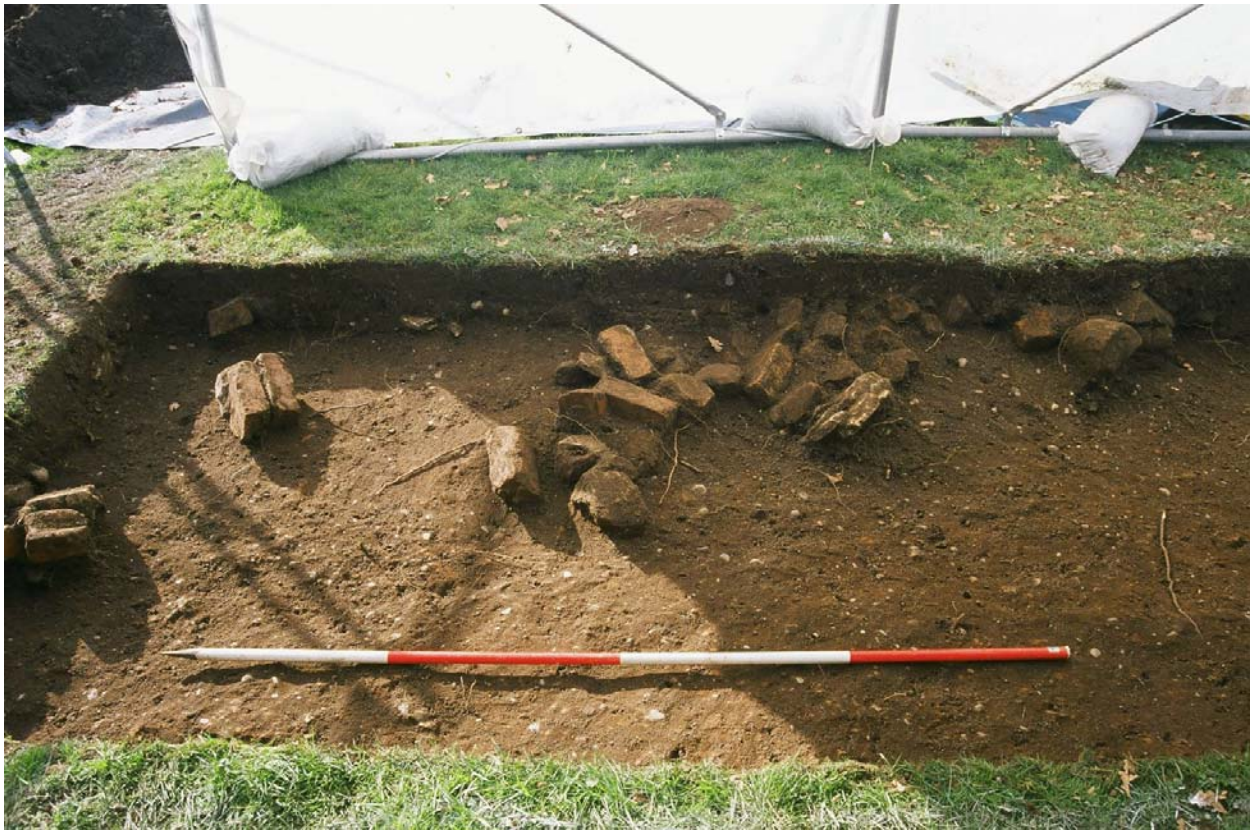
Fig 3a. Photo of brick rubble [0003]. 2-metre scale.

Excavation began with the removal of layer [0002], a dark brown topsoil containing a mix of tile fragments, pottery fragments, and modern artefacts such as lipstick and ice-cream wrappers. The sole fragment of clay pipe-stem came from this layer. The topsoil was approximately 0.25m thick over the whole trench, and was extensively disturbed by burrowing animals. Below this at the southern end of the trench was layer [0003], a spread of frogged bricks and mortar-covered sandstone fragments corresponding to the area of “stones” indicated in the geophysical survey (see fig 3).

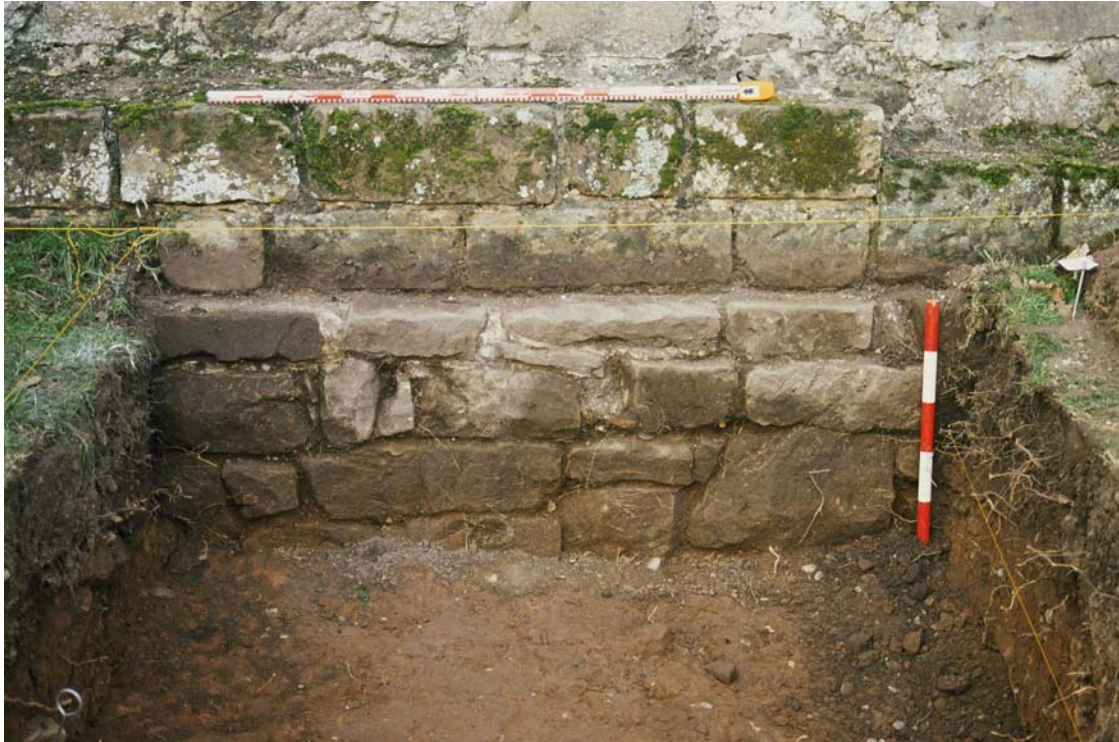
Fig 4. Stepped-out wall footings. 1-metre horizontal scale and 0.5-metre vertical scale.

Against the wall the turf was peeled off to reveal that the wall footings stepped out a distance of 0.10m at a depth of less than 0.05m below ground surface (see fig. 4). This stepped-out course can be seen at either end of the wall where the 1960s clearance has exposed the wall to a further 0.50m. Below the topsoil [0002] was a shallow linear cut feature [0005] filled by a brown soil [0006] (see fig. 5). This cut was 0.60m wide and 0.08m deep, running parallel to the wall, and was interpreted as the base of a narrow trench dug to expose the wall for consolidation. Its edges were sharp and the base of the cut was flat, suggesting careful excavation. Below [0005] was another brown silty deposit [0008] in cut [0009] that again represented some form of linear feature against the wall. It was 0.25m wide, and again was shallow at only 0.08m deep, but was probably truncated when [0005] was dug. Its edges were irregular and not as well defined as [0005], and considerable tree-root disturbance within the feature probably accounts for this.

The inner face of the wall consists of a coursed roughly-squared red sandstone rubble core exposed across most of the wall with fine ashlar facing blocks surviving above the foundation “step” at 82.09mOD (see fig. 4) to the wall’s full height at the north end and on the lower two courses across the rest of the elevation. Below the foundation “step” the wall consists of roughly coursed roughly-squared red sandstone blocks. The ashlar and corework are pointed in a hard whitish mortar with some patches of pinkish mortar representing several episodes of consolidation. The top two foundation courses below the step are also pointed in whitish mortar, but below them the stones sit in a silty soil matrix reminiscent of clay bonding. The outer face of the wall (see fig. 8) similarly retains only part of its ashlar facing and has three horizontal “steps” near the base set one course apart projecting out by approximately 0.10m each. The middle step corresponds in height to the internal step exposed by the excavation, with heights ranging from 81.92 to 82.00mOD along its length. The wall contains little in the way of diagnostic features, and is of a general “late medieval” construction, but the surviving outside corner incorporates at its base a fine fluted block that appears to be reused from a richly moulded column or vault rib. This may be salvaged from the nearby abbey after its dissolution giving the tower wall a mid-16<sup>th</sup> century date or later. However, it could also come from improvements within the castle, potentially allowing an earlier date for its incorporation here.

The step in the wall, and the change in construction below it, suggest that the intended occupation surface of the tower was most likely at present turf level (around 82.20mOD) or higher. The rough stonework below the step was not intended to be seen, so either it was buried during construction or was hidden by a floor structure for which there is no evidence. No evidence was found for internal cross-walls, suggesting that the Gallery Tower was either floored and roofed with single large spans or that it might have actually been an open courtyard space with an earthen or paved floor. However it is also possible that any such evidence lies below the unexcavated portions of layer [0004].

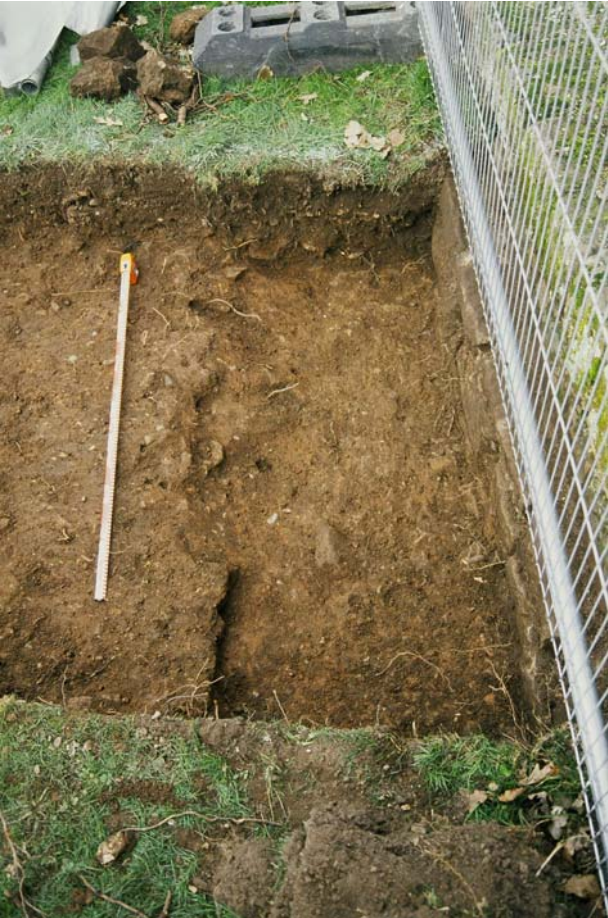
Fig 5. Context 0005. 0.5-metre scale.

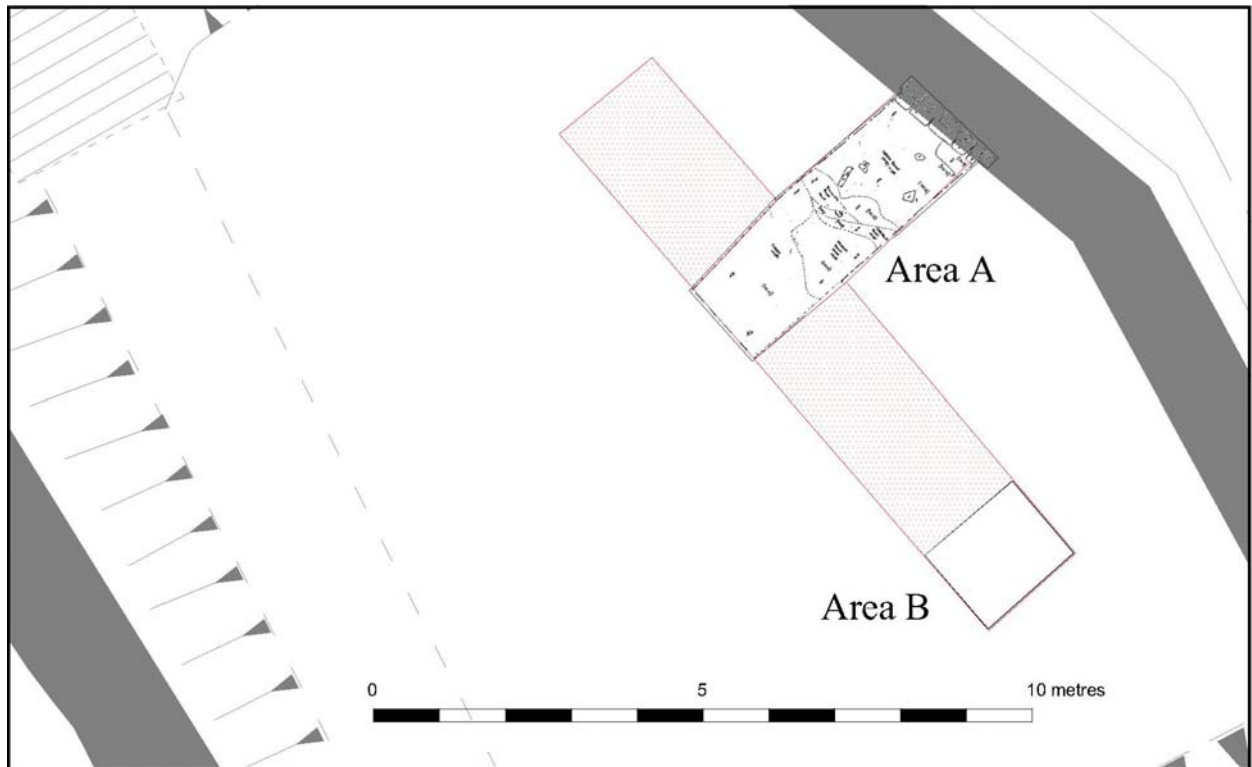
Fig 6. Location of Areas A & B within trench. Note that context 0011 extended beyond the trench in all directions at the base of Area B, unlike Area A (see fig 7).

All of these features and topsoil overlaid context [0004], a flat layer of reddish sandy loam that covered the whole trench right up to the wall footings. This deposit was excavated in two places (Area A and Area B on fig. 6) with the aims of gathering dating evidence and identifying its thickness. Area A was defined by the “side extension” which was then projected across the main trench to form a roughly 4m by 2m area that would test the deposit’s relationship with the wall fabric. Area B was a 1.5m stretch at the southern end of the trench. In both cases the reddish sandy loam was approximately 0.30m thick, and contained numerous pebbles and sandstone fragments. Tile fragments and some pot fragments were recovered which provided a probable late 17<sup>th</sup> century date for the context. Clay pipes were conspicuously absent from the deposit. Lenses of material with slightly different amounts of pebbles or sandstone fragments were recognised within the deposit, but as these generally could not be resolved to discreet features with defined edges they were interpreted as separate loads within the deposit.

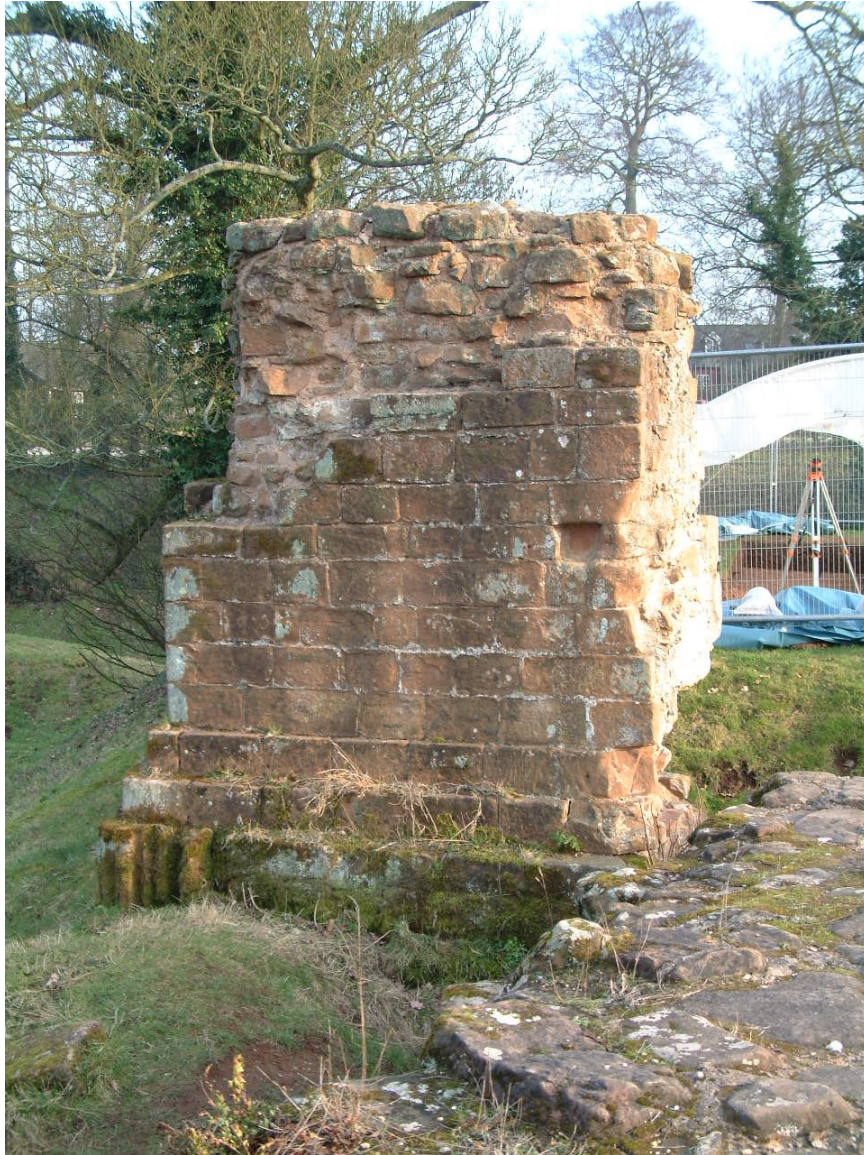
Fig 8. Exterior of Gallery Tower wall showing steps in foundation, as well as fluted block.
