Centre for Archaeology Report 41/2005

**Further Tree-Ring Analysis of Timbers from the Chapter
House, Worcester Cathedral, Worcester**

A J Arnold, R E Howard and C D Litton

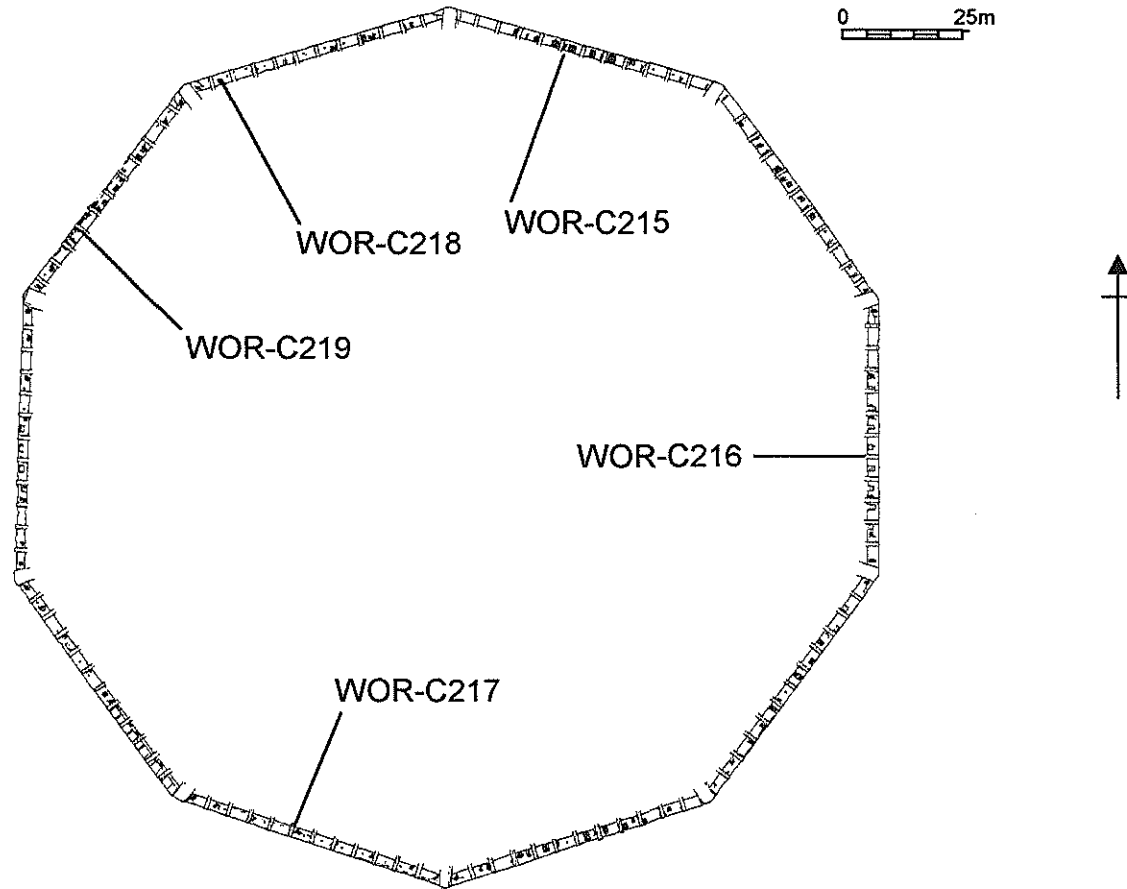
Figure 2: Worcester Cathedral, the high-roof of the Chapter House, showing the location of samples WOR-C215–9 (Christopher Guy)

Five core samples were taken from wall plates still *in situ* within this roof. The cores were taken using a 15mm diameter corer attached to an electric drill. Each sample was given the code WOR-C (for Worcester Cathedral) and numbered 215–9. In addition, a further five sliced samples were taken, using a chainsaw, from wall plates which had been removed from the building. These have been numbered WOR-C220–4. The position of samples WOR-C215–9 was noted at the time of sampling and has been marked on Figure 2. Unfortunately, at the time the sliced samples were taken the timbers had already been removed from the roof and it is not known exactly where these timbers were from within the roof. Further details relating to the samples can be found in Table 1.

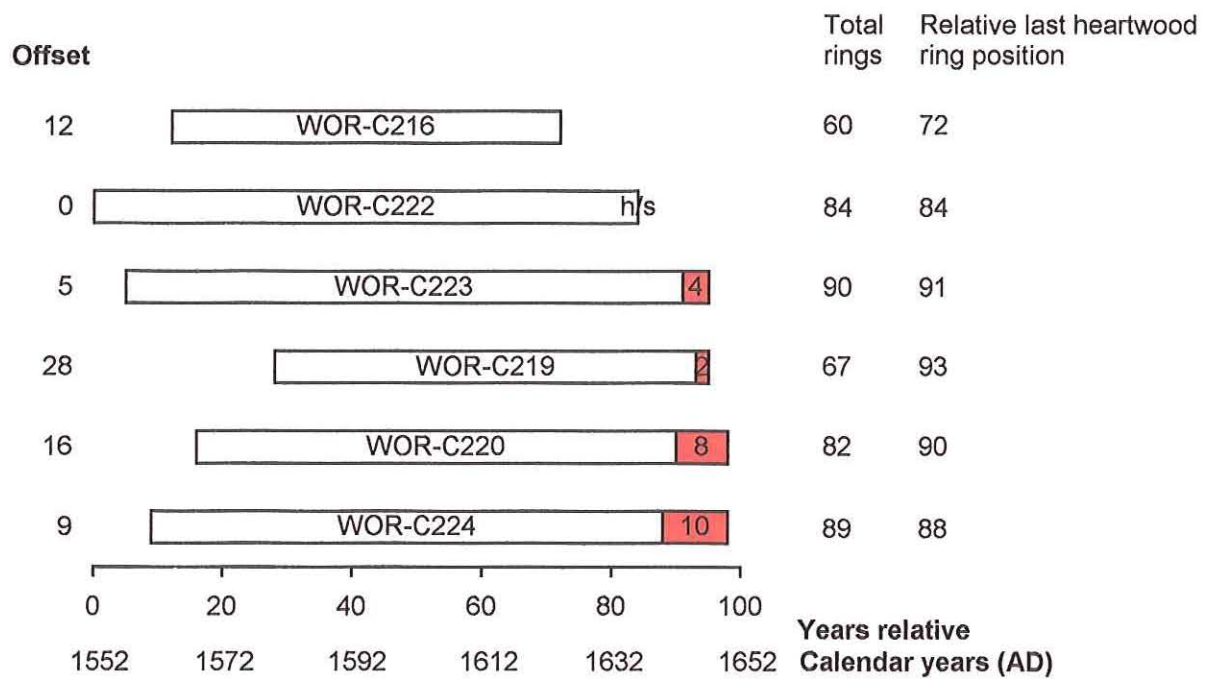
Figure 3: Bar diagram of samples in site sequence WORCSQ06

At a value of $t=4.5$, all ten samples had matched forming two groups. Firstly, six samples matched each other and were combined at the relevant offset positions to form WORCSQ06, a site sequence of 98 rings (Fig 3). This site sequence was then compared with a large number of relevant reference chronologies for oak indicating a consistent match when the date of its first ring is AD 1552 and of its last measured ring is AD 1649. The evidence for this dating is given by the t -values in Table 2.

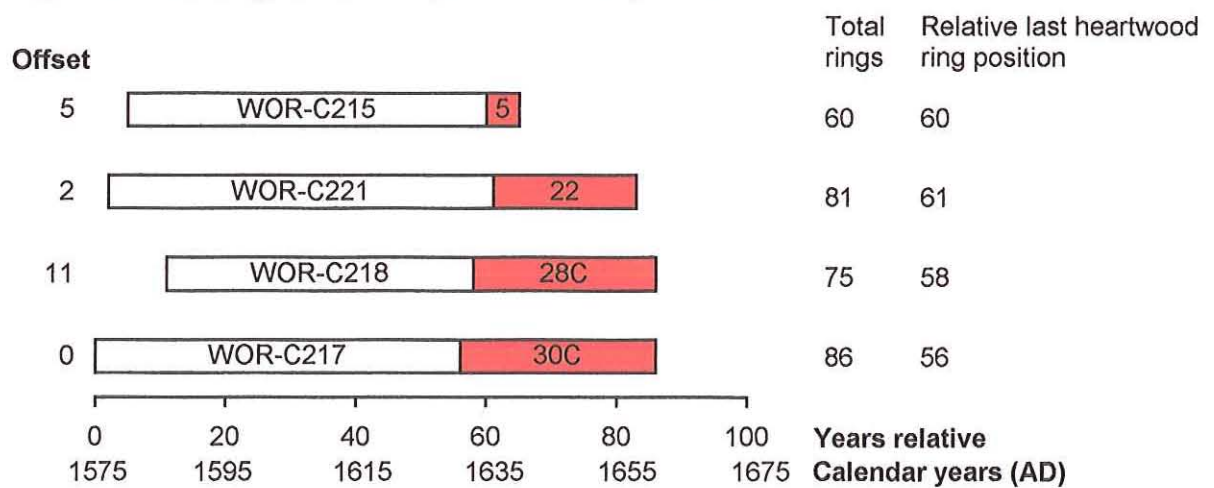
Figure 4: Bar diagram of samples in site sequence WORCSQ07

Four samples matched each other and were combined at the relevant offset positions to form WORCSQ07, a site sequence of 86 rings (Fig 4). This site sequence was then compared with the reference chronologies where it was found to match consistently at a first-ring date of AD 1575 and a last-ring date of AD 1660. The evidence for this dating is given by the t -values in Table 3.

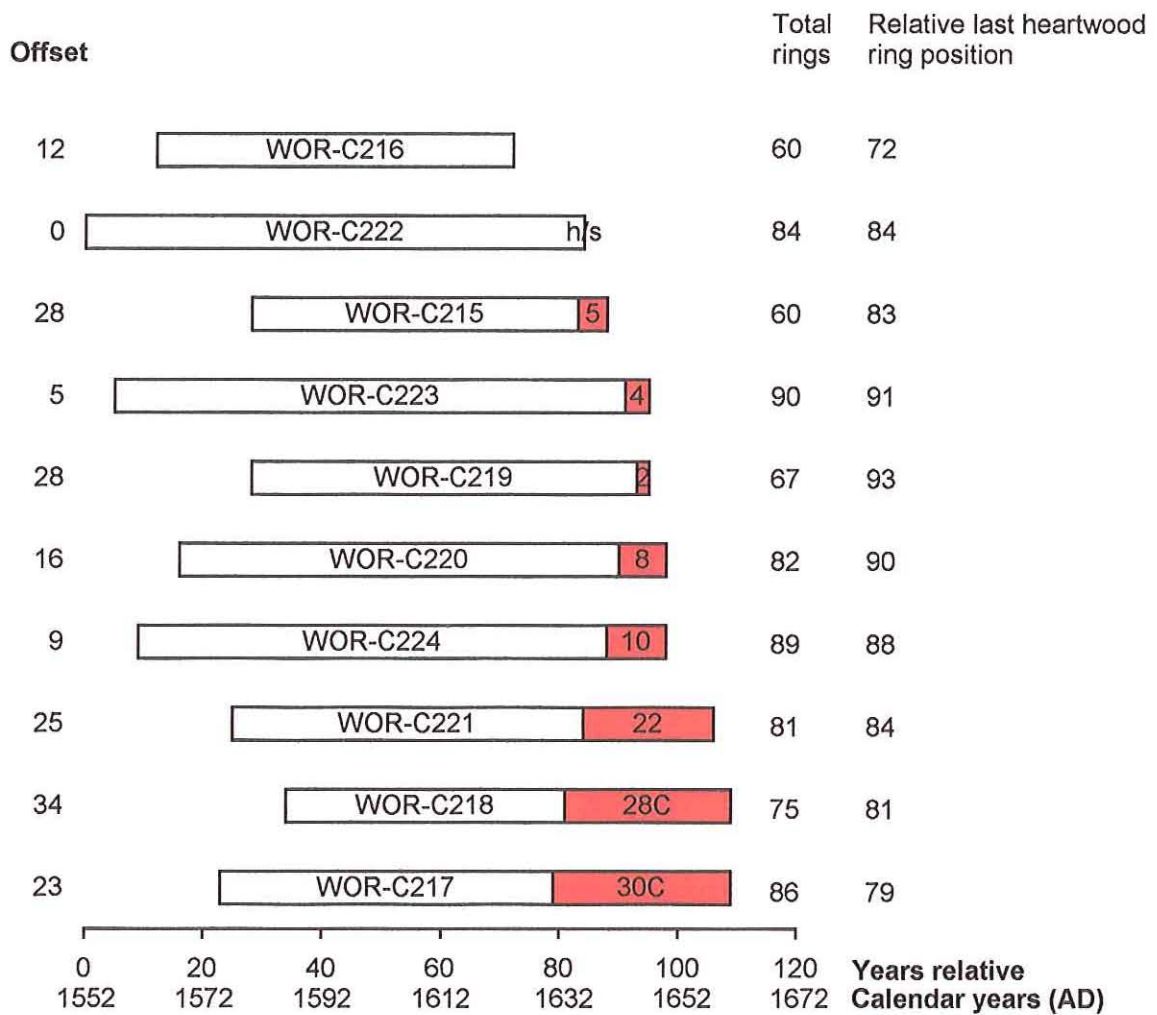
Figure 5: Bar diagram of samples in site sequence WORCSQ08

These two site sequences match each other at the expected offset position at a value of $t=4.2$. Therefore, a third site sequence of 109 rings, WORCSQ08, was then constructed containing all ten samples (Fig 5). This site sequence was again compared with the reference material, where it was found to match

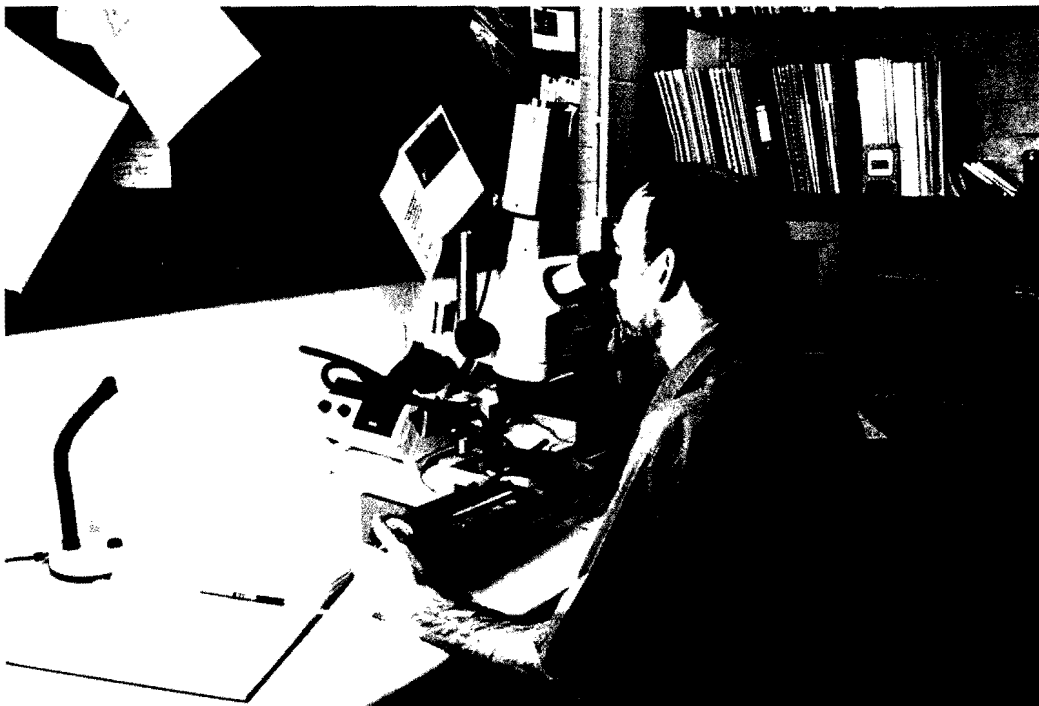
Fig. 3 Measuring ring widths under a microscope. The microscope is fixed while the sample is on a moving platform. The total sequence of widths is measure twice to ensure that an error has not been made. This type of apparatus is needed to process a large number of samples on a regular basis.

2. **Measuring Ring Widths.** Each core is sanded down with a belt sander using medium-grit paper and then finished by hand with flourgrade-grit paper. The rings are then clearly visible and differentiated from each other with a result very much like that shown in Figure 2. The core is then mounted on a movable table below a microscope and the ring-widths measured individually from the innermost ring to the outermost. The widths are automatically recorded in a computer file as they are measured (see Fig 3).
