Centre for Archaeology Report 55/2005

**Tree-Ring Analysis of Timbers from Wolfeton Riding  
House, Wolfeton House, Charminster, Dorset**

Dr Martin Bridge

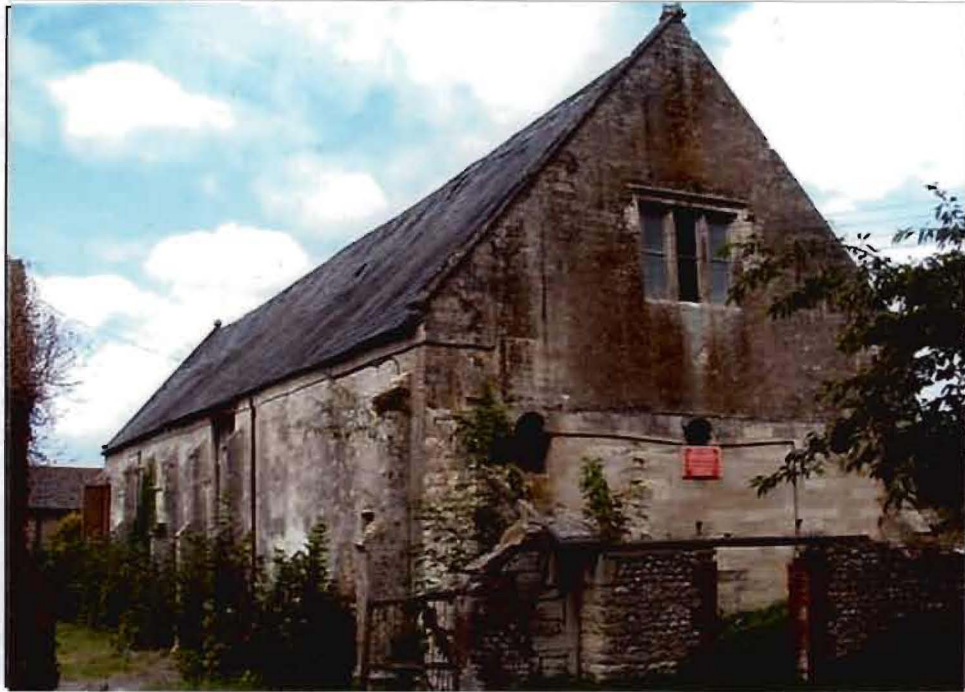
The Riding House (NGR SY 6785 9225; Fig 1) is situated a little more than 100 metres north of Wolfeton House, near the village of Charminster. It is described in detail in a report by Rodwell (1986) from which the following brief notes have been taken. The rectangular stone-built property (Fig 2) is approximately 33.5m by 9.1m, and originally had two ranges projecting at right angles to the north wall. Although latterly used as a barn, the Royal Commission on the Historical Monuments of England (1970) recognised it as having been built as a riding house. The first documented purpose-built riding house in England was erected for Prince Henry at St James' Palace in AD 1607–9, and other examples followed in the early seventeenth century. Wolfeton Riding House is rather narrower than most known examples, and it had a ceiling, where most examples were open to the roof. As a building, Rodwell suggests that its closest parallel is with the 'hospice' at Ansty, Wiltshire, on the Wardour Castle Estate, which is almost identical in size, and very similar in layout. That building is thought to have been built shortly after AD 1594. Other similarities with a riding house at Lulworth Castle, Dorset, built between c AD 1588 and c AD 1610, suggest a date for the Wolfeton riding house around AD 1600, but Rodwell (1991) thought it unlikely to predate the example at St James' Palace.

**Figure 2:** Exterior view of the Riding House from the south east, looking north west

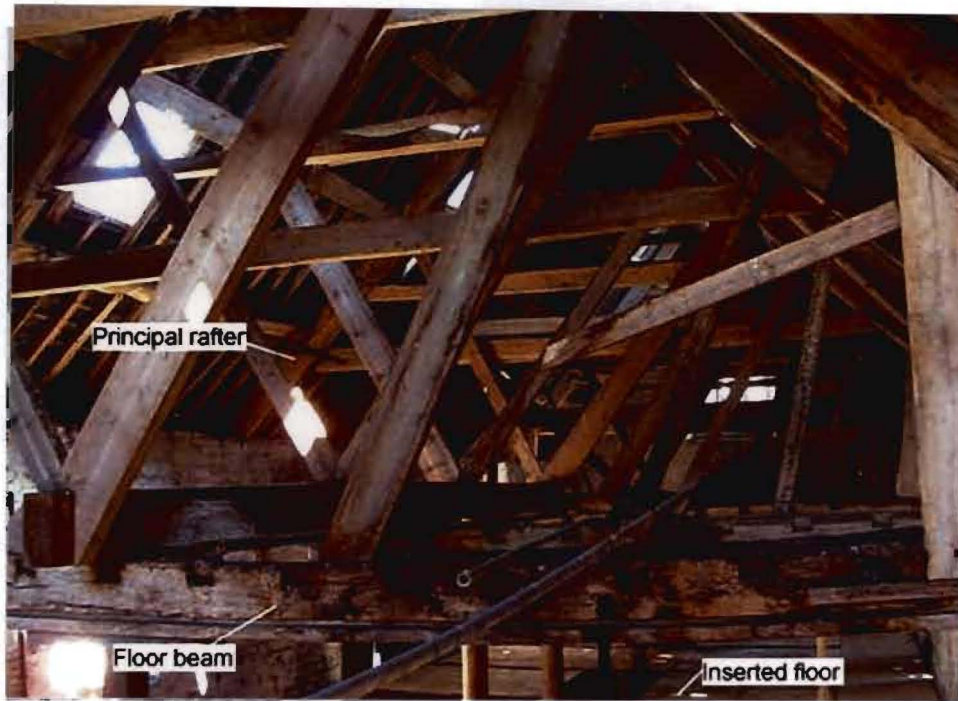
The interior (Fig 3) has an extant inserted floor of coniferous wood construction, now somewhat unsafe in some areas, but providing a good platform for access to the older timbers in many areas. Eight large floor beams, 0.3m square, of which the second from the west end now remains only as a stump in the north wall, are set nearly 1m below wallplate level. Each of these supported 21 ceiling joists, represented by mortices in the east underside of each beam. On the west side a continuous pulley mortice enabled the joists to be inserted after the beams had been set in position. The upper edges of these beams bear mortices for 17 attic floor joists. Holes for the joists in the south wall indicate that at least some of the joists were inserted before the wall was built around them.

**Figure 3:** Internal view of the Riding House, looking towards the east end

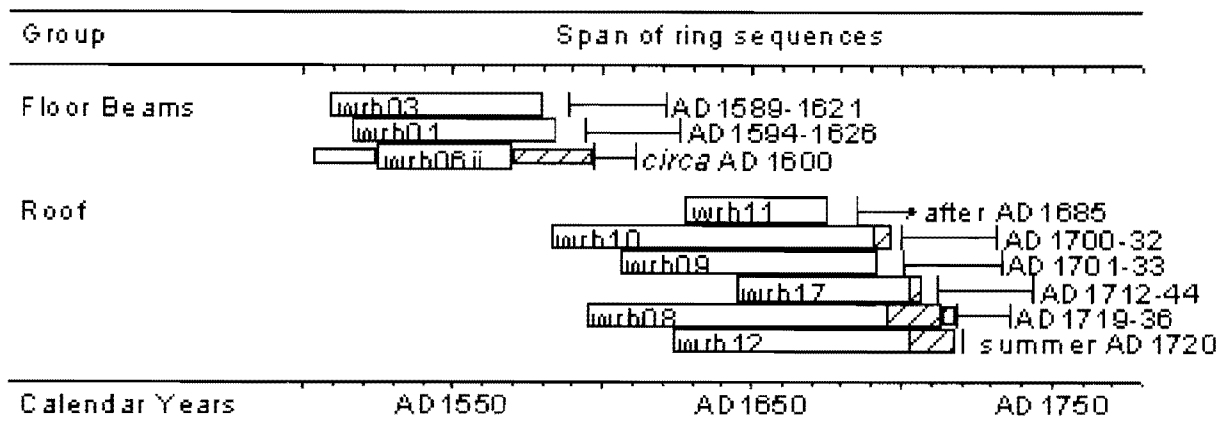
Three series from the original floor beams cross-matched (Table 2) and these were combined to make a 77-year site chronology, **WOLFETN1**. This was subsequently dated to the period AD 1509–85, the evidence being presented in Table 3. The relative positions of overlap of the dated timbers are shown in Figure 6.

Six roof timbers were found to cross-match (Table 4) and these were combined to produce a second site chronology of 137 years, **WOLFETN2**. This was dated to the period AD 1583–1719 by comparison with the reference chronologies, the best results being shown in Table 5. The relative positions of overlap of the dated timbers in this chronology are also illustrated in Figure 6.

**Figure 6:** Bar diagram showing the relative positions of overlap of the dated timbers in chronologies **WOLFETN1** and **WOLFETN2**, along with their interpreted felling dates. Narrow bars represent unmeasured sections of the cores, and hatched areas represent sapwood rings

The three dated timbers from the group of original floor beams appear to represent a group of timbers likely to have been felled at around the same time. Adding the appropriate sapwood estimate to the mean heartwood-sapwood boundary date (AD 1576) gives a likely felling date range for these timbers of AD 1585–1617. The section of sapwood from beam 7 (WRH06) which retained the outermost rings, but may have lost a few of the earliest sapwood rings, allows the felling of this timber to be placed within the few years after AD 1597, probably around AD 1600, and most likely before AD 1607, the date of the earliest previously dated riding house at St James' Palace. It is very inadvisable to date a whole phase on the basis of a single timber, which may have been stock-piled prior to use, but this does suggest that a date in the first decade of the seventeenth century is likely. With so few timbers from this phase available, and with only one retaining complete sapwood, it is not possible to confirm this early date dendrochronologically.

Six of the timbers from elsewhere in the roof did date. One timber retained complete sapwood, allowing its felling date to be determined as summer AD 1720. Other timbers have felling date range estimates that incorporate this date, and it seems highly probable that all the timbers were felled in this year, or within a very few years either side of it. This makes the likely construction date of the present roof AD 1720, or within one or two years after this date, post-dating the initial construction of the riding house by just over a century. The only way to confirm this date would be to sample more timbers with complete sapwood, and this may be possible if access were made possible to higher areas than could be safely sampled from a ladder.
